Building and Timber Pest Inspection Report

Inspection Date: Thu, 26 Mar 2026

Property Address: 102 Old Ropeley Rd, Lower Tenthill QLD
4343, Australia

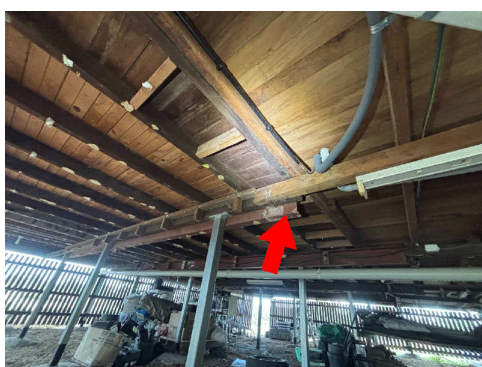
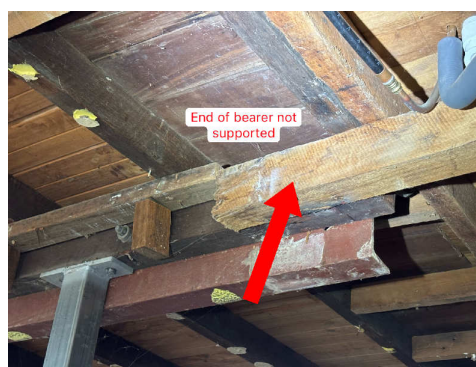
Finding 3.01

Finding: Subfloor - timber bearer end not supported

Information: At the time of the inspection, it was noted that a timber bearer under the family bathroom was not supported at one end. This timber bearer supports 4 timber floor joists under the family bathroom floor.

It is recommended that a support is welded to the steel beam beneath the timber bearer in order to support the timber bearer and prevent future issues.

A licensed builder should be engaged to carry out this repair. This should be done as a short term priority.

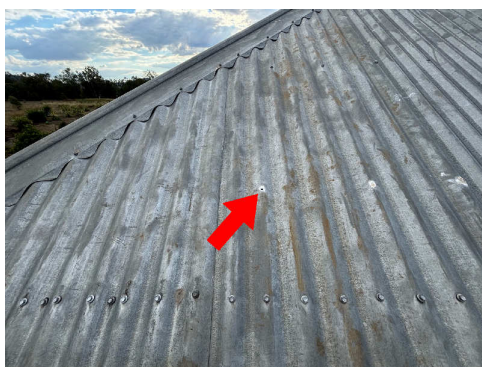
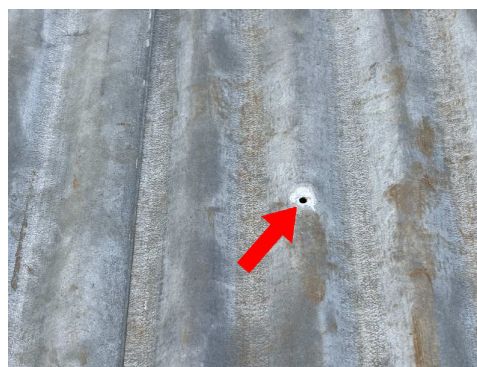
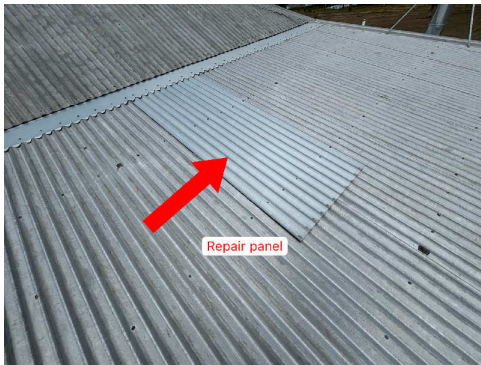
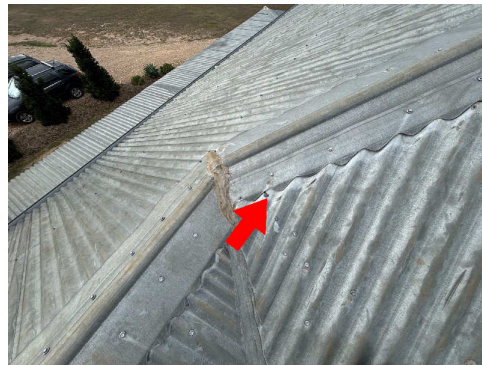
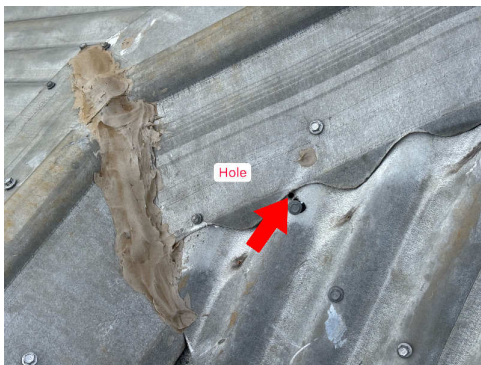
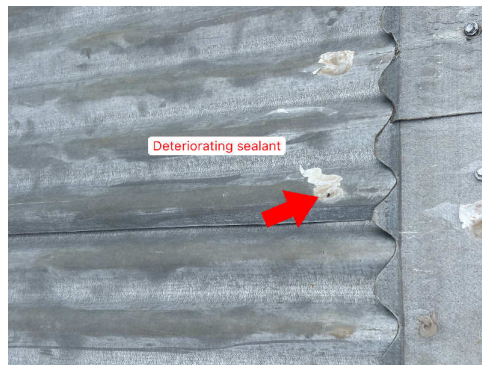
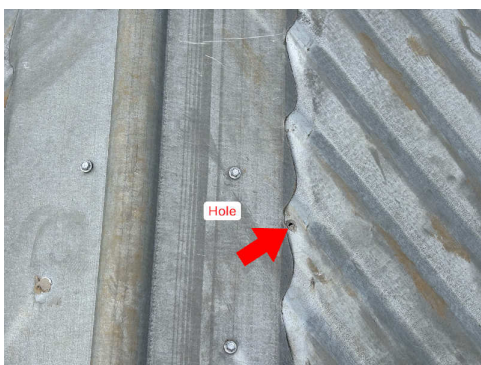
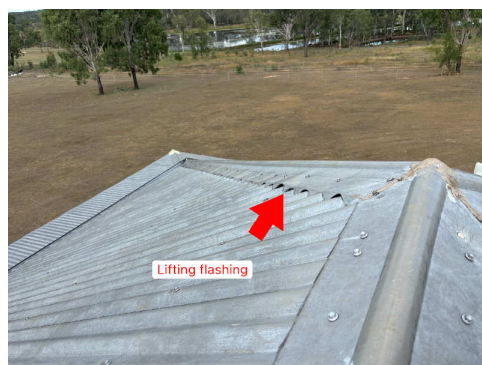
Finding 3.02

Finding: Metal roof covering - Weathered

Information: Upon inspection of the exterior roofing, the majority of the metal roof sheets were considered to be in a fair condition. While weathering of the metal roof sheets is consistent with the age of the property, maintenance works are required.

Several exposed fastener holes were found on the metal roof covering. Sealant applied to these holes has deteriorated. During a house move, roof sheeting may not go back in the original location leading to fastener holes that need to be sealed. A repair panel was found on the rear skillion roof, the reason for the repair panel could not be determine. Best practise would require the two affected roof sheets to be replaced in full rather than repaired in this manner. A section of ridge cap flashing at the front of the dwelling is lifting and may require additional fasteners.

Where left unmanaged, deteriorating metal roof sheets are likely to lead to a number of secondary defects, including minor water leaks and weather exposure to internal roofing structures.

Consultation with a roofing contractor is highly advised to gain advice on cost of remedial works that may be required in the short to medium term. Remedial works are likely to increase the longevity of the exterior roofing structure.

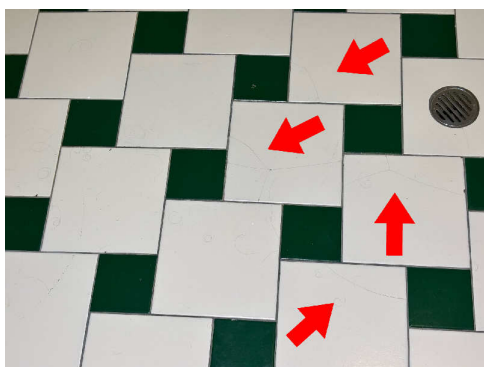
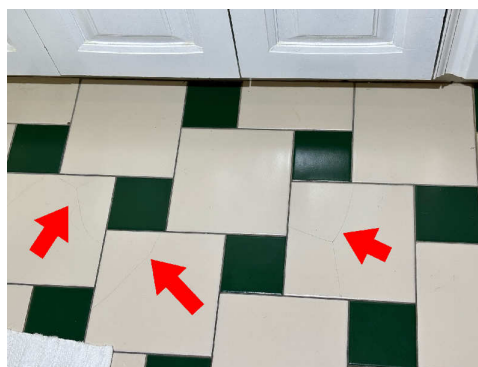
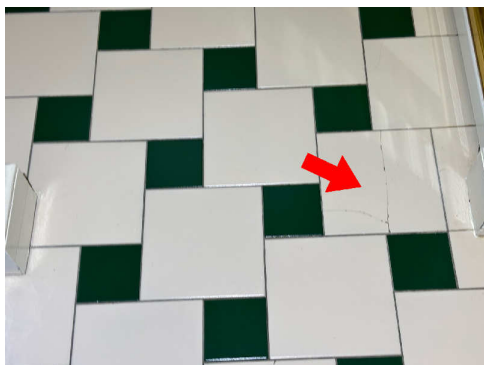
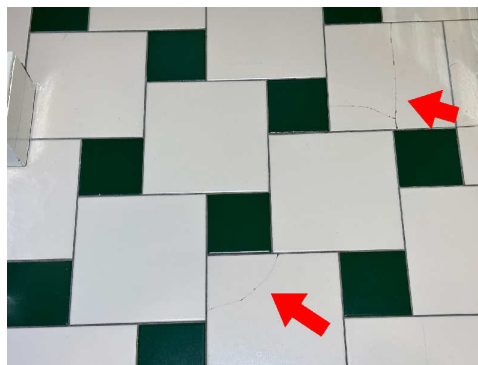
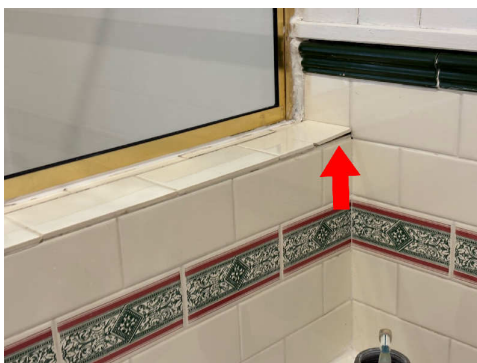
Finding 3.03

Finding: Family bathroom - cracked and loose tiles

Information: At the time of the inspection, it was noted that there were several cracked tiles on the family bathroom floor. Loose tiles were found on the shower nib wall. This may be due to the age of the materials, suspended timber floor and the dwelling being moved to its current location. These can be seen as aesthetic issues.

The client may wish to consider having the bathroom replaced as a long term solution to these issues. A bathroom specialist could be engaged to carry out this work. This can be done at the clients discretion.

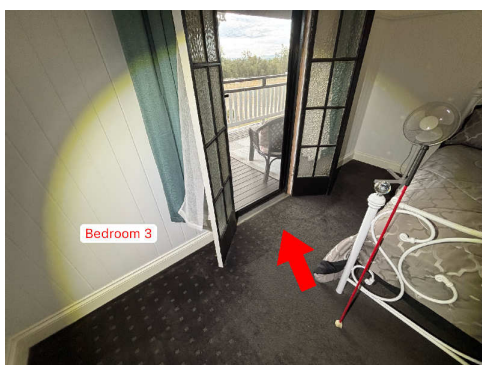
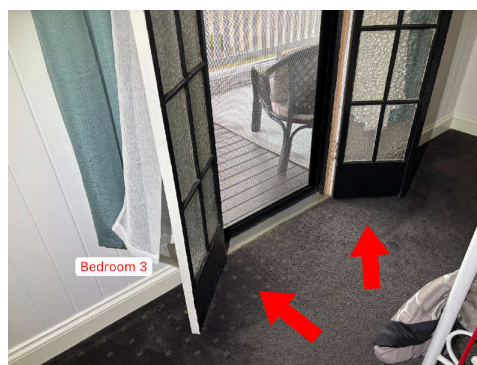
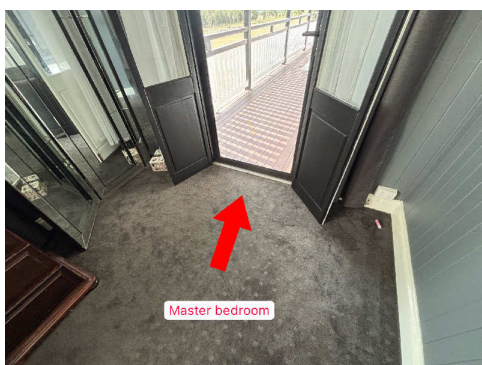
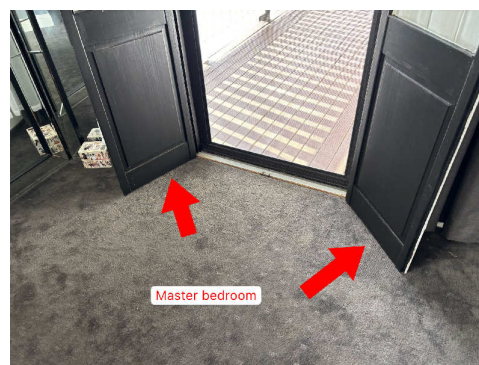
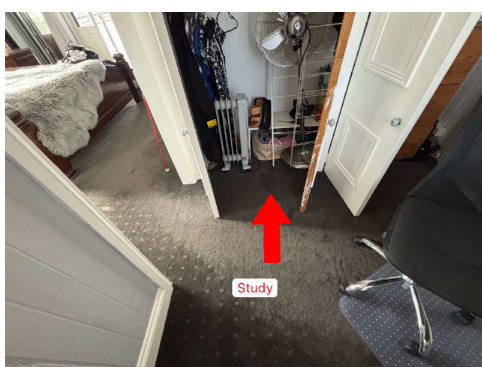
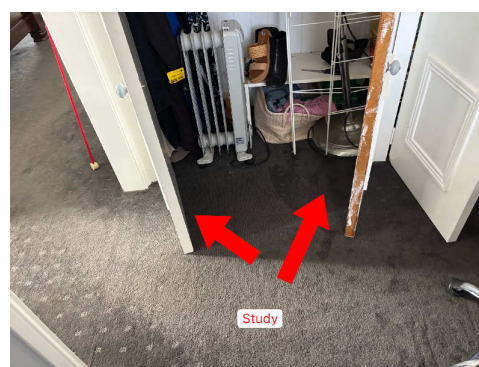
Finding 3.04

Finding: Door binding on carpet

Information: At the time of the inspection, it was noted that several doors were in the dwelling were binding on the carpet during normal operation. Continued use may cause premature wear to the carpet in that area.

A small amount needs to be trimmed off the bottom of the door to clear the carpet.

A building maintenance professional or licensed carpenter could be engaged to carry out these works. This can be done at the clients discretion.

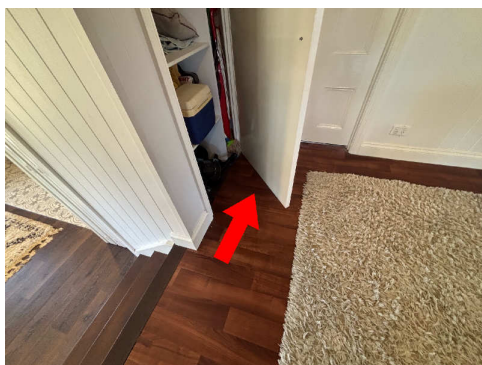
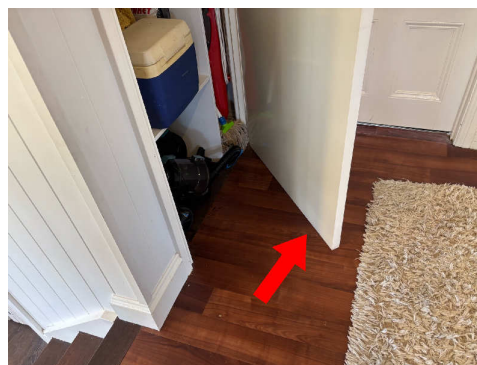
Finding 3.05

Finding: Cupboard - door binding on timber floor

Information: At the time of the inspection, it was noted that the door to the cupboard in the hallway was binding on the timber floor during normal operation. Continued use may cause premature wear to the timber floor in that area.

A small amount needs to be trimmed off the bottom of the door to clear the timber floor.

A building maintenance professional or licensed carpenter could be engaged to carry out these works. This can be done at the clients discretion.

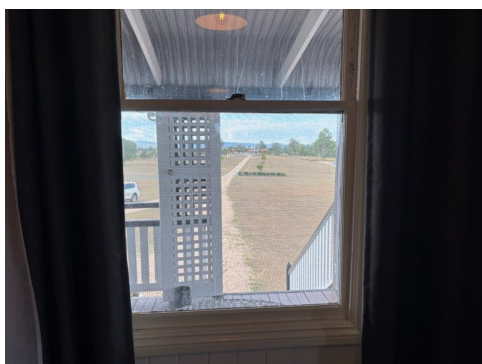
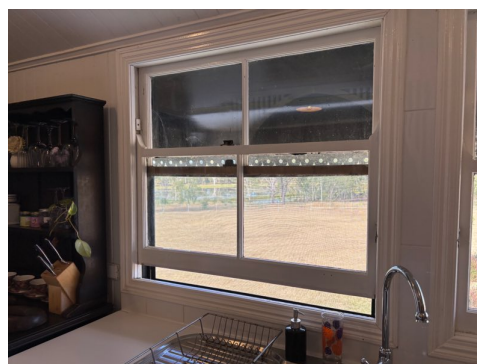
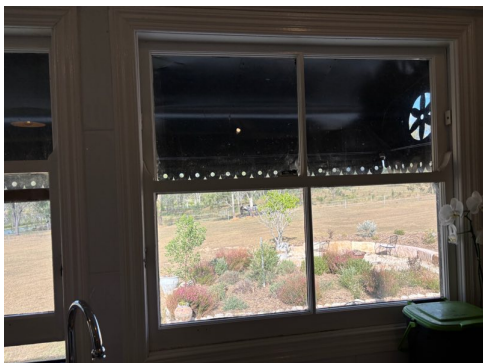
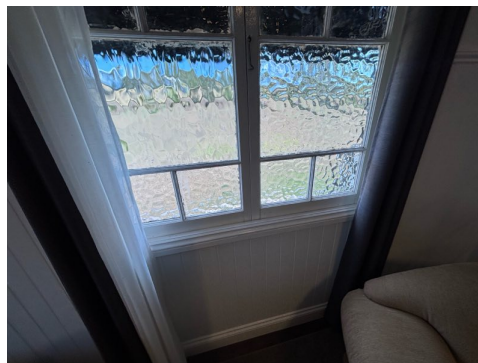
Finding 3.06

Finding: Double hung windows - friction stays or weights not functional

Information: At the time of the inspection, it was noted that several double hung windows throughout the dwelling do not stay open as the associated friction stays or weights are not functional. This may be due to the age of the materials and general wear and tear.

Replacing the friction stays or weights may require invasive work and as such, may not be an economical exercise.

A building maintenance professional could be engaged to install window catches to the affected windows to allow them to be left open. This can be done at the clients discretion.

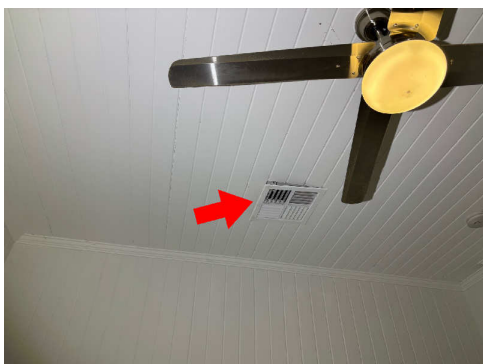
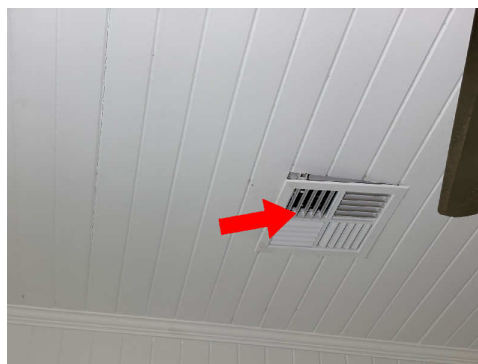
Finding 3.07

Finding: Bedroom 3 - air conditioner vent loose

Information: At the time of the inspection, it was noted that the ducted air conditioner vent in bedroom 3 was loose.

A building maintenance professional could be engaged to re-secure the AC vent. This can be done at the clients discretion.

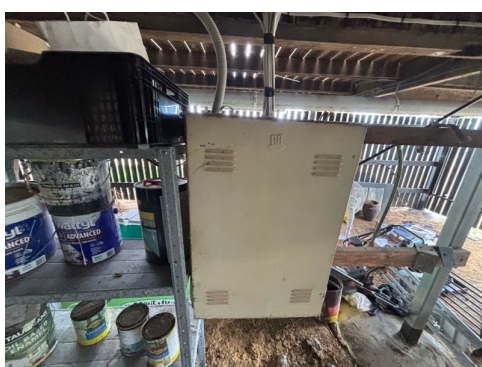
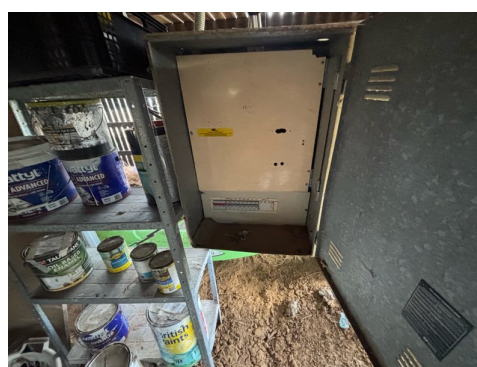
Finding 6.01

Building:	Main Building
Location:	All External Areas
Finding:	Termite Management System - no evidence of a chemical installation
Information:	At the time of the inspection, no evidence of a chemical termite management system was found. There is no durable notice in the meter box.

The application of a post-construction chemical termite barrier is highly recommended for all properties, particularly if live termite activity has been found on the site previously. Such barriers are highly effective in preventing termite attack on any timber building elements throughout the property.

A durable notice should be placed in the switchboard unit to indicate current termite barriers. At the time of inspection, it appeared as though no termite management system has been installed, with no evidence to suggest preventative works taking place.

The client may consider gaining further advice from a pest controller as to the costs and procedures involved with this application. It is recommended that obtaining such advice be a short-term priority.

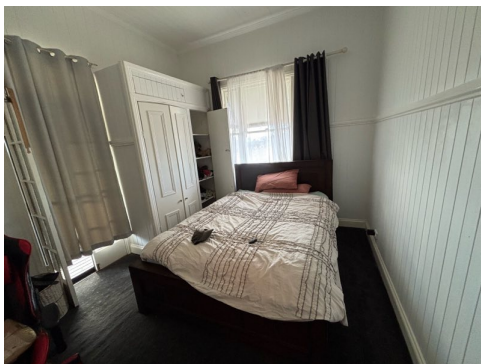
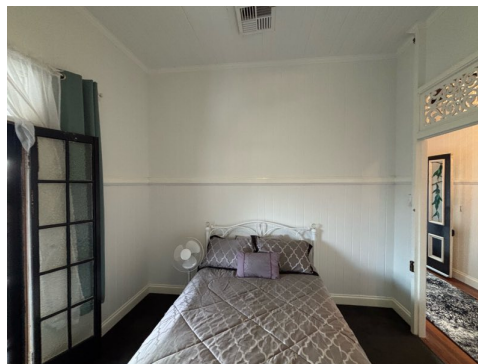
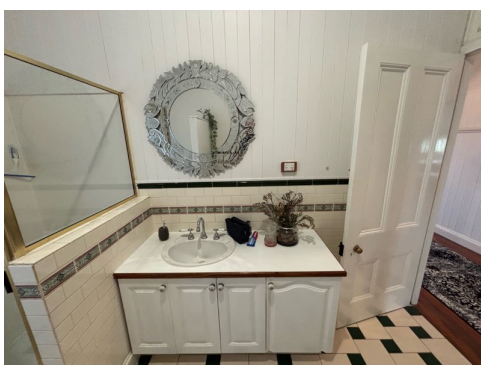
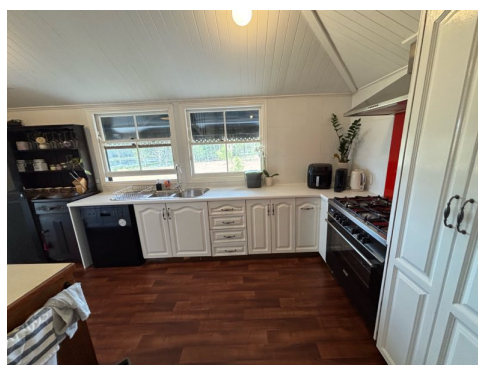
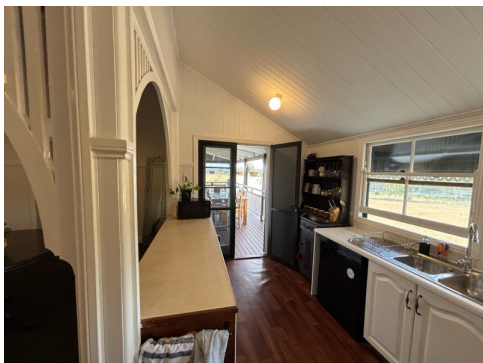
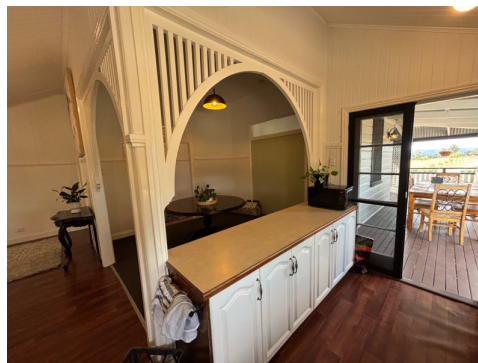
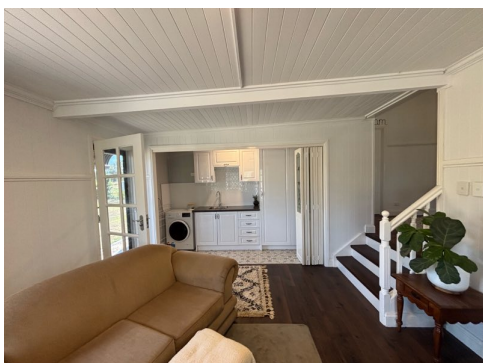
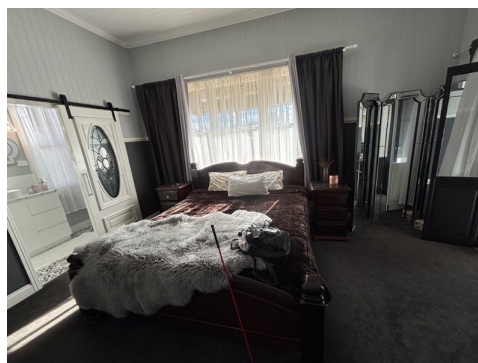
Finding: Obstructions and Limitations - Internal areas

Information: These photographs are an indication of the obstructions and limitations which impeded full inspection of the property of the internal areas at the time of inspection. These obstructions can hide an array of defects and should be removed to allow full inspection to be carried out. A re-inspection is recommended once the areas are made accessible.

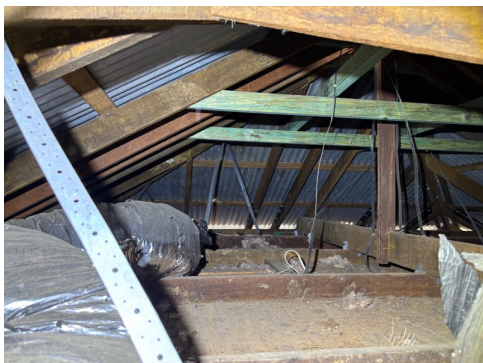
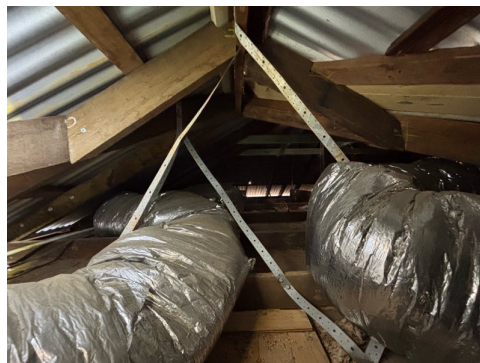
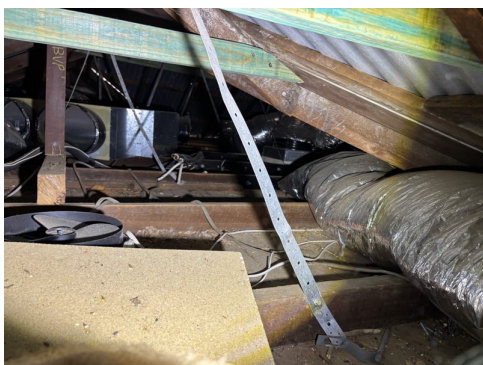
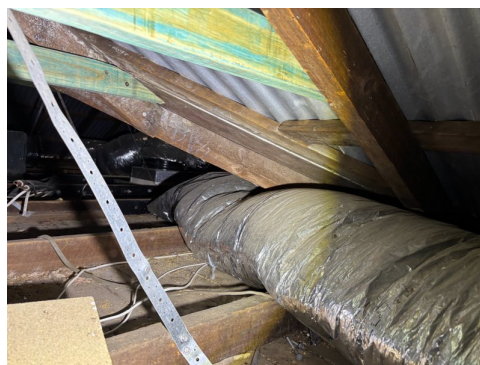
Finding: Obstructions and Limitations - Roof cavity

Information: These photographs are an indication of the obstructions and limitations which impeded full inspection of the property of the roof cavity at the time of inspection. These obstructions can hide an array of defects and should be removed to allow full inspection to be carried out. A re-inspection is recommended once the areas are made accessible.

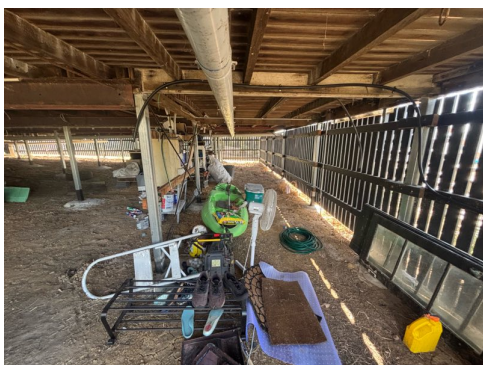
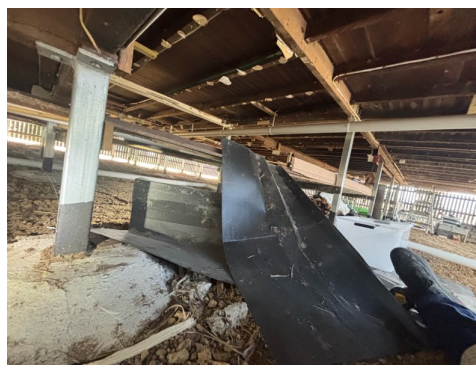
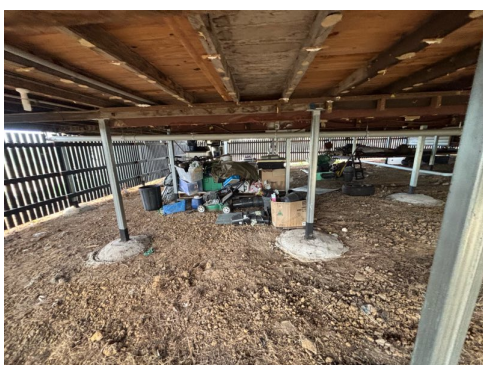
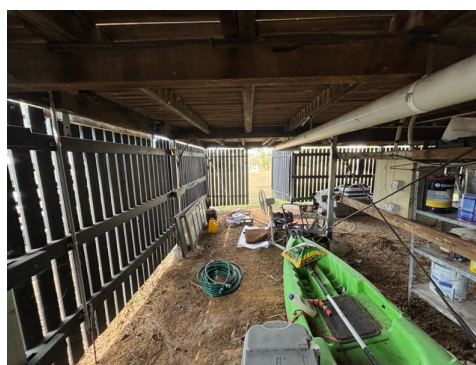
Finding: Obstructions and Limitations - Sub floor cavity

Information: These photographs are an indication of the obstructions and limitations which impeded full inspection of the property of the sub floor cavity at the time of inspection. These obstructions can hide an array of defects and should be removed to allow full inspection to be carried out. A re-inspection is recommended once the areas are made accessible.

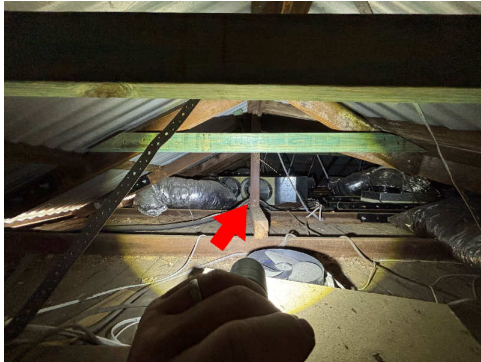
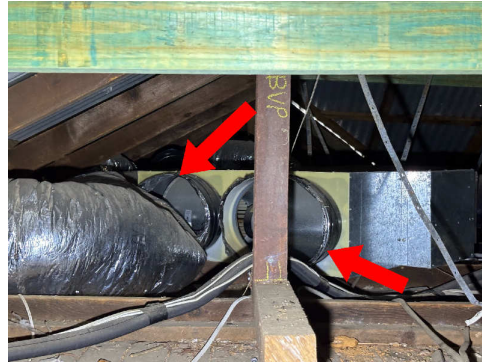
Finding: Ducted air conditioner - ducts not connected

Information: Whilst this inspection does not cover the functionality of air conditioning units, at the time of the inspection, it was noted that the ducting was not connected to the air conditioning unit in the roof void.

An air conditioning specialist should be engaged to assess the ducted air conditioning system. This can be done at the clients discretion.
