Building Inspection Report

Inspection Date: Fri, 27 Feb 2026

Property Address: unit 3/16 Efron St, Nunawading VIC 3131,
Australia

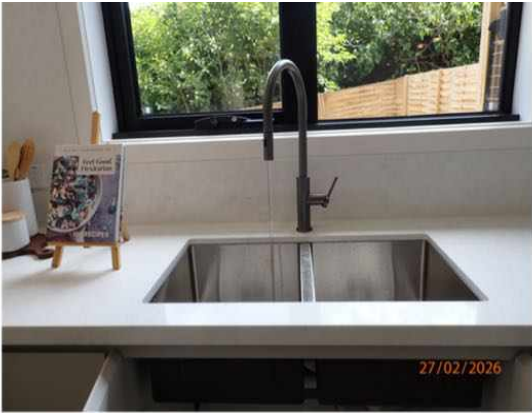
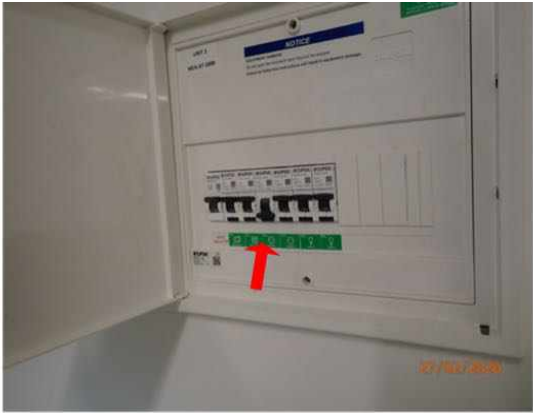
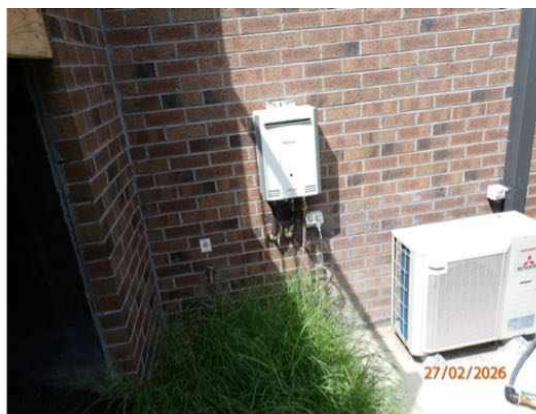
Defects 3.01

Building: Main Building
Location: All Internal Areas
Finding: Hot water system not operational
Information: The new hot water system was noted not operational at the time of inspection; this may be due to an installation/fault issue or the power supply being isolated at the switchboard (a main switch was observed turned off), and if left unresolved it may result in no hot water service and potential concealed electrical/plumbing faults—engage a licensed electrician to confirm power supply and correct isolation/faults, and a licensed plumber to check the installation/commissioning and rectify as required urgently.

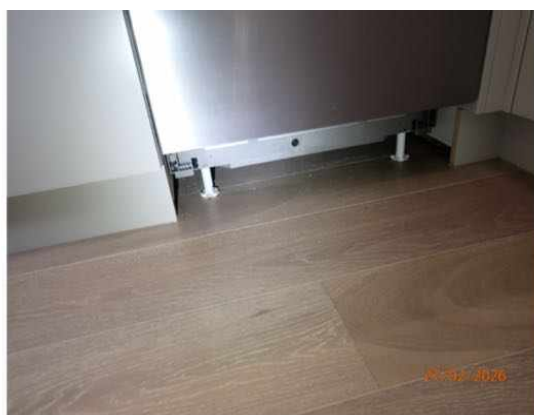
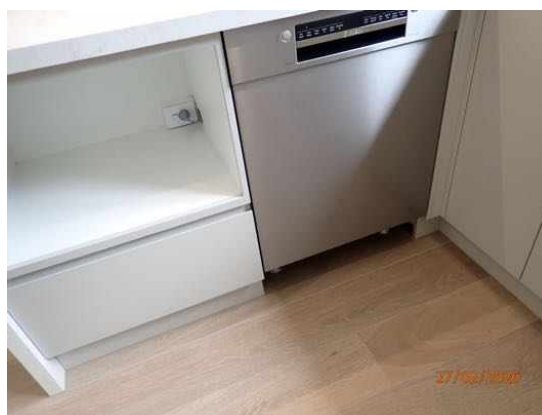
Defects 3.02

Building:	Main Building
Location:	Kitchen
Finding:	Dishwasher kick plate missing
Information:	The dishwasher kick plate/toe-kick (the lower cover panel beneath the dishwasher at the legs) was noted missing/not installed during inspection; while this does not typically affect operation, it leaves the underside/legs exposed, reduces the finished appearance, and may allow debris/moisture to enter under the cabinet over time—engage a qualified carpenter (or handy person if minor refitting only) to supply and securely install the kick plate short term.

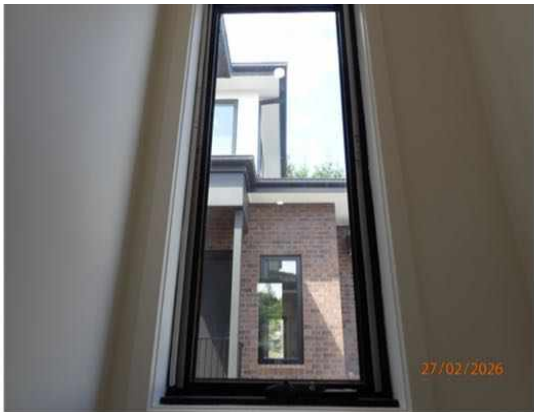
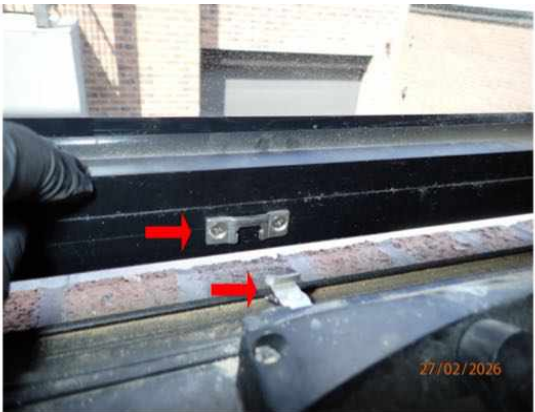
Defects 3.03

Building:	Main Building
Location:	Stairs - Internal
Finding:	Window Winder broken
Information:	The window winder along the internal stairway leading down to the garage was noted disengaged/broken during inspection; this may affect safe operation, security, and weather sealing if left unresolved—engage a handy person to refit/repair or replace the window winder/hardware short term.

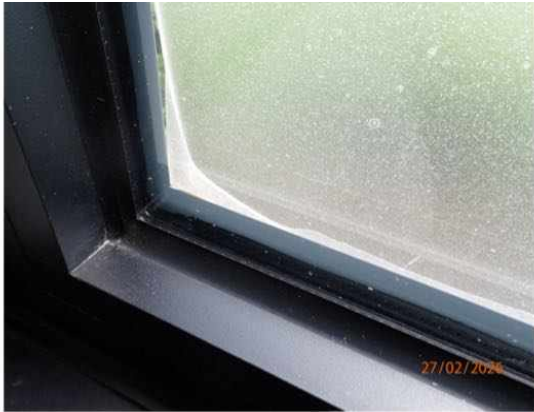
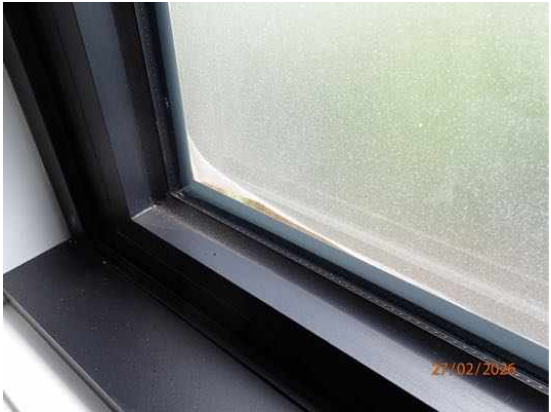
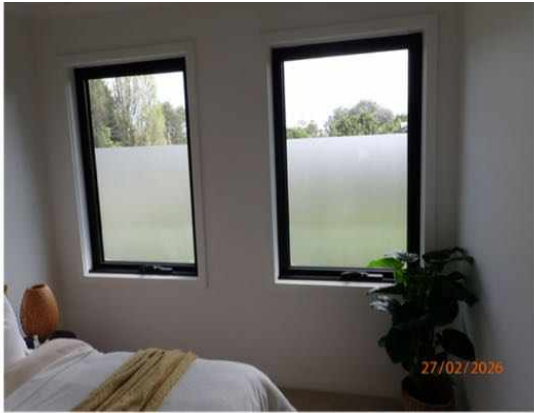
Defects 3.04

Building: Main Building
 Location: Bedroom 2
 Finding: Film peeling
 Information: The translucent window film to Bedroom 2 was noted peeling from the bottom edge during inspection; this is a cosmetic issue that affects appearance and may continue to peel if left unattended—engage a handy person to re-adhere or remove/replace the film neatly short term.

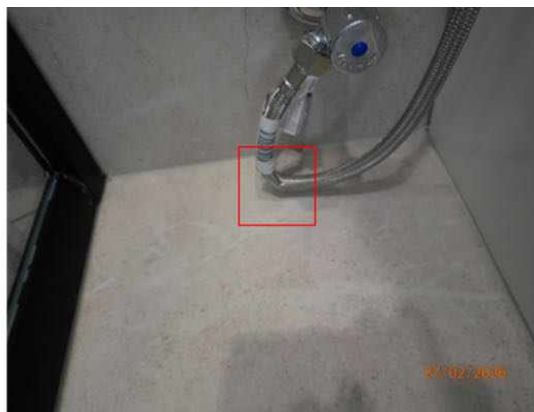
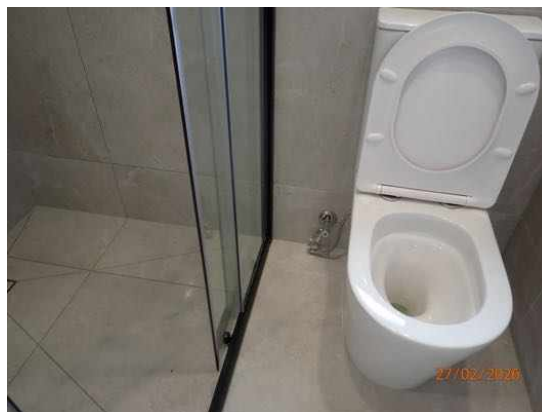
Defects 3.05

Building:	Main Building
Location:	Bathroom
Finding:	Hose Kinked
Information:	The flexible hose connecting the plumbing from the tap to the shower system was noted kinked/squeezed during inspection; a kinked hose can restrict water flow and may split or leak over time causing water damage—engage a licensed plumber to replace and correctly install the hose to prevent leakage short term.

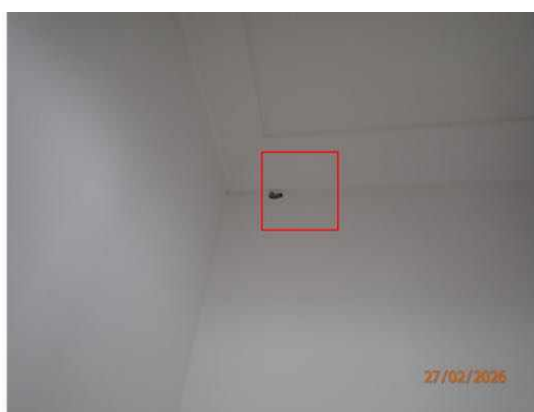
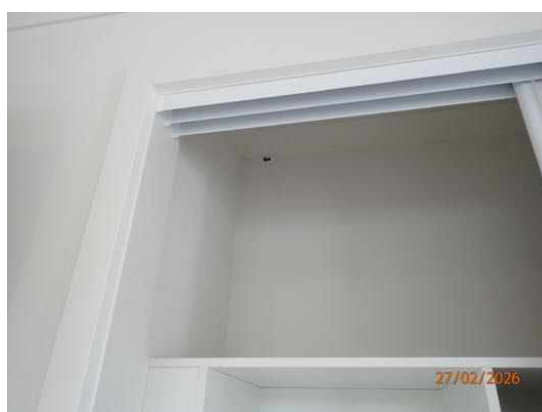
Defects 3.06

Building:	Main Building
Location:	Bedroom 3
Finding:	Hole in plaster board noted
Information:	During the inspection, a hole was noted to the plasterboard lining inside the wardrobe in Bedroom 3. As per the Guide to Standards and Tolerances 2015 (Clause 12.04), mechanical imperfections/damage, holes or any other unfilled depressions are defective if they can be seen from a normal viewing position; it is recommended this be patched, finished, and repainted to an acceptable standard, and please discuss this with your builder.

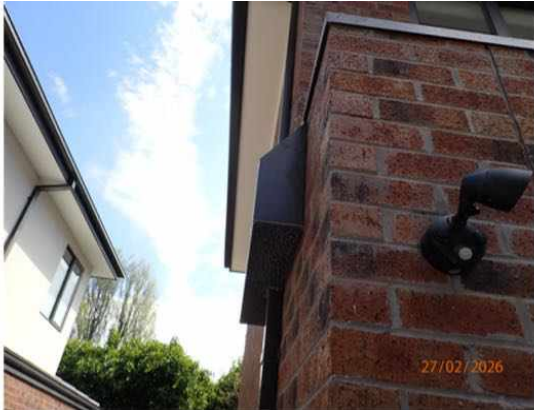
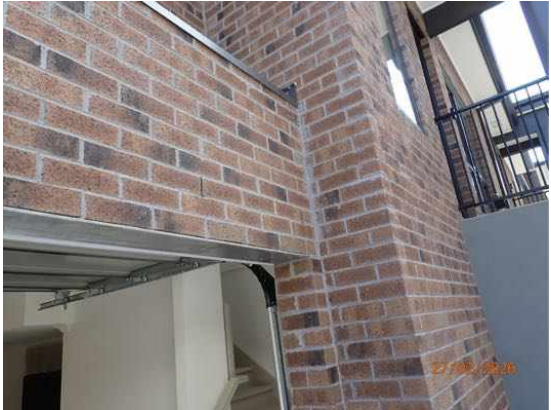
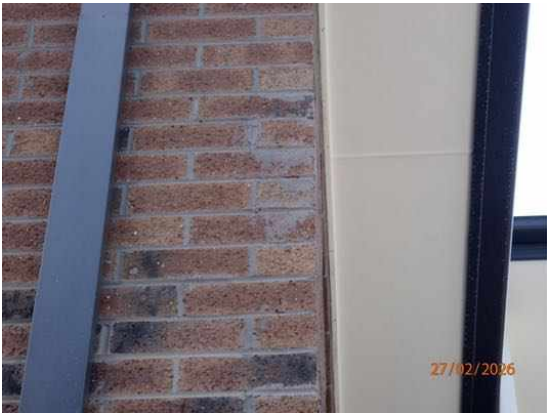
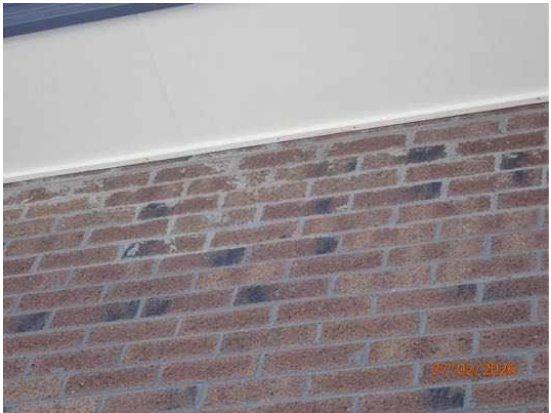
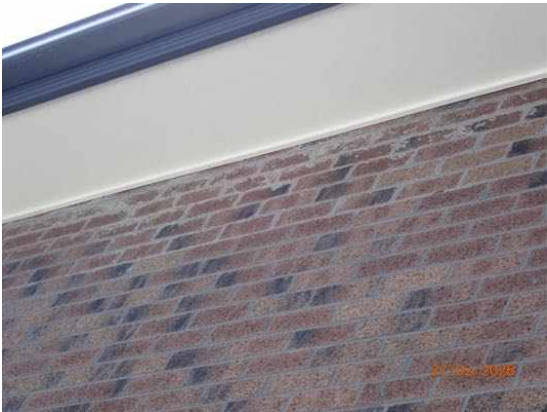
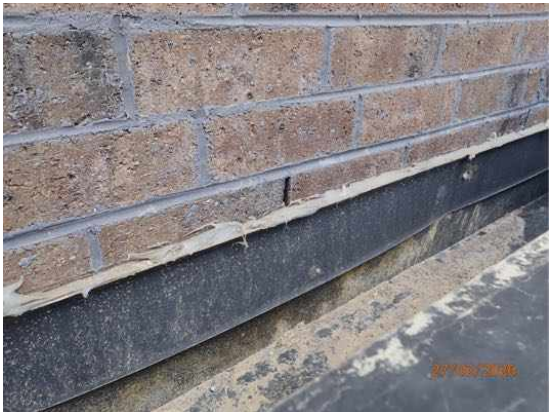
Defects 3.07

Location: All External Areas
Finding: Masonry Mortar Finish
Information: During the inspection, mortar to the external brickwork around the dwelling was noted uneven, smeared and not properly cleaned or finished. In accordance with the Guide to Standards and Tolerances 2015, Section 3.07 Masonry facing and 3.11 Cleaning, mortar smears and stains, masonry faces are defective if not cleaned and free of excess mortar when visible from a normal viewing position . Poorly finished mortar can affect the overall appearance. Please discuss this with your builder to engage a qualified bricklayer to clean and rectify the mortar joints to achieve a neat and acceptable finish.

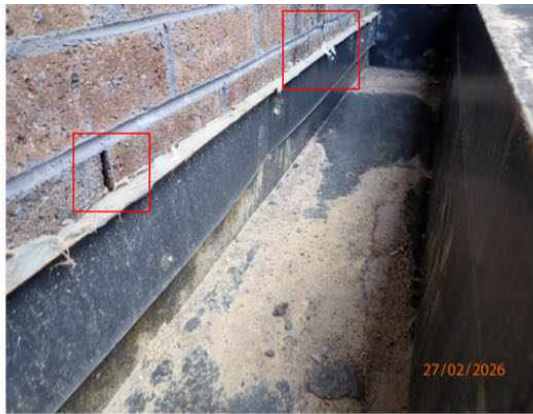
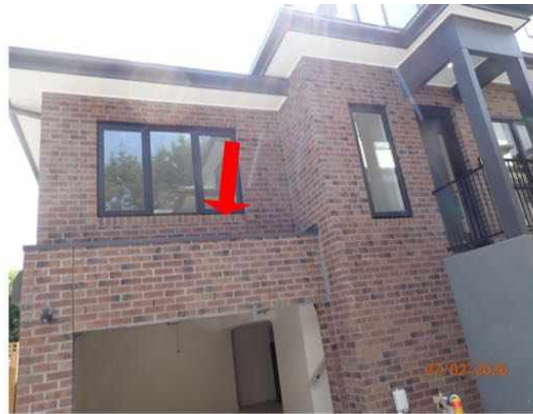
Defects 3.08

Building:	Main Building
Location:	Exterior walls - front
Finding:	Weep holes blocked
Information:	During the inspection, weepholes to the front section of the dwelling at the first level were observed blocked/obstructed (noted at/near the box gutter area), which may reduce cavity drainage and ventilation if left unresolved. This is considered a defect and it is recommended that you discuss this with your builder to confirm the intended detailing and arrange rectification to reinstate clear, effective weepholes.

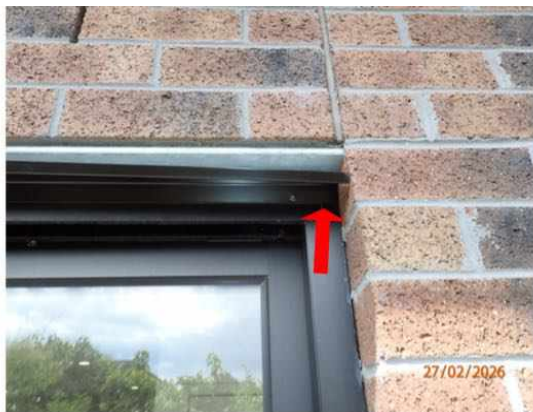
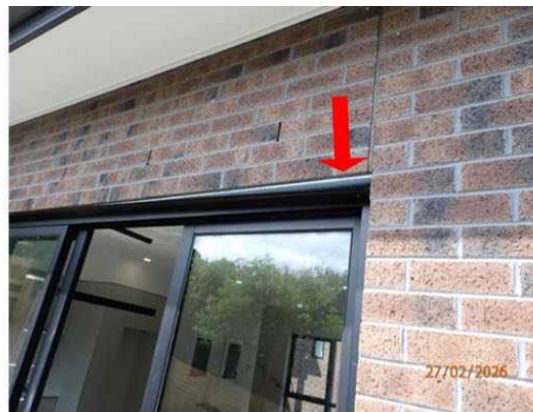
Defects 3.09

Building:	Main Building
Location:	Exterior walls - rear
Finding:	Window head flashing (gap between lintel and window) – loose/bent:
Information:	During the inspection, the flashing installed over the gap between the window and lintel at this location was noted loose/bent and not providing adequate cover, which may reduce weather protection and could allow moisture entry and deterioration to surrounding finishes if left unresolved. It is recommended that you discuss this with your builder to arrange short term rectification by securely refitting/replacing the flashing to achieve adequate cover and weatherproofing.

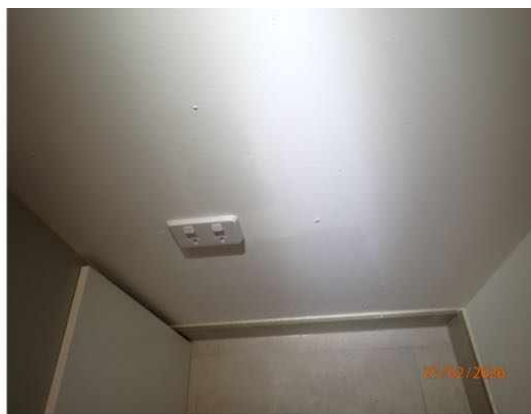
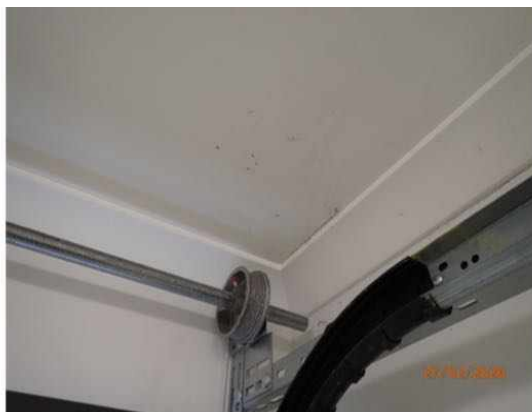
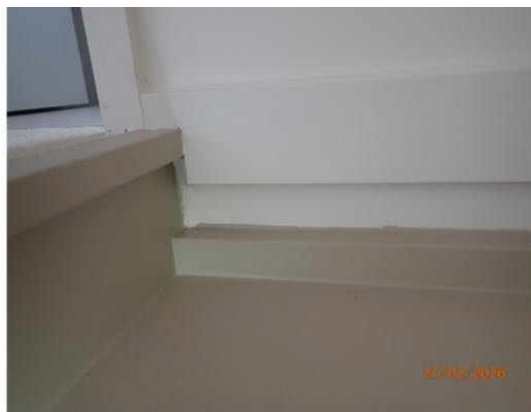
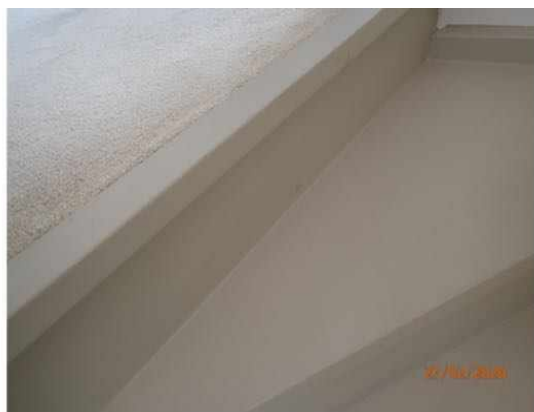
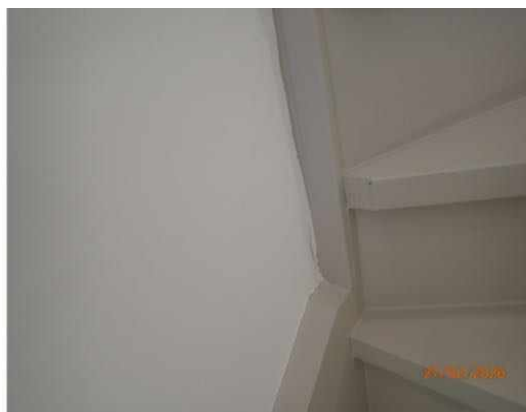
Building:	Main Building
Location:	All Internal Areas
Finding:	Paint finish - Substandard (AS 2311)
Information:	As per Guides to standards and tolerance 12.02 :Surface finish of paintwork

Paintwork is defective if the application has blemishes such as paint runs, paint sags, wrinkling, dust, bare or starved painted areas, colour variations, surface cracks, irregular and coarse brush marks, sanding marks, blistering, non-uniformity of gloss level and other irregularities in the surface that are visible from a normal viewing position.

The paint finish in this area was found to have been completed to a substandard level. This should be brought to the attention of the builder.

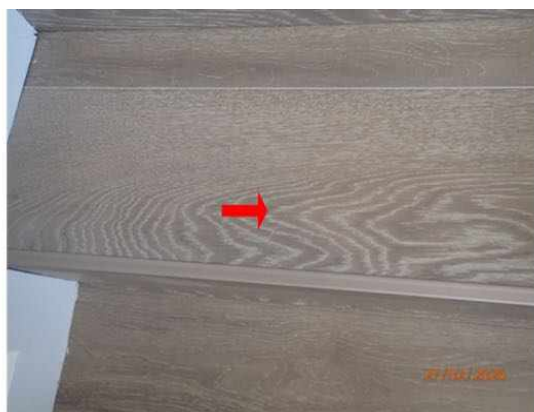
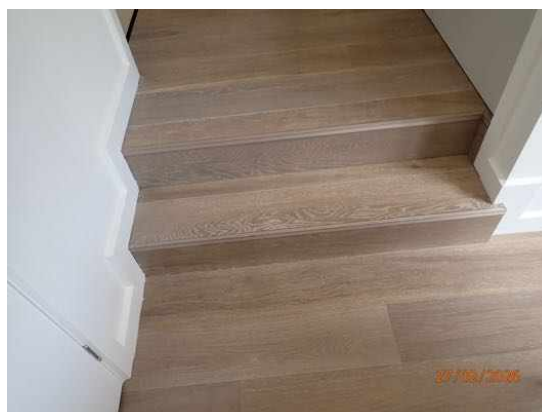
Building: Main Building
 Location: All Internal Areas
 Finding: Floor - Scuffed
 Information: Superficial scuff marks were noted on the flooring in this area during the inspection. These marks, while affecting the appearance, do not indicate any structural or operational issues and are typical of general wear and tear.

The scuff marks are primarily cosmetic and unlikely to cause further damage, so immediate repair or replacement is not necessary.

If the client wishes to address the marks, they can consider refurbishing or replacing the affected areas. A general handyman, cleaning contractor, or flooring specialist can be engaged based on the client's preference.

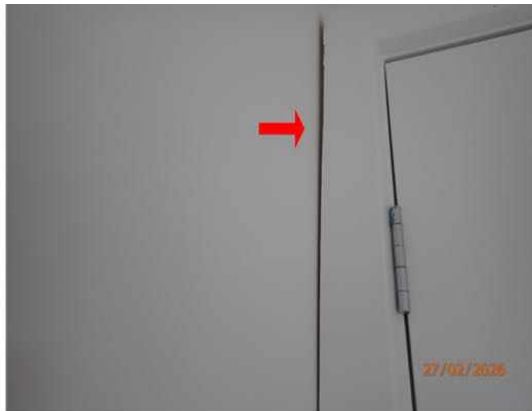
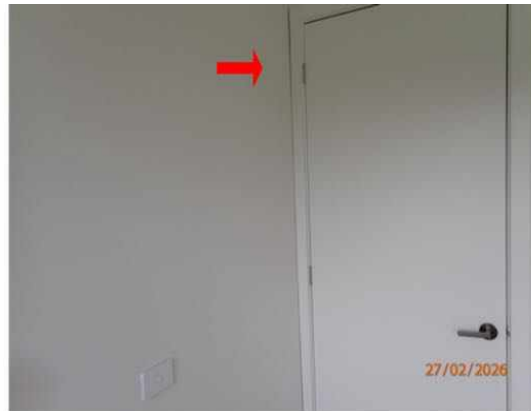
Building: Main Building
 Location: Bedroom 2
 Finding: Architrave - Gap
 Information: During inspection, it was noted that a gap was present between the architrave and the plasterboard behind this door. As per the Guide to Standards and Tolerances 2015,

Clause 10.01, internal joinery and trim finishes are defective where gaps and poor fitment are visible and do not present a neat and uniform finish. Please discuss this with your builder

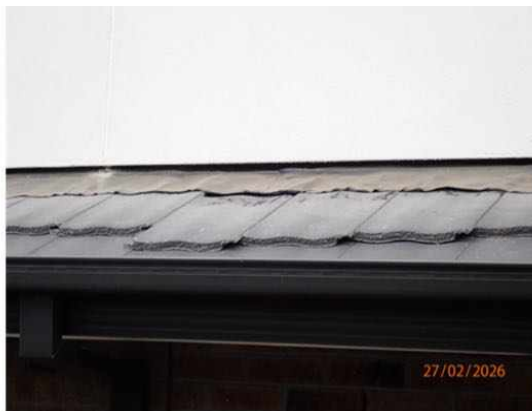
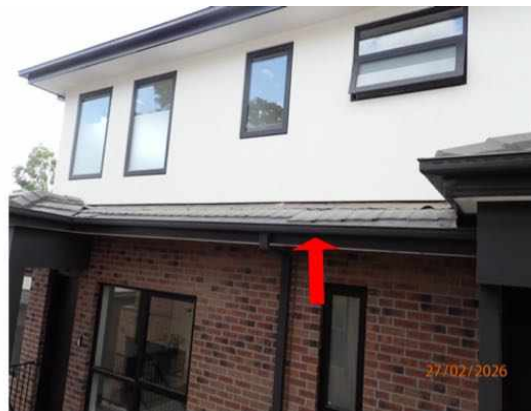
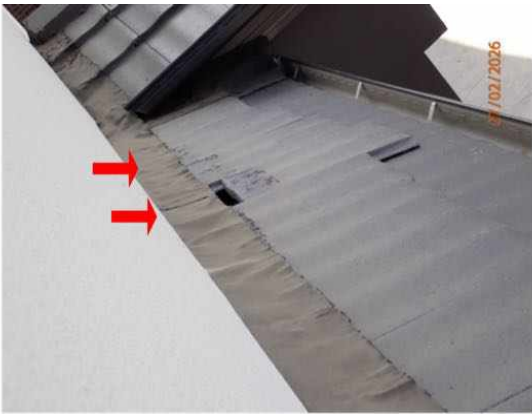
Finding: Roof tiled moved in unit 2

Information: At the adjacent property, a roof tile in this section of the roof was noted displaced/moved, leaving a visible gap between the flashing and roof tiles; if not rectified this gap may allow water entry, leading to roof leaks and damage to roof framing, insulation and internal ceilings—engage a licensed plumber (roof plumbing) to realign/secure tiles and check flashing integrity, with a registered builder to repair any resulting damage if present urgently.

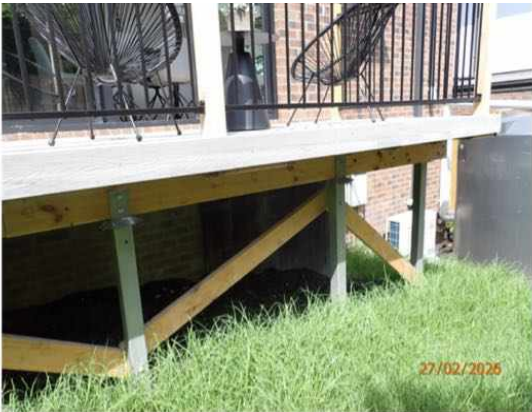
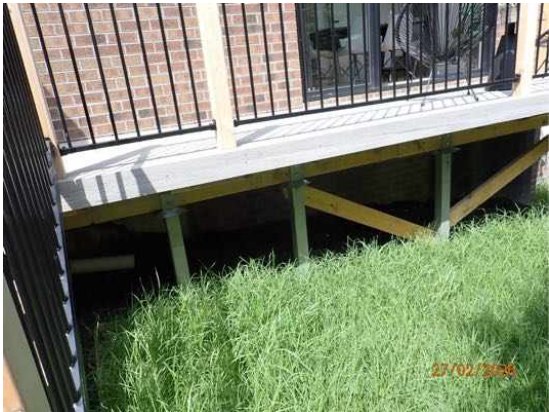
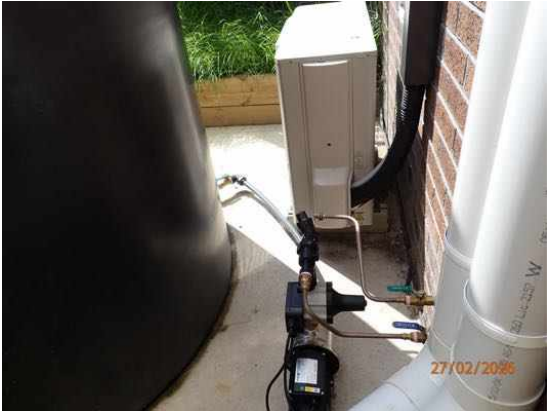
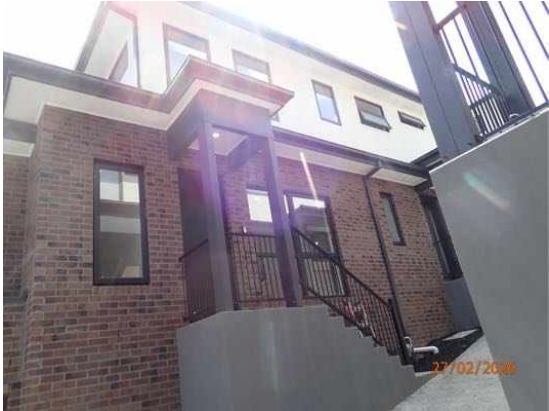
Building: Main Building
 Location: All External Areas
 Finding: Additional Photos - Obstructions and Limitations External Areas
 Information: These photographs are an indication of the obstructions and limitations which impeded full inspection of the External areas of the property at the time of inspection. These obstructions can hide an array of defects and should be removed to allow full inspection to be carried out. A re-inspection is recommended once the areas are made accessible.

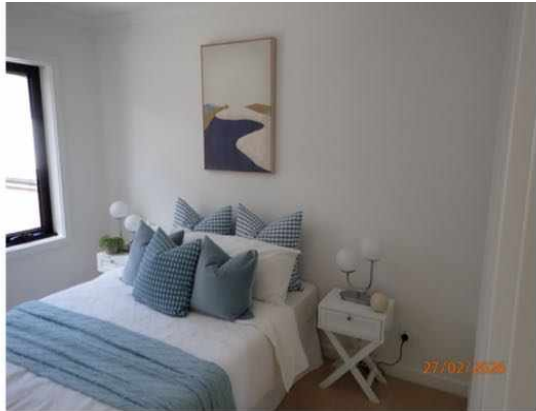
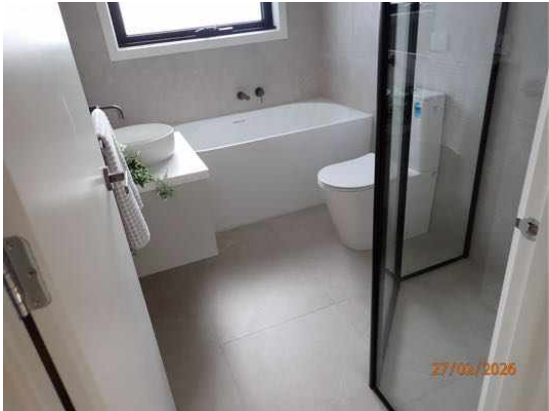
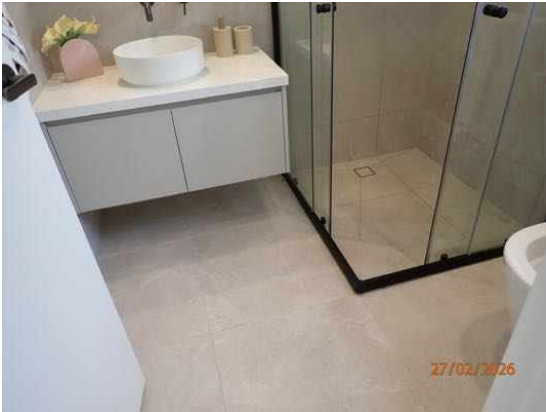
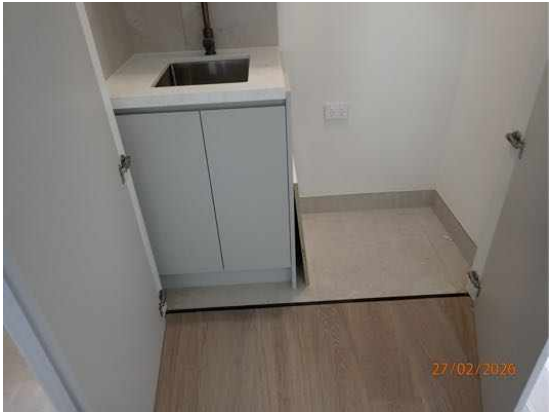
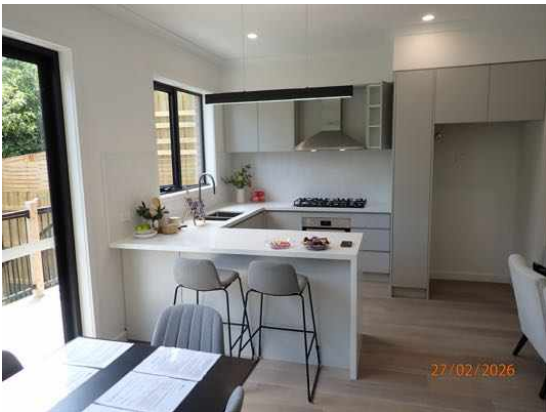
Building: Main Building
Location: All Internal Areas
Finding: Additional Photos - Obstructions and Limitations internal Areas
Information: These photographs are an indication of the obstructions and limitations which impeded full inspection of the internal areas of the property at the time of inspection. These obstructions can hide an array of defects and should be removed to allow full inspection to be carried out. A re-inspection is recommended once the areas are made accessible.

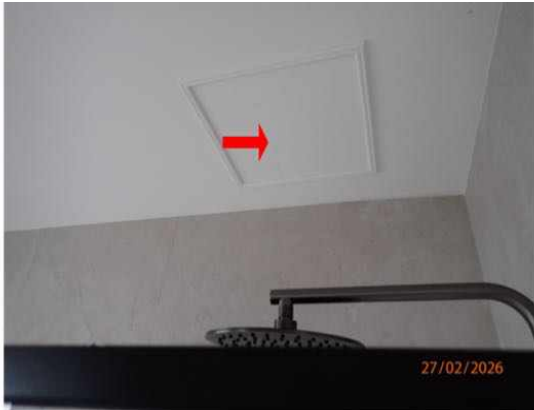
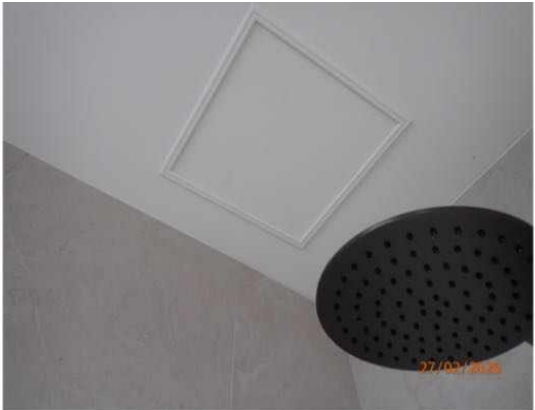
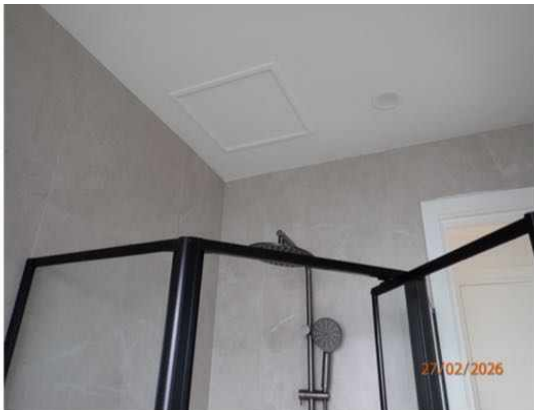
Location: Roof Void
Finding: Additional Photos - Obstructions and Limitations Roof Void
Information: The opening to the Roof void was noted installed inside the shower area with the shower and the shower screen blocking access. No inspection was able to be carried out in the Roof void. These photographs are an indication of the obstructions and limitations which impeded full inspection of the Roof Void of the property at the time of inspection. These obstructions can hide an array of defects and should be removed to allow full inspection to be carried out. A re-inspection is recommended once the areas are made accessible.
