Building and Timber Pest Inspection Report

Inspection Date: Mon, 26 Jan 2026

Property Address: 8 Poplar Ave, Shepparton VIC 3630,
Australia

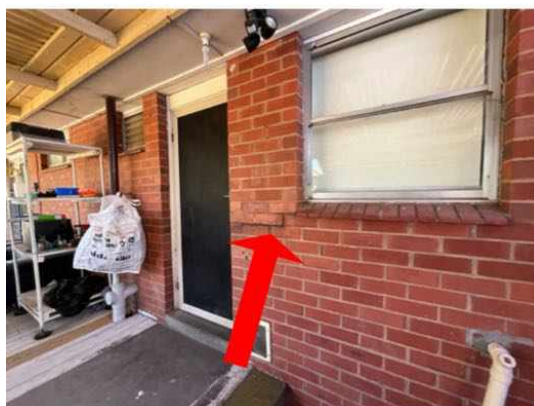
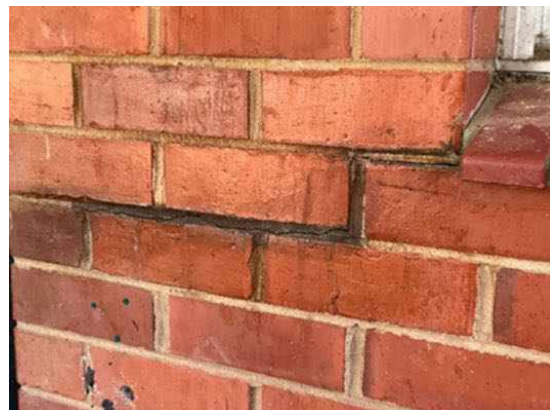
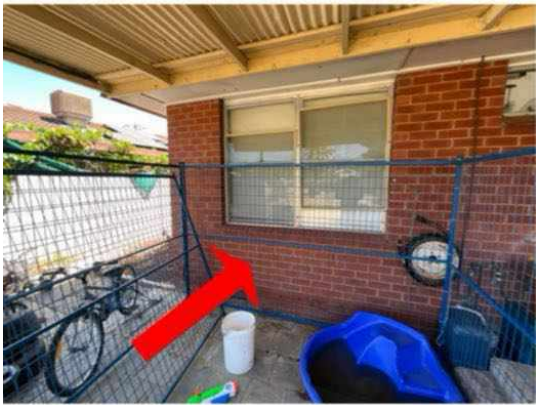
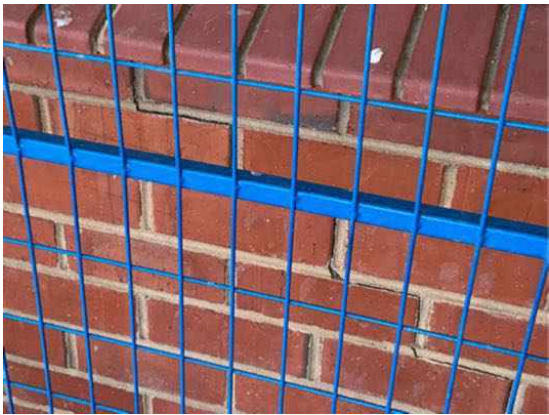
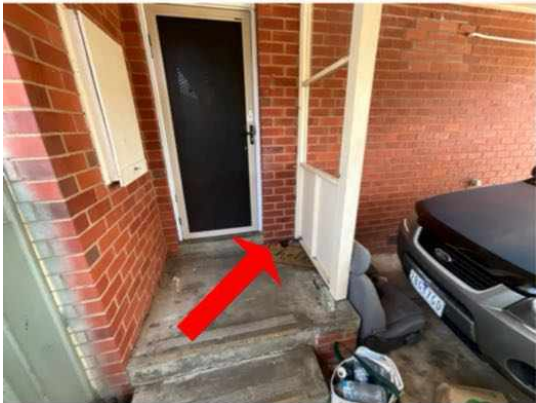
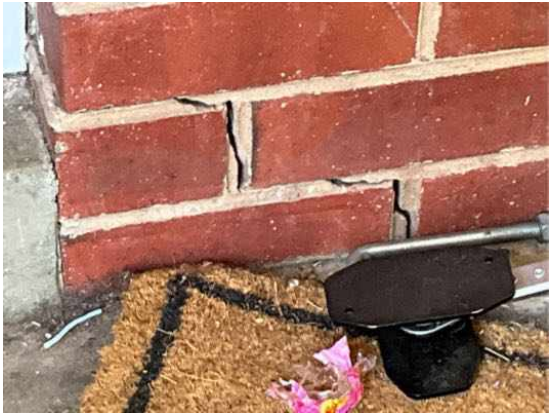
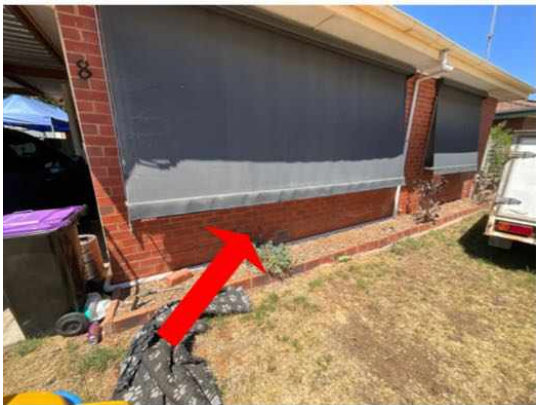
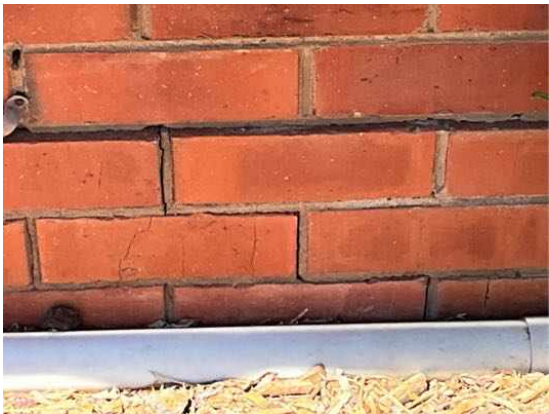
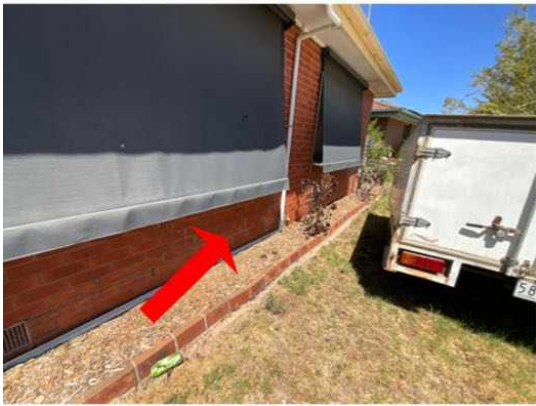
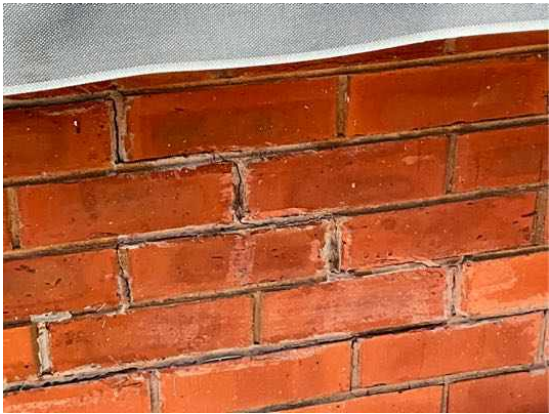
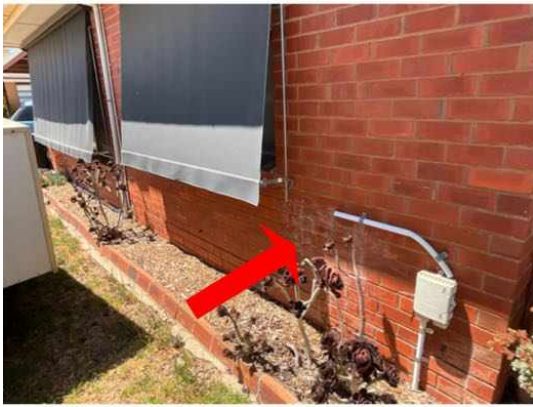
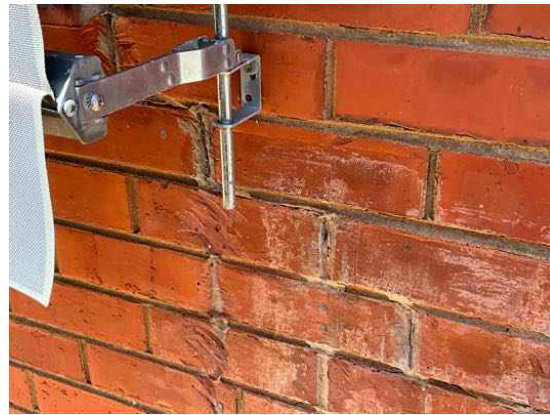
Finding 3.01

Building: Building 1
 Location: Laundry, back and front wall, entry
 Finding: Brickwork- Step cracking
 Information: Step cracking was identified to the brickwork in this area at the time of inspection. Step cracking, which is similar to other forms of cracking, has a variety of possible causes. However, the most common is the subsidence of adjacent footings.

Step cracking is a relatively common defect, and is most likely to occur adjacent to windows, doors and other openings. Mortar failure in the gaps between affected bricks indicates the stresses and tensions affecting the wall.

Minor step cracking can be used as a warning sign to address factors causing stress to the wall, which can include the effect of surrounding trees, water leaks, soil erosion, or even the presence of reactive soils in the surrounding area.

If cracks increase in size or number contact a Licensed builder immediately to make all needed repairs.

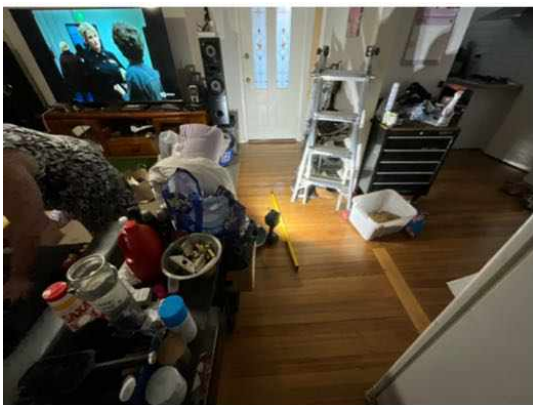
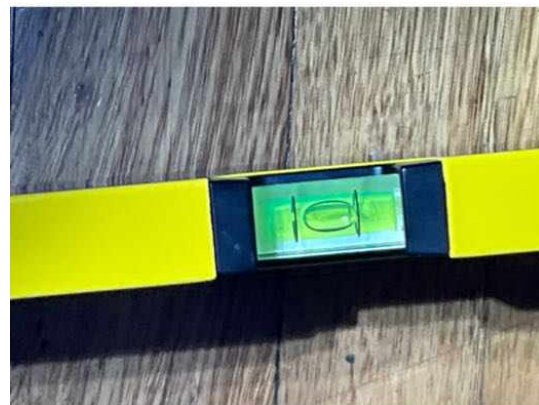
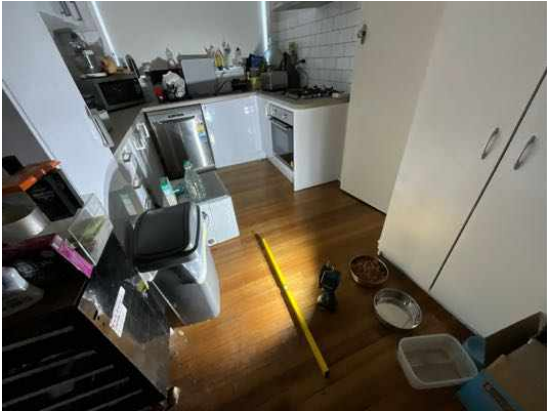
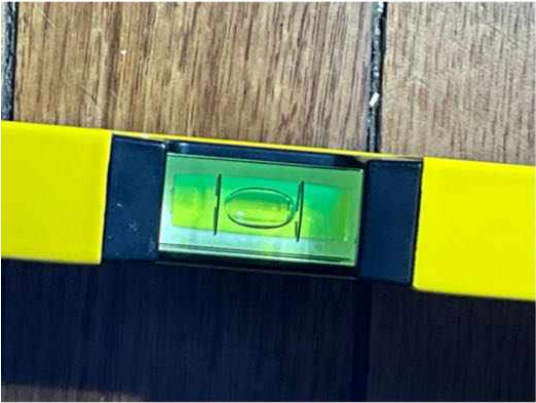
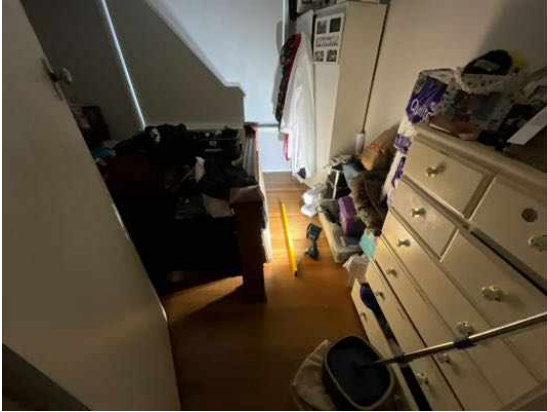
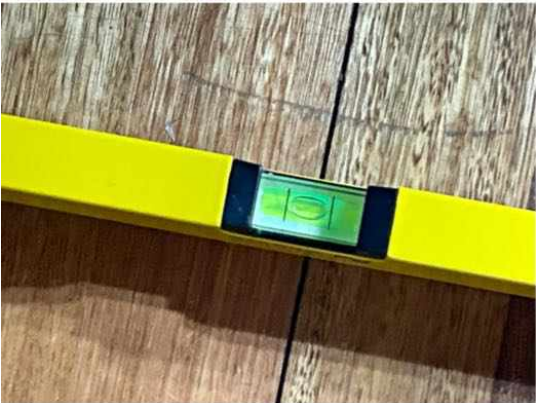
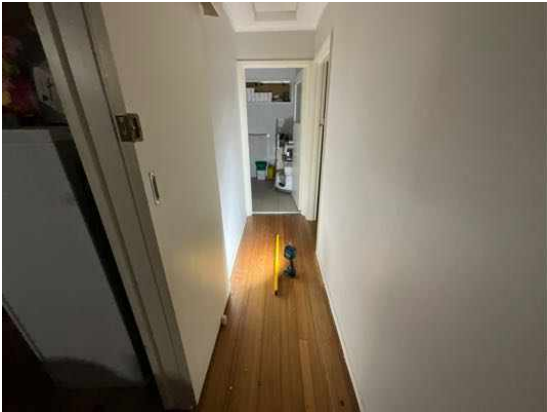
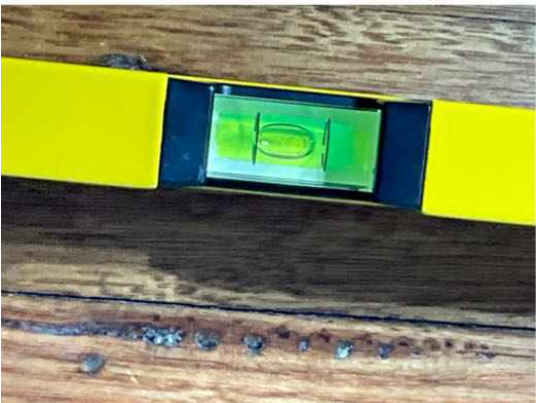
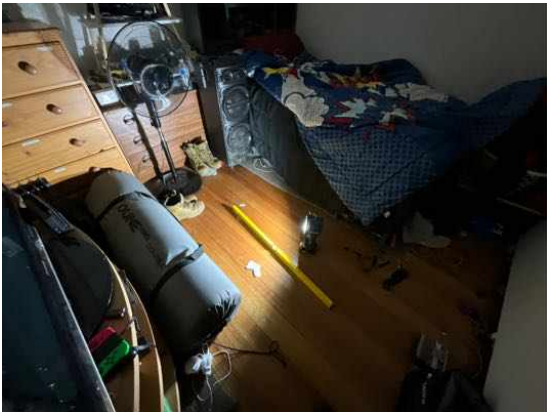
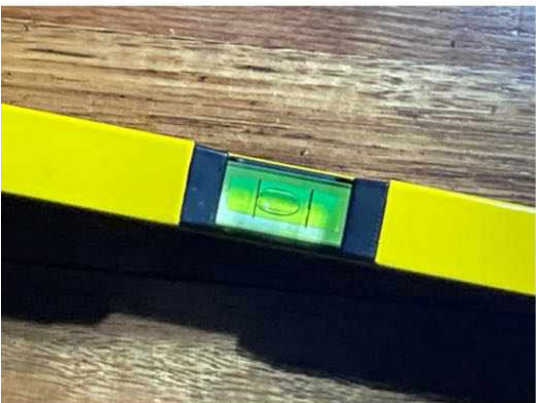
Finding 3.02

Building:	Building 1
Location:	All Internal Areas
Finding:	Flooring - Uneven
Information:	The internal flooring in this area is out of level and uneven. Uneven flooring is likely to indicate minor defects such as expected movement of the foundations of the property, but may also indicate subsidence of the associated subfloor stumps.

It is advised that the flooring be closely monitored to identify any further movement. Where flooring remains relatively unchanged for an extended period of time (i.e. several months), it is likely that this defect has been caused by expected movement of the foundations of the property.

However, where flooring is uneven further, potentially invasive inspection of the subfloor structures and stumps in this area is required. In this case, works to repair are likely to be required, and would be carried out by a registered builder specialising in re-stumping.

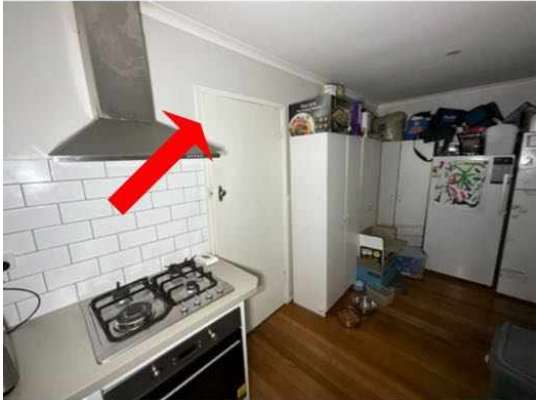
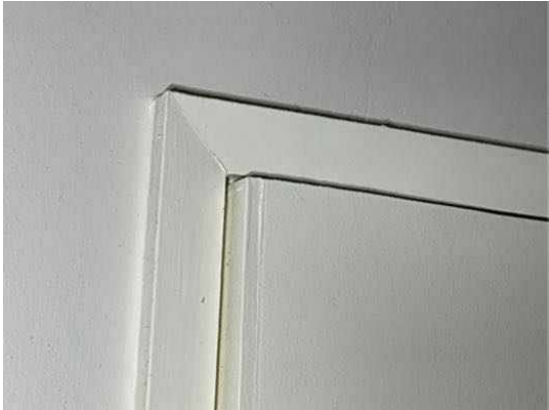
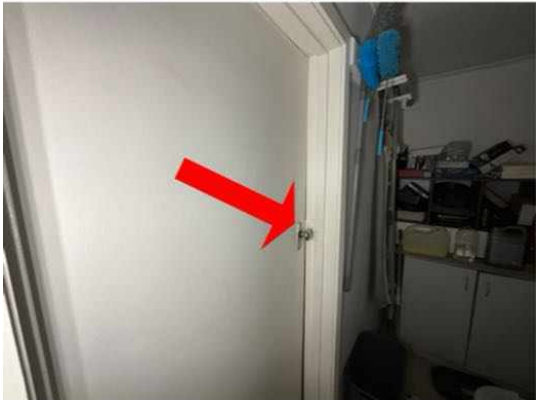
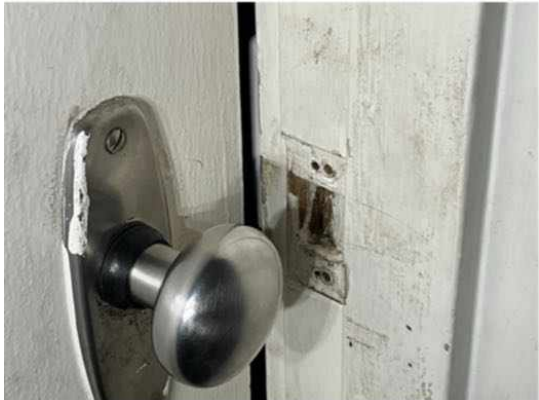
Finding 3.03

Building: Building 1
Location: Kitchen, bathroom
Finding: Door- Binding
Information: Binding and/or jamming of this door is evident during standard operation. This defect inhibits the functionality of the affected door as well as creating potential for secondary defects to associated building elements, such as damage to the floor covering.

A door that binds to flooring or to the associated door frame may have several causes, ranging from minor defects, such as poor installation of the door or deteriorated hinges, through to major structural issues, such as damage to subfloor structures.

A qualified carpenter or general handyperson should be appointed to perform minor rectification works at client discretion.

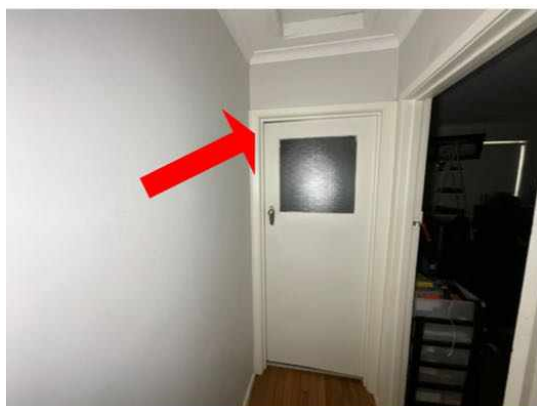
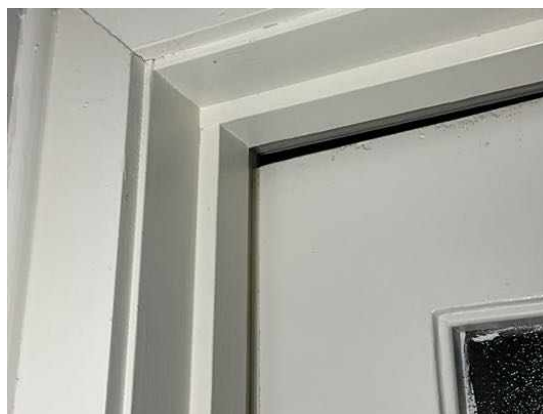
Finding 3.04

Building:	Building 1
Location:	Bedroom 3
Finding:	Cracking - Damage Category 1 - Fine (up to 1mm)
Information:	Although fine cracks are quite noticeable, they are often only considered to be an appearance defect, and usually do not indicate any structural damage. Generally, the cause of a fine crack is indicative of a separation between building materials and finishes (e.g. paint, plaster, etc.) along joins.

Cracking of this nature can generally be repaired with minor sanding, filling and/or repainting. Such works should be performed by a qualified painter or a general handyman.

Monitoring of all cracking should be conducted frequently. Always contact a building inspector should cracks widen, lengthen, or become more numerous.

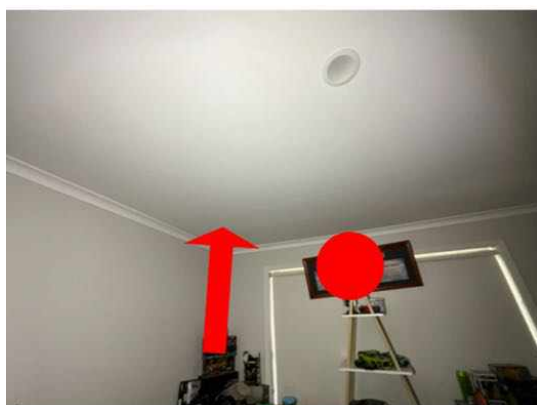
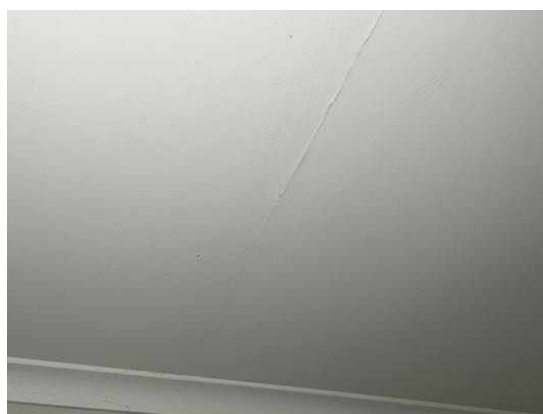
Finding 3.05

Building:	Building 1
Location:	Living Room
Finding:	Cracking - Damage Category 1 - Fine (up to 1mm)
Information:	Although fine cracks are quite noticeable, they are often only considered to be an

appearance defect, and usually do not indicate any structural damage. Generally, the cause of a fine crack is indicative of a separation between building materials and finishes (e.g. paint, plaster, etc.) along joints.

Cracking of this nature can generally be repaired with minor sanding, filling and/or repainting. Such works should be performed by a qualified painter or a general handyman.

Monitoring of all cracking should be conducted frequently. Always contact a building inspector should cracks widen, lengthen, or become more numerous.

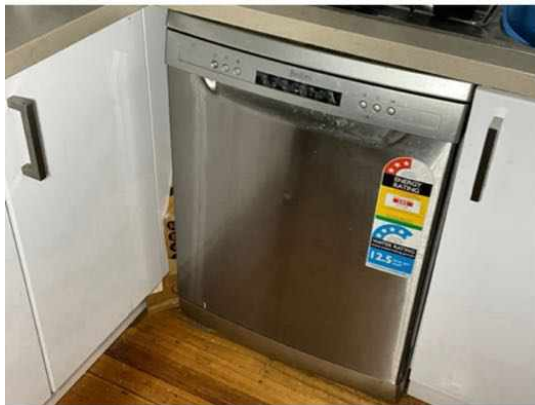
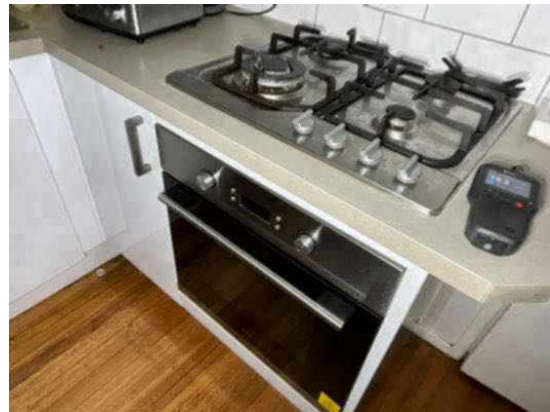
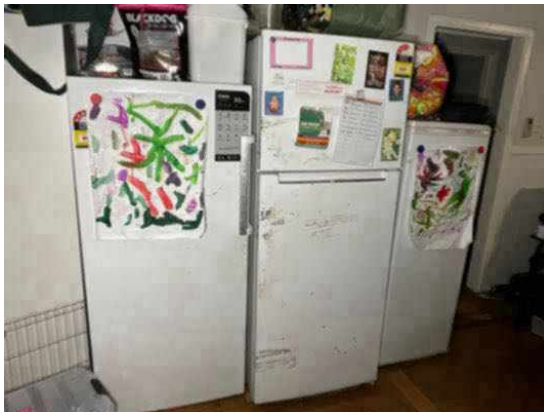
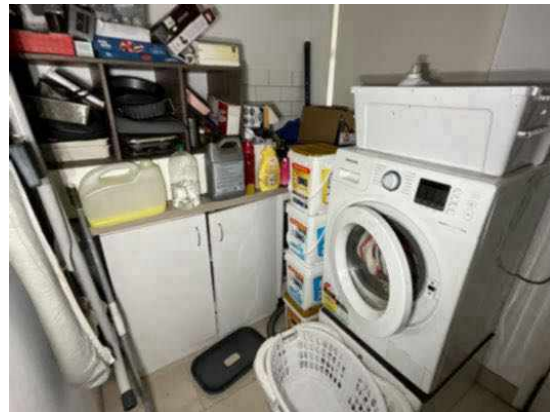
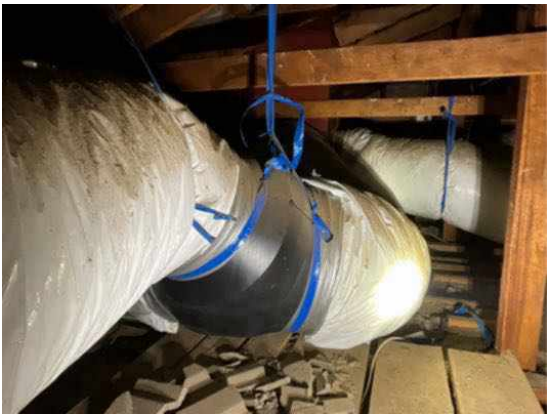
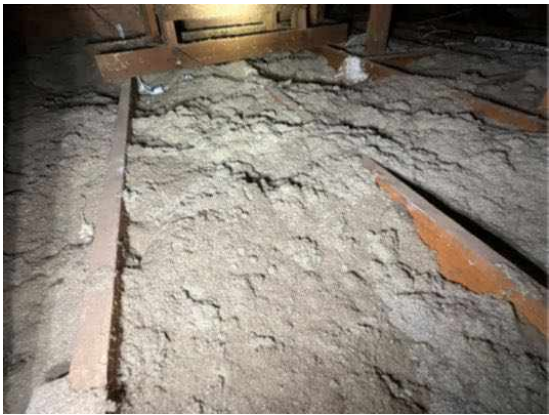
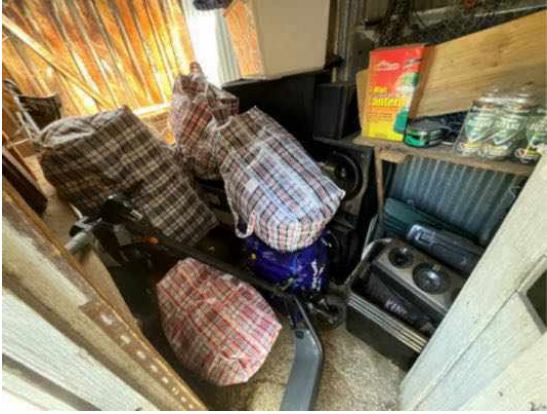
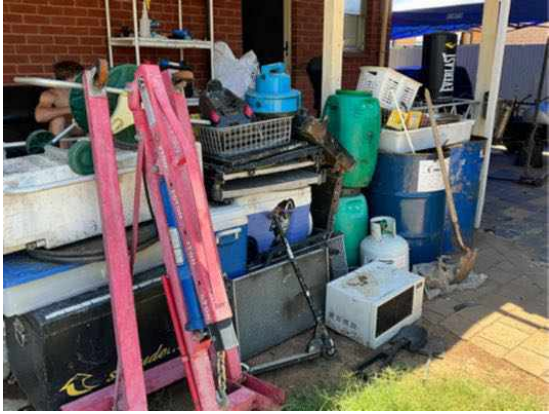
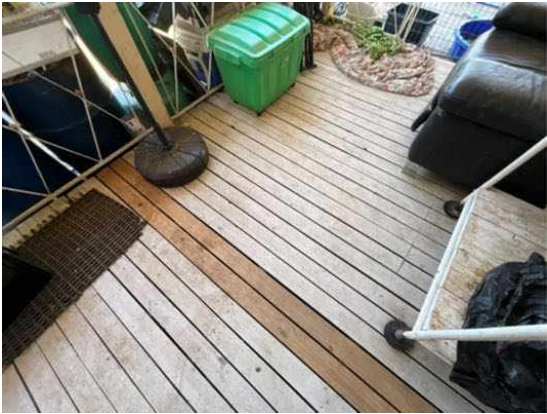
Noted Item

Building: Building 1
Location: All Areas
Finding: Additional Photos - Obstructions and Limitations
Information: These photographs are an indication of the obstructions and limitations which impeded full inspection of the property at the time of inspection. These obstructions can hide an array of defects and should be removed to allow full inspection to be carried out. A re-inspection is recommended once the areas are made accessible.
