## Building Inspection Report

Inspection Date: Wed, 7 Jan 2026

Property Address: 24/5-13 Larkin St, Camperdown NSW 2050,  
Australia

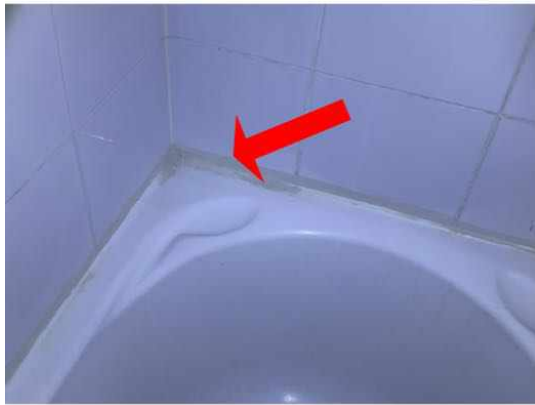
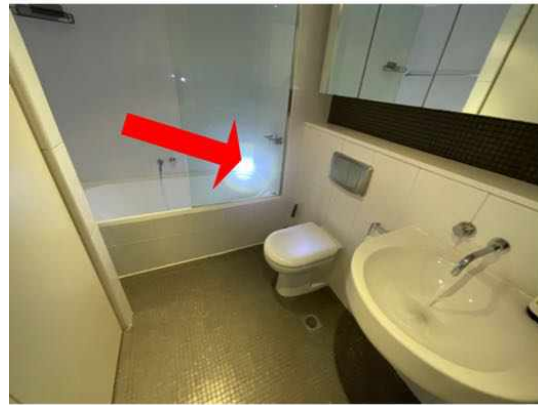
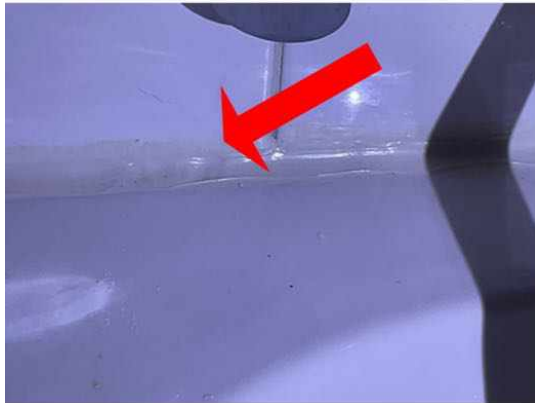
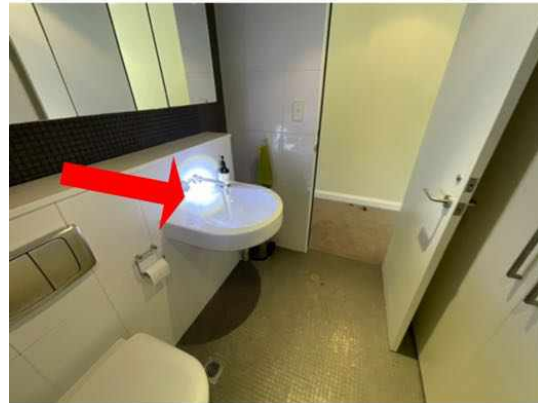
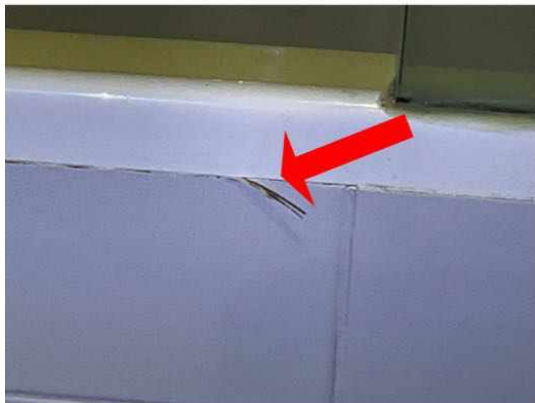
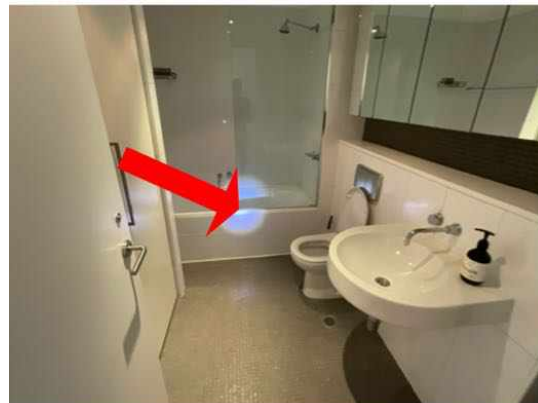
#### Defects 3.01

Building:	Main Building
Location:	Bathroom
Finding:	Sealant and grouting - Missing or damaged
Information:	It was noted on inspection that sealant or grout is degraded to the tiled shower alcove and or other areas of the bathroom.

Different materials and floor areas move at different rates, generally causing cracking to grout or sealant at this point. A flexible sealant is required to allow for expected expansion and contraction, while keeping the joint water tight and protective of all associated building materials.

There appears to be excessive mould to the sealant and grout which will likely require scraping out and replacement.

Flexible and mould resistant materials should be applied to affected areas to prevent any subsequent water damage that is likely to occur. Regular maintenance and replacement of damage or missing or damaged sealant and grout is highly recommended to the wet areas, as this is a regular wear and tear defect. Sealant and grouting in areas that come into regular contact with water should be maintained for the long term care of your property.

A sealant specialist or tiling contractor should be appointed to complete these works as soon as possible

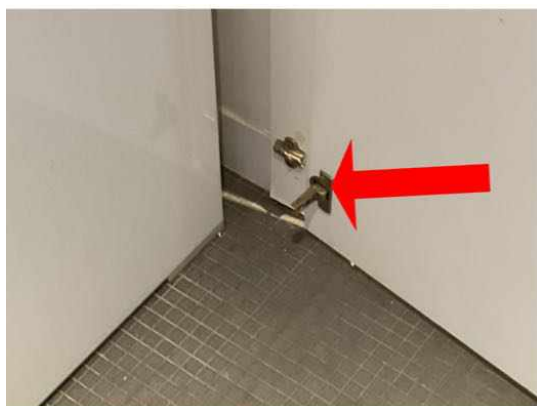
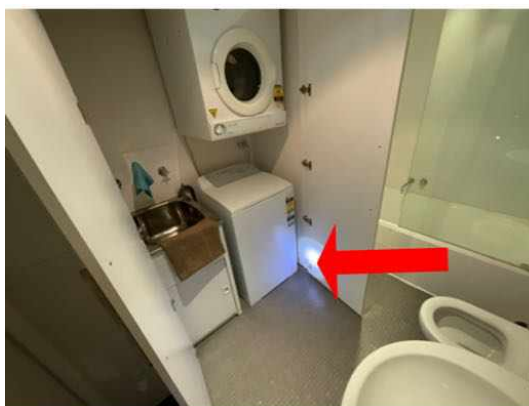
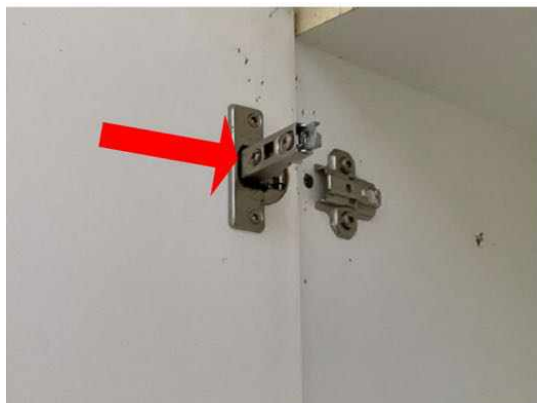
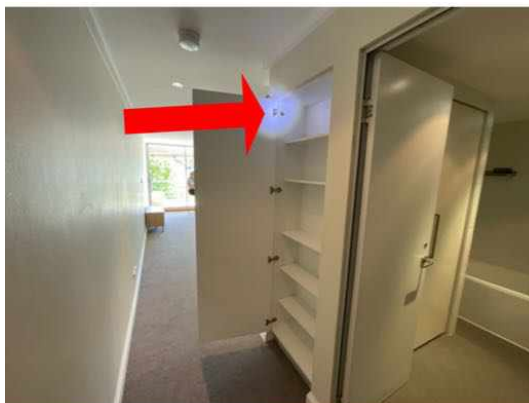
### Defects 3.02

Building:	Main Building
Location:	All Internal Areas
Finding:	Cabinetry - Loose hinges
Information:	Several cupboard doors are not level and detract from the operational state of the cabinetry. Upon further inspection, it was noted that the hinges to the cupboard doors have deteriorated over time and, as a result, have come loose from their original fixing. To improve operation of the affected cupboard doors, a general handyman may be appointed to replace the faulty hinges. Such works should be completed at discretion of the client.

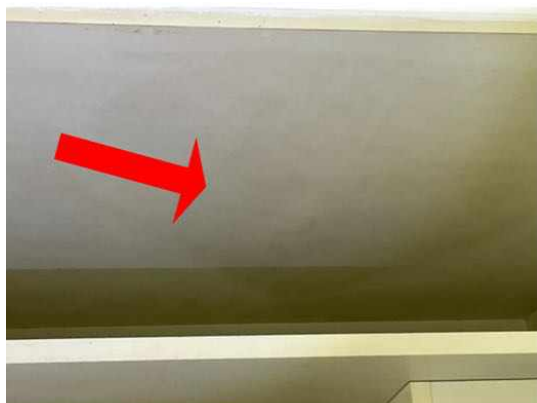
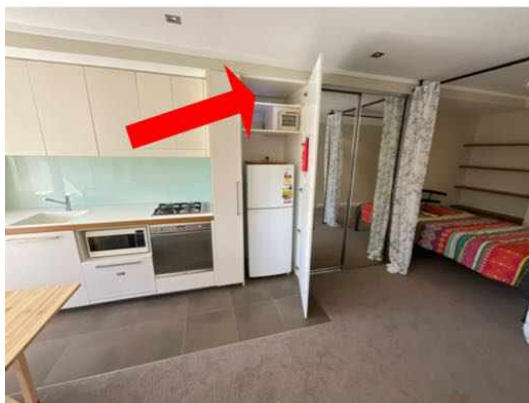
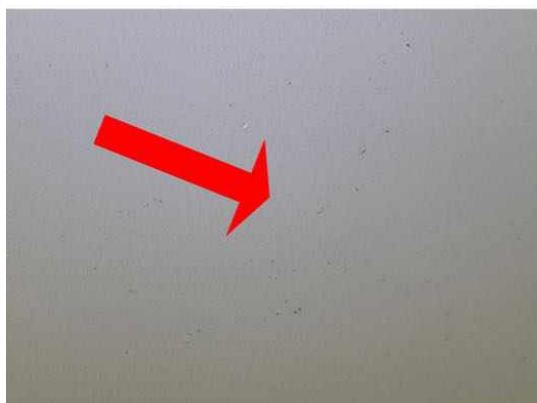
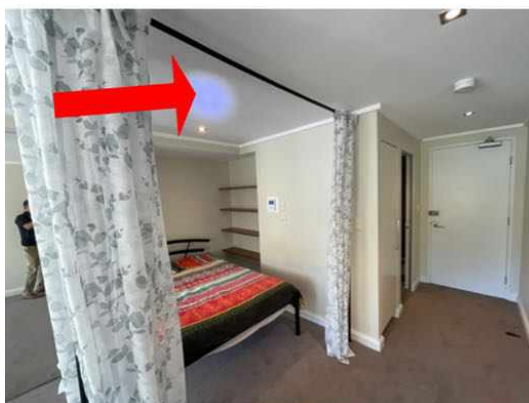
### Defects 3.03

Building:	Main Building
Location:	All Internal Areas
Finding:	Paint finish - Substandard, Wear and Tear
Information:	The paint finish in this area was found to have been completed to a substandard level or wear and tear as the normal deterioration of a property from ordinary, everyday use. Exposure to the elements, time, as well as day to day living can cause fair wear and tear.

If this applies, further areas of poor and incomplete finishes could develop over time. Furthermore, substandard, wear and tear paint finishes in areas exposed to moisture, e.g. external areas or wet areas, could lead to deterioration of underlying building materials.

Substandard, wear and tear paint finishes should be sanded back, filled, leveled and repainted, as applicable. Where inadequate paint protection has led to the deterioration of the associated building element, repair and/or replacement of this building element may be required.

A painting contractor should be appointed as soon as possible to perform necessary works to aid the appearance of the affected area and to ensure that the area is protected against further deterioration. Alternatively, the homeowner following manufacturer instructions may be able to provide this service.

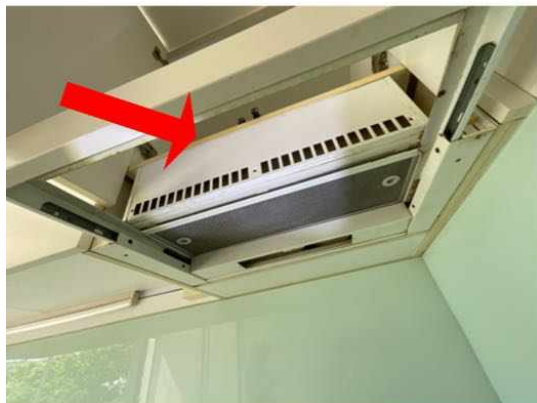
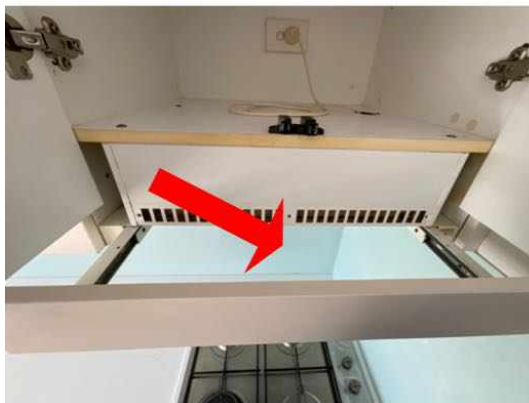
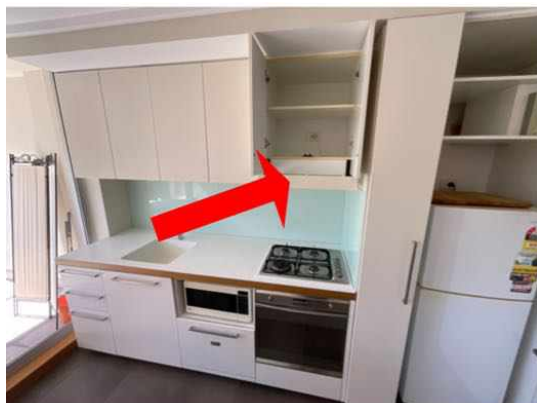
### Defects 3.04

Building:	Main Building
Location:	Kitchen
Finding:	Rangehood - filter missing
Information:	While the range hood appears to be working at a satisfactory level, a filter was missing at the time of inspection.

Without a functional fan, a build-up of grease and evaporative moisture is likely to accelerate deterioration of the range hood and associated flue. This potential build up may also create a minor fire hazard, particularly if left uncleaned.

A licensed electrician should be appointed to replace the filter on the range hood to restore it to a fully operational.

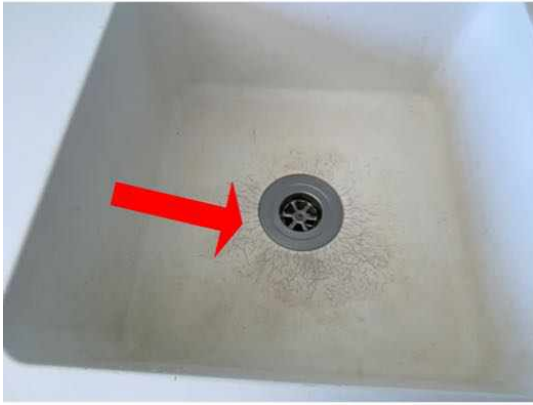
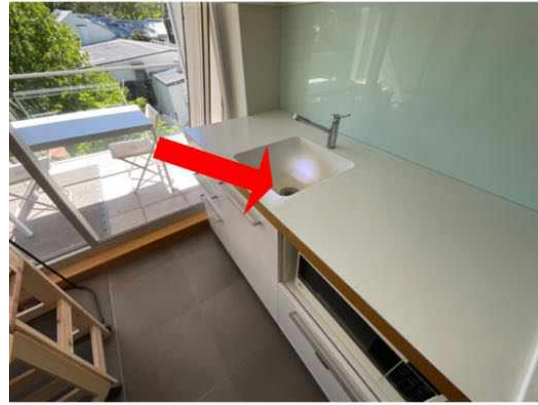
### Defects 3.05

Building:	Main Building
Location:	Kitchen
Finding:	Kitchen sink - cracked or damaged
Information:	Hairline cracking (crazing) was evident to the a vanity in this area at the time of inspection. While the cracking appears to be minor, this area is frequently exposed to water, allowing potential for water penetration into adjoining sections and potentially further damages.

No leakage was evident at the time of inspection; however, ongoing deterioration is possible. A plumber or a qualified tradeperson should be appointed to replace the item that no further damage occurs.

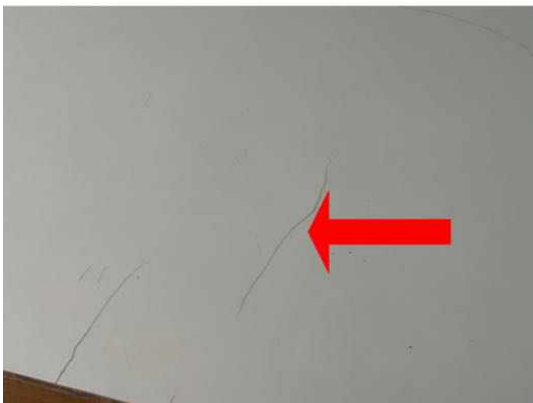
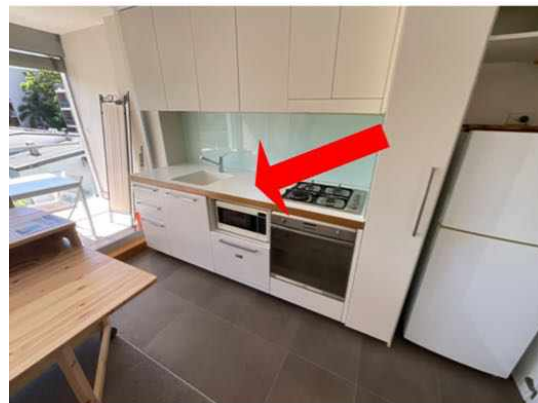
### Defects 3.06

Finding: Stone Benchtop - Crack or Damaged

Information: Cracking was evident to the stone benchtop in the kitchen area at the time of inspection. While the cracking appears to be minor, this area is frequently exposed to water, allowing potential for water penetration into adjoining sections of benchtop. If left unmanaged, water penetration to these areas may lead to subsequent water damage, which is likely necessitate repair work to affected building elements. A stone contractor should be appointed to ensure that no further water damage occurs. The re-application of silicone and grouting throughout is also advised, to further protect the area against water penetration. Where water penetration has led to water damage, appointment of a relevant tradesperson may be required to repair damaged building elements.

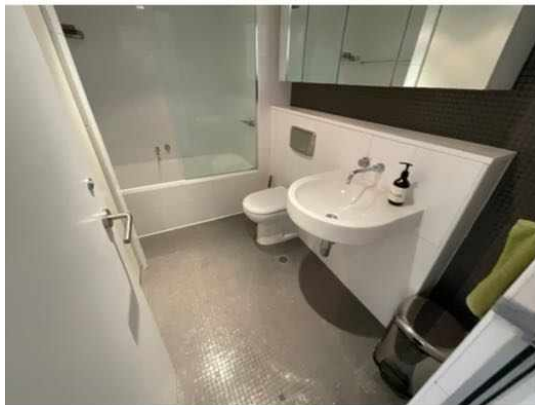
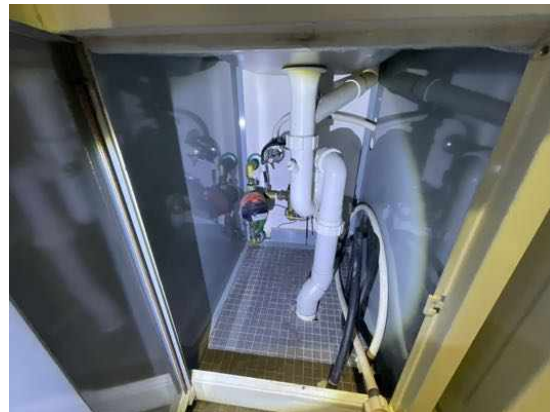
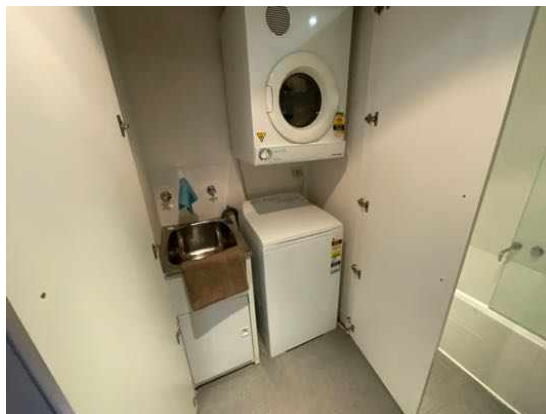
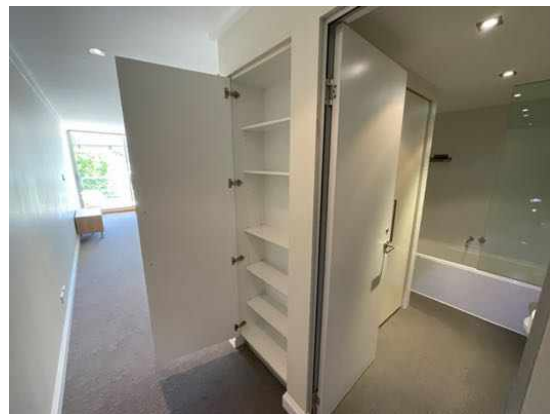
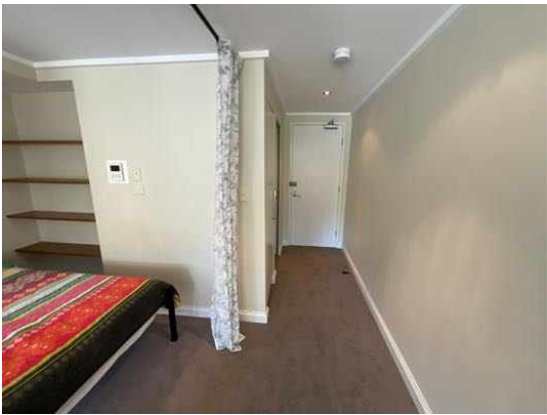
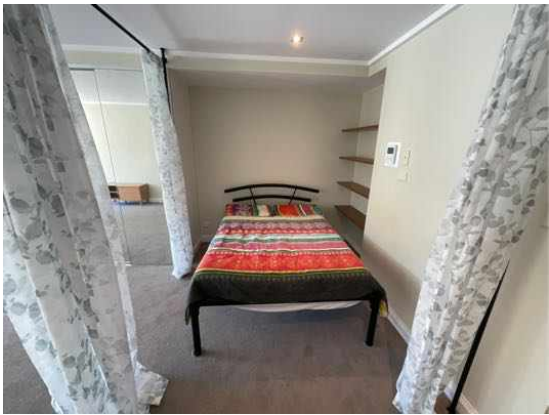
Finding: Additional Photos - Obstructions and Limitations

Information: These photographs are an indication of the obstructions and limitations which impeded full inspection of the property at the time of inspection. These obstructions can hide an array of defects and should be removed to allow full inspection to be carried out. A re-inspection is recommended once the areas are made accessible.

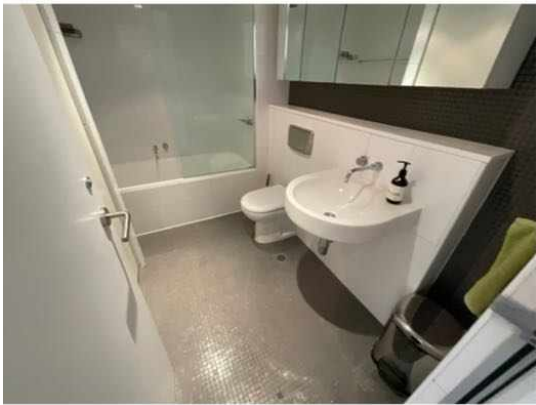
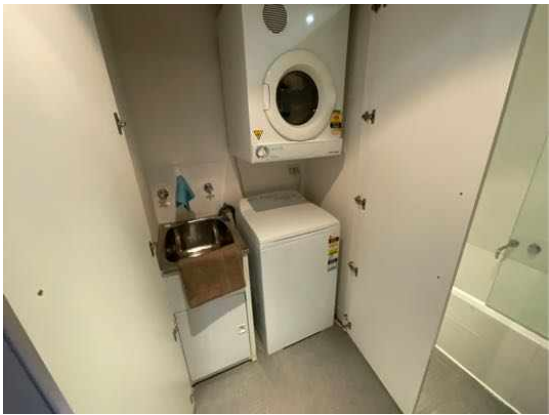
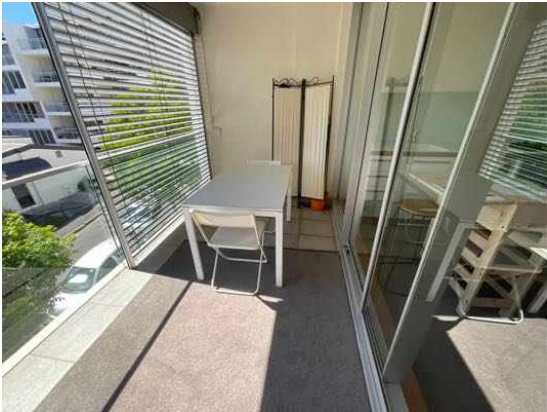
Finding: Water Proofing Membranes - Information Only

Information: Internal Water Proofing Membranes, are crucial in preventing water ingress into the property is important to know that the Membrane System used is to Australian Standards and has been installed correctly. Please refer to the original Building Documents or Maintenance Schedule for the relevant information including; - Membrane used and Manufacturers Specifications. - The Installer and Installation Certification. Especially with older property's where this information is unavailable, all wet areas should be monitored. Generally new waterproofing with a certificate may only have a guarantee of 8yrs. If any leaks, water staining, peeling or bubbling of the paint become evident to any adjacent walls or ceilings below a licensed builder or waterproofing specialist is recommended to investigate further.
