Building and Timber Pest Inspection Report

Inspection Date: Fri, 20 Mar 2026

Property Address: 3 Luss Ct, Glenhaven NSW 2156, Australia

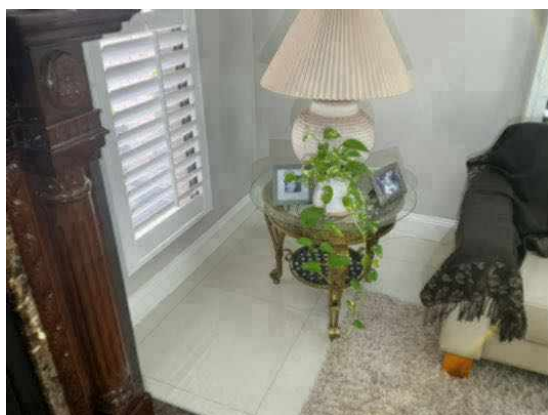
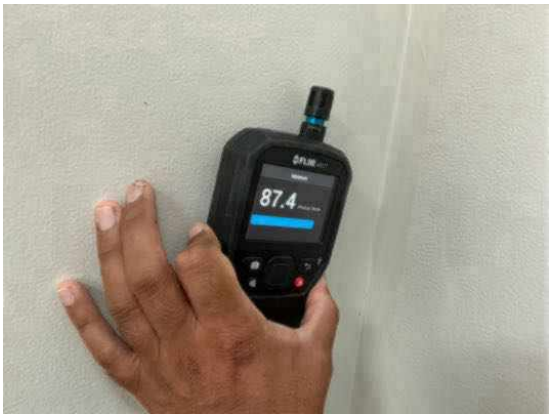
Building:	Main Building
Location:	Formal Lounge
Finding:	Active Moisture / Water Ingress
Information:	At the time of inspection, moisture intrusion was detected to the wall and ceiling areas within the formal lounge. Thermal imaging identified temperature variations consistent with moisture presence, and moisture meter readings were recorded at maximum levels, indicating a high degree of saturation within the affected building elements.

Visible signs of water damage were also noted, including deterioration to skirting boards, swelling/softness to finishes, and peeling/bubbling paint, which are consistent with prolonged moisture exposure.

The moisture pattern and location suggest that the water ingress is likely associated with external factors, such as defective or inadequate flashing, sealing failure, or water penetration around adjoining structural junctions. The leak appears to be active at the time of inspection, which may lead to ongoing deterioration of building materials, including plasterboard damage, timber decay, mould growth, and potential structural implications if left unaddressed.

Given the active nature and severity of the moisture ingress, this condition is considered a major defect requiring urgent attention. The client is strongly advised to engage the services of a licensed roofer as a matter of urgency to inspect the roof area, particularly around flashing, junctions, and adjoining surfaces near the affected corner. Any identified defects should be promptly repaired, sealed, or replaced to prevent further water entry.

Following rectification of the source, damaged internal finishes should be reassessed and repaired as required. Ongoing monitoring is recommended to ensure that the issue has been effectively resolved.

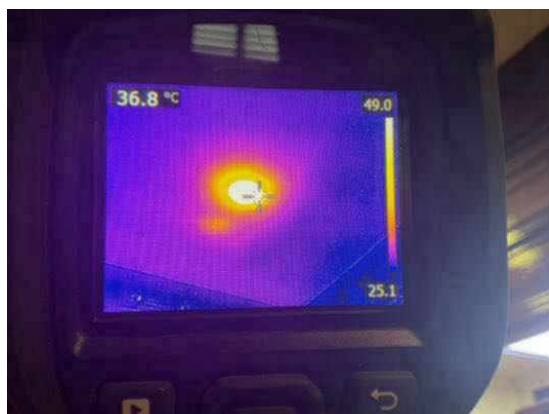
Building:	Main Building
Location:	Theatre Room, Upstairs Hallway
Finding:	Previously Patched Ceiling Areas
Information:	At the time of inspection, a number of ceiling areas were observed to have been previously patched and repaired. The finish to these areas was inconsistent with the surrounding ceiling, resulting in a visible variation in texture and appearance.

A thermal imaging camera was utilised during the inspection, and no signs of active moisture or water ingress were detected at the time, indicating that the issue is cosmetic in nature rather than structural or moisture-related.

It is recommended that a qualified painter be engaged to properly prepare, blend, and repaint the affected areas so that they are aligned with the surrounding ceiling finishes and present a consistent, professional appearance.

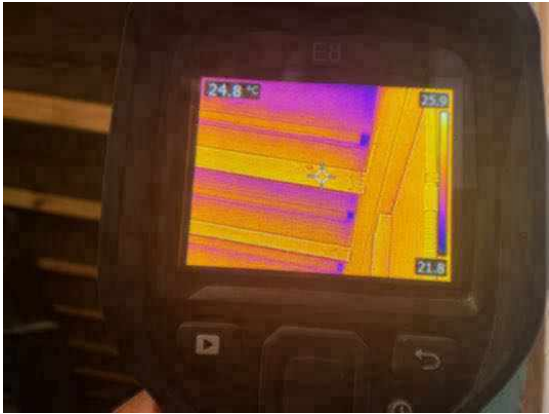
Finding 3.04

Building:	Main Building
Location:	Pool Equipment Room
Finding:	Moisture Ingress to Pool Equipment Room (Below Stairs)
Information:	At the time of inspection, evidence of moisture ingress and water staining was observed to the structural timbers and surrounding areas within the pool equipment room located beneath the stairs. This indicates that water is penetrating into the area from above.

Upon inspection of the stair area above, it was noted that sections appear inadequately sealed, allowing water to enter and migrate into the space below. This condition can lead to ongoing moisture-related deterioration, including timber decay,

mould growth, and potential structural impact if left unaddressed.

It is recommended that a suitably qualified waterproofing or sealant specialist be engaged to inspect the stair area above and carry out appropriate sealing and waterproofing works. All identified gaps, joints, and penetrations should be professionally sealed to prevent further water ingress. Continued monitoring is advised after rectification to ensure the issue has been effectively resolved.

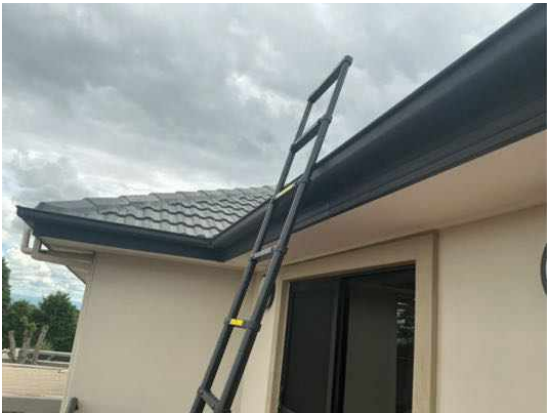
If left unaddressed, this may lead to accelerated deterioration of the gutter system, overflow during rainfall, and potential water ingress into the building.

It is recommended that a suitably qualified tradesperson be engaged to clean all

gutters and remove accumulated debris. In addition, a gutter installation specialist should be engaged to inspect and realign the guttering to ensure appropriate fall and effective drainage, preventing future water pooling.
