Building and Timber Pest Inspection Report VR

Inspection Date: Tue, 17 Mar 2026

Property Address: 12 Handley Ct, Blackburn North VIC 3130,
Australia

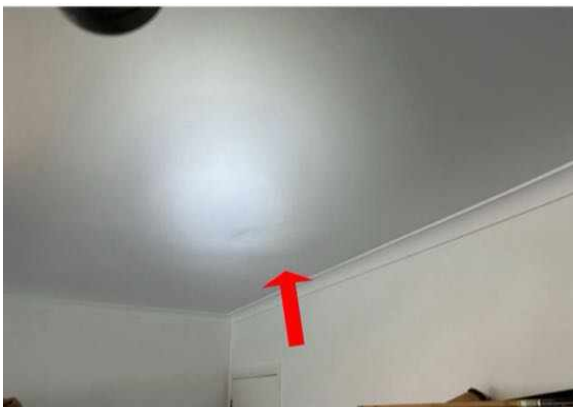
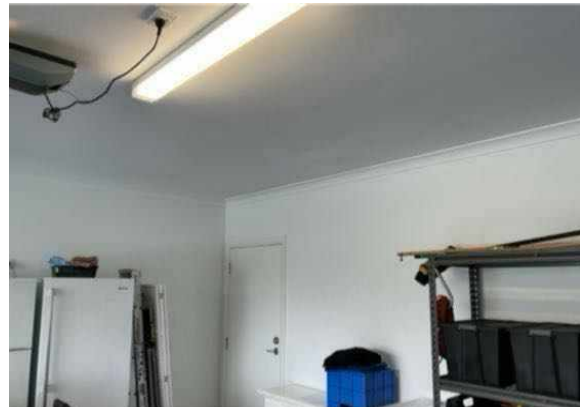
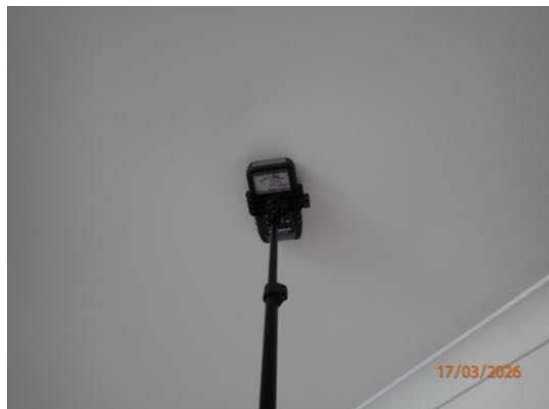
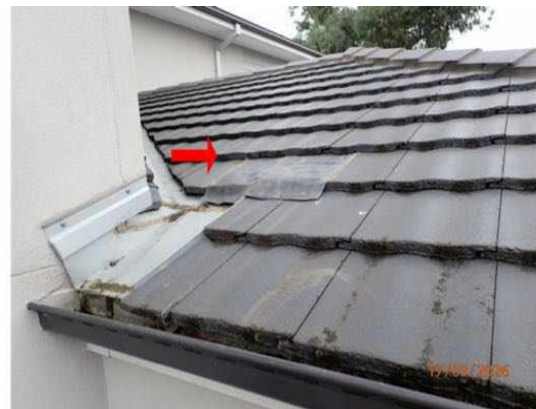
Finding 3.01

Building: Main Building

Location: Garage

Finding: Ceiling Plaster - Sagging

Information: This section of the ceiling plaster was noted sagging during inspection; the sagging appeared very minor and no elevated moisture was detected at the time, however the area should be monitored as minor ceiling movement can worsen over time, engage a roof plumber if the sagging increases or cracking/moisture staining develops.

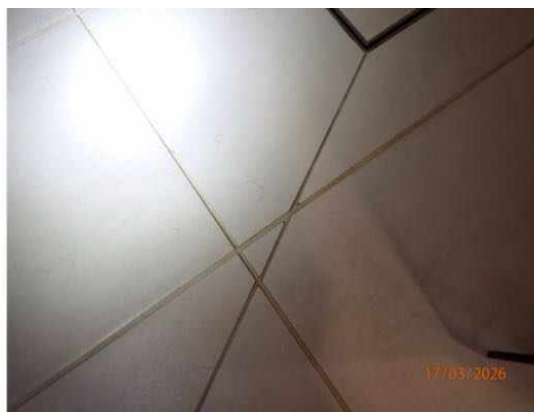
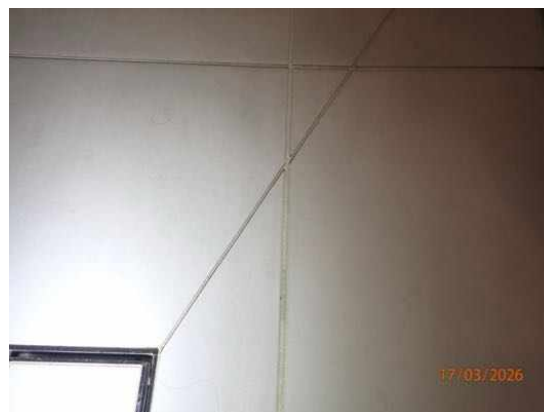
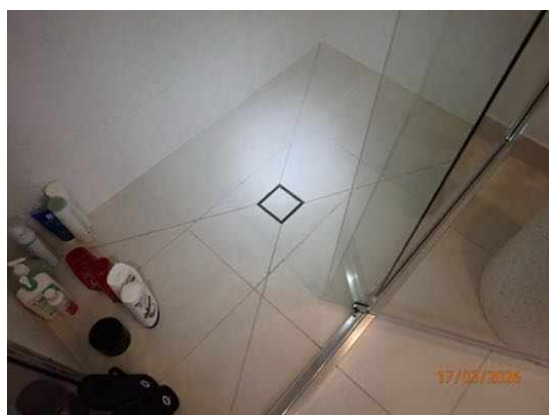
Finding 3.02

Building:	Main Building
Location:	Ensuite - Master
Finding:	Shower grout deterioration:
Information:	Degradation of the grout was noted in the tiled shower alcove during inspection; this appears to be due to normal wear and tear, however deteriorated grout can allow water penetration over time and contribute to moisture-related damage if not maintained engage tiling contractors to regROUT and reseal the shower area short term.

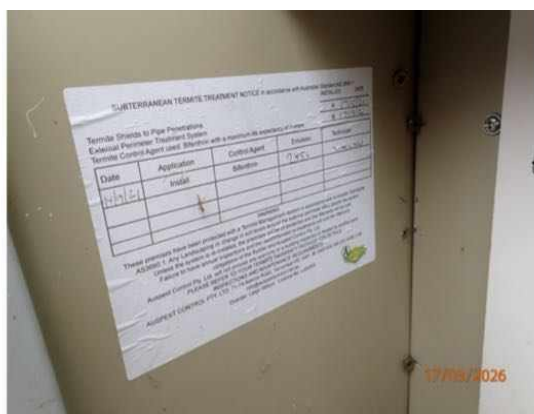
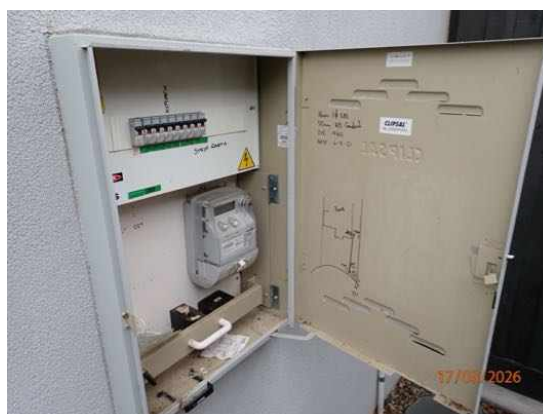
Finding 6.01

Building:	Main Building
Location:	Meter Box
Finding:	Termite Management System - evidence of a chemical installation
Information:	The application of a post-construction chemical termite barrier was noted during the inspection. The perimeter protection for termites need regular maintenance and a expiry date for the barrier was not noted . These barriers are highly effective in preventing termite attack on any timber building elements throughout the property.

The client may consider gaining further advice from a pest controller as to the costs and procedures involved with this application. It is recommended that obtaining such advice be a short-term priority.

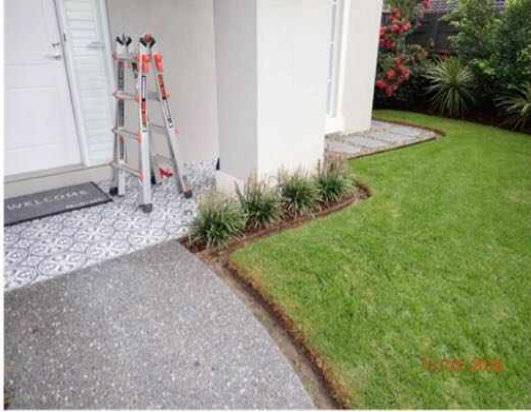
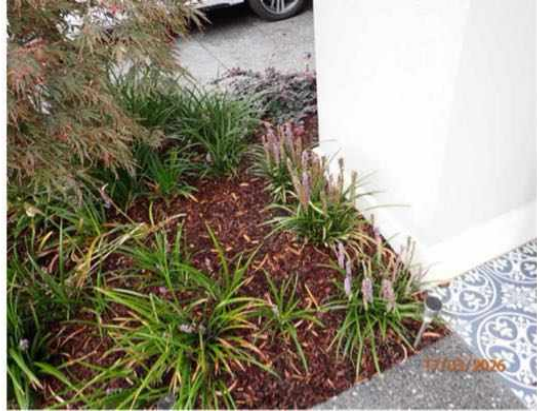
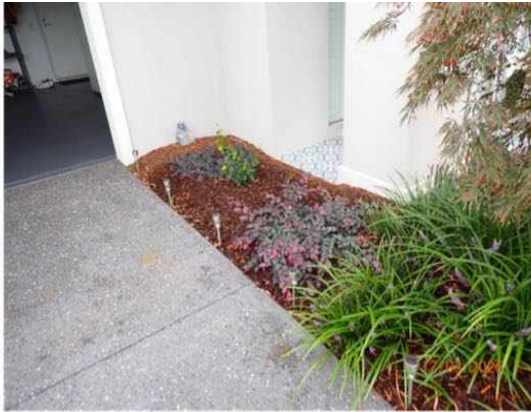
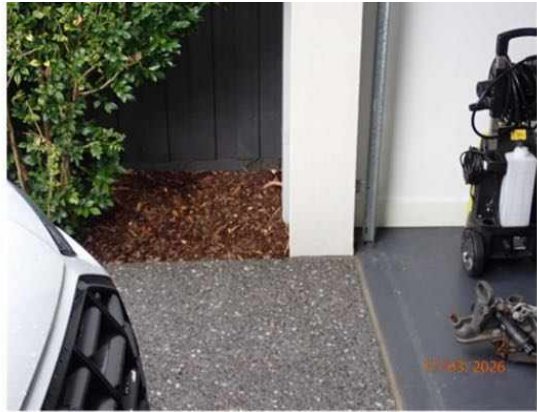
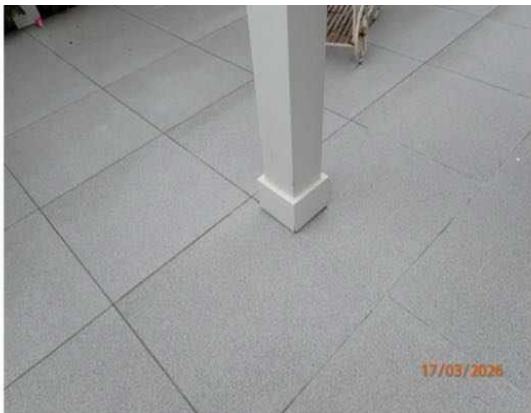
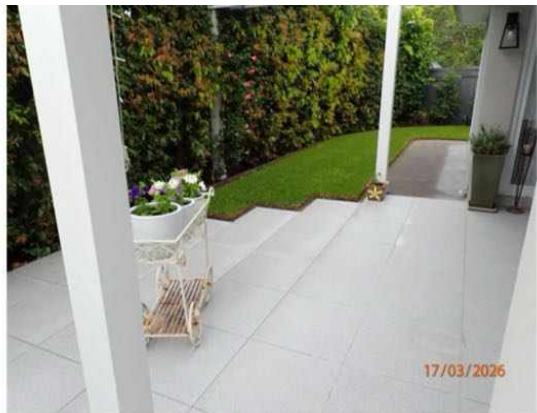
Finding 6.02

Building:	Main Building
Location:	All External Areas
Finding:	Conducive conditions due to Timber.
Information:	During inspection, several timber-related conducive conditions were identified around the property.

Timber elements in direct ground contact.

Garden beds containing containing untreated timber and moisture adjacent to External Walls.

These conditions can also lead to damage to the timber due to external element. It is recommended that a qualified carpenter be engaged to install appropriate barrier between the timber and the ground and create a clear inspection zone. The property owner should arrange a termite management plan or periodic inspections by a licensed pest controller if conducive conditions cannot be fully eliminated. By addressing these defects and eliminating conducive conditions, property owners can significantly reduce the likelihood of termite infestations. If conditions persist, periodic inspections by a licensed pest controller are essential to detect and mitigate potential issues.

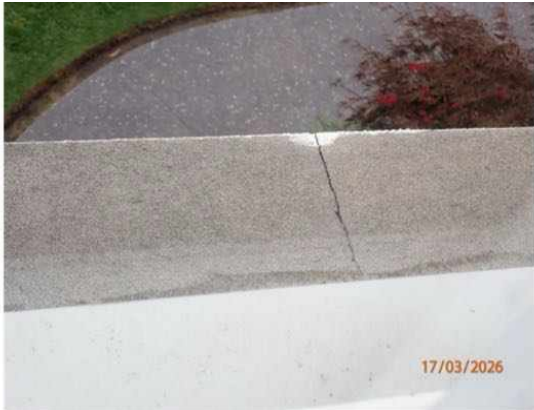
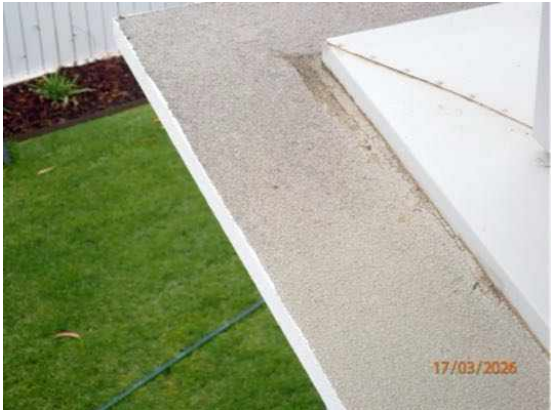
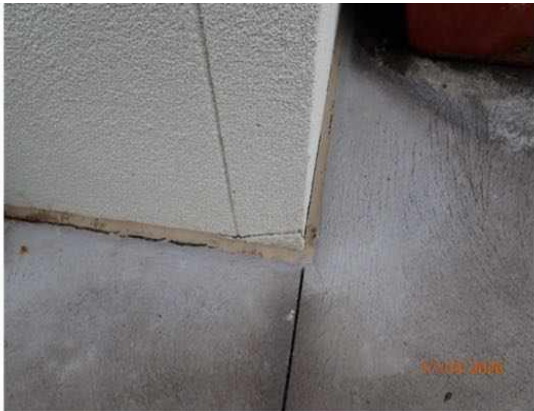
Building: Main Building
Location: All External Areas
Finding: Cracking Render
Information: Cracks on the external render were noted throughout the property. These cracks are very minor in nature and generally are only an appearance defect.

While such cracking may be noticeable, it is quite common and does not indicate any structural damage. However, if left unmanaged, these minor cracks can potentially widen or spread, leading to more noticeable cosmetic issues.

Cracking of this nature can generally be repaired with minor sanding, filling, and/or repainting. Such works should be performed by a qualified painter or a general handyman. Monitoring of all cracking should be conducted frequently. Always contact a building inspector should cracks widen, lengthen, or become more numerous.

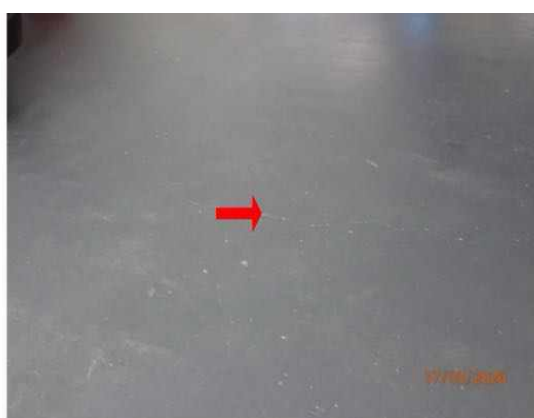
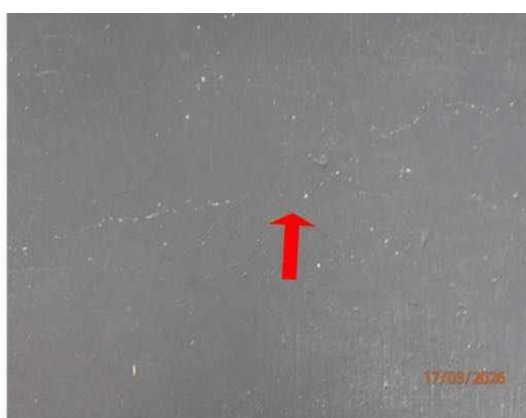
Building: Main Building
 Location: Garage
 Finding: Cracking Concrete - Fine
 Information: Fine cracks were identified in the concrete ceiling during inspection.

While these are typically considered appearance defects and do not usually indicate structural damage, they may worsen over time if left unmanaged. Regular monitoring is advised to assess any changes in the width, length, or number of cracks.

If the cracks expand or further deterioration is observed, it is recommended to engage a structural engineer to assess the condition and provide guidance. Early intervention can help maintain the structural integrity of the concrete and prevent potential future issues.

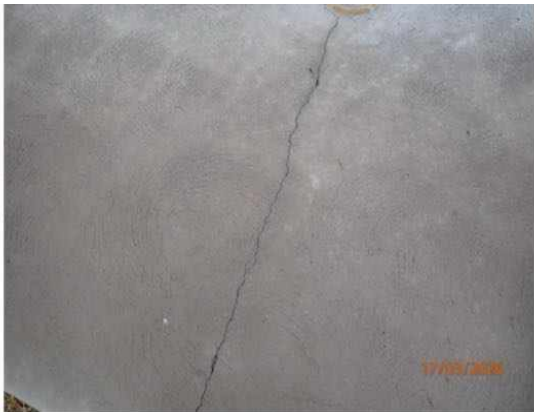
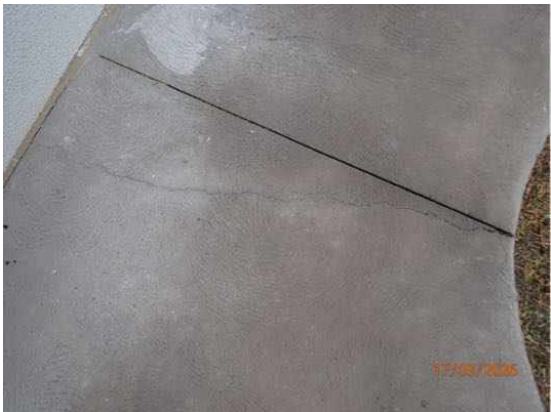
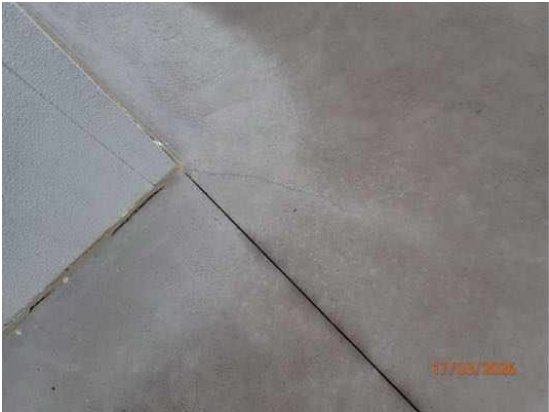
Building: Main Building
 Location: Exterior walls - rear
 Finding: Cracking Concrete - Fine
 Information: Fine cracks were identified in the concrete ceiling during inspection.

While these are typically considered appearance defects and do not usually indicate structural damage, they may worsen over time if left unmanaged. Regular monitoring is advised to assess any changes in the width, length, or number of cracks.

If the cracks expand or further deterioration is observed, it is recommended to engage a structural engineer to assess the condition and provide guidance. Early intervention can help maintain the structural integrity of the concrete and prevent potential future issues.

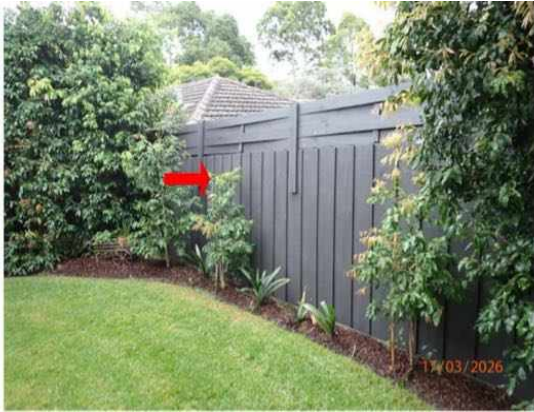
Building: Main Building
Location: Exterior walls - rear
Finding: Fence - leaning
Information: The fence in this section was noted leaning during inspection; this may worsen over time and could lead to further instability if left unaddressed—engage a handy person or registered builder to realign and secure the fence as required short term.

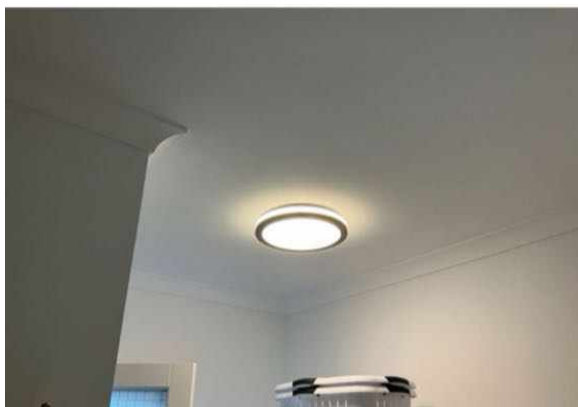
Location:	Laundry
Finding:	Exhaust fan - Missing
Information:	An exhaust fan has not been installed in this area. Missing exhaust fans may lead to the development of more significant defects such as moisture damage to surrounding building materials from inadequate ventilation. Inadequate ventilation in internal areas creates an environment that is conducive to the formation and development of mould and other respiratory hazards. It is highly advised that a licensed electrician be appointed to retrospectively install an exhaust fan. Failure to perform works to aid the ventilation of the area may lead to the development of these secondary defects.

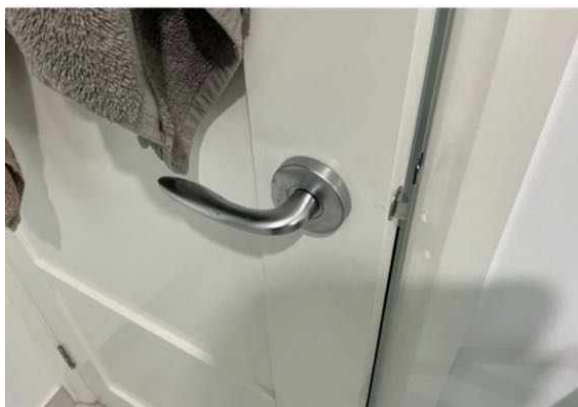
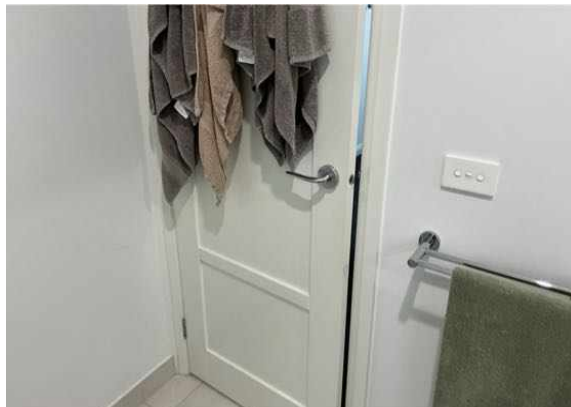
Building:	Main Building
Location:	Bathroom
Finding:	Door - Striker plate misaligned
Information:	The striker plate on this door was noted misaligned during inspection, affecting the door's operation.

Misalignment can result from general wear and tear or substandard installation, making it difficult to open or close the door.

It is recommended to engage a qualified carpenter or general handyman to realign the striker plate and restore the door's proper functionality.

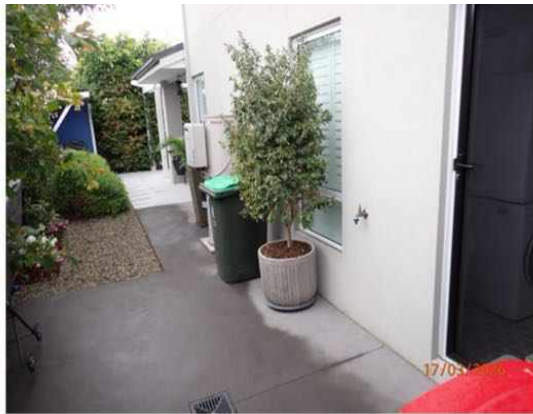
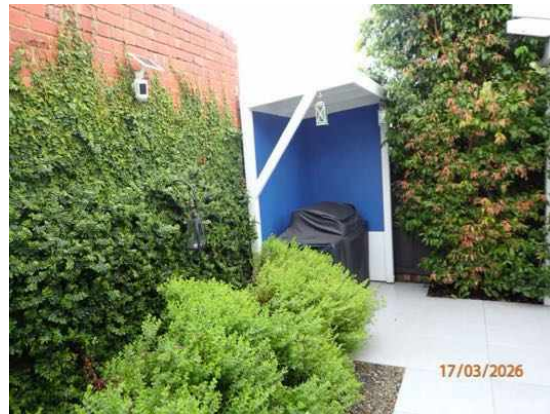
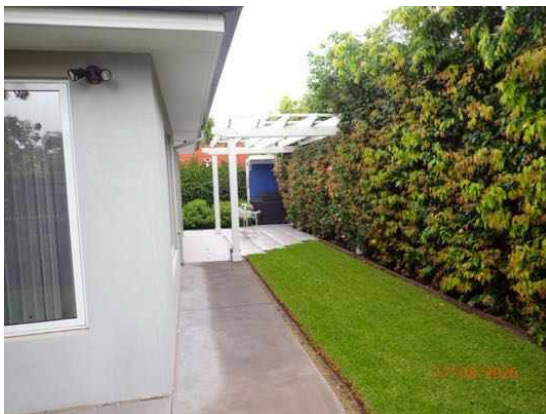
Building:	Main Building
Location:	All External Areas
Finding:	Additional Photos - Obstructions and Limitations External Areas
Information:	These photographs are an indication of the obstructions and limitations which impeded full inspection of the External areas of the property at the time of inspection. These obstructions can hide an array of defects and should be removed to allow full inspection to be carried out. A re-inspection is recommended once the areas are made accessible.

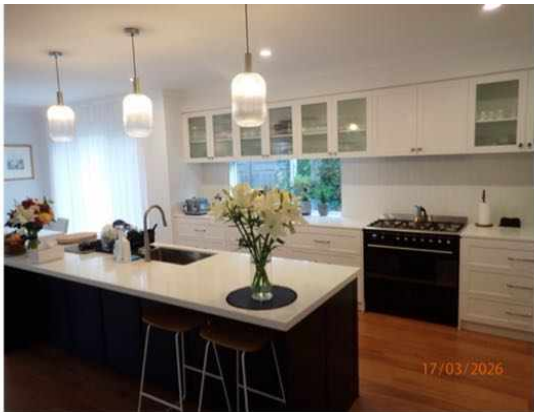
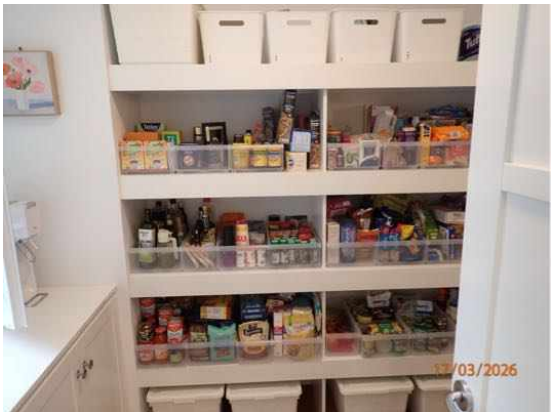
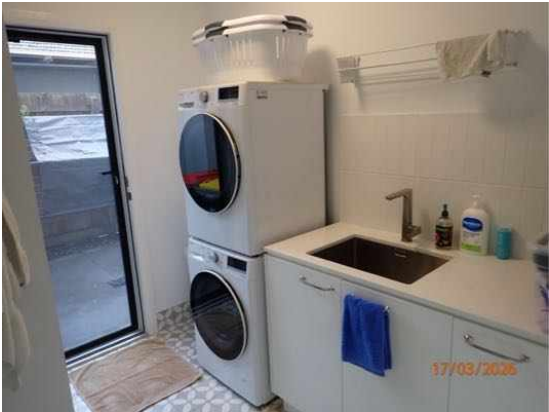
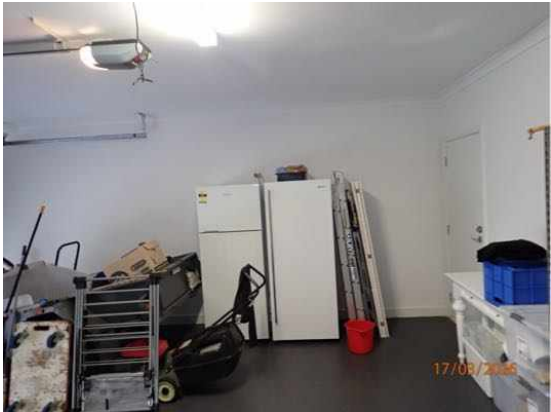
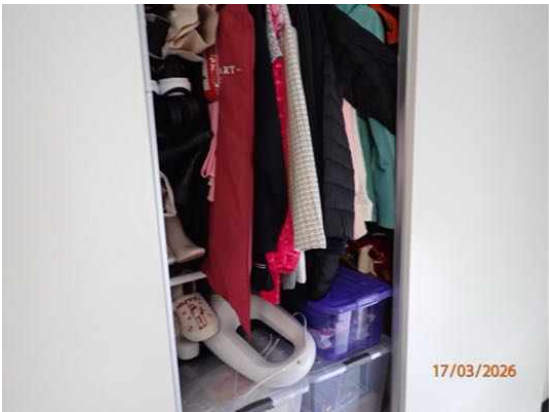
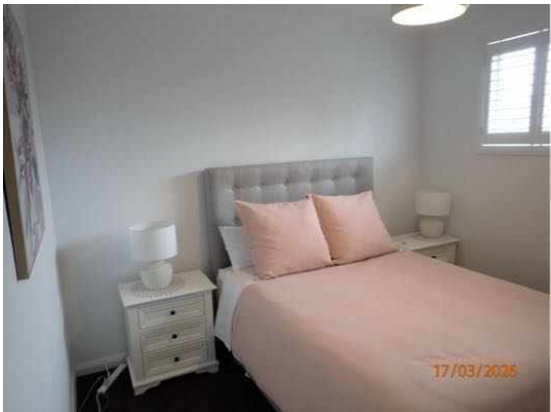
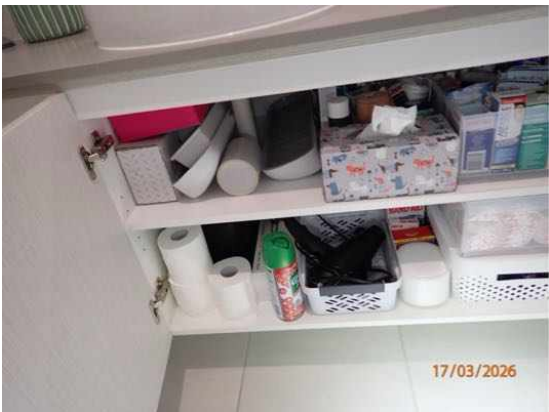
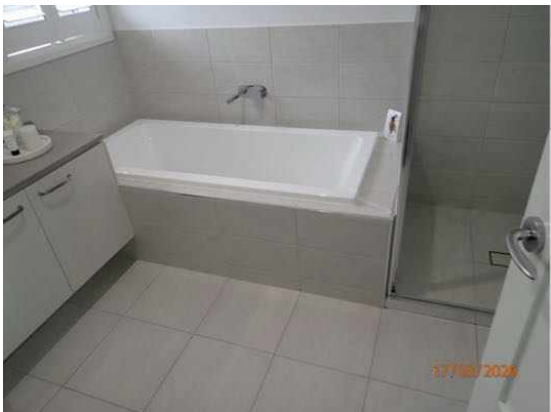
Building:	Main Building
Location:	All Internal Areas
Finding:	Additional Photos - Obstructions and Limitations internal Areas
Information:	These photographs are an indication of the obstructions and limitations which impeded full inspection of the internal areas of the property at the time of inspection. These obstructions can hide an array of defects and should be removed to allow full inspection to be carried out. A re-inspection is recommended once the areas are made accessible.

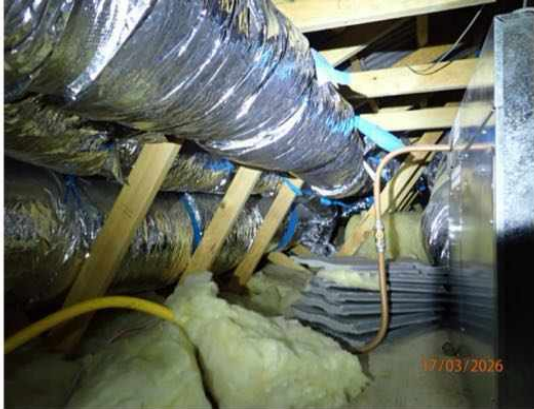
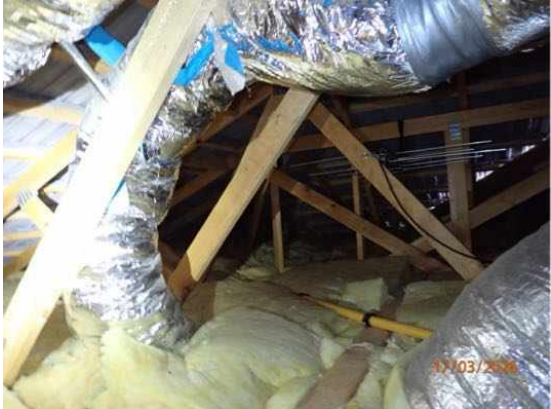
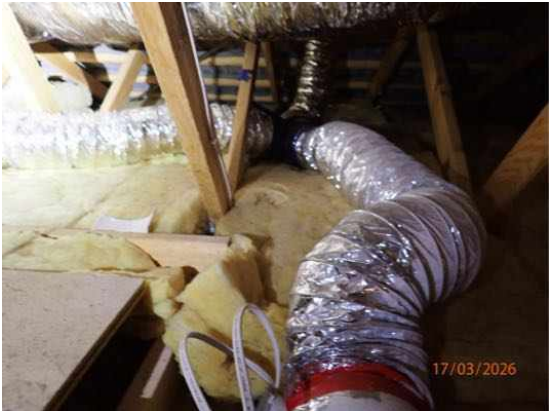
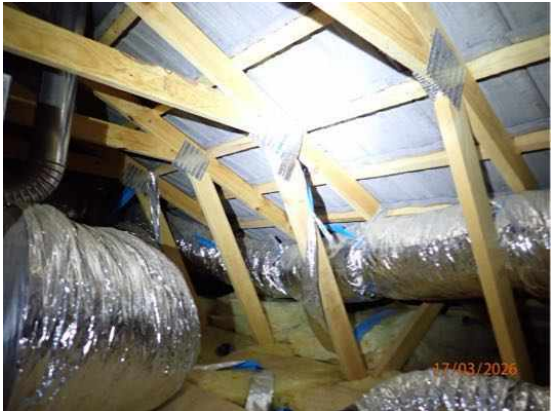
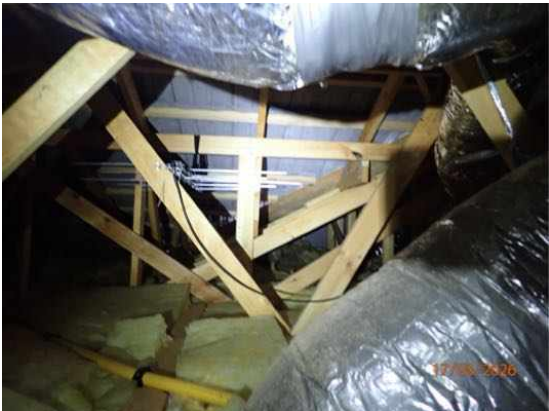
Building: Main Building
Location: Roof Void
Finding: Additional Photos - Obstructions and Limitations Roof Void
Information: These photographs are an indication of the obstructions and limitations which impeded full inspection of the Roof Void of the property at the time of inspection. These obstructions can hide an array of defects and should be removed to allow full inspection to be carried out. A re-inspection is recommended once the areas are made accessible.

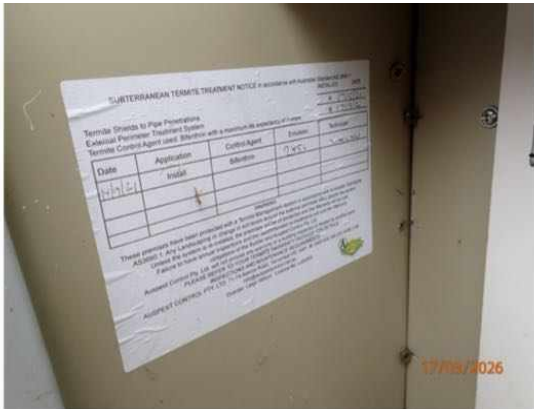
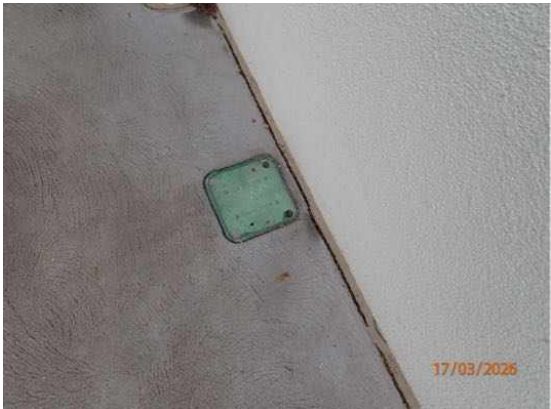
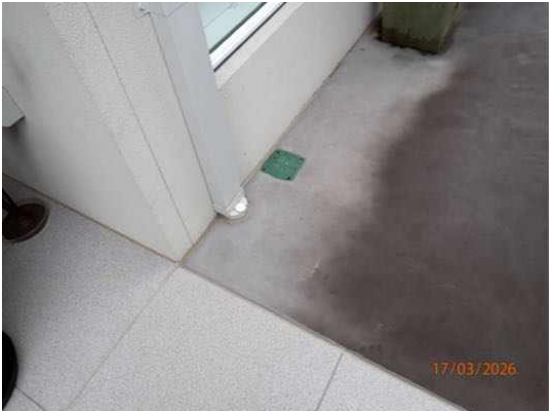
Most chemical termite management systems expire and require replenishment and all physical systems are primarily designed to prevent concealed entry.

Where a Termite Management System has been identified you should refer to the type of barrier date of installation warranty conditions and any documentation provided by a builder or past owner. Consult the company who installed the barrier to confirm whether the system is still under warranty.
