Building and Timber Pest Inspection Report

Inspection Date: Mon, 19 Jan 2026

Property Address: 33 Stewart Street, South Windsor NSW
2756

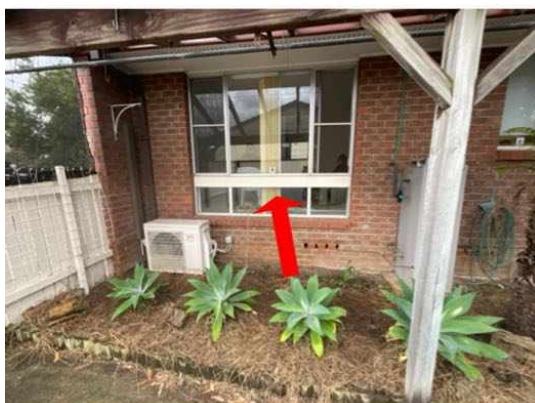
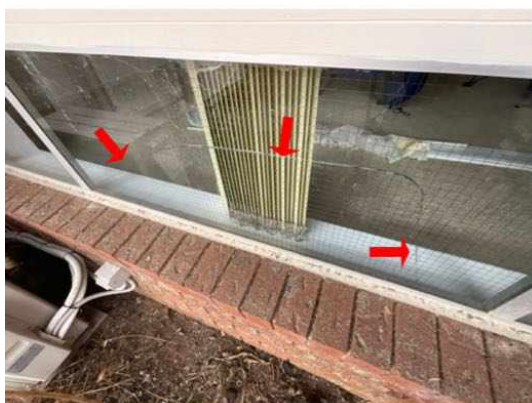
Building:	Main Building
Location:	Exterior window - right side
Finding:	Window - Cracked Glazing.
Information:	Observation

Cracking was identified to the window glazing in this area at the time of inspection. The pattern and nature of the cracking is consistent with impact-related damage. No evidence was available to confirm the timing or cause of the damage; however, the defect is clearly visible and has not been rectified.

Cracked glazing is likely to continue to deteriorate over time, with an increased risk of the glass further cracking or shattering, particularly when exposed to vibration, wind loading, or temperature variation. This condition presents a potential safety hazard to occupants and visitors. In addition, the integrity of the window is compromised, reducing weather tightness and increasing the likelihood of minor water ingress and draughts, which may lead to secondary damage to internal finishes if left unmanaged.

A suitably qualified glazier should be engaged to repair or replace the damaged window glazing as soon as practicable. Until rectification is completed, caution should be exercised by any persons in proximity to the affected window to reduce the risk of personal injury.

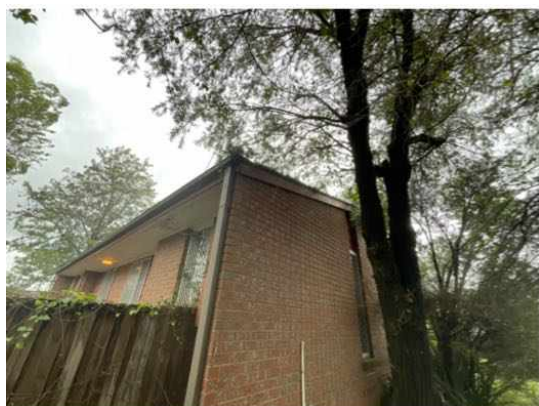
Building: Main Building
Location: Front Elevation
Finding: Overhanging Trees and Gutter Maintenance – Observations & Recommendations.
Information: Overhanging tree branches were observed above the roofline, contributing to the accumulation of leaf litter and debris within the gutters. This condition can adversely affect the performance of the roof plumbing system, particularly during periods of heavy rainfall.

Blocked or restricted gutters impede the effective discharge of stormwater, increasing the likelihood of water pooling or overflow. This may result in accelerated rusting and corrosion of gutters and downpipes, as well as the creation of damp conditions that are conducive to termite activity and other pest issues.

- Prune or remove overhanging tree branches to minimise debris accumulation.
- Clean all gutters and downpipes to restore full drainage capacity.
- Consider the installation of gutter guards as a preventative measure, particularly in heavily treed areas.

General gutter cleaning may be undertaken by the homeowner; however, pruning of larger branches should be carried out by a suitably qualified arborist or landscape contractor. A licensed roof plumber should be engaged to assess the condition of the guttering system and undertake any necessary remedial works. Regular maintenance will assist in preserving roof plumbing components, protecting the building envelope, and reducing the risk of moisture-related damage or pest activity.

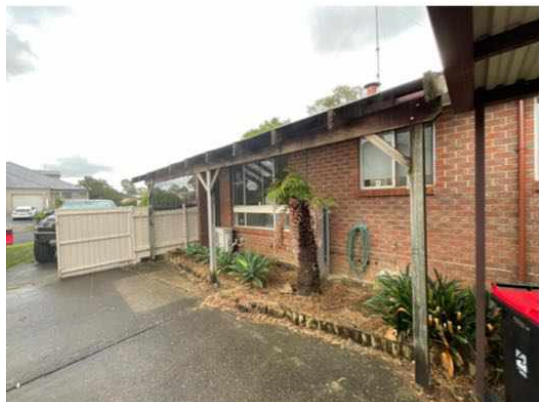
Finding 3.02

Building:	Main Building
Location:	Pergola
Finding:	External Timber Elements – Weather Exposure and Maintenance.
Information:	Findings:

- External timber components of the building, which are frequently exposed to harsh weather conditions, show signs of wear and lack adequate protective treatment.
- In areas where timbers have not been properly painted or sealed, deterioration is likely to progress at an accelerated rate due to constant exposure to moisture, UV radiation, and temperature changes.
- Without timely intervention, the condition of these timbers may continue to degrade, potentially requiring replacement in the short-term future.

To prolong the life of external timber elements and prevent further degradation, prompt treatment and ongoing maintenance are essential. Untreated or poorly protected timbers will continue to deteriorate under environmental exposure, leading to avoidable replacement costs if not addressed in a timely manner.

- Where timber elements have already deteriorated, repairs will be necessary.
- A qualified carpenter should be appointed to assess and carry out any required structural or cosmetic timber repairs.

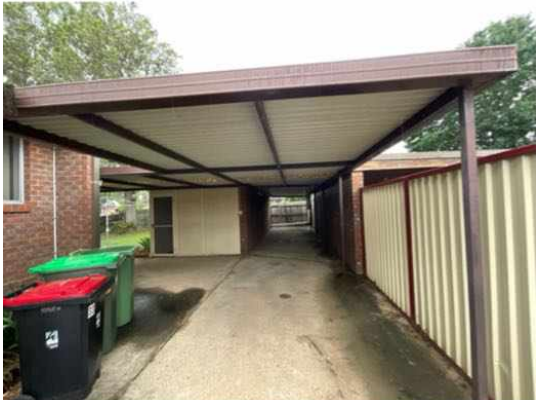
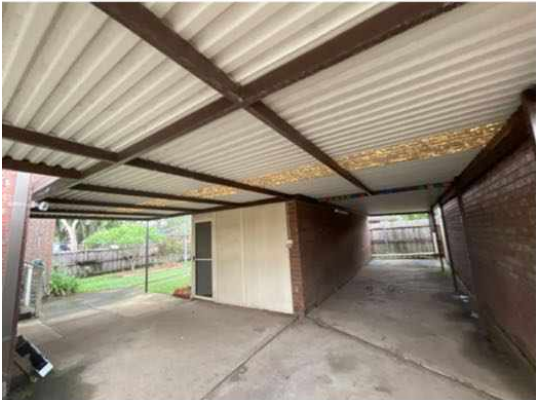
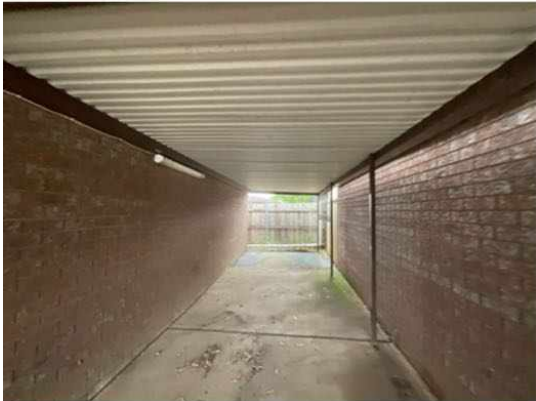
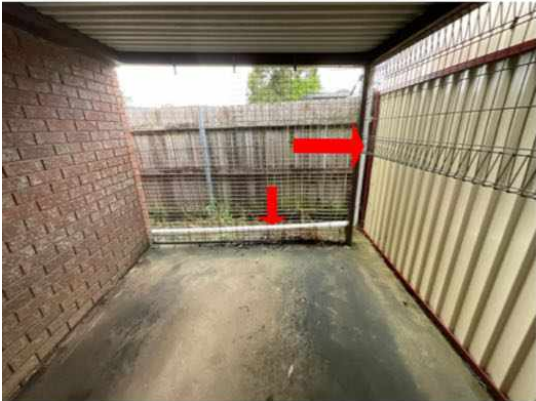
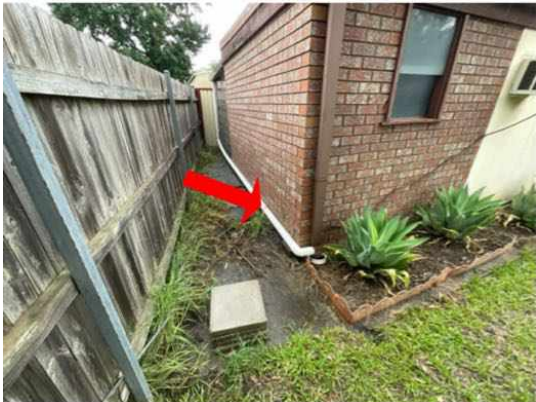
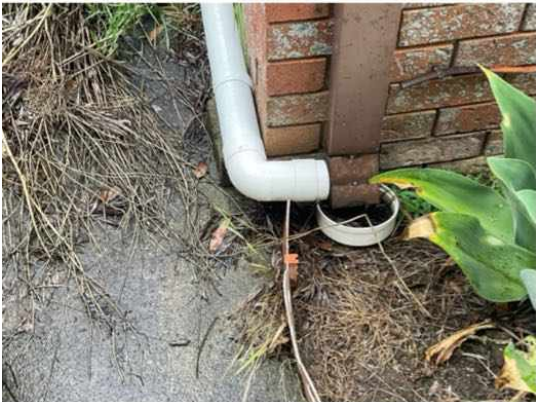
Finding 3.03

Building:	Out Building
Location:	Roof Exterior
Finding:	Roof Plumbing - Insufficient Capacity and Overflow Risk.
Information:	Observation:

During heavy rainfall, the roof plumbing overflows, causing damp conditions against external surfaces and the building perimeter base. This creates a risk of water damage and increased susceptibility to termite and timber pest activity.

- Engage a licensed and registered roofing plumber to assess and upgrade the roof drainage system as needed to ensure proper function.
- In the interim, ensure all gutters and downpipes are clear of debris and blockages to reduce overflow risk.

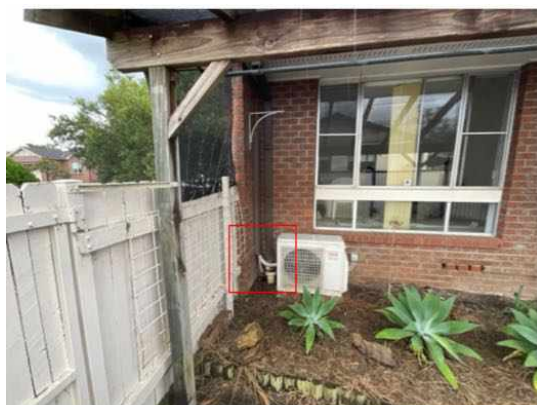
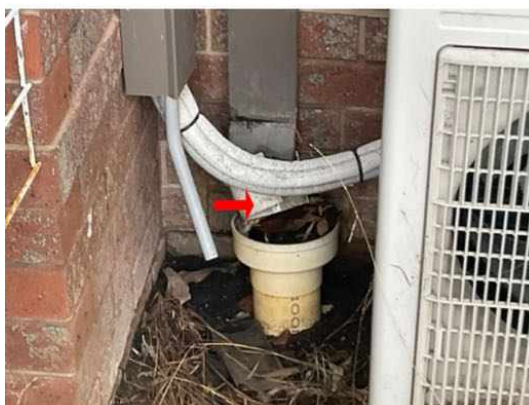
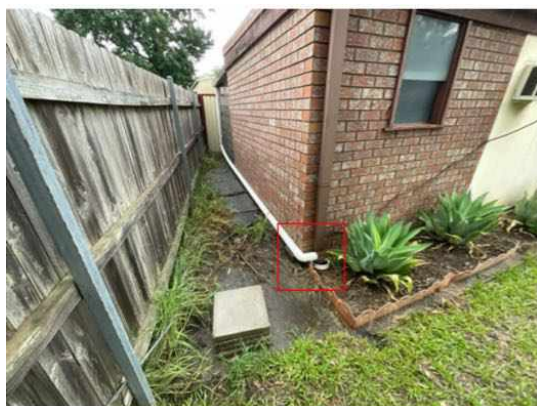
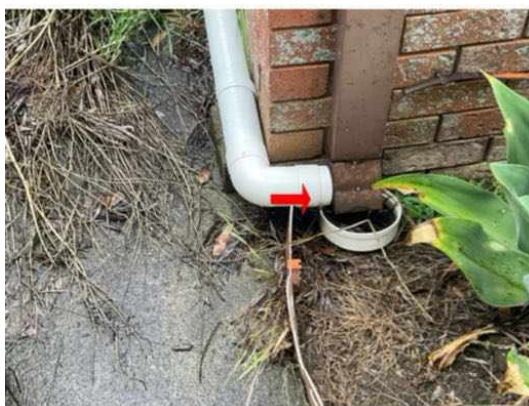
Finding 3.04

Building: Main Building
Location: Front Elevation
Finding: Downpipe - Damaged or Modified.
Information: Modified or Damaged Downpipe – Stormwater Drainage Concern

- This may suggest an attempt to bypass a blocked stormwater drainage pipe or redirect water flow due to inadequate drainage performance.

- Poorly sealed or disconnected downpipes can result in:
- Water pooling around the base of the building
- Excessively damp conditions at the foundation or subfloor level
- Increased risk of foundation movement, moisture ingress, or wood rot
- Water runoff may also be diverted to a neighbouring property, which is non-compliant with building codes and may create legal or council-related issues.

- Rectification is strongly advised.
- A licensed plumber should be appointed to:
- Inspect the area thoroughly
- Assess the condition of the stormwater system
- Repair, replace or properly connect all downpipes to ensure compliant and effective drainage

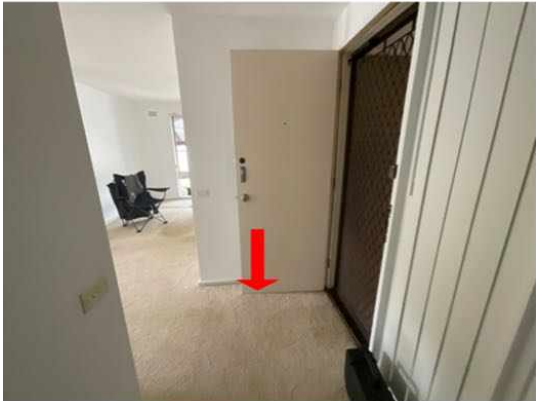
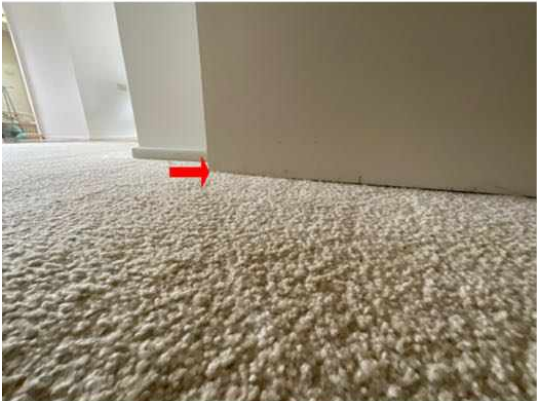
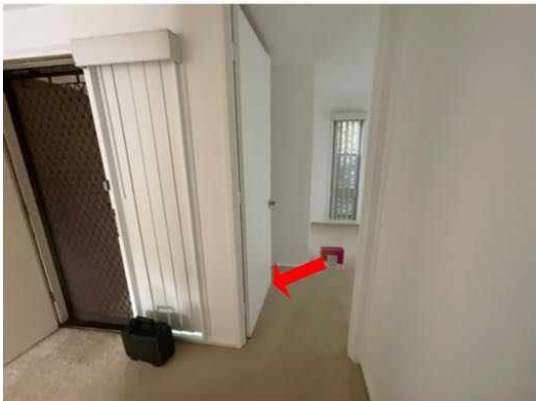
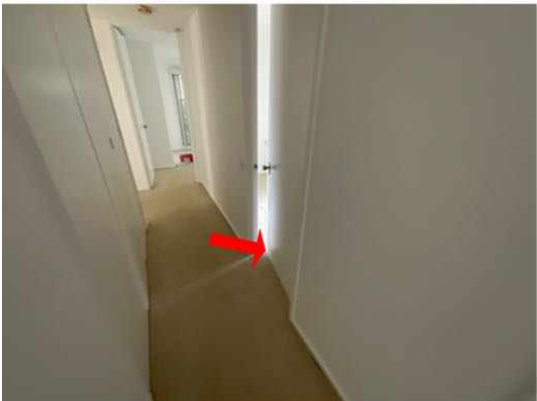
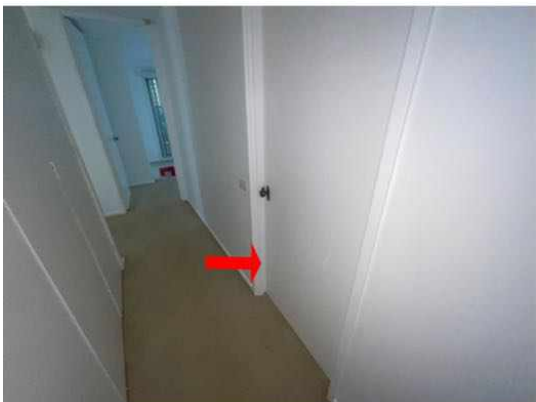
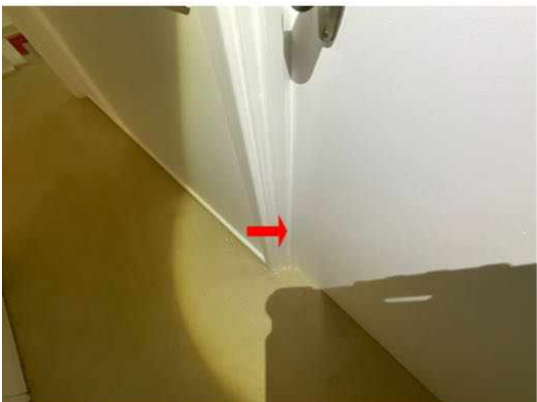
Finding 3.05

Building:	Main Building
Location:	All Areas
Finding:	Door - Binding and/or Jamming.
Information:	Functional Defect Identified

Binding and/or jamming of doors was observed during standard operation and appeared to be rubbing or binding. This issue impairs the normal functionality of the door and may lead to secondary damage to adjacent building elements, such as scuffing or tearing of floor coverings, or stress to door hardware and framing.

- Poor door installation
- Worn, damaged, or misaligned hinges
- Swelling or warping of materials
- Differential movement in the building structure (e.g. due to settlement, subfloor deflection, or foundation issues)

- If the issue appears to be related to major structural movement, it is recommended that a registered builder with experience in re-stumping or subfloor repairs be engaged to assess the extent of the movement and provide a quotation for necessary remedial works.
- Where the issue is minor in nature, a qualified carpenter or general handyperson may be appointed to carry out corrective works at the client's discretion.

Prompt assessment and remediation are advised to prevent further deterioration or related damage.

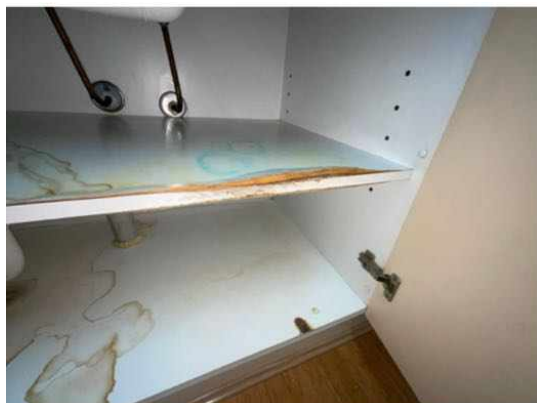
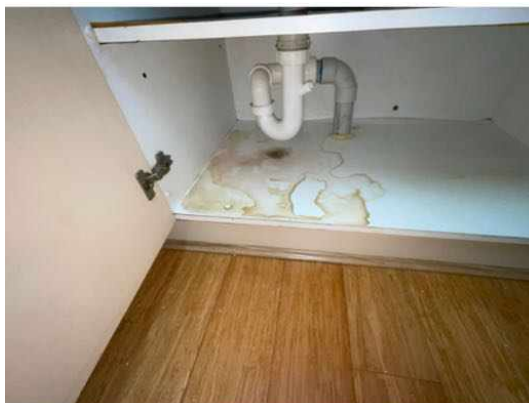
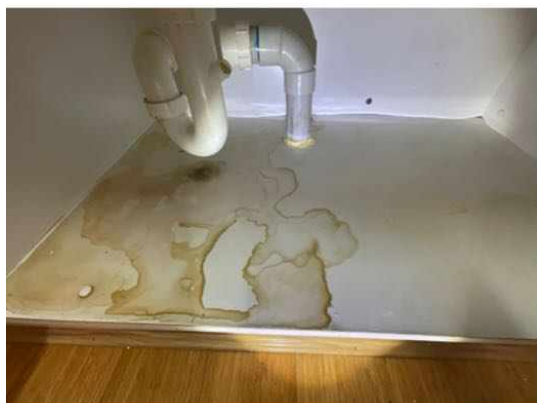
Finding 3.06

Building: Main Building
Location: Kitchen
Finding: Cabinetry - Swollen or Water Damaged.
Information: Observation:

Swelling to cabinet panels was observed at the time of inspection. This condition is generally indicative of prolonged exposure to excessive moisture, resulting in deterioration and expansion of the panel materials. The damage may also suggest that moisture-resistant materials were not used during the original construction or

Continued exposure to moisture is likely to result in further deterioration of the affected cabinet panels and may lead to secondary damage to adjoining cabinetry components or associated building elements. If left unmanaged, progressive deterioration could necessitate more extensive and costly remedial works.

It is recommended that the source of moisture be identified and rectified as a priority. Remedial works may include repair or replacement of the affected cabinet panels by a suitably qualified cabinet maker, at the client's discretion. Ongoing monitoring is advised to ensure no further moisture-related damage develops.

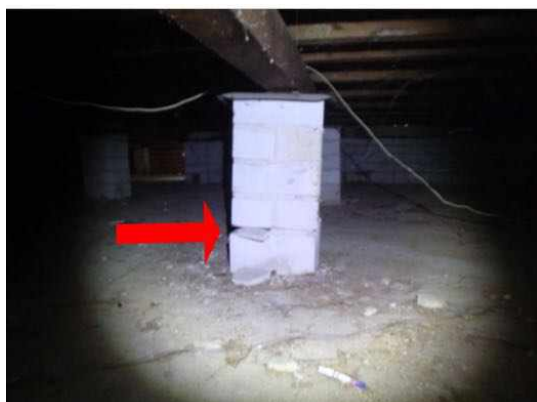
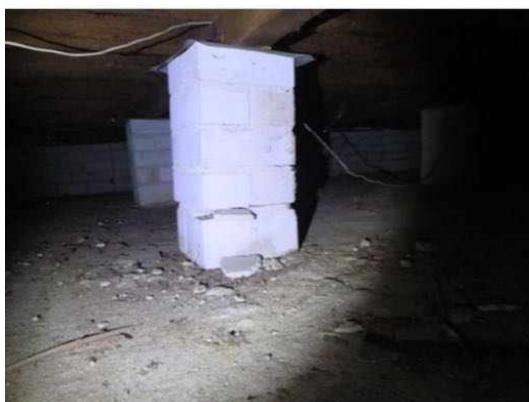
Finding 3.07

Building:	Main Building
Location:	Subfloor
Finding:	Minor Defect – Subfloor Pier Damage
Information:	Observation:

At the time of inspection, one of the piers supporting the subfloor structure was observed to be partially damaged. The defect appeared localised and minor in nature, with no significant distortion, excessive movement, or widespread failure evident in the surrounding subfloor elements at the time of inspection.

Although the damage is currently assessed as minor, a compromised pier may reduce its load-bearing capacity and, if left unaddressed, could contribute to uneven support of the subfloor structure. Over time, this may lead to further deterioration or secondary issues such as minor movement, creaking floors, or misalignment of supported elements.

As a precautionary measure, it is recommended that the damaged pier be assessed and repaired as required. A suitably qualified tradesperson (such as a licensed builder) should be engaged to carry out any necessary remedial works to ensure the pier provides adequate and ongoing support to the subfloor structure.

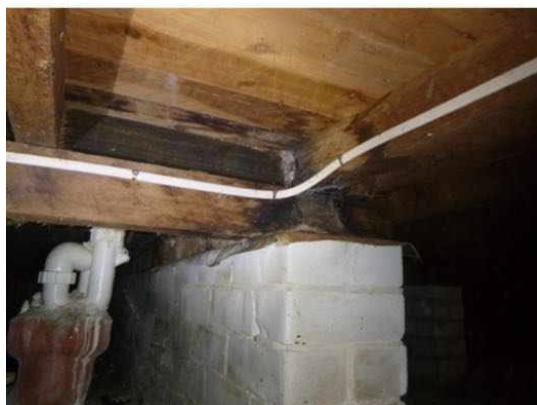
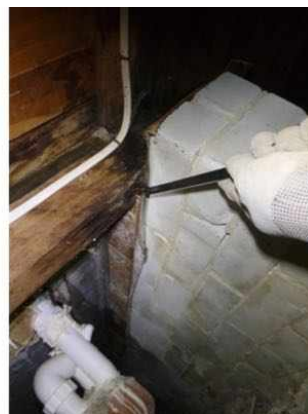
Finding 3.08

Building: Main Building
 Location: Subfloor
 Finding: Subfloor structure - Water stains below bathroom evident.
 Information: Observation:

Water staining and minor decay was identified to the subfloor areas beneath the bathrooms at the time of inspection. This type of staining is commonly associated with previous or intermittent water leaks, often originating from the shower base, plumbing penetrations, or failed or deteriorated waterproofing. The affected areas appeared dry at the time of inspection. No elevated moisture levels were detected to the shower wall tap fittings within the bathrooms at the time of inspection.

While no active moisture was detected during the inspection, the presence of water staining indicates that leakage has occurred at some point. If the bathrooms are not in regular or constant use, leaks may not be evident at the time of inspection, as many plumbing or waterproofing failures only become apparent during frequent use. Should leakage be ongoing or recur, continued moisture exposure may result in deterioration of subfloor timbers, structural elements, and associated building components, potentially leading to significant repair works.

It is recommended that the affected areas be monitored over time, particularly after the bathrooms are placed into regular use. A licensed plumber should be engaged to carry out further investigations, including testing of tap fittings and flood testing of the shower bases, to determine whether any leaks are active or ongoing. If leakage is confirmed, a suitably qualified bathroom renovation specialist should be appointed promptly to identify the source and carry out necessary repairs.

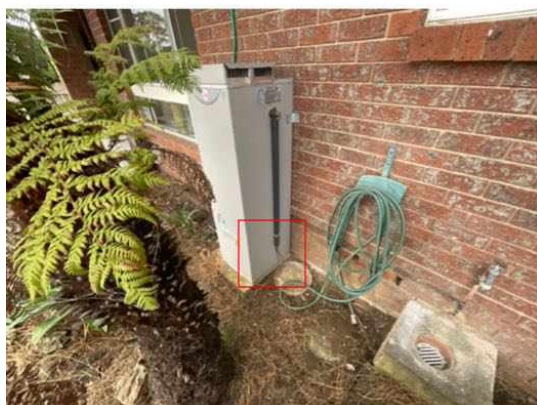
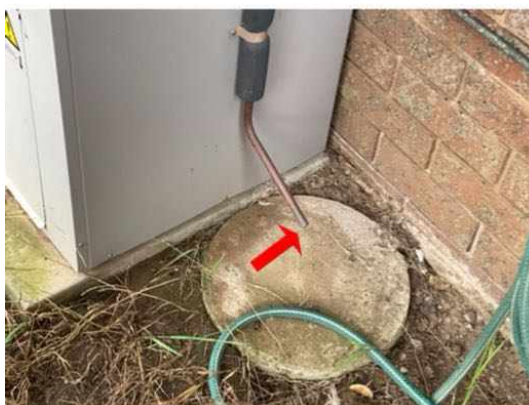
Building:	Main Building
Location:	All External Areas
Finding:	Overflow Management – Risk of Termite Activity..
Information:	Observation: Water Pooling from HWS and Air Conditioning Overflows

Water discharge from the Hot Water System (HWS) pressure relief valve and air conditioning unit overflows was observed discharging close to the base of the structure, contributing to water pooling around the building perimeter.

Persistent moisture near the foundation or subfloor area significantly increases the likelihood of termite activity. Termites are highly attracted to damp environments, and stagnant water near structural elements provides ideal conditions for foraging and infestation.

It is highly recommended that all overflows from the HWS and air conditioning units be redirected away from the building, preferably via fixed drainage or extension piping, to prevent water accumulation near the structure.

These minor corrective works should be undertaken promptly to minimise the risk of both termite ingress and potential structural damage due to ongoing moisture exposure.

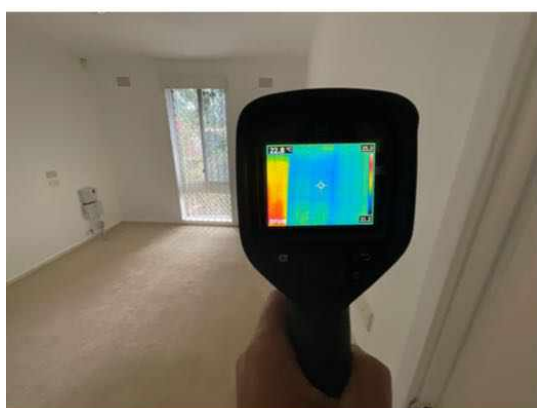
At the time of the inspection, no abnormalities indicating live termite activity were observed. However, it's important to note that various factors—such as obstructions, ambient temperature, and wall material/thickness—can impact the accuracy of thermal readings. In cases where surfaces are visually restricted or obstructed, a comprehensive thermal scan may not always be feasible.

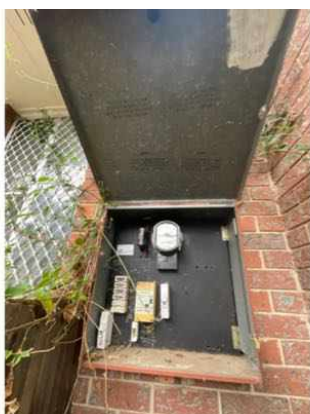
Building:	Main Building
Location:	All Areas
Finding:	Termite Management System - Missing Durable Notice..
Information:	Observation: Missing Durable Notice for Termite Management System

Proper maintenance and documentation are essential to ensure continued protection. Without a visible durable notice, there is no clear indication of what system (if any) is in place, which may limit the effectiveness of future termite inspections and hinder warranty claims.

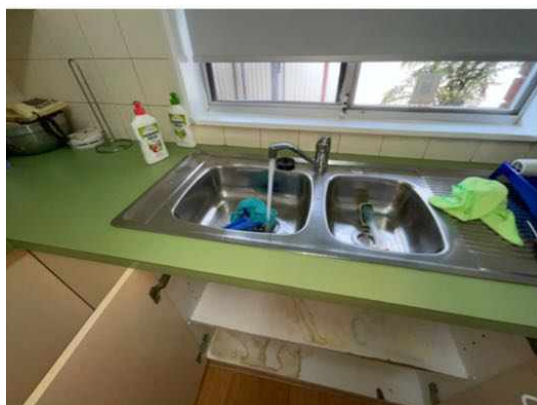
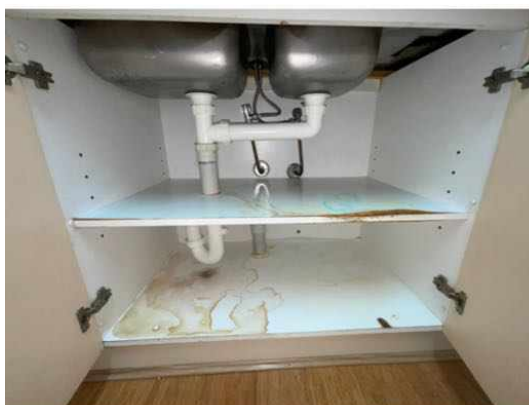
Building: Main Building
 Location: Kitchen
 Finding: Kitchen Sink – Overall Condition & Recommendations.
 Information: Observations:

- Further monitoring and testing are recommended once the tap(s) are in constant use, to identify any drainage issues or signs of slow leaks not evident during the limited inspection.
- Flexible, mould-resistant sealant should be applied at wall junctions and other wet-area interfaces to prevent water ingress and potential damage. This is considered routine maintenance, and damaged or missing sealant should be replaced as needed.

- For long-term property care, it is advised that sealant and grouting in water-exposed areas be regularly inspected and maintained. A sealant specialist or tiling contractor may be engaged to carry out these works where necessary.
