Building and Timber Pest Inspection Report

Inspection Date: Tue, 27 Jan 2026

Property Address: 1/20 Lorensen Ave, Coburg North VIC
3058, Australia

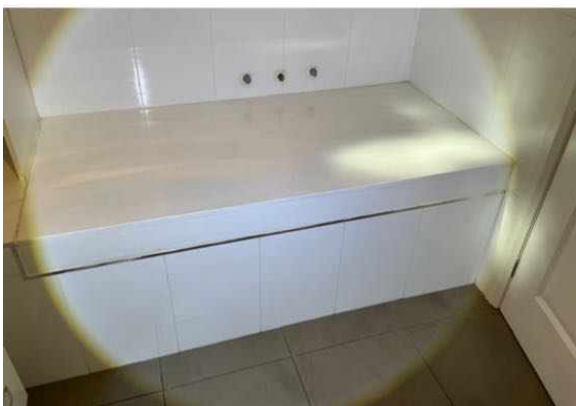
Finding 3.01

Building:	Main Building
Location:	Bathroom
Finding:	Sealed / Decommissioned Bathtub – Cause Unknown (Further Enquiry Required)
Information:	As observed during inspection, the bathtub within the bathroom had been fully boxed-in/covered and the tap set/fittings had been removed and/or capped off (services appeared sealed at the wall). Due to this non-standard modification, the bathtub could not be operated or tested, and the subfloor beneath this area was not accessible (as noted elsewhere in the report), therefore the condition of concealed plumbing, waterproofing, and the supporting structure could not be confirmed.

No elevated moisture readings were detected around the perimeter of this enclosure at the time of inspection using a moisture meter and thermal camera; however, the reason for the bathtub being sealed remains unknown and should be clarified with the vendor as a priority. Possible explanations may include: (1) a previous leak or waterproofing failure that was isolated by decommissioning the bath, (2) preparation for a renovation/refit that was not completed, (3) prior plumbing defects (e.g., failed waste connection) that were temporarily taken out of service, or (4) intentional removal for safety/maintenance reasons (e.g., reducing water use, child safety, or ongoing mould/odour concerns). Supporting documentation such as invoices, plumber reports, or insurance/renovation records should be requested to confirm the history and scope of any prior works.

It is recommended that this matter be investigated and rectified as soon as practical and prior to reliance on this bathroom. A licensed plumber and, if required, a registered builder should be engaged to (a) confirm why the fixtures were removed, (b) inspect for any concealed defects/damage, and (c) reinstate the bathtub for safe use or formally remove/replace it in a compliant manner. The key concern is that the enclosure may be concealing a past defect, and undiscovered moisture damage (if present historically) can lead to deterioration of adjoining materials and future repair costs.

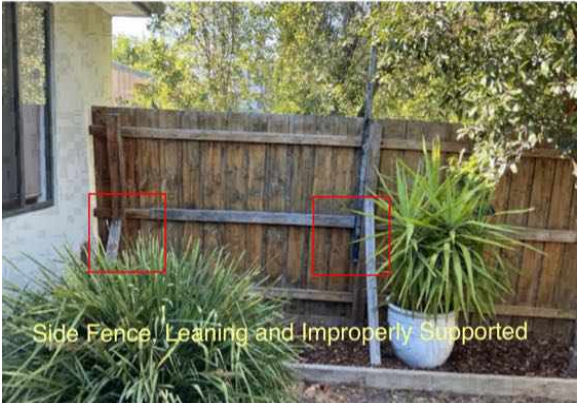
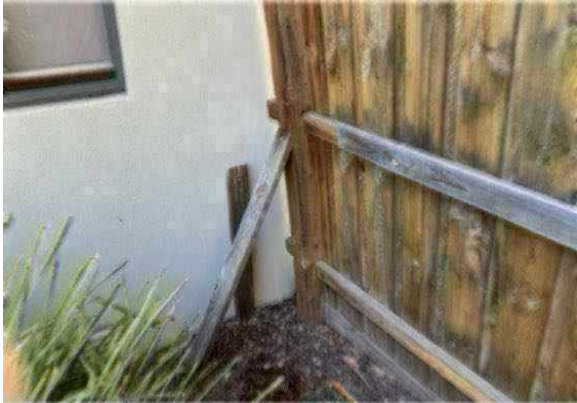
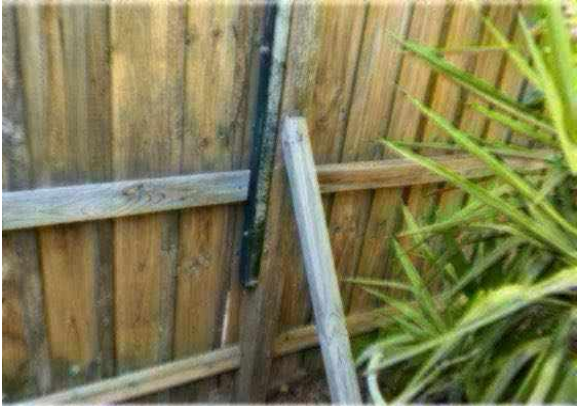
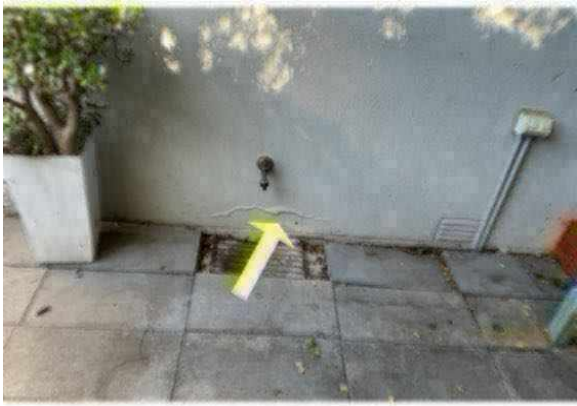
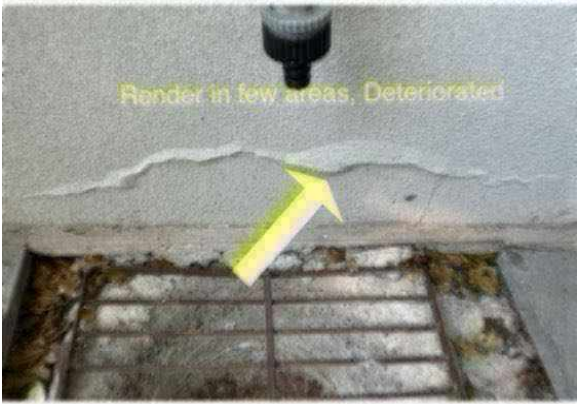
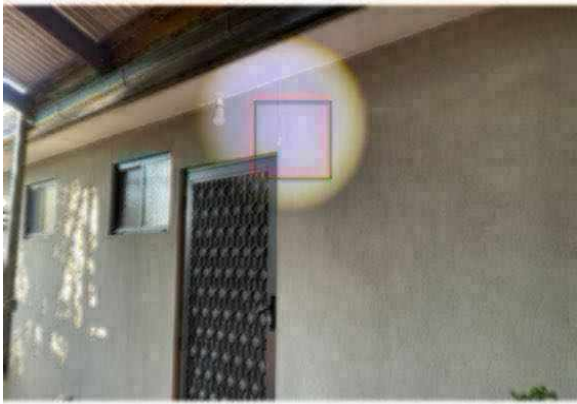
Finding 3.03

Finding: Common Maintenance Defects (Wear and Tear)

Information: In every home, regardless of age, there are maintenance defects or normal wear and tear that occur over time. These issues are completely normal and can be grouped under a broad category of expected wear, which can either be overlooked as part of the home's character or addressed through repairs. Examples of these defects might include hairline cracks in concrete or walls, loose door or window handles, patched sections on walls, and dents or deformities in fences or other building elements. These are all typical issues that arise from the natural aging of a house.

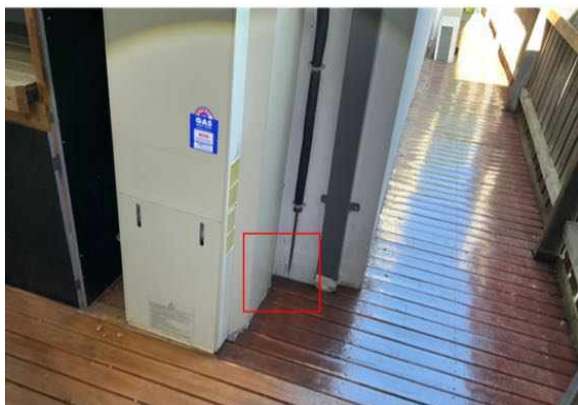
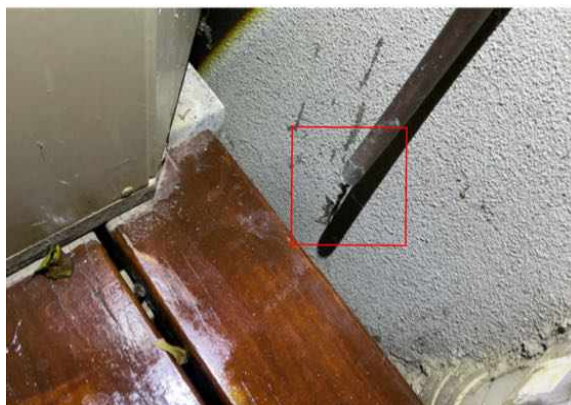
Finding 3.04

Building: Main Building
 Location: Exterior walls - rear
 Finding: HWS - Drip tray missing
 Information: The drip tray for the Hot Water System unit is missing, allowing leaks from the unit to affect the surrounding building elements. Generally, a drip tray will be installed to catch expected leaks from the unit, and allow them to evaporate without creating excessive moisture in the area.

Without a drip tray, the leaks from the HWS unit are creating conditions in the area that is likely to develop in the rust, corrosion, or wood rot of associated building elements. Additionally, excessive moisture creates an environment that is conducive to

termite and timber pest activity, creating potential for further secondary damage.

It is recommended to install the drip tray in order to prevent any secondary damage.

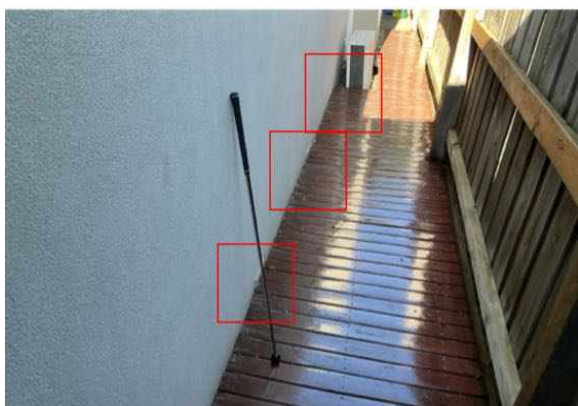
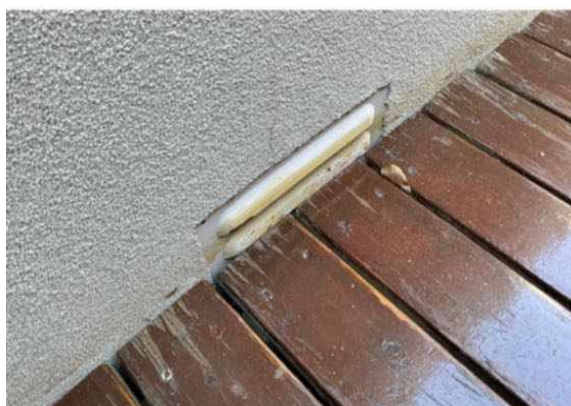
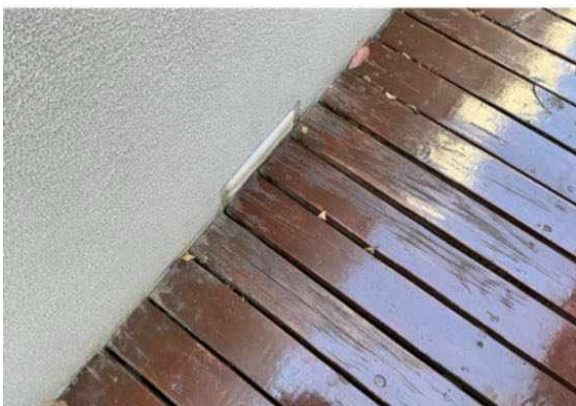
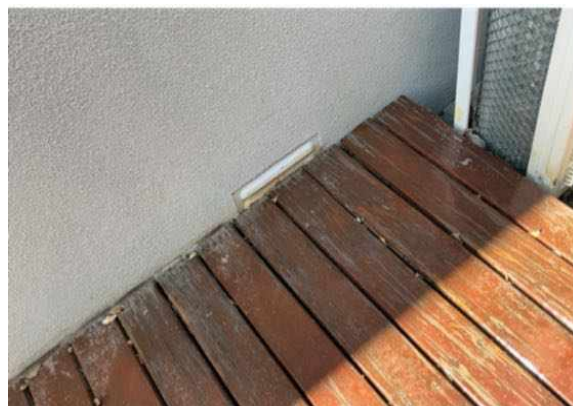
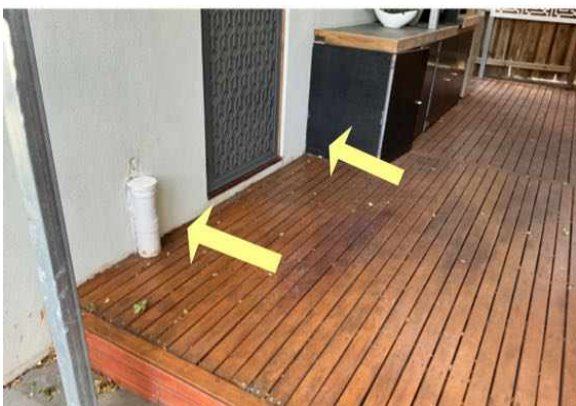
Finding 3.05

Information: During the inspection, it was noted that some of the subfloor ventilation vents were partially or fully blocked. This observation is provided for your information only, as no immediate action is required at this stage.

While current conditions do not indicate any major concerns, it is generally advisable to keep these vents clear to maintain proper airflow and prevent potential moisture buildup over time. Regular monitoring is recommended as part of ongoing maintenance.

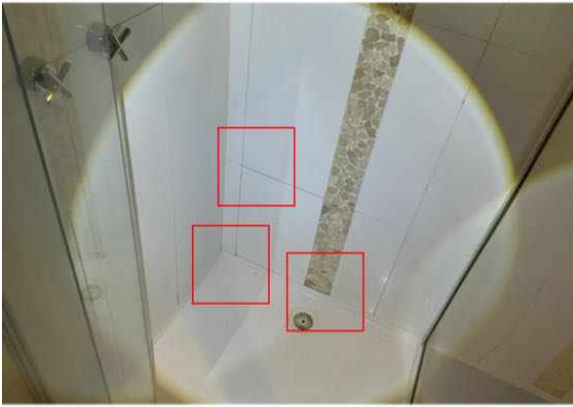
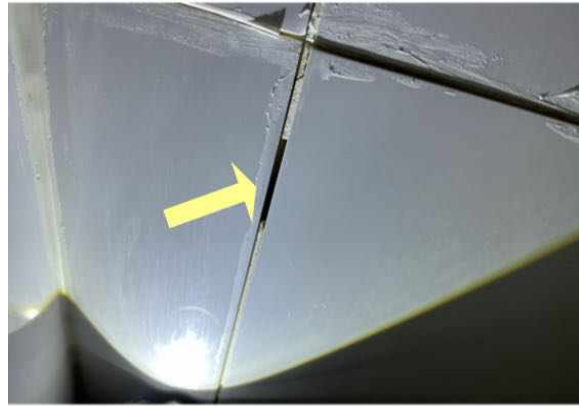
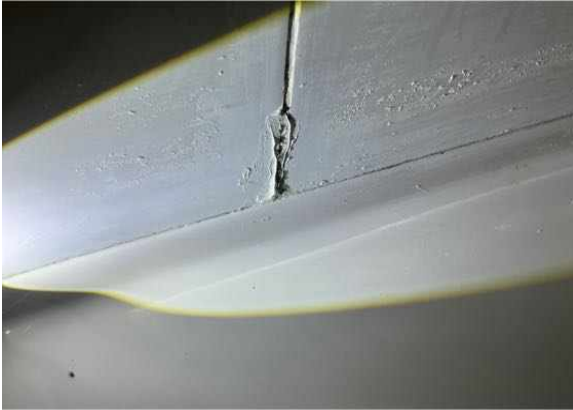
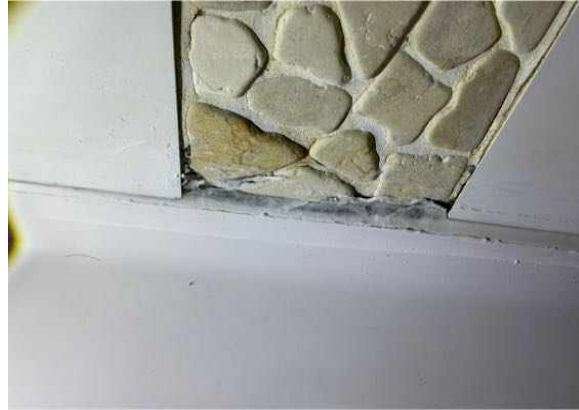
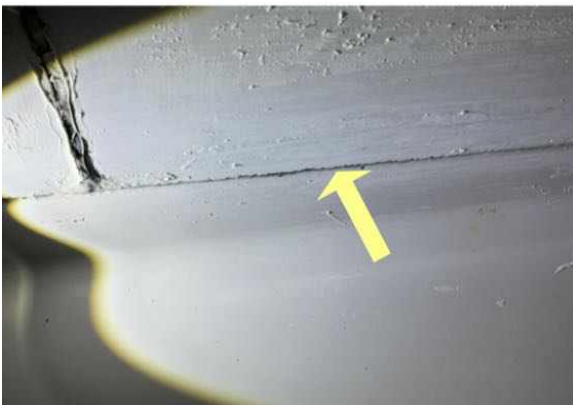
Finding 3.06

Building: Main Building
Location: Bathroom
Finding: Shower Alcove – Sealant and Grout Defects
Information: Degraded sealant and grout were observed in several areas of the shower alcove. These defects reduce the effectiveness of the waterproofing system and create potential pathways for water penetration into adjoining surfaces.

Repairs are recommended, including removal of the deteriorated sealant and grout and reapplication with suitable waterproof products. Timely maintenance will assist in preventing moisture ingress, deterioration of surrounding materials, and possible hidden damage.

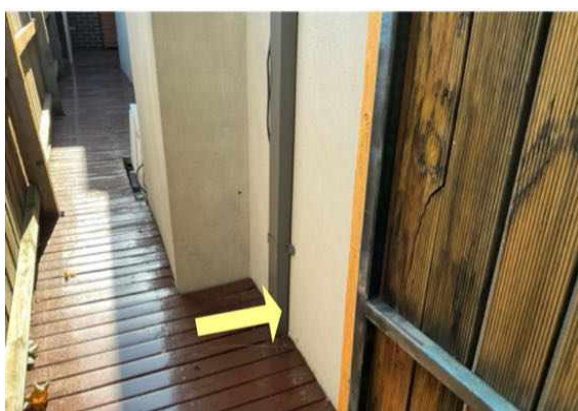
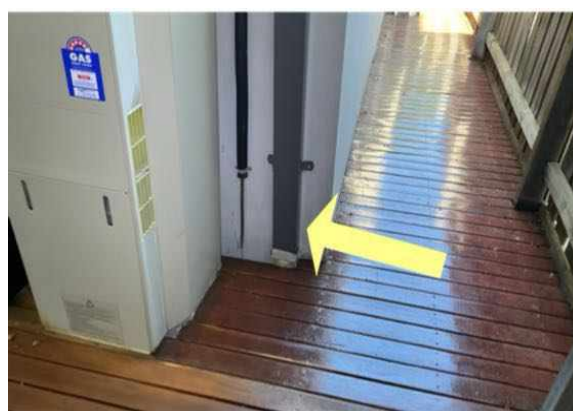
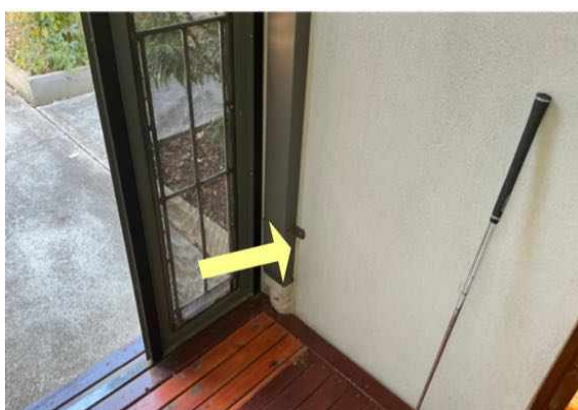
Where any part of an attachment to a building is not isolated and is not provided with a clear gap of not less than 25mm from the building, bridging occurs. Attachments to buildings such as hot water services, downpipes, verandahs, decks, steps, fences, service conduits and the like provide the opportunity for concealed entry.

Building attachments of this nature need to be frequently inspected for termite activity by a qualified inspector.

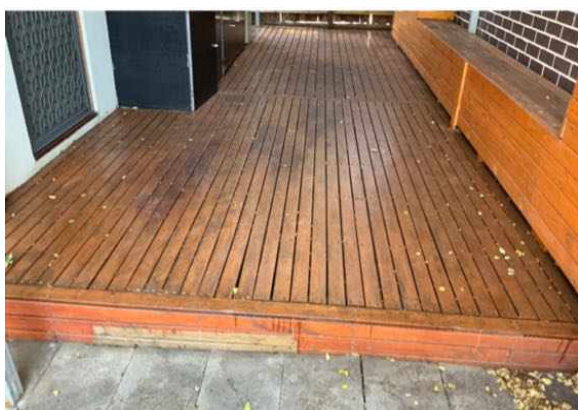
Finding 6.02

Building:	Main Building
Location:	Yard - Back
Finding:	Ground level deck - conducive to moisture and timber decay
Information:	The ground level deck can be conducive to timber pest infestations due to its close proximity to the soil. With out proper precautions, the moisture in the soil can create an ideal environment for timber decay and other termites to thrive. Regular inspection and treatments can help prevent infestations and protect the decks structural integrity.

An invasive inspection of the area is recommended to determine further actions .

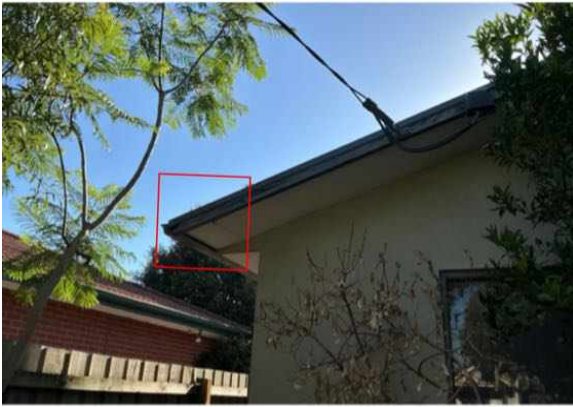
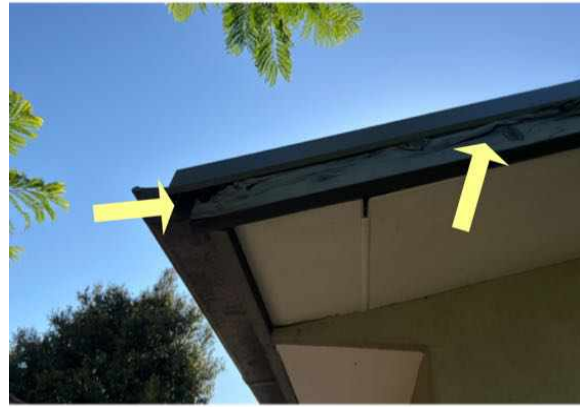
Finding 7.01

Building:	Main Building
Location:	Front Fascia Boards
Finding:	Wood rot
Information:	These element showed evidences of wood rot. Wood rot, also known as Fungal Decay, occurs when timbers and other cellulose building materials are exposed to damp conditions on an ongoing basis. This could be the result of exposure to weathering over a prolonged period of time, or the attraction of excessive moisture from other abutting building materials. Contributing factors also include poor air ventilation in the area.

Wood rot is often associated with general damp problems and is evidenced by a 'musty' smell or mould and mildew occurring on surfaces. If left unmanaged, damp conditions can lead to further health problems and the decay of timbers will continue.

Early intervention and regular maintenance, particularly of exterior timbers, will prolong the useful life of these building elements. Prior to any works being performed, the cause of the moisture that has created the visible wood rot should be identified and addressed in a suitable manner. Replacement of affected timbers may then be a necessary step in protecting surrounding building elements from such deterioration.

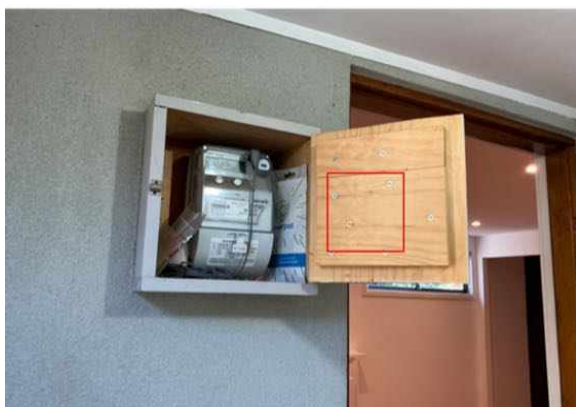
Building: Main Building
 Location: Meter Box
 Finding: Termite Management System - no evidence of a chemical installation
 Information: The application of a post-construction chemical termite barrier is highly recommended for all properties, particularly if live termite activity has been found on the site previously. Such barriers are highly effective in preventing termite attack on any timber building elements throughout the property.

A durable notice should be placed in the switchboard unit to indicate current termite barriers. At the time of inspection, it appeared as though no termite management system has been installed, with no evidence to suggest preventative works taking place.

The client may consider gaining further advice from a pest controller as to the costs and procedures involved with this application. It is recommended that obtaining such advice be a short-term priority.

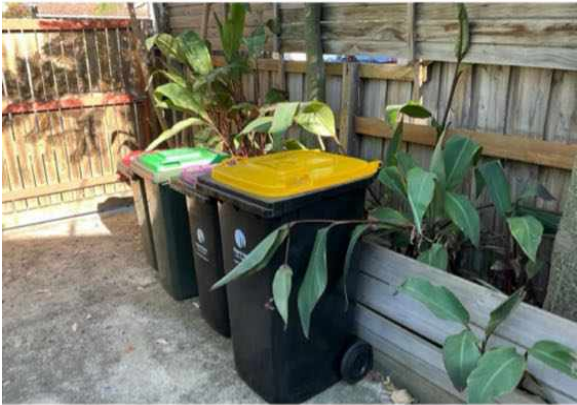
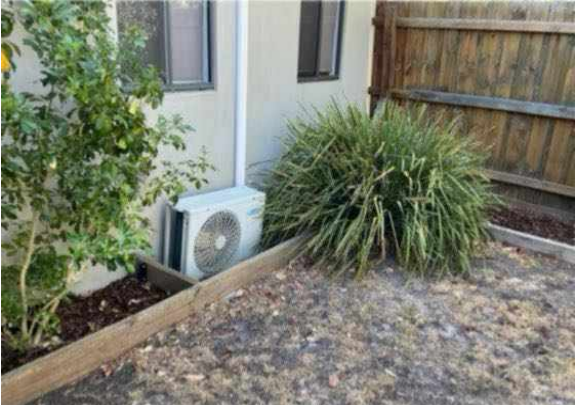
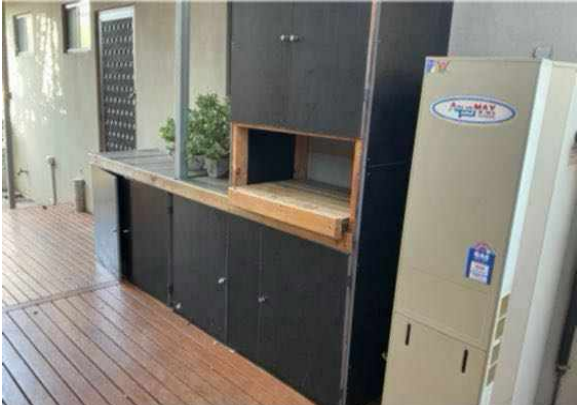
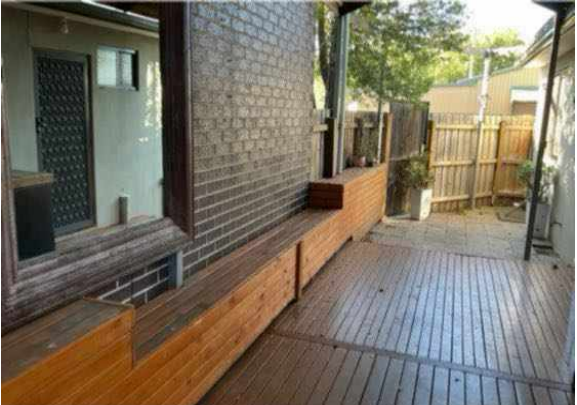
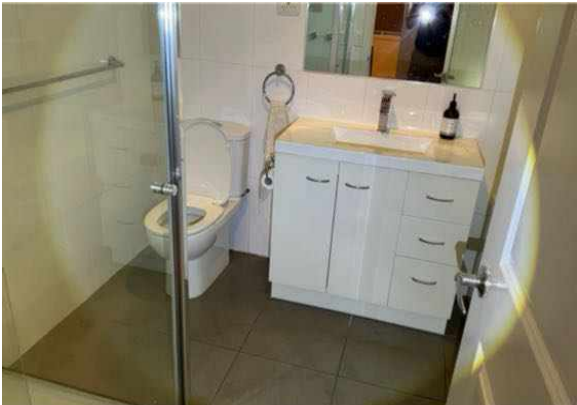
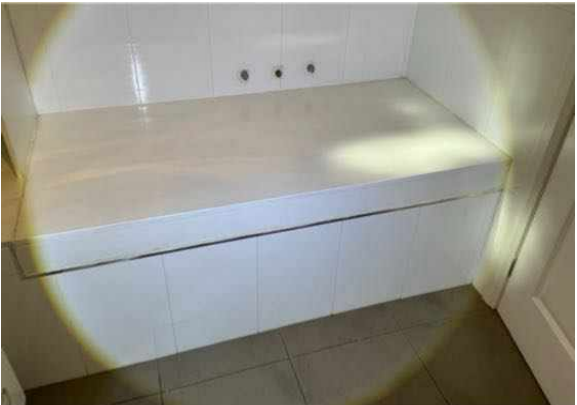
Building: Main Building
 Location: All Areas
 Finding: Additional Photos - Obstructions and Limitations
 Information: These photographs are an indication of the obstructions and limitations which impeded full inspection of the property at the time of inspection. These obstructions can hide an array of defects and should be removed to allow full inspection to be carried out. A re-inspection is recommended once the areas are made accessible.

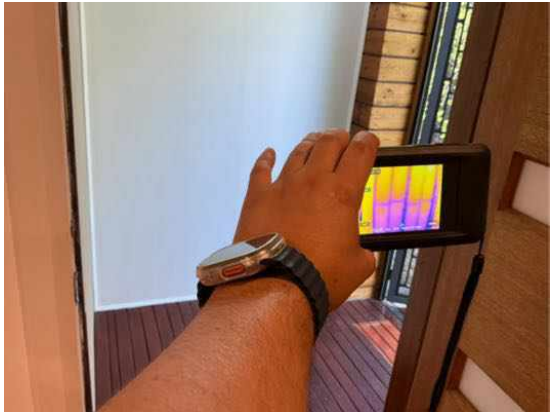
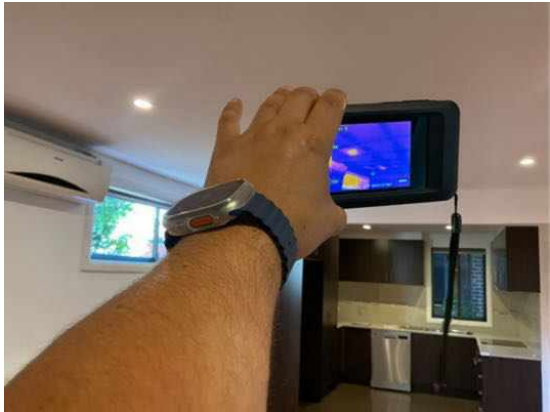
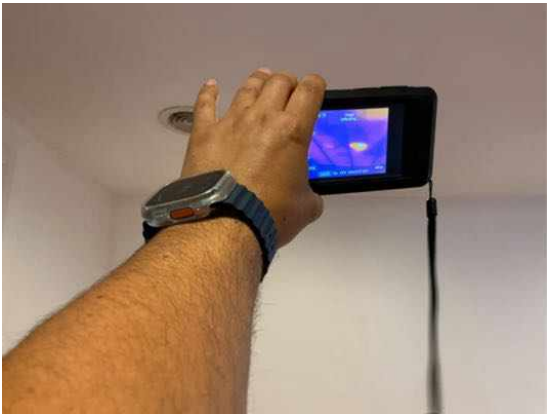
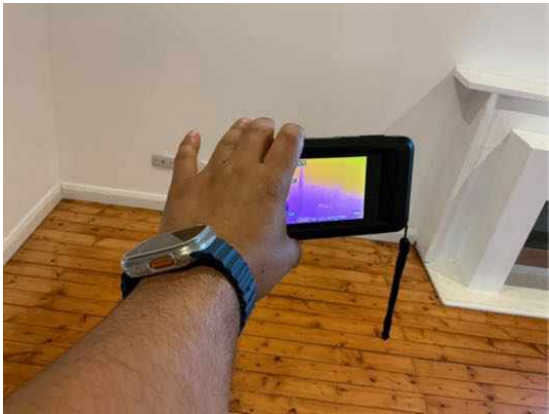
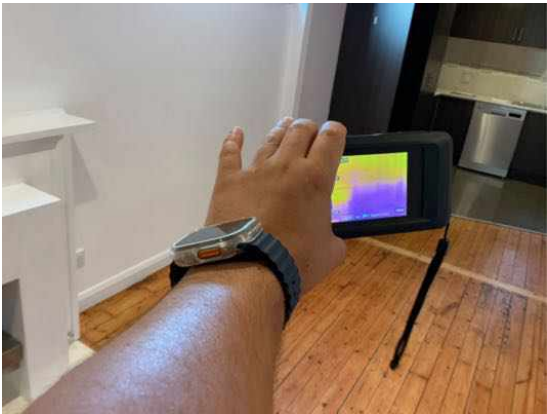
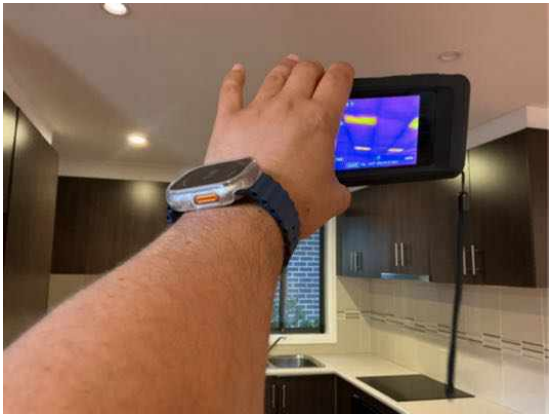
Building: Main Building
Location: All Internal Areas
Finding: No moisture was present at the time of inspection - Good condition
Information: During the inspection, a moisture meter and thermal camera were used to check for the possible existence of excessive moisture, particularly in wet areas, walls adjacent to wet areas, and around all openings.

As can be seen in the attached pictures, no high moisture readings were present at the time of inspection. This suggests that there were no significant moisture issues detected in these areas.

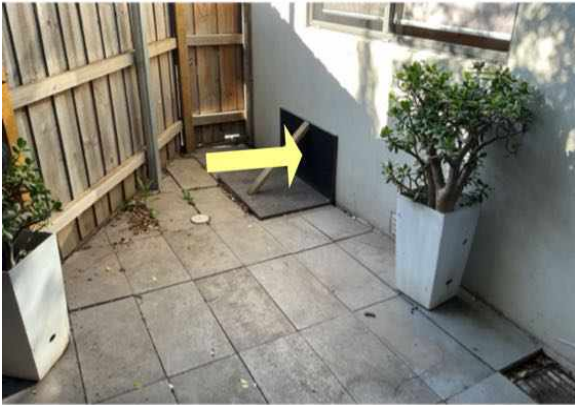
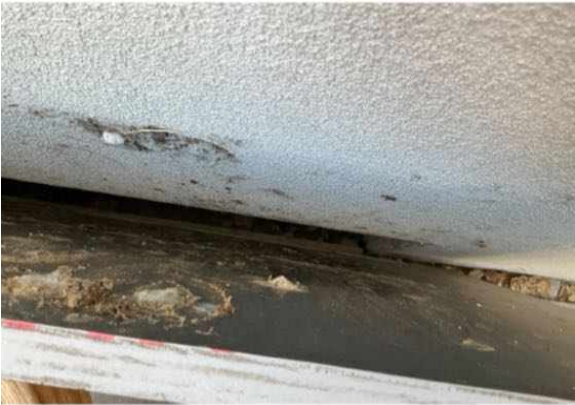
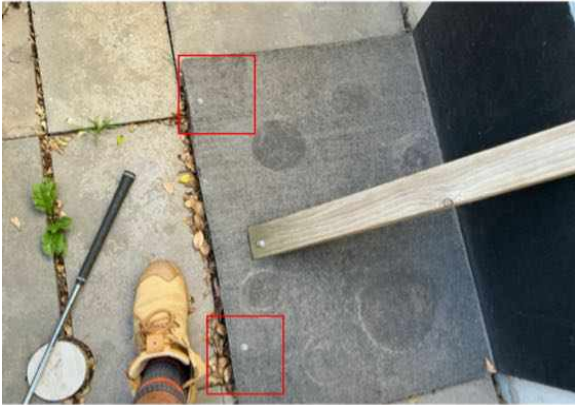
Building:	Main Building
Location:	Subfloor
Finding:	Subfloor Access Hatch – Inadequate / Non-Professional Installation
Information:	The subfloor access in the external side area was found to be non-professionally installed. Instead of a proper hatch/lid, two timber boards had been screwed over the opening, and they could not be removed during the inspection (only slightly lifted). Even if removed, the opening appeared too narrow for safe entry, limiting subfloor inspection and future maintenance.

It is recommended that a proper, adequately sized subfloor access hatch be installed as soon as practicable to allow safe access for future inspections and plumbing/maintenance works. Rectification should be completed by a registered builder/carpenter or a suitable handyman.
