# Building and Timber Pest Inspection Report

Inspection Date: Mon, 16 Feb 2026

Property Address: 96 Lieutenant Bowen Rd, Bowen Mountain  
NSW 2753, Australia

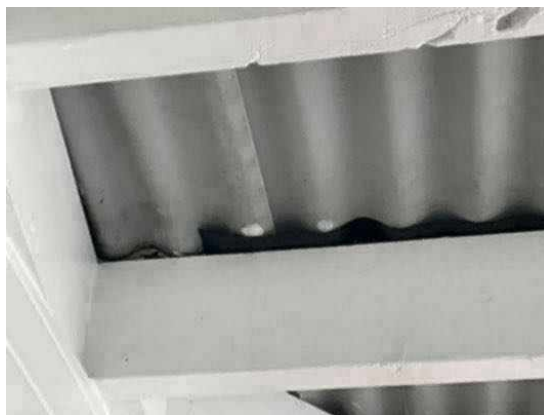
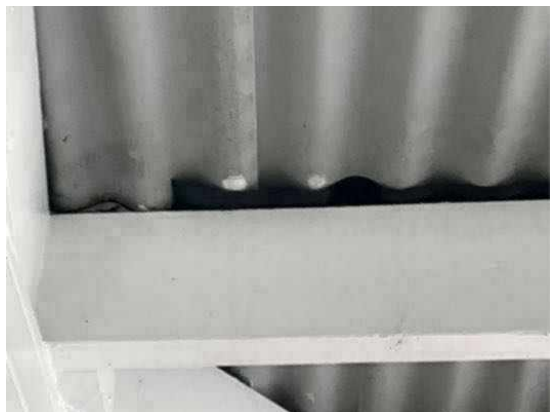
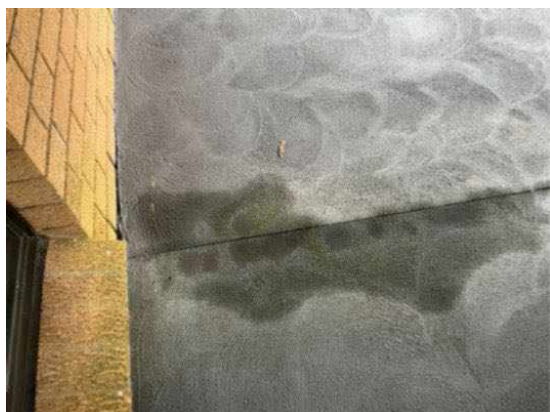
Building: Main Building  
Location: Carport  
Finding: Roof Leakage Suspected – Carport  
Information: Evidence of moisture staining and active water ponding was observed to the carport concrete slab below the roof structure. Water marks appear to align with the roof sheeting above. Inspection of the underside of the corrugated roof sheeting indicates potential gaps at sheet laps and/or inadequate sealing at junctions.

The observed staining and pooling suggests water ingress from the roof covering, possibly due to:

- Deteriorated or missing flashings
- Inadequate sheet overlaps
- Failed or missing fastener seals
- Lack of sarking or waterproof membrane
- Inadequate fall causing backflow during rainfall

- Timber beam deterioration and rot
- Corrosion of fixings and roof sheeting
- Mould growth
- Structural deterioration over time

- Conduct further inspection during rainfall or water testing

- Inspect sheet laps, flashings and fixings
- Reseal, refix or replace defective components as required
- Confirm adequate fall and drainage compliance

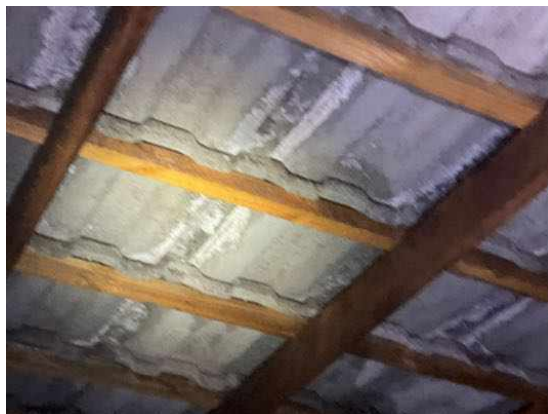
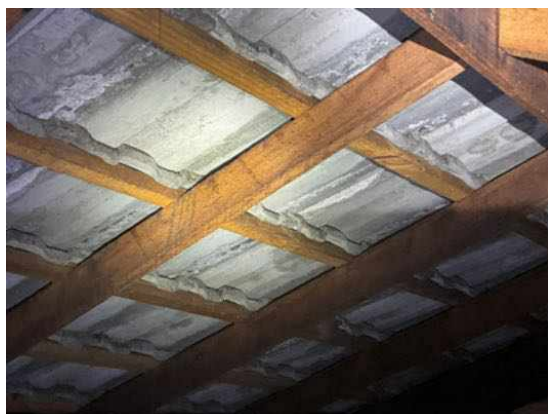
Building: Main Building  
Location: Roof Void  
Finding: Roof void - Suspected water leak  
Information: Suspected water leak in the roof void, as evidenced by the presence of water stains, indicating potential gaps or holes.

- **Structural Damage:** Continuous water leakage can weaken the structural integrity of the roof and ceiling, leading to potential collapse.
- **Mold and Mildew:** Persistent moisture can promote the growth of mold and mildew, posing health risks such as respiratory problems and allergic reactions.
- **Electrical Hazard:** Water intrusion near electrical wiring can create a risk of short circuits, fires, or electrical shocks.
- **Insulation Damage:** Prolonged exposure to moisture can damage insulation, reducing its effectiveness and increasing energy costs.

A licensed roofing contractor should be contacted immediately to inspect, diagnose, and repair the source of the leak to prevent further damage.

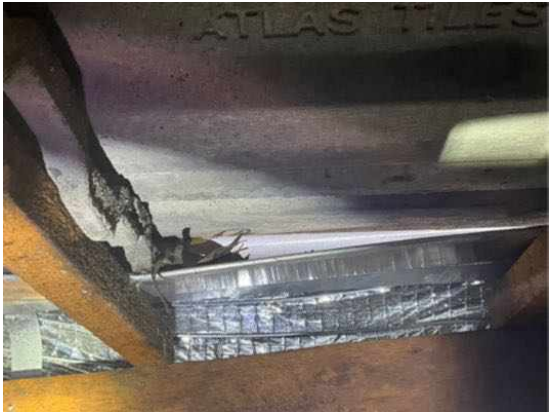
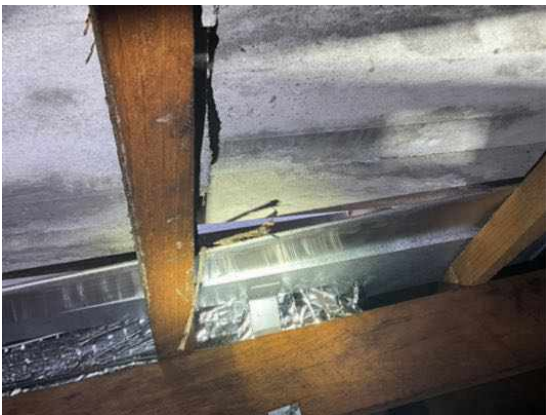
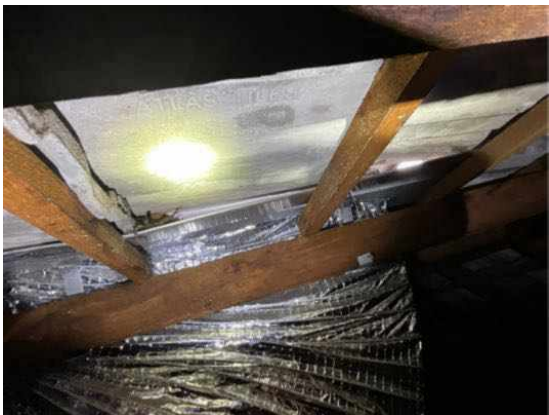
### Finding 2.04

Building:	Main Building
Location:	Roof Void
Finding:	Skylight Installation – Visible Daylight Entry
Information:	Daylight is observed entering the roof cavity through the perimeter of a skylight installation. The light penetration appears to be occurring around the flashing or junction between the skylight and the roof sheeting.

- **Water Ingress:** Poorly sealed skylight installations are a common entry point for rainwater, which can lead to water damage, ceiling staining, and mould growth.
- **Pest Intrusion:** Unsealed gaps may allow insects or small pests into the roof cavity.
- **Energy Inefficiency:** Lack of insulation or air sealing can reduce thermal performance and increase energy consumption.

Have a licensed roofing or skylight contractor inspect the skylight installation. Flashing and sealing should be assessed to ensure the skylight is weathertight and thermally sealed to prevent future issues.

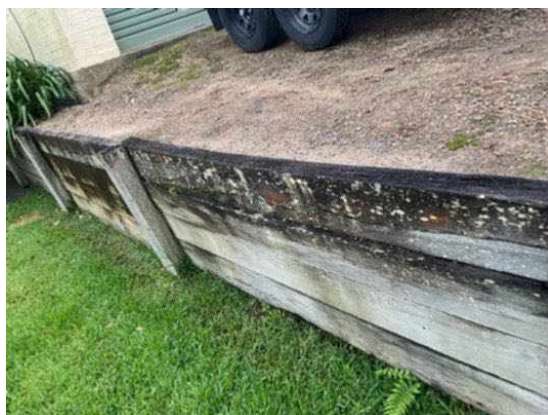
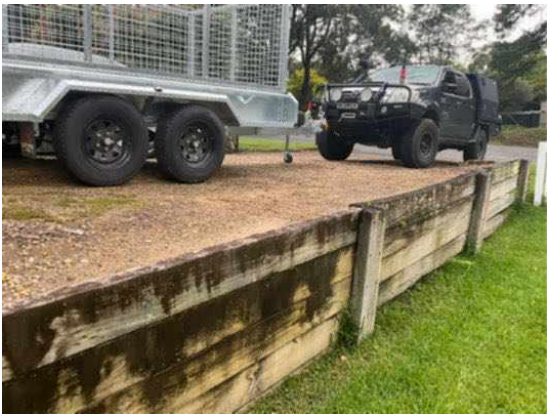
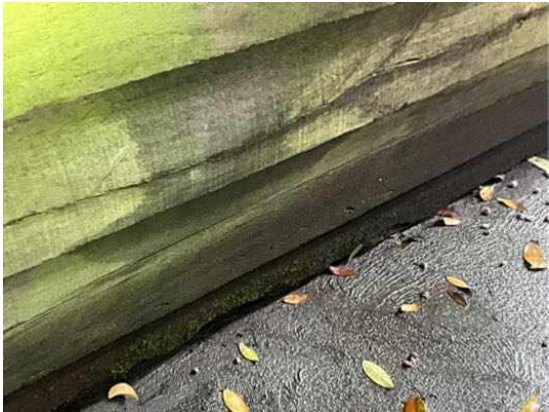
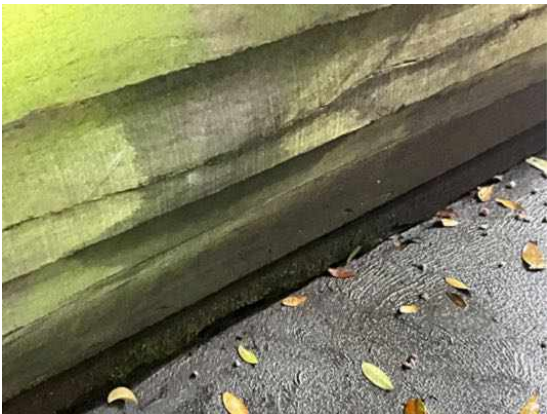
### Finding 3.01

Finding: Retaining wall - Defective

Information: The retaining wall in this area was found to be defective at the time of inspection. Generally, defective retaining walls are caused by poor original design or material use. However, deteriorated retaining walls may also be a result of substandard construction, poor site drainage or unmanaged stormwater flows.

If left unmanaged, the retaining wall may become a safety hazard if it continues to destabilise. Where retaining walls further rot and decay, an environment is created that is conducive to termite and pest infestation.

Significant repair and replacement should be expected. Where retaining walls are considered structural walls, a structural engineer / surveyor should be consulted regarding required remedial works. Otherwise, a landscaper or retaining wall installer may be appointed to repair or replace the wall, at the discretion of the client.

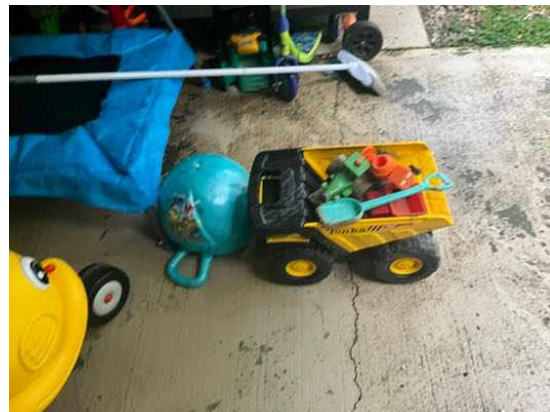
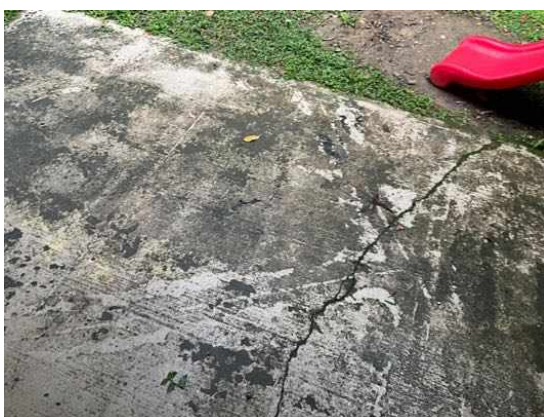
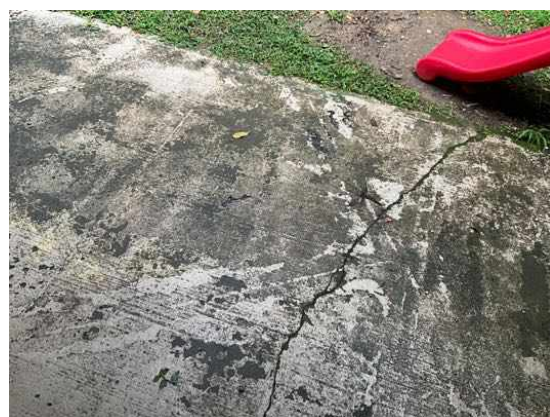
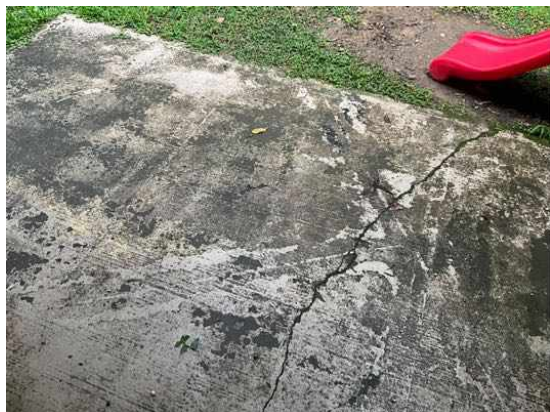
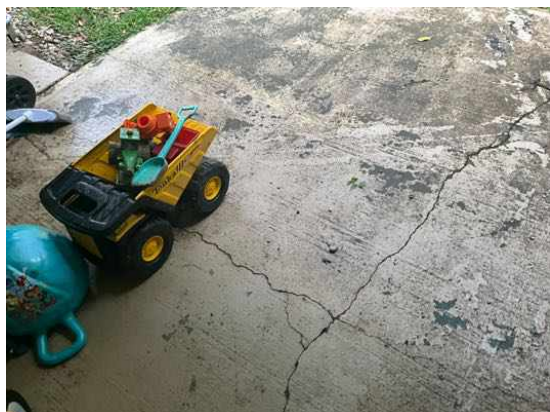
Building:	Main Building
Location:	All Areas
Finding:	Noticeable Cracking in Concrete Slab
Information:	Noticeable cracking has been observed in the concrete slab, failing to meet the required construction and quality standards.

- Cracks are visible on the surface and may extend through the depth of the slab.
- Evidence of improper curing or inadequate reinforcement leading to cracking.

The presence of noticeable cracks in the concrete slab can result in:

- Compromised structural integrity of the slab, potentially leading to failure under load.

- Water ingress through cracks, causing corrosion of reinforcement and further weakening the structure.
- Potential trip hazards and aesthetic issues, reducing the overall value and safety of the property.
- Increased maintenance and repair costs due to ongoing deterioration.

- A structural engineer should be engaged to assess the extent of the cracking and recommend appropriate repair methods.
- A licensed contractor or concrete repair specialist should carry out the recommended repairs under the guidance of the structural engineer.

A detailed inspection should be conducted post-repair to confirm compliance with the required standards and to ensure that the structural integrity of the concrete slab has been restored.

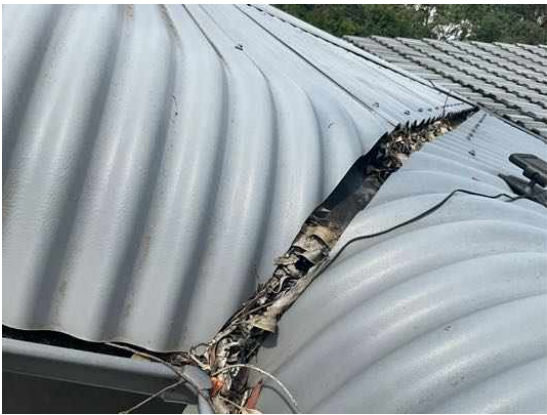
Building:	Main Building
Location:	Roof Exterior
Finding:	Blocked gutters - organic debris
Information:	The roof gutter system was observed to be blocked with organic debris and moss growth, as evident in the provided images.

- Water ingress into the eaves or walls,
- Timber rot or deterioration of fascia and soffits,
- Accelerated moss and algae growth, promoting further blockages,
- Potential foundation issues if water pools near the base of the structure.

A licensed roofing contractor or qualified gutter cleaning service should be engaged to remove the debris and inspect the system for any further issues.

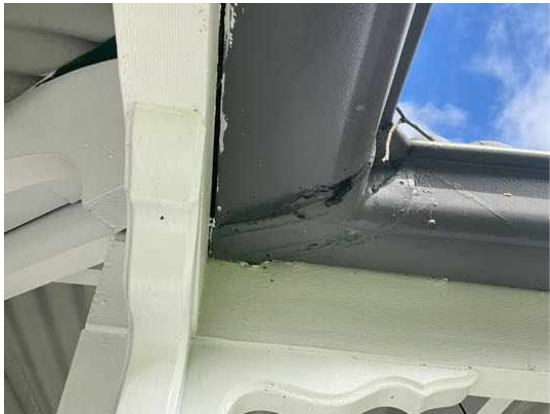
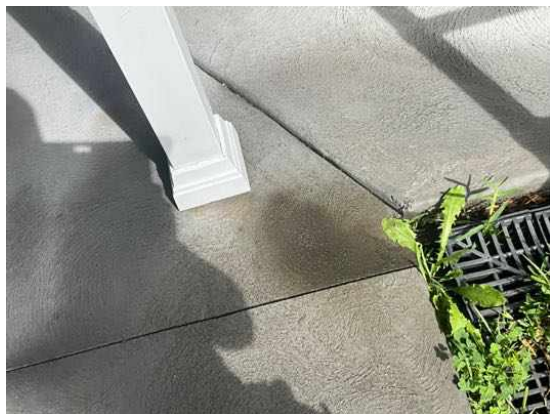
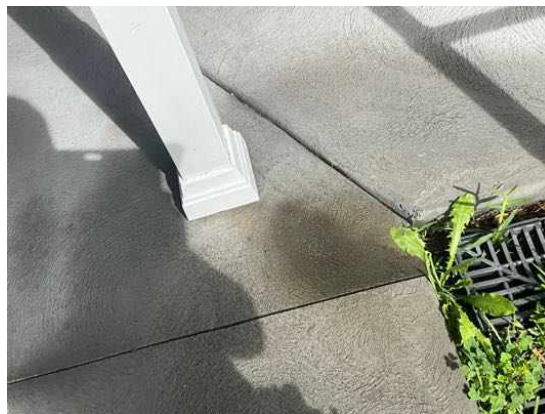
**Finding 3.06**

Building: Main Building  
Location: Roof Exterior  
Finding: Roofing Gutters - leak  
Information: Roofing gutters are experiencing leaks, compromising their ability to channel water effectively, posing a risk of water damage to the building structure and surroundings.

Risk: "The gutter leaks may result in water seepage into the foundation, potential interior damage, and deterioration of the building's exterior surfaces."

Resolution: "To address the issue, it is recommended to hire a licensed roofing plumber or gutter specialist to inspect, identify, and repair the leaks promptly."

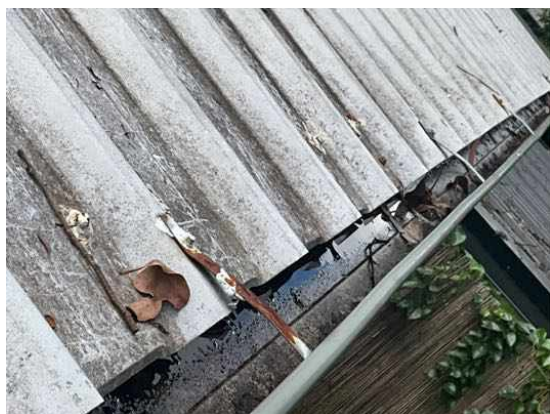
### Finding 3.07

Information: Water was found to be pooling in sections of the roof guttering. This is generally a secondary defect caused by blocked or partially blocked gutters. Such blockages and subsequent water pooling are likely to lead to rust and water damage to associated structures if left unattended.

Any areas of guttering that shows evidence of water pooling should be checked for partial or full blockages and any secondary damage that may have occurred as a result. Depending on the extent of the damage, building elements may require repair and/or replacement to ensure adequate roof drainage and function of exterior plumbing system.

A roofing plumber should be appointed as soon as possible to rectify this issue. It is highly advised that all gutters be maintained on a frequent basis to ensure the condition of roof plumbing.

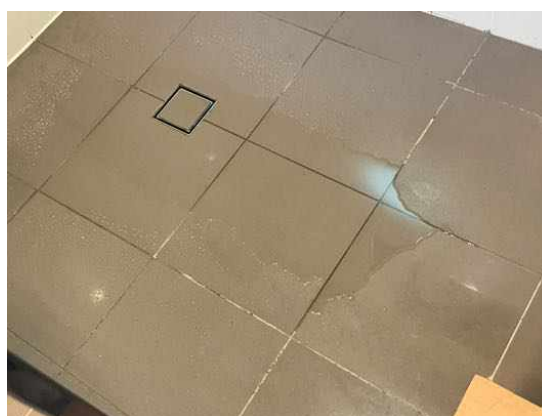
### Finding 3.08

Building:	Main Building
Location:	Bathroom
Finding:	Shower base - Water pooling
Information:	Evidence of water pooling around the floor waste in the shower recess was noticed at the time of inspection. It is suspected that this excessive moisture is attributed to insufficient fall in the shower floor tiles.

This pooling is minor overall but is still considered unsatisfactory, as standard tiling practices would not permit this situation to occur. Pooling water around floor wastes can create a slip hazard in extreme cases and create conditions that are conducive to mould growth over time. Where left unmanaged, the degradation of sealant and grouting is also likely to occur, possibly necessitating further repair works.

Remedial works may involve some sections of tiling and flooring repair and replacement. A tiling contractor or bathroom specialist should be appointed to provide further advice on reparation options and to perform works as necessary.

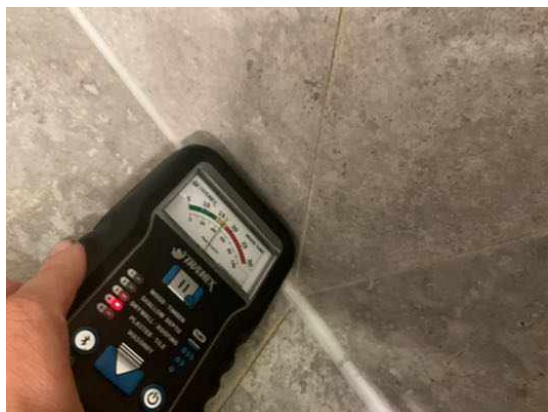
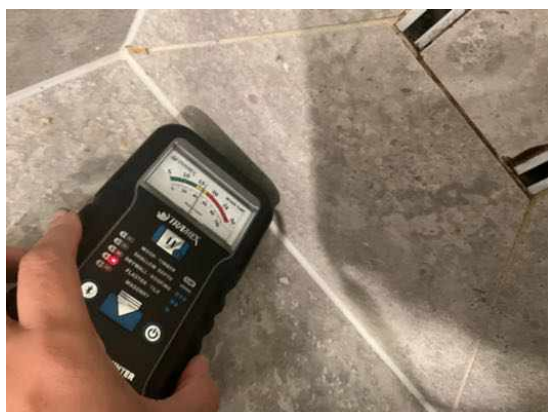
### Finding 3.09

Building:	Main Building
Location:	Ensuite
Finding:	Shower - Damp
Information:	Damp is evident to the lower 300mm of wall to the shower alcove. This defect is quite common, and is suspected to have been caused by moisture permeating through the grouting in this area, which shows evidence of deterioration. Leaking pipes within the adjoining wall is also a possible cause.

Unmanaged damp in the shower recess is likely to facilitate the formation and development of mould and fungi growth, decaying associated building materials and compromising their structural integrity. It is important to address damp conditions, as the World Health Organisation notes that excess moisture leads - on almost all indoor materials - to growth of microbes such as moulds, fungi and bacteria, which subsequently emit spores and other matter into the indoor air. Exposure to these contaminants is associated with a wide range of respiratory and other health-related problems.

Consultation with a qualified plumber or bathroom specialist is advised immediately to identify the cause of damp and to perform remedial works as required. Where excessive mould growth is present, further inspection by a specialist environmental health inspector should also be considered.

Always ensure that sealant and grout is in good condition to prevent any moisture issues occurring in the future.

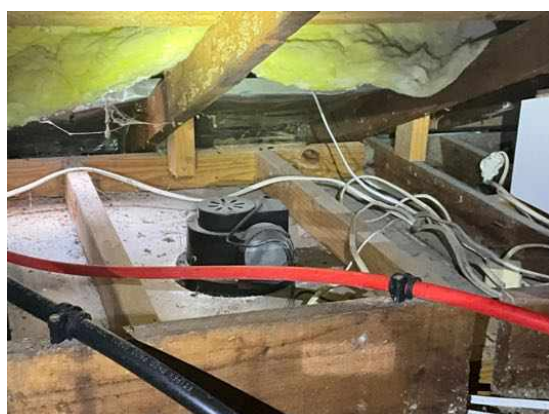
### Finding 3.10

Information: The exhaust fan located within the roof void is not appropriately ducted to the external atmosphere and is currently discharging moist air directly into the roof space. This is considered a defect under AS 4349.1, as it does not meet the minimum standard of residential building performance expected under normal residential building practices.

This condition may lead to excessive condensation within the roof void, increasing the

risk of mould growth, deterioration of insulation, timber decay, and overall reduced durability of building elements. It may also result in poor indoor air quality, potentially affecting occupant health.

It is recommended that the exhaust fan be modified by a licensed HVAC contractor or qualified builder, ensuring it is properly ducted to discharge externally in accordance with manufacturer specifications, the National Construction Code (NCC), and applicable Australian Standards.

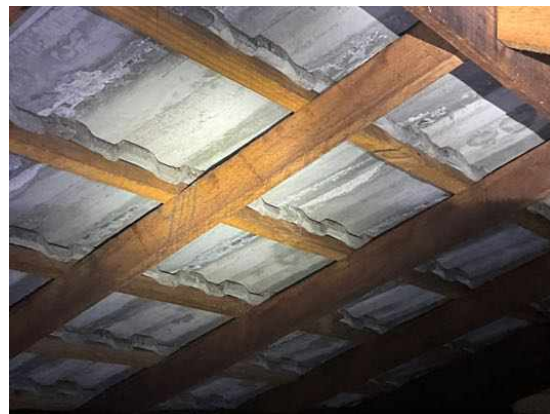
### Finding 3.11

Building:	Main Building
Location:	Roof Void
Finding:	Sarking - Missing
Information:	Sarking is missing under the roof sheeting. Sarking acts as an insulator that helps with noise reduction and protects against water penetration. Sarking plays a key role in the operation and function of the overall roofing structure and its performance.

Although not a requirement at the time of construction, replacement of any missing building element is advisable (although this can be quite expensive to do after the time of construction). Where sarking is missing, regular inspections of the roof tiles for cracking and potential moisture penetration is required.

Sarking may be retrospectively fitted by a registered builder at the discretion of the client.

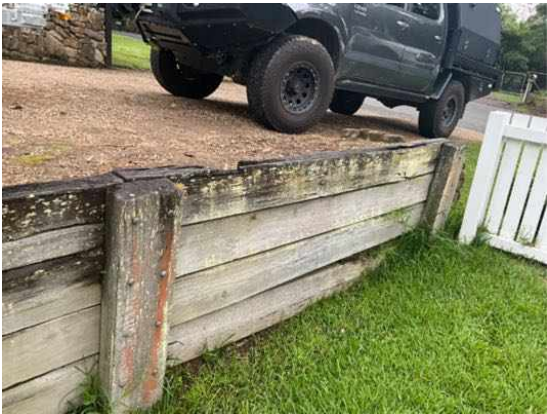
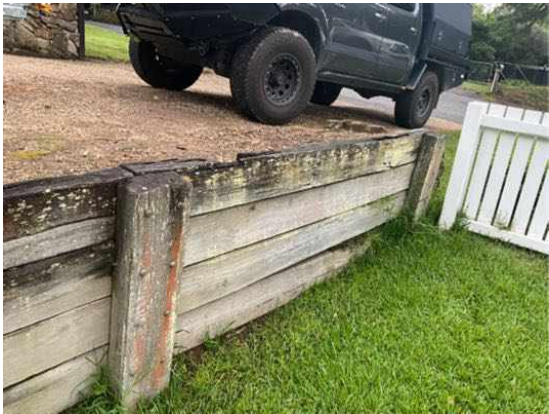
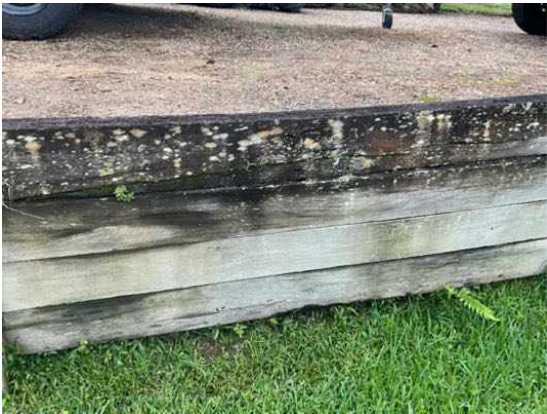
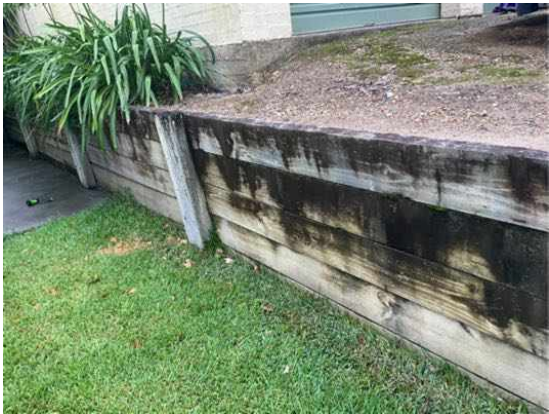
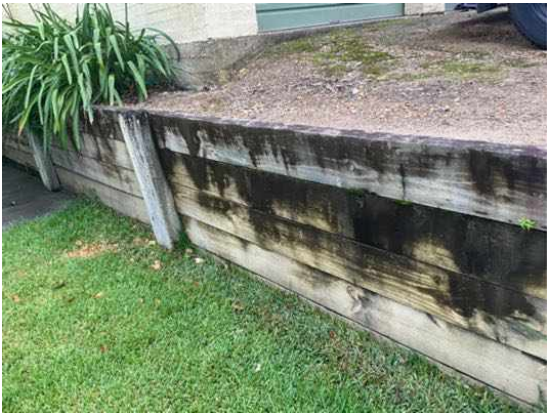
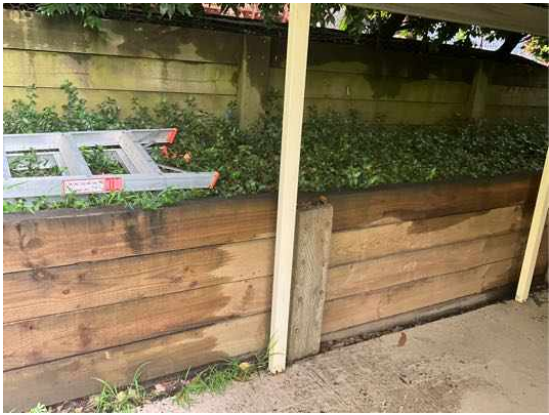
**Finding 6.02**

Building: Main Building  
Location: All Areas  
Finding: Timber on ground / conducive conditions to termite damage  
Information: Timber on the ground is indeed conducive to termite damage. Termites are known to thrive in moist environments, and wood in contact with soil or moisture is more susceptible to infestation.

To prevent this, it's important to keep timber elevated and away from direct ground contact. Regular inspections and proper termite control measures are also essential to protect your wooden structures from termite damage.

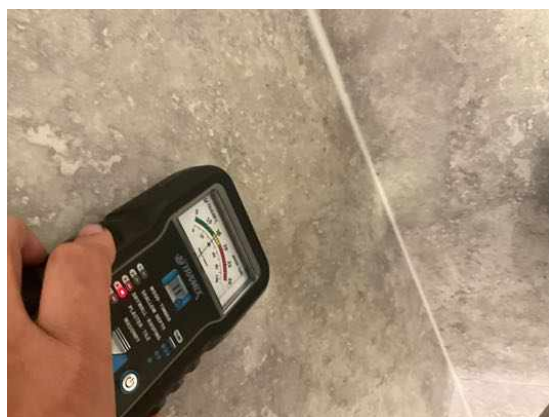
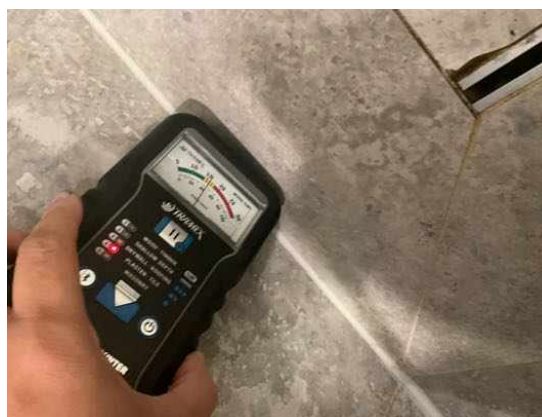
Building: Main Building  
Location: Ensuite  
Finding: Excessive moisture - Conducive to Timber pest  
Information: Excessive moisture can attract termites and produce conditions that promote fungal growth and wood decay.

Excessive moisture is generally caused by deteriorated inadequate or missing roof drainage leaking plumbing pipes or fixtures poorly plumbed HWS overflows or condenser units and poor site drainage.

Prior to any remedial works being performed a qualified plumber should be appointed to further inspect the property and to identify the cause of the excessive moisture. Works to remove affected building elements may then be necessary and should be performed by an appropriate tradesperson.

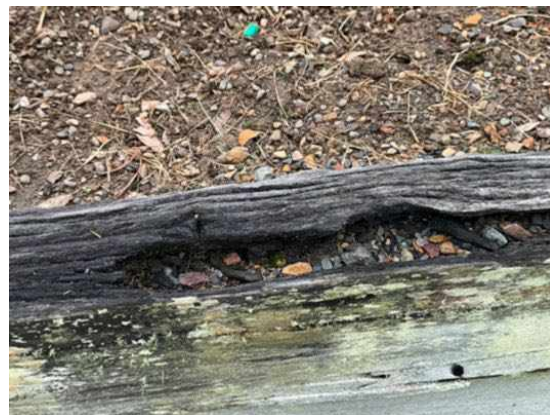
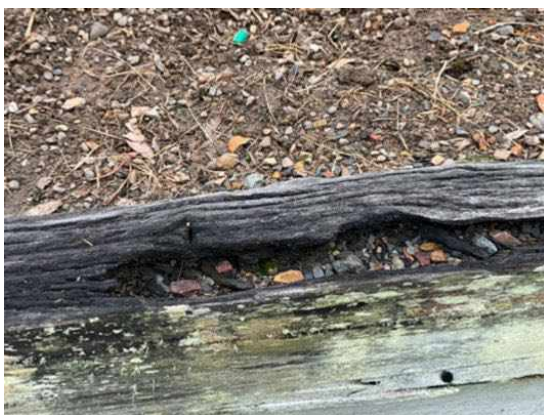
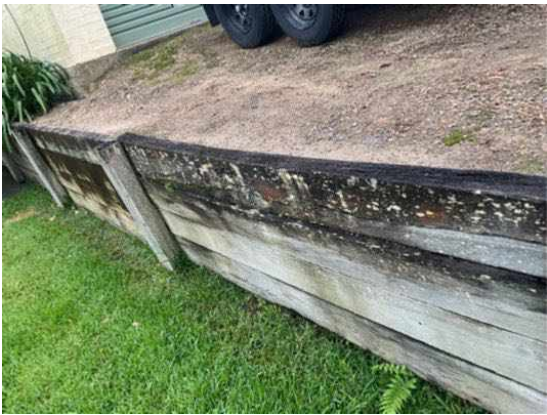
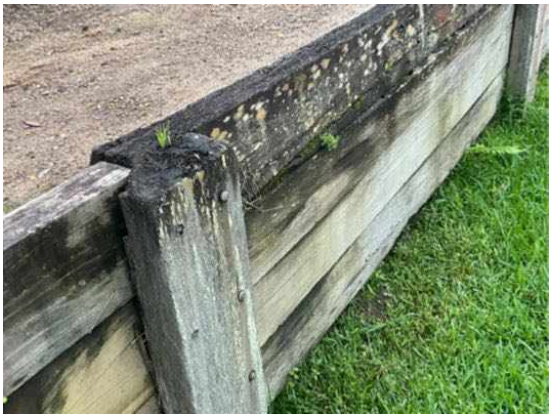
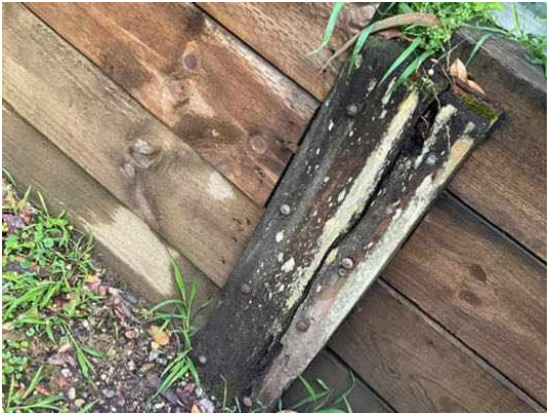
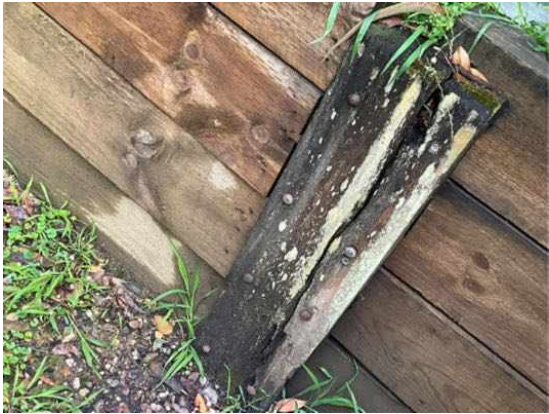
### Finding 7.01

Building:	Main Building
Location:	All Areas
Finding:	Wood rot
Information:	This building element shows evidence of wood rot. Wood rot, also known as Fungal Decay, occurs when timbers and other cellulose building materials are exposed to

damp conditions on an ongoing basis. This could be the result of exposure to weathering over a prolonged period of time, or the attraction of excessive moisture from other abutting building materials. Contributing factors also include poor air ventilation in the area.

Wood rot is often associated with general damp problems and is evidenced by a 'musty' smell or mould and mildew occurring on surfaces. If left unmanaged, damp conditions can lead to further health problems and the decay of timbers will continue.

Early intervention and regular maintenance, particularly of exterior timbers, will prolong the useful life of these building elements. Prior to any works being performed, the cause of the moisture that has created the visible wood rot should be identified and addressed in a suitable manner. Replacement of affected timbers may then be a necessary step in protecting surrounding building elements from such deterioration.

A qualified plumber may be appointed to assess the cause of excessive moisture and to provide advice on any remedial works as required. A qualified carpenter or registered builder may also be required to replace affected building materials.
