Building and Timber Pest Inspection Report

Inspection Date: Wed, 21 Jan 2026

Property Address: 25/158 Green Camp Rd, Wakerley QLD
4154, Australia

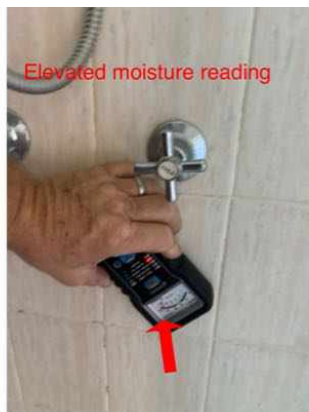
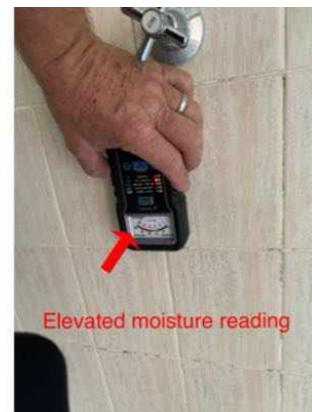
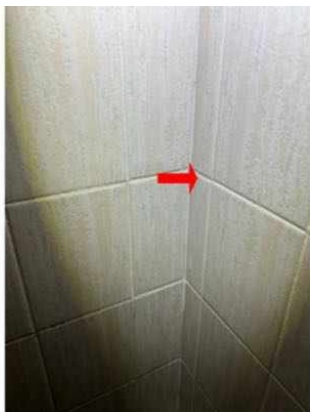
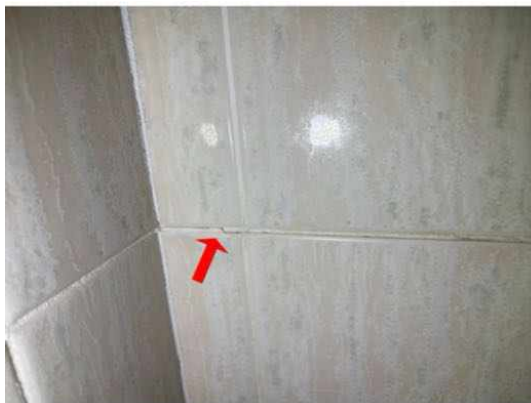
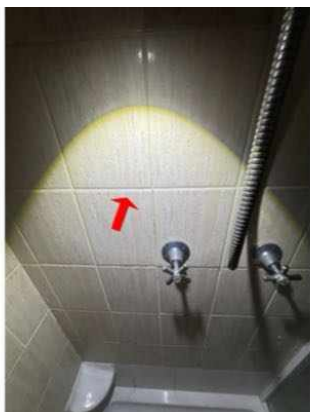
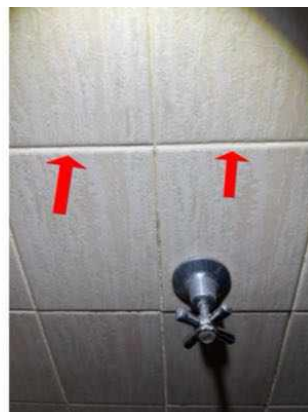
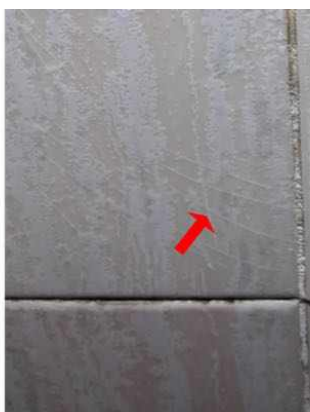
Finding 3.01

Finding: Bathroom - elevated moisture levels

Information: At the time of the inspection, it was noted there were elevated moisture readings recorded around the taps in the shower. Cracking and general deterioration of the grout was found to the shower walls. It is suspected that moisture is getting behind the wall tiles. Crazeing of the shower walls tiles was also noted.

If left unaddressed, undetected damage will occur to the associated building materials and become a major defect.

A bathroom specialist should be engaged to replace the grout and seal the wall tiles in the shower cubicle. This should be done as a matter of urgency.

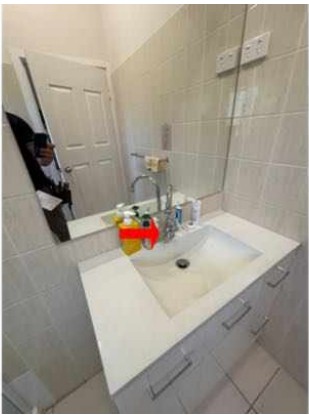
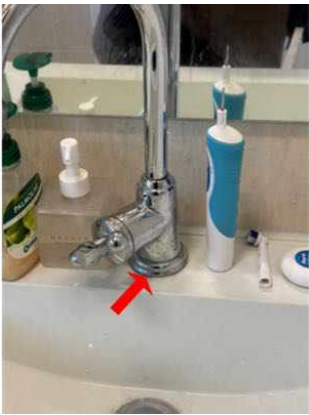
Finding 3.02

Finding: Bathroom - vanity mixer tap loose

Information: At the time of inspection, it was noted that the vanity mixer tap in the bathroom was loose. This may be due to general wear and tear. If left unaddressed, deterioration of the mixer tap may occur and moisture will penetration the cabinet below the basin.

A licensed plumber should be engaged to re-secure or replace the vanity mixer tap. This should be done as a matter of urgency.

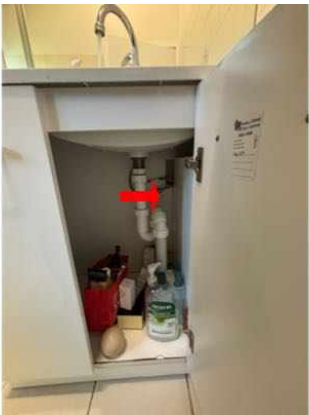
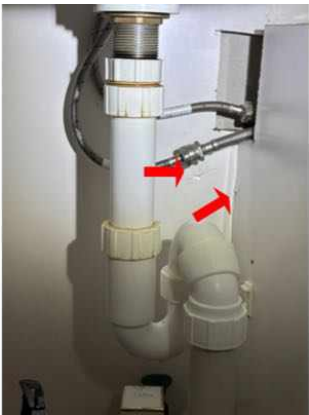
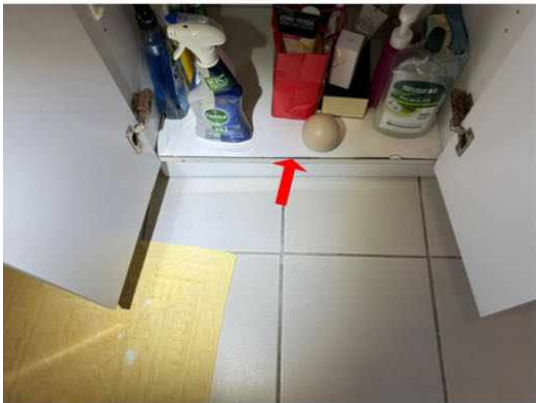
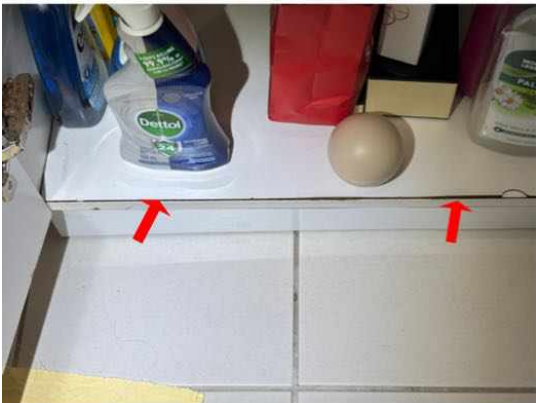
Finding 3.03

Building: Main Building
Location: Bathroom
Finding: Bathroom - vanity has signs of moisture damage
Information: At the time of the inspection, it was noted that the vanity cabinet had signs of moisture damage. No signs of an active leak were found. This may be due to the cabinet being found in a moist environment.

A building maintenance professional could be engaged to carry out repairs to the vanity cabinet. This can be done at the clients discretion.

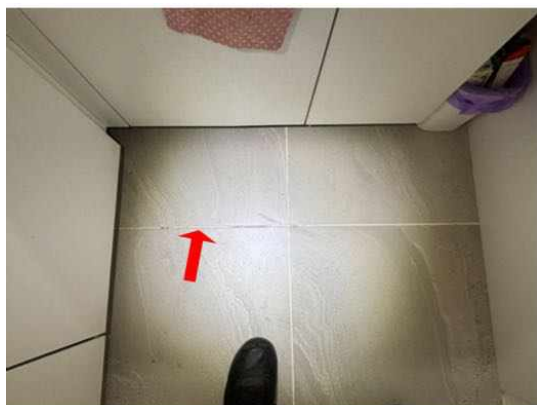
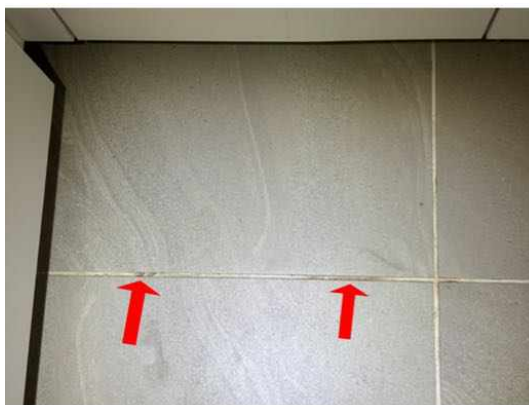
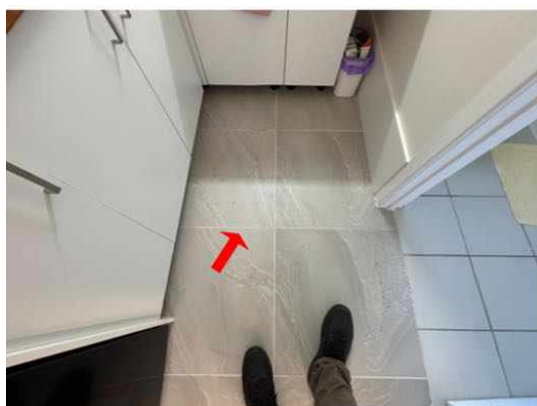
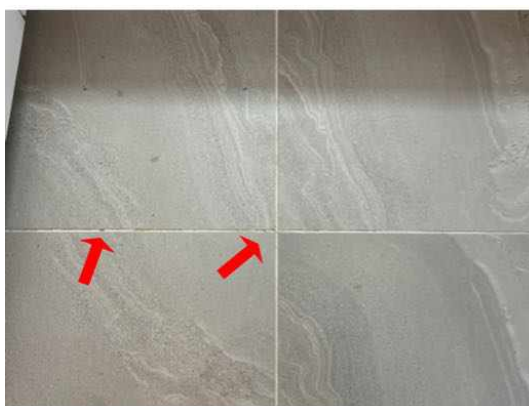
Finding 3.04

Building: Main Building
 Location: Kitchen
 Finding: Kitchen - grout missing
 Information: At the time of the inspection, it was noted that sections of grout were missing from the kitchen floor. Grout missing may result in damage to the edges of the tiles and allow moisture to penetrate beneath the floor tiles.

A building maintenance professional or tiler could be engaged to replace the missing grout. This can be done at the clients discretion.

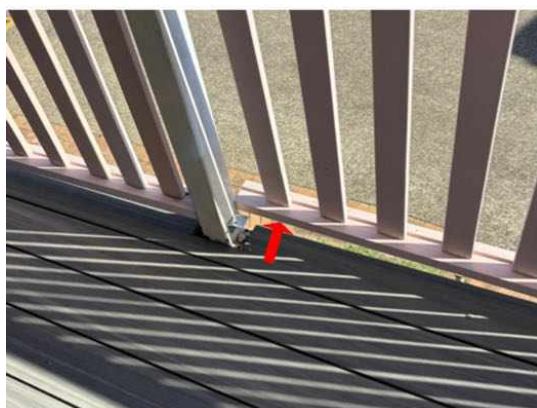
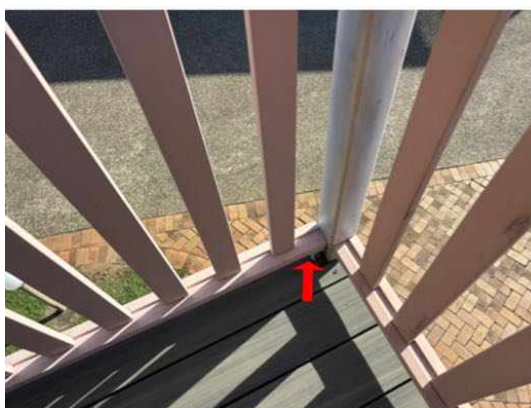
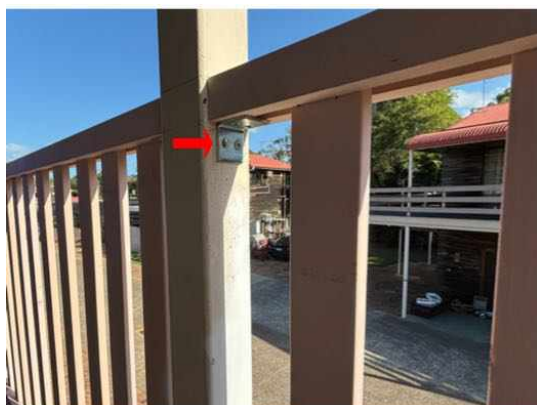
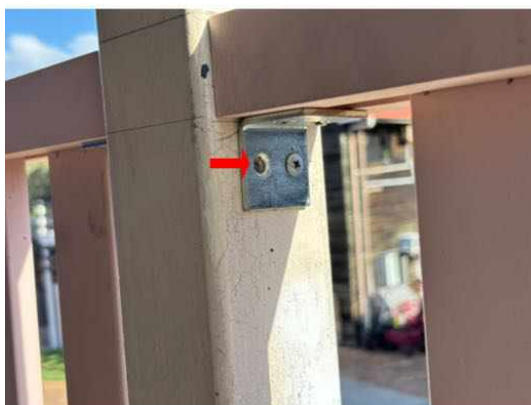
Finding 3.05

Building: Main Building
 Location: Deck area
 Finding: Handrail - screws missing
 Information: At the time of the inspection, it was noted that several screws were missing from a section of the newly installed handrails. The bottom rail can be pushed out.

The client should inform the body corporate in order to have the missing screws installed to secure the handrail.

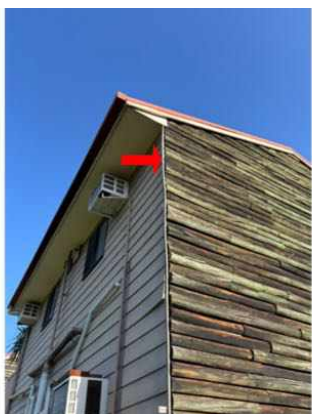
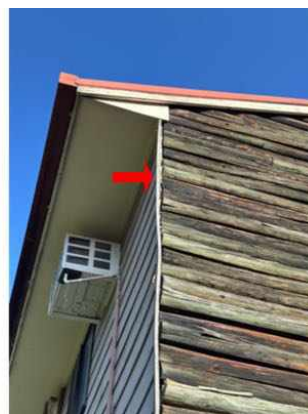
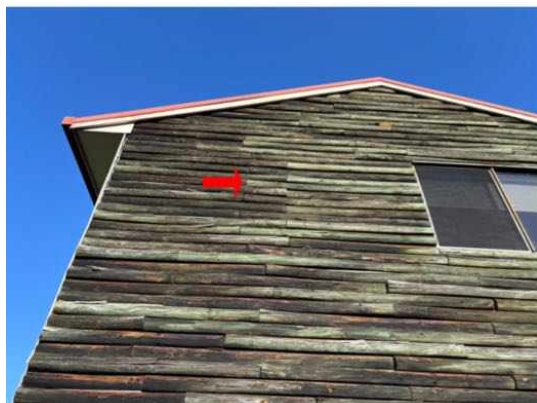
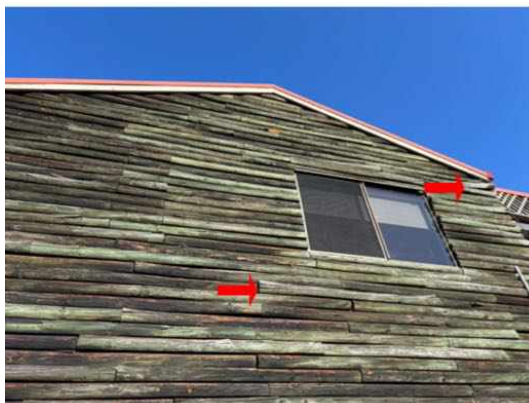
Finding 3.06

Building:	Main Building
Location:	Cladding
Finding:	Cladding - deteriorating
Information:	At the time of the inspection, it was noted that the timber external cladding showed signs of deterioration. This potentially creates ingress points for moisture into the wall cavity.

Moisture in wall cavities creates a conducive environment for termite activity and can cause undetected damage to the associated building materials.

The client should inform the body corporate so that the external timber cladding can be assessed and any necessary maintenance carried out.

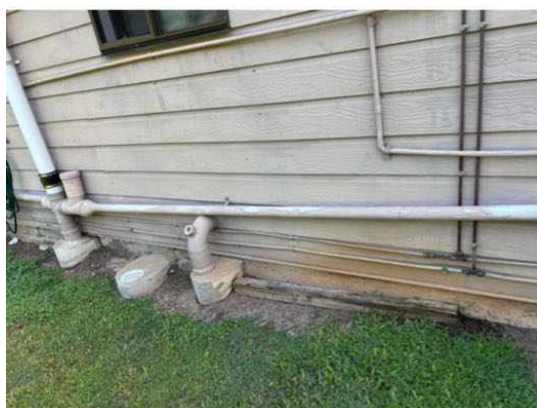
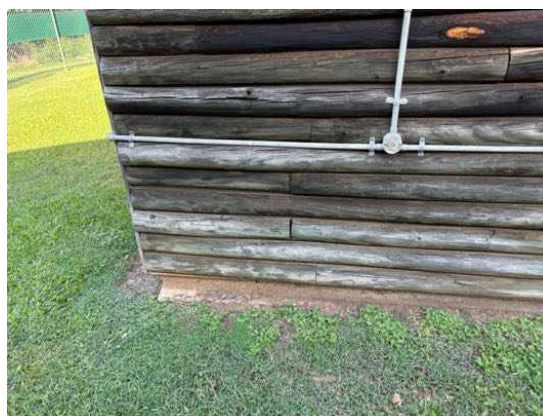
Finding 6.01

Building:	Main Building
Location:	All External Areas
Finding:	Termite Management System - no evidence of a chemical installation
Information:	At the time of the inspection, no evidence of a chemical termite management system was found.

A durable notice should be placed in the switchboard unit to indicate current termite barriers. At the time of inspection, it appeared as though no termite management system has been installed, with no evidence to suggest preventative works taking place.

The client may wish to enquire of the body corporate as to the nature of the termite management and if annual termite inspections are being performed and up to date.

The application of a post-construction chemical termite barrier is highly recommended for all properties, particularly if live termite activity has been found on the site

The client may consider gaining further advice from a pest controller as to the costs and procedures involved with this application. It is recommended that obtaining such advice be a short-term priority.

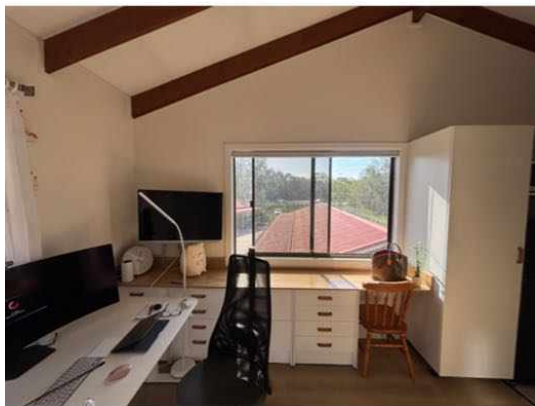
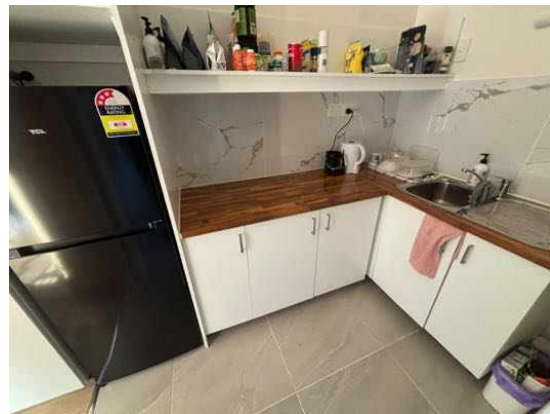
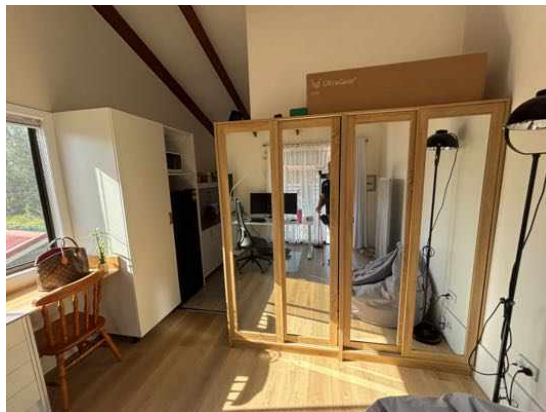
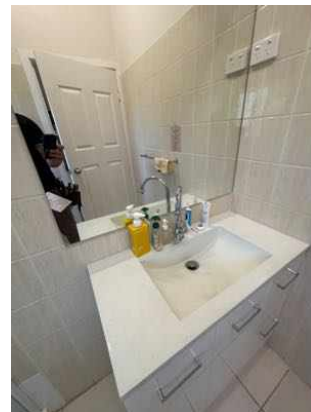
Noted Item

Building: Main Building
Location: All Internal Areas
Finding: Obstructions and Limitations - Internal areas
Information: These photographs are an indication of the obstructions and limitations which impeded full inspection of the property of the internal areas at the time of inspection. These obstructions can hide an array of defects and should be removed to allow full inspection to be carried out. A re-inspection is recommended once the areas are made accessible.
