# Building and Timber Pest Inspection Report

Inspection Date: Tue, 20 Jan 2026

Property Address: unit 19/1740 Pacific Hwy, Wahroonga NSW  
2076, Australia

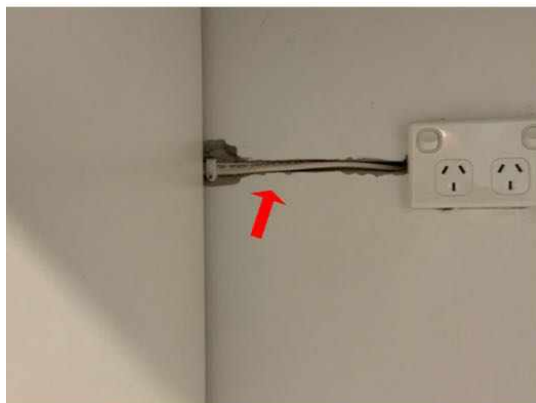
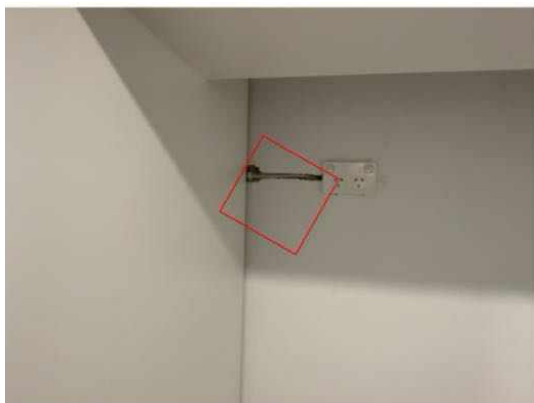
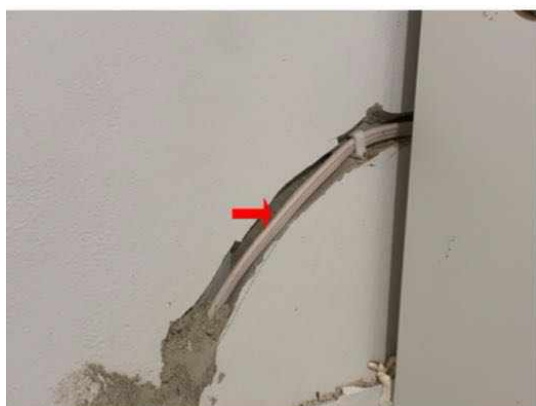
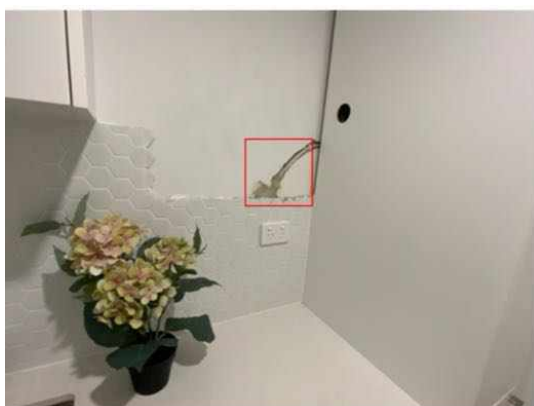
#### Finding 1.01

Building: Main Building  
Location: Kitchen/laundry  
Finding: Conduit - Missing  
Information: A conduit has not been installed to exterior wires in this area. This is a safety measure that is aimed at protecting the wires and preventing any personal injury that may result if wires are squashed or damaged.

Without a conduit providing adequate protection, external wiring is likely to become damaged and deteriorated over time, creating an electrical safety hazard. Damage to the wiring is also likely to result in the associated elements losing function.

A qualified electrician should be contacted immediately to install a conduit around the wires and provide any further advice on additional works that may be required to increase the safety of the wiring and its surrounding area.

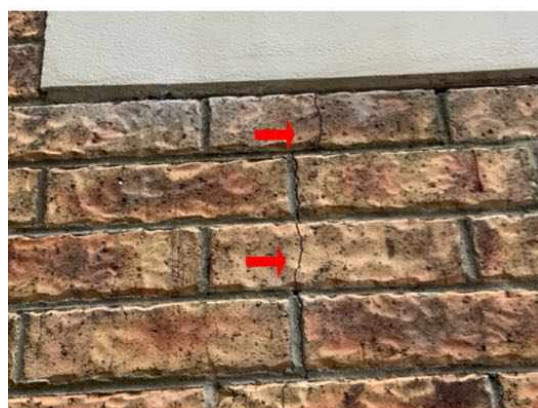
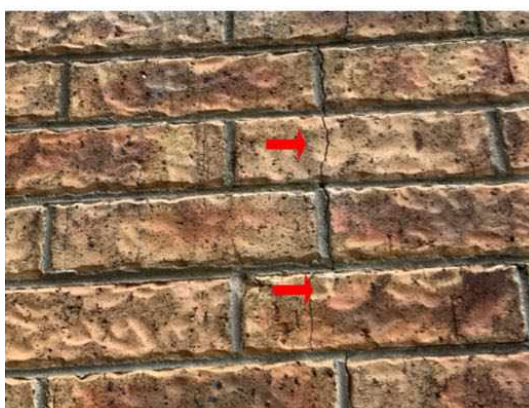
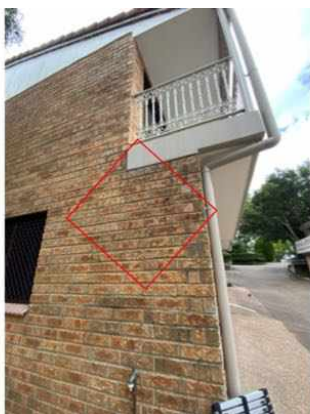
### Finding 3.01

Building: Main Building  
Location: Exterior walls - front  
Finding: Subsidence  
Information: It appears that the wall structure has been affected by movement of the foundations, often referred to as sinking or subsidence. Whilst a degree of movement is expected in subfloors over time, especially as environmental conditions change and buildings 'settle' after construction, this degree of subfloor movement requires attention.

General subsidence is usually initiated by changes in soil moisture content. The most critical factor is identifying the specific causes, and identifying if this is a recurring or ongoing problem, or one that has been resolved by previous works in the past.

Subsidence can have complex and varying causes, which will influence the required remedial works. It is advised to begin by consulting a structural engineer to determine the required scope of works. This generally includes some form of underpinning, as well as addressing the underlying cause. Consultation with a geotechnical engineer may also be necessary where changes to soil moisture content is apparent.

A Registered Builder specialising in re-stumping would then generally carry out works as advised by an Engineer.

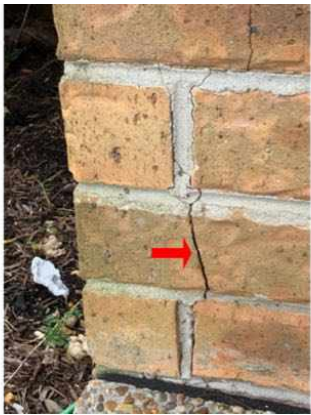
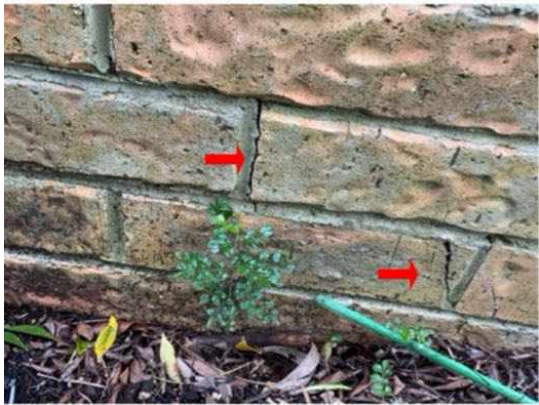
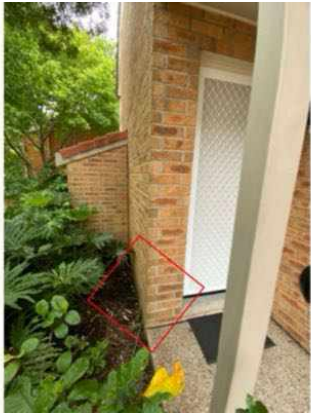
### Finding 3.02

Building:	Main Building
Location:	Exterior walls - front
Finding:	Subsidence Monitor
Information:	It appears that the wall structure has been affected by movement of the foundations, often referred to as sinking or subsidence. A degree of movement is expected in subfloors over time, especially as environmental conditions change and buildings settle after construction.

The apparent subsidence is evidenced by some gaps and cracks to brickwork.

General subsidence is usually initiated by changes in soil moisture content. The most critical factor is identifying the specific causes, and identifying if this is a recurring or ongoing problem, or one that has been resolved by previous works in the past.

Subsidence can have complex and varying causes, which will influence the required remedial works. If movement continues It is advised to consult a structural engineer to determine if repair works are warranted. Works may include some form of underpinning, as well as addressing the underlying cause. Consultation with a geotechnical engineer may also be necessary where changes to soil moisture content is apparent.

A Registered Builder would then generally carry out works as advised by an Engineer.

At this point it is recommended to contain storm water flows, ensure pavements flow away from the building to lessen any excessive wetting and drying effects.

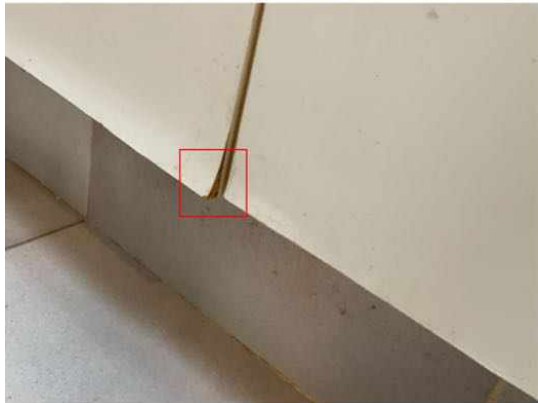
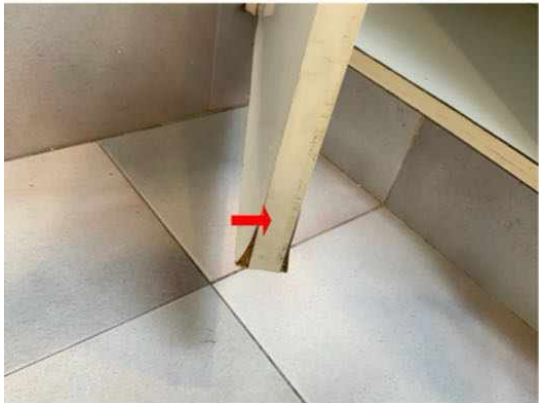
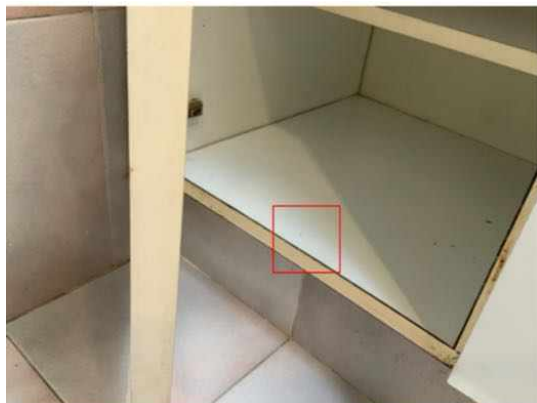
**Finding 3.03**

Building: Main Building  
Location: Ensuite - Master  
Finding: Vanity/Deterioration  
Information: It was noted that the vanity was damaged due to exposure to water and moisture. This could be due to low quality of the vanity itself, or the misuse by the occupant or the excessive exposure to steam and lack of ventilation.

A qualified plumber should be contacted to make good vanity or replace it.

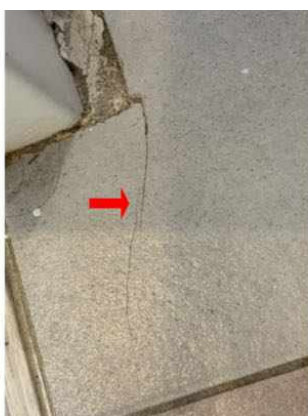
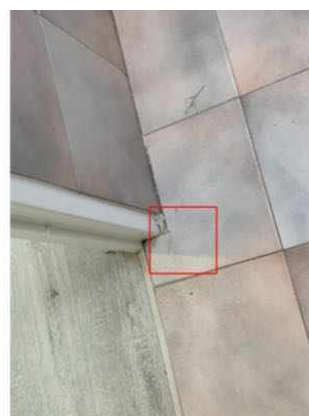
### Finding 3.04

Building:	Main Building
Location:	Ensuite - Master
Finding:	Cracked floor tiles
Information:	Cracking in the floor tiles was evident in this area at the time of inspection. It is suspected that this cracking has occurred as a result of minor settlement or shrinkage of the slab.

Cracked tiles throughout the household detract from the overall appearance of the affected areas however it is unlikely to create or lead to any secondary defects.

While not considered a matter of urgency, replacement of cracked floor tiles is recommended at the clients discretion. A tiling contractor may be appointed to perform these works. Where cracks become more numerous, contact a licensed building inspector for further investigation.

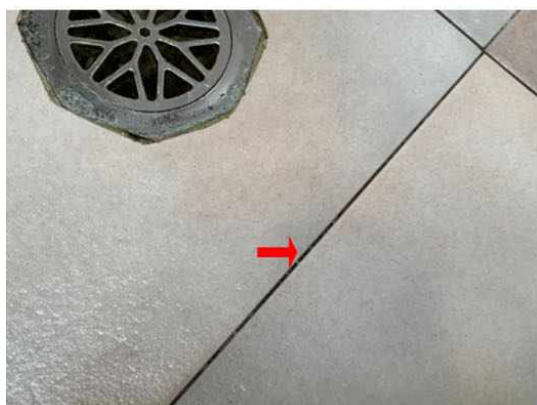
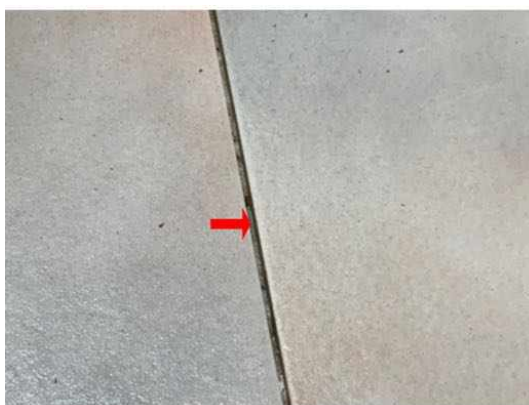
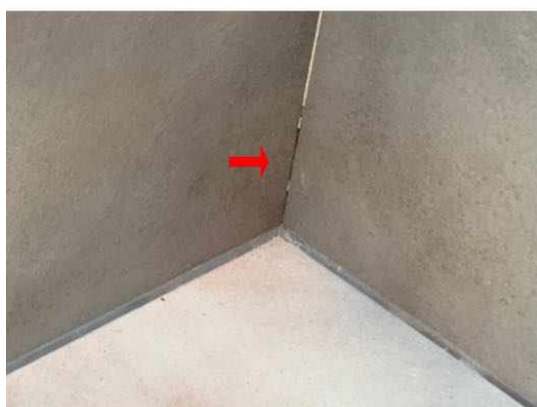
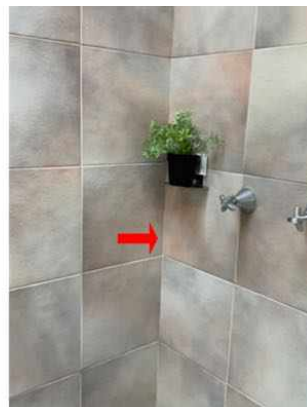
### Finding 3.05

Building:	Main Building
Location:	Ensuite - Master
Finding:	Sealant and grouting - Missing or damaged
Information:	It was noted on inspection that sealant or grout is degraded to the tiled shower alcove

and or other areas of the bathroom.

Different materials and floor areas move at different rates, generally causing cracking to grout or sealant at this point. A flexible sealant is required to allow for expected expansion and contraction, while keeping the joint water tight and protective of all associated building materials.

There appears to be excessive mould to the sealant and grout which will likely require scraping out and replacement.

Flexible and mould resistant materials should be applied to affected areas to prevent any subsequent water damage that is likely to occur. Regular maintenance and replacement of damage or missing or damaged sealant and grout is highly recommended to the wet areas, as this is a regular wear and tear defect. Sealant and grouting in areas that come into regular contact with water should be maintained for the long term care of your property.

A sealant specialist or tiling contractor should be appointed to complete these works as soon as possible

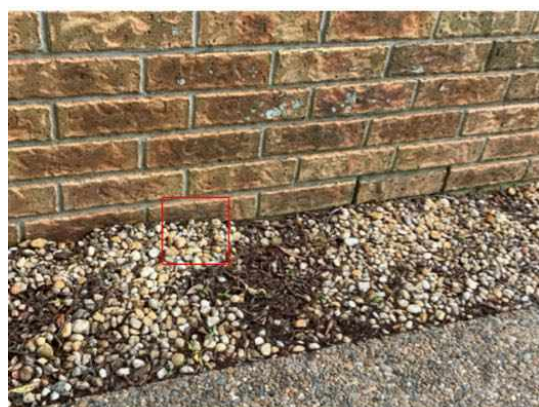
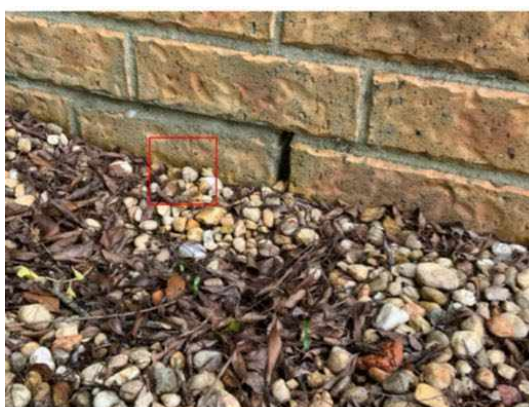
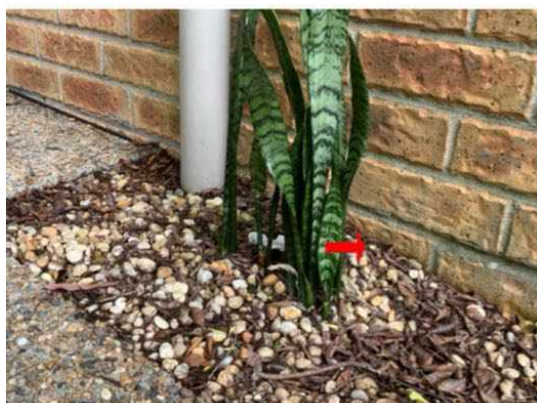
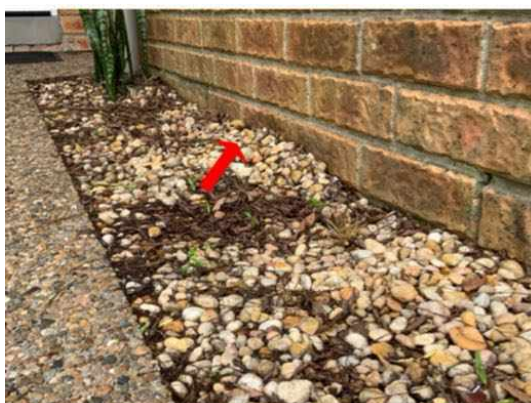
#### Finding 6.01

Building: Main Building  
Location: Exterior walls - front  
Finding: Bridging - damp course level  
Information:

Damp proof course (DPC) is a barrier of impervious material built into a wall or pier to prevent moisture from moving to any part of the building. Where external ground levels are built up over this barrier ingress is provided for moisture from the exterior grounds into the base brickwork or other building material and allowed to rise.

Such conditions attract termites into these damp areas which is likely to lead to infestation if left untreated.

While retrospective fitting of DPC is considered to be impractical works are required in order to prevent the extraction of moisture from the external environment into exterior brickwork or wall materials. Landscaping or re-paving of external grounds may be considered by the client. Regular annual inspections are strongly advised.

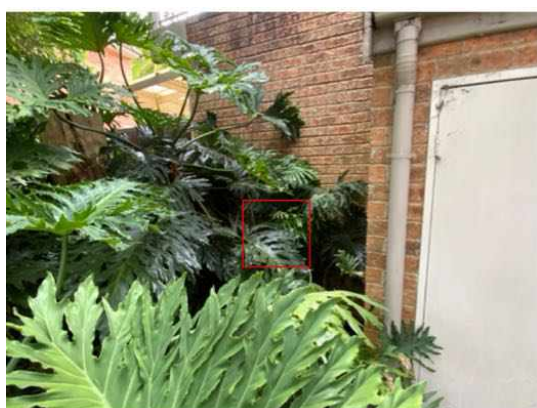
**Finding 6.02**

Building: Main Building  
 Location: Exterior walls - left side  
 Finding: Bridging - Vegetation  
 Information: Where vegetation obstructs inspection of building elements, also known as bridging as it provides a bridging point for the access of termites, full inspection can not be achieved. Consequently moisture or dampness may be present and the areas becomes conducive to termite activity. Plants against or very close to buildings provide cover, shade and can provide an environment that is attractive to termite infestation.

The removal and replanting of species that do not provide "cover" or cutting back of existing vegetation will assist greatly in preventing Bridging from occurring.

The removal of any such materials that may be conducive to termite activity should be carried out as soon as possible and arrange re inspection to minimize the risk of termite attack.

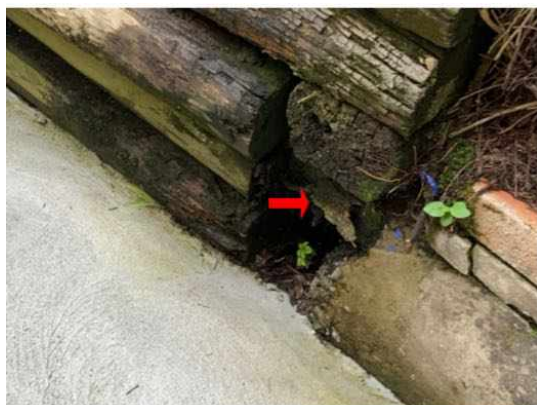
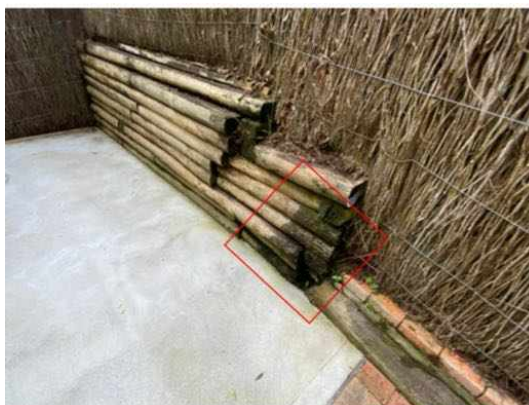
**Finding 6.03**

Building: Main Building  
 Location: Exterior walls - rear

Finding: Wood rot /identified in landscaping  
 Information: Upon inspection of the property site sections of the landscape timbers have deteriorated with wood rot evident.

This appears to be due to general ageing and deterioration of the structure which is to be expected of its age.

Wood rot which is technically known as fungal decay occurs when timbers and other cellulose building materials are exposed to damp conditions on an ongoing basis.

This could be the result of exposure to weathering in the long term or the pooling of water or absorbed moisture from other abutting building materials. Wood rot is often associated with general damp problems and if left unmanaged damp conditions can lead to further decay of timbers.

Where timber elements are in direct contact with the ground and consequently moisture or dampness they become conducive to termite activity. Whether timber is used as a building element part of a fencing structure, landscaping or stored as an unused item they can provide an environment that is attractive to termite infestation.

It is highly recommended that all susceptible timbers be removed and replaced with non-susceptible timber.

A landscaping contractor or handyman may be appointed to perform these works.

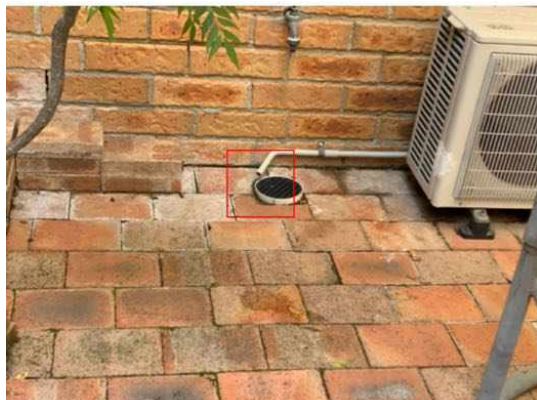
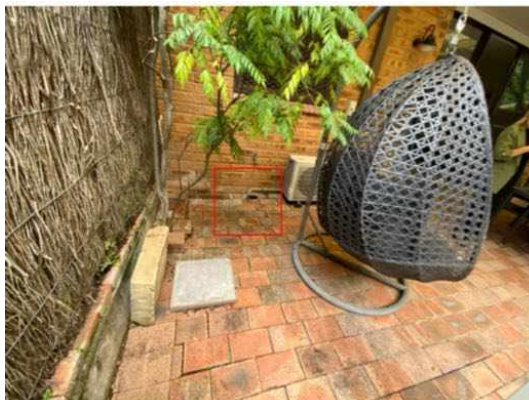
### Finding 6.04

Building: Main Building  
 Location: Exterior walls - rear  
 Finding: Air conditioner - Disconnected overflow  
 Information: The Air Conditioner (A/C) overflow was found to be disconnected from storm water drainage and is creating excessive moisture in the surrounding area.

Such leaking creates an environment which is conducive to an array of defects, including water damage to associated building elements and the attraction of termite

or timber pest infestation.

It is highly recommended that a licensed plumber be appointed to connect the A/C overflow in order to prevent such an environment from being created. These minor works should be carried out as soon as possible.

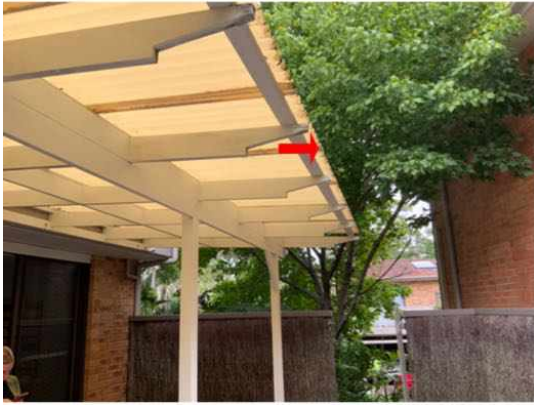
### Finding 6.05

Building:	Main Building
Location:	Exterior walls - rear
Finding:	Roof plumbing - Missing
Information:	Some sections of the roof are not adequately drained via gutters and downpipes. Gutters and downpipes that are not installed adequately are likely to result in excessively damp conditions against the exterior surfaces and around the base perimeter of the building.

Excessive moisture creates an environment which accelerates the deterioration of building elements in the area, as well as being conducive to termite and pest infestation. Such an environment is likely to necessitate repair and/or replacement of building elements, which are prone to sustaining wood rot, rust or corrosion.

A roofing plumber should be appointed as soon as possible to install relevant roof plumbing materials. Depending on the extent of the damage, repair and/or replacement of damaged building elements may be required.

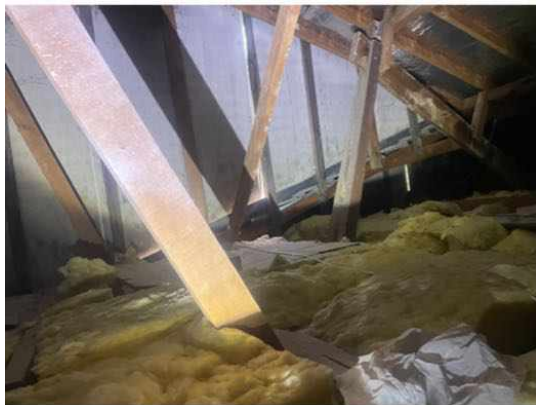
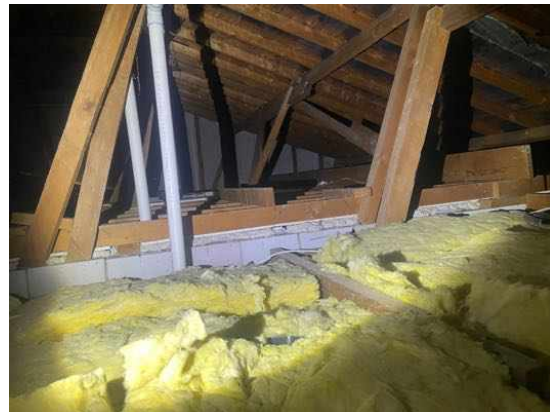
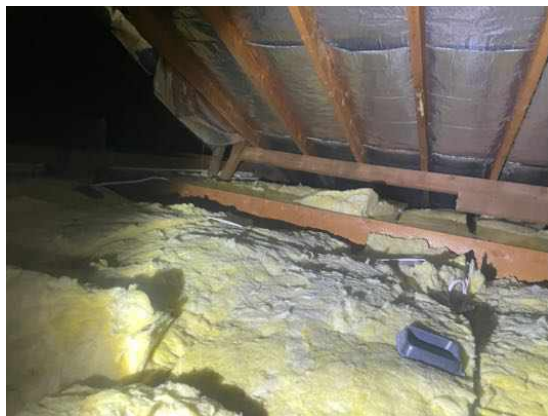
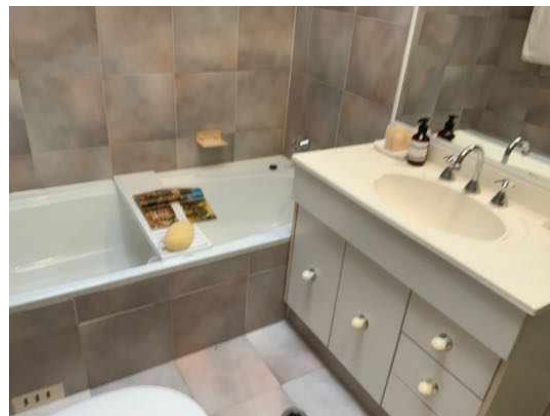
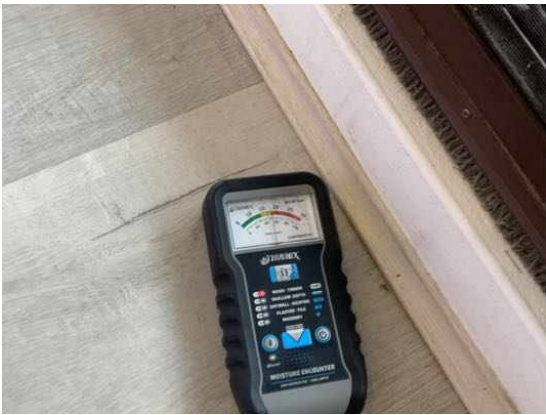
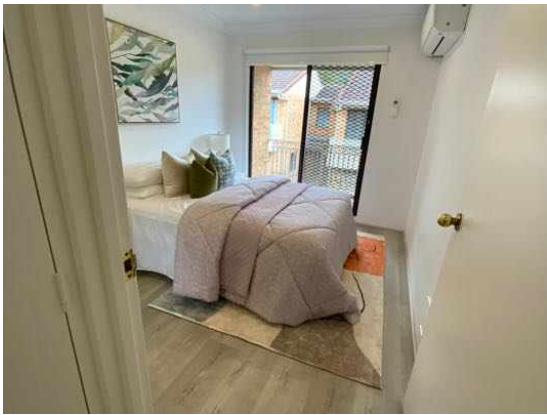
Finding: Additional Photos - Obstructions and Limitations

Information: These photographs are an indication of the obstructions and limitations which impeded full inspection of the property at the time of inspection. These obstructions can hide an array of defects and should be removed to allow full inspection to be carried out. A re-inspection is recommended once the areas are made accessible.
