Building and Timber Pest Inspection Report

Inspection Date: Wed, 14 Jan 2026

Property Address: u5/6 Runway Dr, Marcoola QLD 4564,
Australia

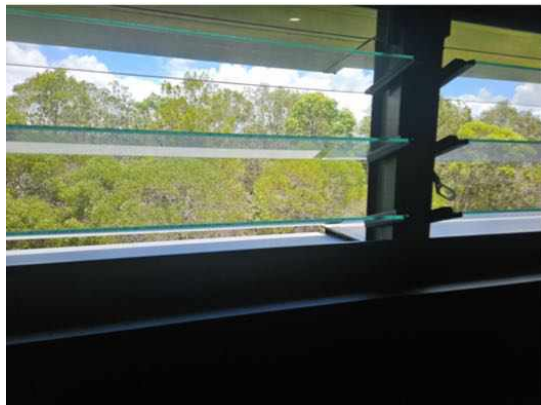
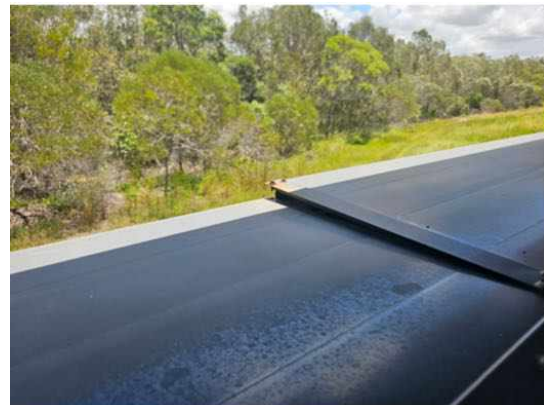
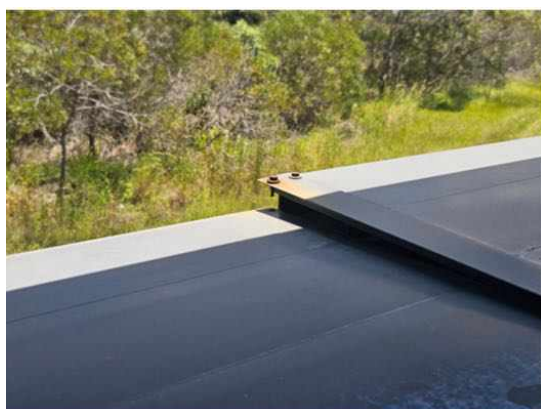
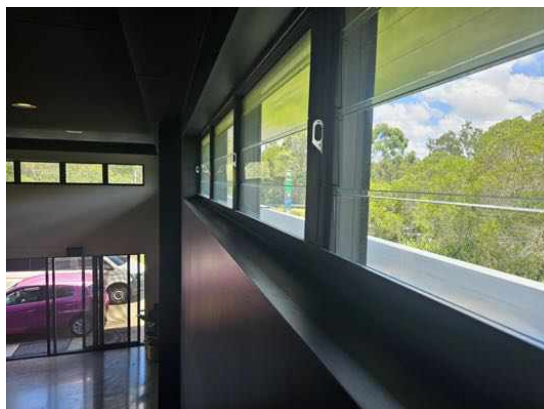
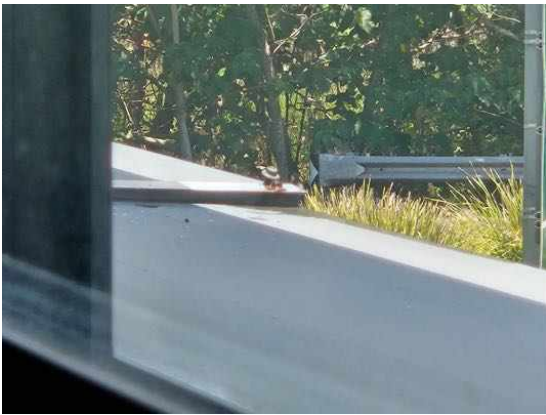
Finding 3.01

Finding: Awning - damaged.

Information: On the day of inspection it was noted that the aluminium window awning at the left side around the windows of the mezzanine was damaged. The retaining screws have become dislodged.

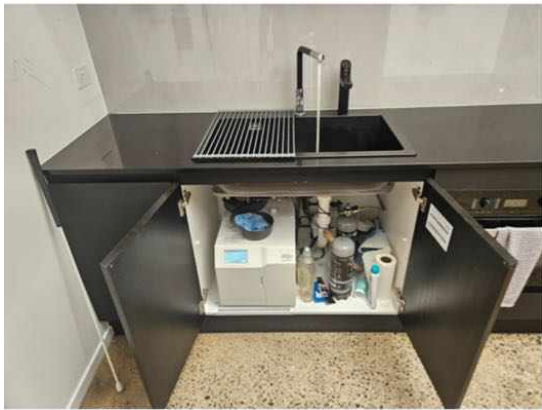
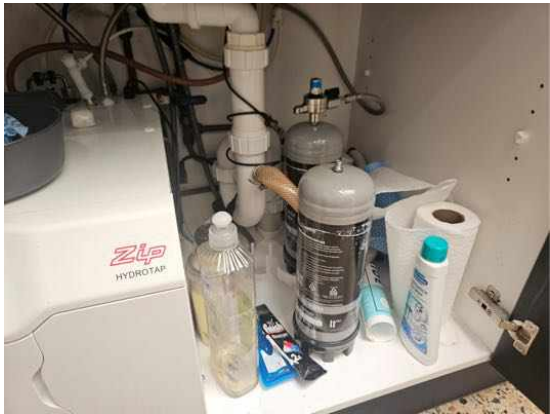
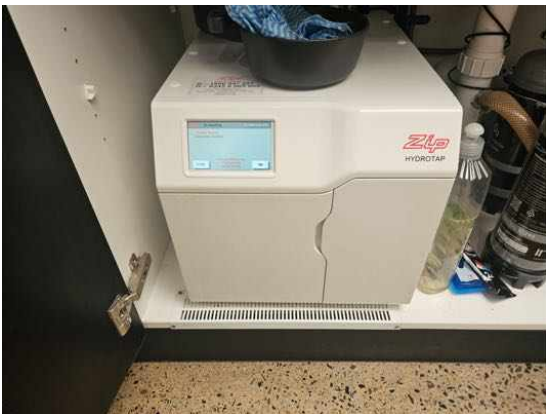
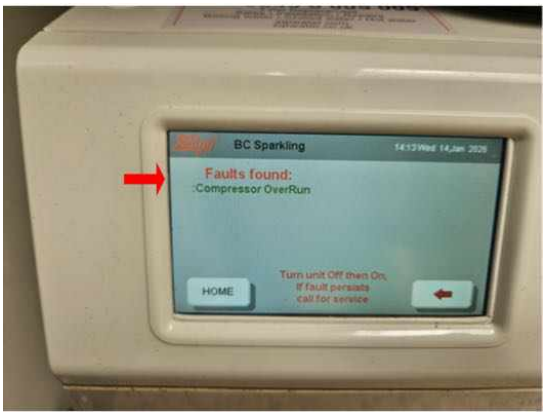
Finding 3.02

Building: Main Building
 Location: Kitchen
 Finding: Zip unit faulty.
 Information: On the day of inspection, the under bench water filtration unit was showing a fault and was not able to operated. A service call is recommended.

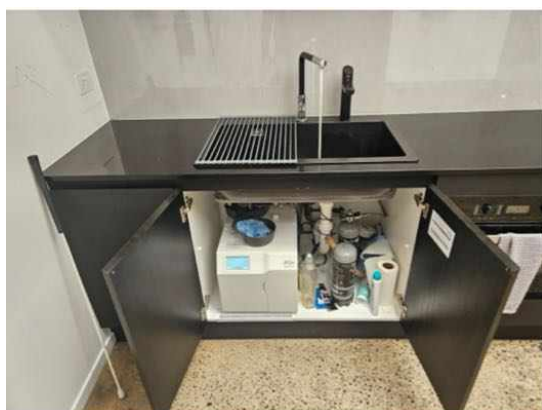
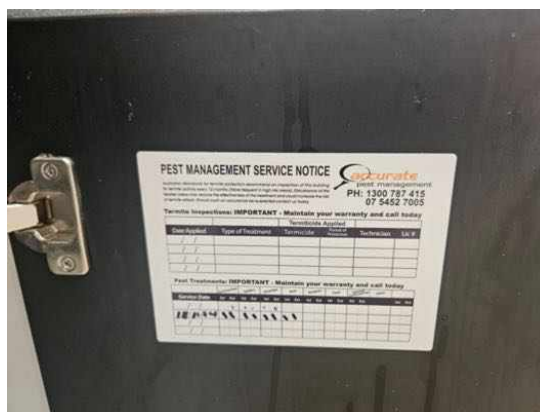
Finding 6.01

Building: Main Building
 Location: All Areas
 Finding: No termite management system detected
 Information: There are a number of factors which indicate the presence of a previously installed or applied termite barrier. The most common are a durable notice (to the inside of your meter box and / or the kitchen sink cupboard) observable physical barriers installed to building perimeter and in ground reticulation systems.

There were no indicators that a system or barrier is in place within the subfloor area of the building. Although the type of construction is low risk and the installation of a barrier system may not be viable, regular inspections should be carried out and it is recommended that an inspection programme be established.

It is recommended that a licensed pest controller be consulted to initiate a regular inspection programme.

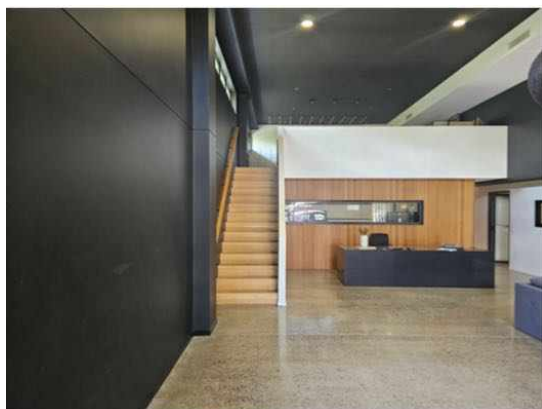
Building:	Main Building
Location:	Reception
Finding:	Stairs compliant - AS 1657:2018
Information:	The stair case as inspected on the day, is compliant with the Australian Standard, AS 1657 : 2018.

It is sound and of good standard of installation and manufacture.

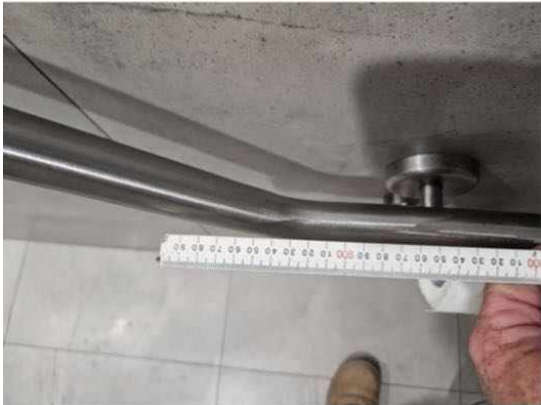
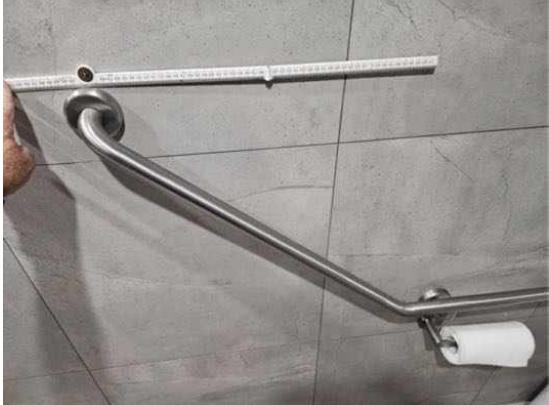
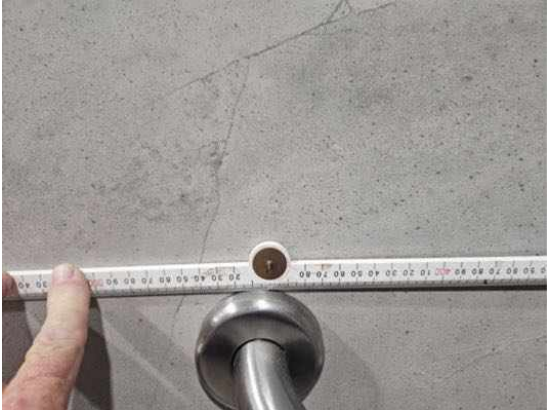
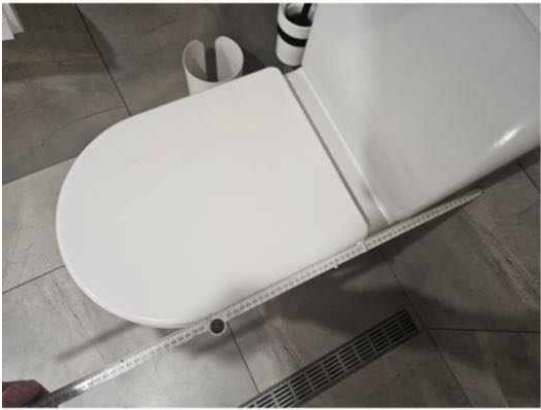
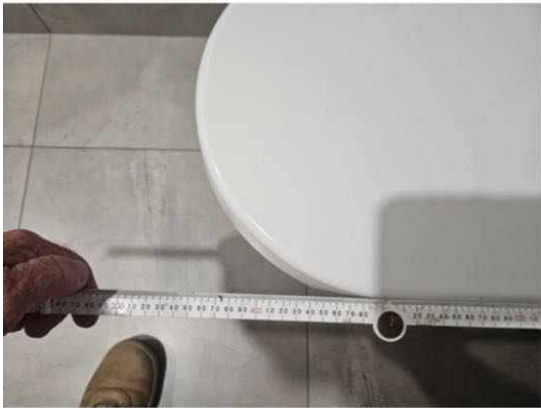
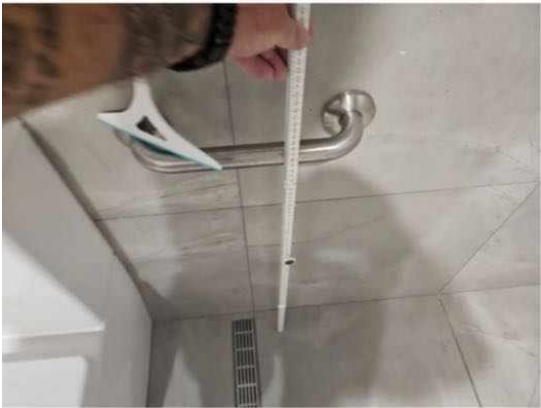
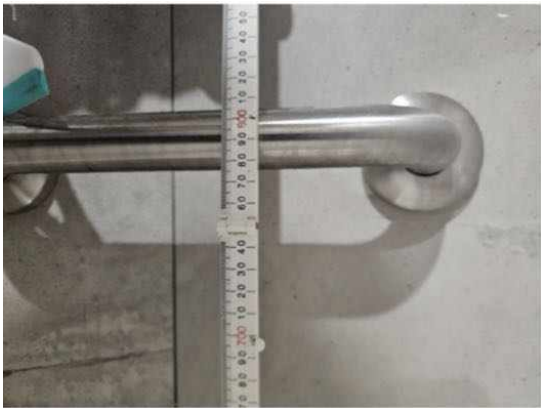
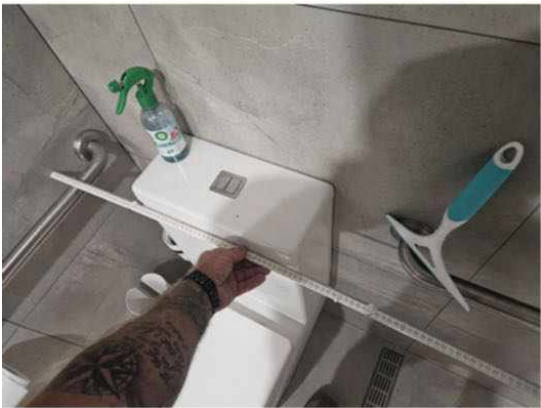
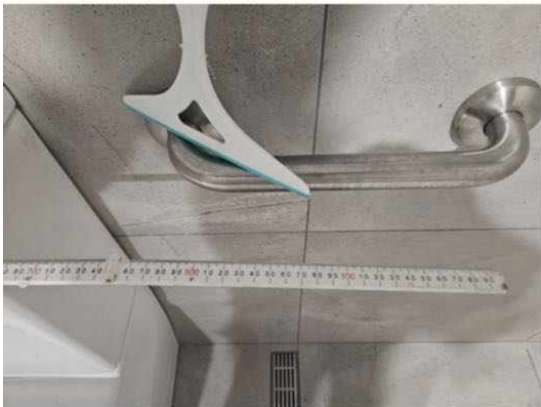
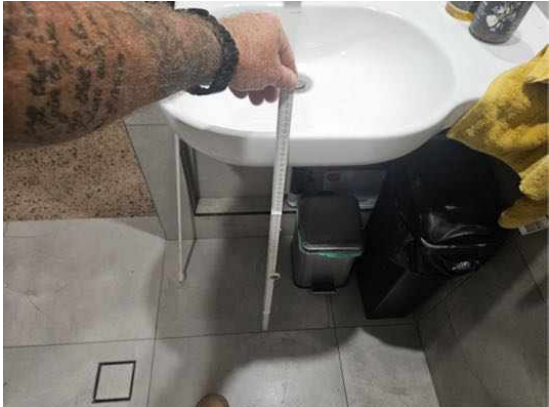
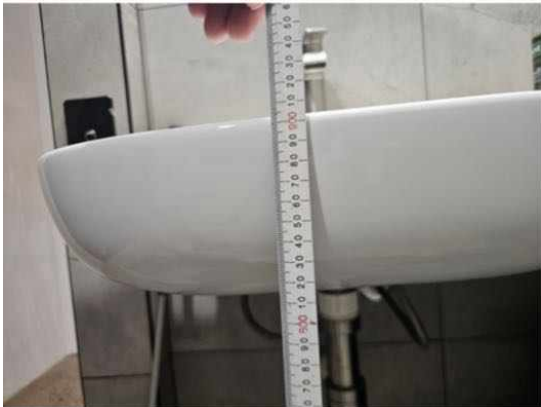
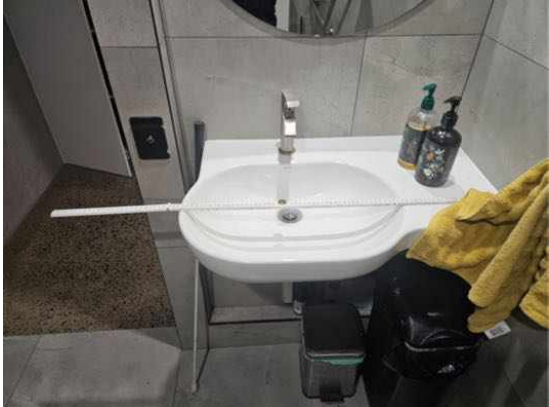
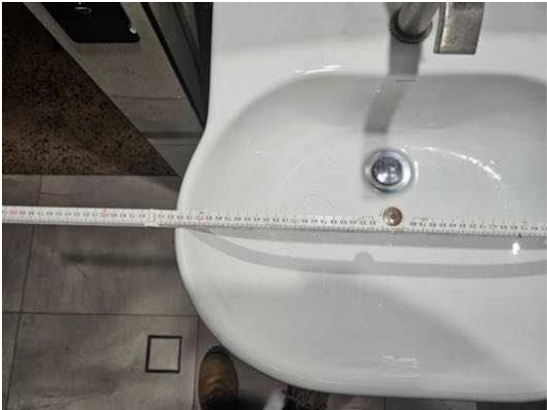
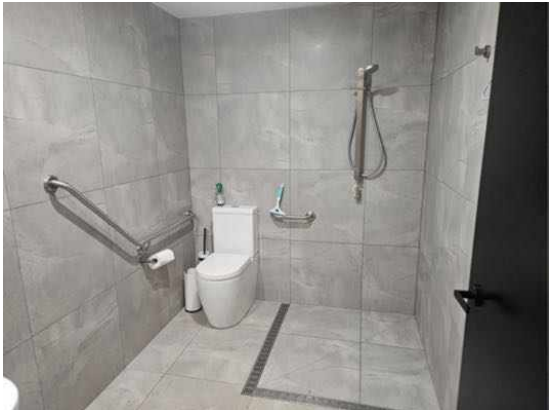
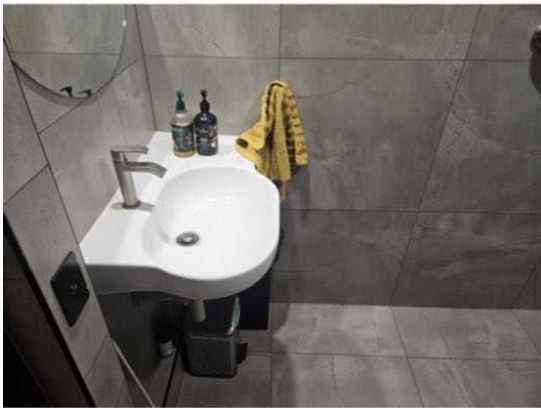
Building:	Main Building
Location:	Bathroom
Finding:	Toilet facilities compliant
Information:	During the inspection the toilet facilities are assessed against AS 1428 - 2009 for compliance. All elements comply except for the vanity basin, which is 60mm above the specified height of 840mm.

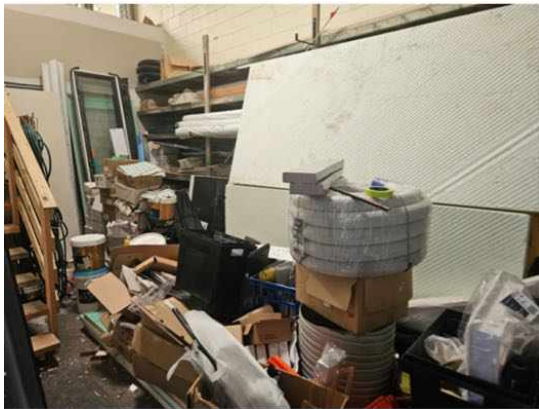
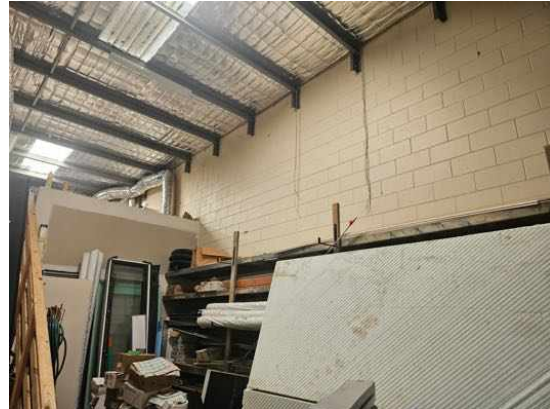
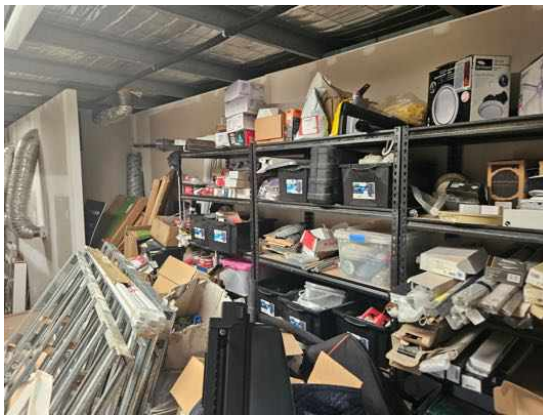
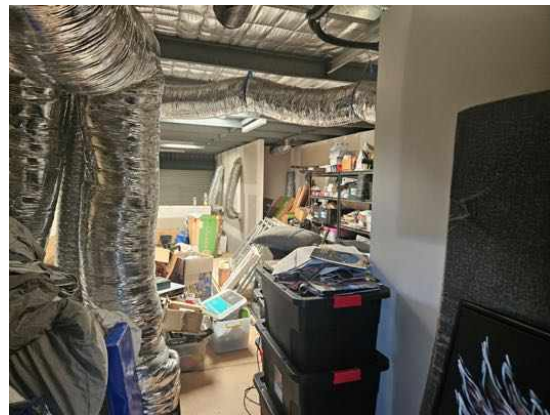
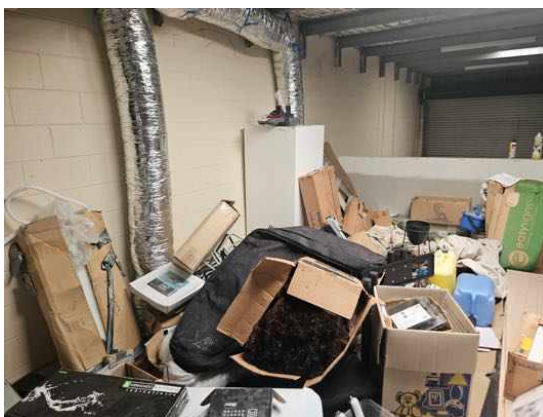
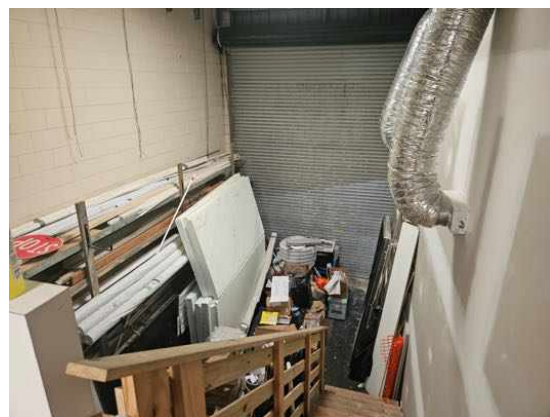
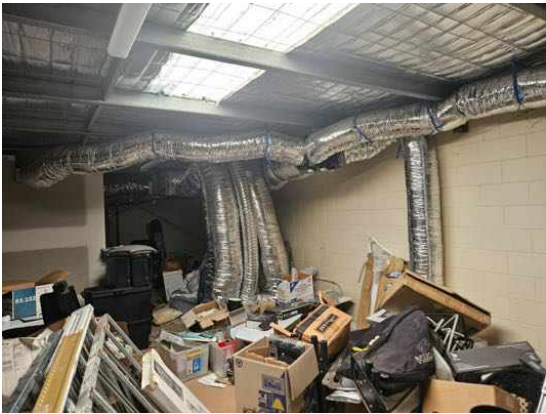
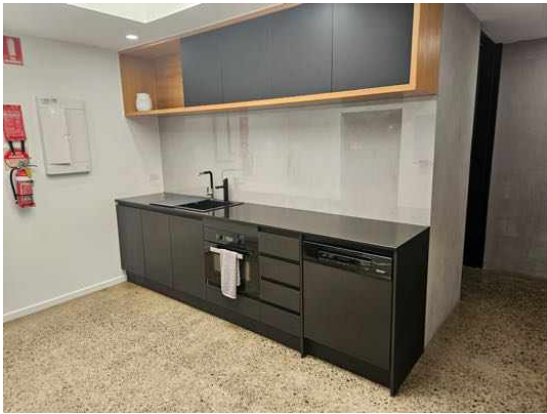
Finding: Additional Photos - Obstructions and Limitations

Information: These photographs are an indication of the obstructions and limitations which impeded full inspection of the property at the time of inspection. These obstructions, some of which cannot be removed, can hide an array of defects and, where possible, should be inspected when removed. A re-inspection may be carried out should it be required, once the areas are made accessible.

Roof space photos show restrictions to a visual inspection or to access to the roof void due to restrictive roof framing and / or insulation.
