# Building and Timber Pest Inspection Report

Inspection Date: Mon, 30 Mar 2026

Property Address: 55 Glenfields Blvd, Mountain Creek QLD  
4557, Australia

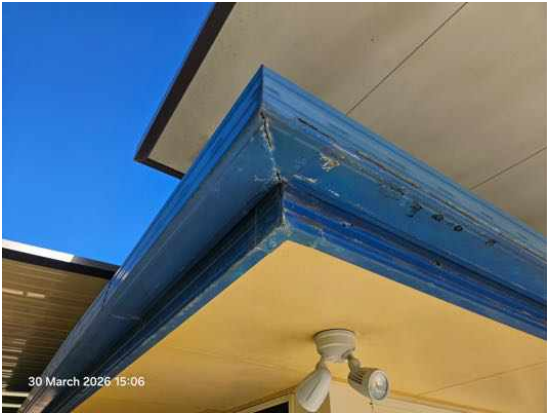
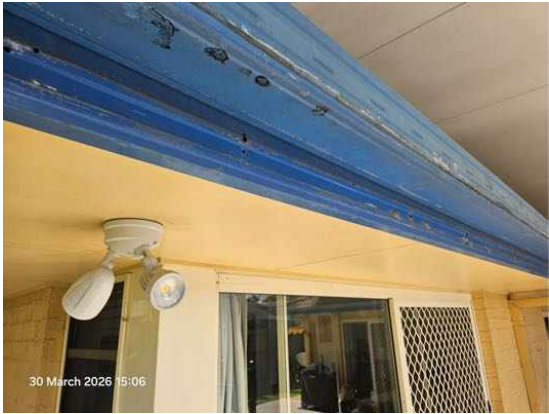
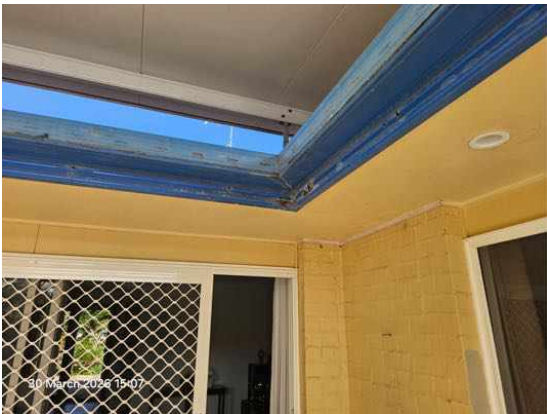
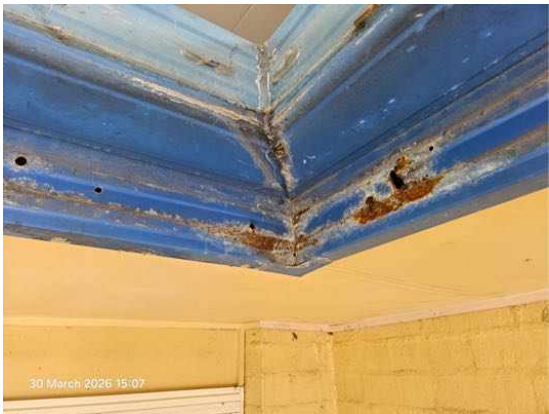
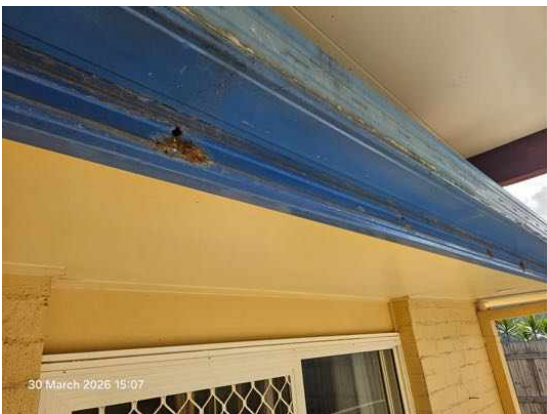
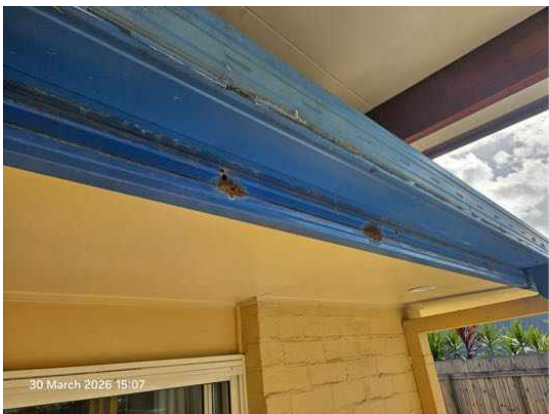
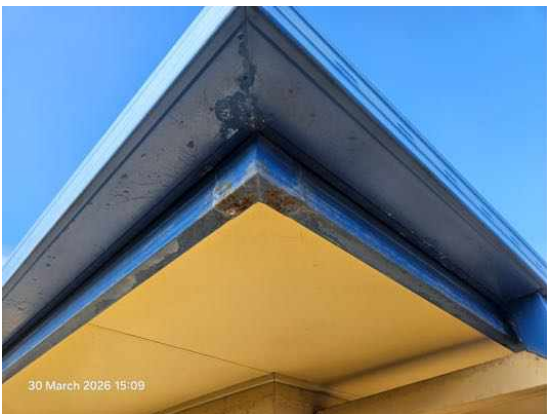
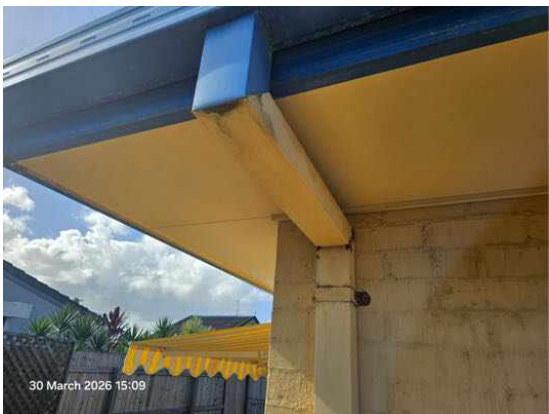
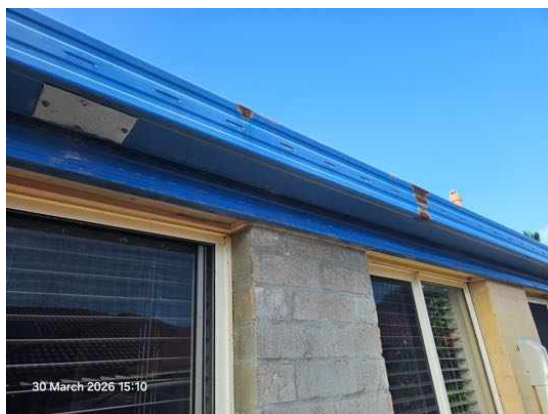
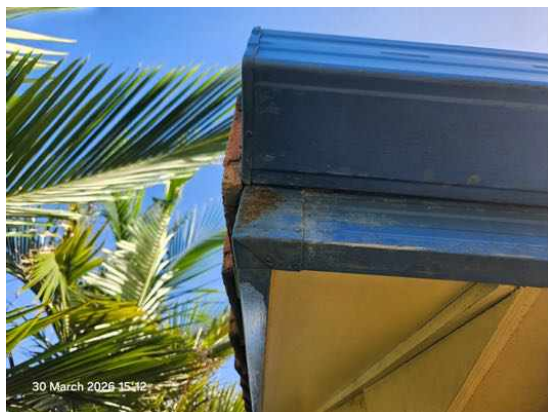
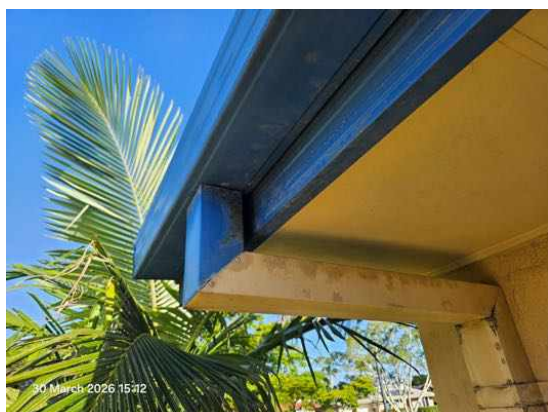
Building:	Main Building
Location:	All Areas
Finding:	Roof gutter rusted
Information:	The sections of the fascia and roof gutter shown in the photos has areas of surface rust visible.

Rusted roof plumbing will generally develop holes and leaks that can affect other building elements with poor drainage of storm water. Poorly drained roof areas will also lead to damp conditions surrounding the base perimeter of the building which, if left unmanaged, can lead to a range of secondary building defects.

Repair of rusted roof plumbing and gutters is required in order to maintain the roof drainage system in a fully operational level. To further maintain these areas, gutters should be cleaned frequently, allowing the avoidance of any partial blockages. They can also have an effect on the moisture levels in the soil against the building edge, this could become a conducive condition for timber pests.

A licensed painter could be appointed to undertake these works. It is advised that such works be completed in the short term to prevent any further damage and deterioration.

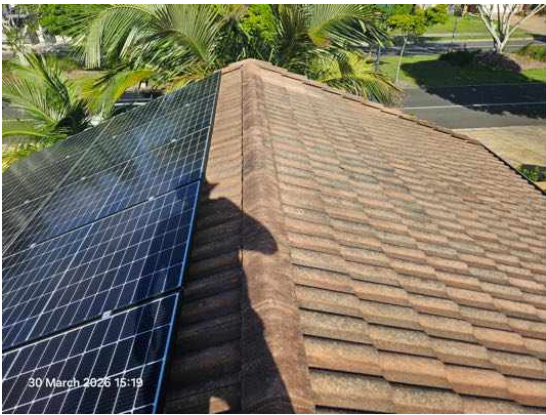
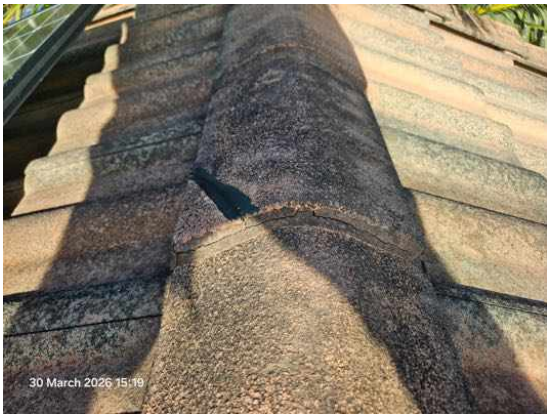
### Finding 3.02

Building:	Main Building
Location:	All Areas
Finding:	Roof tiles - bed and point
Information:	Upon inspection of the exterior roofing, the majority of roof tiles were considered to be in a fair to good condition. While weathering of the tiles is consistent with the age of the property, maintenance works are required. The ridge cap tiles require re-bedding and pointing. Some ridge tiles were tested for fixing adherence, an of the tiles tested they were found to be loose showing that the bedding has reached its service life. There were chipped tiles noted.

This has the potential to become a major defect if not rectified in the short term. The

roof has sisalation fitted under the tiles, which will eliminate much of the leak risk.

A roofing tiling contractor should be engaged to carry out the required repairs.

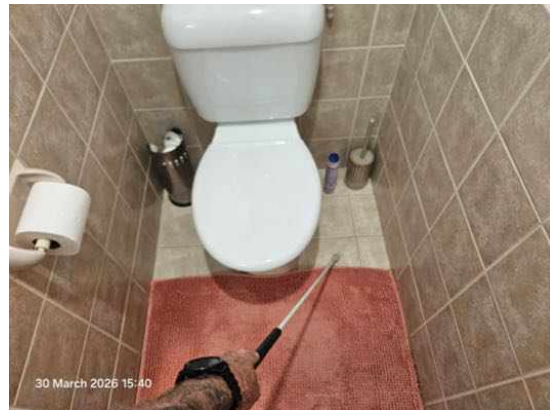
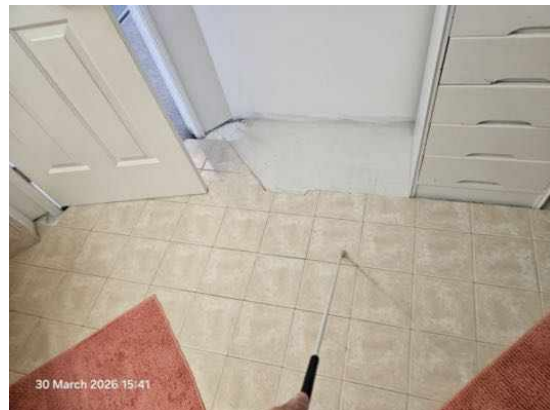
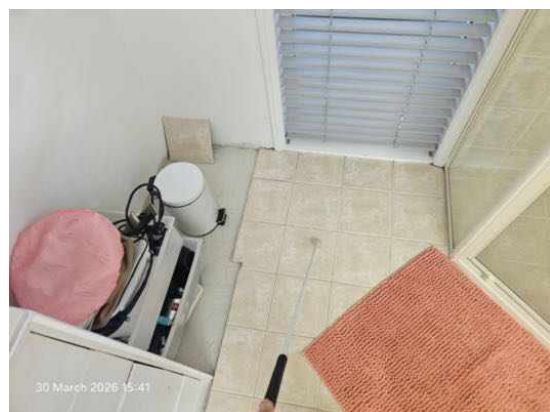
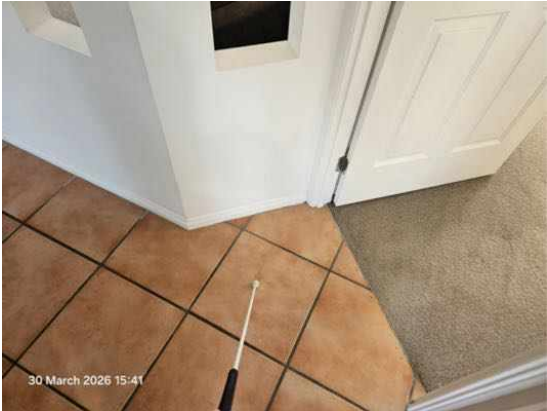
Building:	Main Building
Location:	As shown
Finding:	Tiles - Drummy and / or cracked
Information:	Drummy and / or cracked tiled areas were identified at the time of inspection.

The term 'drummy' refers to tiles that have become detached from their fixing, despite otherwise being in relatively good condition. Such defects are generally caused by

physical or moisture damage to the area. Drummy tiled areas may also be a direct result of poor workmanship during the construction process.

Tiled areas may swell and shrink with changes in air humidity if the area has sustained moisture damage. Any exposure to moisture is capable of causing tiled areas to become drummy and/or cracked over a prolonged period of time. Drummy tiled areas generally require removal and replacement of affected tiles.

Specialist trades are available for these types of services. A licensed builder may be required to undertake works if damage is extensive or if secondary building defects have resulted. Otherwise, it is advised that a tiling contractor be appointed to perform works as necessary.

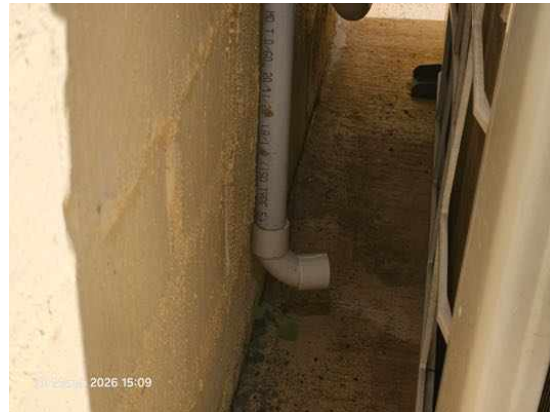
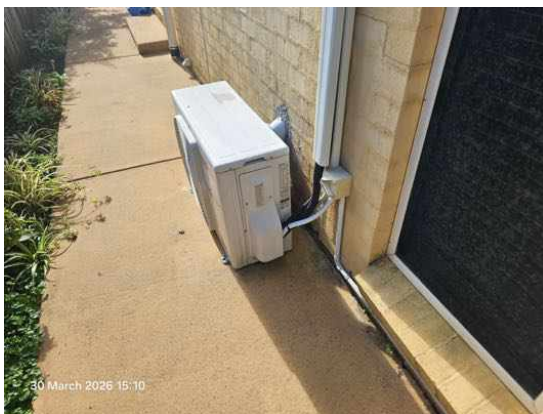
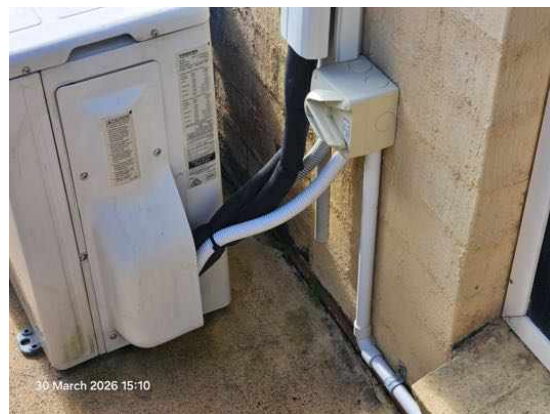
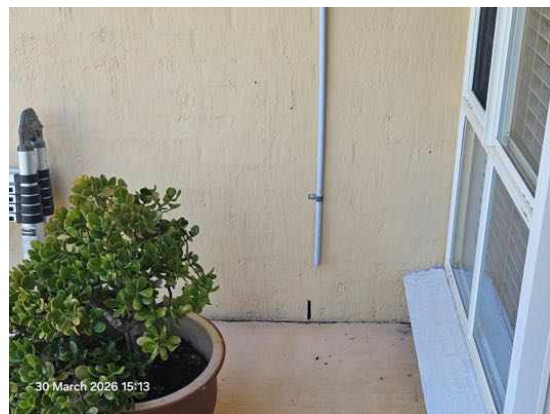
Building:	Main Building
Location:	As shown
Finding:	Air conditioner - Disconnected drain
Information:	The Air Conditioner (A/C) overflow was found to be disconnected from storm water drainage and could create excessive moisture in the surrounding area.

Such leaking creates an environment which is conducive to an array of defects, including water damage to associated building elements and the attraction of termite or timber pest infestation.

It is recommended that a licensed plumber be appointed to connect the A/C overflow to a drainage source in order to prevent such an environment from being created. An alternative is to extend the overflow further into the garden away from the building perimeter.

These minor works should be carried out in the short term.

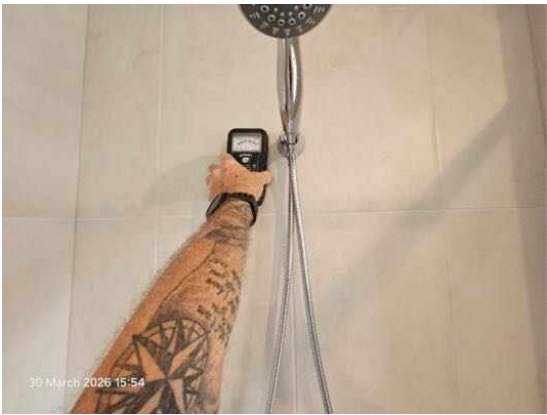
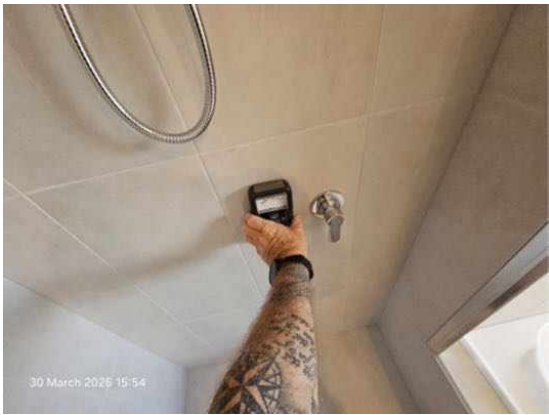
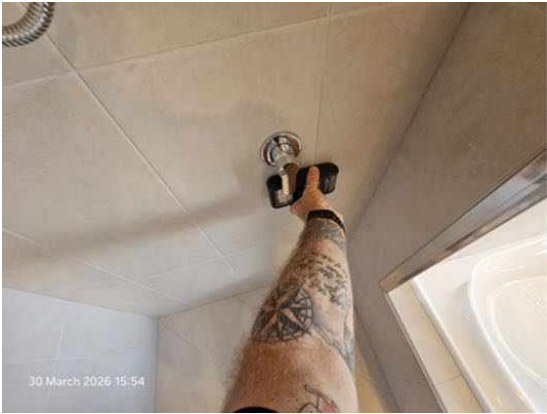
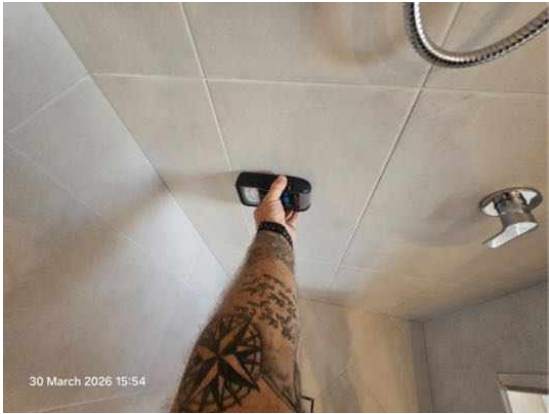
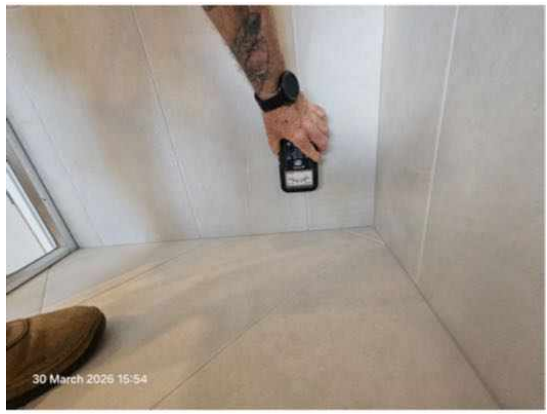
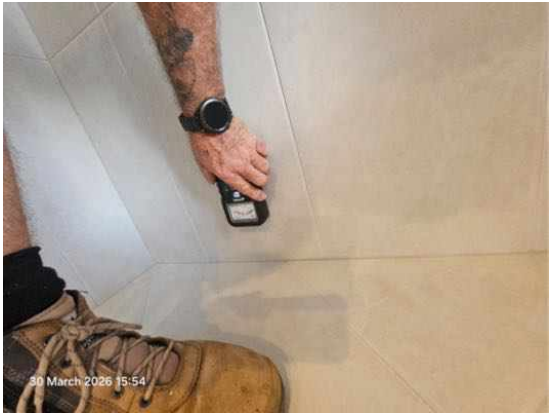
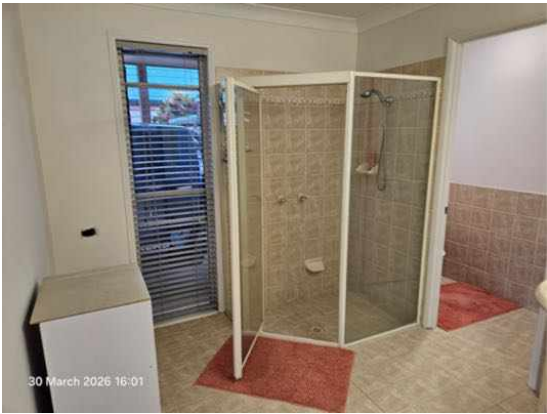
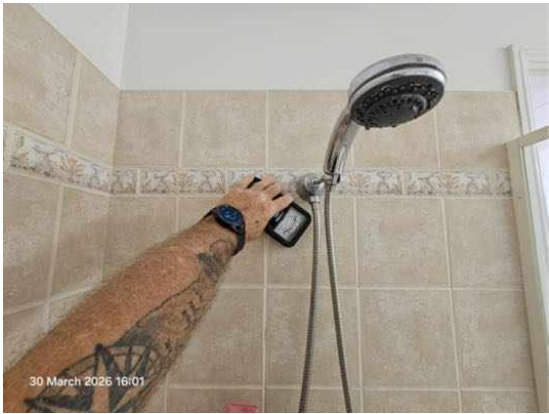
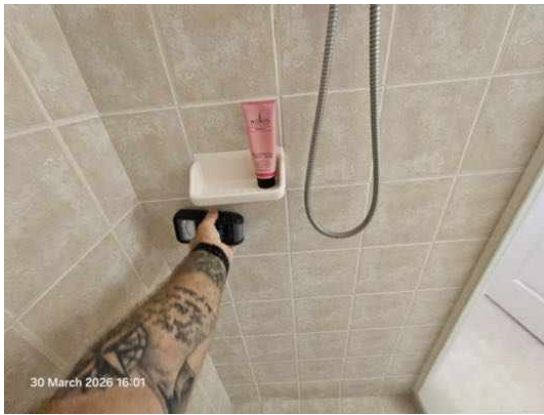
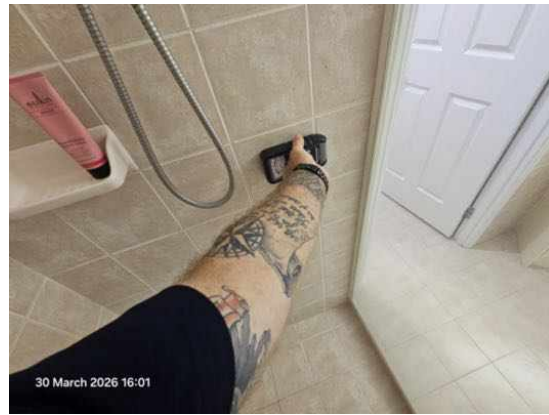
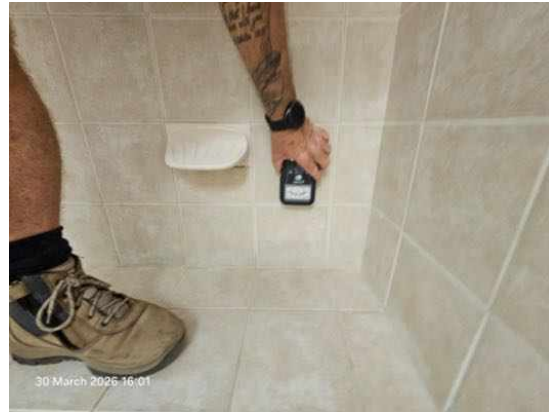
Building: Main Building  
 Location: Bathroom, ensuites  
 Finding: No moisture detected in bathroom / ensuite  
 Information: On the day of inspection the showers in the bathroom/s and ensuite/s are measure for moisture using a "Tramex" moisture meter. During this inspection no moisture was detected in these areas and the tiled / sheeted surfaces appear to be in good order.

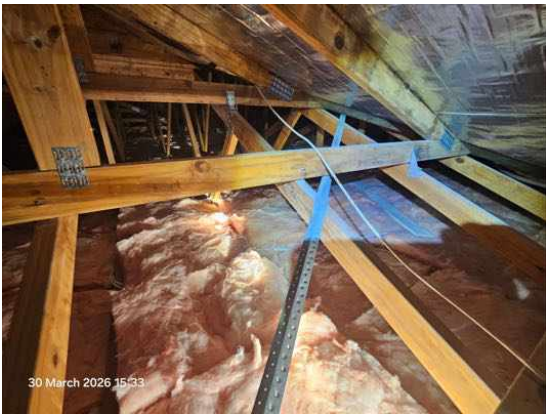
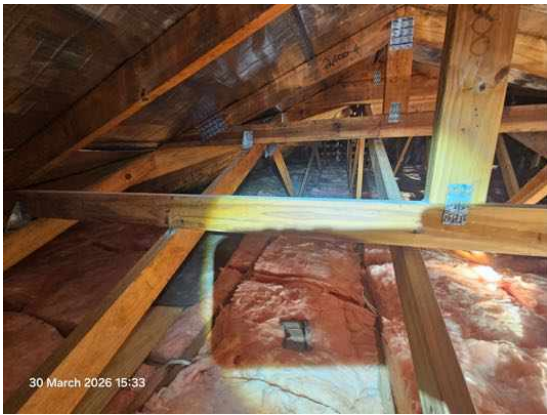
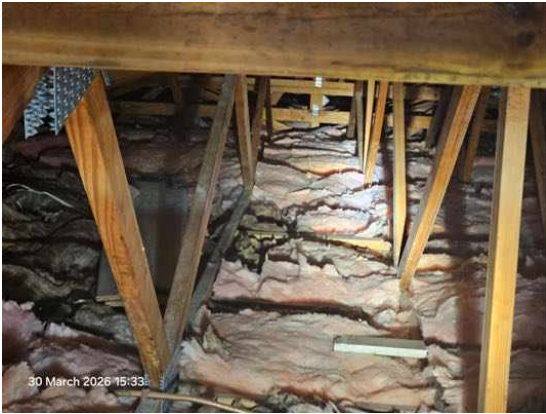
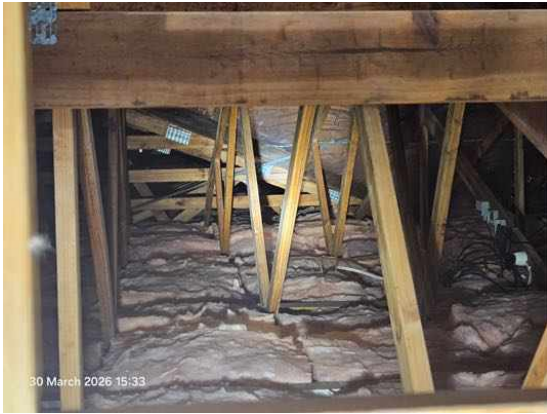
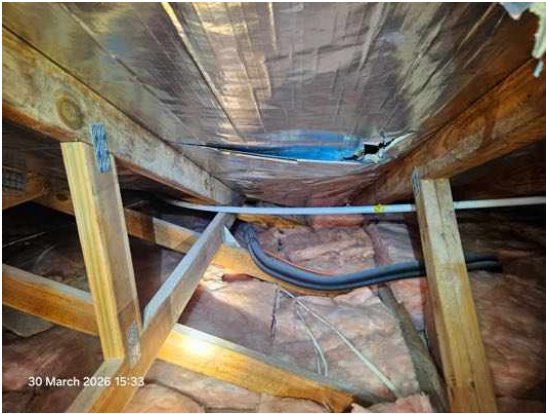
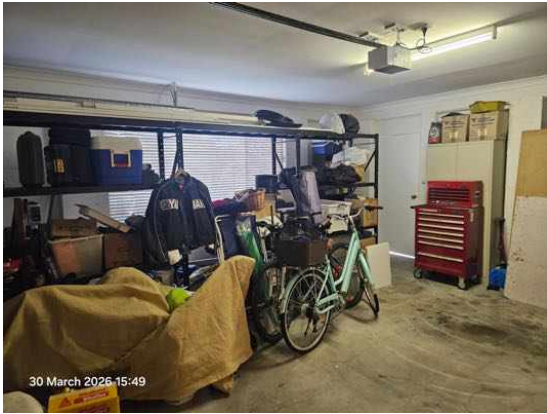
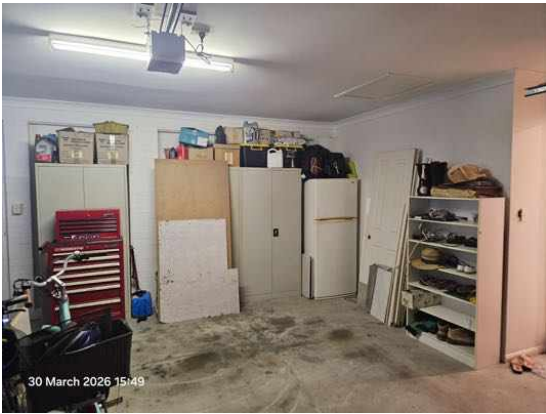
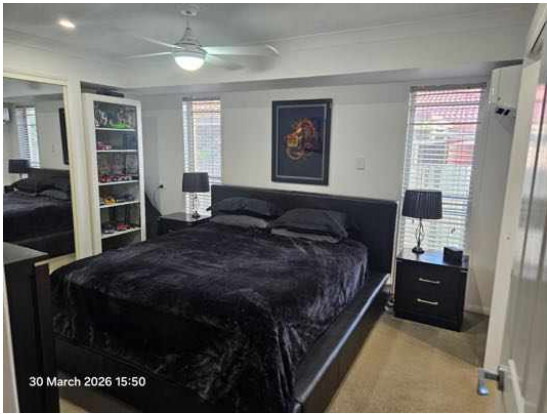
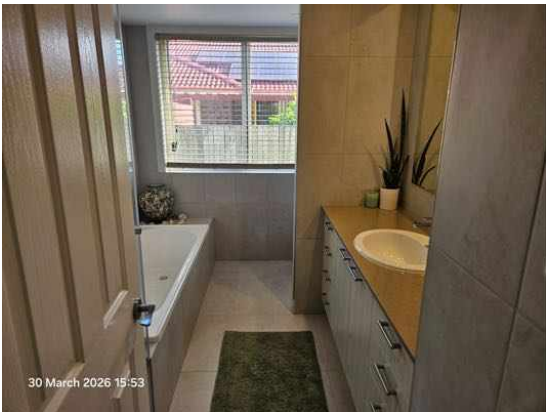
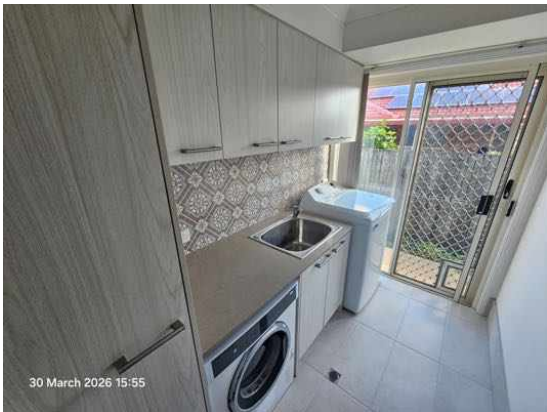
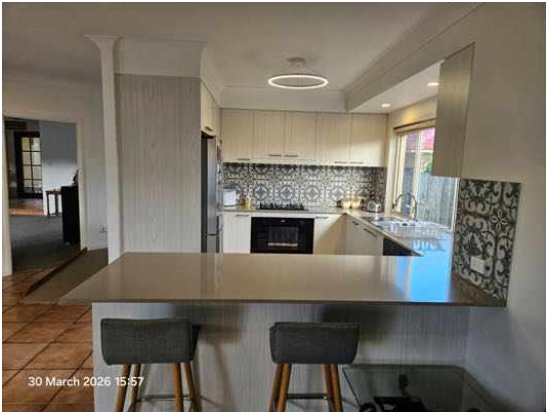
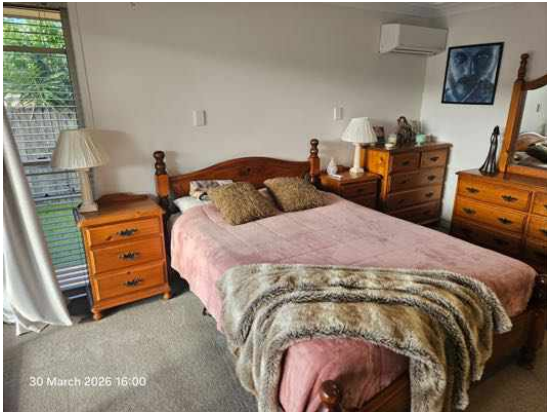
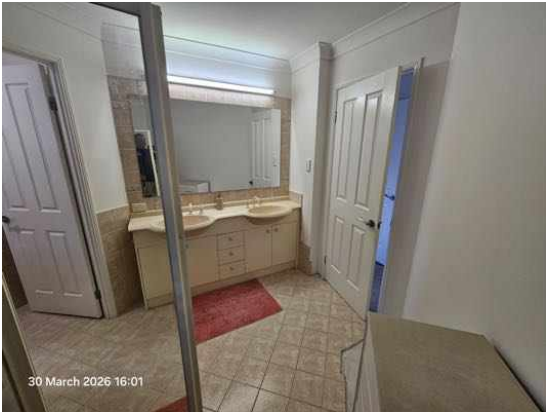
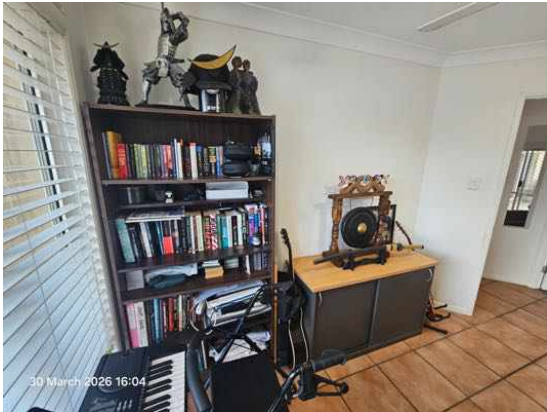
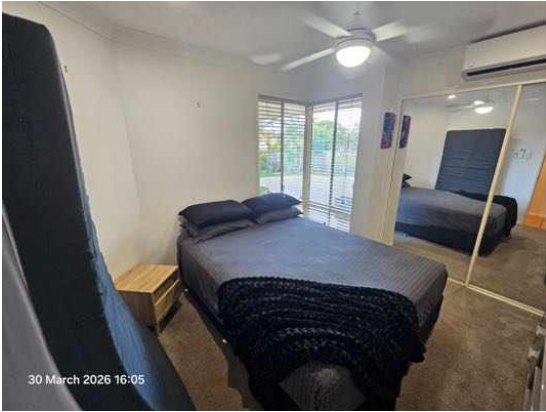
Building: Main Building  
 Location: All Areas  
 Finding: Additional Photos - Obstructions and Limitations  
 Information: These photographs are an indication of the obstructions and limitations which impeded full inspection of the property at the time of inspection. These obstructions can prevent full inspections of the areas shown.
