Building and Timber Pest Inspection Report

Inspection Date: Wed, 11 Mar 2026

Property Address: 4/45 Galloway Dr, Ashmore QLD 4214,
Australia

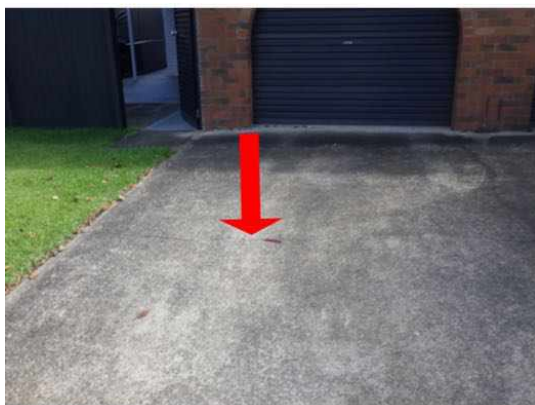
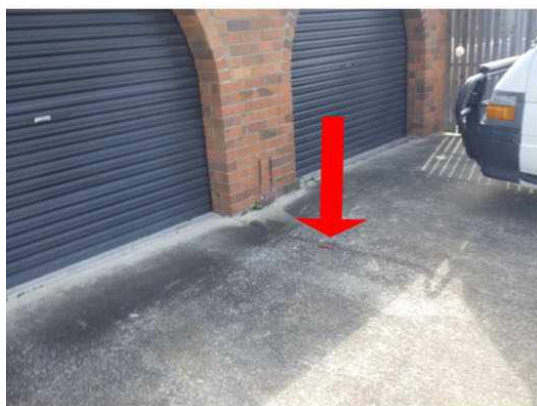
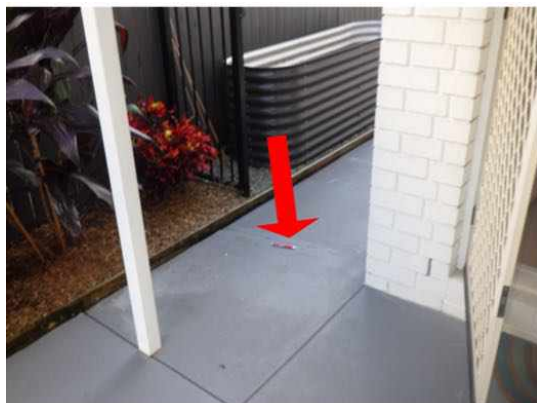
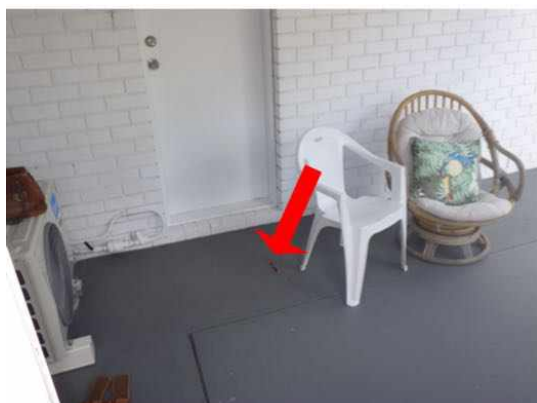
Building: Main Building
Location: Driveway > Ground Level
Finding: Cracking in concrete slab - Category 1 - 2
Information: Cracking coded as Category 1 was identified in the driveway and footpaths concrete slabs (as per example photos). A Category 1 crack is described as a fine but noticeable crack, with the slab at an otherwise reasonable level.

To be considered Category 1, the approximate width of the crack is less than 1.0mm, or a less than 10mm change in offset when a 3m straight edge is placed over the defect.

Category 1 cracks should be monitored for a period of 12 months. At the end of the monitoring period, identified cracks that are rated greater than Category 2 are considered defects, and require rectification.

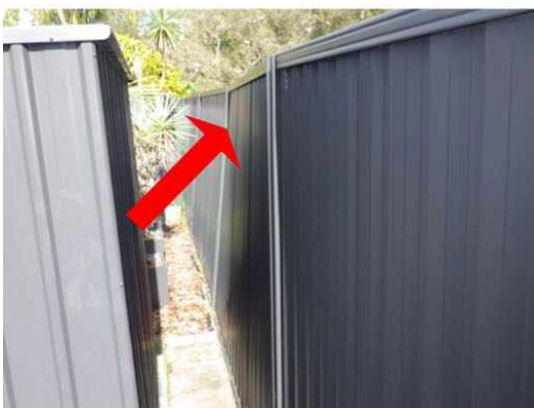
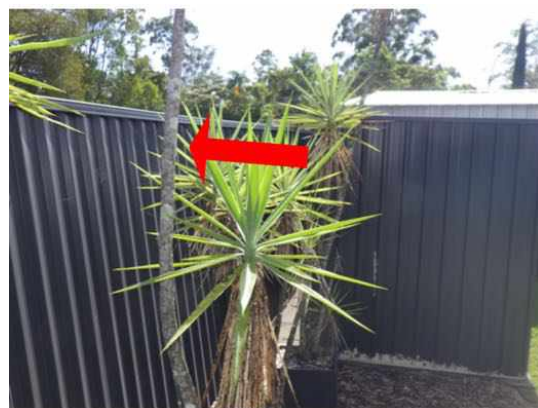
Information: It was noted at the time of inspection that sections of the fabricated metal fencing to the rear boundary of the property have moved significantly. Typically fencing movement of this type is due to ground erosion or subsidence, due to prolonged exposure to weather conditions. Sometimes inadequate installation or maintenance can be to blame.

If left unattended, it is likely that further damage will occur. It is suspected that repair of several elements of the fencing footings may be required and construction of a retaining wall to limit ground erosion may be a consideration of the client also.

A licensed fencing contractor should be appointed to provide further advice and perform rectification works as necessary.

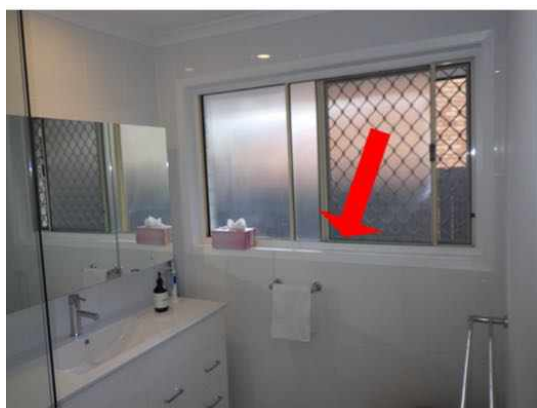
Finding 3.05

Building: Main Building
 Location: Bathroom > Centre Right
 Finding: Window - Stiff to Slide
 Information: The aluminium sliding window in the bathroom area was stiff to operate at the time of the inspection. Windows provide ventilation to the adjoining area and should be at a fully operational level to ensure user comfort. Restricted function of the window may also pose as a potential safety hazard if required for emergency egress from the building.

Generally, factors such as general age of the building element and a lack of maintenance are the usual causes for this type of defect.

An aluminium window service agent will be required to repair the affected windows.

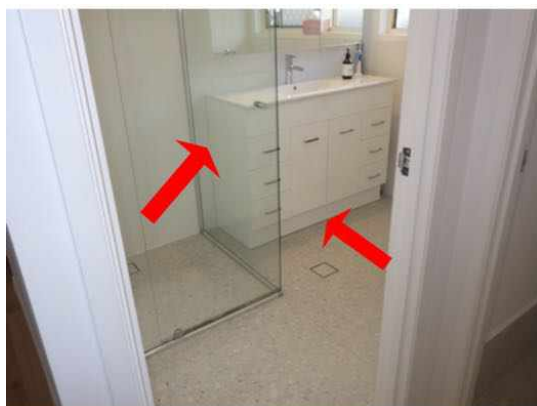
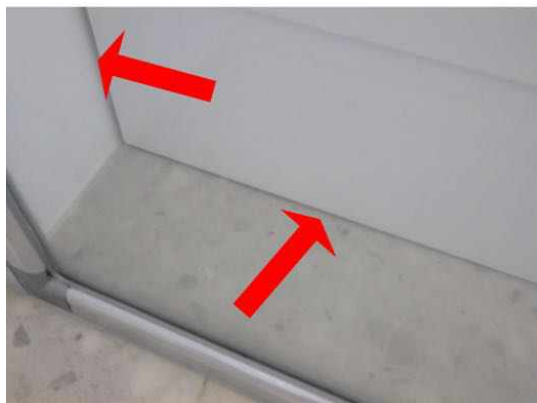
Finding 3.06

Building: Main Building
 Location: Bathroom > Centre,Rear
 Finding: Sealant Missing
 Information: It was noted on inspection that sealant is missing from the bathroom vanity / tiled floor and wall intersections. It is important these areas are sealed to prevent moisture or liquids penetrating the generally unsealed edges. Sealant also prevents vermin from accessing and or nesting in these areas.

A flexible sealant is required to allow for expected expansion and contraction, while keeping the joint water tight and protective of all associated building materials.

A sealant specialist or tiling contractor should be appointed to complete these works as soon as possible.

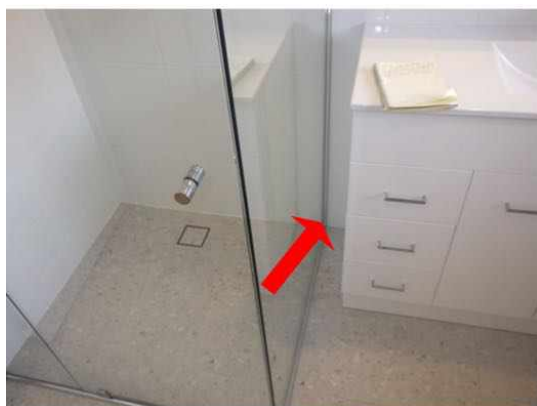
Finding 3.07

Building:	Main Building
Location:	Bathroom > Rear
Finding:	Shower Screen - Leaking
Information:	The bathroom shower screen/ wall tile connection joint appeared to be leaking at the time of inspection.

It is suspected that the leaking has occurred as a result of sealant deterioration or general ageing of the building elements.

Leaking from the shower screens, where left unattended, can lead to water damage to adjoining flooring and walls. Active water leaks may create an environment that is susceptible to the formation and development of mould.

Appointment of a shower sealant specialist is required to repair the affected area. Such works should be performed as soon as possible to ensure that no further damage occurs.

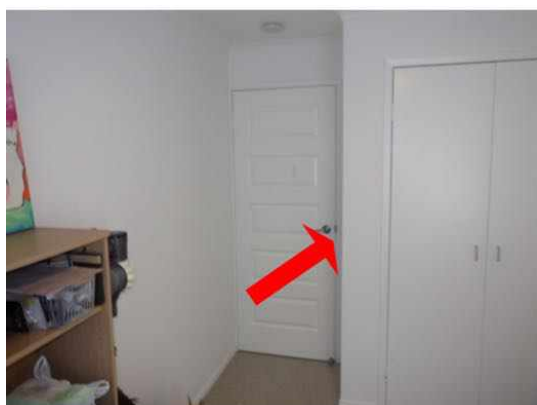
Finding 3.08

Building:	Main Building
Location:	Bedroom 2 > Front
Finding:	Door - Binding/Jamming
Information:	Binding and/or jamming of the bedroom 2 door on the door frame was evident during standard operation. This defect inhibits the functionality of affected door as well as creating potential for secondary defects to associated building elements, such as damage to the door framing.

A door that binds to the associated door frame or sill may have several causes, such as poor installation of the door or deteriorated hinges.

A qualified carpenter or general handyperson could be appointed to perform minor rectification works at client discretion.

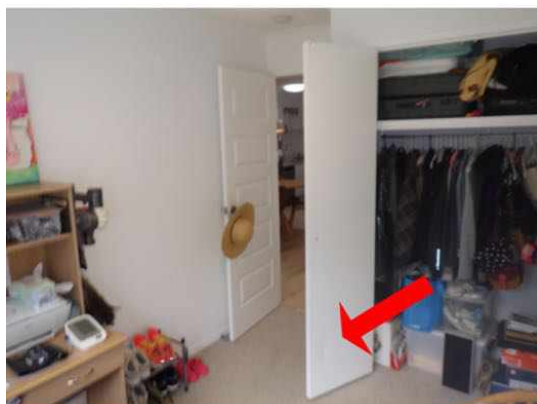
Finding 3.09

Building:	Main Building
Location:	Bedroom 2 > Front Left
Finding:	Damaged Door
Information:	The bedroom 2 robe door has suffered damage to the back surface.

Damage occurs generally when the building materials have aged and decayed, but

appears to be indicative of impact damage.

A qualified carpenter or general handyman could be appointed to repair/replace the door at the clients discretion.

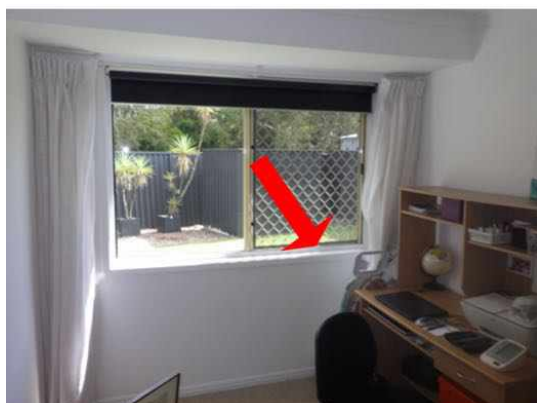
Finding 3.10

Building:	Main Building
Location:	Bedroom 2 > Centre,Rear
Finding:	Window - Stiff to Slide
Information:	The aluminium sliding window in bedroom 2 was stiff to operate at the time of the inspection. Windows provide ventilation to the adjoining area and should be at a fully operational level to ensure user comfort. Restricted function of the window may also pose as a potential safety hazard if required for emergency egress from the building.

Generally, factors such as general age of the building element and a lack of maintenance are the usual causes for this type of defect.

An aluminium window service agent will be required to repair the affected windows.

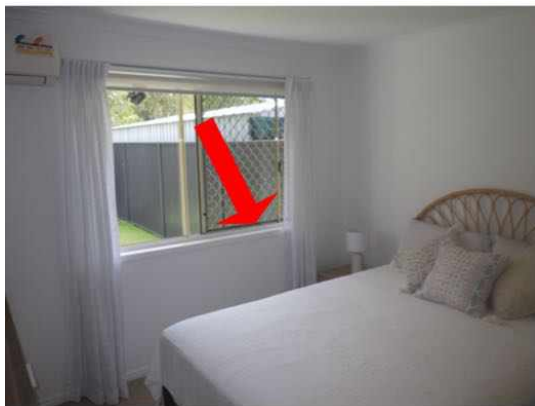
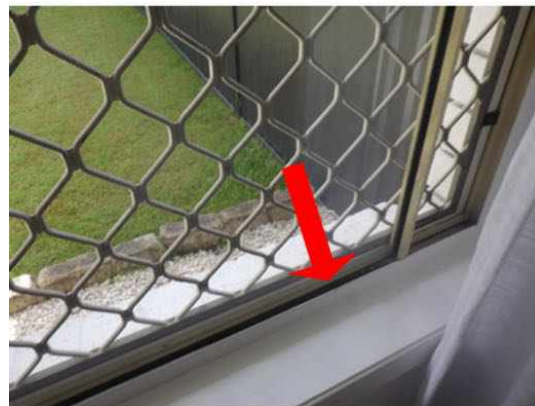
Finding 3.11

Location: Bedroom - Master > Rear
 Finding: Window - Stiff to Slide
 Information: The aluminium sliding window in the main bedroom area was stiff to operate at the time of the inspection. Windows provide ventilation to the adjoining area and should be at a fully operational level to ensure user comfort. Restricted function of the window may also pose as a potential safety hazard if required for emergency egress from the building.

Generally, factors such as general age of the building element and a lack of maintenance are the usual causes for this type of defect.

An aluminium window service agent will be required to repair the affected windows.

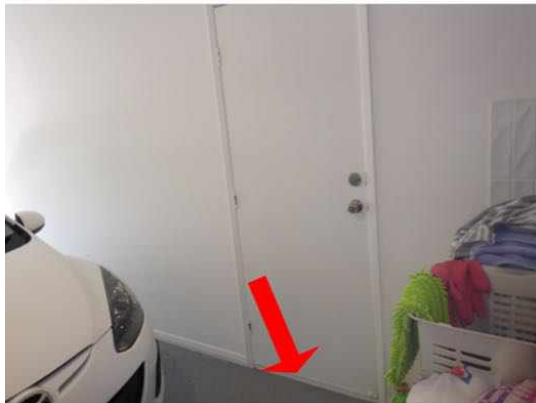
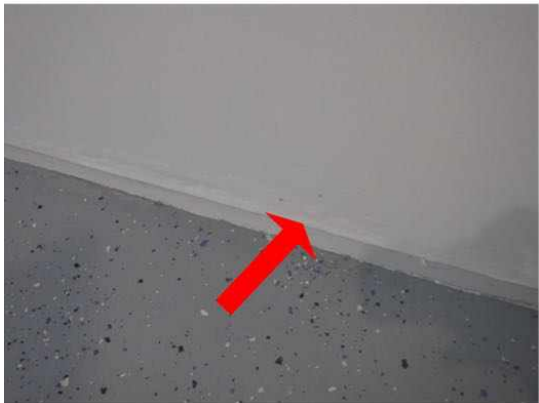
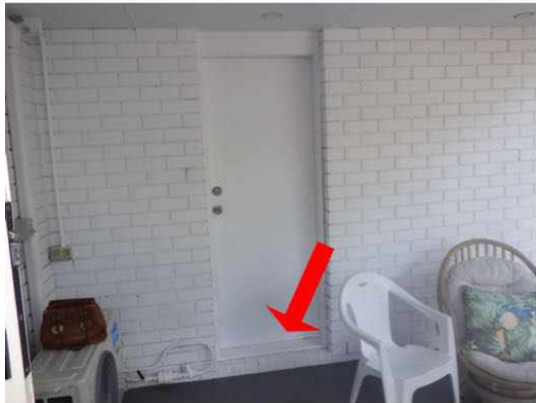
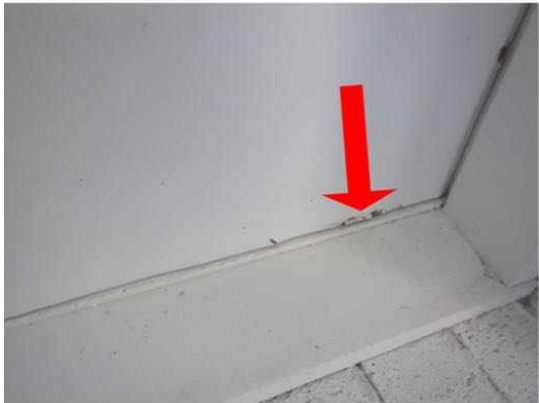
Finding 3.12

Building: Main Building
 Location: Garage > Rear Left
 Finding: Damaged Door
 Information: The garage area external door has suffered damage to the bottom edge.

Damage occurs generally when the building materials have aged and decayed, but in this instance the damage appears to be the result of exposure to moisture, possibly from the bottom and/or top edges of the door not being sealed with a suitable paint or sealant at the time of construction.

A qualified carpenter or general handyman could be appointed to repair/replace the door at the clients discretion.

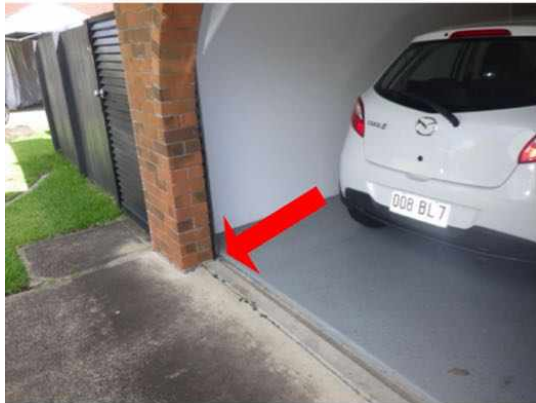
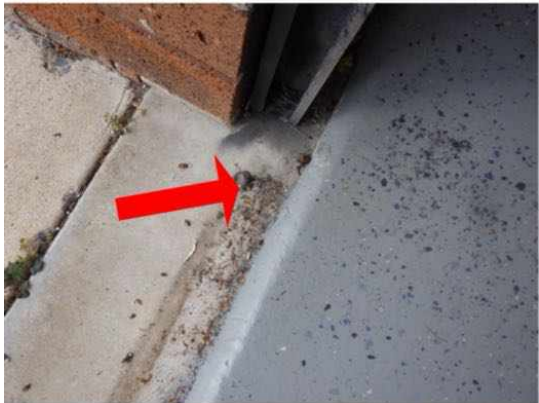
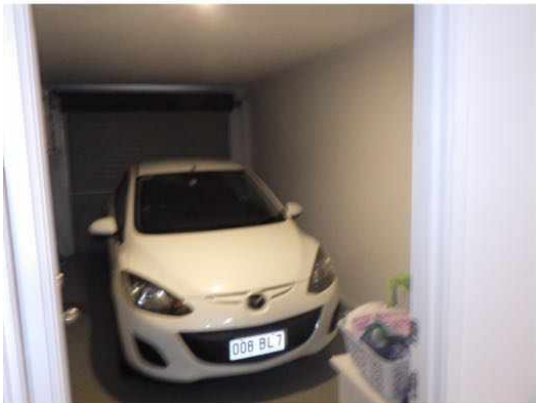
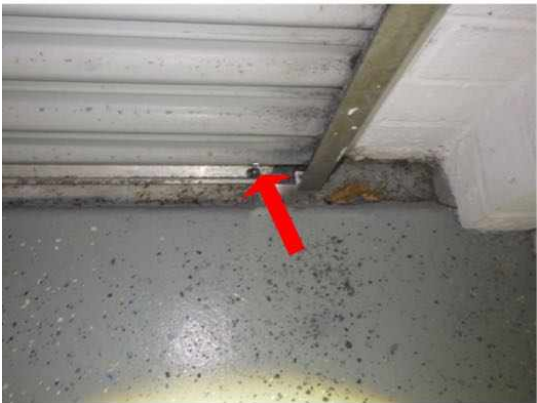
Finding 3.13

Building: Main Building
Location: Garage > Front Left
Finding: Bolt Protruding
Information: At the time of inspection there was a bolt protruding from the garage floor concrete slab. The protruding bolt may pose a potential trip hazard for persons or foot traffic when the roller door is in the open position.

A general handyman could be engaged to remove the bolt, at the clients discretion.

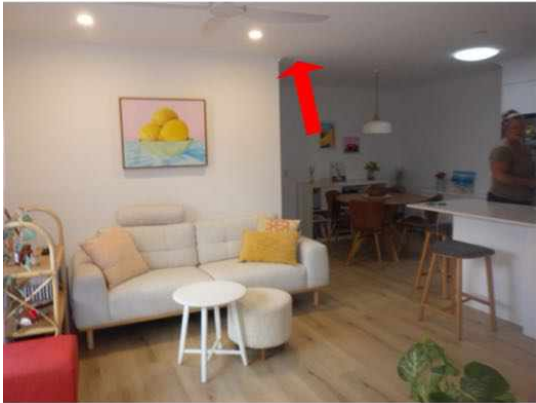
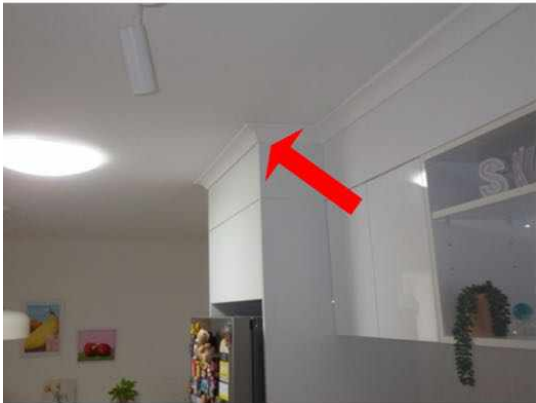
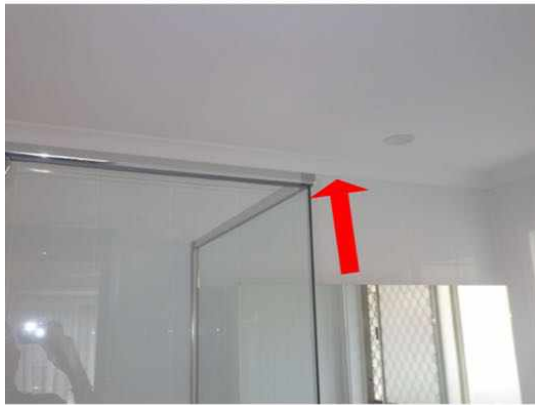
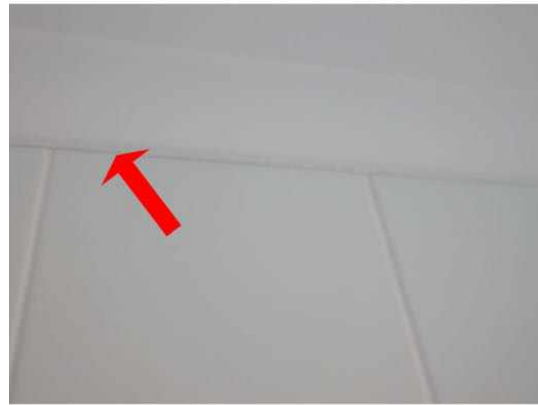
Finding 3.14

Building: Main Building
Location: Internal Areas > Existing
Finding: Wear and Tear
Information: At the time of inspection the building interior showed signs of minor cracking to walls, ceiling linings and cornices (as per example photos).

The level of damage appears consistent with general building movement and/or wear and tear.

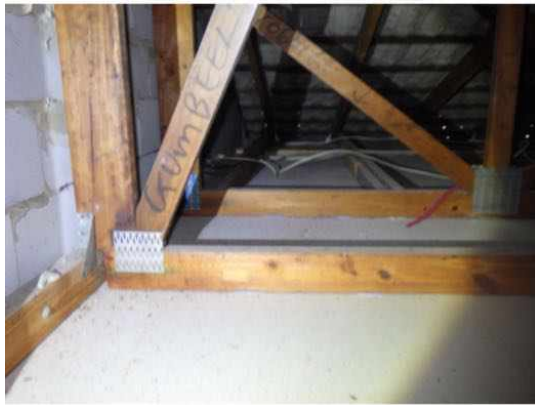
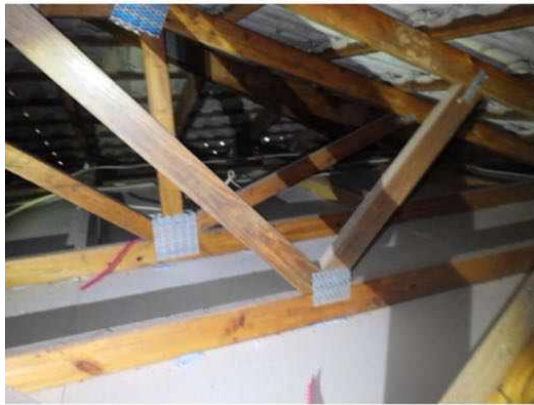
Finding 3.15

Building:	Main Building
Location:	Attic > Existing
Finding:	Insulation - Poor Installation
Information:	Insulation has been installed in the roof void with some large gaps in the coverage found at the time of inspection. A number of insulation batts have been installed on top of piping and other building materials within the roof cavity, decreasing the effectiveness of the insulation.

An insulation contractor or general handyman should be engaged to undertake rectification work.

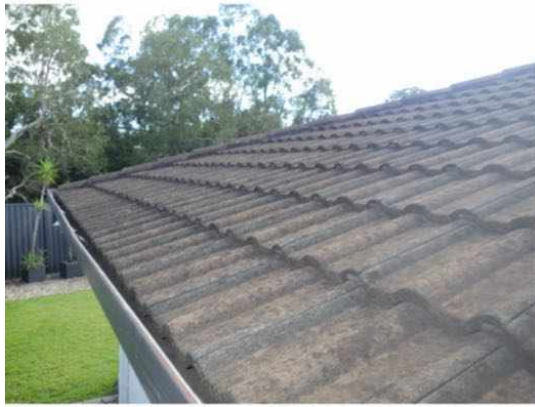
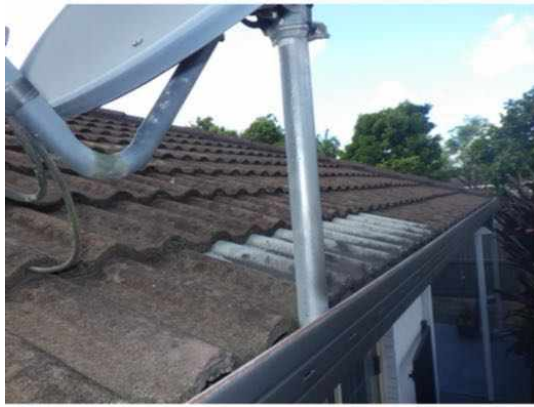
Finding 3.16

Building: Main Building
 Location: Roof Exterior > Existing
 Finding: Roof tiles - Weathered
 Information: Upon inspection of the exterior roofing, the majority of roof tiles were considered to be in a fair condition. While weathering of the tiles is consistent with the age of the property, maintenance works will be required.

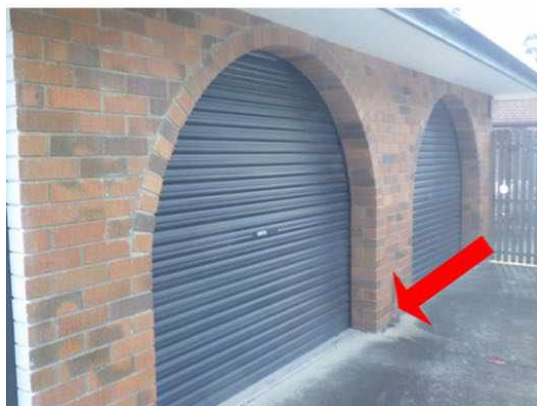
Finding 6.02

Building:	Main Building
Location:	Exterior walls - front > Front Right

Finding: Overflow - Not plumbed for drainage

Information: The hot water system overflow is not plumbed or connected to suitable drainage, which can result in the surrounding area becoming excessively damp. These damp conditions can lead to secondary defects such as rot, rust or corrosion of associated building elements, the formation of fungal decay, or even the creation of potential slip hazards. When coupled with poor site drainage, pooling of water may also attract termite activity to this area. It is highly recommended that a qualified plumber be appointed to install adequate drainage to the overflow. These works will ensure that the area remains dry and free of any secondary defects.

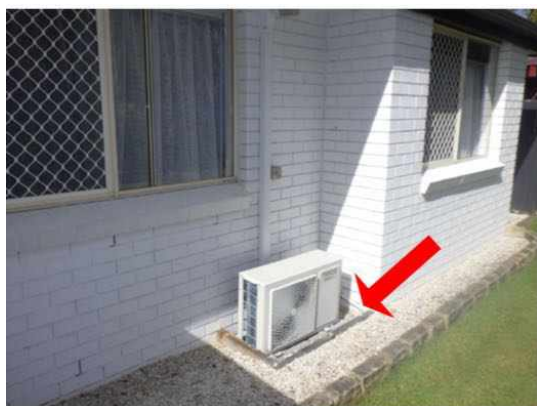
Finding 6.03

Finding: Overflow - Not plumbed for drainage

Information: The air conditioning unit overflow is not plumbed or connected to suitable drainage, which can result in the surrounding area becoming excessively damp. These damp conditions can lead to secondary defects such as rot, rust or corrosion of associated building elements, the formation of fungal decay, or even the creation of potential slip hazards. When coupled with poor site drainage, pooling of water may also attract termite activity to this area. It is highly recommended that a qualified plumber be appointed to install adequate drainage to the overflow. These works will ensure that the area remains dry and free of any secondary defects.

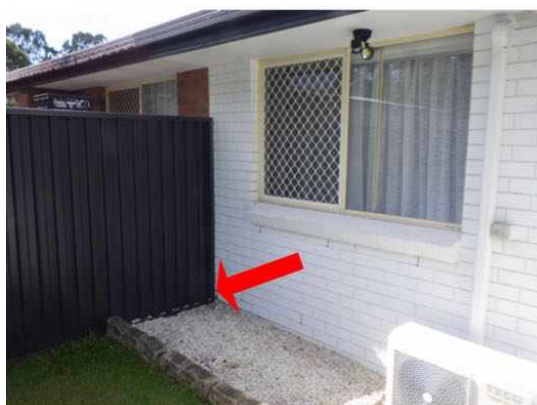
Finding 6.04

Building:	Main Building
Location:	Exterior walls - rear > Rear Right
Finding:	In ground contact
Information:	The metal fence post fixed to the exterior wall brickwork is in direct contact with the finished ground surface.

Any materials in direct ground contact provide opportunity for concealed termite entry and are likely to be subject to premature rust and decay as the ground retains moisture or damp conditions against the materials.

Ideally these types of fencing members would be clear of the ground area by a minimum of 50mm to provide a clear inspection zone.

Frequent pest inspections are advised to readily identify any termite activity in these areas.
