Building and Timber Pest Inspection Report

Inspection Date: Tue, 24 Mar 2026

Property Address: 34 Kabi Cres, Widgee QLD 4570, Australia

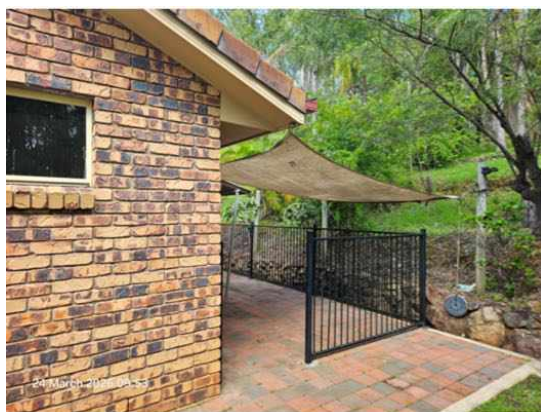
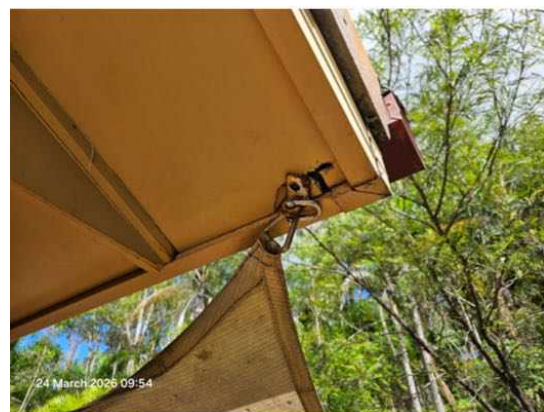
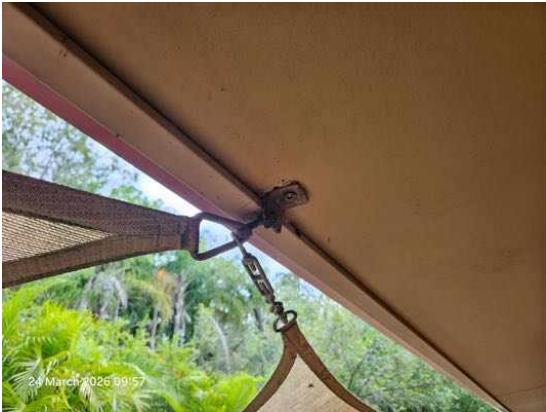
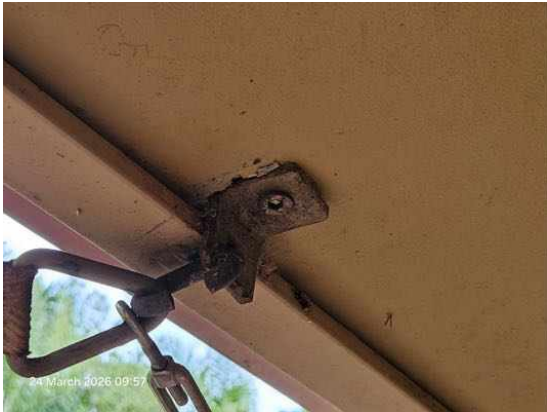
Finding 3.01

Building: Main Building
Location: Rear side
Finding: Shade sail post - connections deteriorated
Information: The shade sail at the rear of the property, at the point where the house connections are, shows signs of deterioration. It appears that the connection method used is not satisfactory. The screws appear to be attached to the soffit / eaves battens and through constant movement, are causing damage to the eaves sheets and possibly to the eaves framing.

With continued movement this could become a major defect.

Shade sails require secure attachment to compensate for constant stress from wind exposure. These connections should be reviewed and a more secure method implemented.

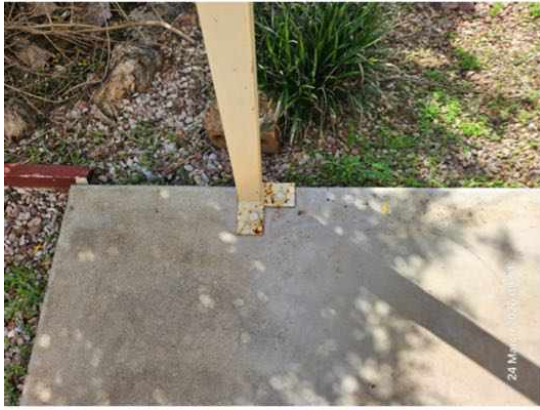
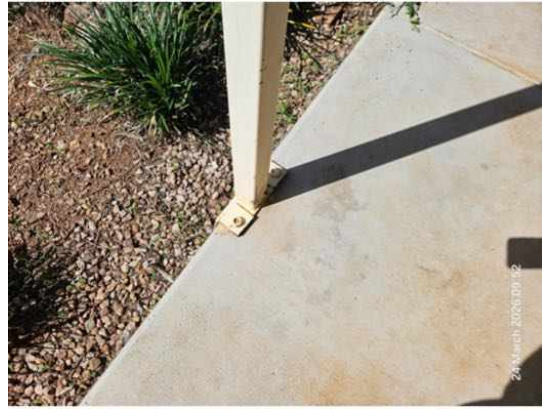
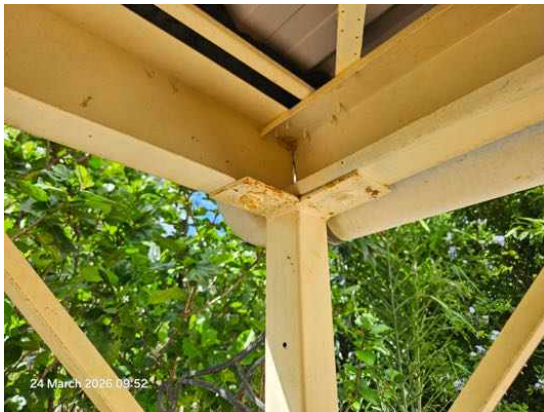
Finding 3.04

Building:	Main Building
Location:	Carport
Finding:	Pergola steel frame - surface rust present.
Information:	On the day of inspection it was noted that the steel framing members of the rear pergola at the front of the house had surface rust developing. The surface coating / paint has deteriorated and the base metal could be exposed if not re-coated.

It is advised that an application of a suitable moisture resistant protective coating and a rust treatment method be implemented.

Engaging the services of a licensed painter or suitably qualified handy person could assist with providing a solution.

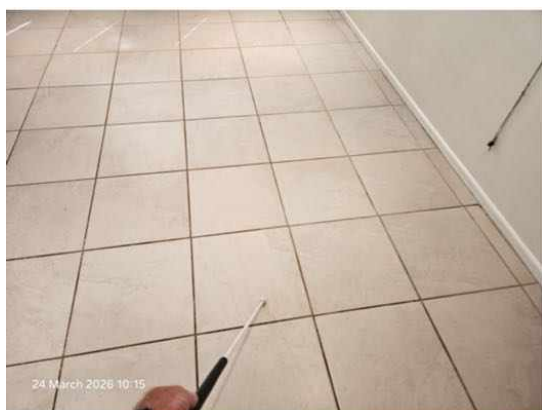
Finding 3.06

Building:	Main Building
Location:	As shown
Finding:	Tiles - Drummy
Information:	A drummy tile was identified at the time of inspection. Please see the attached photos for locations.

The term 'drummy' refers to tiles that have become detached from their fixing, despite otherwise being in relatively good condition. Such defects are generally caused by physical or moisture damage to the area. Drummy tiled areas may also be a direct result of poor workmanship during the construction process.

Tiled areas may swell and shrink with changes in air humidity if the area has sustained moisture damage. Any exposure to moisture is capable of causing tiled areas to become drummy and/or cracked over a prolonged period of time. Drummy tiled areas generally require removal and replacement of affected tiles.

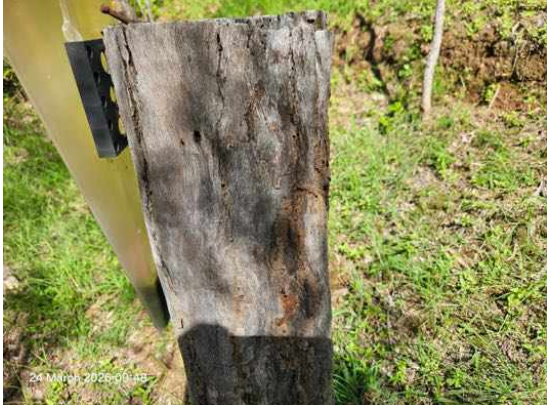
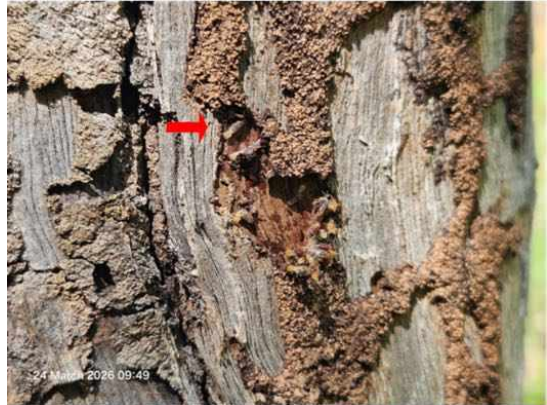
Finding 4.01

Building:	Yard
Location:	As shown
Finding:	Termite damage - active presence
Information:	During the inspection of the stump at the rear of the building termite activity was observed. As shown in the photographs, active termites are seen.

It is highly recommended that a pest controller be engaged to carry out the required program to eliminate this activity.

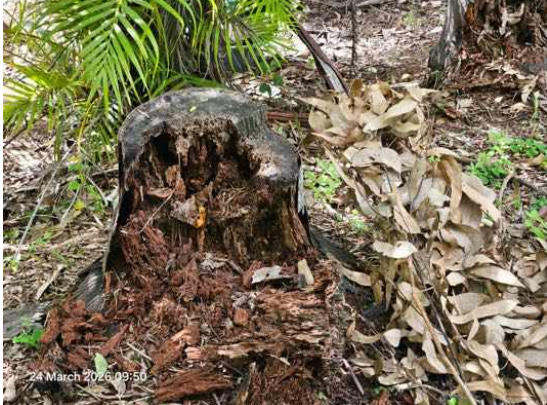
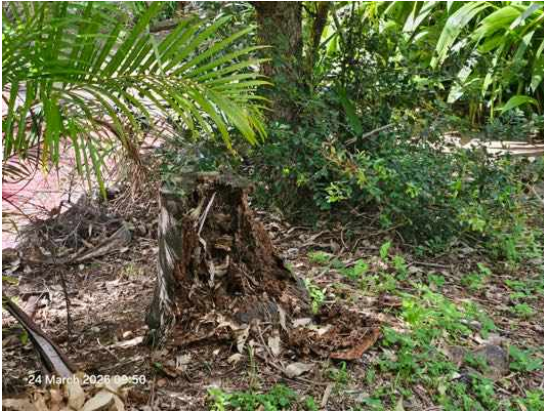
Finding 5.01

Finding: Evidence of previous inactive termite damage

Information: On the day of inspection multiple areas of minor to moderate inactive termite damage were noted. The damage is localised and appears to be confined to the stumps shown.

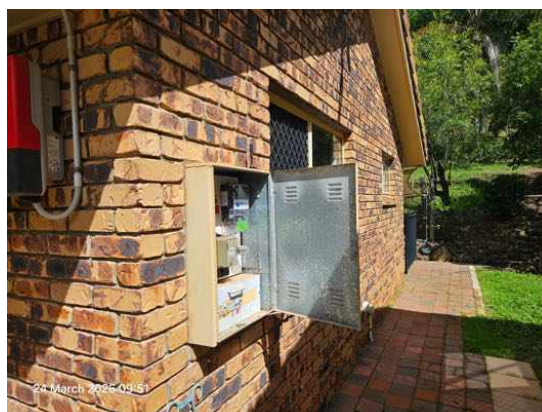
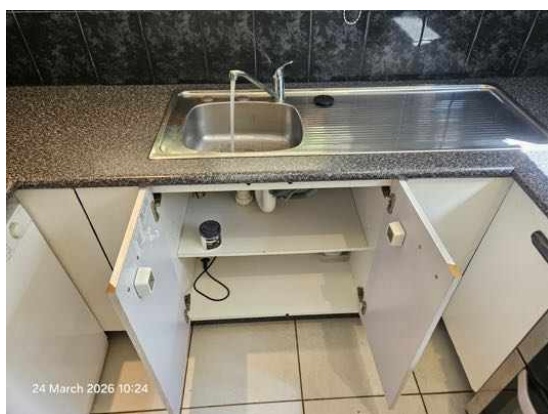
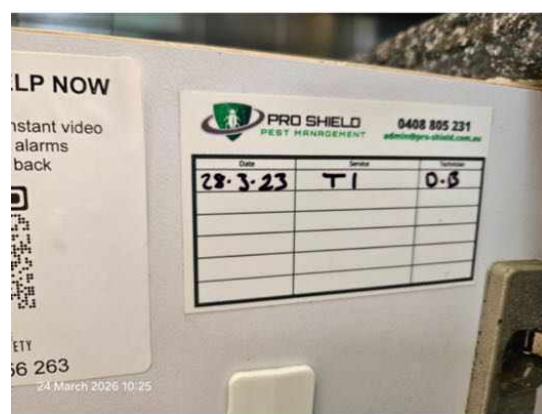
Building: Main Building
 Location: Meter box, kitchen cupboard
 Finding: Durable pest inspection notice - out of date
 Information: On the day of inspection it was noted that the durable pest inspection / treatment notice was missing, not visible or out of date. These notices / stickers are to verify the timber pest inspection dates, the inspector, the currency and type of timber pest system / barrier in place or being used in and around the property.

There has been an annual inspection programme in place previously. It was out of date on the day of inspection and will fall due 12 months from this inspection.

It is recommended that the inspector of the day or a licensed timber pest controller be contacted to assess the property's needs and provide costings for an annual inspection programme.

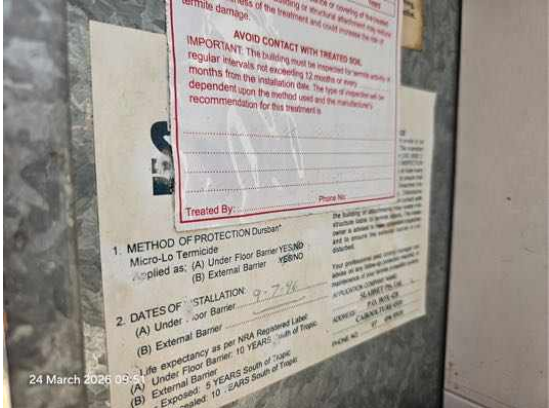
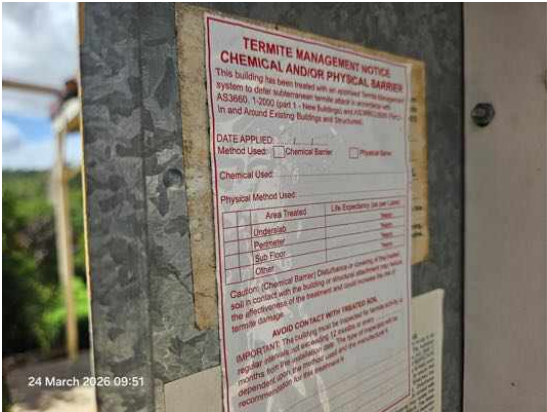
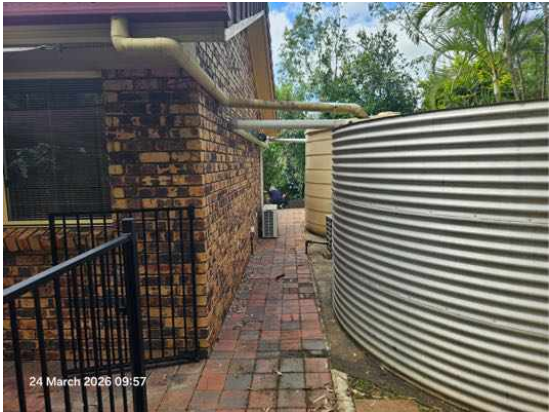
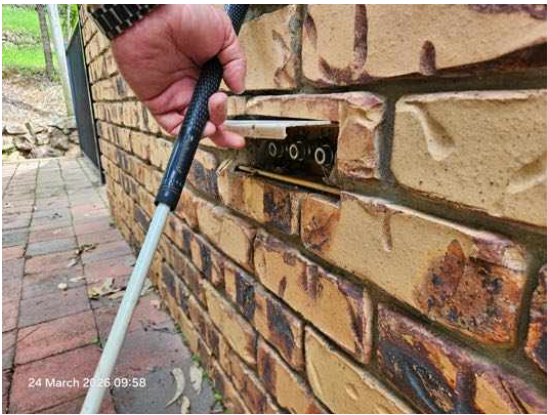
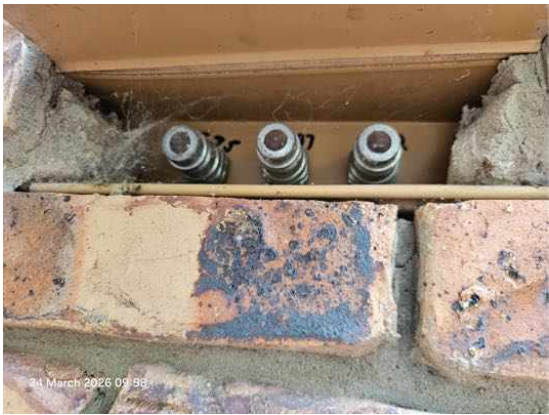
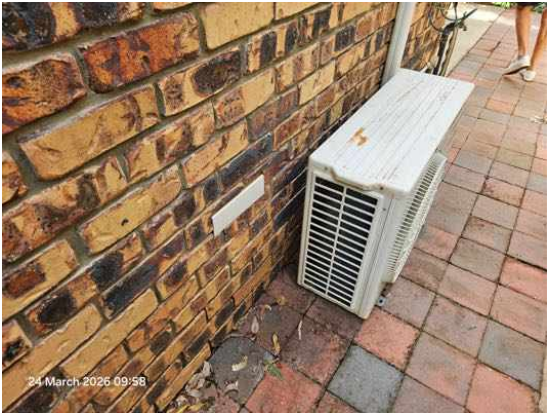
The building previously employed a "Slabset" chemical barrier system to the perimeter and slab penetrations. A more recent system has been implemented; however, the notice is faded and it cannot be determined what type or brand is. It is recommended that a timber pest controller be engaged to recharge the barrier system.

In order for a barrier system to be effective, the property must have regular inspections at intervals of not greater than 12 months. Depending on the risk profile attributed to the property, these inspections may be recommended at lesser time periods.
