Building and Timber Pest Inspection Report

Inspection Date: Mon, 9 Mar 2026

Property Address: 137 Halcrows Rd, Glenorie NSW 2157,
Australia

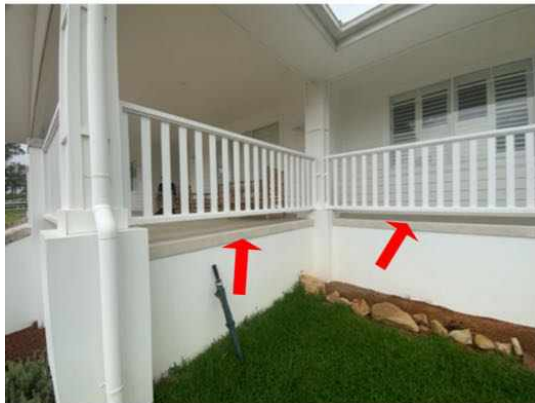
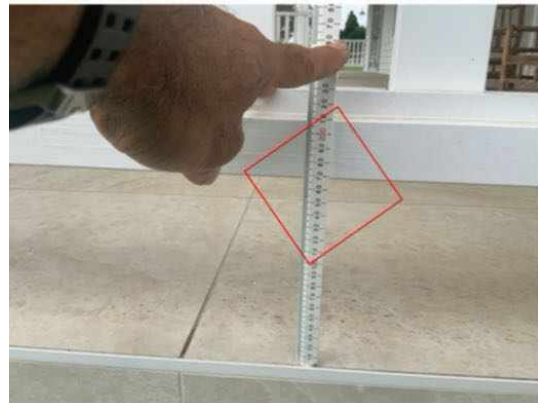
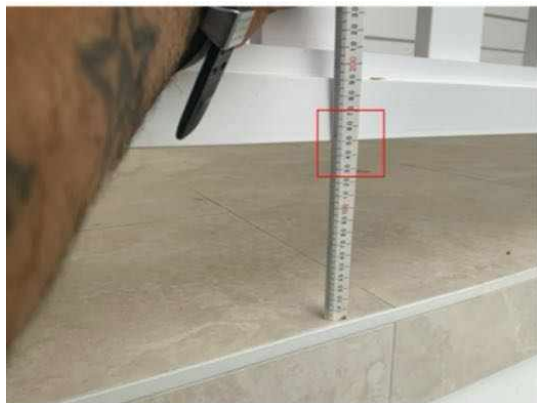
Finding 1.01

Building: Main Building
Location: Exterior walls - front
Finding: Balustrade - Suspected Non-Compliance
Information: The balustrade was measured and found to be less than the present building regulation requirement of 1000mm high. Additionally the gaps between the balustrade cladding were found to be greater than the present building regulation requirement of 125mm.

This defect creates a potential safety hazard and should be rectified as soon as possible to ensure the safety of the area and to meet present building standards and regulations.

A registered builder should be contacted to discuss possible rectification solutions.

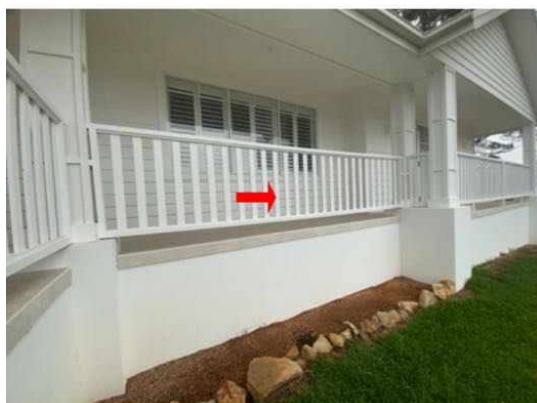
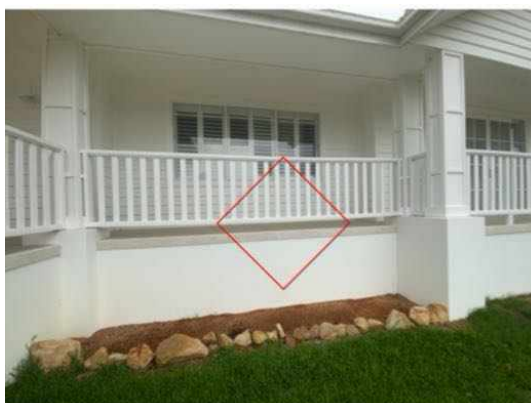
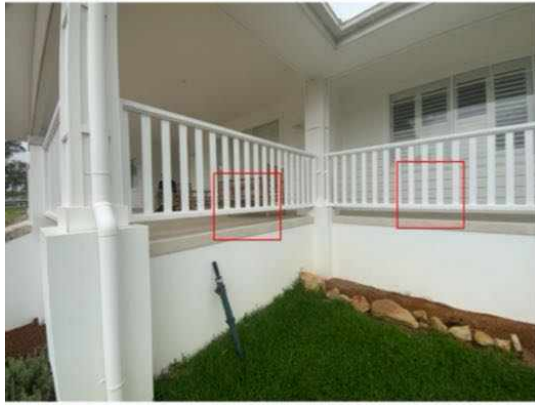
Finding 3.01

Building: Main Building
Location: Exterior walls - front
Finding: Non-compliance
Information: The hand rail bottom and top members was found to be sagging and over spanning .

If left unmanaged it could compromise the integrity of the structure.

A qualified carpenter can be contacted to make good.

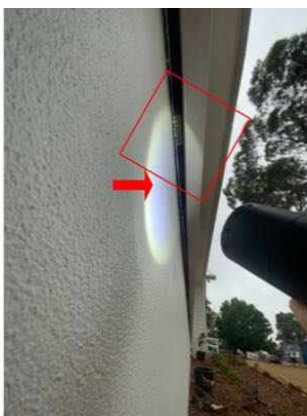
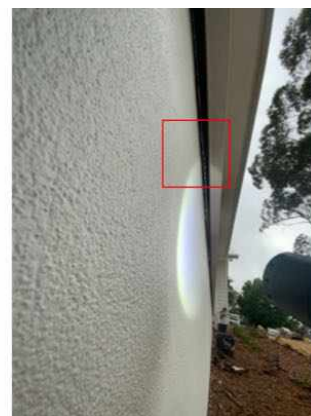
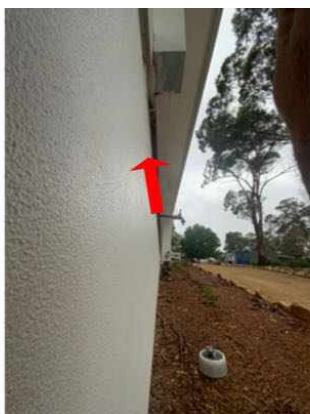
Finding 3.02

Building:	Main Building
Location:	Exterior walls - right side
Finding:	Cladding Installation - cavity is open
Information:	The installation of the cladding appears to have been completed to a substandard level of workmanship .Generally substandard installations are related to poor workmanship, the use of inappropriate materials, or a failure to complete installation to a suitable standard.

Where installation is substandard and non-compliance , the owner should undertake rectification. Unfinished and substandard building works are likely to degrade more quickly and may create potential for secondary defects to associated building elements.

To stop vermin and other materials entering The cavity ,the base must be sealed using a cavity closer.

Also the cavity closer must not exceed 2 mm gaps to stop any flying ambers during a bush fire event.

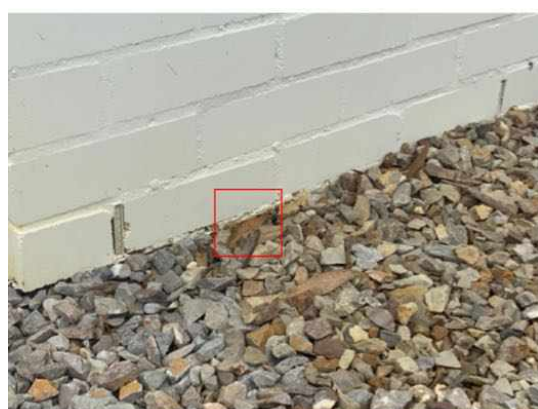
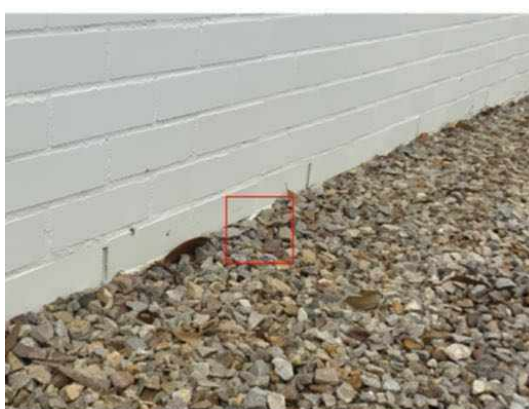
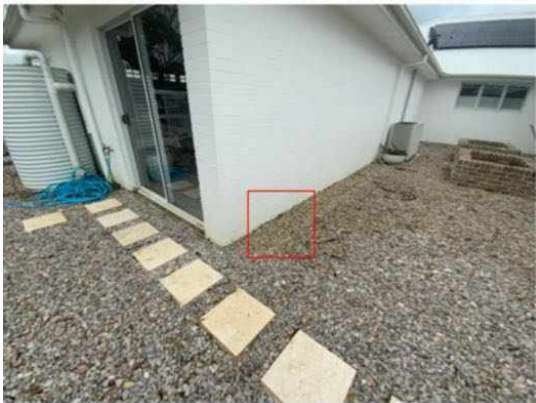
Finding 3.03

Building:	Main Building
Location:	Exterior walls - rear
Finding:	Bridging or breaching of termite barriers - damp course level
Information:	Bridging is the spanning of a termite barrier or inspection zone so that subterranean termites are provided with passage over or around that barrier.

Damp proof course (DPC) is a barrier of impervious material built into a wall or pier to prevent moisture from moving to any part of the building. Where external ground levels are built up over this barrier ingress is provided for moisture from the exterior grounds into the base brickwork or other building material and allowed to rise.

Such conditions attract termites into these damp areas which is likely to lead to infestation if left untreated.

Landscaping or re-paving of external grounds may be considered by the client. Regular annual inspections are strongly advised.

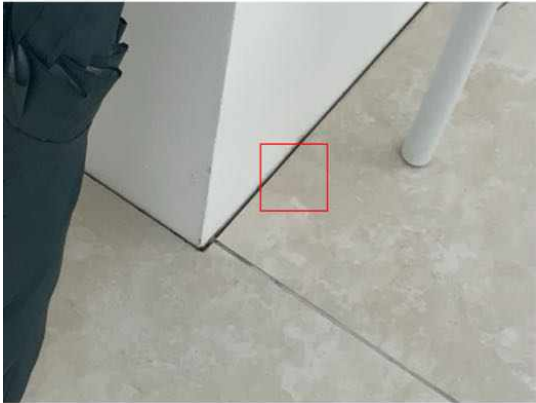
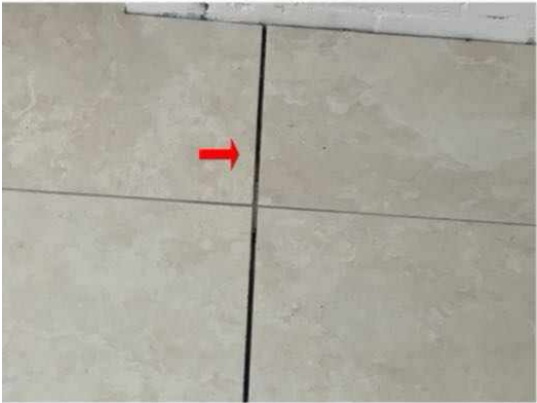
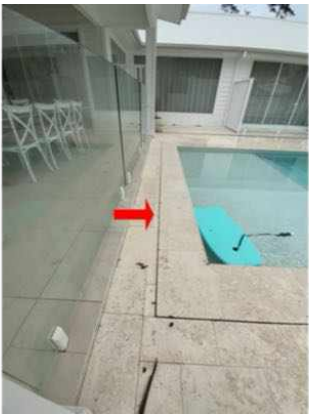
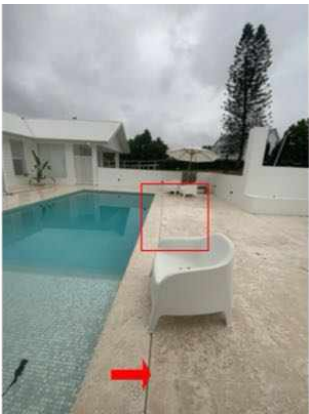
Finding 3.04

Building: Main Building
Location: Alfresco
Finding: Grout /sealant- Missing
Information: Grout and sealant are missing in this area. Grout is used to protect gaps and crevices in building materials to ensure that they are water-tight and prevent water penetration to the associated structures.

Where grout is missing, a tiling contractor should be appointed immediately to apply grout and re-apply any silicone where necessary. Failure to do so is likely to lead to water damage to the surrounding area.

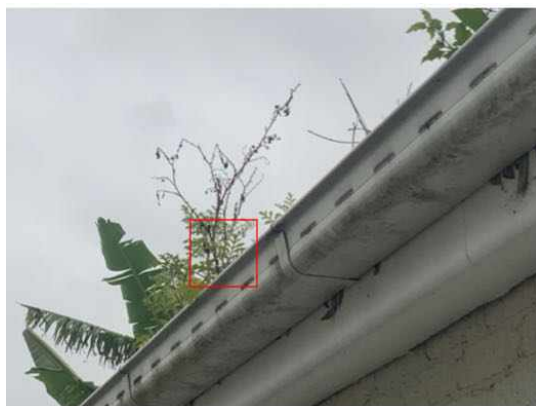
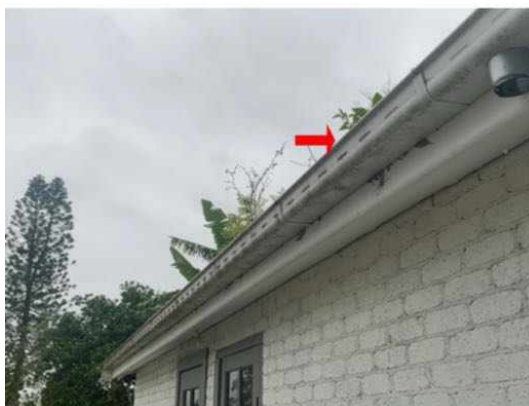
Finding 3.05

Building:	Granny-Flat
Location:	Exterior walls - left side
Finding:	Gutters - Blocked
Information:	Roof plumbing structures, such as guttering and downpipes, should be free of all debris to prevent blockages. Blockages of the guttering and downpipes will lead to pooling and accumulated water overflows, which is likely to subsequently flood eaves and exterior walls.

Blocked gutters are likely to lead to high levels of moisture in the affected areas. Such moisture will not only cause rust and decay of the associated building materials, but can also provide conditions that are conducive to termite and timber pest activity. Blockages in gutters should therefore be removed immediately to ensure dry conditions are maintained.

Consult a Licensed Plumber for further specific advice on remedial works that may be required. In the interim, it is highly advised that blocked gutters be removed by the homeowner or a general handyperson as a matter of urgency.

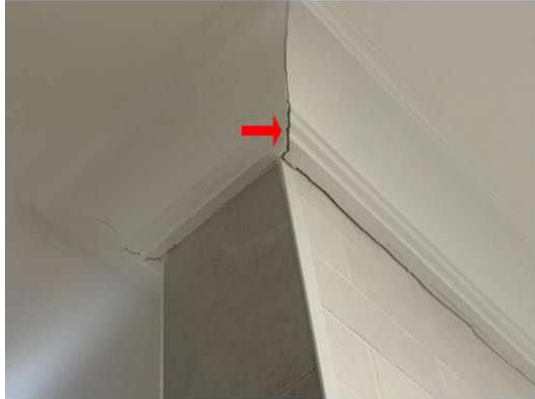
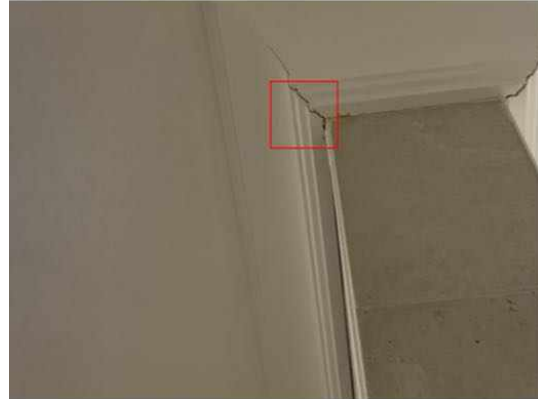
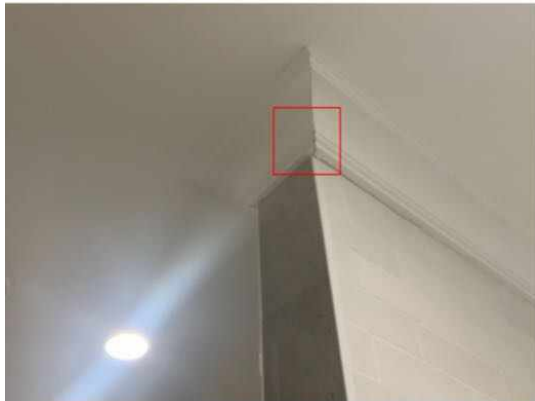
Finding 3.06

Building:	Main Building
Location:	Bathroom
Finding:	Cracking - Damage Category 1 - Fine (up to 1mm)
Information:	Although fine cracks are quite noticeable, they are often only considered to be an appearance defect, and usually do not indicate any structural damage. Generally, the cause of a fine crack is indicative of a separation between building materials and finishes (e.g. paint, plaster, etc.) along joints.

Cracking of this nature can generally be repaired with minor sanding, filling and/or

repainting. Such works should be performed by a qualified painter or a general handyman.

Monitoring of all cracking should be conducted frequently. Always contact a building inspector should cracks widen, lengthen, or become more numerous.

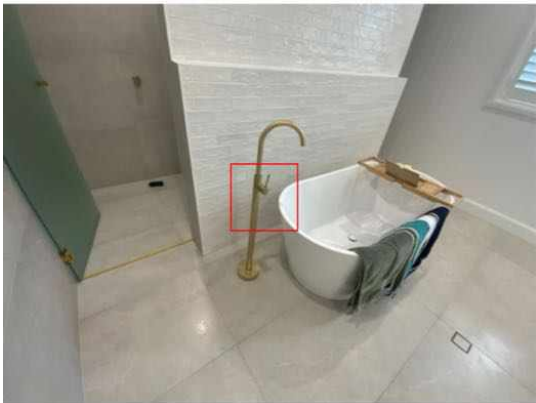
Finding 3.07

Building:	Main Building
Location:	Bathroom
Finding:	Tap - Loose
Information:	The tap in this area has not been installed correctly, or has deteriorated with age, and is consequently loose. This tap being loose creates potential for water leaks and subsequent water damage to the surrounding area.

Where taps or spouts are loose, a qualified plumber should be appointed to re-fix the plumbing fitting.

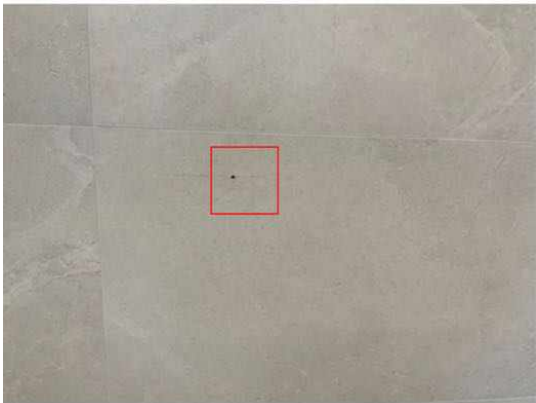
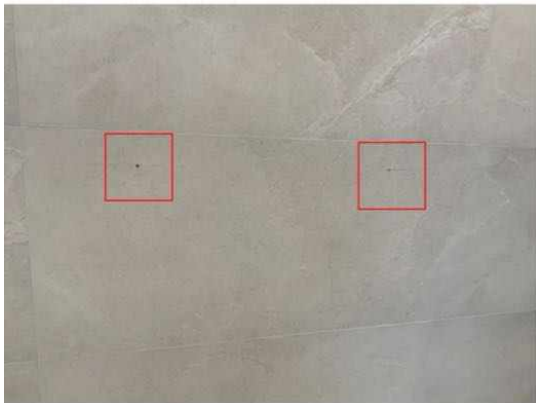
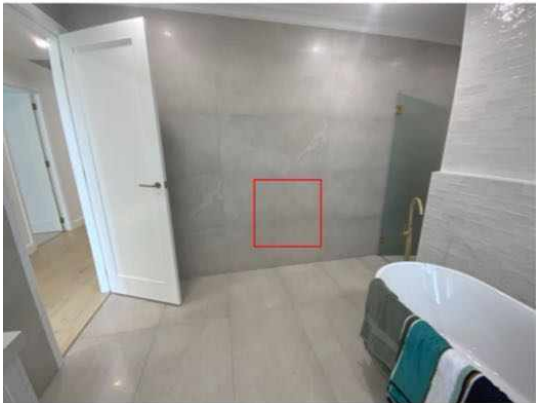
Finding 3.08

Building: Main Building
Location: Bathroom
Finding: Towel rail - missing
Information: The towel rail was found missing at the time of inspection. While not a major operational defect, it affects the functionality of the bathroom and detract from the overall look of the place (two drilled holes)in the wall .

A general handyperson may be required to make good.

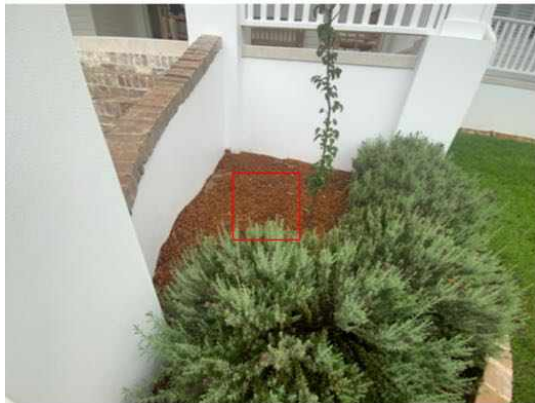
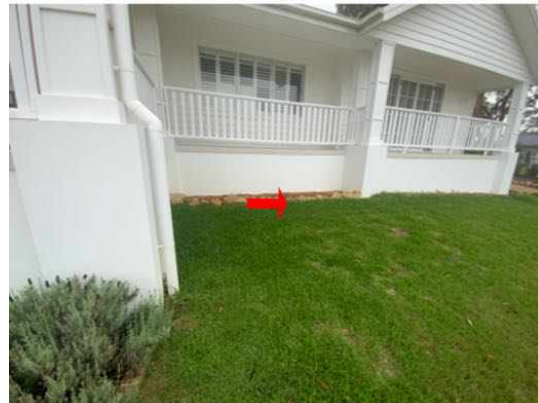
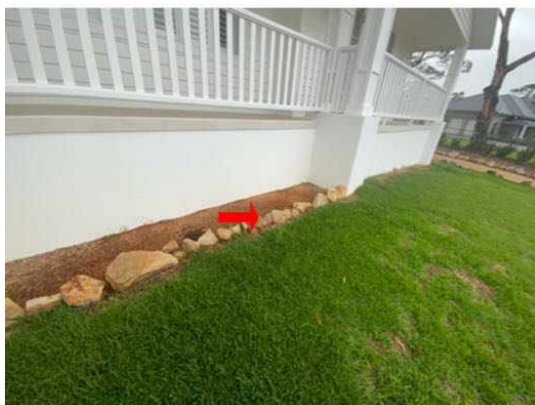
Finding 6.01

Building: Main Building
Location: Exterior walls - front
Finding: Garden Beds - Conditions Conducive to Termites
Information: Garden beds were found to be evident in the garden area. These garden beds can include untreated timber, and with a combination of moisture from watering hosing can make conditions conducive to termite activity and termite ingress.

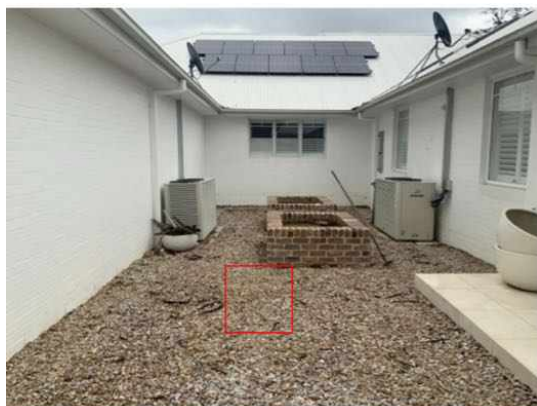
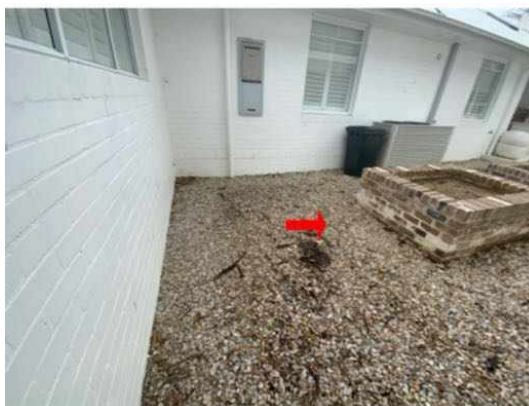
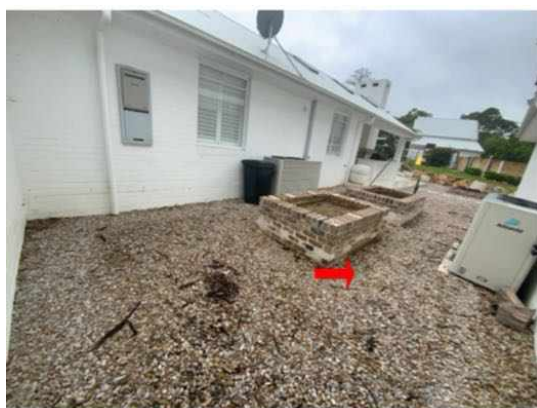
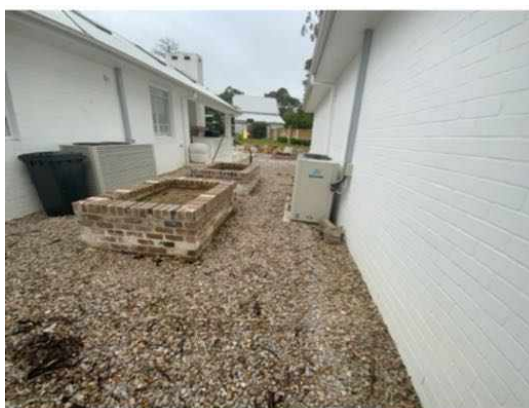
Finding 6.02

Building: Main Building
Location: Exterior walls - rear

Finding: Site drainage - Inadequate
 Information: The site drainage in this area was found to be inadequate at the time of inspection, creating potential for subsequent water damage to associated building elements.

It is important that water does not lie against the base of walls; surrounding paths and ground levels should be sloped to drain water away from walls. Downpipes should not discharge stormwater onto lower walls or plinths. Stormwater should be carried away by large, regularly cleaned drains. Ground levels may need to be lowered to expose a buried DPC.

Where site drainage is inadequate, installation of an Agricultural (Aggie) Drain may be required. A qualified plumber should be appointed to further inspect the property and perform any remedial works as necessary. Water damage and secondary defects are likely to occur if left unmanaged.

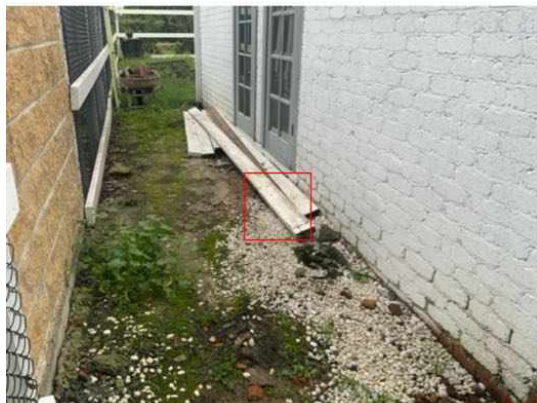
Finding 6.03

Building: Granny-Flat
 Location: Exterior walls - left side
 Finding: Stored timbers - external area
 Information: The storing of timbers around the external property increases the risk of termite activity being present. As they are likely to come into contact with weather conditions or excessive moisture wood rot is likely to develop on timbers that are not treated.

It is highly recommended that any stored timbers be immediately removed from areas in which they may attract any termite / timber pest attack. Minimisation of risk / prevention of termite attack is far more adequate than dealing with the presence of termite activity.

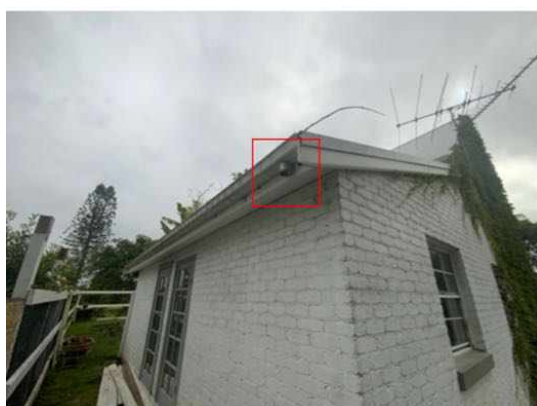
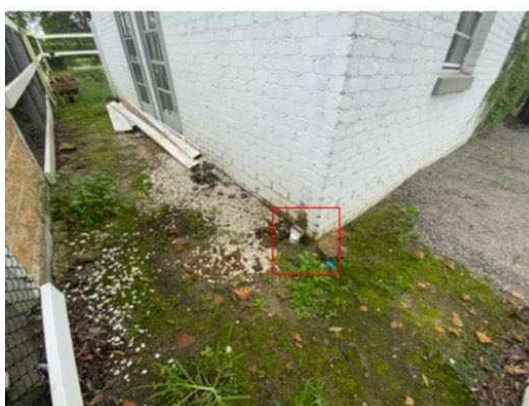
Finding 6.04

Building: Granny-Flat
 Location: Exterior walls - left side
 Finding: Stormwater drain - Not connected
 Information: The roof plumbing is not adequately connected to stormwater drainage on the site. This disconnection negatively impacts the functional capacity of the roof plumbing.

Where roof plumbing doesn't drain adequately, the area at the base perimeter can become excessively damp, potentially creating an environment that is susceptible to rust and corrosion of surrounding building elements, as well as attracting termites and other pests.

It is highly recommended that a plumber be appointed to further inspect the area and to install adequate drainage equipment where necessary.

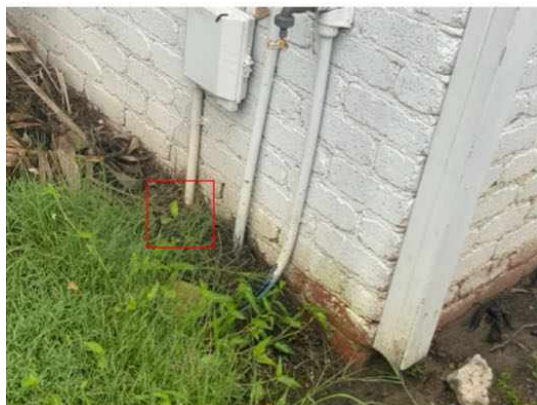
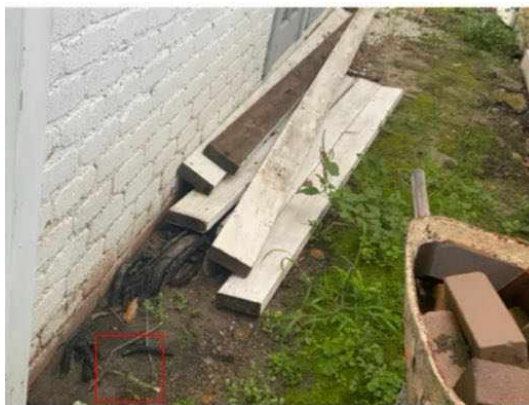
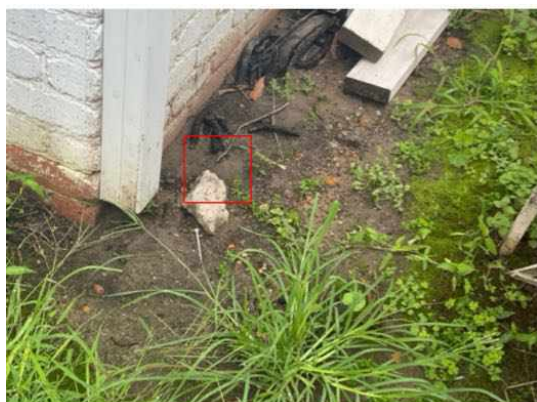
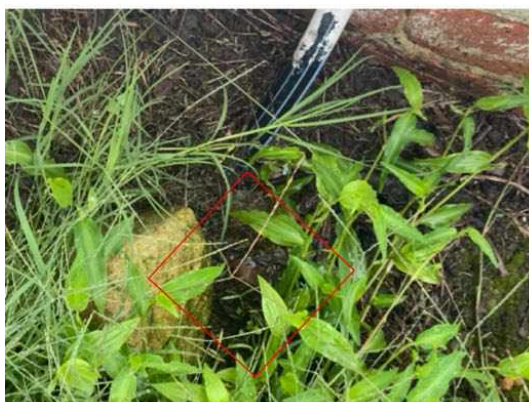
Finding 6.05

Building:	Granny-Flat
Location:	Exterior walls - left side
Finding:	Foundations - adjacent water pooling
Information:	Water pooling near foundations and footings is a serious concern with the potential to adversely impact on the longevity of the dwelling. The Building Code of Australia (BCA) outlines that the soil must be graded away from the dwelling at a minimum of 50mm over 1m (1:50 fall).

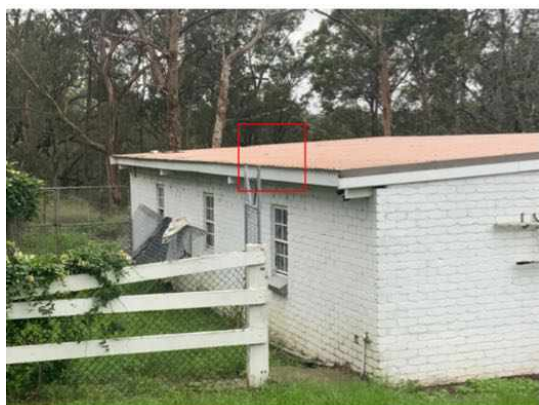
Finding 6.06

Building:	Granny-Flat
Location:	Garage
Finding:	Roof plumbing - Missing
Information:	Some sections of the roof are not adequately drained via gutters and downpipes. Gutters and downpipes that are not installed adequately are likely to result in excessively damp conditions against the exterior surfaces and around the base perimeter of the building.

Excessive moisture creates an environment which accelerates the deterioration of building elements in the area, as well as being conducive to termite and pest infestation. Such an environment is likely to necessitate repair and/or replacement of building elements, which are prone to sustaining wood rot, rust or corrosion.

A roofing plumber should be appointed as soon as possible to install relevant roof plumbing materials. Depending on the extent of the damage, repair and/or replacement of damaged building elements may be required.

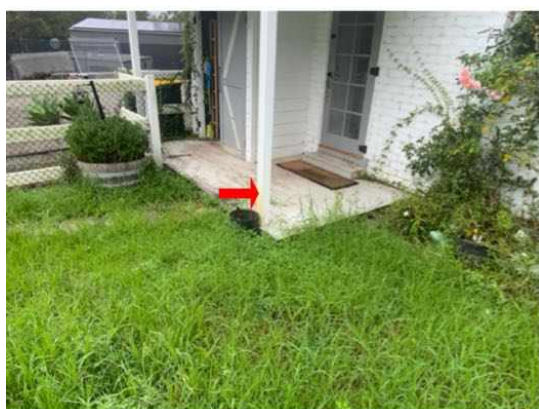
Finding 6.07

Building:	Granny-Flat
Location:	Exterior walls - rear
Finding:	Building materials in direct ground contact - conducive to termites
Information:	Where timber elements are in direct contact with the ground and consequently moisture or dampness they become conducive to termite activity. Whether timber is used as a building element part of a fencing structure or stored as an unused item they can provide an environment that is attractive to termite infestation.

When met with excessive moisture timber begins to decay and develop wood rot. Any timbers that are in direct contact with external grounds especially if left untreated or non-durable also provide ingress for subterranean termites into that particular element.

The removal of any such materials that may be conducive to termite activity should be removed as soon as possible to minimise the risk of termite attack.
