Building and Timber Pest Inspection Report

Inspection Date: Tue, 3 Mar 2026

Property Address: 28/6 Ruby St, Carramar NSW 2163, Australia

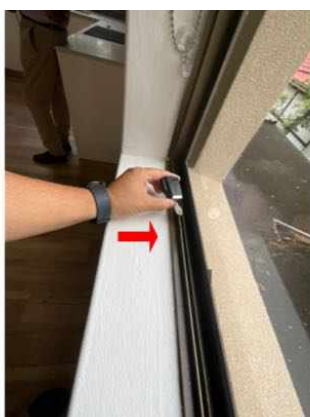
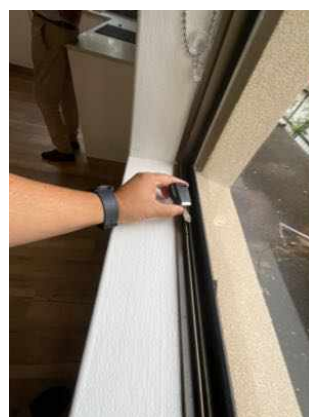
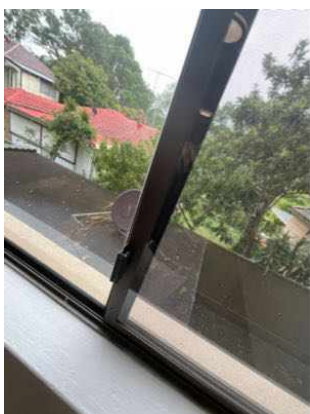
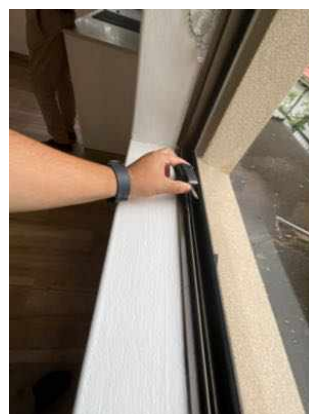
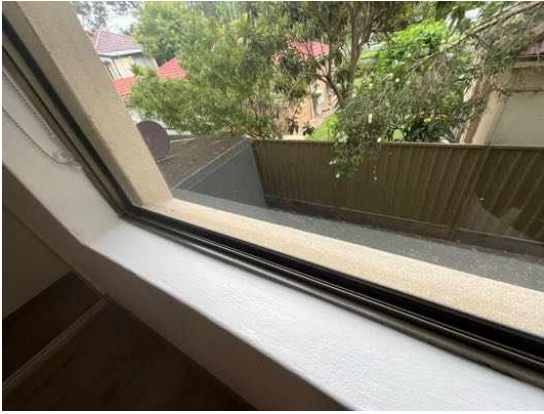
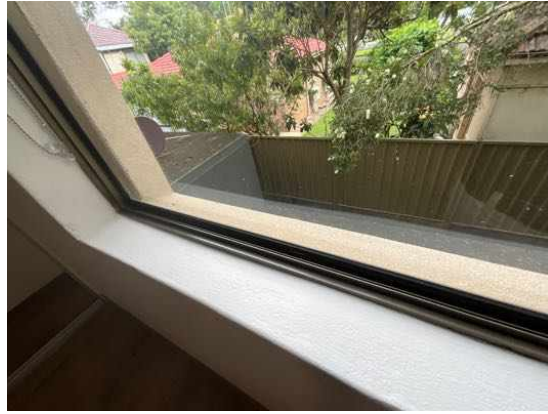
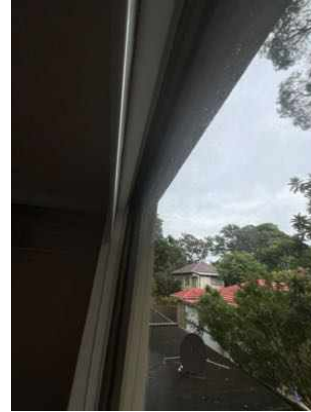
Finding 1.01

Building:	Main Building
Location:	All Areas
Finding:	Window child lock missing
Information:	The window in question lacks a child lock mechanism, which poses a potential safety risk to young occupants in the premises. As per Australian Standards windows accessible to children should be equipped with appropriate child safety locks to prevent accidental opening, reducing the risk of falls and ensuring compliance with safety regulations.

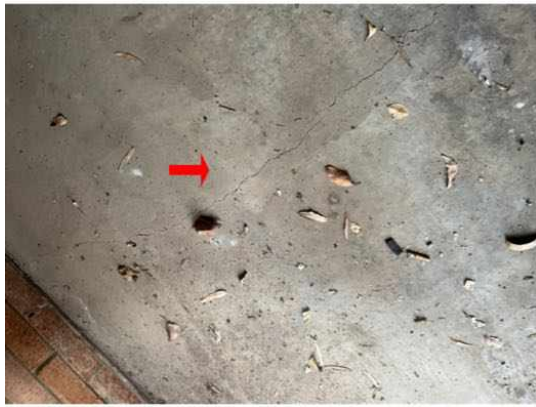
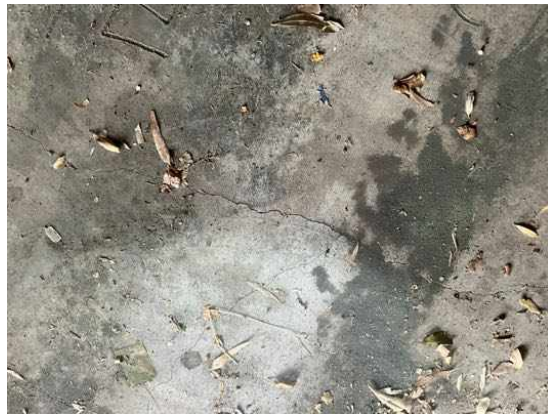
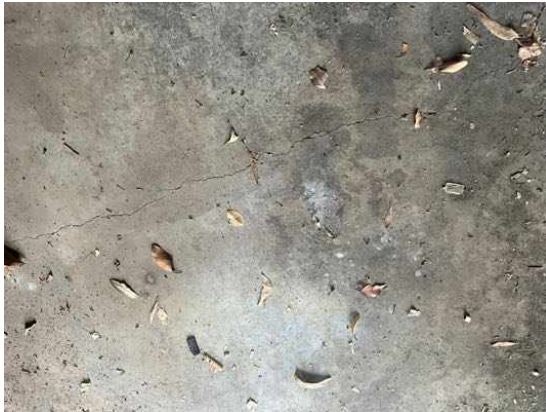
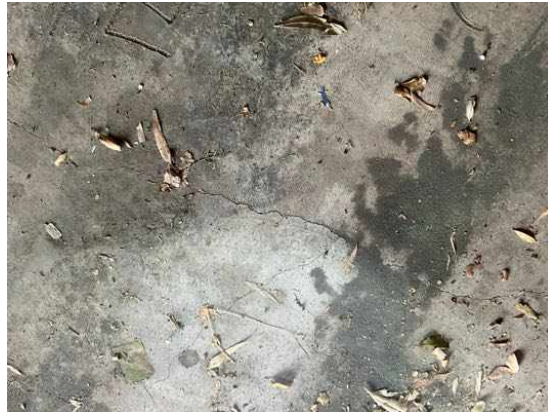
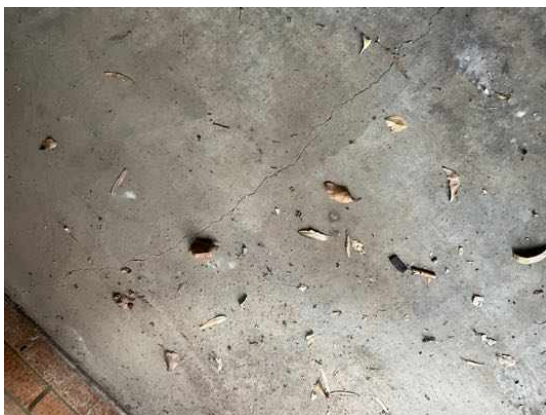
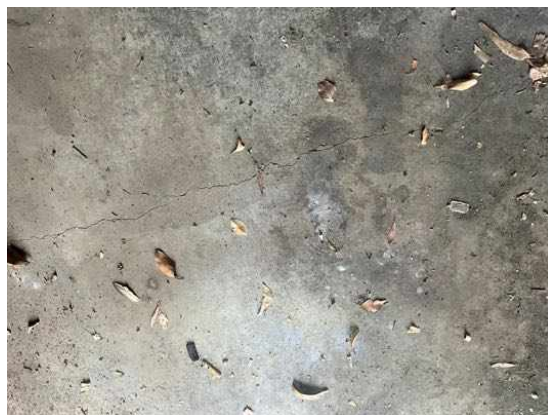
Finding 3.01

Building: Main Building
 Location: Garage
 Finding: Crack in concrete slab - Category 0
 Information: A crack coded as Category 0 was identified in the slab. A Category 0 crack is described as a hairline crack, representing insignificant movement of slab from level.

The approximate width of the crack to be considered Category 0 is 0.3mm, or change in offset of less than 8mm when a 3m straight edge is placed over the defect.

No rectification is required at this time. However, all cracking should be monitored over a 12 month period to identify any further damage in the area.

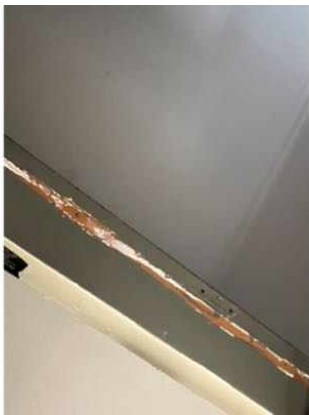
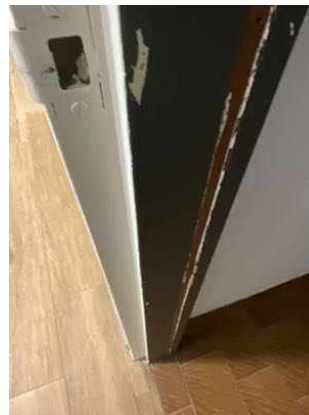
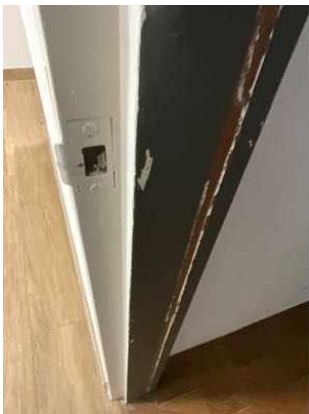
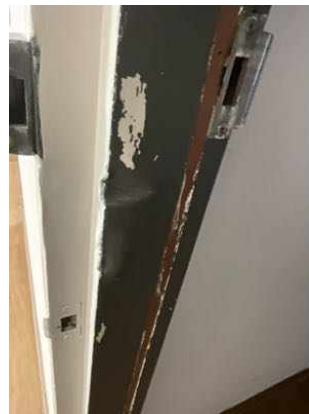
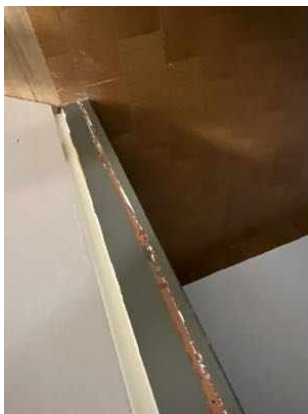
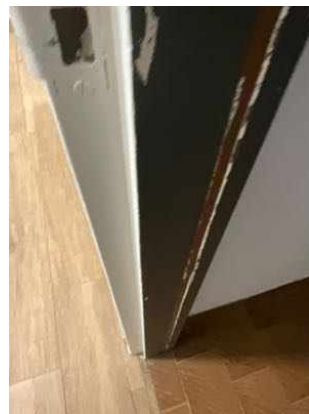
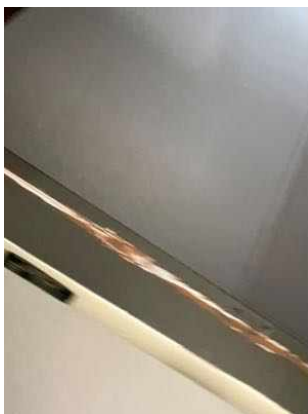
Finding 3.02

Building: Main Building

Location: Front Door

1. Aesthetic Degradation: Scratches mar the appearance of the painted surface,

2. Corrosion Vulnerability: Exposed areas of bare metal due to scratched paint are susceptible to corrosion, leading to structural damage and compromised durability.

3. Environmental Hazards: Scratched paint can release hazardous chemicals into the environment, posing risks to both human health and the ecosystem.

A qualified painter should address the issue promptly to repair the scratched paint. Depending on the severity of the scratches, repair options may include sanding, priming, and repainting the affected area to restore the integrity and appearance of the paint surface.

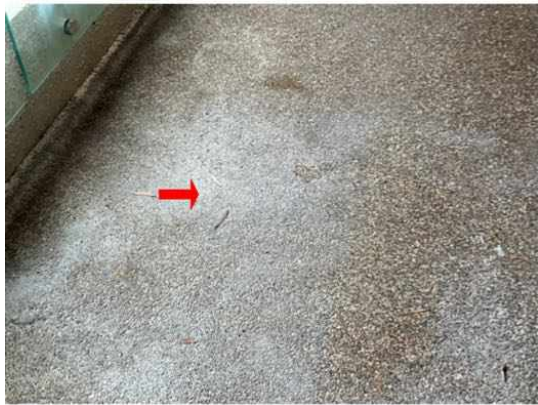
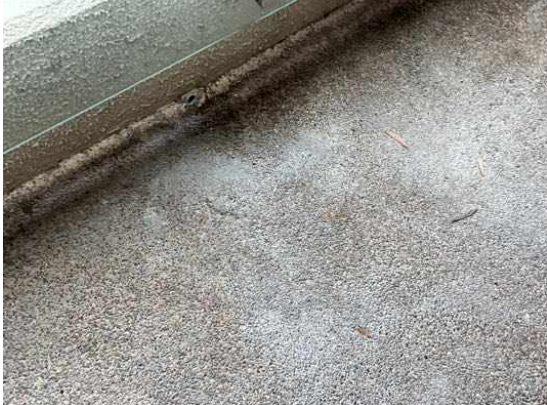
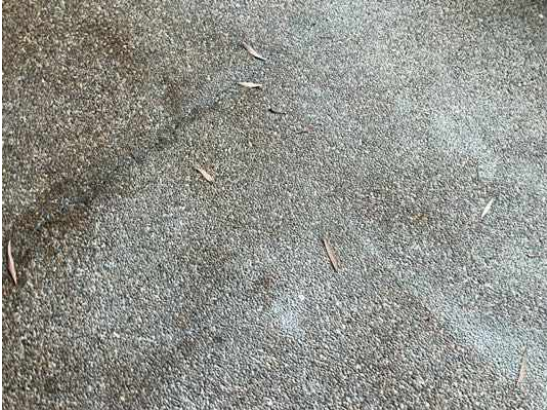
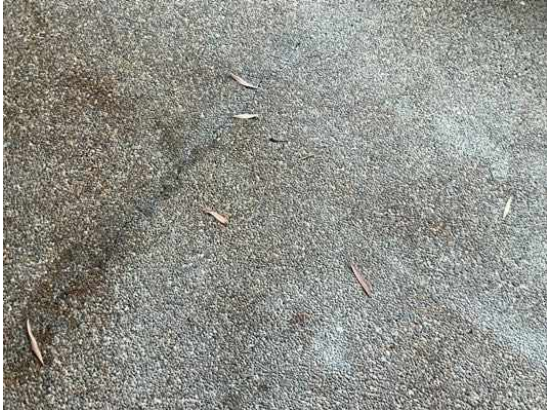
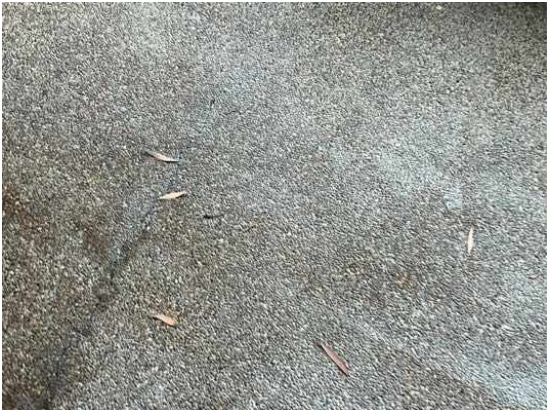
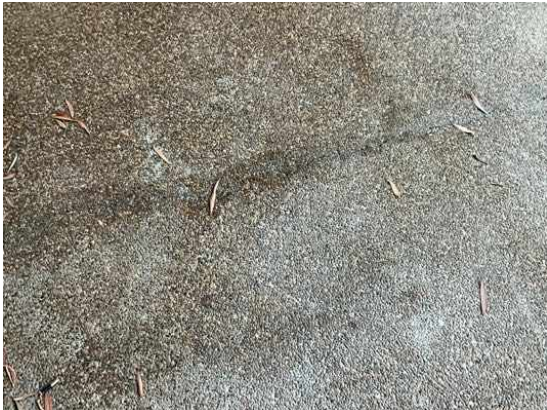
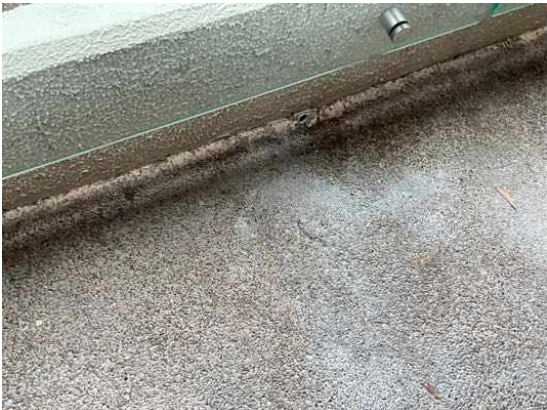
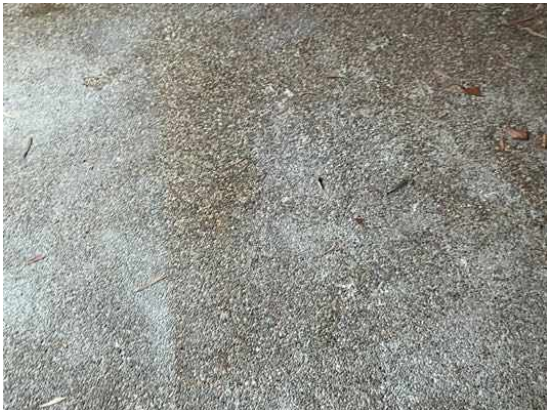
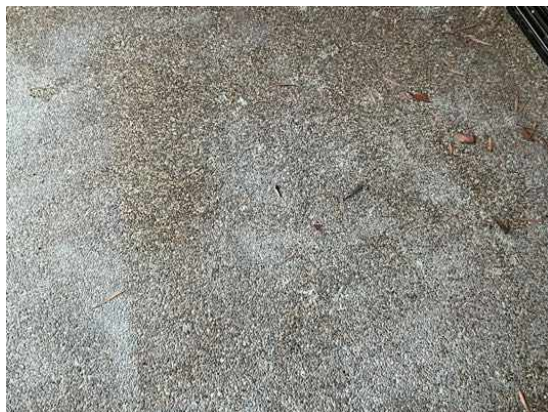
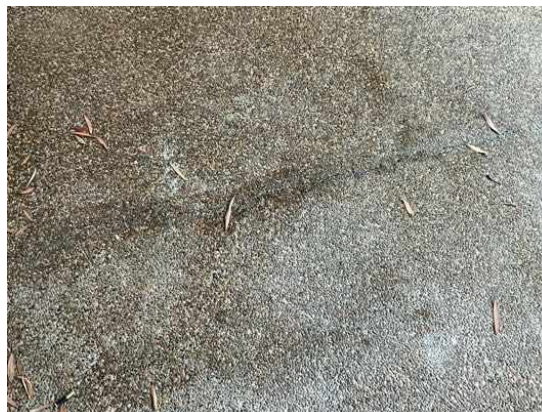
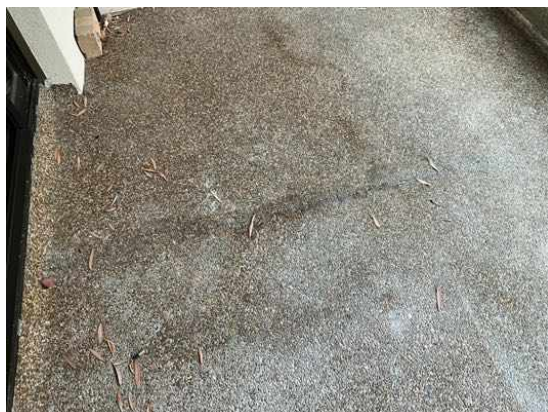
Finding 3.03

Finding: Water staining

Information: Water staining was evident in this area at the time of inspection. Water staining indicates that surfaces have been exposed to excessive moisture over time. The minerals and other elements in the water lead to staining, which may graduate to corrosion and deterioration if left unmanaged.

While mostly an appearance defect, water staining can be indicative of more serious defects, which may be currently concealed by other building elements.

Where water staining is active, a licensed plumber must be consulted to identify the cause of the staining and to provide advice on any reparation works that may be required. Replacement of any broken or damaged structures is advised.

Conversely, where water staining is old and inactive, affected building materials may be repaired or replaced at client discretion. A qualified carpenter or registered builder may be appointed to perform these works.

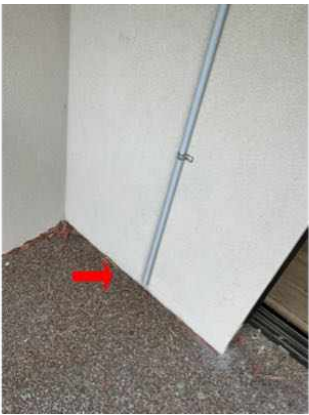
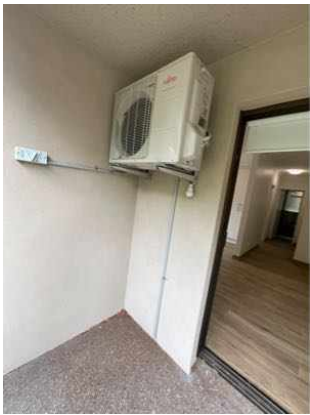
Finding 3.04

Building:	Main Building
Location:	Balcony
Finding:	Air conditioner - Disconnected overflow
Information:	The Air Conditioner (A/C) overflow was found to be disconnected from storm water drainage and is creating excessive moisture in the surrounding area.

Such leaking creates an environment which is conducive to an array of defects, including water damage to associated building elements and the attraction of termite or timber pest infestation.

It is highly recommended that a licensed plumber be appointed to connect the A/C overflow in order to prevent such an environment from being created. These minor works should be carried out as soon as possible.

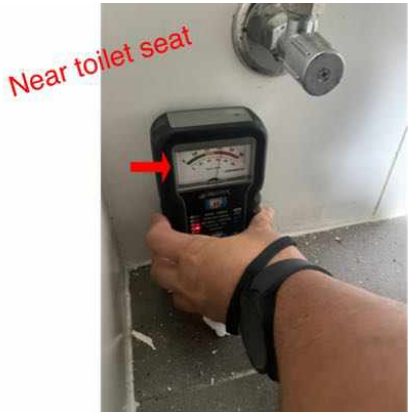
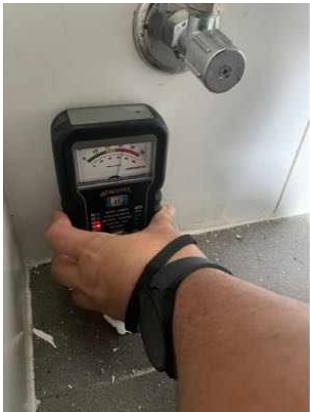
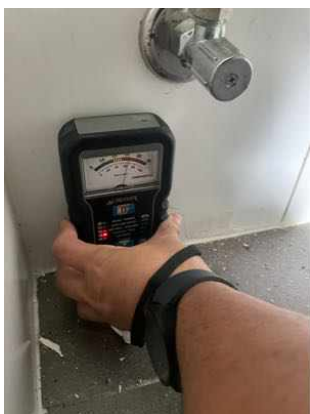
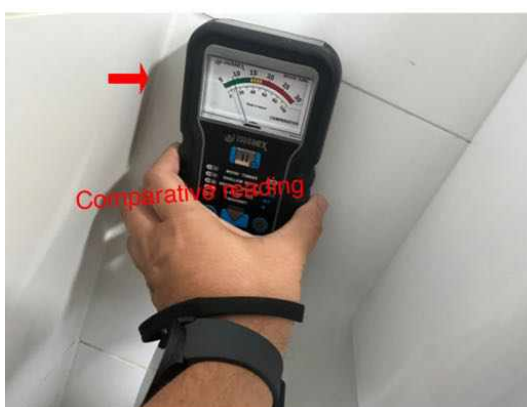
Finding 3.05

Building: Main Building
Location: Bathroom
Finding: Evidence of excessive moisture was present at the time of inspection
Information: Excessive moisture is present behind the bathroom tiles, indicating a potential water leakage issue within the wall.

The prolonged presence of moisture can lead to mold growth, deteriorate the structure, and create an environment conducive to health hazards. Additionally, it may compromise the adhesive holding the tiles, leading to their detachment.

A licensed plumber or a qualified contractor specializing in water damage remediation should investigate the source of the moisture, fix any leaks, and address the damage. Additionally, replacing affected tiles and ensuring proper waterproofing are crucial to preventing future issues.

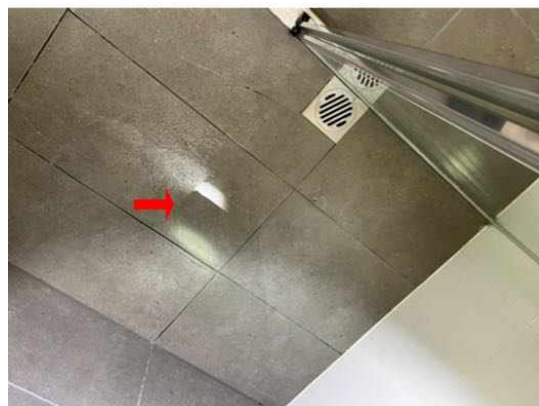
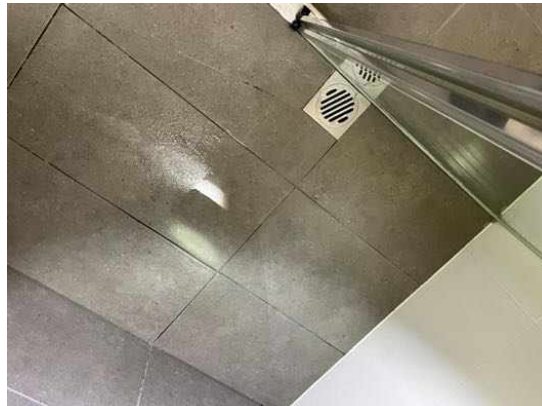
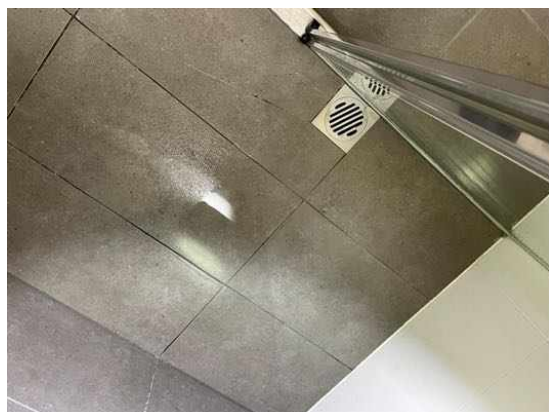
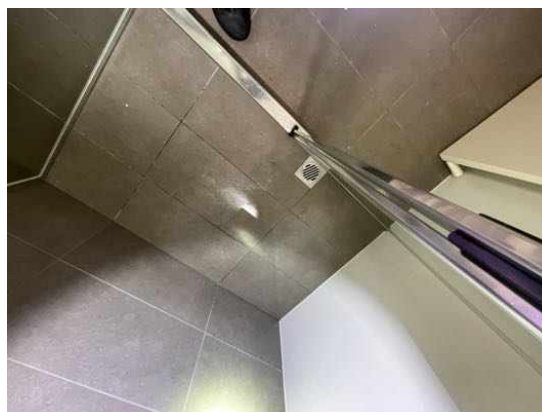
Building:	Main Building
Location:	Bathroom
Finding:	Shower base - Water pooling
Information:	Evidence of water pooling around the floor waste in the shower recess was noticed at the time of inspection. It is suspected that this excessive moisture is attributed to insufficient fall in the shower floor tiles.

This pooling is minor overall but is still considered unsatisfactory, as standard tiling practices would not permit this situation to occur. Pooling water around floor wastes can create a slip hazard in extreme cases and create conditions that are conducive to mould growth over time. Where left unmanaged, the degradation of sealant and

grouting is also likely to occur, possibly necessitating further repair works.

Remedial works may involve some sections of tiling and flooring repair and replacement. A tiling contractor or bathroom specialist should be appointed to provide further advice on reparation options and to perform works as necessary.

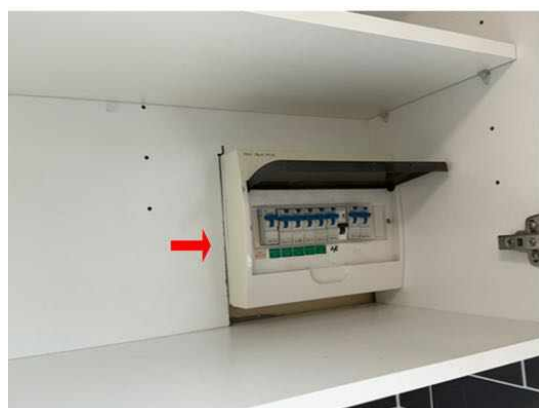
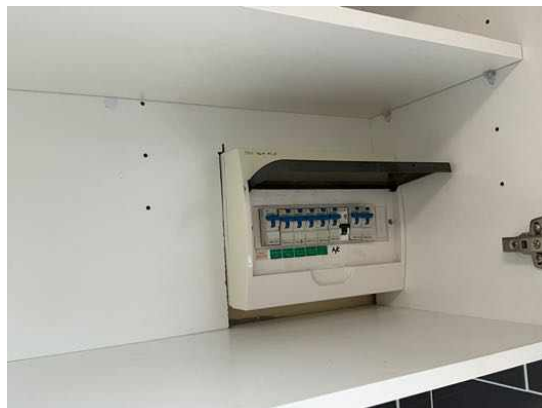
A durable notice was not placed in the switchboard unit to indicate current termite barriers is legible at the time of inspection.

Client must seek further information from the vendor or real estate agent if the conditions of termite management systems were maintained.

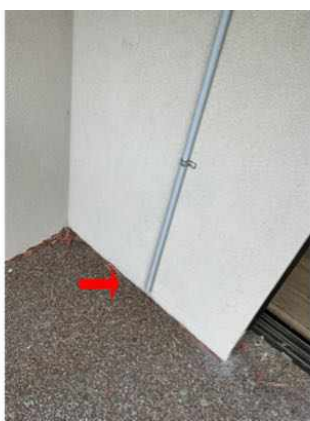
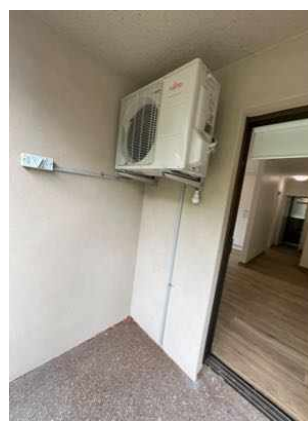
Finding 6.02

Building: Main Building
 Location: Balcony
 Finding: Aircon - Excessive moisture conducive condition near Air-conditioner
 Information: Excessive moisture near an air conditioner can indeed create conducive conditions for termites. Termites are attracted to damp and decaying wood, which can be found in areas with high moisture levels. To fix this issue:

1. Fix Leaks: Check for any leaks or condensation around your air conditioning unit. Repair any damaged pipes, drains, or insulation

2. Proper Drainage: Ensure that your air conditioner has proper drainage. Make sure the condensate drain line is clear and directed

3. Ventilation: Improve ventilation around the unit. Ensure that the area is well-ventilated to reduce humidity levels.

5. Please consult a HVAC Technician: HVAC (Heating, Ventilation, and Air Conditioning) technicians are trained to diagnose and

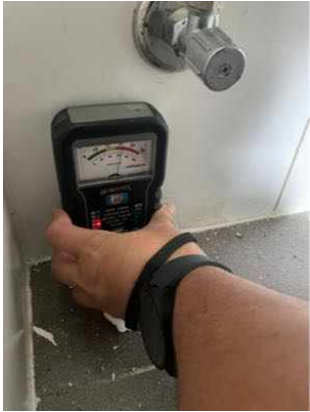
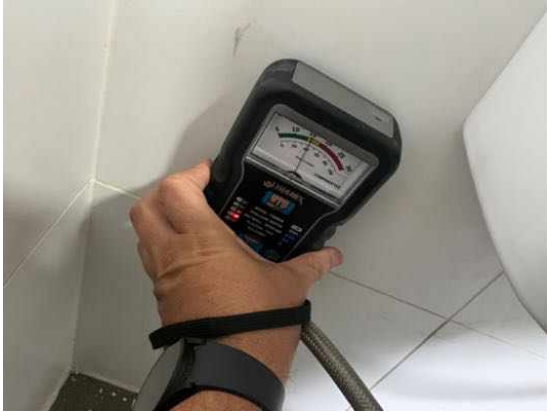
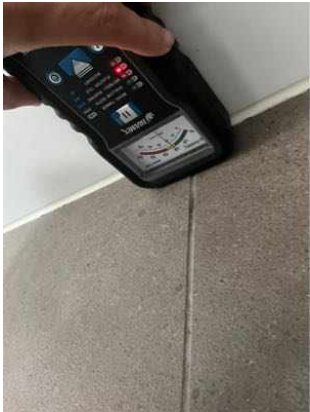
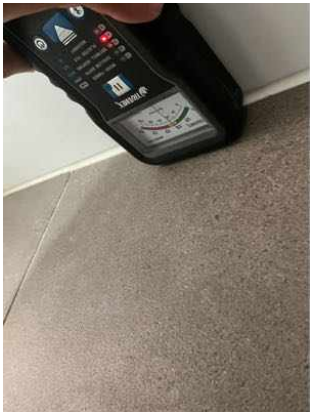
Finding 6.03

Building:	Main Building
Location:	Bathroom
Finding:	Excessive moisture - Conducive to Timber pest
Information:	Excessive moisture can attract termites and produce conditions that promote fungal growth and wood decay.

Excessive moisture is generally caused by deteriorated inadequate or missing roof drainage leaking plumbing pipes or fixtures poorly plumbed HWS overflows or condenser units and poor site drainage.

Prior to any remedial works being performed a qualified plumber should be appointed to further inspect the property and to identify the cause of the excessive moisture. Works to remove affected building elements may then be necessary and should be performed by an appropriate tradesperson.
