Building and Timber Pest Inspection Report

Inspection Date: Wed, 8 Apr 2026

Property Address: 7/11 Harrington Ave, Castle Hill NSW 2154, Australia

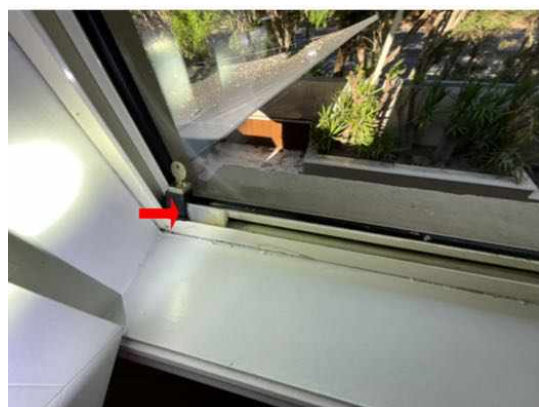
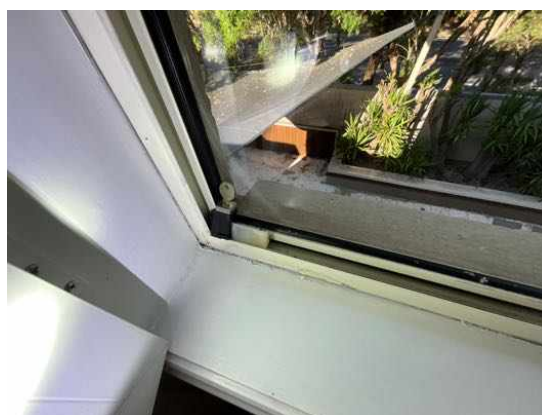
Finding 1.01

Building:	Main Building
Location:	All Areas
Finding:	Window child lock missing
Information:	The window in question lacks a child lock mechanism, which poses a potential safety risk to young occupants in the premises. As per Australian Standards windows accessible to children should be equipped with appropriate child safety locks to prevent accidental opening, reducing the risk of falls and ensuring compliance with safety regulations.

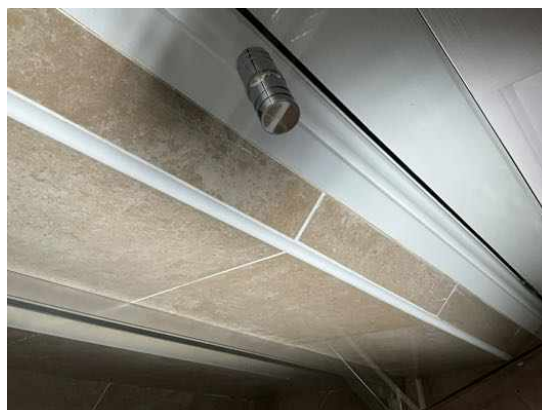
Finding 1.02

Building:	Main Building
Location:	Ensuite
Finding:	shower screen door hitting tiles
Information:	The shower screen door makes contact with the adjacent tiles when opened. This indicates inadequate clearance between the shower screen and the wall. The door's operation is impeded and presents a safety concern.

- Potential for impact damage to the wall and shower screen.
- Increased risk of glass breakage, posing a personal injury hazard.
- Ongoing stress may lead to hardware failure or misalignment of the door.

This condition does not comply with the intent of AS 4349.1-2007, Appendix C –

Significant Items, under “Defects in the condition of secondary and finishing elements,” specifically where normal use may cause failure or injury.

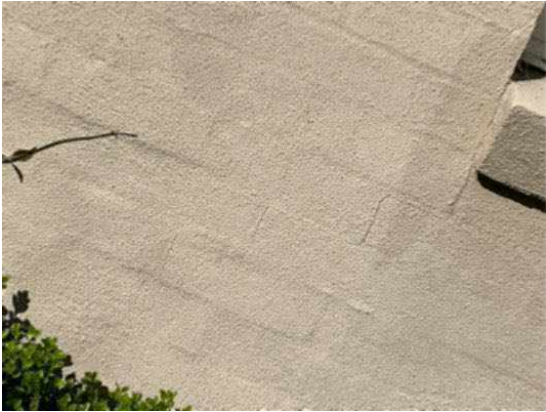
Finding 2.01

Building: Main Building
 Location: All Areas
 Finding: Brickwork - Cracking [Repair required]
 Information: cracking was identified to the brickwork in this area. Cracks of this type are likely to have been caused by minor expected movement of building elements, but may also have a structural cause that is more significant.

A crack of this size may be repaired by extensive filling. Additionally, further remedial works to associated building elements,

A qualified bricklayer should be contacted immediately to estimate and perform repair and restoration works. Consultation with a structural engineer may be required where structural instability is found to be the underlying cause of the cracking.

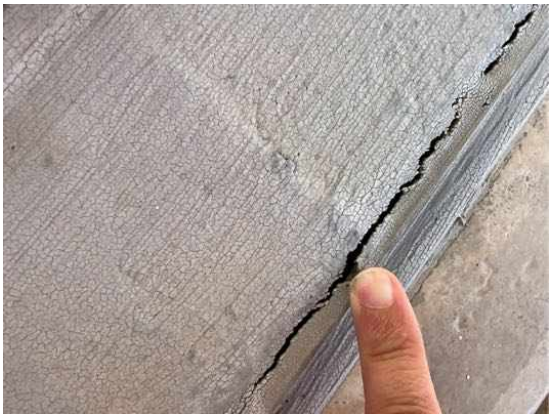
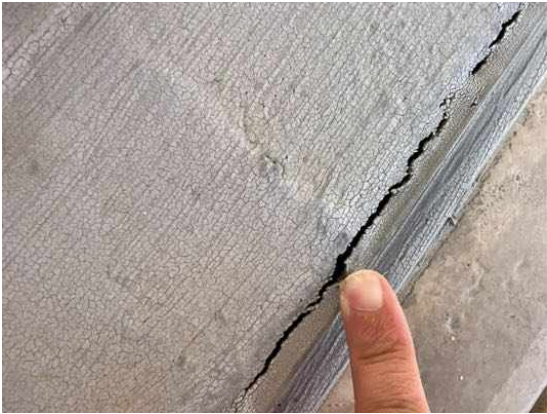
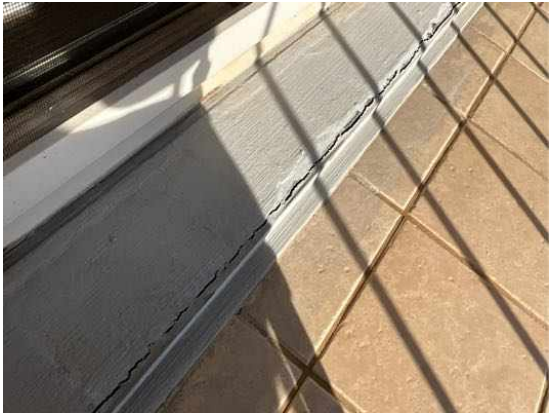
Finding 3.01

Building:	Main Building
Location:	All Areas
Finding:	Expansion Joint – Sealant Deterioration
Information:	The vertical expansion joint between the brickwork is observed with an open gap and missing or deteriorated sealant. Expansion joints are designed to allow thermal and structural movement between materials; however, the current joint condition may compromise weatherproofing.

Minor – If left unsealed, water penetration may occur behind the wall, causing dampness, efflorescence, or damage to internal materials over time.

AS 3700 – Masonry Structures (Clause 4.7: Control Joints).

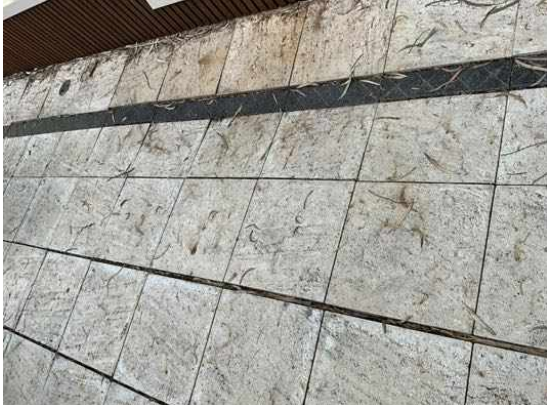
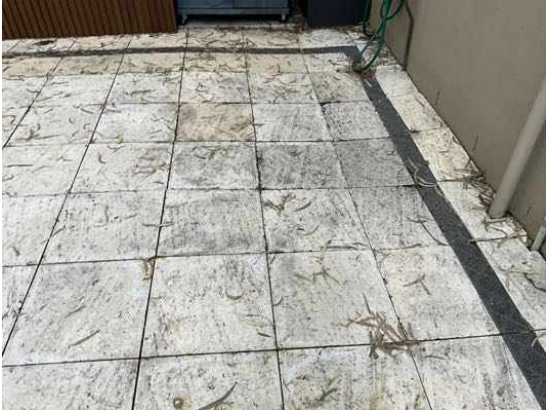
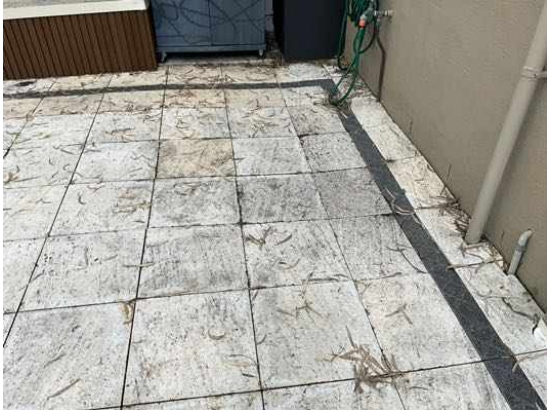
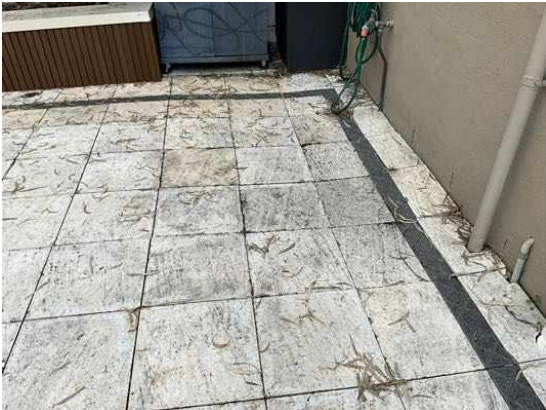
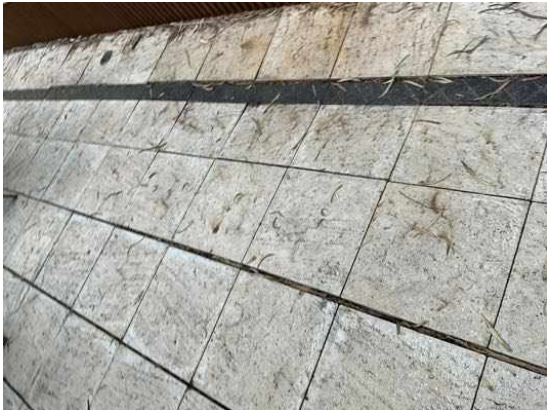
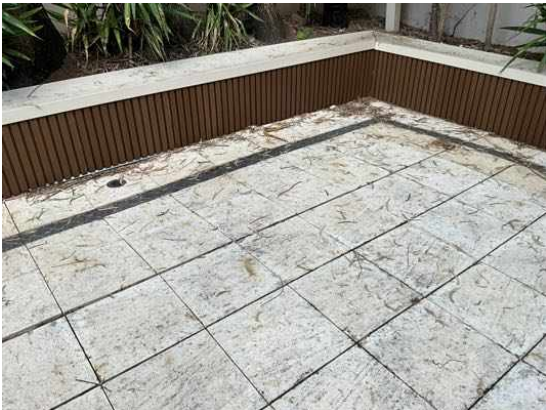
Finding: loose pavers and improper proper drainage

Information: The yard of the property have uneven, loose pavers, which may impede proper drainage and access. The area shows signs of poor maintenance, potential water pooling, and trip hazards due to moss-covered, unstable surfaces.

Risk: Increased risk of personal injury due to slips and trips, mosquito breeding from stagnant water, and potential structural moisture damage from inadequate site drainage.

Recommended Action: A licensed landscaper or drainage specialist should be engaged to clear vegetation, regrade the area for proper water runoff, and relay or replace pavers to ensure a safe and accessible walkway.

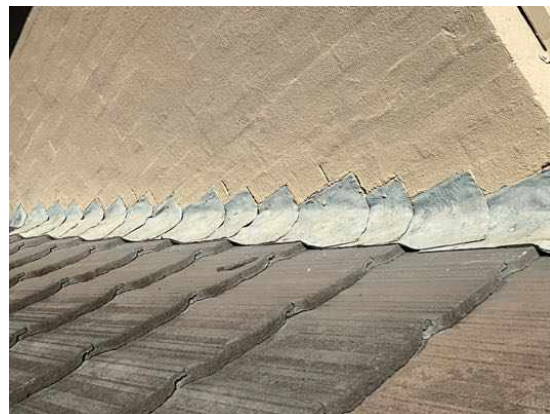
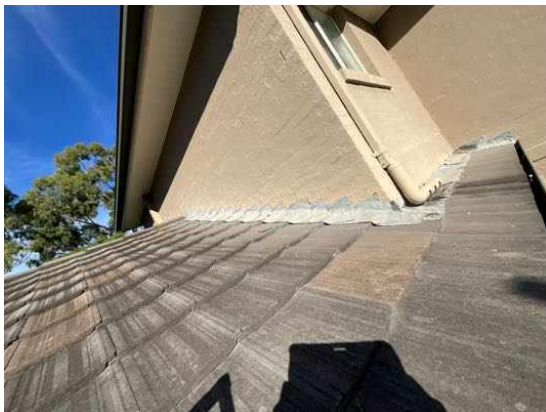
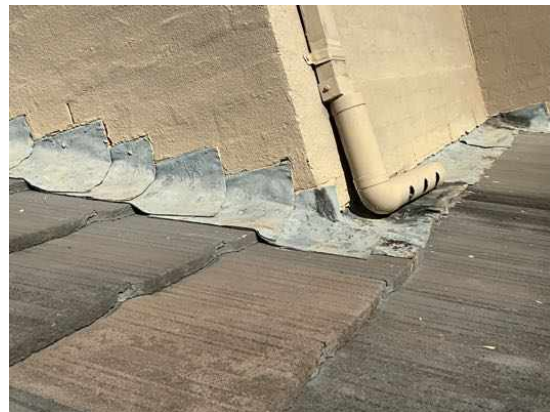
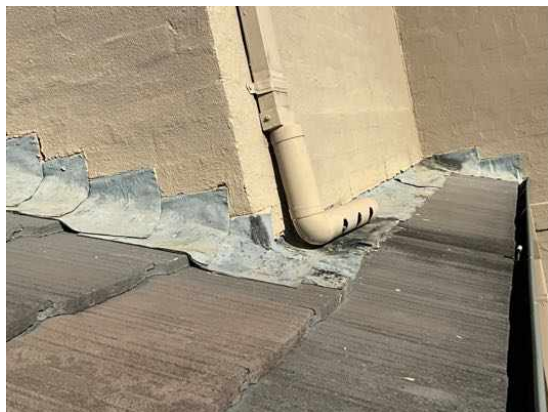
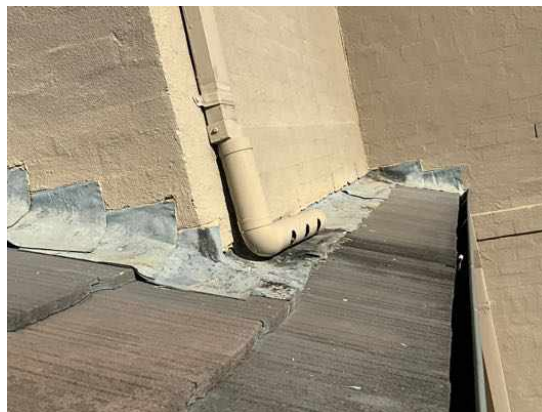
Finding 3.04

Building: Main Building
Location: All Areas
Finding: Roof Weathered
Information:

Inspection of the roof revealed widespread weathering to the tiled roof surface. The tiles show loss of surface finish, colour fading, and age-related deterioration typical of older roof coverings. Although no significant cracking was noted, weathering can lead to increased porosity, reduced water-shedding capability, and a higher risk of future cracking or displacement during adverse weather conditions.

A licensed roofer should be engaged to undertake a closer inspection, carry out routine maintenance, and replace any tiles that may be compromised. Ongoing monitoring is recommended due to the age and condition of the roof covering.

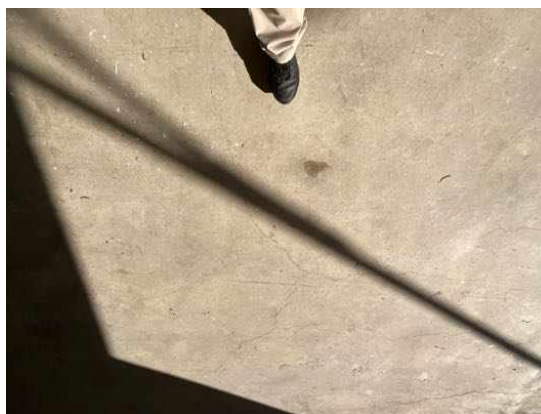
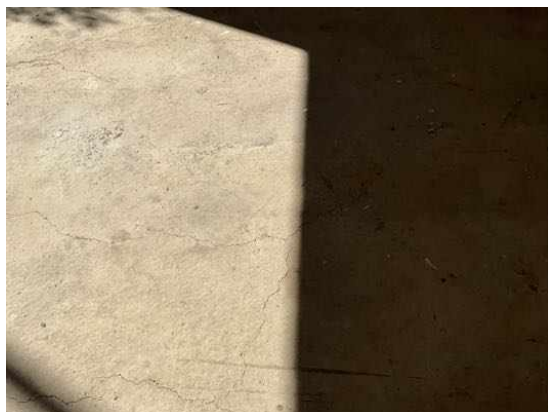
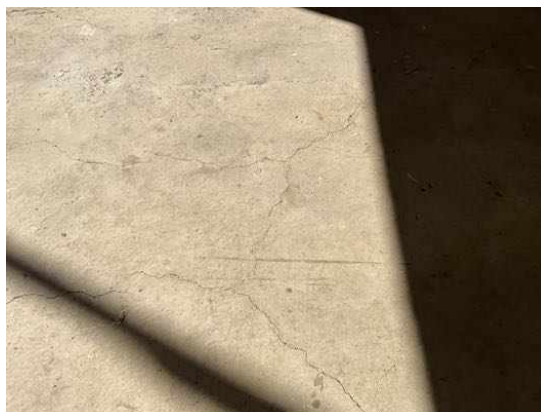
Finding: Crack in concrete slab - Category 0

Information: A crack coded as Category 0 was identified in the slab. A Category 0 crack is described as a hairline crack, representing insignificant movement of slab from level.

The approximate width of the crack to be considered Category 0 is 0.3mm, or change in offset of less than 8mm when a 3m straight edge is placed over the defect.

No rectification is required at this time. However, all cracking should be monitored over a 12 month period to identify any further damage in the area.

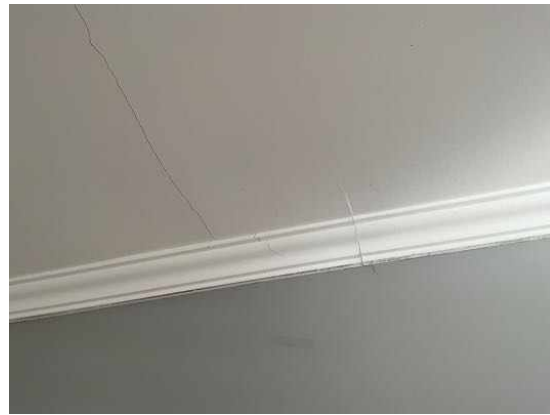
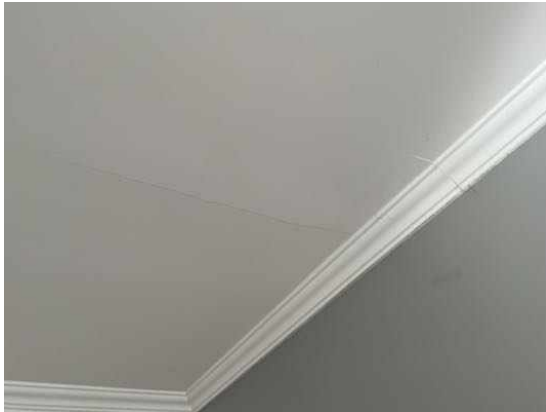
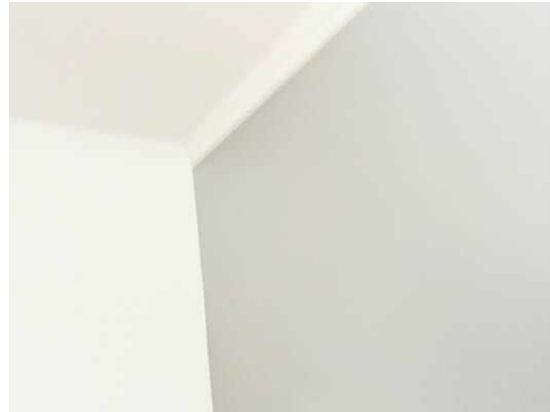
Finding 3.07

Building:	Main Building
Location:	Living Room
Finding:	Ceiling – Plasterboard Fine Cracking
Information:	Fine cracking was observed to the ceiling plasterboard. This is commonly associated with normal building movement, shrinkage, or minor settlement and is generally cosmetic in nature.

However, cracking may worsen over time and affect appearance if left unattended.

Recommendation / Who can fix it: Repair and monitoring by a qualified plasterer or painter is recommended.

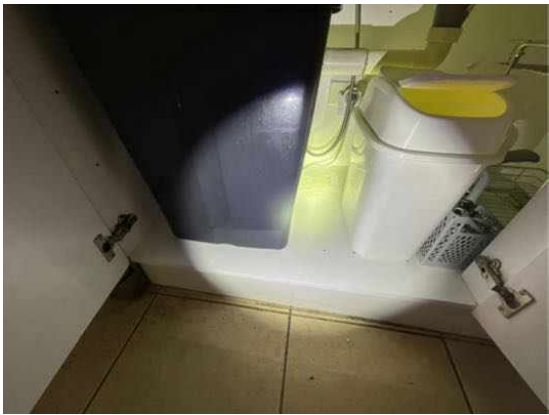
Finding 3.08

Building: Main Building
Location: Kitchen
Finding: Water Stains in Vanity
Information: "Water stains observed in the vanity area, compromising its appearance and potentially causing damage."

Continued water exposure may lead to material damage, mold growth, and diminished aesthetic appeal.

A licensed plumber or maintenance professional should assess and fix any leaks contributing to the water stains, while a cleaning or restoration service may be needed to address the visible stains and prevent further damage.

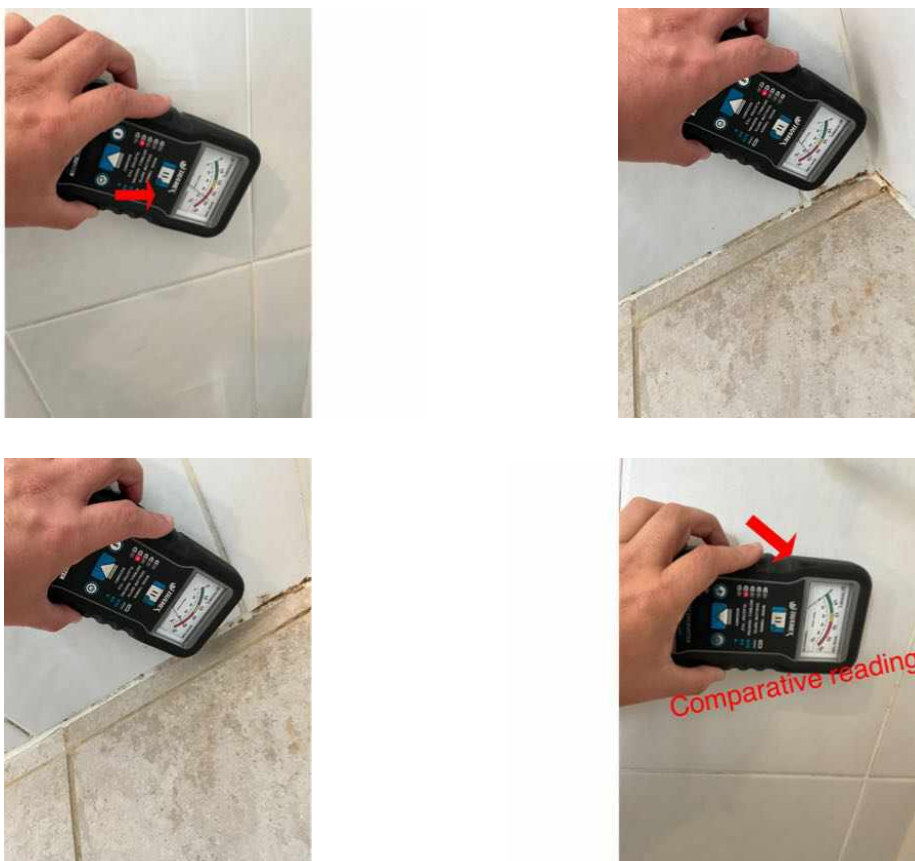
Building:	Main Building
Location:	Bathroom
Finding:	Shower - Damp
Information:	Damp is evident to the lower 300mm of wall to the shower alcove. This defect is quite common, and is suspected to have been caused by moisture permeating through the grouting in this area, which shows evidence of deterioration. Leaking pipes within the adjoining wall is also a possible cause.

Unmanaged damp in the shower recess is likely to facilitate the formation and development of mould and fungi growth, decaying associated building materials and compromising their structural integrity. It is important to address damp conditions, as the World Health Organisation notes that excess moisture leads - on almost all indoor materials - to growth of microbes such as moulds, fungi and bacteria, which subsequently emit spores and other matter into the indoor air. Exposure to these contaminants is associated with a wide range of respiratory and other health-related problems.

Consultation with a qualified plumber or bathroom specialist is advised immediately to identify the cause of damp and to perform remedial works as required. Where excessive mould growth is present, further inspection by a specialist environmental health inspector should also be considered.

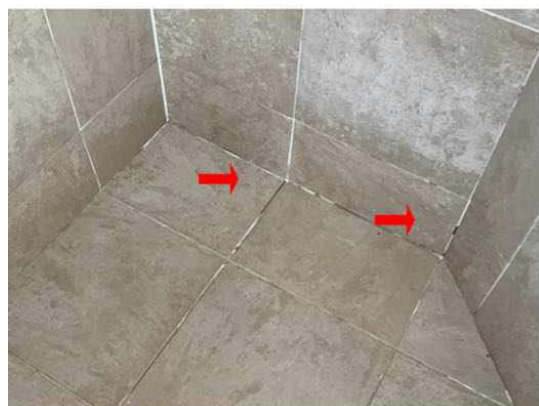
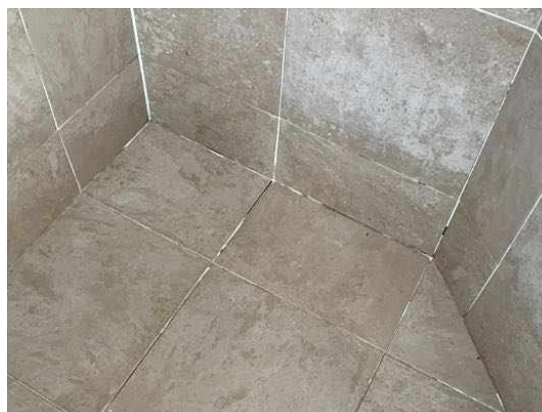
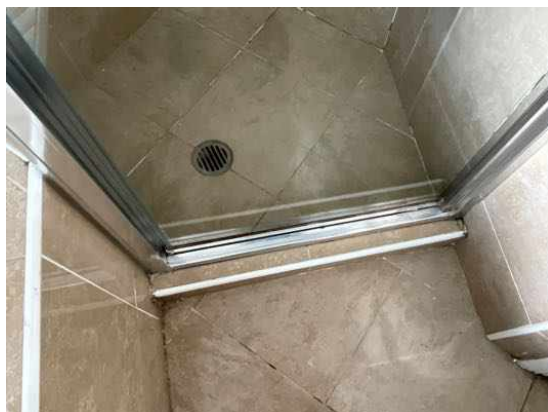
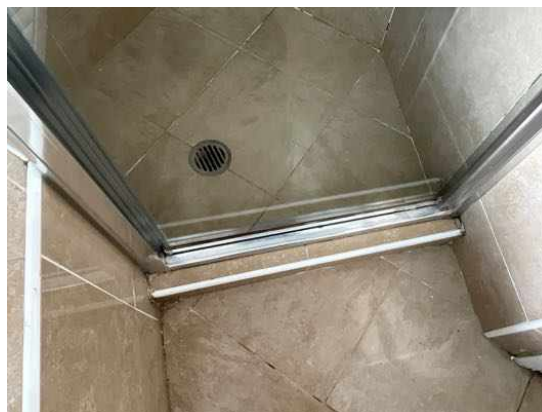
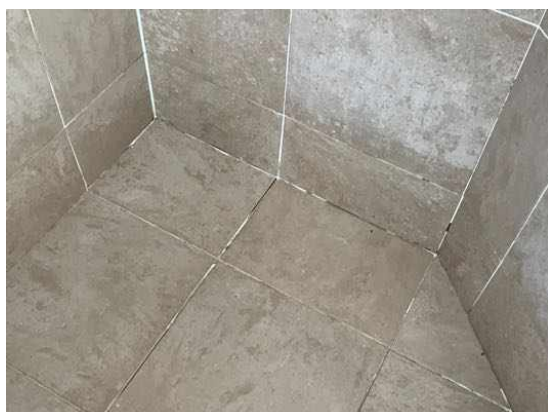
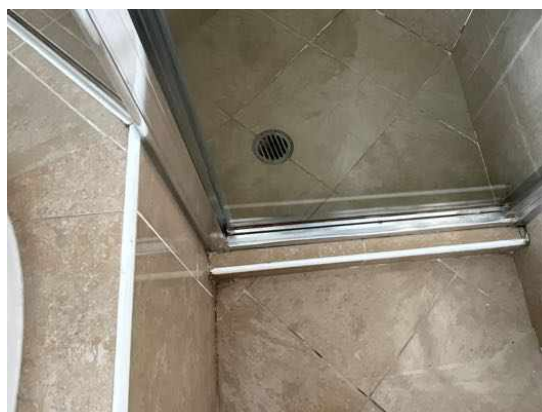
Building:	Main Building
Location:	Ensuite
Finding:	Sealant and grouting - Missing or damaged
Information:	It was noted on inspection that sealant or grout is degraded to the tiled shower alcove and or other areas of the bathroom.

There appears to be excessive mould to the sealant and grout which will likely require scraping out and replacement.

Flexible and mould resistant materials should be applied to affected areas to prevent any subsequent water damage that is likely to occur. Regular maintenance and replacement of damage or missing or damaged sealant and grout is highly recommended to the wet areas, as this is a regular wear and tear defect. Sealant and grouting in areas that come into regular contact with water should be maintained for the long term care of your property.

A sealant specialist or tiling contractor should be appointed to complete these works as soon as possible

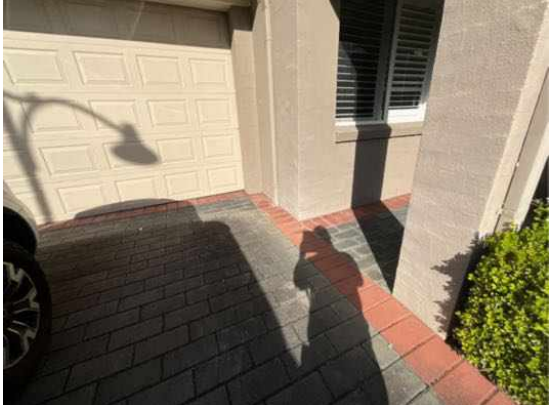
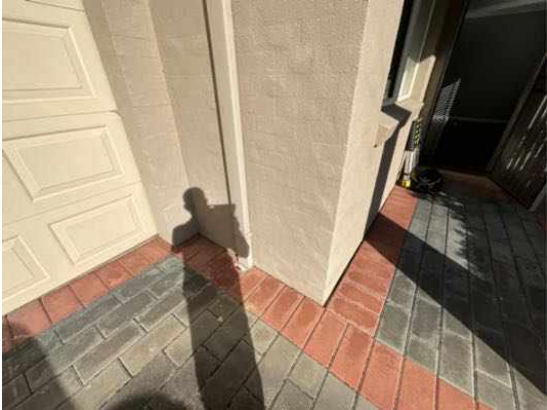
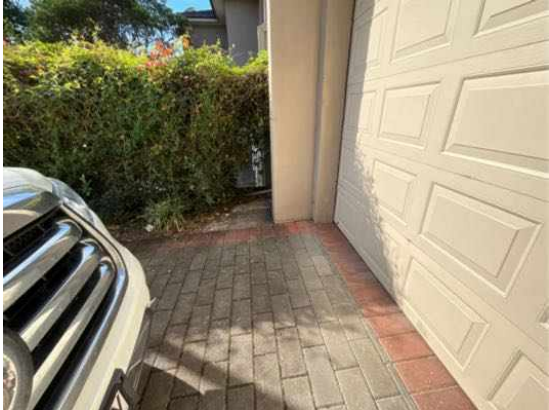
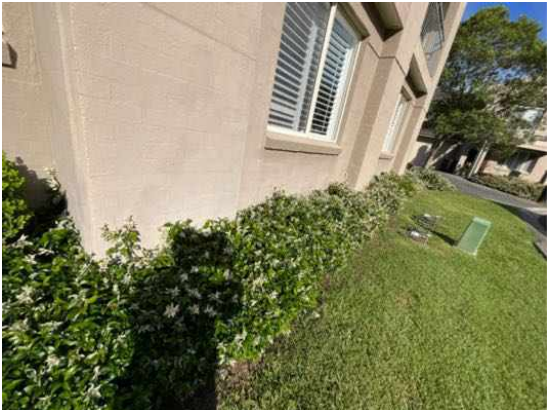
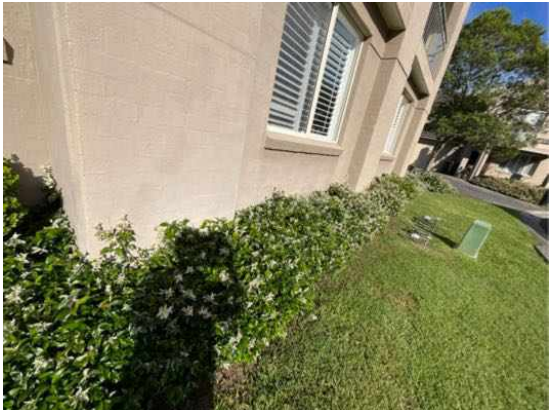
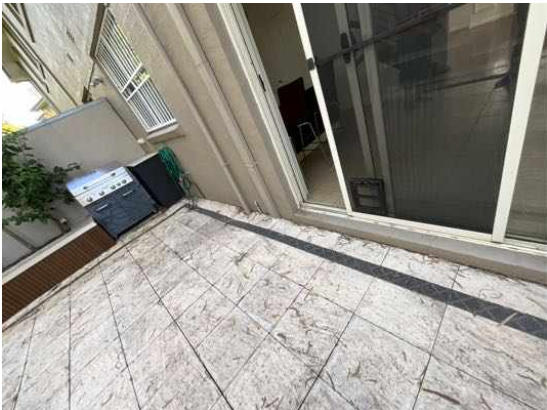
If the slab edge is not properly exposed there is a high risk of termite attack. Sometimes, in order to determine the type of slab, a suitably qualified person such as an architect or builder may be required to consult the construction plans.

Where the slab edge cannot be properly inspected, it is highly recommended that termite or timber pest inspections be carried out every 6-12 months to aid protection of the property against infestation.

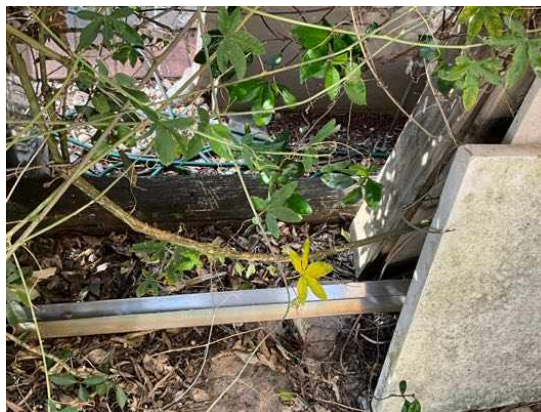
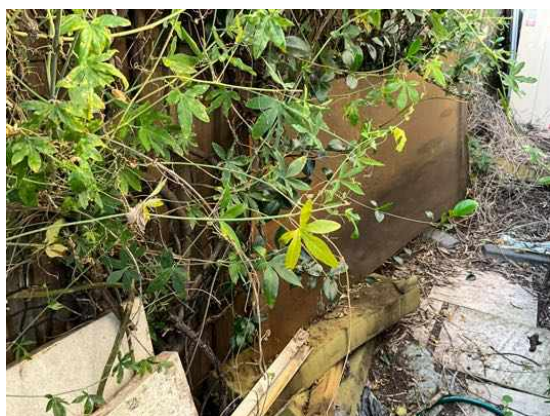
Building:	Main Building
Location:	All Areas
Finding:	Timber on ground / conducive conditions to termite damage
Information:	Timber on the ground is indeed conducive to termite damage. Termites are known to

thrive in moist environments, and wood in contact with soil or moisture is more susceptible to infestation.

To prevent this, it's important to keep timber elevated and away from direct ground contact. Regular inspections and proper termite control measures are also essential to protect your wooden structures from termite damage.

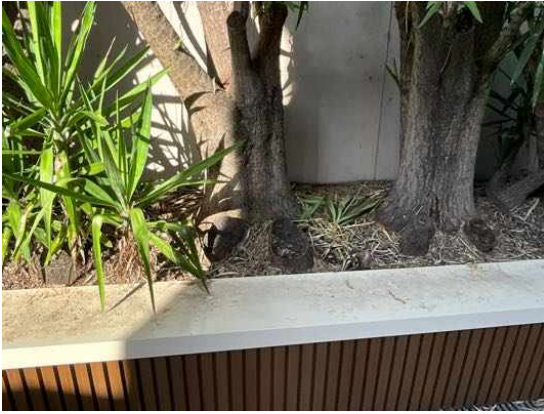
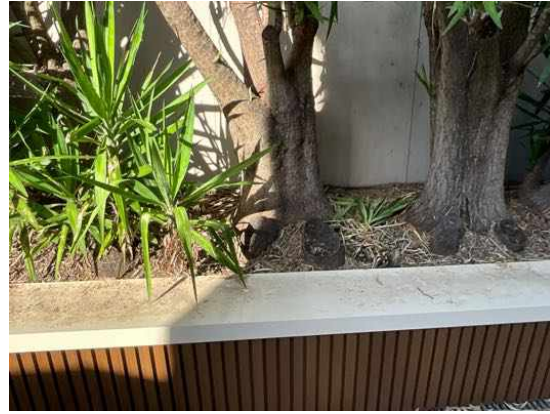
Please contact Licenced pest controller for further advice. Pictures attached for your reference.

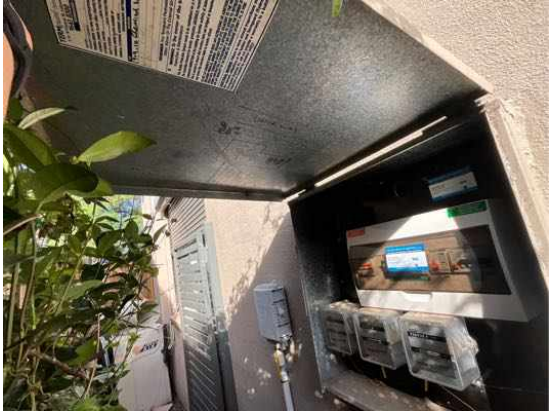
A durable notice placed in the switchboard unit to indicate termite barriers at the time of inspection.

Client must seek further information from the vendor or real estate agent if the conditions of termite management systems were maintained as per the label or seek advise from licensed pest controller.
