Building and Timber Pest Inspection Report

Inspection Date: Wed, 11 Feb 2026

Property Address: 46 Dulcimere St, Tahmoor NSW 2573,
Australia

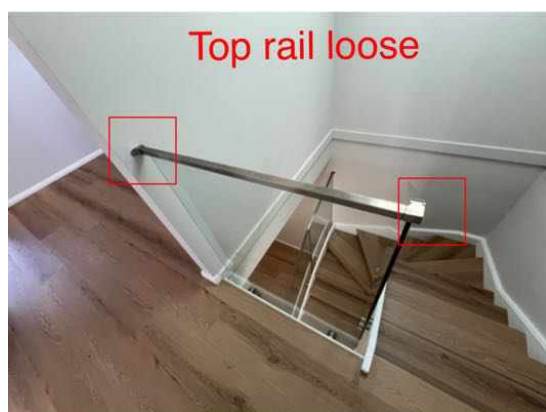
Building:	Main Building
Location:	Stairs - Internal > Upstairs
Finding:	Stair Balustrade - Excessive Movement
Information:	Excessive movement was observed in the stairs' balustrade at the time of inspection. This may be due to inadequate fixings, deterioration of materials, or substandard installation.

A loose balustrade presents a significant safety risk, as it may not provide adequate support or restraint, particularly under load. If left unmanaged, further movement or potential failure of the structure may occur.

It is recommended that a registered builder be engaged urgently to assess and rectify the issue to ensure the balustrade is securely fixed and meets safety requirements.

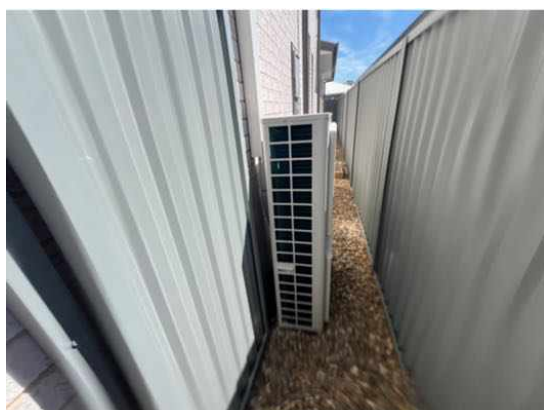
Building:	Main Building
Location:	Exterior walls - right side
Finding:	Air Conditioning - Electrical Fault Indicated
Information:	The air-conditioning system was observed to trip the main circuit via the residual current device (RCD) during operation. Tripping of an RCD indicates the presence of an electrical fault condition, such as current leakage, which may be associated with the air-conditioning unit, associated wiring, or connected components.

While the RCD is functioning as intended to protect occupants, repeated tripping indicates an underlying issue that requires attention. If left unmanaged, this condition may affect the reliability of the electrical system and presents an ongoing safety concern.

It is recommended that a licensed electrician assess the air-conditioning system and associated electrical components to identify the cause of the RCD tripping and carry out any necessary rectification.

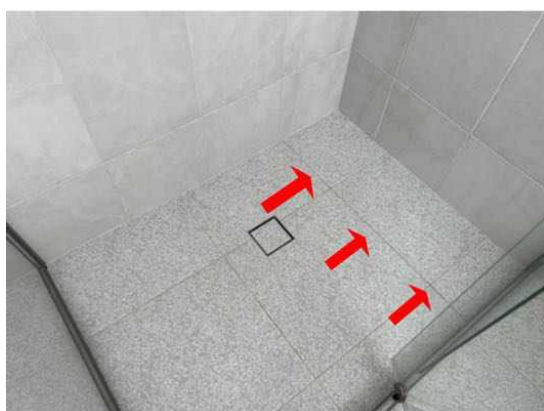
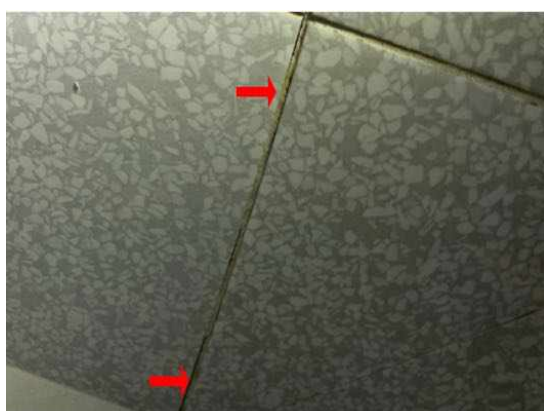
Finding 2.01

Building:	Main Building
Location:	Bathroom > Upstairs
Finding:	Shower Recess - Drummy and Popped Tiles
Information:	Grout deterioration and several popped or drummy tiles were observed within the tiled shower recess. Drummy or loose tiles indicate that the bond between the tile and substrate has weakened, likely due to moisture ingress, thermal movement, or substandard installation at the time of tiling.

This condition compromises the waterproofing integrity of the recess, allowing moisture to track behind the tiles and into concealed wall or floor structures. If left unmanaged, progressive water penetration may result in mould development, decay of framing materials, and deterioration of finishes.

A qualified tiler should be engaged to assess the extent of detachment and replace affected tiles to restore proper bonding and surface waterproofing.

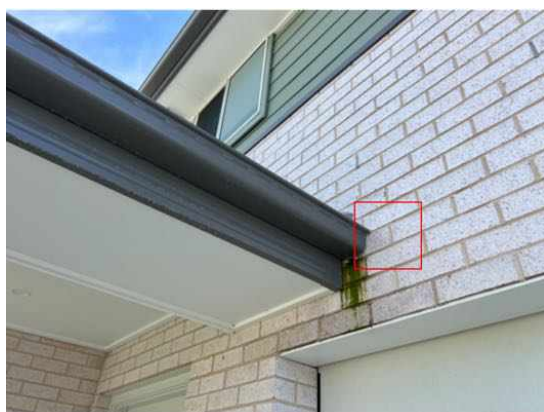
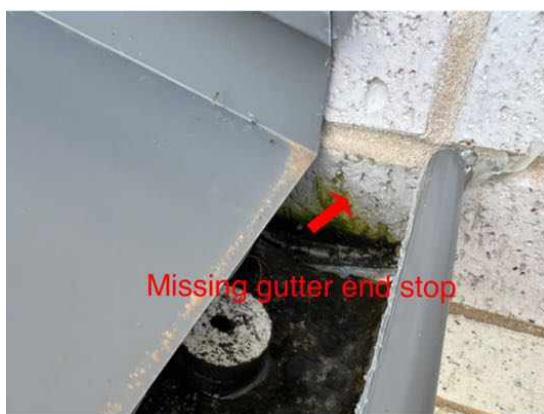
Finding 2.02

Building:	Main Building
Location:	Verandah >
Finding:	Gutter Termination - Moisture Discharge to Wall

Information: The guttering was observed to terminate directly against the masonry wall without an appropriate end stop or formed termination detail. Sealant has been applied at the junction; however, staining and biological growth to the adjacent brickwork indicate ongoing moisture discharge at this location.

Gutters should be adequately terminated to prevent water escaping at wall interfaces. Discharge against masonry can allow moisture penetration into the wall cavity and contribute to deterioration of finishes and concealed structural elements over time.

This installation is considered substandard and poses an elevated risk of water ingress. Assessment and rectification by a licensed roof plumber or registered builder is recommended.

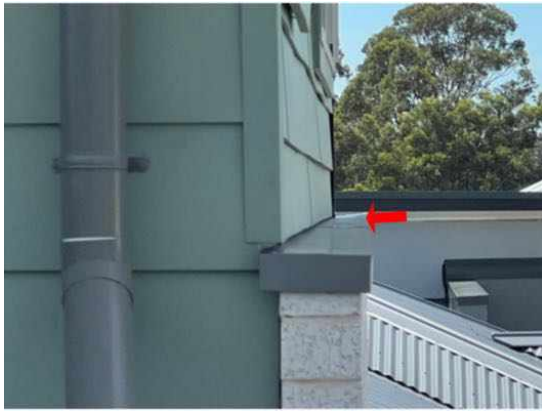
The parapet flashing to the upper-level roof area was observed to be installed with a fall directed back toward the wall rather than away from the structure. Flashings are intended to shed water away from building elements, and incorrect fall may allow water to pond or track toward the building envelope.

Where parapet flashings do not adequately discharge water, there is an increased risk of moisture penetration into adjoining cladding and wall systems. If left unmanaged, this condition may lead to concealed deterioration of internal building elements.

It is recommended that a registered builder assess the parapet flashing installation and undertake rectification as required to ensure adequate drainage and weatherproofing.

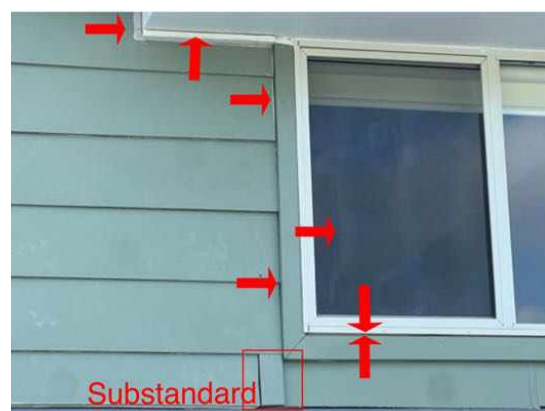
Finding 2.06

Building:	Main Building
Location:	Exterior walls - 1st floor > Upstairs
Finding:	Window Trims - Inadequate Sealing to Cladding
Information:	Gaps were observed between the external cladding boards and window trims, with junctions not sealed using an appropriate flexible sealant. Inconsistent detailing was noted, including trims installed over the face of cladding in some locations and cladding butting into trims in others without effective sealing. Based on visual assessment, the installation appears substandard and not in keeping with typical weatherproof detailing practices.

Perimeter junctions around windows are particularly susceptible to moisture ingress where sealing and detailing are incomplete. Unsealed interfaces at these locations increase the risk of water penetration into concealed wall cavities, which may lead to deterioration of framing members, corrosion of fixings, and damage to internal linings over time.

Further assessment by a registered builder is recommended to determine the adequacy of the installation and to address the weatherproofing detailing as required.

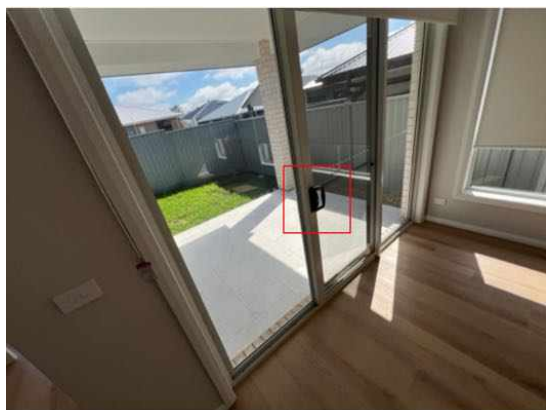
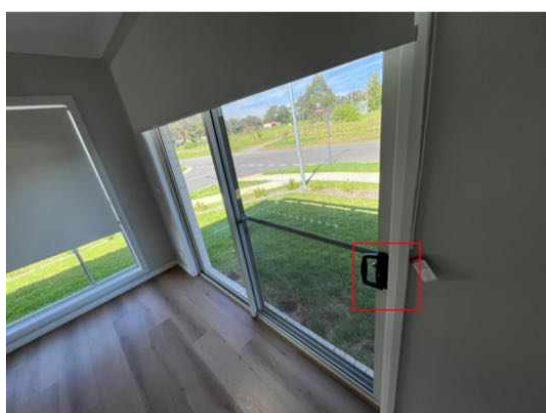
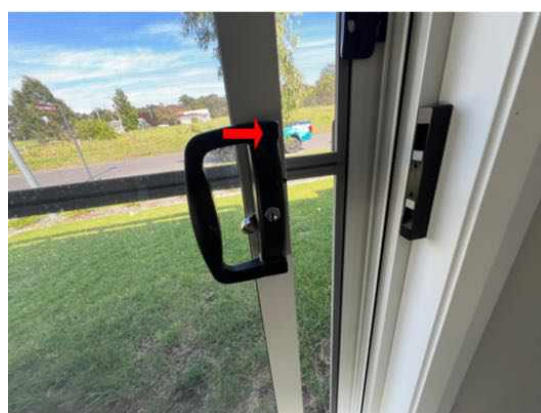
Building:	Main Building
Location:	Bedroom - Guest, Dining Room
Finding:	Door Handle - misaligned/loose
Information:	The door handle in this area was found to be misaligned/loose at the time of inspection. Breakage occurs generally when the building materials have aged and decayed, but may be indicative of impact damage (accidental or deliberate).

A qualified carpenter or general handyman should be appointed to repair the door handle at the client's discretion.

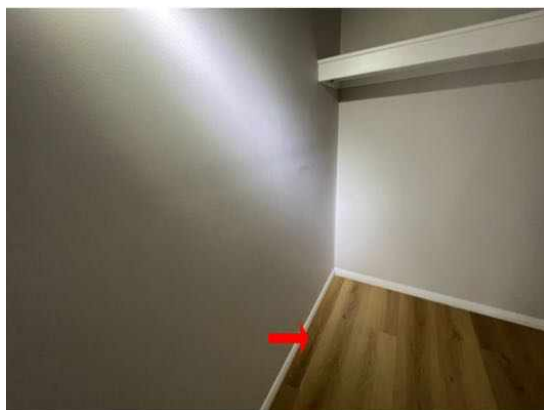
Finding 3.03

Building:	Main Building
Location:	Walk-In Robe - Guest
Finding:	Laminate Floor – Board Separation
Information:	Sections of the floating laminate flooring were observed with visible separation between adjoining boards. The flooring is installed over a concrete slab and no expansion joints were identified throughout the floor area. Floating floor systems rely on adequate expansion allowances to accommodate natural movement, and the absence of these joints can lead to board separation or uneven gaps forming over time.

While the condition appears cosmetic, it may indicate installation practices that do not fully align with manufacturer recommendations. Further advice should be sought from a qualified flooring installer if confirmation of installation quality or long-term performance is required.

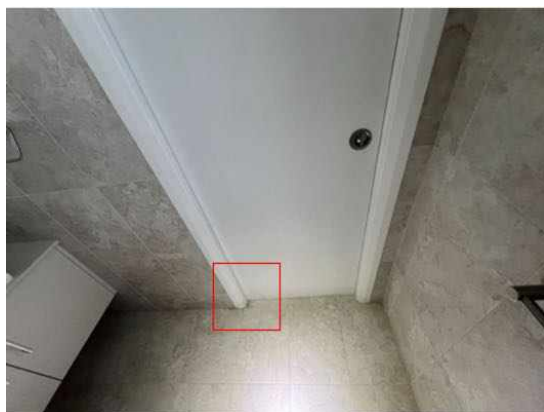
Finding 3.04

Building:	Main Building
Location:	Ensuite - Guest
Finding:	Cavity Sliding Door – Door Guide Missing
Information:	The cavity sliding door was noted to be misaligned or not running correctly within its floor or wall guide. This condition is typically caused by loose fixings, missing door guides, movement within the door frame, or lack of proper adjustment to the guide mechanism.

If left unadjusted, the door may scrape, jam, or fail to close properly over time.

A carpenter should be engaged to realign and adjust or install door guides to ensure smooth and correct operation.

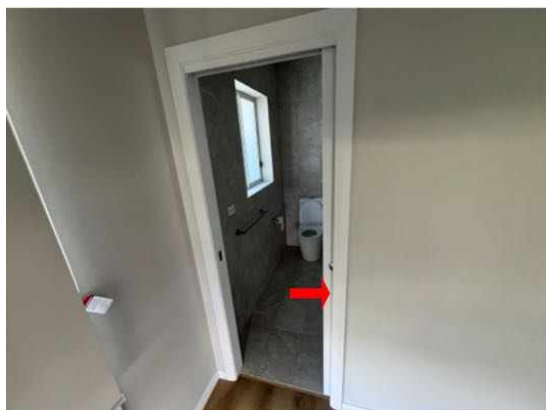
Finding 3.05

Building:	Main Building
Location:	Ensuite - Guest
Finding:	Cavity Slider Door - Scratched Surface
Information:	A scratch was observed on the cavity slider door at the time of inspection. The damage appears to have been caused by a protruding nail or fixing inside the door pocket, which has made contact with the door surface during operation.

If left unmanaged, continued use of the door may result in further deterioration of the door surface and potential operational issues.

It is recommended that a qualified carpenter be engaged to assess and rectify the issue by removing or adjusting the protruding fixing and, if necessary, repairing or refinishing the affected door surface.

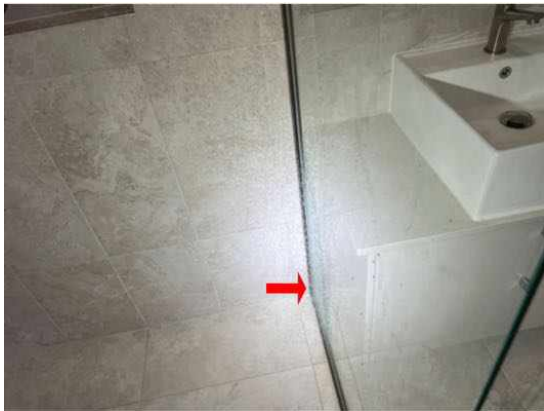
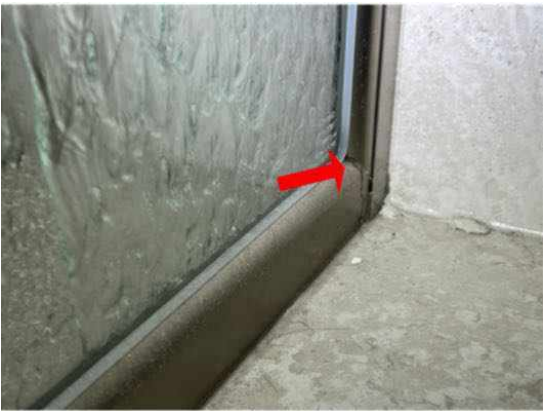
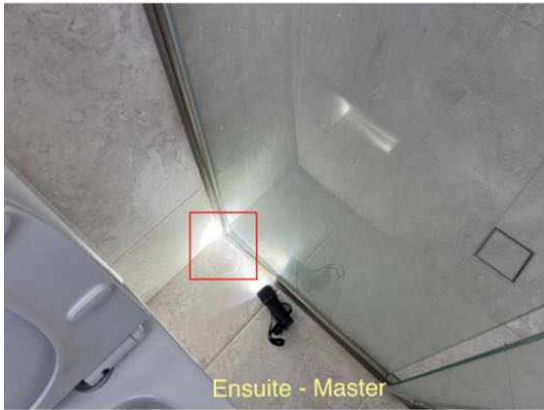
Finding 3.08

Building:	Main Building
Location:	Ensuite - Guest, Ensuite - Master, Bathroom
Finding:	Sealant and grouting - Missing or damaged
Information:	It was noted on inspection that sealant or grout is degraded to the tiled shower alcove and or other areas of the bathroom.

Resealing is recommended to restore a watertight seal and prevent further deterioration.

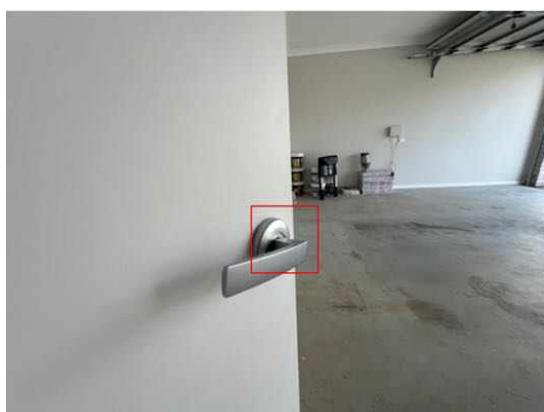
Finding 3.11

Building: Main Building
 Location: Garage
 Finding: Door - Broken handle
 Information: The door handle in this area was found to be broken at the time of inspection. Breakage occurs generally when the building materials have aged and decayed, but may be indicative of impact damage (accidental or deliberate).

A qualified carpenter or general handyman should be appointed to repair/replace the door handle at the client's discretion.

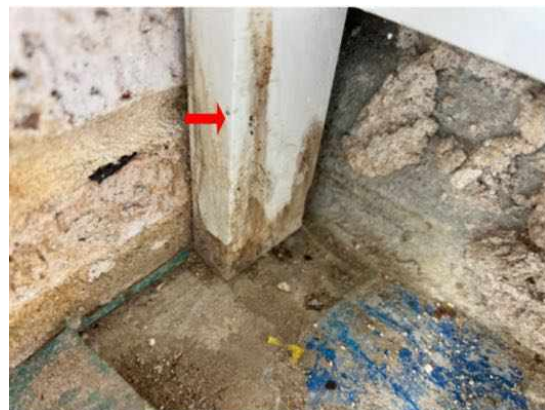
Finding 3.12

Building: Main Building
 Location: Garage
 Finding: Timber - Water Stained
 Information: Water staining was observed to sections of the timber element. The staining pattern indicates intermittent or prolonged exposure to moisture rather than a single isolated event.

Further investigation is recommended to identify the source of moisture and determine whether remedial works are required. Maintenance or repair may include drying, surface treatment, or repair of affected timber elements, depending on the extent of deterioration.

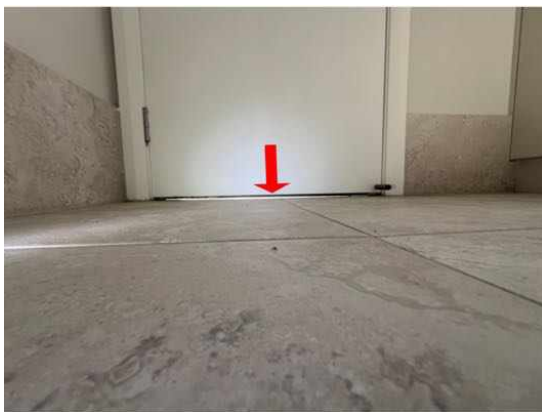
Finding 3.13

Finding: Door - weather seals (inadequate)

Information: The weather seals to the external door appear to be either missing, incomplete, or inadequately installed. Properly fitted weather seals are essential for preventing air and water infiltration, improving energy efficiency, and ensuring compliance with standard construction practices. Where seals are not installed correctly, gaps may allow drafts, moisture ingress, or pest intrusion. The fix out carpenter should assess the installation and undertake corrective work as required to ensure the weather seals are fitted to an acceptable standard.

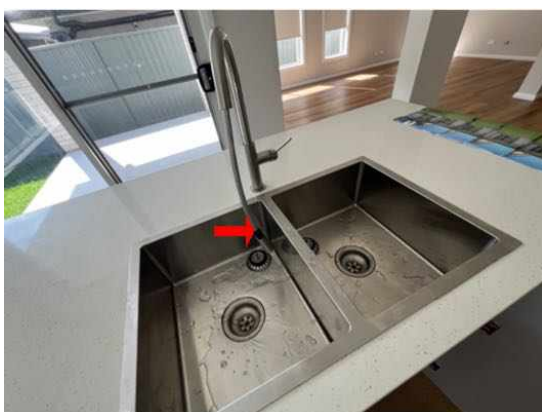
Finding 3.17

Building:	Main Building
Location:	Kitchen
Finding:	Mixer (veggie sprayer) - counterweight
Information:	The counterweight for the mixer with a veggie sprayer is obstructed by the plumbing beneath the benchtop, preventing smooth retraction of the hose. This issue is typically caused by insufficient clearance or poor positioning of the plumbing in relation to the mixer assembly. Where movement is restricted, the functionality of the sprayer is compromised, leading to potential strain on the fittings. The responsible plumber should assess the installation and undertake corrective work as required to ensure the counterweight operates freely without obstruction.

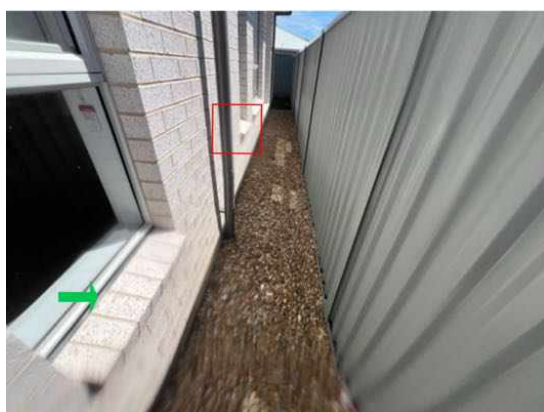
Finding 3.26

Building:	Main Building
Location:	Exterior walls - right side
Finding:	Window Sill Seals - damaged/compromised
Information:	The window seals have been damaged/compromised at the time of installation and subsequent failure to provide adequate protection and coverage. Due to frequent exposure to weather conditions and subsequent moisture, will lead to water ingress, energy loss and even pest entry.

It is recommended that all window sill seals be replaced by a general handyman or sealant expert to prevent any further damage and to restore the window to a fully functional level.

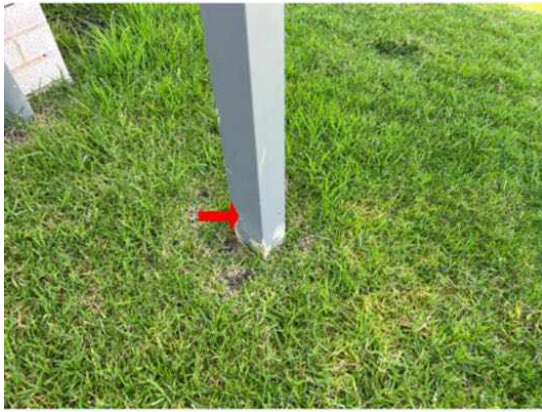
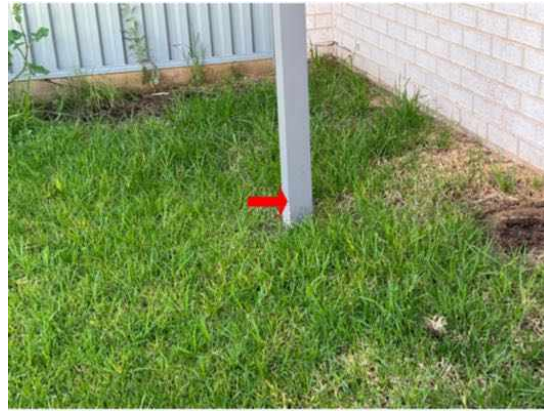
Finding 6.03

Building: Main Building
 Location: Verandah, Alfresco
 Finding: Bridging of physical termite barriers - Concrete Patio
 Information: The tiled concrete pad to the verandah and alfresco including other areas directly abuts dwelling causing bridging. Bridging is the span of a physical termite barrier or inspection zone so that subterranean termites have an entry point over or around that barrier.

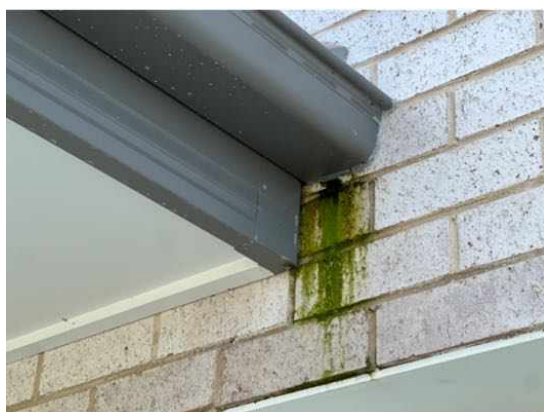
Finding 6.07

Building:	Main Building
Location:	Verandah
Finding:	Evidence of excessive moisture was present at the time of inspection (Photos shown in previous defect section)
Information:	Excessive moisture can attract termites and produce conditions that promote termite attack, fungal growth and wood decay. Excessive moisture is generally caused by deteriorated, inadequate or missing roof drainage, leaking plumbing pipes or fixtures, poorly plumbed HWS overflows or condenser units and poor site drainage. It is highly recommended that all plumbing and drainage fixtures and fittings be maintained regularly in order to prevent excessive moisture being present in the external / internal property.

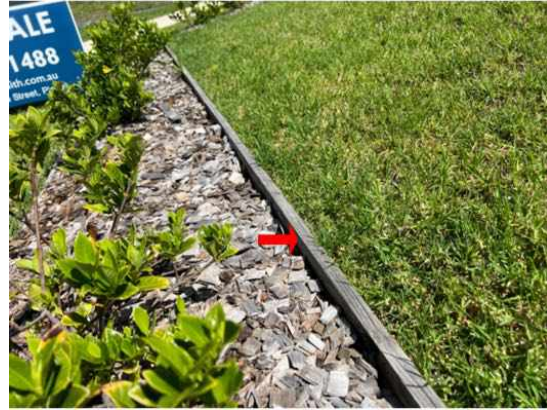
Finding 6.08

Building:	Yard
Location:	Yard - Front
Finding:	In ground contact
Information:	Any timbers in direct ground contact provide opportunity for concealed termite entry and are likely to be subject to premature rot and decay as the soil retains moisture or damp conditions against the timbers.

Remove untreated timber that is in direct contact with external grounds. Consider replacement with more durable materials i.e. treated timber or non timber elements. Frequent pest inspections are advised to readily identify any termite activity in these areas.

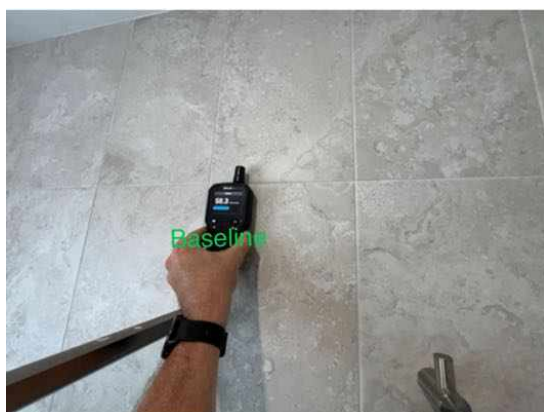
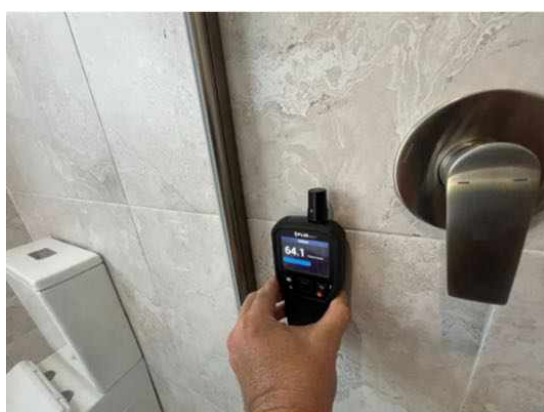
Building: Main Building
Location: Ensuite - Guest
Finding: Moisture in shower - No action required
Information: Moisture is evident behind the tiles to the shower alcove. This defect is quite common, and is suspected to have been caused by moisture permeating through the grouting in this area.
