Building and Timber Pest Inspection Report

Inspection Date: Thu, 9 Apr 2026

Property Address: 402/8 Ada Ave, Wahroonga NSW 2076,
Australia

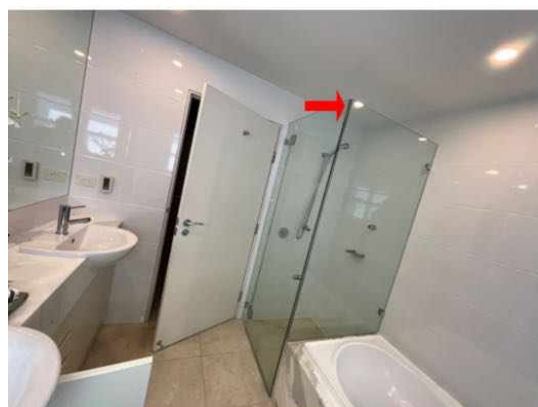
Binding and/or jamming of shower doors were evident during standard operation at the time of inspection. This defect is a potential safety hazard if the shower screen breaks due to impact or jamming force.

It appears this is due to poor initial installation of the shower components.

Bed 1 ensuite shower door was found to be jamming against the adjacent glass panel, requiring urgent and relatively minor repairs to ensure any cracking or breakage to the glass is prevented.

A licensed glazier is required immediately for repairs and to ensure the safety of the area.

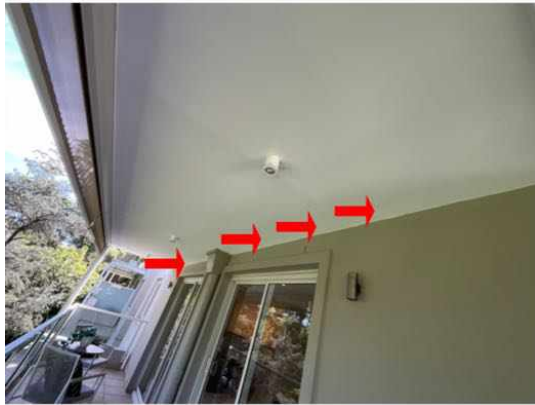
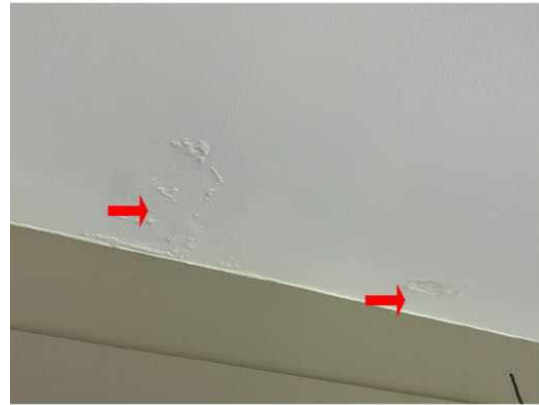
Finding 2.01

Building: Main Building
 Location: Main balcony
 Finding: Water Damage
 Information:

Where water damage is evident, the primary requirement is to identify and rectify the source of the leak. It is suspected that an active leak is affecting the surfaces from upstairs planter boxes. A licensed plumber must be appointed urgently for further assessment and to confirm the source of leak. Major works should be expected to be required by a waterproofing expert.

Water damage was identified to the main balcony ceiling. It is suspected that an active leak is affecting the surfaces from upstairs planter boxes. A licensed plumber must be appointed urgently for further assessment and to confirm the source of leak. Major works should be expected to be required by a waterproofing expert.

Once the leak is repaired, consultation with relevant tradespeople, including

carpenters, plasterers and painters, is advised.

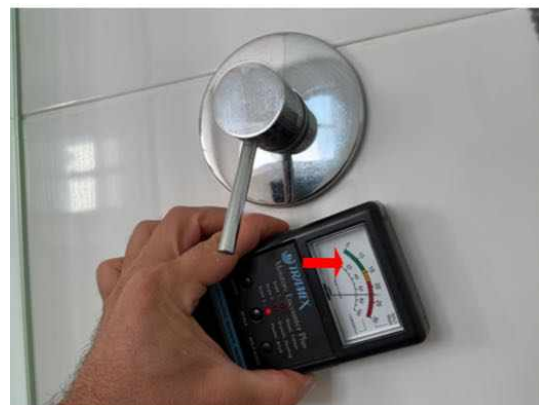
Finding 2.02

| Finding: | Water leak - Suspected |
| Information: | A water leak is suspected in this area as excessive moisture was detected at the time of inspection. Another potential cause maybe moisture ingress behind the tiles from around the wall fittings and penetrations. |

Excessive moisture was identified to the walls in bed 1 ensuite shower. There maybe a water leak OR otherwise moisture maybe penetrating around the fittings. A licensed plumber must be appointed urgently for further assessment and repairs.

In extreme cases, structural damage may develop due to a prolonged water leak. It is highly advised that internal water leaks be addressed by a licensed plumber as a matter of relative urgency.

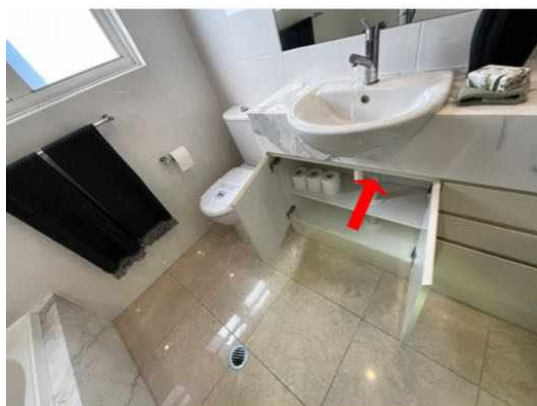
Finding 3.01

| Finding: | Water leak - Active |
| Information: | Generally, water leaks occur when a particular area of the property is not weather or water tight. As the surrounding area was found to be damp at the time of inspection, the leak is considered ongoing and hence requires urgent action. |

It is highly advised that the cause of the leak be identified and resolved immediately by a licensed plumber to prevent any further damage. Depending on the extent of the damage previously sustained, repair and/or replacement of any affected building materials may be required.

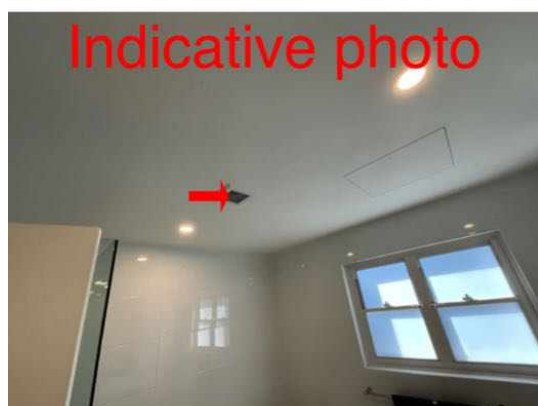
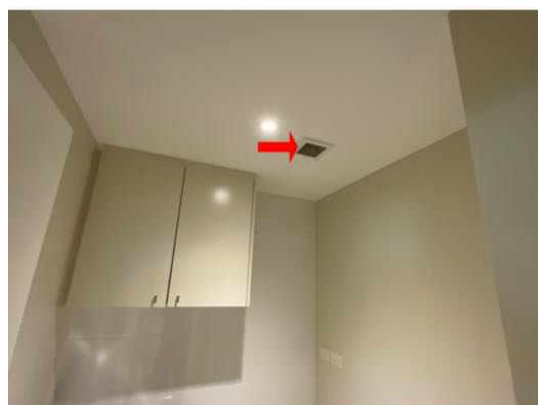
Finding 3.02

| Information: | The exhaust fans to the following areas appear to be damaged or blocked and is not operating as intended. If left unmanaged, a lack of general maintenance is likely to lead to the development of more significant defects, such as water damage to surrounding building materials from inadequate ventilation. If left unattended for a prolonged period of time, poor ventilation in this area may also be conducive to the development of mould. |

Where no secondary damage has developed, the Homeowner may undertake minor

cleaning of the area and consider replacement of the exhaust fan. Alternatively, consultation with a Licensed Electrician is required to check for any secondary or concealed damage and consider repair or replacement.

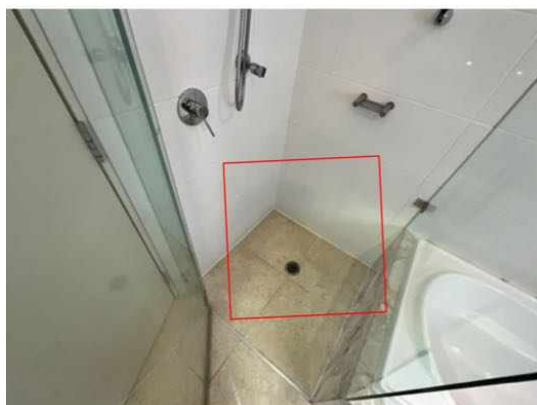
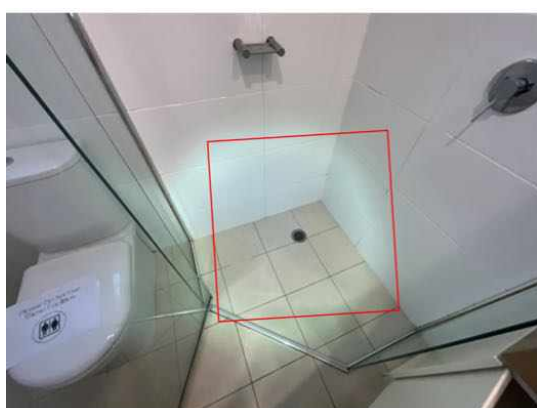
Finding 3.03

Building: Main Building
 Location: All Wet Areas
 Finding: Sealant and grouting - Missing or damaged
 Information:

It was noted on inspection that sealant or grout is degraded to this area.

Different materials and floor areas move at different rates, generally causing cracking to grout or sealant at this point. A flexible sealant is required to allow for expected expansion and contraction, while keeping the joint water tight and protective of all associated building materials.

Flexible and mould resistant materials should be applied to affected areas to prevent any subsequent water damage that is likely to occur. Regular maintenance and replacement of damage or missing or damaged sealant and grout is highly recommended to the wet areas, as this is a regular wear and tear defect. Sealant and grouting in areas that come into regular contact with water should be maintained for the long term care of your property.

A sealant specialist should be appointed to complete these works as soon as possible.

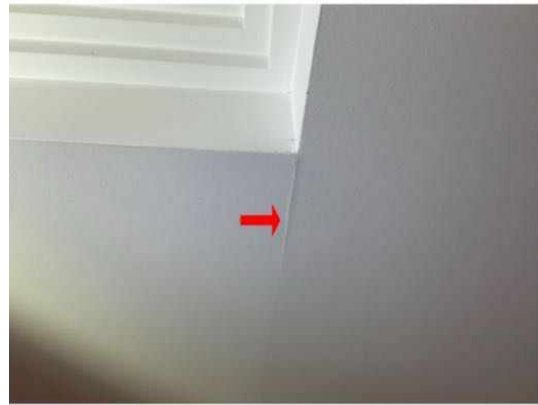
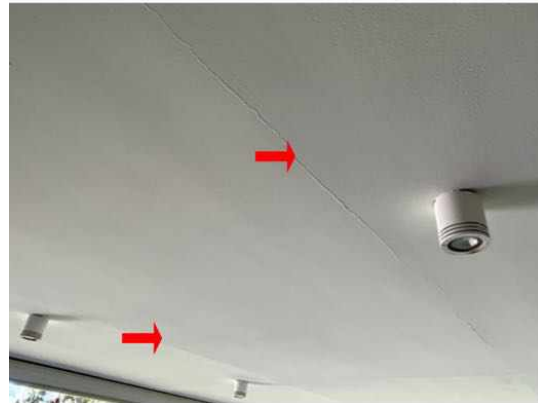
Finding 3.04

| Finding: | Cracking - Damage Category 1 - Fine (up to 1mm) |
| Information: | Although fine cracks are quite noticeable, they are often only considered to be an appearance defect, and usually do not indicate any structural damage. Generally, the cause of a fine crack is indicative of a separation between building materials and finishes (e.g. paint, plaster, etc.) along joints. |

Cracking of this nature can generally be repaired with minor sanding, filling and/or repainting. Such works should be performed by a qualified painter or a general handyman.

Monitoring of all cracking should be conducted frequently. Always contact a building inspector should cracks widen, lengthen, or become more numerous.

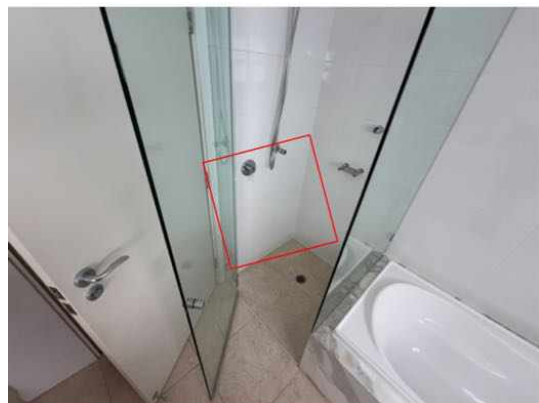
Building: Main Building
 Location: Bed 1 Ensuite
 Finding: Water leak - Suspected
 Information: A water leak is suspected in this area as excessive moisture was detected at the time of inspection. Another potential cause maybe moisture ingress behind the tiles from around the wall fittings and penetrations.

Internal water leaks can be detrimental to surrounding building elements; their potential causes include damage to plumbing fittings and fixtures, through to water damage and deterioration of associated building elements.

In extreme cases, structural damage may develop due to a prolonged water leak. It is highly advised that internal water leaks be addressed by a licensed plumber as a matter of relative urgency.
