Building Inspection Report

Inspection Date: Wed, 18 Mar 2026

Property Address: 130 Harbour Blvd, Shell Cove NSW 2529,
Australia

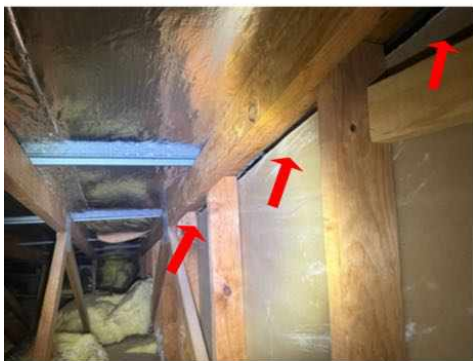
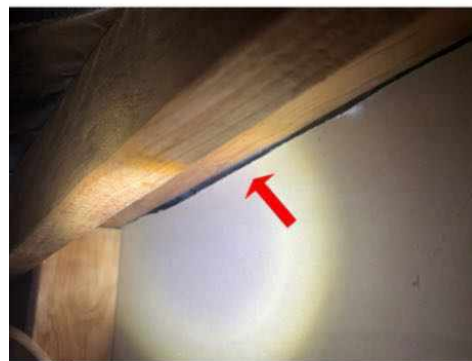
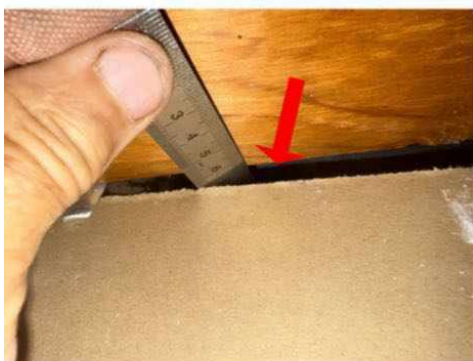
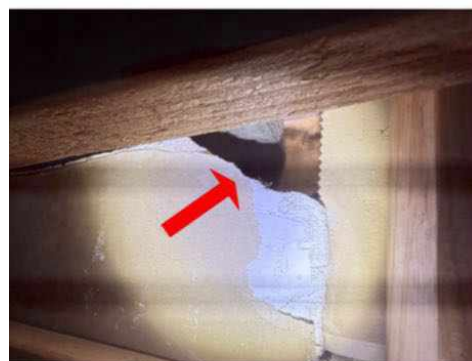
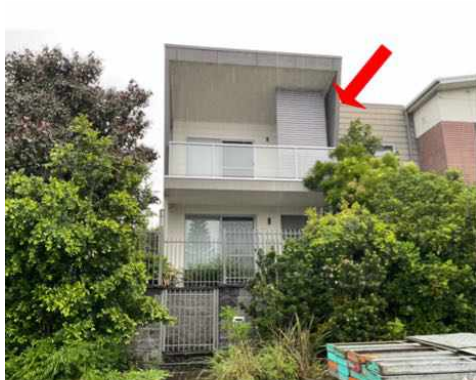
Defects 1.01

Building:	Building 1
Location:	Roof Void
Finding:	Firewalls in Class 1 Buildings - National Construction Code 2019 Vol 2 Amendment 1
Information:	This dividing wall between the neighbouring property does not appear to comply with the National Construction Code for fire walls in Class 1 Buildings.

This wall has gaps and damage at the top of the wall, and these gaps do not appear to be “packed with mineral fibre or other suitable fire-resisting material (see below code)

(ii) must have any gap between the top of the wall and the underside of the roof covering packed with mineral fibre or other suitable fire-resisting material.

This needs to be repaired to protect both townhouses from fire spreading.

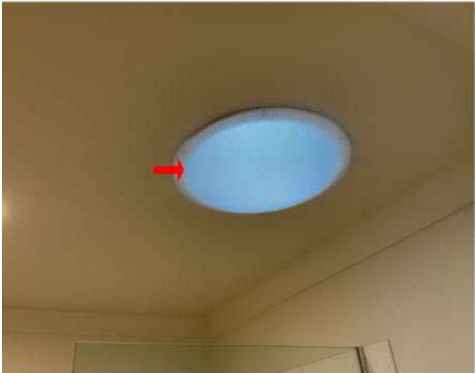
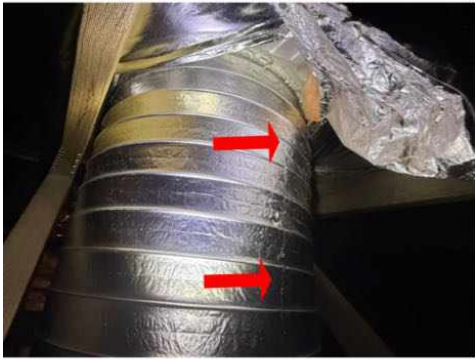
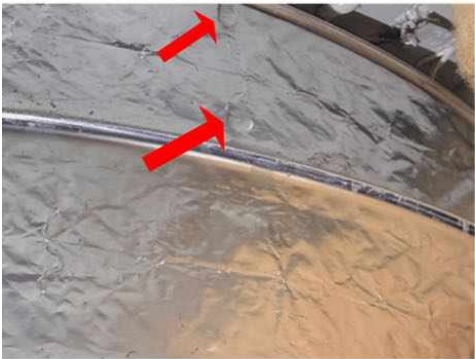
Defects 3.01

Building:	Building 1
Location:	Roof Void
Finding:	Exterior roof - Leaking
Information:	Active roof leaks were evident at the time of inspection. Roof leaks can have a number of causes, including damage to roof coverings, deterioration of roof fixtures and fittings, or loosely associated materials (fascias etc.).

Where water leaks are active, rain penetration is likely to cause water damage to associated structures and building elements in this area, which can have a range of implications. If left unmanaged, the development of major structural damage to the roofing and associated structures may occur.

A roof plumber should be appointed as soon as possible to primarily identify the cause of the leak, and to provide subsequent repair works as necessary. Depending on the extent of the damage, replacement of sections of the roof covering and/or roofing structures may be required, and may be performed by a registered builder or qualified carpenter.

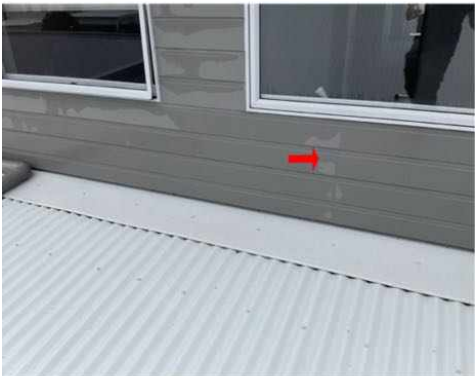
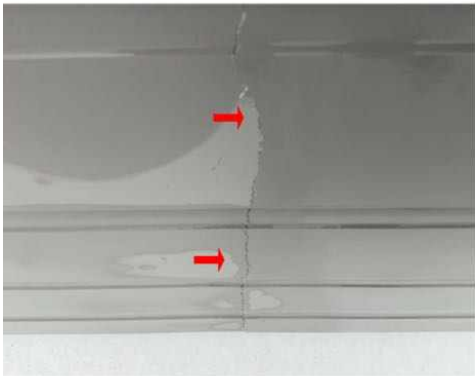
Defects 3.02

Building: Building 1
 Location: Roof Exterior - rear
 Finding: Cladding damaged
 Information: Evidence of damage was identified to the rear upper wall where the cladding has cracked. A carpenter would be the trade responsible for rectification of this wall area.

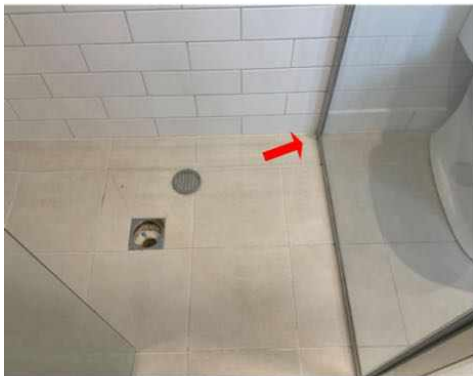
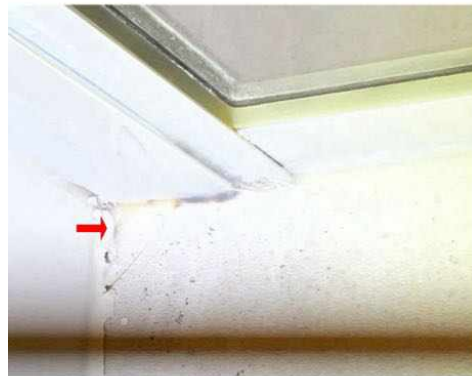
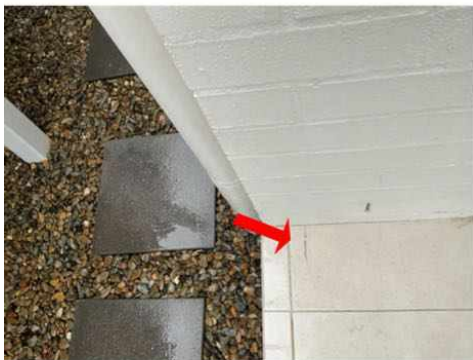
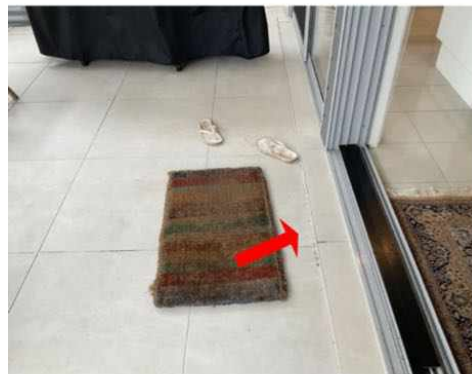
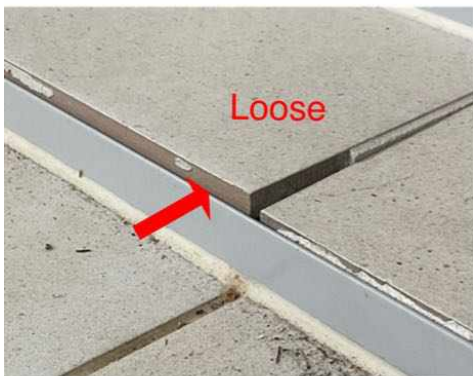
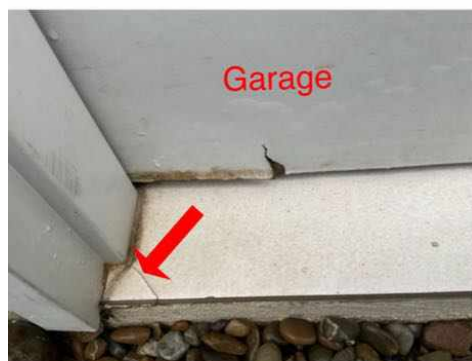
Defects 3.03

Building: Building 1
 Location: Bathroom, porch, garage

Finding: Tiles cracked or loose

Information: Cracked and loose tiles were evident in these pictured areas at the time of inspection. It is suspected that this cracking has occurred as a result of minor settlement or impact damage. Cracked tiles throughout the household detract from the overall appearance of the affected areas. In wet areas of kitchens and bathrooms, it can lead to water damage of adjoining walls and floors.

Replacement of cracked tiles is recommended as soon as possible. A tiling contractor may be appointed to perform these works. Where cracks become more numerous, contact a licensed building inspector for further investigation.

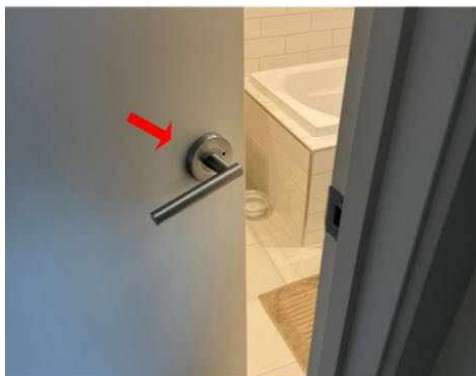
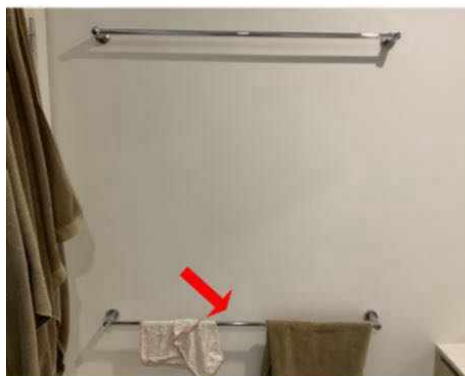
Defects 3.04

Building: Building 1
 Location: Bathroom
 Finding: Door handle and towel rail - loose
 Information: The door handle and towel rail in this area was found to be loose at the time of the inspection. Repair of the loose door handle and rail is advised to improve the operational state of the associated door.

A qualified carpenter or general handyman should be appointed to repair the door handle at the client's discretion.

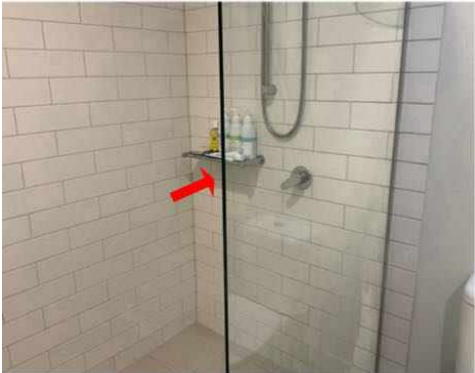
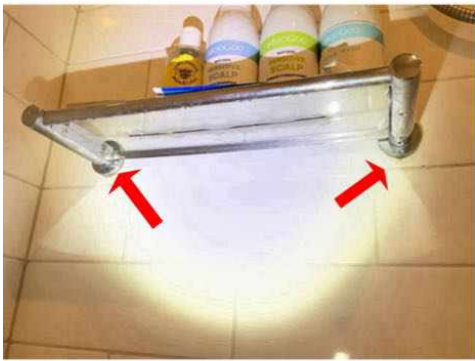
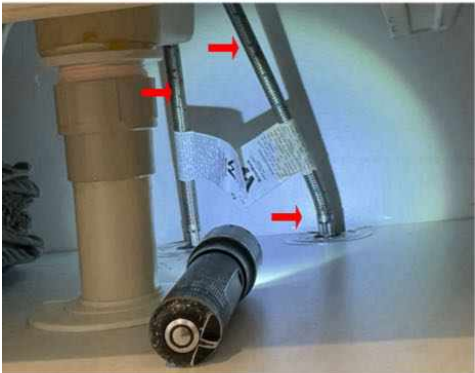
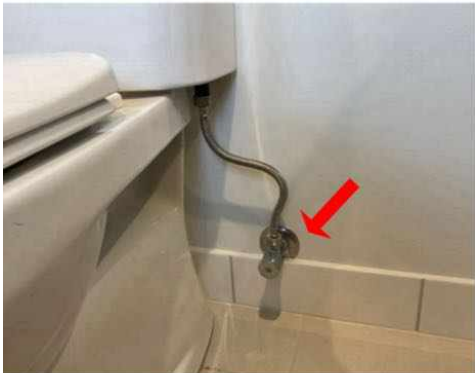
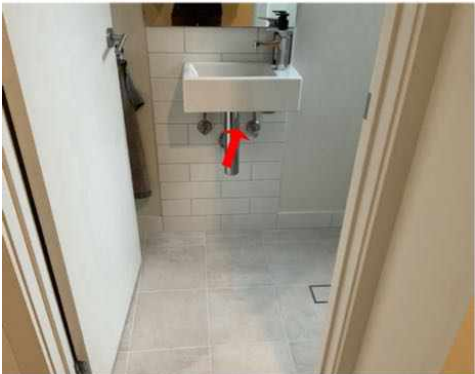
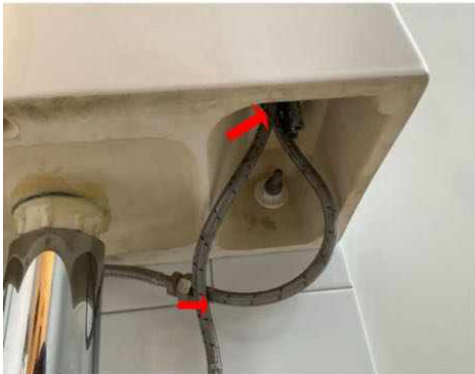
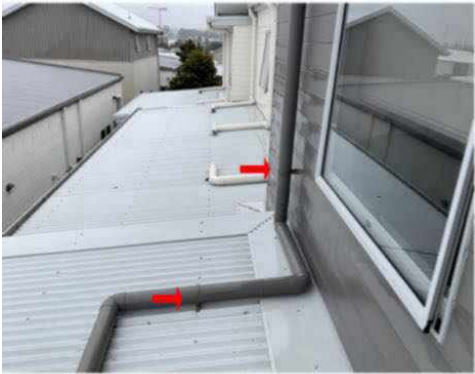
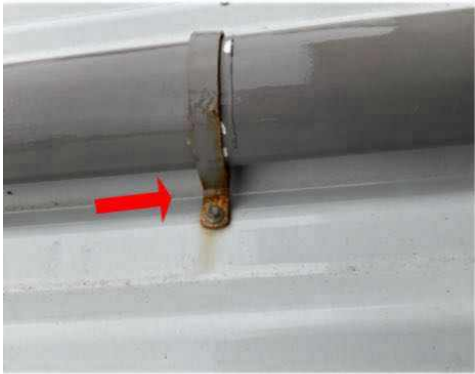
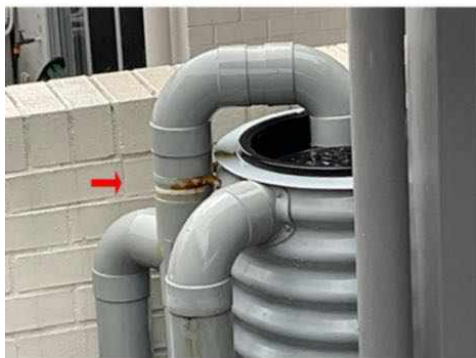
Defects 3.05

Building: Building 1
 Location: Bathrooms and external wall areas
 Finding: Building element - Rusted or corroded
 Information: This building element shows evidence of rusting and corrosion, which is likely to have developed as a result of excessive exposure to moisture and or inadequate coatings.

As surface rust provides no protection to the underlying iron, the deteriorating condition is likely to worsen if not addressed in the short-term future.

Where possible, the use of galvanized (treated) metals or aluminium coated metals aid in rust prevention, as does regular general maintenance. Rust formation can be controlled with coatings, such as paint, that isolate the iron from the environment.

Rusting and corrosion should be managed by ideally removing or limiting the affected surface from exposure to moisture. A registered builder may be appointed to replace any building elements that have been severely affected by rust or water damage.

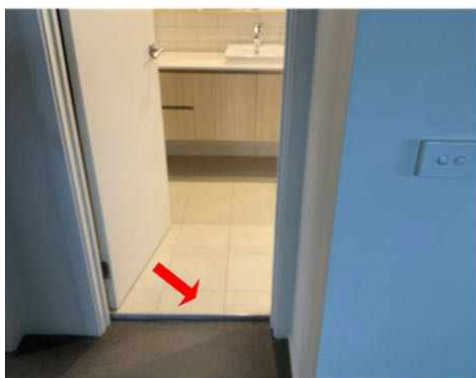
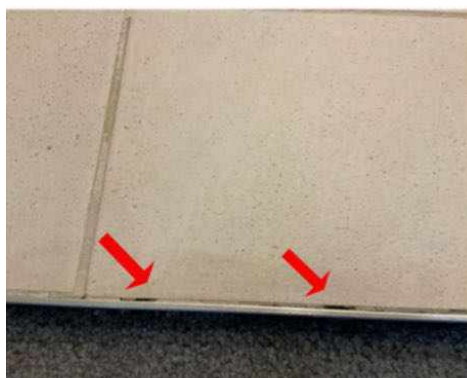
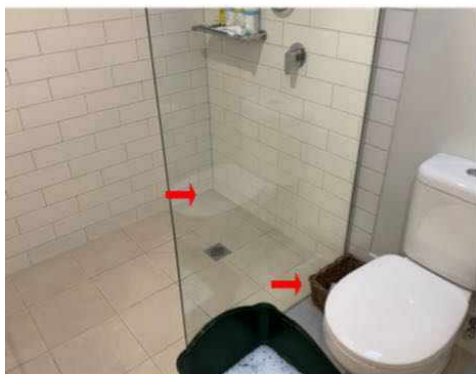
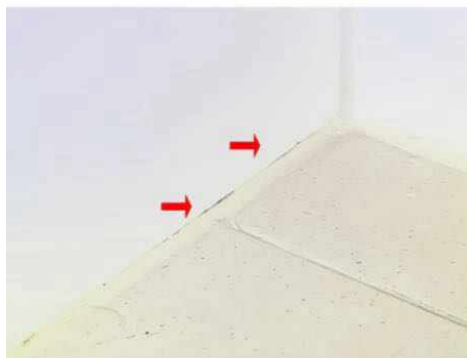
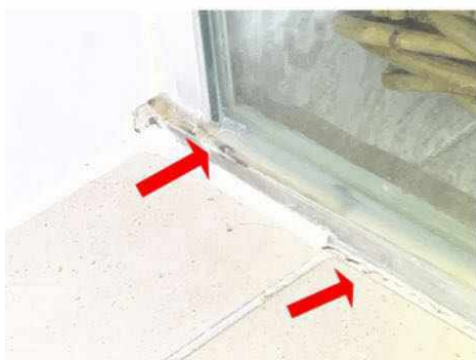
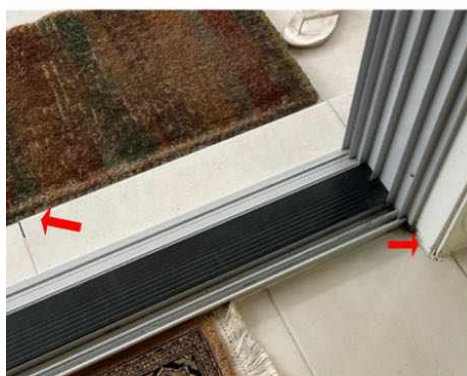
Defects 3.06

Building:	Building 1
Location:	Bathrooms and external areas
Finding:	Sealant and grouting - Missing or damaged
Information:	It was noted on inspection that sealant or grout is degraded to these pictured areas.

Different materials and floor areas move at different rates, generally causing cracking to grout or sealant at this point. A flexible sealant is required to allow for expected expansion and contraction, while keeping the joint water tight and protective of all associated building materials.

Flexible and mould resistant materials should be applied to affected areas to prevent any subsequent water damage that is likely to occur. Regular maintenance and replacement of damage or missing or damaged sealant and grout is highly recommended to the wet areas, as this is a regular wear and tear defect. Sealant and grouting in areas that come into regular contact with water should be maintained for the long term care of your property.

A sealant specialist or tiling contractor should be appointed to complete these works as soon as possible

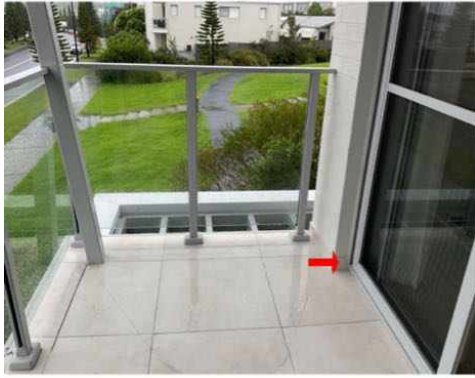
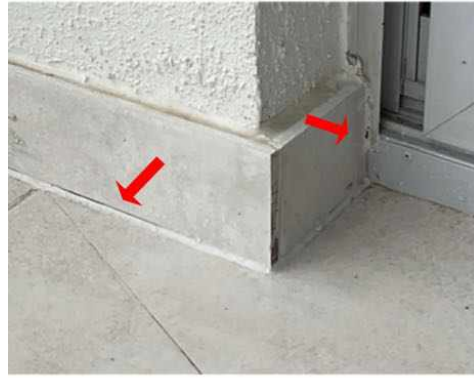
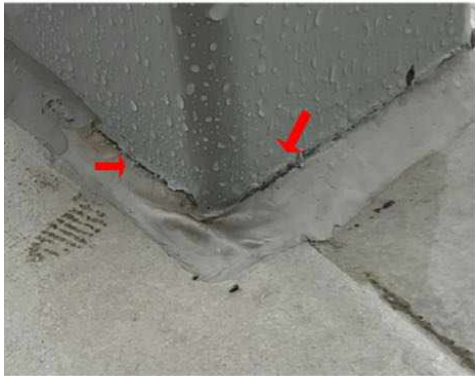
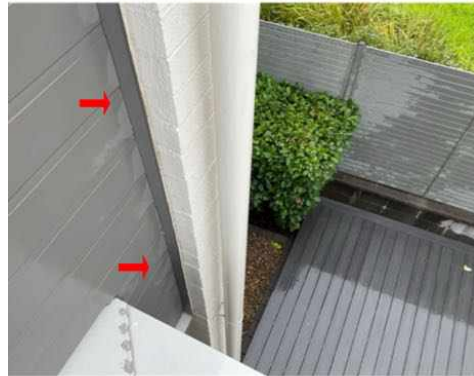
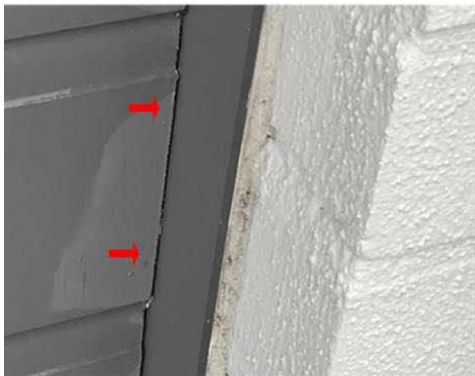
Defects 3.07

Building:	Building 1
Location:	Exterior front and rear walls
Finding:	Sealant (external) - missing
Information:	It was noted on inspection that areas of external sealant was missing to these pictured wall and window areas.

A flexible sealant or flashing is required to protect the associated building materials from rainwater ingress.

Flexible sealants should be applied to these affected areas to prevent any subsequent water damage that is likely to occur.

A sealant specialist or skilled handy person should be appointed to complete these works as soon as possible

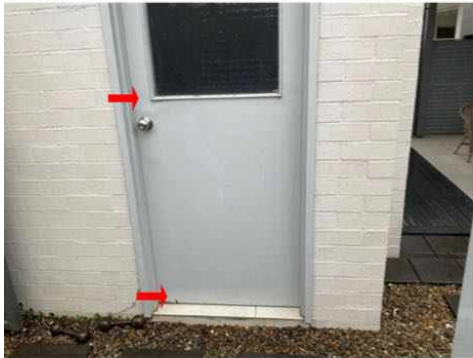
Defects 3.08

Building:	Building 1
Location:	Garage door
Finding:	Wood rot
Information:	This door show evidence of wood rot. Wood rot, also known as Fungal Decay, occurs when timbers and other cellulose building materials are exposed to damp conditions on an ongoing basis. This could be the result of exposure to weathering and a lack of sealant/ protective paint.

Early intervention and regular maintenance, particularly of exterior timbers, will prolong the useful life of these building elements. Replacement of affected door may then be a necessary step in protecting surrounding building elements from such deterioration.

A qualified carpenter or registered builder may also be required to replace affected building materials.

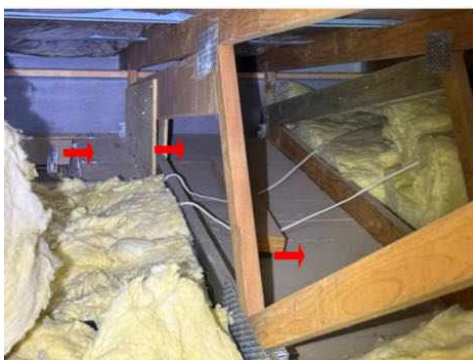
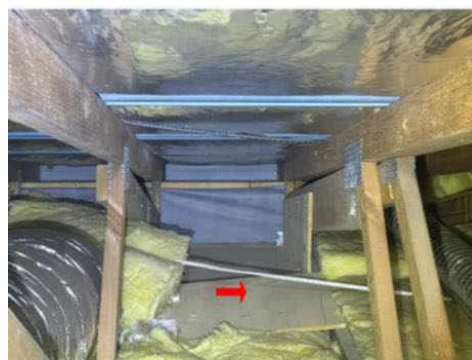
Defects 3.09

Building:	Building 1
Location:	Roof Void
Finding:	Insulation - Moved (AS4859)
Information:	Although the insulation batts appear to have been installed correctly, it appears as though many batts have been moved by other tradespeople and replaced incorrectly post-works. As a general rule, a 5% gap in the insulation creates potential for a 50% decrease in the energy efficiency of the property.

Failure to do so results in non-compliance with AS4859.1 Materials for Thermal Insulation of Buildings.

All insulation batts should be reinstated prior to final handover to comply with standards and to ensure maximal energy efficiency within the property.

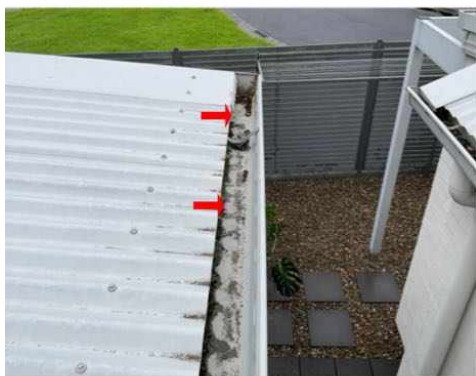
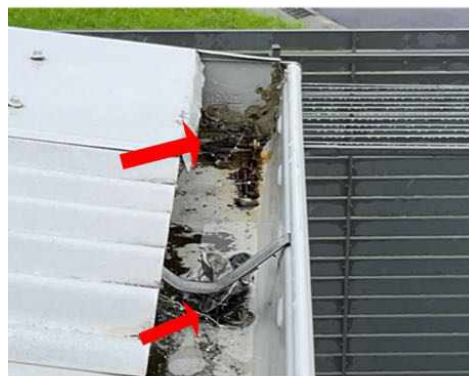
Defects 3.10

Location: Roof Exterior - rear
 Finding: Building waste in drains
 Information: Builders waste was found inside the rear gutters at the time of the inspection. Builders waste left in these areas has the potential to interrupt the normal function of these gutters and may lead to blockages and flooding of surrounding areas.

A handy person or plumber is required to remove this waste from these drains as soon as possible .

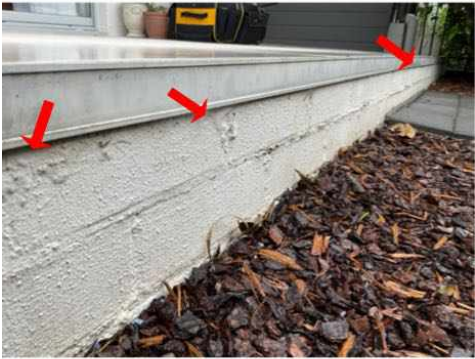
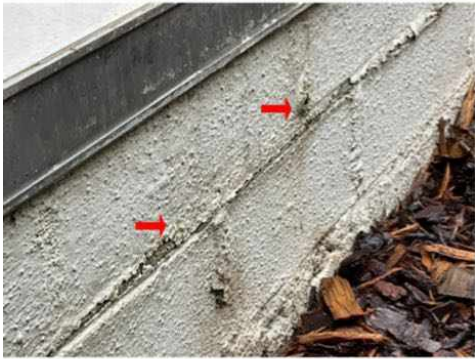
Defects 3.11

Building: Building 1
 Location: Front porch
 Finding: Paint damaged
 Information: The paint finish throughout the front porch brick wall was found to be damaged. Damaged painting is generally classified as an appearance defect. However, the appearance may also be indicative of poor surface preparation and substandard workmanship. Damaged paint finishes in areas exposed to moisture, e.g. external areas or wet areas, could lead to deterioration of underlying building materials. Here it appears there may be rising damp from the ground. Damaged paint finishes should be sanded back, filled, leveled and repainted, as applicable. If the cause is rising damp, a strip drain may be required.

A painting contractor should be appointed as soon as possible to perform necessary works to aid the appearance of the affected area and to ensure that the area is protected against further deterioration.
