Building and Timber Pest Inspection Report

Inspection Date: Mon, 09 Mar 2026

Property Address: unit 6/18 Pemell St, Wyoming NSW 2250,
Australia

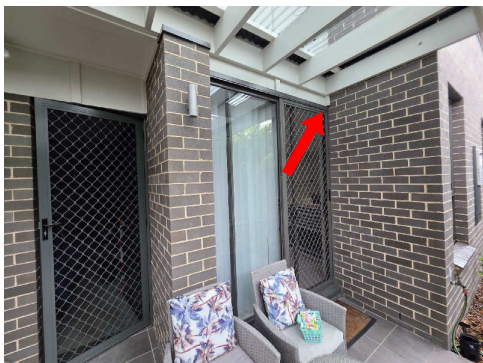
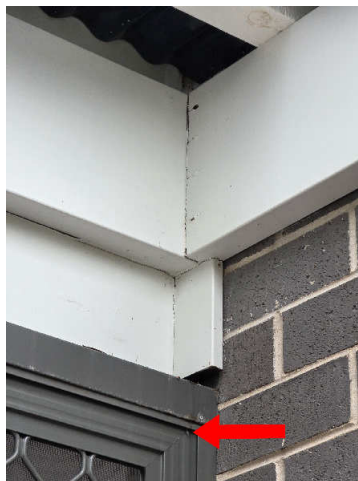
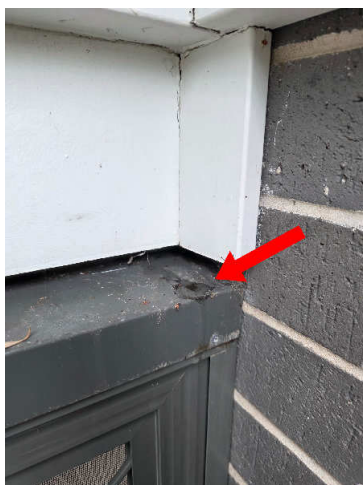
Finding 3.01

Location: Alfresco

Finding: Water Ingress – Roof Structure Above Rear Door

Information: Water was observed dripping from the internal corner of the clear roof structure above the rear door in the alfresco area. The roof is constructed of clear sheeting fixed to a timber frame. The moisture appears to be entering from higher up the wall junction and tracking down internally, which may be due to defective flashing, inadequate sealing, or water ingress behind the wall junction.

No deterioration or fungal decay was observed to the surrounding materials at the time of inspection. However, ongoing moisture exposure may eventually lead to timber deterioration, fungal decay, or other building defects if not addressed. There is also a possibility that concealed damage may already be present in areas not visible at the time of inspection.

A licensed builder should investigate the wall and roof junction and carry out repairs as required to prevent further water penetration. This issue should be addressed without delay to avoid further deterioration.

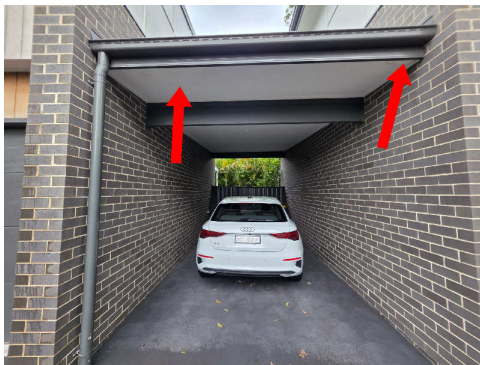
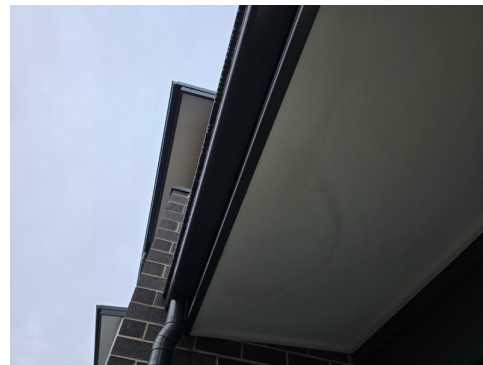
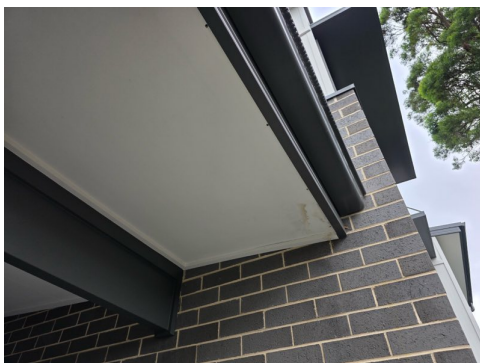
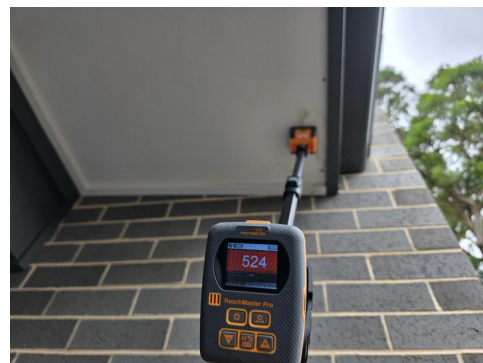
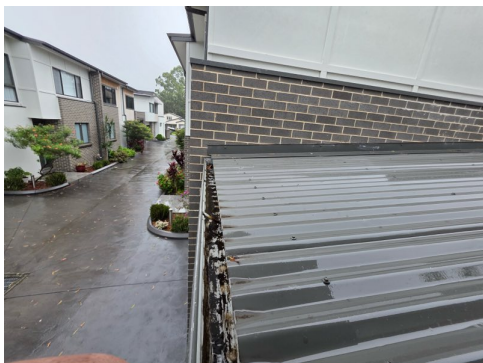
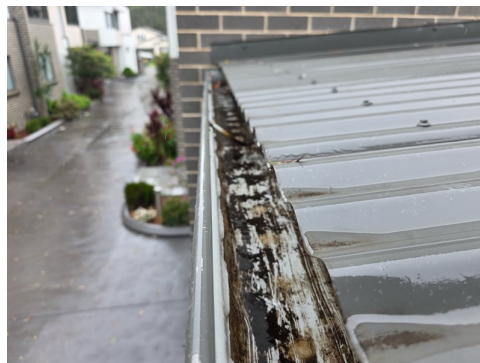
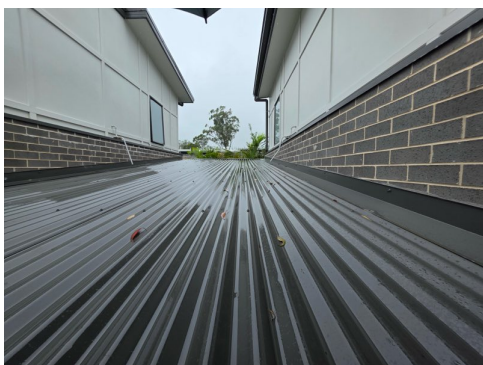
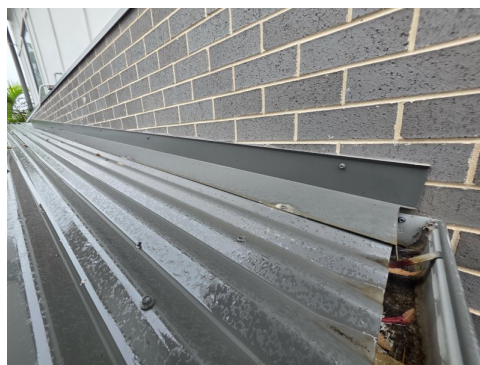
Finding 3.02

Building: Main Building
Location: Carport
Finding: Gutter Holding Water – Carport Roof

The gutter to the roof over the carport was observed to be holding water rather than draining freely. Watermarks were also noted to the adjacent eave lining, including one near the downpipe end and another at the high end of the gutter. Elevated moisture readings were recorded near the high end, indicating ongoing moisture exposure.

The exact source of the moisture causing the staining to the eave lining could not be confirmed at the time of inspection. While the ponding gutter is the most likely contributor, it is also possible that water may be entering through defective flashing or roof junctions further up the roof structure and tracking down internally before appearing at the eaves.

Where gutters retain water, overflow or leakage can occur and moisture may continue to affect surrounding building elements. A licensed builder should investigate the gutter fall, drainage, flashing, and associated roof junctions and carry out repairs as required. This issue should be addressed without delay to prevent further moisture exposure and deterioration of the surrounding building elements.

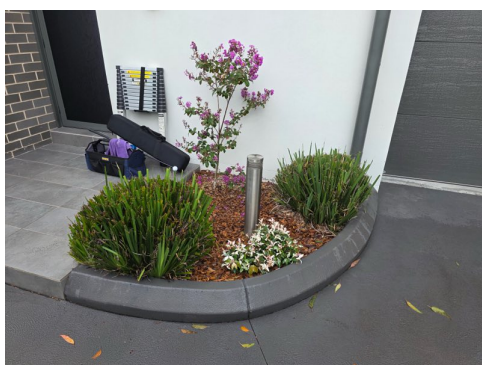
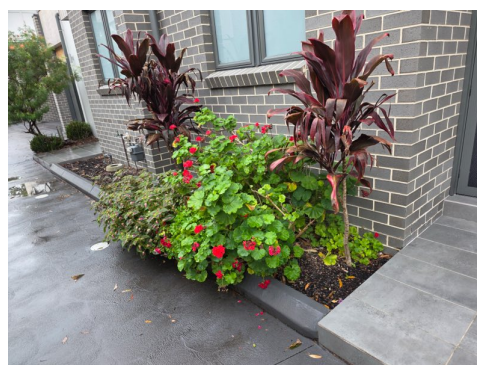
Finding 6.01

Location: Yard - Front

Finding: Garden Beds - Conditions Conducive to Termites

Information: Garden beds, particularly those constructed from untreated timber, were noted adjacent to the dwelling. These create a highly conducive environment for termite activity due to the combination of retained soil moisture from watering, direct soil contact, and the organic material in the soil and timber edging. Such conditions increase the risk of concealed termite ingress into the property, as termites can travel through the garden beds and enter the structure undetected.

Where practical, garden beds should be removed, relocated, or modified so that they do not abut the dwelling. Where this is impractical or undesirable, the risk of concealed termite activity remains. In these cases, a licensed pest controller should establish an ongoing termite management plan, and regular timber pest inspections should be carried out every 6–12 months to assist in protecting the property against infestation.

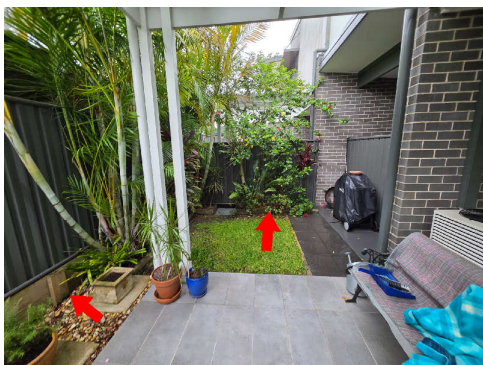
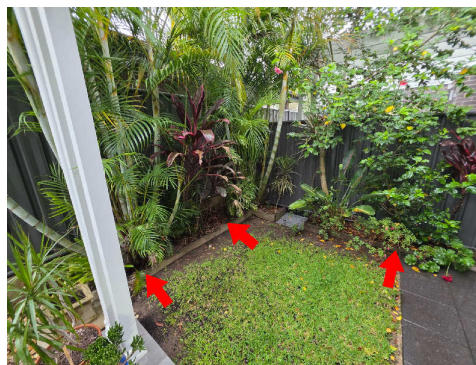
Finding 6.02

Building: Main Building
Location: Yard - Back
Finding: Ground - Timber materials in direct ground contact

Information: Timber elements in direct contact with the ground, and consequently exposed to moisture or dampness, create conditions conducive to termite activity. Whether timber is used as part of a building structure, such as a fence or retaining wall, or stored as unused material, it can attract termite infestations.

When exposed to excessive moisture, timber begins to decay and develop wood rot. Any timber in direct contact with the ground - especially untreated or non-durable timber - provides an easy entry point for subterranean termites into the material.

To minimize the risk of termite attack, it is recommended to remove any materials that could foster termite activity. If removal is impractical or undesirable, it is strongly advised that termite or timber pest inspections be conducted every 6 to 12 months to protect the property from potential infestation.

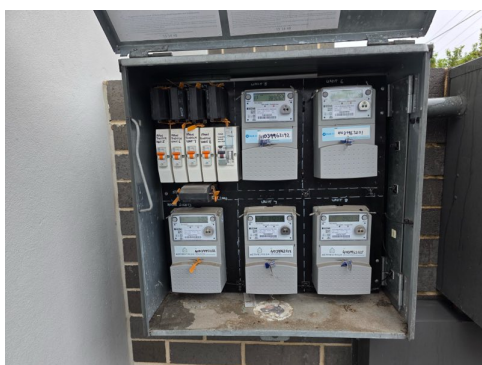
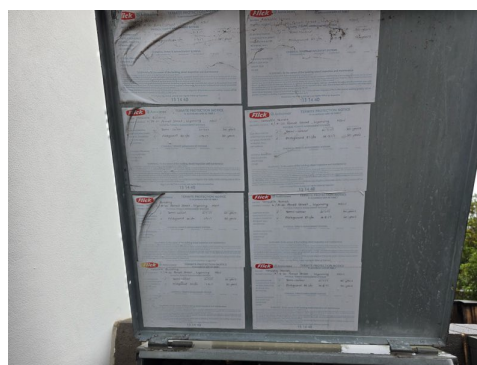
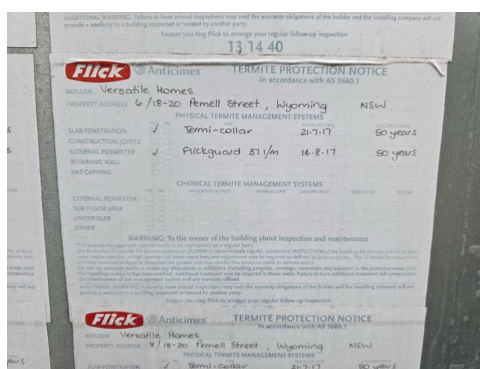
Finding 9.01

Location: Meter Box

Finding: Durable Present - Durable notice observed in meter box

A durable notice was observed in the meter box at the time of inspection, indicating that a termite management system has been installed at the property. The notice provides information on the type of system and treatment date, as required under AS 3660.1 and AS 3660.2.

While this confirms the presence of a past treatment, it does not verify the current effectiveness of the system. It is strongly advised that an ongoing termite management plan be established by a licensed pest controller. This should be addressed without delay.

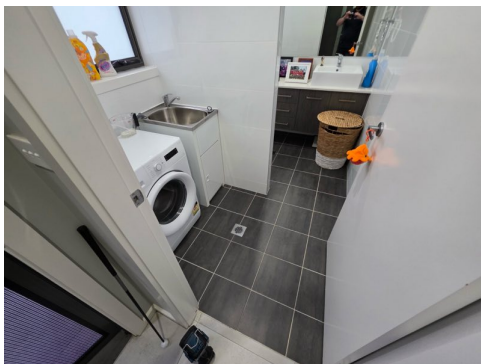
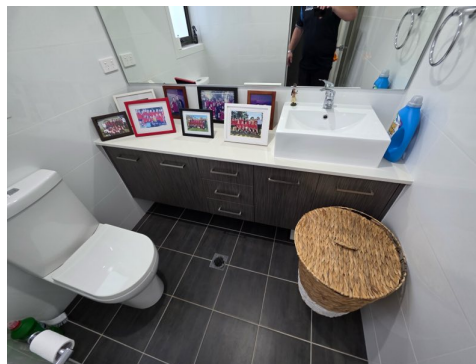
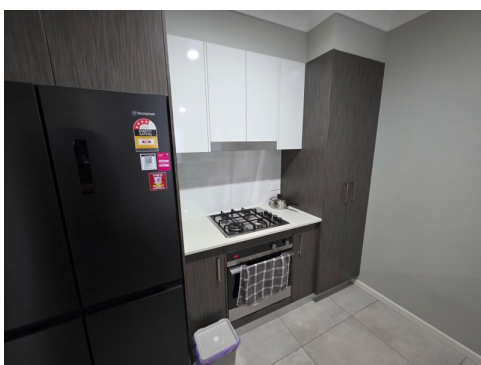
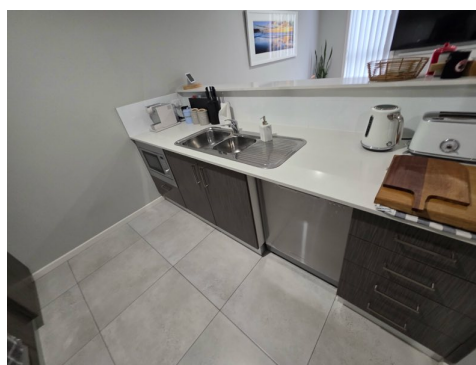
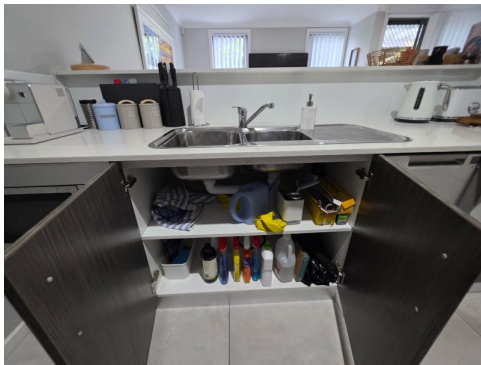
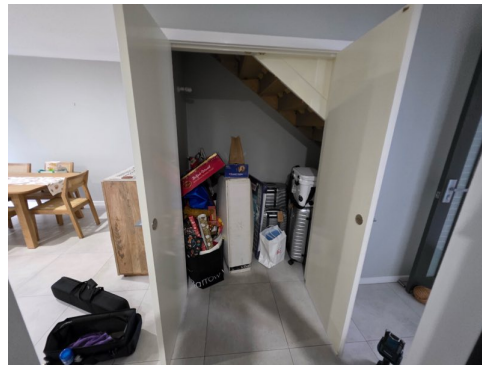
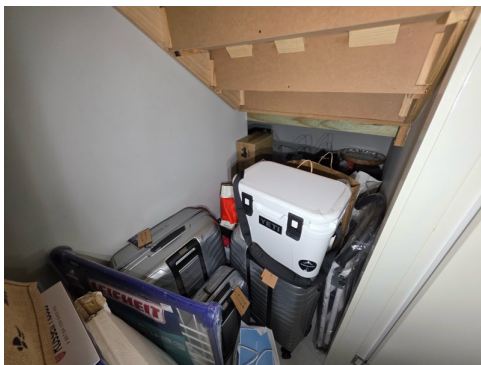
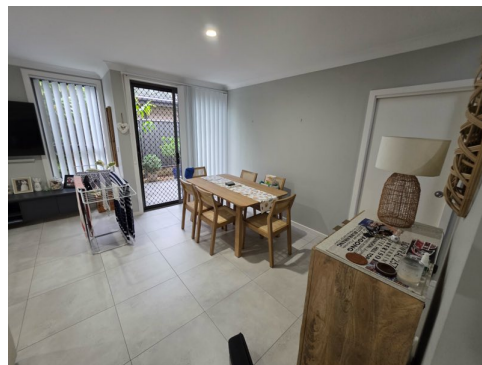
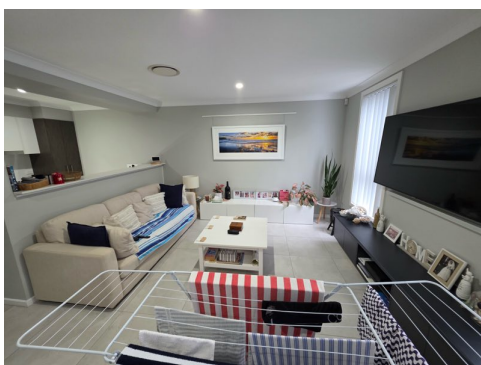
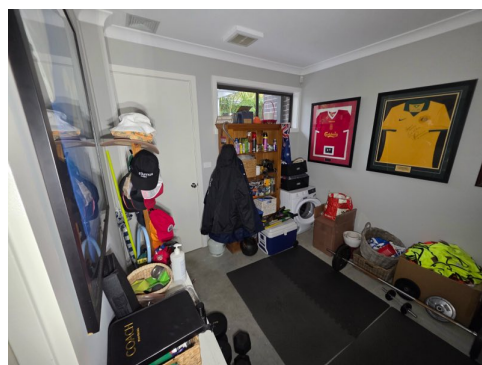
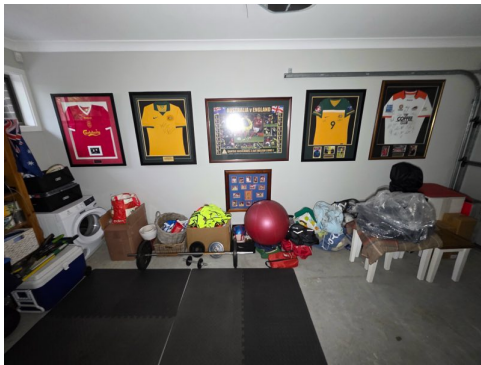
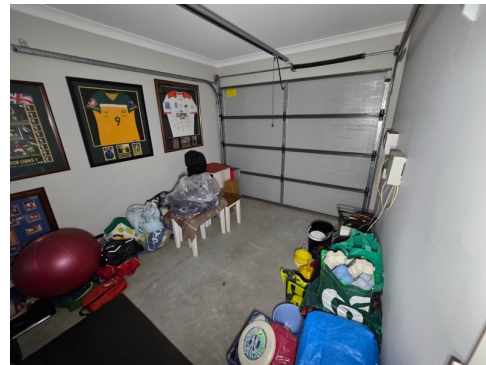
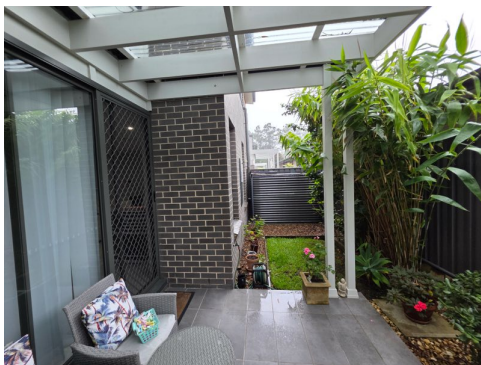
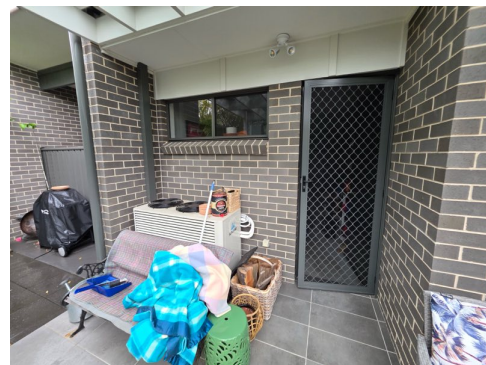
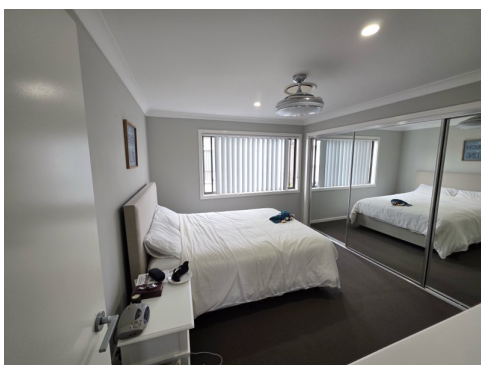
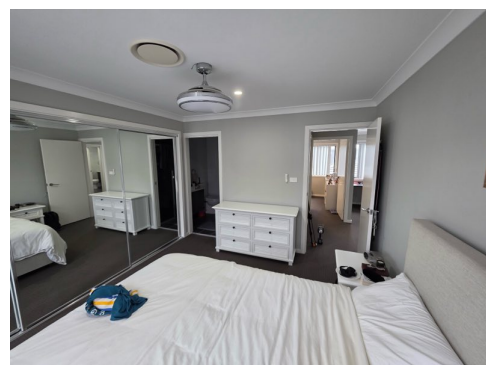
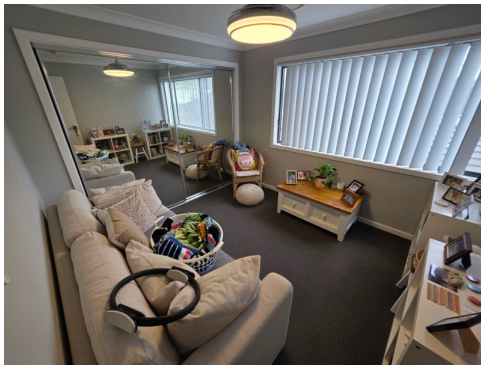
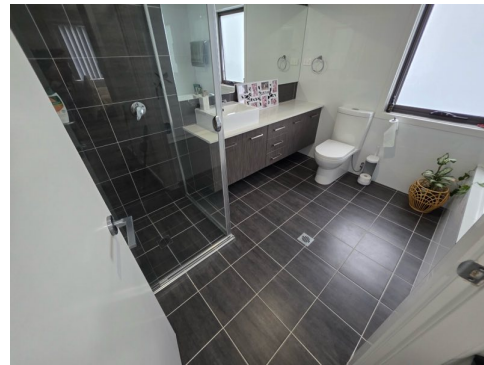
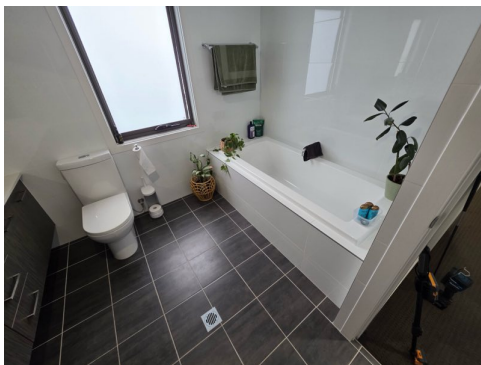
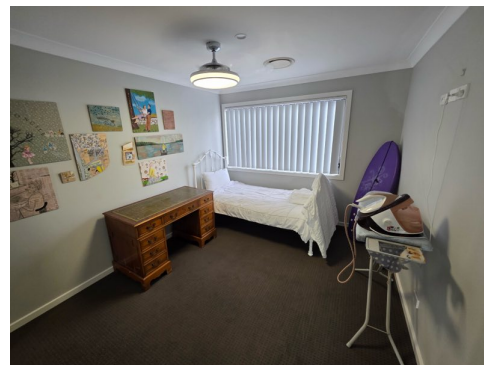
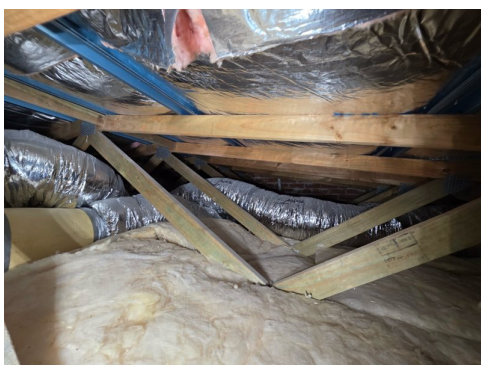
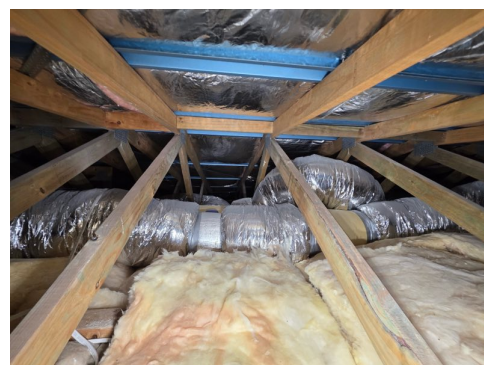
Location: All Areas

Finding: Additional Photos - Obstructions and Limitations

Information: These photographs are an indication of the obstructions and limitations which impeded full inspection of the property at the time of inspection. These obstructions can hide an array of defects and should be removed to allow full inspection to be carried out. A re-inspection is recommended once the areas are made accessible.

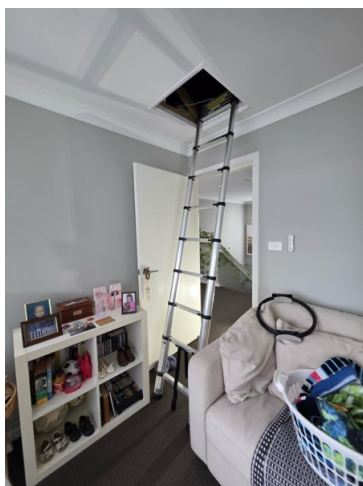
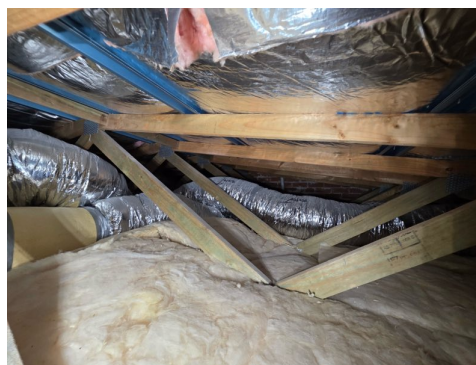
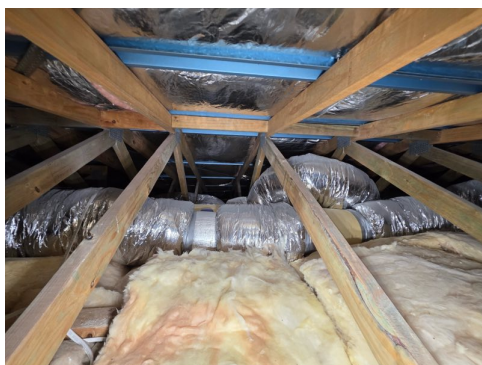
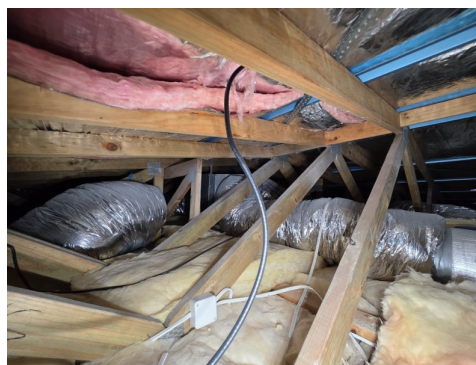
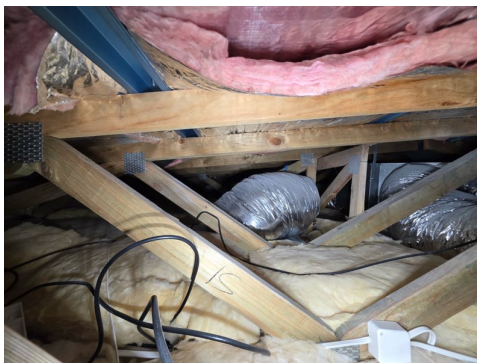
Location: Roof Void

Finding: Limited Access – Roof Void

Information: Access into the roof void was restricted due to the small crawl space and the presence of ducting obstructing movement in the area. As a result, only a limited visual inspection was possible from the access point.

Where roof spaces cannot be fully accessed, concealed defects may remain undetected. A licensed builder should improve access if a more thorough inspection is required. This can be addressed at the owner's discretion.

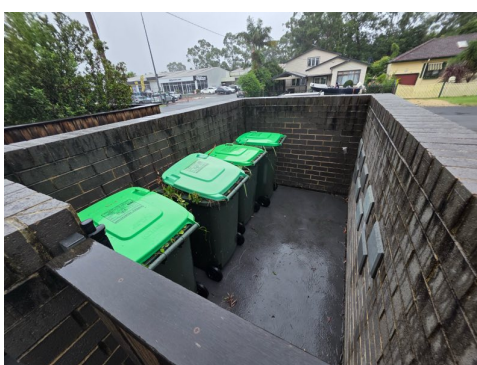
Location: Bin Storage Area

Finding: Bin Storage Location – For Your Information

Information: A designated bin storage location was observed at the property. Where waste bins are stored close to the dwelling, moisture and organic material can accumulate, which may attract pests or contribute to localised moisture exposure.

This item is provided for your information. Adjustments can be made at the owner's discretion if required.

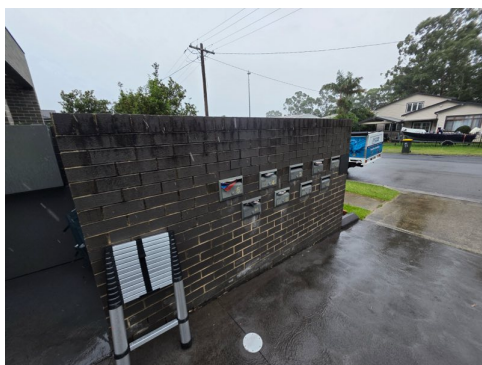
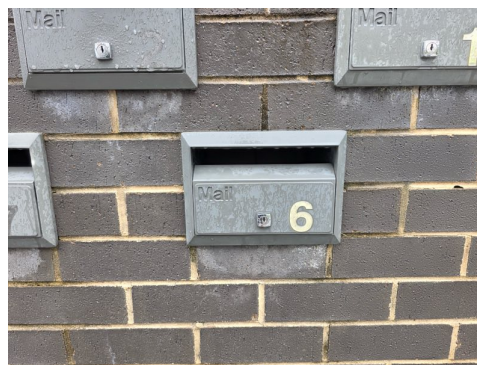
Location:	Letterbox
Finding:	Letterbox – For Your Information
Information:	A letterbox was present at the front boundary of the property. This item forms part of the general site fixtures and was noted during the inspection. This item is provided for your information. No action is required.

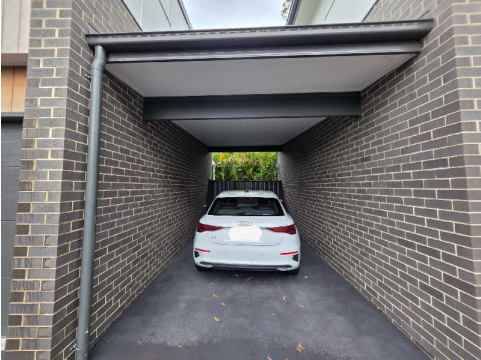
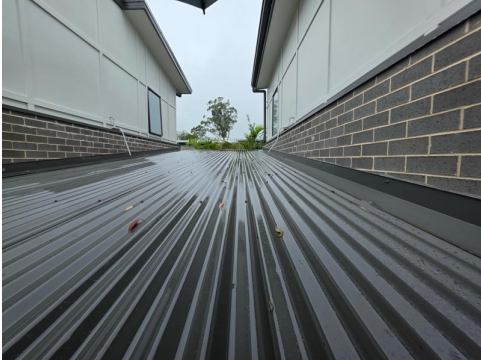
Building:	Main Building
Location:	Carport
Finding:	Roof Space - Concealed roof construction (raked ceilings)
Information:	The carport incorporate raked/vaulted ceilings and no roof void access was available at the time of inspection. The roof framing, sarking, insulation and flashing junctions could therefore not be visually inspected. Internal ceiling linings were checked and no active moisture staining or distortion was observed at the time of assessment.

Concealed roof construction limits the ability to identify early roof leaks or flashing defects, as moisture entry may not become visible internally until deterioration is advanced or after periods of heavy rainfall. The inspection of these areas is therefore restricted. The ceilings should be monitored during occupancy and any future staining, dampness or mould growth should be investigated by a licensed builder without delay.
