Building and Timber Pest Inspection Report

Inspection Date: Fri, 16 Jan 2026

Property Address: 5 Baden-Powell Pl, Strathdale VIC 3550,
Australia

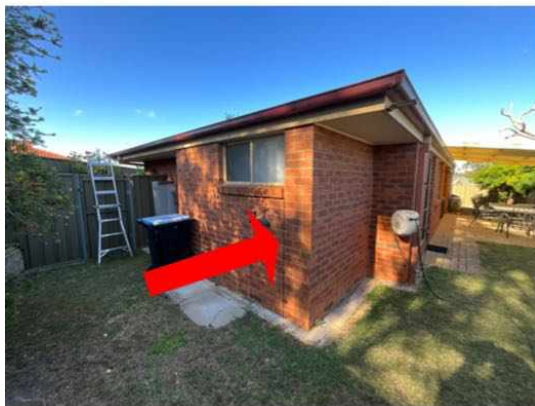
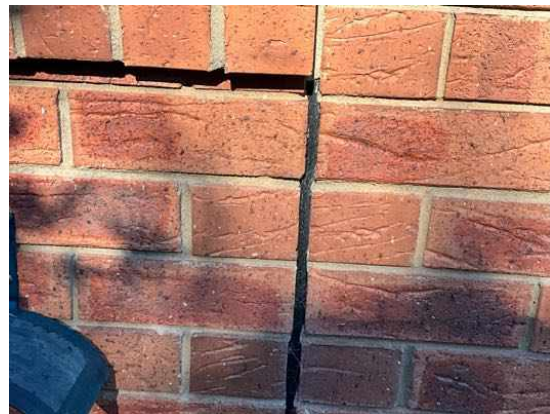
Finding 3.01

Building: Building 1
 Location: Expansion joints
 Finding: Inadequate sealant/caulking
 Information: This area has a lack of effective Sealant or Grout. This may be allowing the ingress of water to the structure.

The presence of water encourages Termite attack, Mould and Fungal Decay.

A Caulker or General Handy person must be contacted soon to effect repairs and prevent possible deterioration.

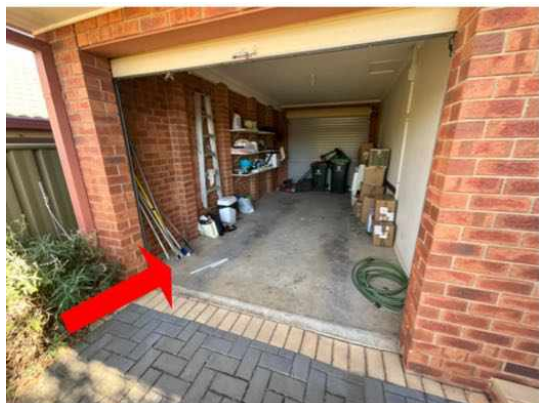
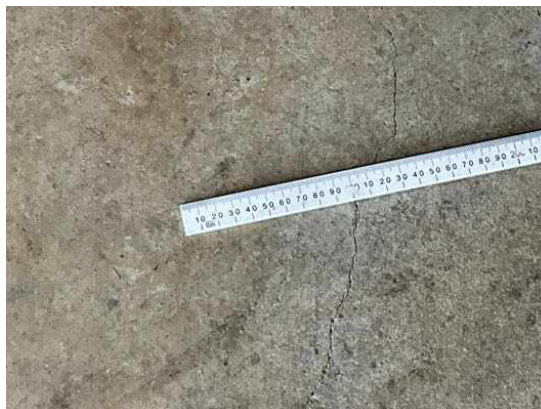
Finding 3.02

Building: Building 1
 Location: Garage
 Finding: Crack in concrete slab - Category 1
 Information: A crack coded as Category 1 was identified in the slab. A Category 1 crack is described as a fine but noticeable crack, with the slab at an otherwise reasonable level.

To be considered Category 1, the approximate width of the crack is less than 1.0mm, or a less than 10mm change in offset when a 3m straight edge is placed over the defect.

Category 1 cracks should be monitored for a period of 12 months. At the end of the monitoring period, identified cracks that are rated greater than Category 2 are considered defects, and require rectification.

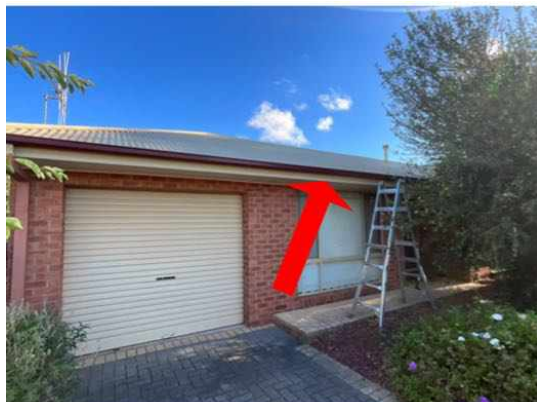
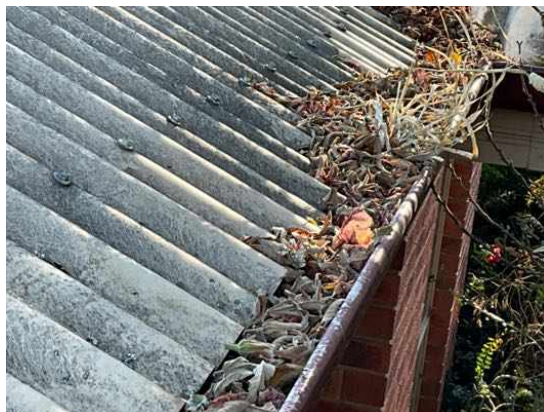
Finding 6.01

Building:	Building 1
Location:	Eaves
Finding:	Gutters- Blocked
Information:	Roof plumbing structures, such as guttering and downpipes, should be free of all debris to prevent blockages. Blockages of the guttering and downpipes will lead to pooling and accumulated water overflows, which is likely to subsequently flood eaves and exterior walls.

Blocked gutters are likely to lead to high levels of moisture in the affected areas. Such moisture will not only cause rust and decay of the associated building materials, but can also provide conditions that are conducive to termite and timber pest activity. Blockages in gutters should therefore be removed immediately to ensure dry conditions are maintained.

Consult a Licensed Plumber for further specific advice on remedial works that may be required. In the interim, it is highly advised that blocked gutters be removed by the homeowner or a general handyperson as a matter of urgency.

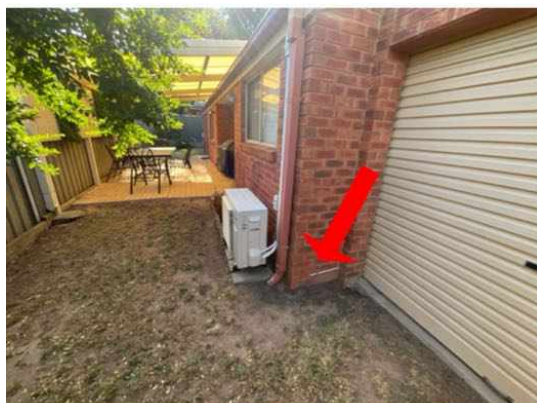
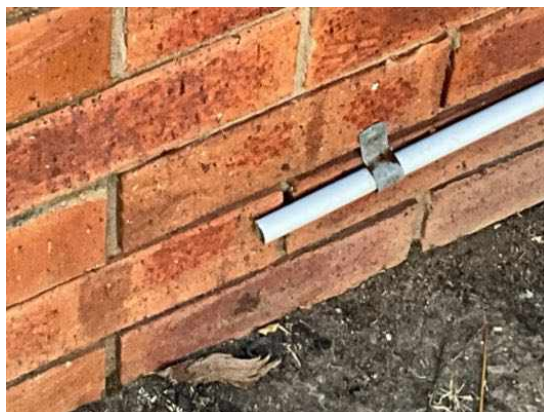
Finding 6.02

Building: Building 1
 Location: Yard - Back
 Finding: Air conditioner - Disconnected overflow
 Information: The Air Conditioner (A/C) overflow was found to be disconnected from storm water drainage and is creating excessive moisture in the surrounding area.

Such leaking creates an environment which is conducive to an array of defects, including water damage to associated building elements and the attraction of termite or timber pest infestation.

It is highly recommended that a licensed plumber be appointed to connect the A/C overflow in order to prevent such an environment from being created. These minor works should be carried out as soon as possible.

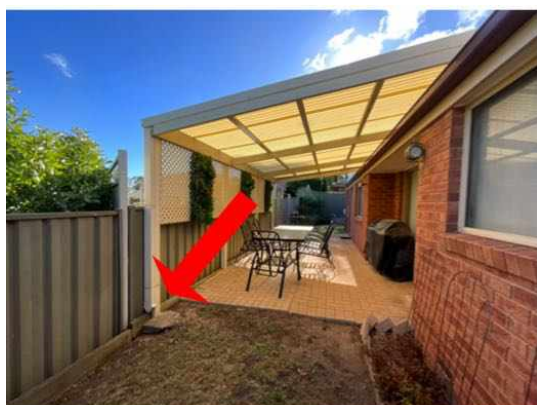
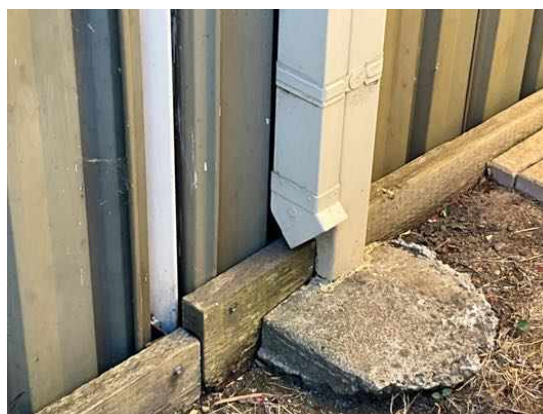
Finding 6.03

Building: Building 1

Location: Alfresco
 Finding: Stormwater drain - Not connected
 Information: The roof plumbing is not adequately connected to stormwater drainage on the site. This disconnection negatively impacts the functional capacity of the roof plumbing.

Where roof plumbing doesn't drain adequately, the area at the base perimeter can become excessively damp, potentially creating an environment that is susceptible to rust and corrosion of surrounding building elements, as well as attracting termites and other pests.

It is highly recommended that a plumber be appointed to further inspect the area and to install adequate drainage equipment where necessary.

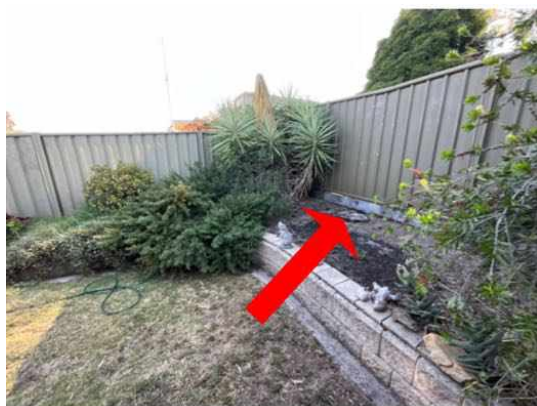
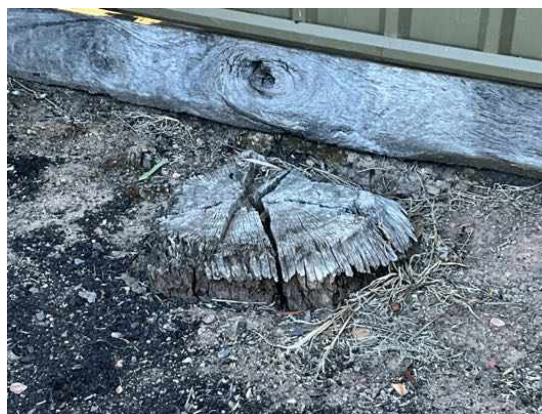
Finding 6.04

Building: Building 1
 Location: Yard - Back
 Finding: Tree Stump in Ground
 Information: Any tree stumps in the yard not removed during the tree removal process provides the opportunity for Termite infestation and is likely to be subject to decay from damp conditions against the stump.

All tree stumps should be removed by professional tree removal services where possible. Meanwhile regular inspections are advised to identify any termite activity in the areas identified.

Services for tree stump removal should be contacted as soon as possible to reduce the risk of timber pest attack.

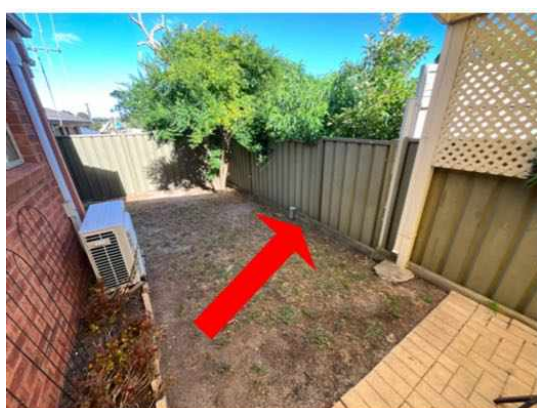
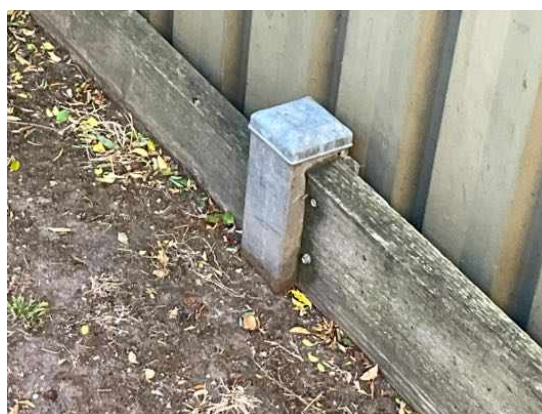
Finding 6.05

Building:	Building 1
Location:	Yard - Back
Finding:	Untreated or non-durable timbers in a hazardous environment
Information:	To reduce the risk of timber pest attack it is essential that timber used in a hazardous environment (e.g. in direct contact with the ground or frequently exposed to damp conditions) is of sufficient durability and/or is adequately preservative treated.

Untreated timbers in direct contact with the ground are likely to develop severe wood rot and/or fungal decay if left unattended creating attraction for subterranean termites to infest the timbers from surrounding areas.

If untreated or non-durable timbers are found to be in a hazardous environment it is highly advised that replacement of these building elements be performed as soon as possible to aid the protection of the property against termite / timber pest attack.

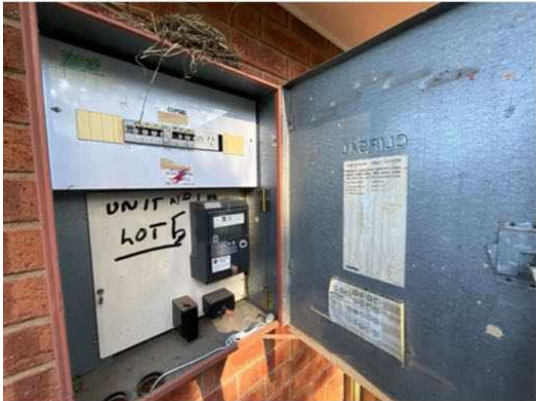
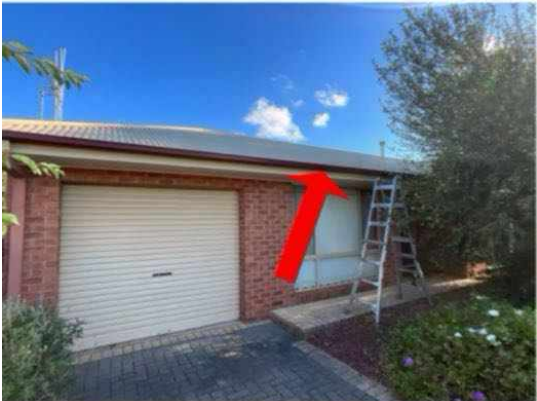
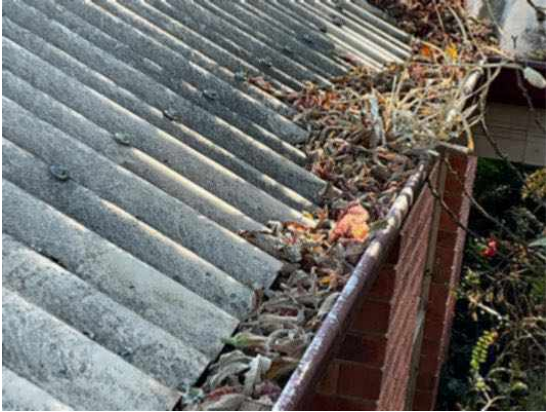
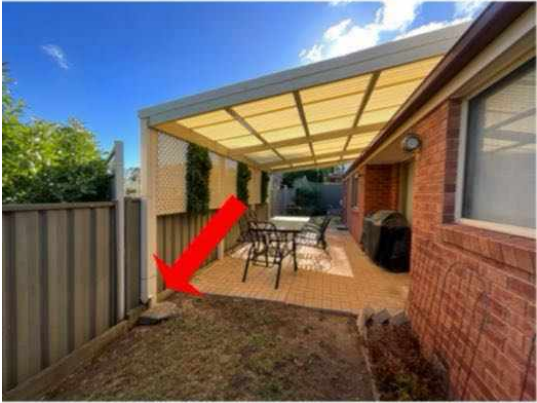
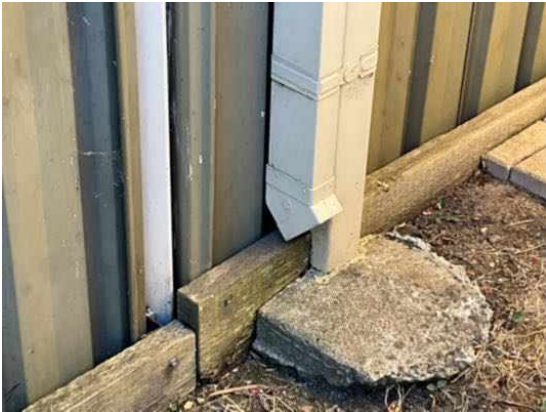
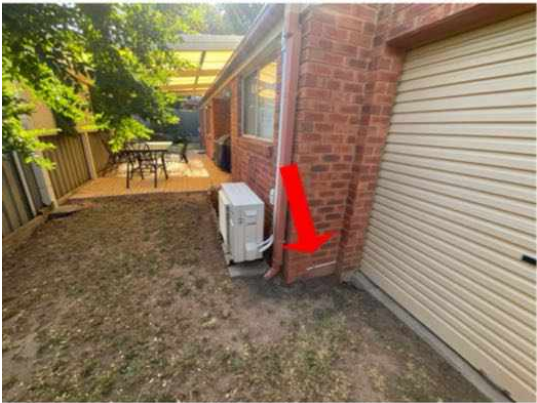
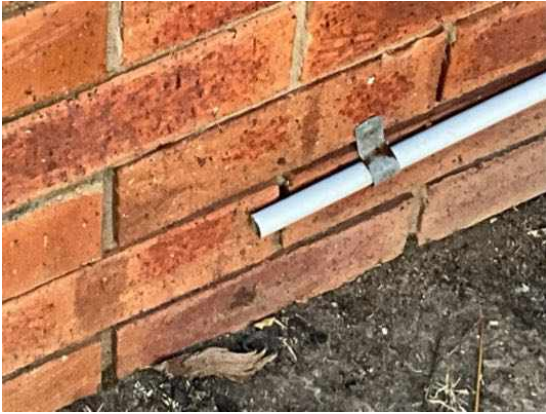
Finding 6.06

Building:	Building 1
Location:	All External Areas
Finding:	Termite Management System - no evidence of a chemical installation
Information:	The application of a post-construction chemical termite barrier is highly recommended

for all properties, particularly if live termite activity has been found on the site previously. Such barriers are highly effective in preventing termite attack on any timber building elements throughout the property.

A durable notice should be placed in the switchboard unit to indicate current termite barriers. At the time of inspection, it appeared as though no termite management system has been installed, with no evidence to suggest preventative works taking place.

The client may consider gaining further advice from a pest controller as to the costs and procedures involved with this application. It is recommended that obtaining such advice be a short-term priority.

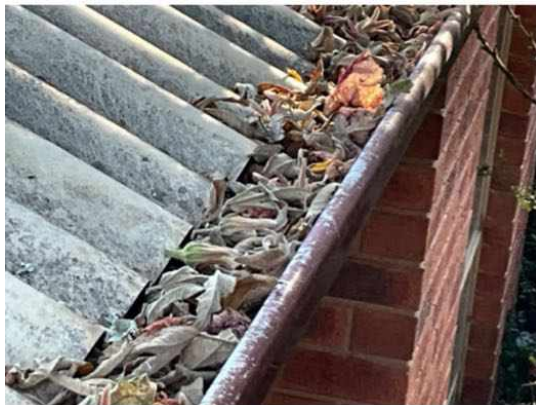
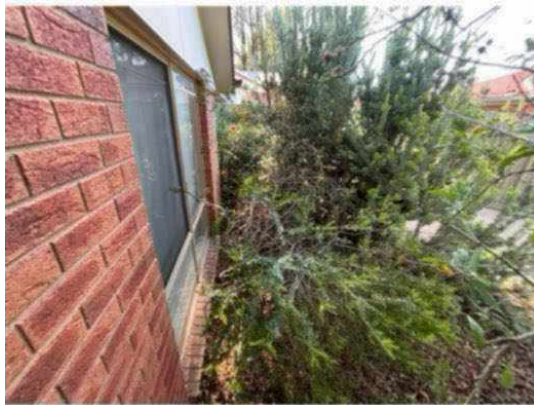
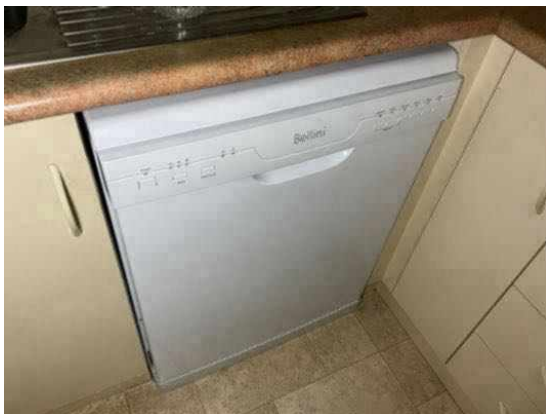
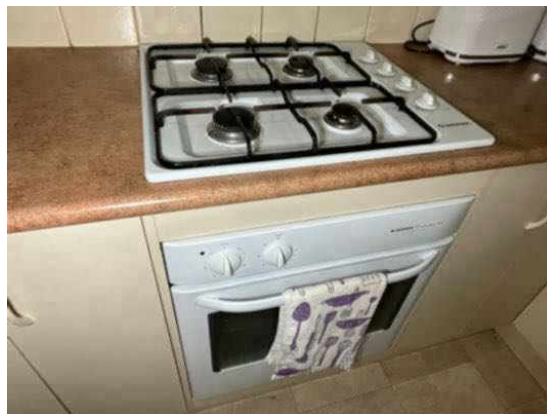
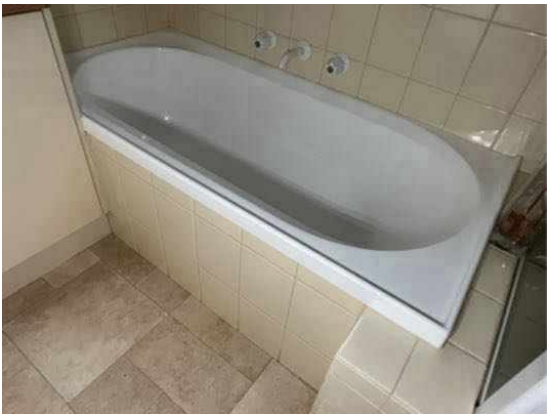
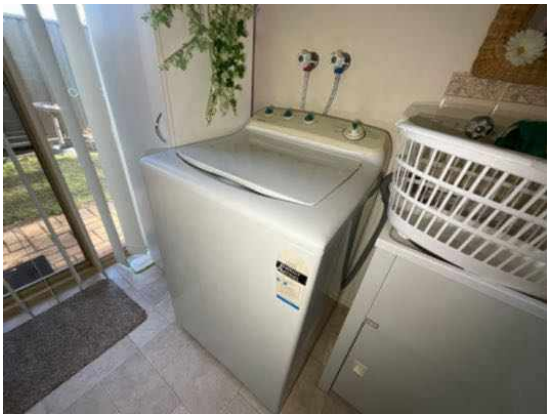
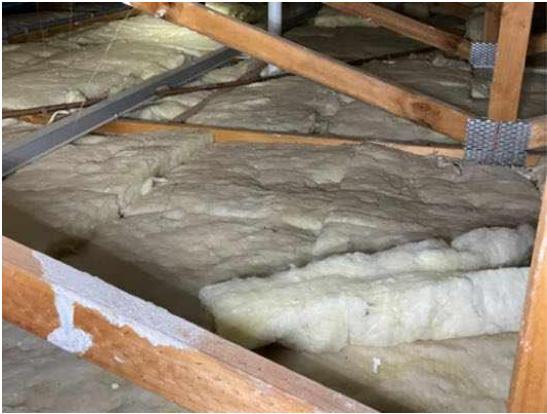
Noted Item

Building: Building 1
Location: All Areas
Finding: Additional Photos - Obstructions and Limitations
Information: These photographs are an indication of the obstructions and limitations which impeded full inspection of the property at the time of inspection. These obstructions can hide an array of defects and should be removed to allow full inspection to be carried out. A re-inspection is recommended once the areas are made accessible.
