Building and Timber Pest Inspection Report

Inspection Date: Mon, 19 Jan 2026

Property Address: 39 Epaulet Circuit Jordan Springs NSW
2747

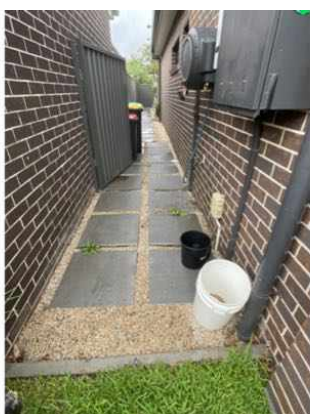
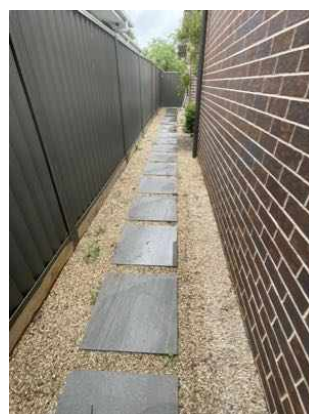
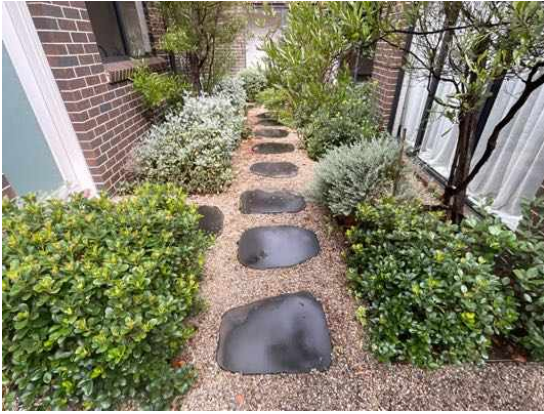
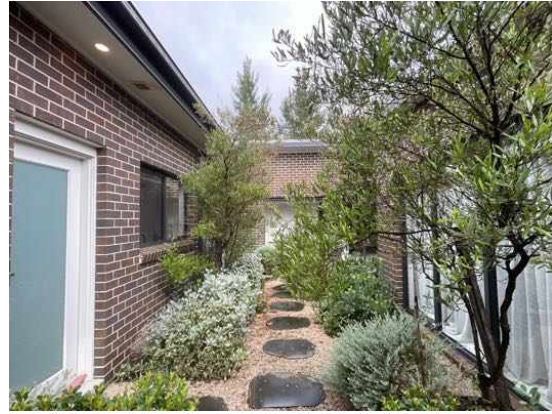
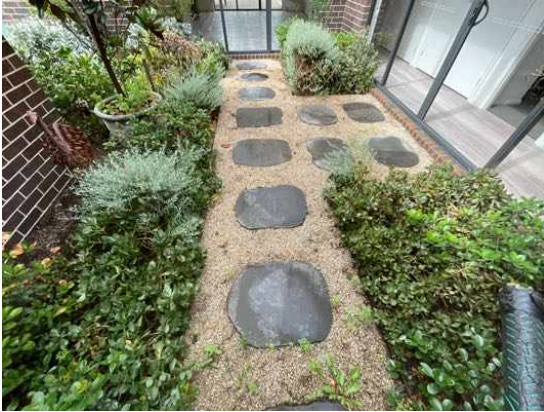
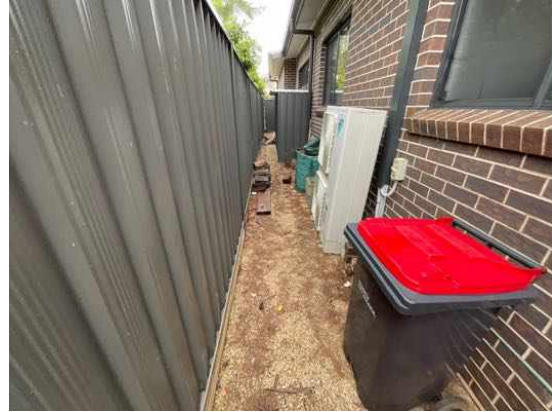
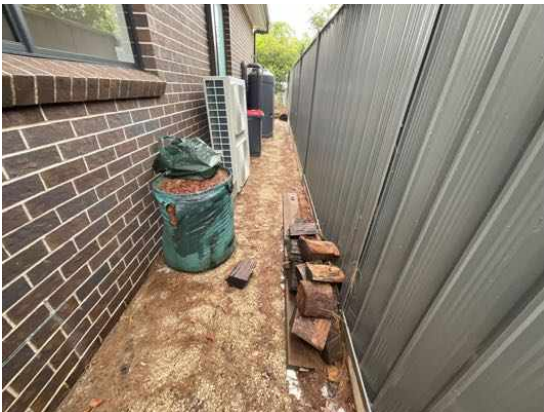
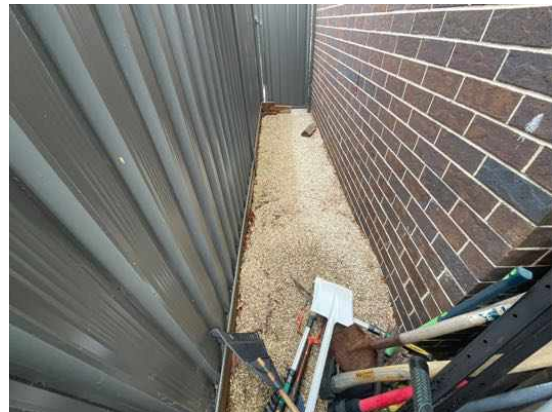
Building:	Main Building
Location:	Exterior - left & right sides
Finding:	Site/Yard Drainage – Below Average.
Information:	Defect – Below Average Site Drainage

Site drainage in the inspected areas appears to be below average, with no surface drains observed at the time of inspection. Ground surfaces and paved areas adjacent to the building do not appear to be adequately graded to facilitate effective surface water runoff.

- Water should not be allowed to accumulate against the base of external walls or around the perimeter of the dwelling.
- Prolonged moisture exposure can contribute to:

- Dampness and structural deterioration
- Movement of footings or erosion of subsoils
- Conditions that are conducive to timber pest activity, including termites, which are attracted to moist environments
- Best practice site drainage includes:
 - Paved surfaces falling away from the building by at least 25mm over the first metre
 - Bare ground sloping away by at least 50mm over the first metre

Failure to meet these minimum drainage falls increases the risk of water ingress, foundation issues, and secondary building defects.

- A licensed plumber and/or landscaping contractor should be engaged to:
 - Evaluate the current site grading and surface runoff conditions
 - Install or upgrade surface water drainage (e.g. strip drains, spoon drains, grated channels) as required
 - Improve grading around the building to ensure water flows away from the structure

Addressing these issues proactively will assist in protecting the structural integrity of the building, while also reducing environmental conditions favourable to termite activity.

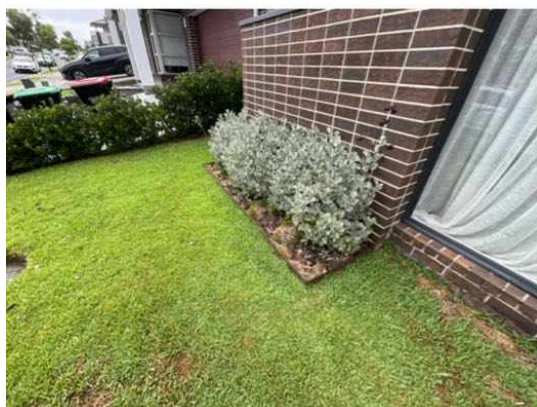
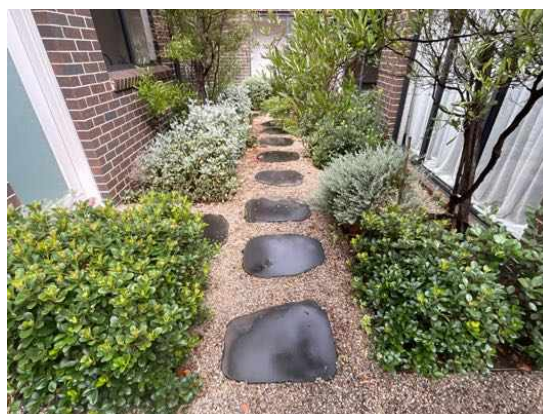
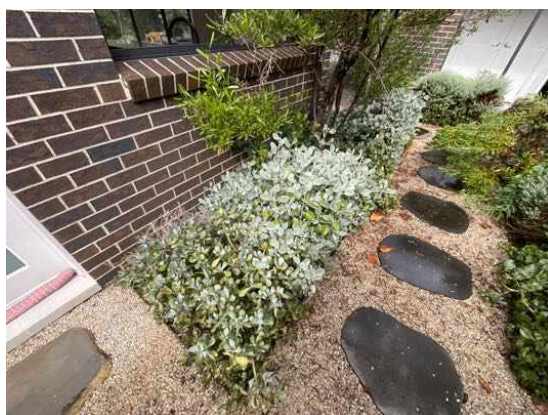
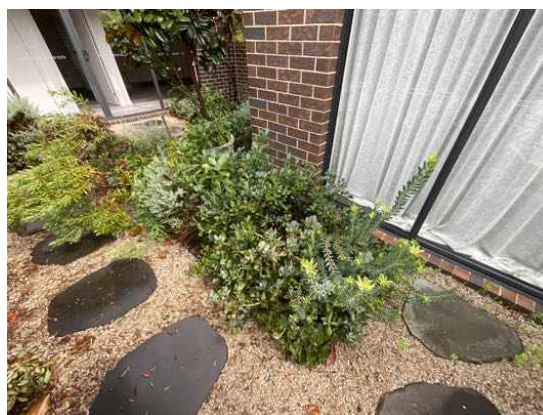
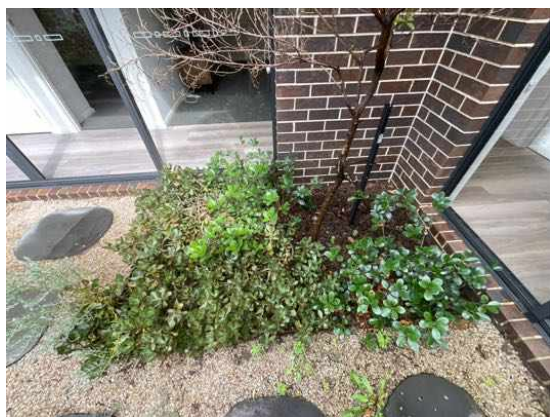
Building:	Main Building
Location:	Exterior walls
Finding:	Plumbing and/or yard drainage - Conducive conditions..
Information:	Observation: Drainage Issues Around Property

Areas of the property—both around the perimeter and within the external yard—were noted to have drainage problems, resulting in water pooling, ponding, or stagnation. These conditions are considered highly conducive to timber pest activity.

- **Termite Attraction:** Excessive moisture around or beneath the structure creates an environment favourable to termite foraging and colonisation.
- **Fungal Decay:** Prolonged dampness also promotes fungal growth and wood decay, which can compromise structural timbers.
- **Underlying Causes:** Such moisture issues are typically associated with plumbing defects (e.g. leaking pipes, overflows) or landscaping problems (e.g. poor site drainage, negative grading).

Garden beds were observed directly against the perimeter of the building. This condition can result in water pooling or retention during rainfall or from regular watering/hosing, which may lead to moisture ingress beneath the structure.

- Persistent moisture buildup around the base of the building creates an environment that is conducive to termite activity and timber decay.
- Plants and vegetation close to or in contact with external walls can provide shade and cover, further increasing the likelihood of termite infestation.
- Garden beds may also conceal weep holes, slab edges, or termite barriers, reducing visibility during inspections and allowing for undetected termite entry.

It is important that appropriate drainage improvements be undertaken to prevent moisture build-up around the building. This may include plumbing repairs, grading adjustments, or installation of drainage systems.

It is strongly recommended that garden beds be removed or relocated away from the building perimeter. Maintaining a clear inspection zone around the structure helps reduce moisture retention and improves visibility during regular pest inspections. This preventative measure significantly lowers the risk of termite ingress and related structural damage.

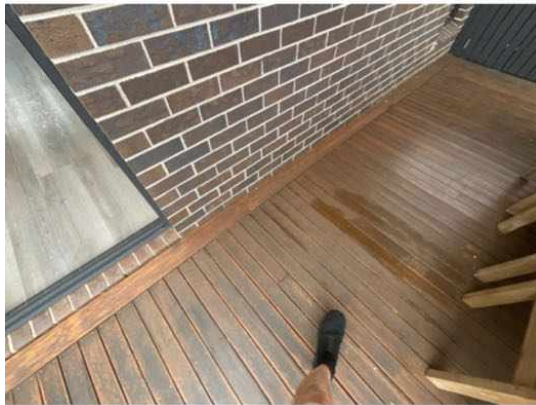
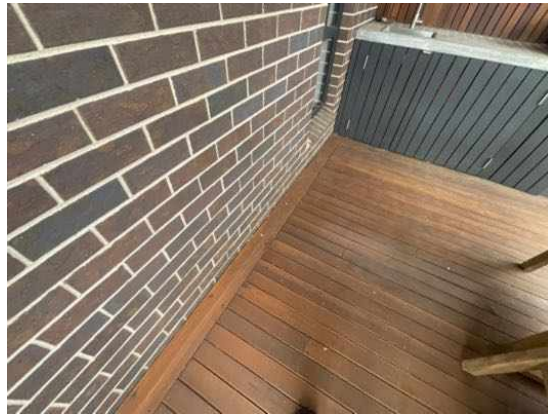
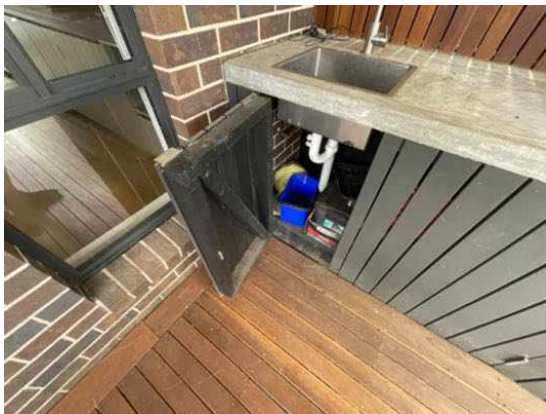
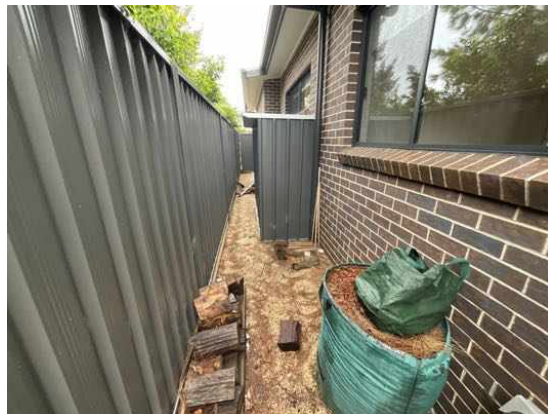
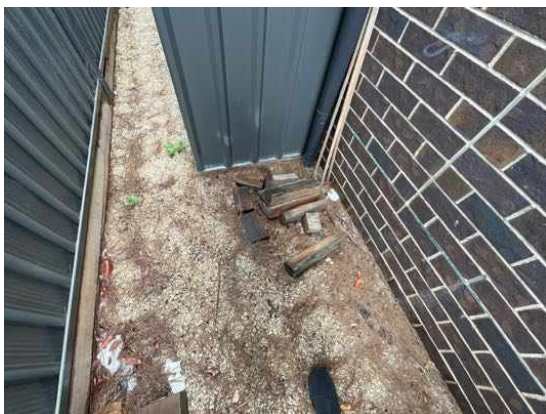
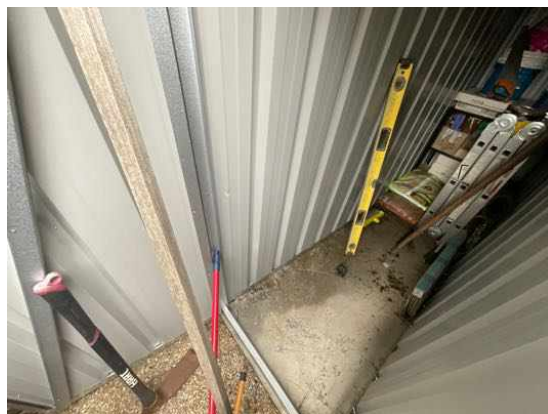
Finding 6.03

Building:	Main Building
Location:	Exterior walls - rear
Finding:	Bridging or obstruction - Deck & Shed..
Information:	Restricted Inspection – Decking and Shed Obstructing External Wall and Weep Holes

- The obstruction prevents a full inspection for signs of moisture, structural damage, or termite activity
- The deck bridges the termite inspection zone and may allow undetected termite access into the building
- Moisture may accumulate beneath or behind the decked area, creating a conducive environment for termites and fungal decay
- Decks that are not adequately separated from external walls can provide cover, warmth, and humidity, conditions ideal for termite infestation

building and the structure, in line with termite management requirements

- Remove any materials in the obstructed area that may be conducive to termite activity
- Once modifications are complete, a re-inspection is strongly recommended to assess for previously hidden issues and to ensure compliance with termite management standards

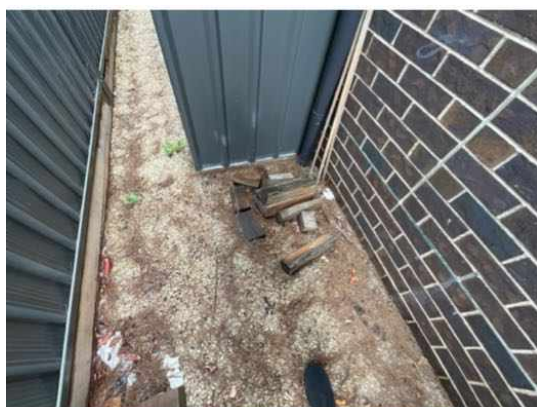
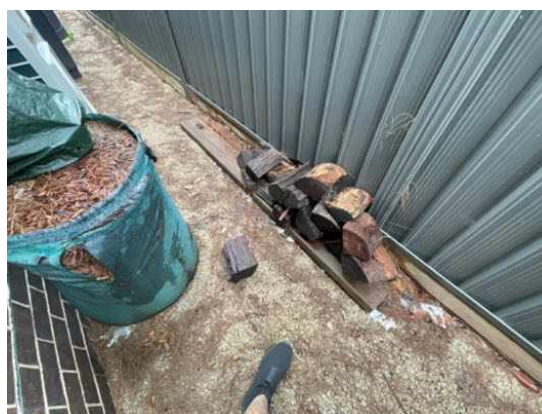
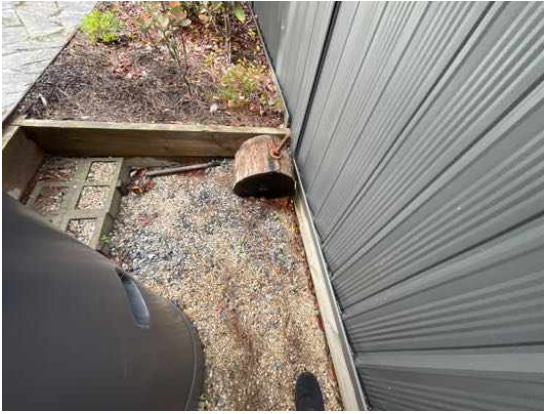
Finding 6.04

Building: Main Building
Location: Exterior - right side

Timber materials were observed stored around the external areas of the property. These timbers appear to be untreated and are exposed to weather conditions and potential ground contact.

- Stored timbers in contact with the ground or exposed to moisture are highly conducive to timber pest activity, particularly subterranean termites.
- Prolonged exposure to moisture can also lead to wood rot or fungal decay, further increasing the risk of termite attraction.

It is strongly recommended that all stored or unused timbers be immediately removed from around the building perimeter and yard areas. Reducing conducive conditions is a critical part of termite risk management.

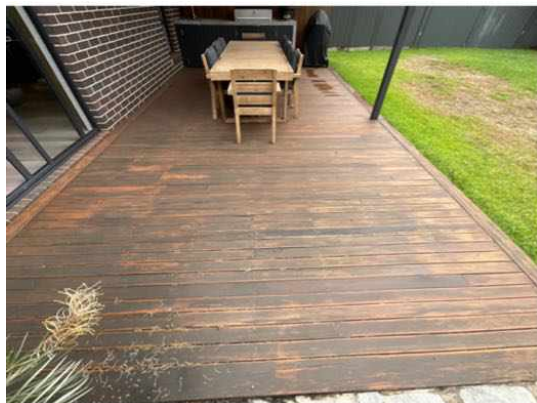
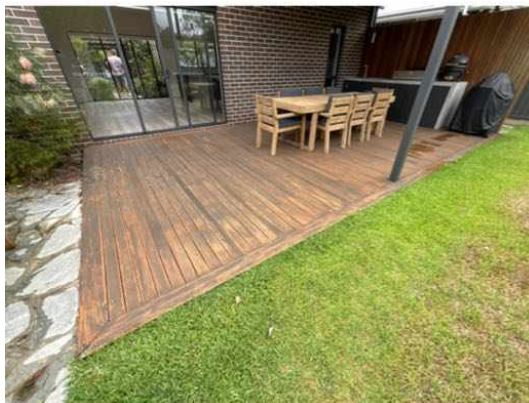
The ground level directly beneath the deck, which is attached to the house perimeter, appears to be lower than the surrounding yard. This creates a natural depression where stormwater may pool if adequate sub-deck drainage is not provided. Given the reduced visibility and lack of access beneath the deck, the assessment relies partly on information supplied by the vendor. The concealed nature of this area prevents full confirmation of existing drainage conditions.

A low-lying sub-deck area without effective drainage can trap moisture, leading to persistent dampness, soft or unstable soil, and potential water ingress to adjacent building elements. Prolonged pooling can also contribute to timber deterioration, attract timber pests, and create ideal conditions for mould or fungal growth. If unchecked, long-term moisture build-up may impact the durability of the deck structure or nearby foundations.

Monitor the area during periods of rain to determine whether water is collecting beneath the deck. If ponding is observed, consult a licensed drainage plumber to assess the site and install appropriate measures such as sub-surface drainage, spoon drains, or regrading to redirect stormwater away from the deck perimeter. Ensuring consistent drainage will reduce moisture-related risks and support long-term structural performance.

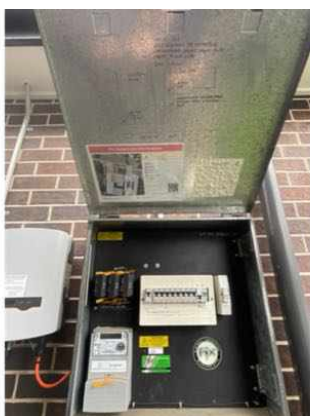
Building: Main Building
 Location: All Areas
 Finding: Termite Management System - Missing Durable Notice..
 Information: Observation: Missing Durable Notice for Termite Management System

Proper maintenance and documentation are essential to ensure continued protection. Without a visible durable notice, there is no clear indication of what system (if any) is in place, which may limit the effectiveness of future termite inspections and hinder warranty claims.

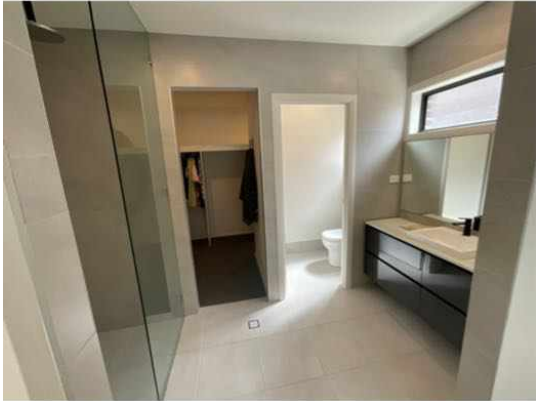
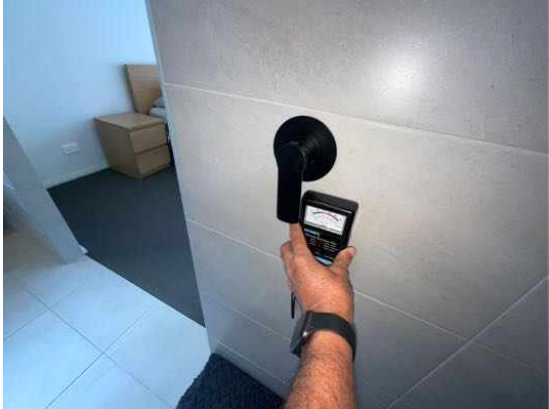
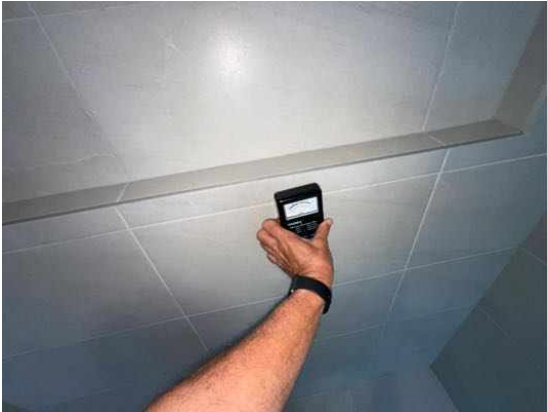
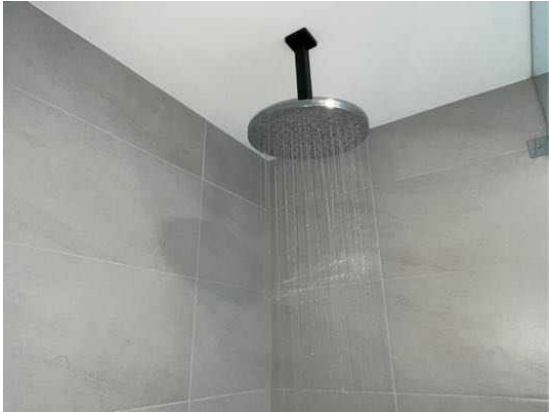
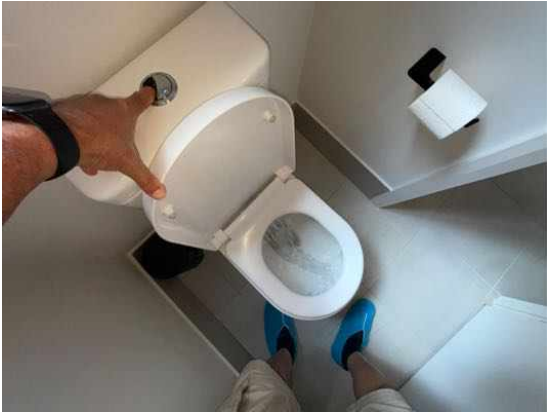
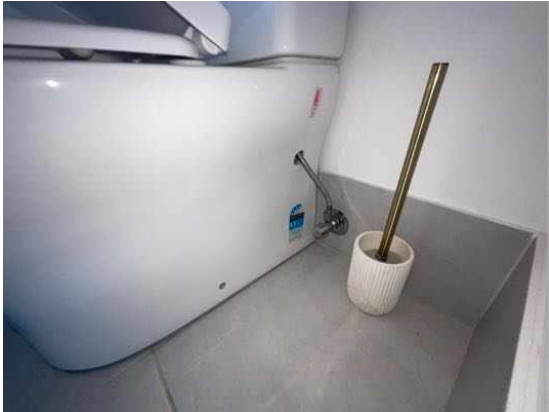
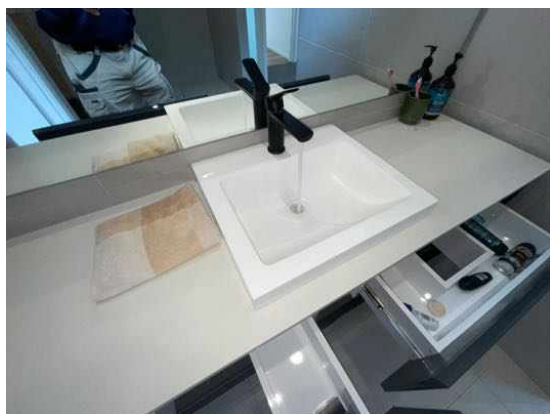
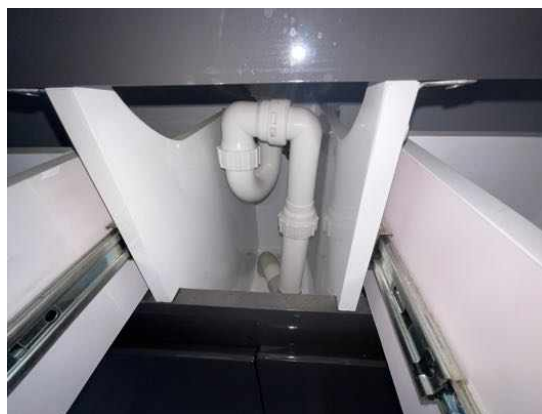
Building: Main Building
 Location: Bathroom
 Finding: Wet Areas - Bathroom(s) - Overall Condition & Recommendations.
 Information: Overall Condition & Recommendations
