# Building and Timber Pest Inspection Report

Inspection Date: Tue, 20 Jan 2026

Property Address: 27 Mount Keira Rd, West Wollongong NSW  
2500, Australia

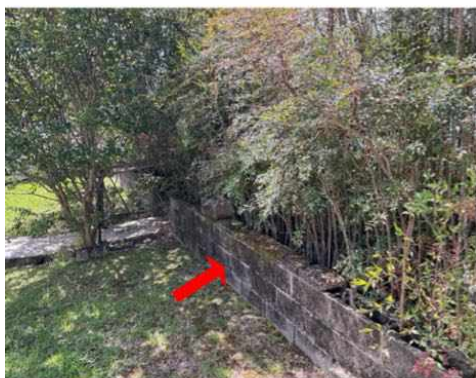
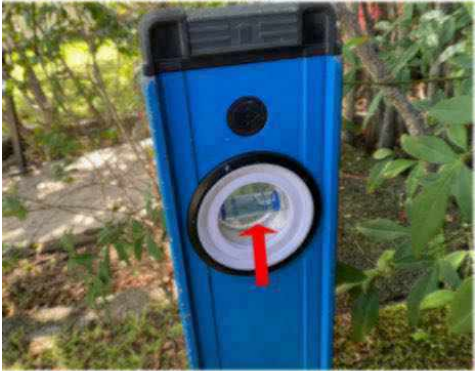
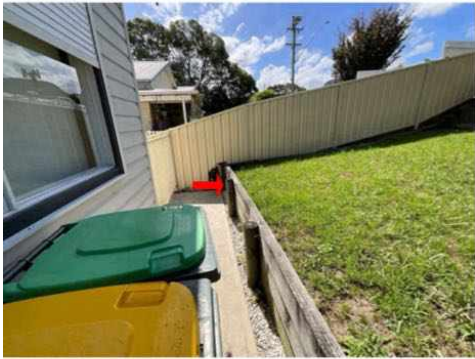
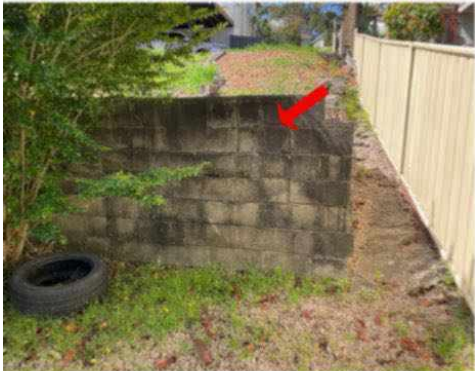
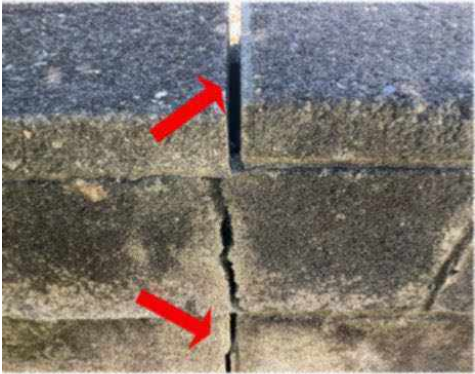
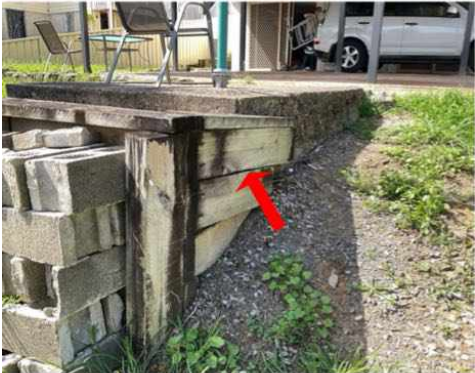
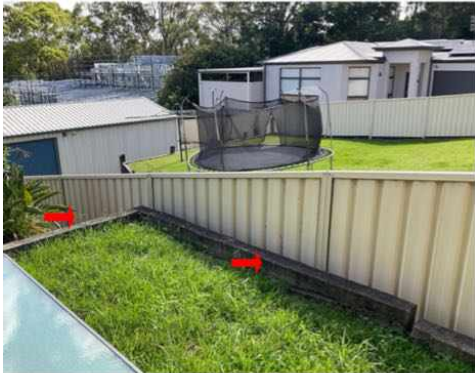
Building: Building 1  
Location: Most retaining walls  
Finding: Retaining walls - Defective  
Information: Most retaining walls were found to be defective at the time of inspection. Most are leaning and some have major and minor step cracking to the blockwork.

Generally, defective retaining walls are caused by poor original design or material use. However, deteriorated retaining walls may also be a result of substandard construction, poor site drainage or unmanaged stormwater flows. Where timber retaining walls further rot and decay, an environment is created that is conducive to termite and pest infestation.

Significant repair and replacement should be expected. A landscaper or retaining wall installer may be appointed to repair or replace the wall, at the discretion of the client.

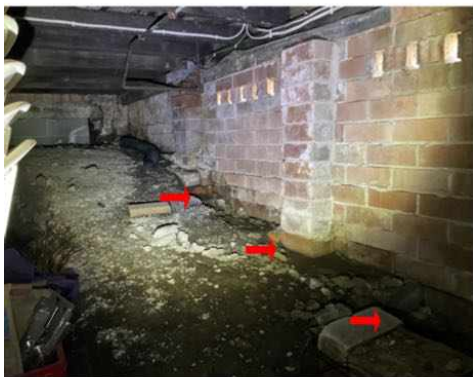
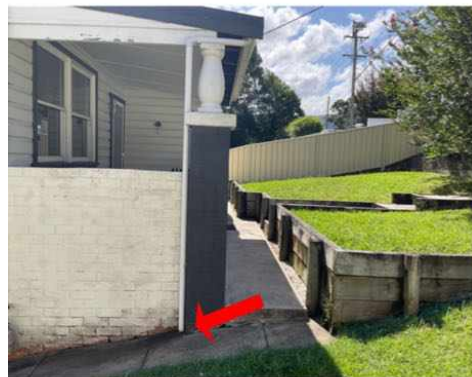
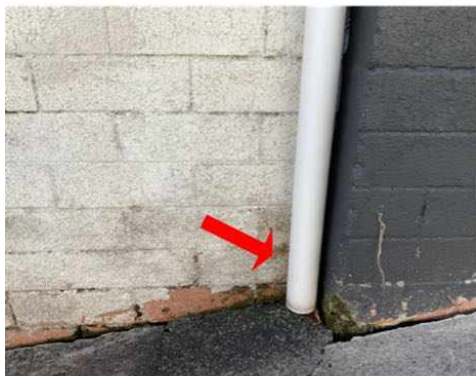
Building:	Building 1
Location:	Left Wall areas
Finding:	Site drainage - Inadequate
Information:	The site drainage in this area was found to be inadequate at the time of inspection, creating potential for subsequent water damage to associated building elements.

The air conditioner and hot water system overflow run against the house walls.

It is important that water does not lie against the base of walls; surrounding paths and ground levels should be sloped to drain water away from walls. Downpipes should not discharge stormwater onto lower walls or plinths. Stormwater should be carried away by large, regularly cleaned drains. Ground levels may need to be lowered to expose a buried DPC.

Where site drainage is inadequate, installation of an Agricultural (Aggie) Drain may be required. A qualified plumber should be appointed to further inspect the property and perform any remedial works as necessary. Secondary defects are likely to occur if left unmanaged.

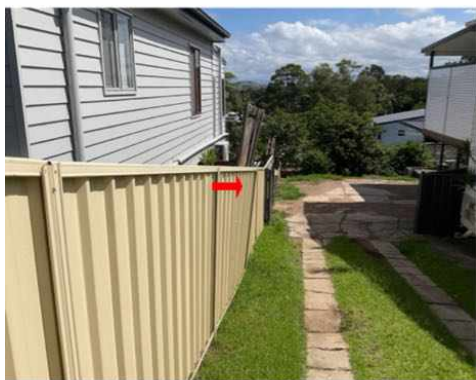
### Finding 3.02

Building:	Building 1
Location:	Pictured left fence
Finding:	Fence damaged - leaning
Information:	Evidence of damage to the pictured fence was identified at the time of the inspection. The likely cause of this fence leaning is not enough concrete used in the post footings and the neighbour leaning heavy items on this fence. If left unmanaged this fence may deteriorate further. It is suggest a fencing contractor be engaged for rectification when convenient.

The cost of repairing fences is often shared between neighbours.

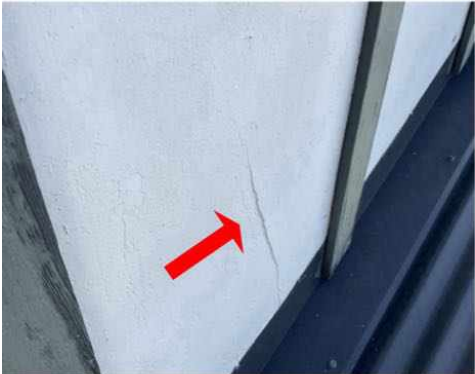
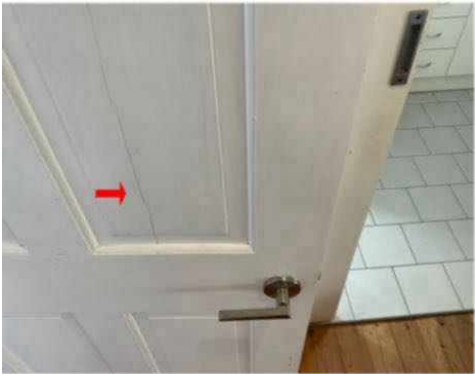
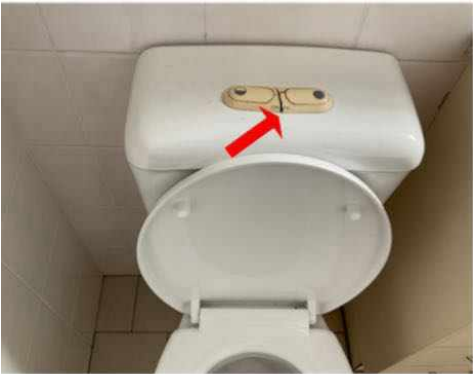
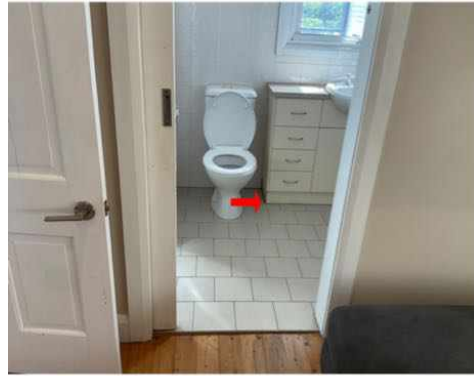
### Finding 3.03

Building:	Building 1
Location:	Pictured areas
Finding:	Building elements - Damaged
Information:	Evidence of minor missing or damaged areas was identified at the time of the inspection. These include -

1. One panel of front upper cladding has cracked and some rear timber cladding has minor damage.

2. The right rear timber kitchen door has split at the bottom, this door was not opened so as not to cause further damage to this door.

4. The towel rail is loose requiring refixing and the vanity shows minor swelling at the base.

A carpenter would be the trade responsible for rectification of these areas when convenient.

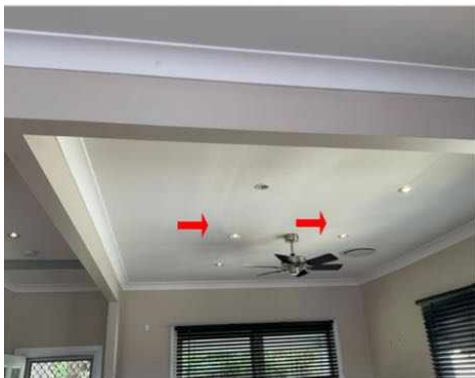
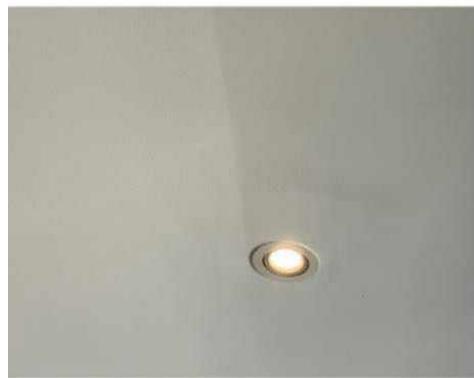
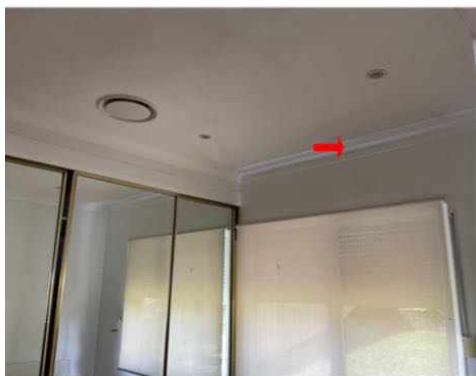
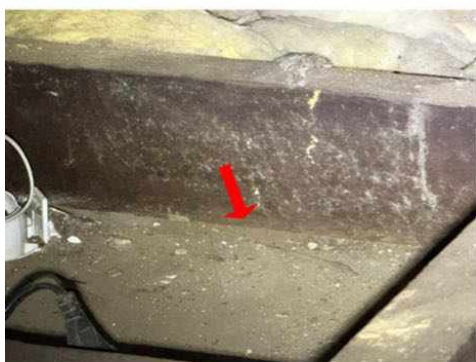
### Finding 3.04

Building:	Building 1
Location:	Upstairs areas
Finding:	Ceiling - minor sagging/deflection evident
Information:	These pictured upstairs ceilings were found to show very minor sagging at the time of inspection. Sagging to the fixed ceiling structure generally indicates that the building materials have swollen, due to contact with water, or that fixings (e.g. nails or glue) have become loose and require reattachment. The ceiling over the rear upstairs door showed repairs evident.

Where minor sagging is evident, comparatively minor works, such as re-gluing of ceiling sheets, may be required. Such works may be performed by relevant tradespeople, such as plasterers or carpenters. Monitoring of all ceilings annually is required to ensure movement does not continue.

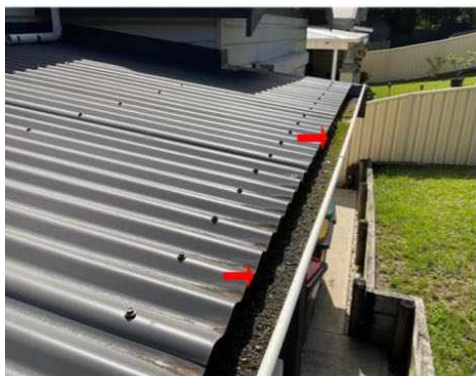
### Finding 3.05

Building:	Building 1
Location:	Roof exterior
Finding:	Gutters - Full and blocked
Information:	The guttering on around the roof was found to be blocked at the time of the inspection. Roof plumbing structures, such as guttering and downpipes, should be free of all debris to prevent blockages. Blockages of the guttering and downpipes will lead to pooling and accumulated water overflows, which is likely to subsequently flood eaves and exterior walls.

Blocked gutters are likely to lead to high levels of moisture in the affected areas which can cause rust and decay of the gutters and downpipes and wood rot to adjoining timber areas. Blockages in gutters should therefore be removed immediately to ensure dry conditions are maintained.

It is highly advised that gutters be cleaned by the homeowner or a general handyperson as a matter of urgency.

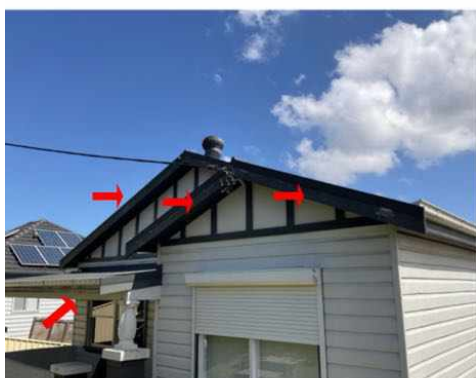
### Finding 3.06

Building:	Building 1
Location:	Pictured areas
Finding:	External painting deteriorated
Information:	Much of the external paintwork including but not limited to windows, fascias, guttering, veranda and other external fitments have been neglected and require attention to prepare and re-paint.

Whilst incomplete or missing paint finish is generally an appearance defect, it can also lead to the development of secondary building defects over time. Incomplete areas of paint finish expose the area to moisture, potentially accelerating the deterioration of underlying building materials.

Degraded paint finishes should be sanded back, filled, leveled and painted, as applicable. Where inadequate or missing paint protection has led to the deterioration of the associated building element, repair and/or replacement of this building element may be required.

A painting contractor should be appointed as soon as possible to perform necessary works to aid the appearance of the affected area and to ensure the area is protected against further deterioration. Alternatively, the homeowner following manufacturer instructions may perform these works.

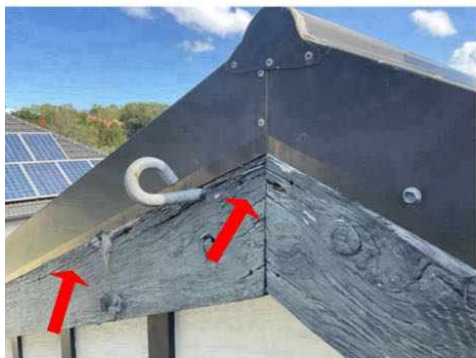
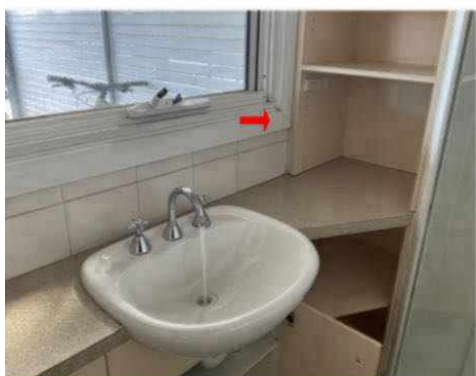
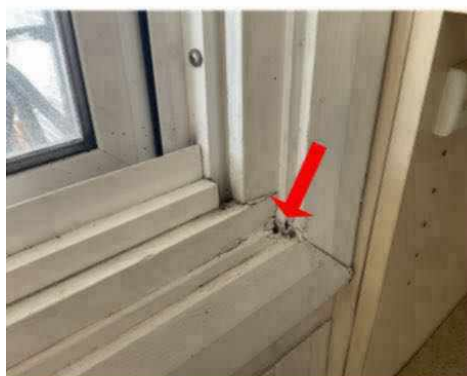
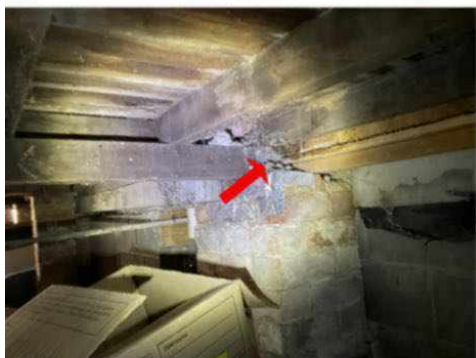
### Finding 3.07

Building:	Building 1
Location:	Pictured areas
Finding:	Wood rot
Information:	The building shows evidence of wood rot. It all appears to be minor in nature. Wood rot, also known as Fungal Decay, occurs when timbers and other cellulose building materials are exposed to damp conditions on an ongoing basis. This could be the result of exposure to weathering over a prolonged period of time, or the attraction of excessive moisture from other abutting building materials.

Early intervention and regular maintenance, particularly of exterior timbers, will prolong the useful life of these building elements. Prior to any works being performed, the cause of the moisture that has created the visible wood rot should be identified and addressed in a suitable manner. Replacement of affected timbers may then be a necessary step in protecting surrounding building elements from such deterioration.

A qualified carpenter or registered builder may also be required to replace affected building materials in pictured 1-4 in the next year. The rot in picture 1 can be refilled with builders bog and repainted.

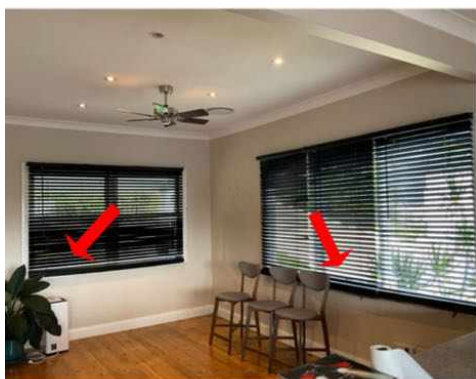
### Finding 3.08

Building:	Building 1
Location:	Pictured areas
Finding:	Window - Binding/jamming or not functioning
Information:	Binding and/or jamming of this right pictured window and jamming of the left pictured window was evident during standard operation. This defect inhibits the functionality of the windows. A window that binds to frame may have several causes, ranging from minor defects, such deteriorated hinges, through to major structural issues, such as wall movement.

Where binding/jamming appears to indicate major structural issues, a registered builder should be appointed to provide an estimate on the cost of rectification.

For minor causes like this, a qualified carpenter or general handyperson should be appointed to perform minor rectification works at client discretion.

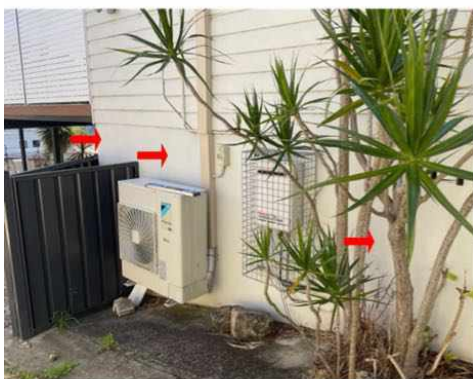
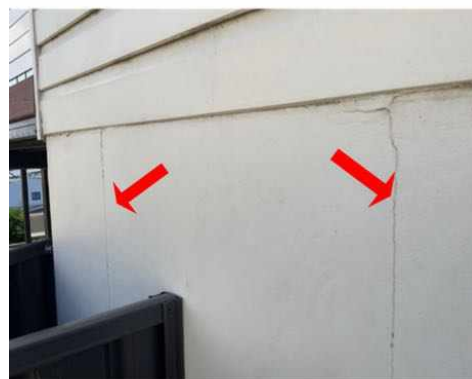
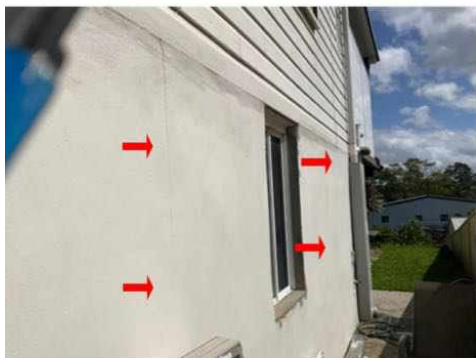
Building:	Building 1
Location:	Exterior rear walls
Finding:	Render - Drummy
Information:	Drummy rendered areas were identified at the time of inspection. The term 'drummy'

refers to render that has become detached from its fixing, despite it still being solid. Such defects are generally caused by physical or moisture damage to the area. Drummy render may also be a direct result of poor workmanship during the construction process.

Render may swell and shrink with changes in air humidity if the area has sustained moisture damage. Any exposure to moisture is capable of causing rendered areas to become drummy and/or cracked over a prolonged period of time. Drummy render generally requires chipping off and re-rendering or painting in the future.

Building:	Building 1
Location:	Exterior rear walls
Finding:	Render (external) cracking.
Information:	It has been observed that very small cracking to some external rendered surfaces. The degree of damage is described as "slight" noticeable cracks which are easily filled.

This cracking is mostly 1 mm in width.

Always contact your building inspector should cracks widen, lengthen, or become more numerous.

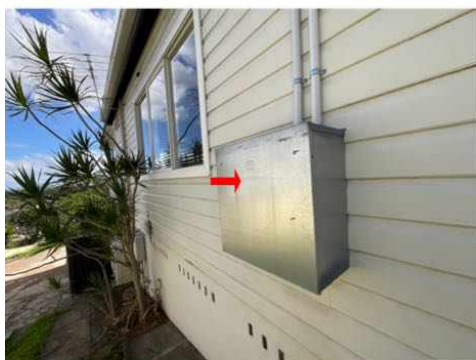
Building:	Building 1
Location:	Meter Box
Finding:	Termite Management System - no evidence of a chemical installation
Information:	The application of a post-construction chemical termite barrier is highly recommended for all properties. Such barriers are highly effective in preventing termite attack on any timber building elements throughout the property.

A durable notice should be placed in the switchboard unit to indicate current termite barriers. At the time of inspection, no durable notice was evident and it appeared as though no chemical termite management system has been installed, with no evidence to suggest preventative works taking place since the property was built.

The client may consider gaining further advice from a pest controller as to the costs and procedures involved with a 'chemical' application. It is recommended that obtaining such advice be a short-term priority.

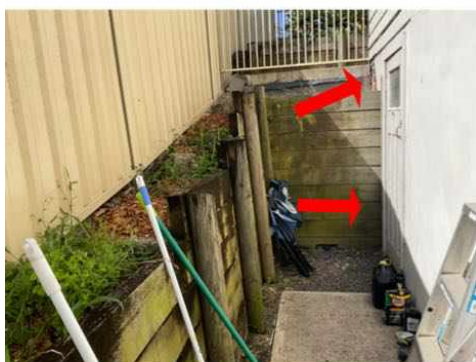
### Finding 6.02

Building:	Building 1
Location:	Yard - front
Finding:	Bridging of termite barrier
Information:	Bridging of termite barriers occurs when termites bridge (usually by building a mud tunnel) a termite barrier or inspection zone or where termites have a passage allowing them to bridge the barrier.

Generally this takes the form of finished ground levels, external paving or concrete being retrospectively installed above the damp course level, the adjacent internal floor level or weep and ventilation holes.

Where bridging has occurred full inspection is prevented and termites may enter a property in a concealed or undetectable manner.

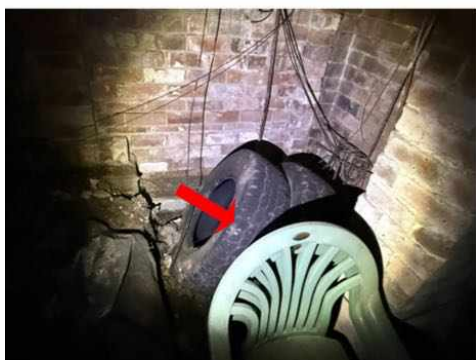
Information: An array of debris was found in the subfloor area at the time of inspection. Debris in this area restricts subfloor ventilation and creates potential for concealed pest entry. Stored timbers and other materials may also make the area susceptible to termite activity and wood rot.

A clear and empty subfloor will be better ventilated and easier to maintain in a dry condition. The removal of any timber debris is vital in minimising the risk of termite or wood borer activity.

Debris in the subfloor should be removed as soon as possible. Depending on the location and amount of debris and stored items, the homeowner may elect to undertake this task. Alternatively there are a large number of rubbish removal subcontractors that could undertake these works.

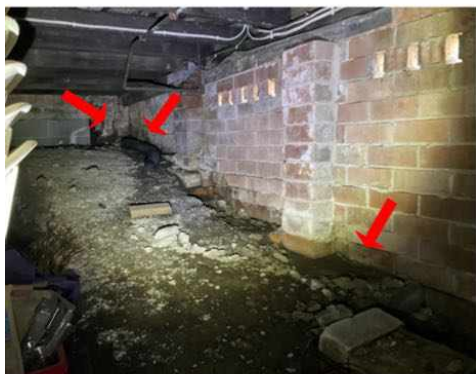
### Finding 6.05

Rising damp is generally managed by the installation of a damp proof course during construction. A Damp Proof Course (DPC) is an impermeable barrier at the base of the wall above ground level. However, many 19th Century buildings have no damp course installed, or the materials have failed. The DPC may have been omitted as a consequence of poor workmanship, or it may have been bridged where materials built up against the side of the house allow moisture ingress above the DPC level.

The first step in addressing rising damp is to diagnose the cause. The identified cause should be addressed first before addressing the appearance and other defects which have resulted from the rising damp. If the original cause is not resolved, further cases of damp are likely to ensue, resulting in secondary defects.

Consultation with a qualified plumber is advised immediately to identify the cause of the damp and perform remedial works as required.

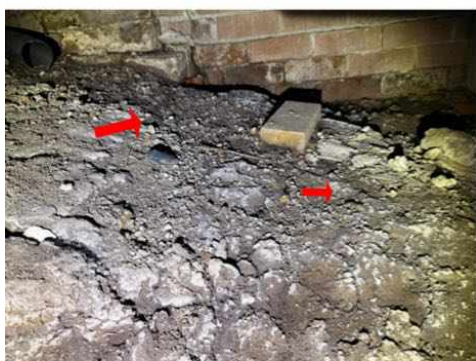
### Finding 6.06

Building:	Building 1
Location:	Subfloor
Finding:	Mould - Present in subfloor
Information:	Where evidence of mould growth was noted, there may be environmental, biological or health issues associated with the report. A specialist inspection by a suitably qualified environmental health inspector is warranted, where mould is extensive or where any queries regarding air quality spores or other related issues apply.

Subfloor mould is generally caused by moisture ingress, lack of external drainage, lack of adequate ventilation and subfloor debris present. These issues need rectification

Generally, the client is advised to ensure that the general environment is free of moisture and humidity to aid in the prevention of mould formation and development.

to stop mould development. Any mould found during the inspection should be cleaned immediately by a cleaning contractor or the homeowner as applicable.

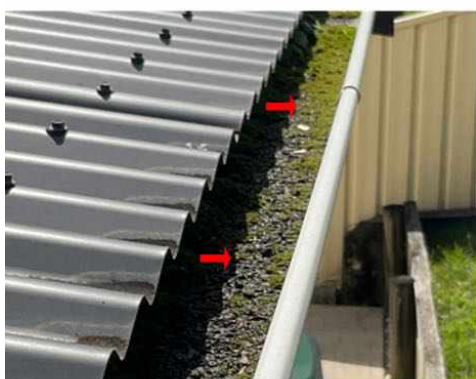
### Finding 6.07

Building:	Building 1
Location:	Roof exterior
Finding:	Gutters - Full and blocked
Information:	The guttering on around the roof was found to be blocked at the time of the inspection. Roof plumbing structures, such as guttering and downpipes, should be free of all debris to prevent blockages. Blockages of the guttering and downpipes will lead to pooling and accumulated water overflows, which is likely to subsequently flood eaves and exterior walls.

Blocked gutters are likely to lead to high levels of moisture in the affected areas. Such moisture will not only cause rust and decay of the associated building materials, but can also provide conditions that are conducive to termite and timber pest activity. Blockages in gutters should therefore be removed immediately to ensure dry conditions are maintained.

It is highly advised that gutters be cleaned by the homeowner or a general handyman as a matter of urgency.

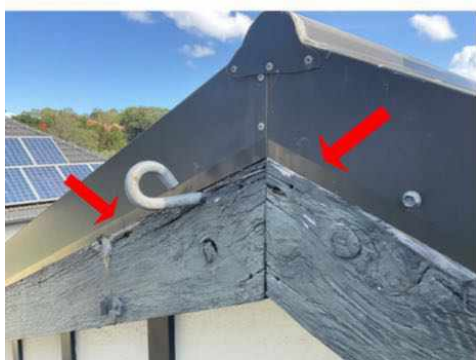
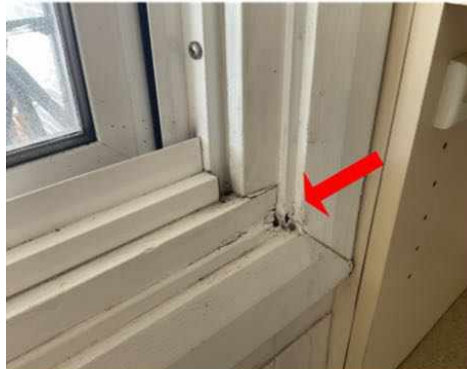
### Finding 7.01

Building:	Building 1
Location:	Pictured areas
Finding:	Fungal decay - present (localised)
Information:	Fungal decay also known as wood decay or wood rot generally refers to the deterioration of timber elements when in contact with excessive levels of moisture for a prolonged period of time.

The development of fungal decay is accelerated by temperatures from 5degreeC to 40degreeC as well as the presence of oxygen. Generally fungal decay develops on timber elements that are in use in an external environment which are exposed to rain penetration.

In this case, the affected timber elements in pictured 3 & 4 are in a decaying state and will need repair or replacement by a carpenter or licensed builder.

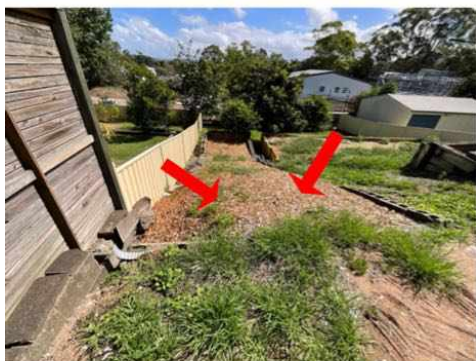
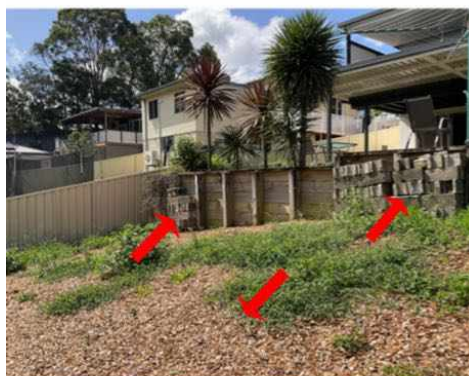
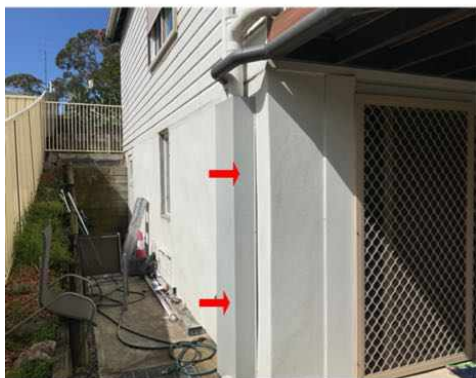
Building: Building 1  
Location: All External Areas  
Finding: Additional Photos - Obstructions and Limitations of EXTERNAL AREAS  
Information: These photographs are an indication of the obstructions and limitations which impeded full inspection of external areas at the time of inspection. These obstructions can hide an array of defects and should be removed to allow full inspection to be carried out. A re-inspection is recommended once the areas are made accessible.

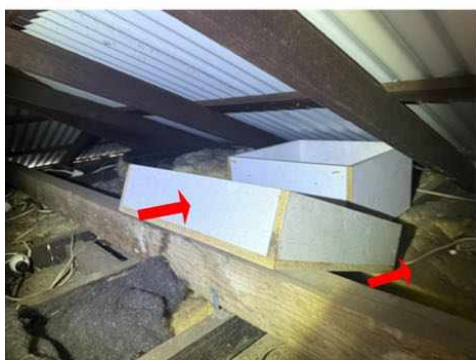
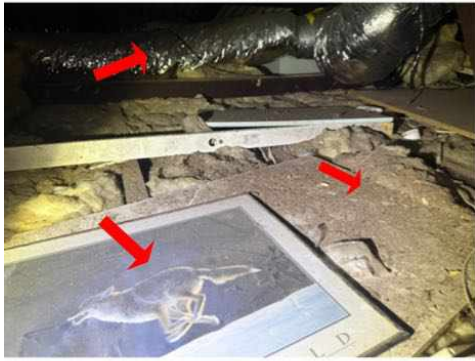
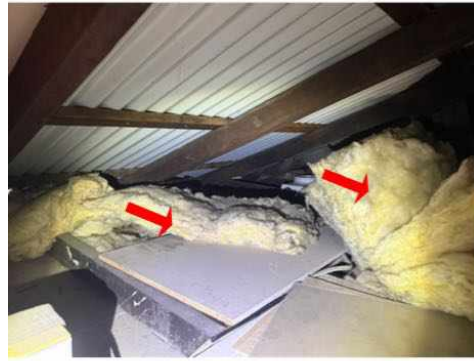
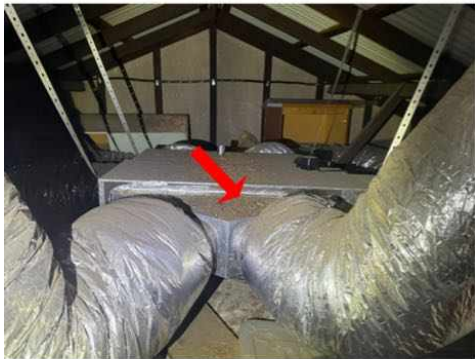
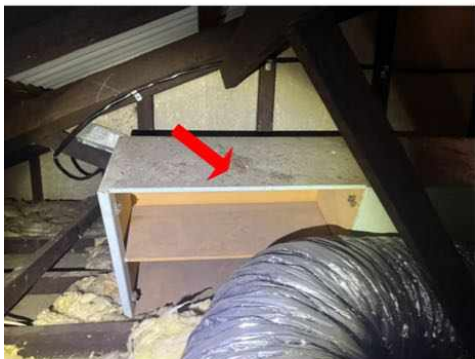
Building: Building 1  
 Location: All Roof cavity areas  
 Finding: Additional Photos - Obstructions and Limitations of the ROOF CAVITY  
 Information: These photographs are an indication of the obstructions and limitations which impeded full inspection of roof cavity areas at the time of inspection. These obstructions can hide an array of defects and should be removed to allow full inspection to be carried out if applicable. A re-inspection is recommended once the areas are made accessible.

The inspection was also limited to areas with an allowable crawl space of 600mm x 600mm, in particular towards the external walls where the roof line diminishes, these areas were not accessible.

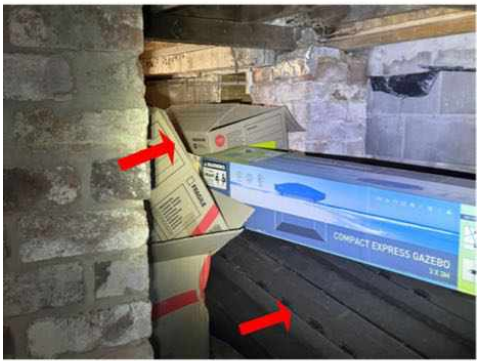
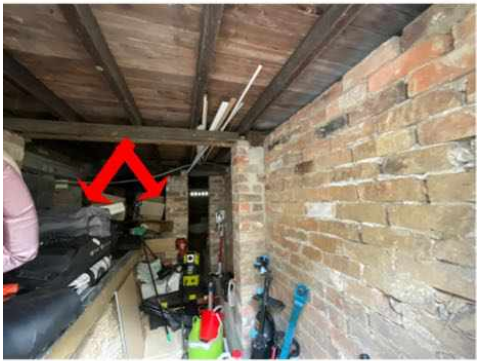
Building:	Building 1
Location:	All Subfloor Areas
Finding:	Additional Photos - Obstructions and Limitations of SUBFLOOR AREAS
Information:	These photographs are an indication of the obstructions and limitations which impeded full inspection of subfloor areas at the time of inspection. These obstructions can hide an array of defects and should be removed to allow full inspection to be carried out. A re-inspection is recommended once the areas are made accessible.
