Building and Timber Pest Inspection Report

Inspection Date: Thu, 22 Jan 2026

Property Address: 73 Cecily St, Lilyfield NSW 2040, Australia

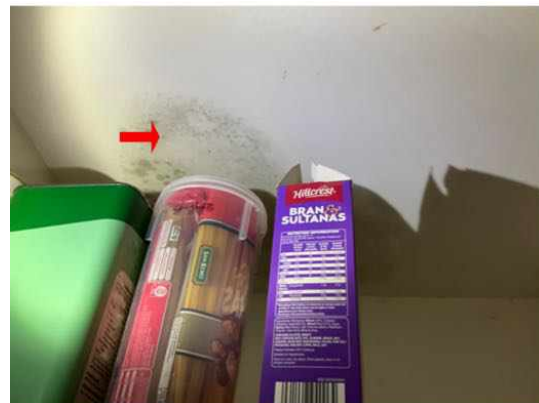
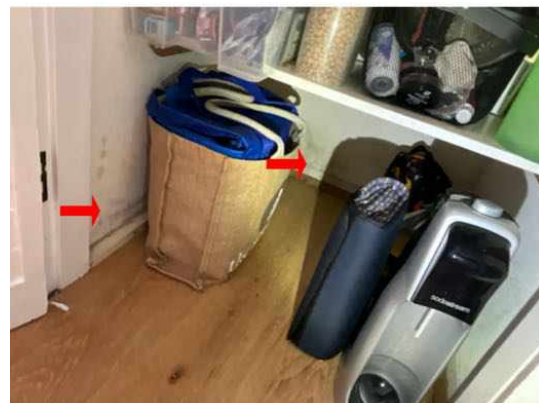
| Information: | Evidence of mould growth was noted, which is believed to have grown due to lack of ventilation to the area. |

Generally, the client is advised to ensure that the general environment is free of moisture and humidity to aid in the prevention of mould formation and development. Any mould found during the inspection should be cleaned immediately by a cleaning contractor or the homeowner as applicable.

Although the exhaust fan was found to be working at the time of inspection, however a licensed electrician May be appointed to ensure the full exhaust fan operation.

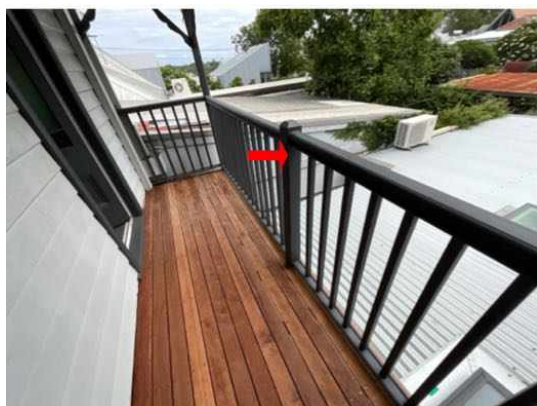
Finding 1.02

| Finding: | Loose handrail — Fall from heights |

The handrail was further loose and moving upon minimal force applied with hand.

These handrails pose a risk and persons coming in contact may fall from heights if these handrails fail, thus causing severe injury.

A licensed builder must be appointed as soon as possible to rectify any non-compliance.

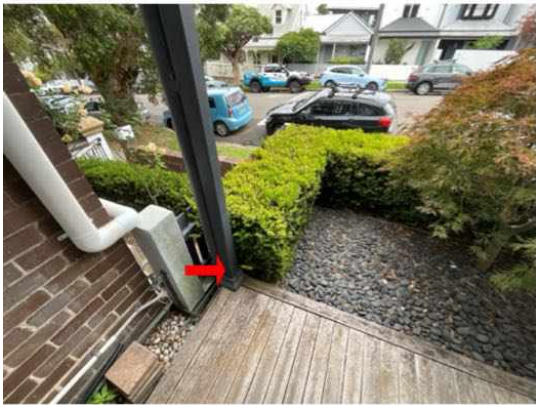
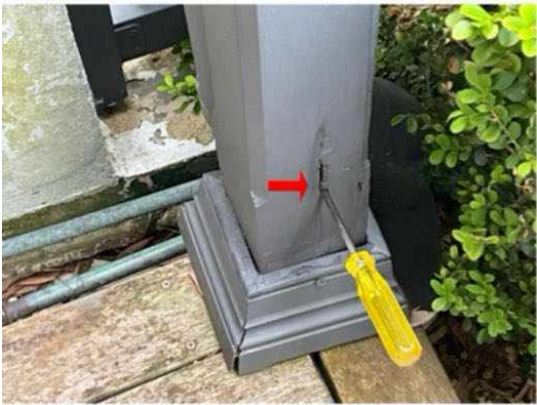
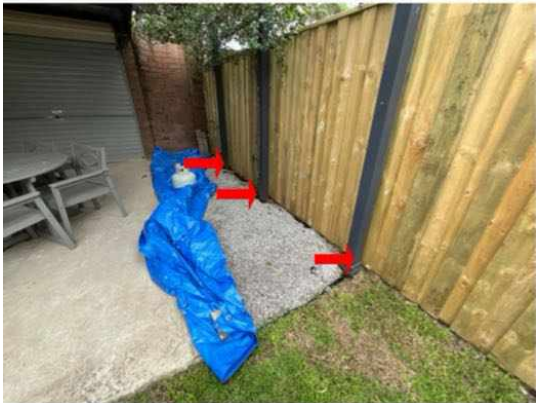
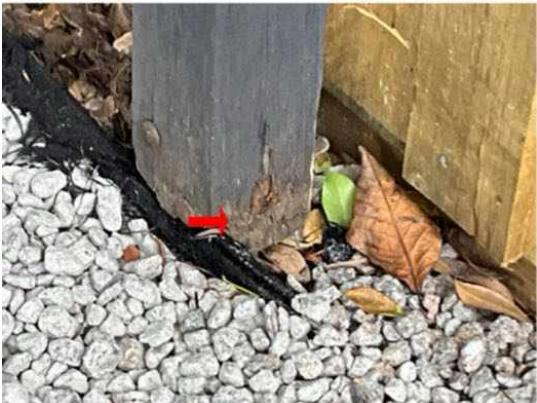
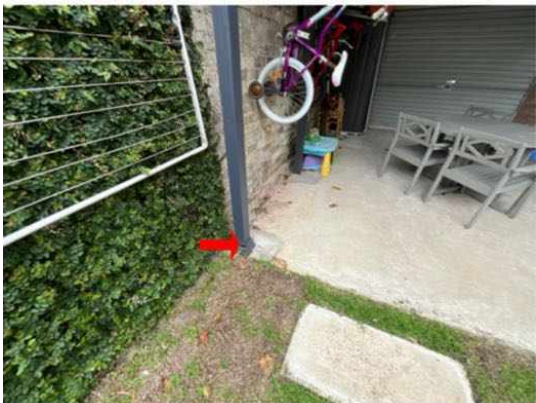
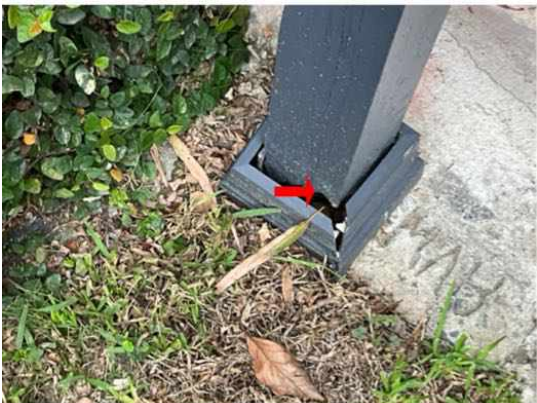
Finding 2.01

| Finding: | Wood rot/decay |
| Information: | This building element shows evidence of severe wood rot. Wood rot, also known as Fungal Decay, occurs when timbers and other cellulose building materials are exposed to damp conditions on an ongoing basis. This could be the result of exposure to weathering over a prolonged period of time, or the attraction of excessive moisture from other abutting building materials. |

Replacement of affected timbers is a necessary step in protecting surrounding building elements from such deterioration.

A licensed carpenter is required to replace affected building materials.

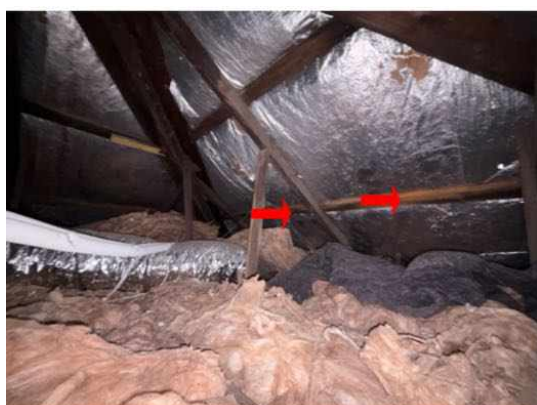
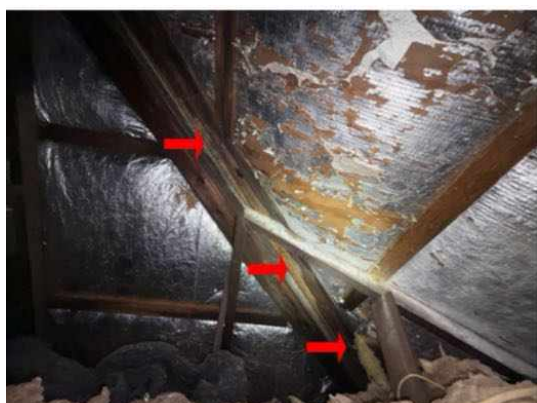
Finding 3.01

| Information: | Chemical delignification also known as wood defibration refers to the chemical breakdown of timber building elements. This breakdown of the Lignin deteriorates the wood impacting on the structural integrity and tensile strength of the affected building element. |

Chemical delignification is most common near marine environments due to the high levels of salt in the air however this deterioration may also occur in other areas where timber elements are frequently exposed to damaging gases chemicals etc.

Where timber building elements have deteriorated repair and / or replacement is required immediately to ensure the safety of the associated structures. The likely cause of the defibration should also be investigated and dealt with accordingly.

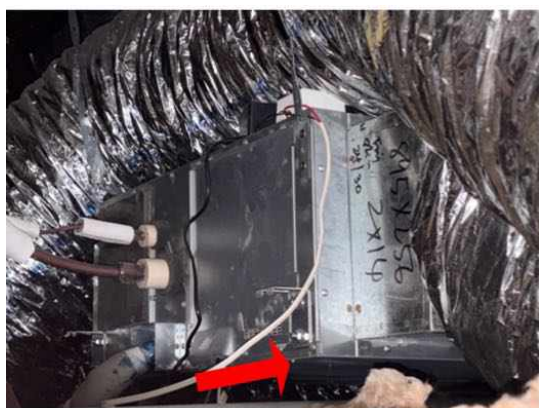
Finding 3.02

| Finding: | Internal air conditioning unit - Missing condensation tray |
| Information: | The internal air conditioning unit in the roof was found to be missing the condensation tray at the time of inspection. |

An internal air conditioning unit inside the roof must have a secondary drip tray with a separate drain line to ensure any condensation is dealt with accordingly to avoid water leaks.

A HVAC specialist must be appointed urgently for consultation and rectification, ensuring the manufacturer guidelines are closely followed.

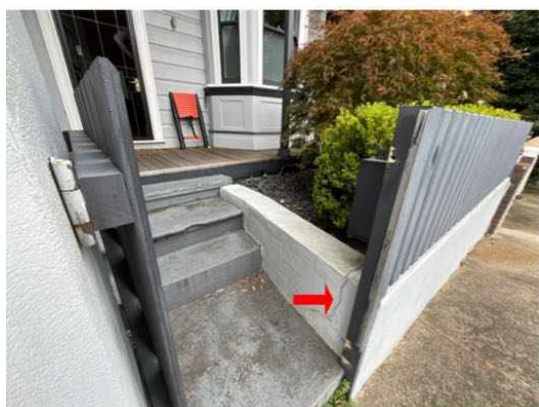
Finding 3.03

| Finding: | Retaining wall — Cracking |
| Information: | Cracking on retaining walls were identified in these areas. Generally, defective retaining walls are caused by poor original design or material use. However, deteriorated retaining walls may also be a result of substandard construction, poor site drainage or unmanaged stormwater flows. |

A landscaper must be appointed for rectifications.

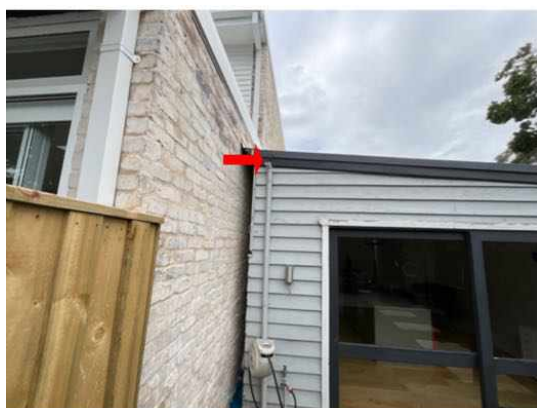
Finding 3.04

Works that have not been completed to a satisfactory level create potential for the development of building defects and may impede on the safety and integrity of the overall structure.

It is highly recommended that the relevant trades be appointed to complete these works and ensure the safety of the area and the longevity of all associated building elements.

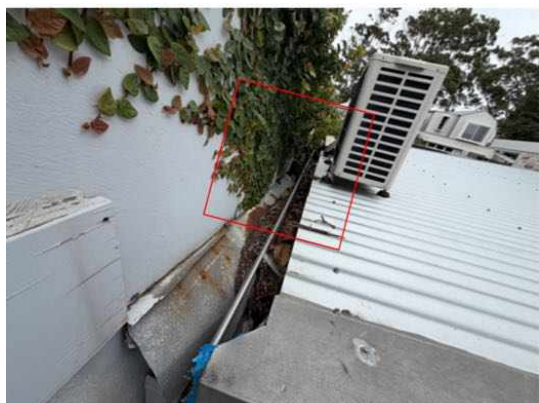
Finding 3.05

Gutters are a critical part of the building's management of storm water and rain. It is therefore important that they be kept clear to prevent secondary damage to associated building elements, including exterior and interior walls, ceiling linings and any adjoining building elements. Where gutters are blocked, pooling of rainwater is likely to occur, fast-tracking rust and corrosion of the roof plumbing elements.

It is highly advised that all overhanging tree branches be removed as soon as possible to prevent any further damage. Repair and/or replacement of sections of damaged guttering may also be required where the extent of the damage necessitates.

Such works should be performed by the homeowner; however, appointment of a landscape contractor or an arborist may be required. Consultation with a licensed roof plumber is required where guttering has been damaged.

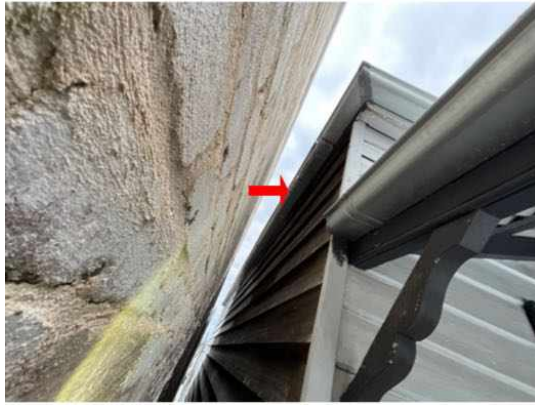
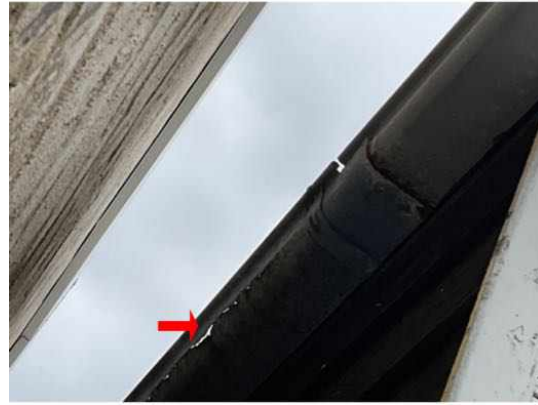
| Finding: | Roof plumbing - Rusted or corroded |
| Information: | The roof plumbing has areas of rust and corrosion. It is suspected that this has been caused by blockages, resulting in pooling or standing water, that have prematurely rusted elements of the roof plumbing. |

Rusted roof plumbing will generally develop holes and leaks that can affect other building elements with poor drainage of storm water. Poorly drained roof areas will also lead to damp conditions surrounding the base perimeter of the building which, if left unmanaged, can lead to a range of secondary building defects.

Repair and/or replacement of rusted roof plumbing is highly required in order to reinstate the roof drainage system to a fully operational level. To further maintain these areas, gutters should be cleaned frequently, allowing the avoidance of any partial blockages.

A licensed plumber or specialist roof restoration company should be appointed to undertake these works. It is advised that such works be completed as soon as possible to prevent any further damage and deterioration.

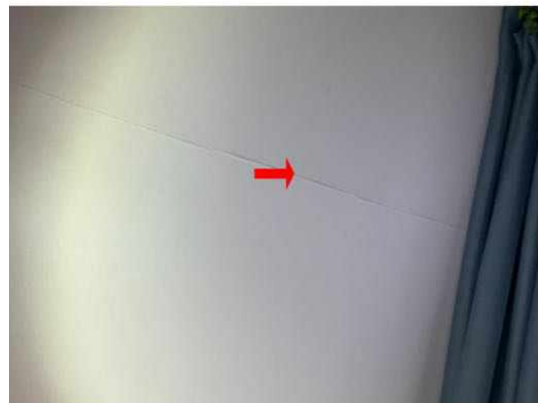
Finding 3.08

| Finding: | Cracking - Damage Category 1 - Fine (up to 1mm) |
| Information: | Although fine cracks are quite noticeable, they are often only considered to be an appearance defect, and usually do not indicate any structural damage. Generally, the cause of a fine crack is indicative of a separation between building materials and finishes (e.g. paint, plaster, etc.) along joins. |

Cracking of this nature can generally be repaired with minor sanding, filling and/or repainting. Such works should be performed by a qualified painter or a general handyman.

Monitoring of all cracking should be conducted frequently. Always contact a building inspector should cracks widen, lengthen, or become more numerous.

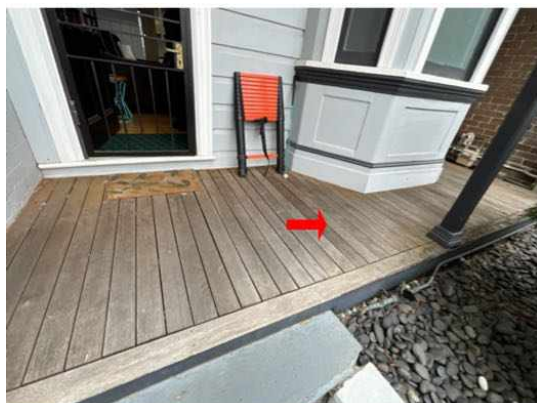
Finding 3.09

| Information: | External timbers that are frequently exposed to harsh weather conditions require |

adequate protection in order to maintain their condition. Where timbers have not been painted or treated adequately, general deterioration is likely to occur at an accelerated rate.

If left unattended, replacement of these timbers is likely to be necessary in the short-term future. Adequate treatment of these timbers is required as soon as possible by a painting contractor or general handyman.

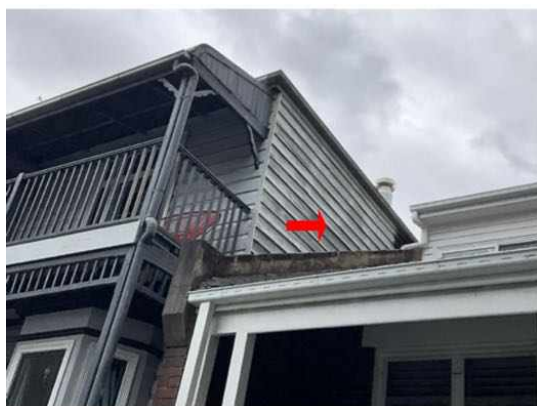
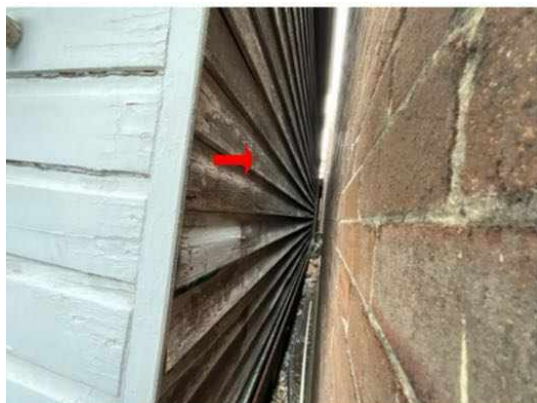
Finding 3.10

| Finding: | External painting deteriorated |

Whilst incomplete or missing paint finish is generally an appearance defect, it can also lead to the development of secondary building defects over time. Incomplete areas of paint finish expose the area to moisture, potentially accelerating the deterioration of underlying building materials.

Degraded paint finishes should be sanded back, filled, leveled and painted, as applicable. Where inadequate or missing paint protection has led to the deterioration of the associated building element, repair and/or replacement of this building element may be required.

A painting contractor should be appointed as soon as possible to perform necessary works to aid the appearance of the affected area and to ensure the area is protected against further deterioration. Alternatively, the homeowner following manufacturer instructions may perform these works.

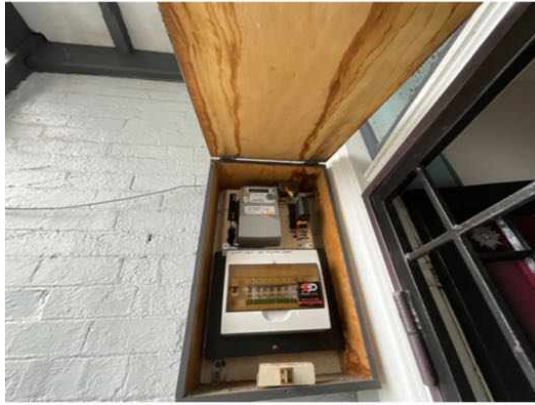
Building: Main Building
 Location: Meterbox
 Finding: Termite Management System - no evidence of installation
 Information: The application of a post-construction chemical termite barrier is highly recommended for all properties, particularly if live termite activity has been found on the site previously. Such barriers are highly effective in preventing termite attack on any timber building elements throughout the property.

system has been installed, with no evidence to suggest preventative works taking place.

The client may consider gaining further advice from a pest controller as to the costs and procedures involved with this application. It is recommended that obtaining such advice be a short-term priority.

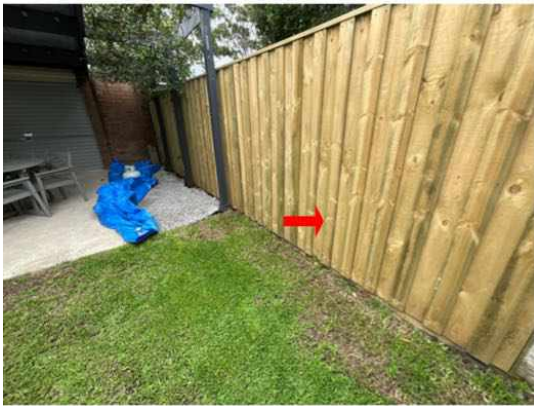
| Information: | Where timber elements are in direct contact with the ground and consequently moisture or dampness they become conducive to termite activity. Whether timber is used as a building element part of a fencing structure or stored as an unused item they can provide an environment that is attractive to termite infestation. |

When met with excessive moisture timber begins to decay and develop wood rot. Any timbers that are in direct contact with external grounds especially if left untreated or non-durable also provide ingress for subterranean termites into that particular element.

The removal of any such materials that may be conducive to termite activity should be

removed as soon as possible to minimise the risk of termite attack.

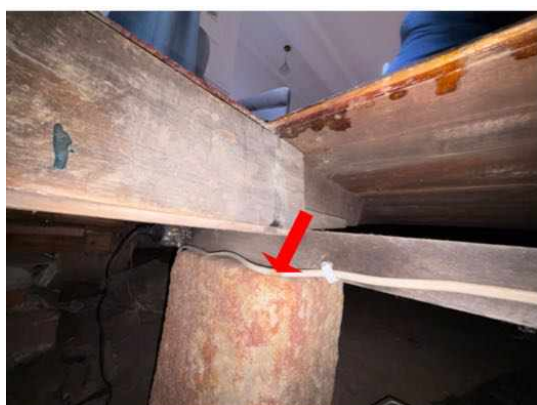
Where ant caps have not been installed, frequent monitoring of these areas should be carried out in order to identify any signs of termite or timber pest workings.

A licensed builder must be appointed urgently to replace any missing ant caps.

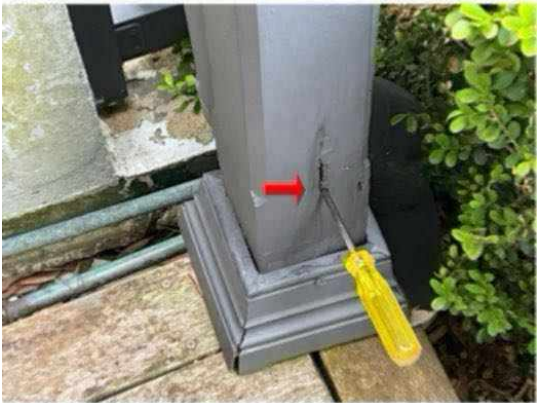
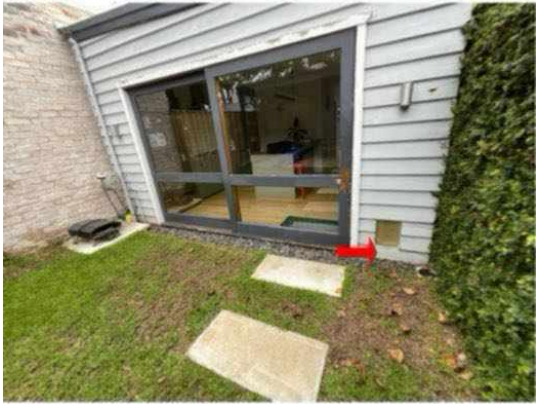
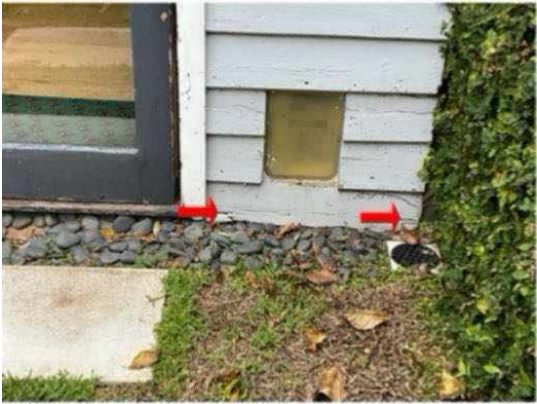
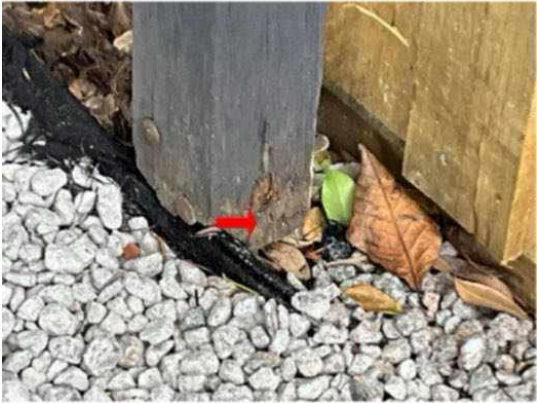
Finding 7.01

Finding: Wood rot/decay
Information: This building element shows evidence of wood rot. Wood rot, also known as Fungal Decay, occurs when timbers and other cellulose building materials are exposed to damp conditions on an ongoing basis. This could be the result of exposure to weathering over a prolonged period of time, or the attraction of excessive moisture from other abutting building materials.

Replacement of affected timbers is a necessary step in protecting surrounding building elements from such deterioration.

A licensed carpenter is required to replace affected building materials.

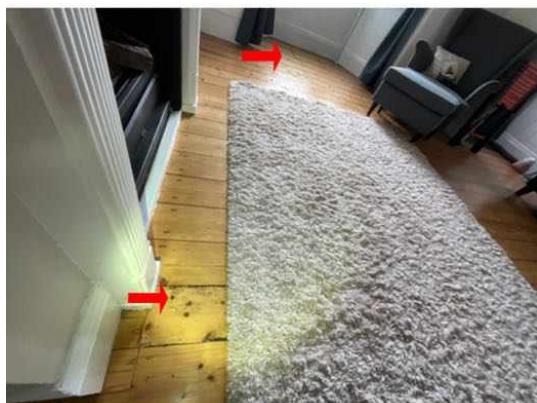
| Information: | Wood borers small beetles that colonise in exposed timber elements are a common timber pest that are regularly mistaken for termites. Although wood borer activity is generally not detrimental to the affected timber they may lead to serious damage and necessitate replacement of certain building elements if left unattended. |

The other commonly known borer the Anobium borer is more likely to attack floorboards and may cause severe structural damage to flooring areas.

As no live wood borer activity was identified treatment is not required at this time. Replacement of affected timbers may be considered by the client for superficial reasons.

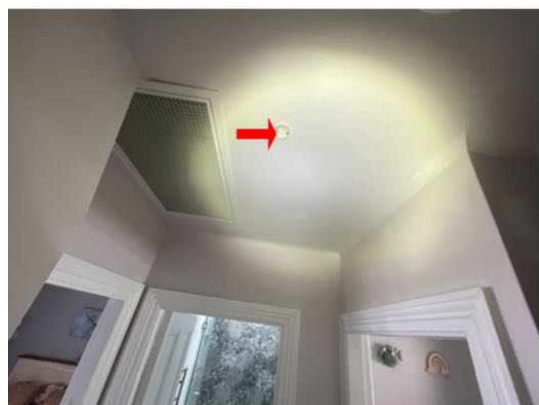
Please note that this defect is highlighted as a caution only. We suspect, based on our experience in the building industry, that the absence of smoke detectors, or their poor condition, should be addressed as a matter of urgency to improve occupant safety.

Always ensure sufficient working and suitable smoke detectors are installed prior to occupying any building. Additionally, it is advised that all smoke detectors be tested by the homeowner on a monthly basis.

Please refer to AS3786 and state based legislation, which may also apply.
