Building and Timber Pest Inspection Report

Inspection Date: Mon, 23 Mar 2026

Property Address: 13 Betula Grove, Bundanoon NSW 2578,
Australia

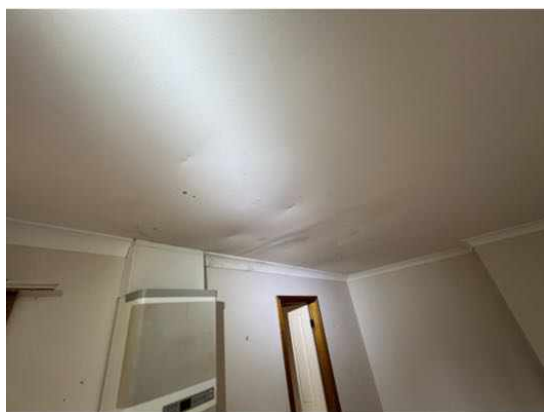
Building: Main Building
Location: Family Room
Finding: Ceiling - Water damaged
Information: Water damage to the ceiling lining is generally an indication of excessive moisture being present in the roof void, usually via a leak to the roof covering.

Where water damage is evident to the ceiling, the primary requirement is to identify and rectify the source of the leak. A roofing plumber should be appointed as soon as possible to identify the leak and perform rectification works as necessary, ensuring the water damage is restricted.

Once the leak is repaired, consultation with relevant tradespeople, including plasterers and painters, is advised. Rectification works may include replacement of ceiling lining or minor repainting, depending on the extent of the damage.

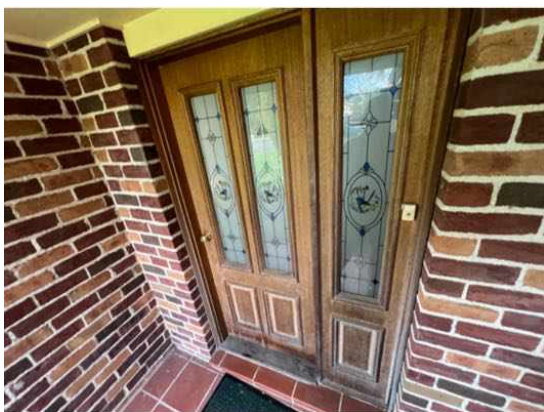
Building:	Main Building
Location:	Porch
Finding:	Timber door - exposed to weather
Information:	External timber doors that are frequently exposed to harsh weather conditions require adequate protection in order to maintain their condition. Where timbers have not been painted or treated adequately, general deterioration is likely to occur at an accelerated rate.

If left unattended, replacement of these timber doors is likely to be necessary in the short-term future by a licensed carpenter. Adequate treatment of these timber door/jamb is required as soon as possible by a painting contractor or general handyman.

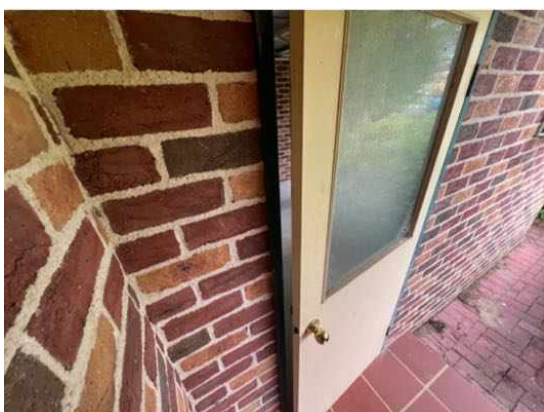
Finding 3.03

Building:	Main Building
Location:	Garage
Finding:	Door - Binding/jamming
Information:	Binding and/or jamming of this door is evident during standard operation. This defect inhibits the functionality of the affected door as well as creating potential for secondary defects to associated building elements, such as damage to the floor covering.

A door that binds to flooring or to the associated door frame may have several causes, ranging from minor defects, such as poor installation of the door or deteriorated hinges, through to major structural issues, such as damage to subfloor structures.

Where door binding/jamming appears to indicate major structural issues, a registered builder specialising in re-stumping should be appointed to provide an estimate on the cost of rectification.

For minor causes, a qualified carpenter or general handyperson should be appointed to perform minor rectification works at client discretion.

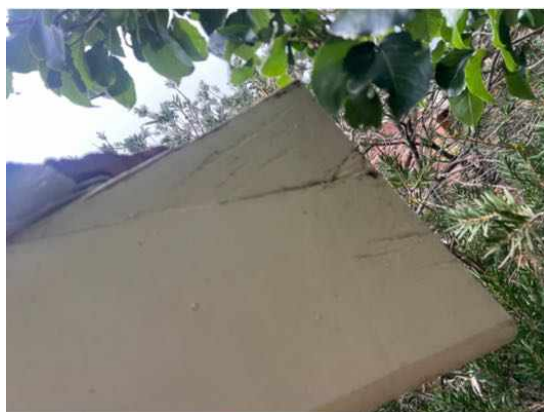
Finding 3.04

Location: Garage
Finding: Barge - Wood rot
Information: Wood rot was found to be affecting fascias and barges in this area, evidenced by the presence of mould on the surface in some areas. Wood rot, also known as Fungal Decay, occurs when timbers and other cellulose building materials are exposed to damp conditions on an ongoing basis.

It is likely that this wood rot has developed as a result of faults in the roof plumbing, creating excessive moisture in this areas. Frequent exposure to rain and other weather conditions also make fascias and barges susceptible to accelerated deterioration.

Early intervention and regular maintenance will prolong the useful life of these building elements. Prior to any works being performed, the cause of the moisture that has created the visible wood rot should be identified and addressed in a suitable manner.

It is advised that a roof plumber be appointed to inspect all roof plumbing and subsequently identify the cause of the wood rot. Replacement of affected fascias and barges may then be a necessary step in protecting surrounding building elements from such deterioration.

A qualified plumber may be appointed to assess the cause of excessive moisture and to provide advice on any remedial works as required. A qualified carpenter or registered builder may also be required to replace affected building materials.

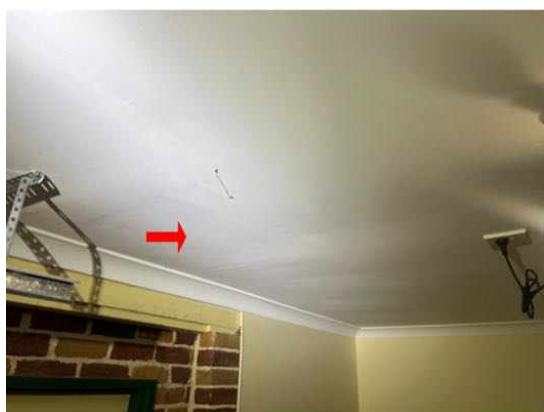
Finding 3.05

Building:	Main Building
Location:	Garage
Finding:	Ceiling - Incomplete or substandard works
Information:	The works to this area appear to be incomplete or have been completed to a substandard level.

Works that have not been completed to a satisfactory level create potential for the development of building defects and may impede on the safety and integrity of the overall structure.

It is highly recommended that a licensed plasterboard contractor and or painter should be appointed to repair the ceiling. To ensure the safety of the area and the longevity of all associated building elements.

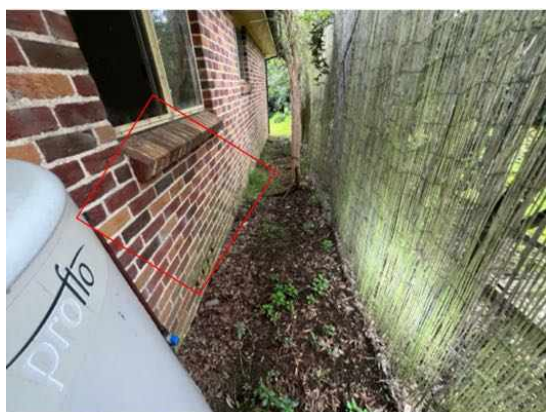
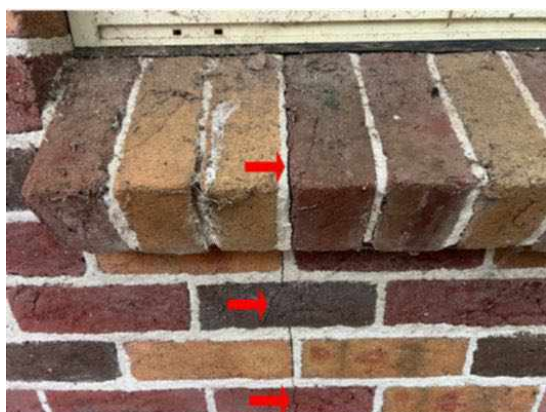
Building:	Main Building
Location:	Exterior walls - right side
Finding:	Brickwork - Cracking noticeable
Information:	There were several cracks and or crack repairs evident to external brickwork.

Noticeable cracks are a common occurrence in external brickwork and are a likely result of age expected building movement, general expansion, and/or contraction of building materials in different weather conditions. Noticeable cracks in brickwork may develop if left unattended, with potential for necessitating major remedial works or

replacement of the brickwork.

It is highly advised that a qualified bricklayer be appointed to provide necessary works to cracked brickwork to prevent any further damage. Such works should be conducted as soon as possible.

Always monitor these cracks and contact a building inspector should cracks widen, lengthen, or become more numerous.

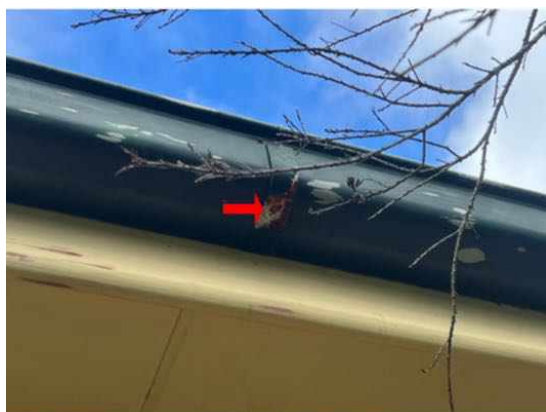
Building: Main Building
 Location: All External Areas
 Finding: Gutter brackets - Rusted or corroded
 Information: This building element shows evidence of rusting and corrosion, which is likely to have developed as a result of excessive exposure to moisture and or inadequate coatings.

As surface rust provides no protection to the underlying iron, the deteriorating condition is likely to worsen if not addressed in the short-term future.

Where possible, the use of galvanized (treated) metals or aluminium coated metals aid in rust prevention, as does regular general maintenance. Rust formation can be

controlled with coatings, such as paint, that isolate the iron from the environment.

Rusting and corrosion should be managed by ideally removing or limiting the affected surface from exposure to moisture. A registered builder may be appointed to replace any building elements that have been severely affected by rust or water damage.

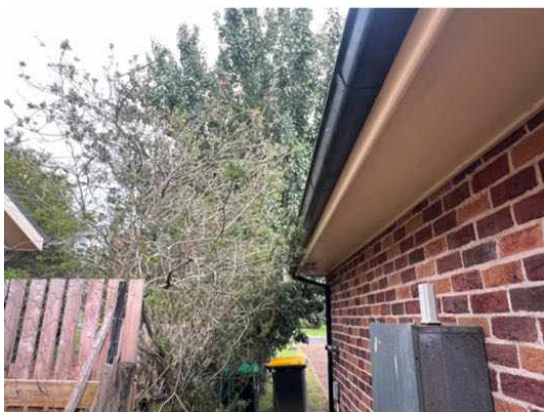
Finding 3.17

Building:	Main Building
Location:	Roof Exterior
Finding:	Gutters - Blocked
Information:	Roof plumbing structures, such as guttering and downpipes, should be free of all debris to prevent blockages. Blockages of the guttering and downpipes will lead to pooling and accumulated water overflows, which is likely to subsequently flood eaves and exterior walls.

It is highly advised that all overhanging tree branches be removed as soon as possible to prevent any further damage. Repair and/or replacement of sections of damaged guttering may also be required where the extent of the damage necessitates.

Such works should be performed by the homeowner; however, appointment of a landscape contractor or an arborist may be required. Consultation with a licensed roof plumber is required where guttering has been damaged.

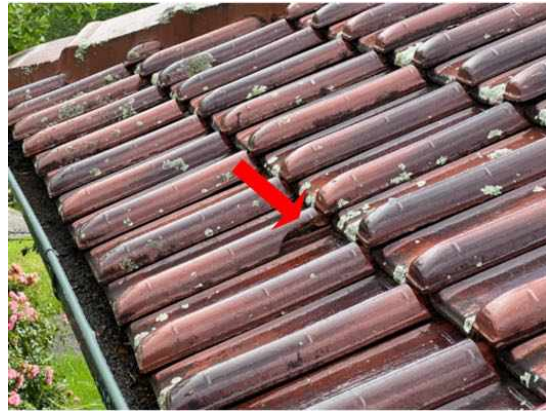
Finding 3.19

Building:	Main Building
Location:	Roof Exterior
Finding:	Roof tiles - Broken
Information:	Upon inspection of the exterior roof covering, broken roofing tiles were identified. Broken and friable roof tiles are generally the result of ageing and weathering of what is essentially a porous material.

Replacement of broken tiles is required and should be performed by a roofing contractor as soon as possible.

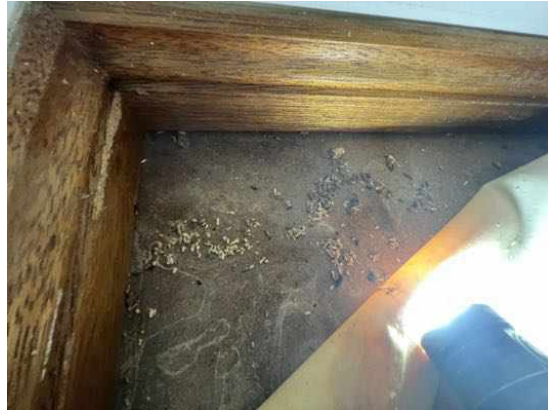
Finding 3.32

Building:	Main Building
Location:	Kitchen
Finding:	Vermin Activity - Evidence Observed
Information:	Evidence of vermin activity was observed within the property, including droppings and odour in accessible areas.

If left unmanaged, vermin activity may continue and result in further deterioration of building materials and hygiene concerns.

It is highly advised that a licensed pest controller be appointed to address the infestation and implement appropriate control measures.

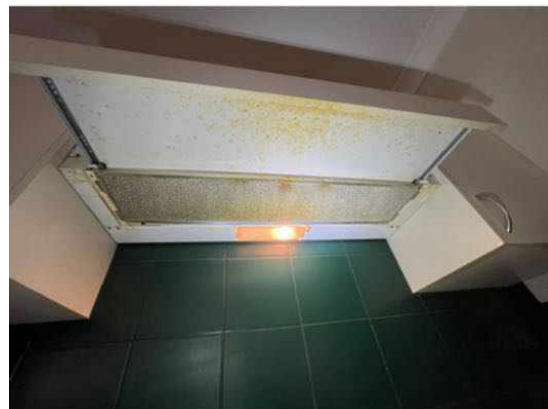
Finding 3.33

Building:	Main Building
Location:	Kitchen, Bathroom
Finding:	Surface - Requires cleaning
Information:	Regular cleaning and maintenance improves the longevity of all building elements. A build up of dirt and debris can reduce the useful life of building materials and may result in earlier replacement of items being required.

Excessive dirt is also likely to lead to secondary hazards, including potential health hazards, as the building elements begin to harbour bacteria and/or mould.

Remedial cleaning is recommended in order to improve the appearance of this area as well as to counteract the development of bacteria. Such works can be performed by a cleaning contractor and should be completed at the discretion of the client.

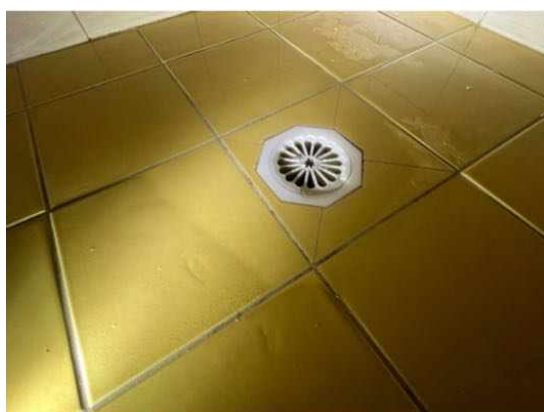
This pooling is minor overall but is still considered unsatisfactory, as standard tiling practices would not permit this situation to occur. Pooling water around floor wastes can create a slip hazard in extreme cases and create conditions that are conducive to mould growth over time. Where left unmanaged, the degradation of sealant and grouting is also likely to occur, possibly necessitating further repair works.

Remedial works may involve some sections of tiling and flooring repair and replacement. A tiling contractor or bathroom specialist should be appointed to provide further advice on reparation options and to perform works as necessary.

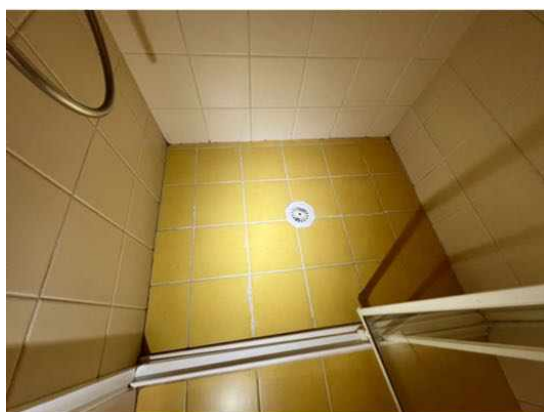
If left unmanaged, this condition may contribute to gradual deterioration of grout joints and affect the overall presentation of the surface.

Cleaning and maintenance of the affected areas is advised to manage buildup and maintain the condition of the tiled surface.
