Building Inspection Report

Inspection Date: Thu, 9 Apr 2026

Property Address: 55 Seaway Rd, Hallett Cove SA 5158,
Australia

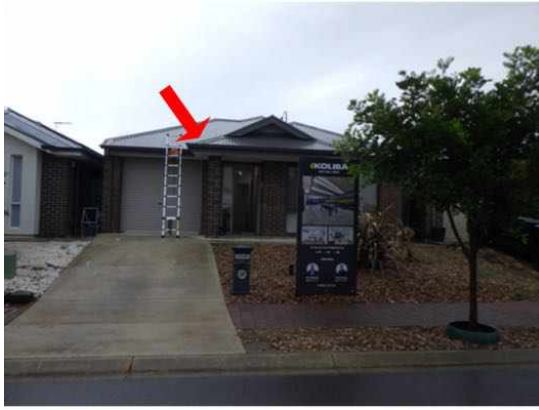
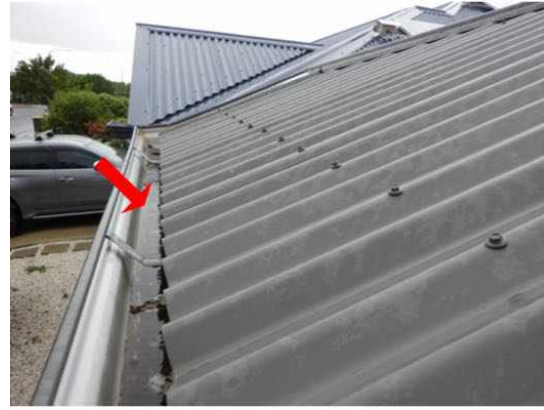
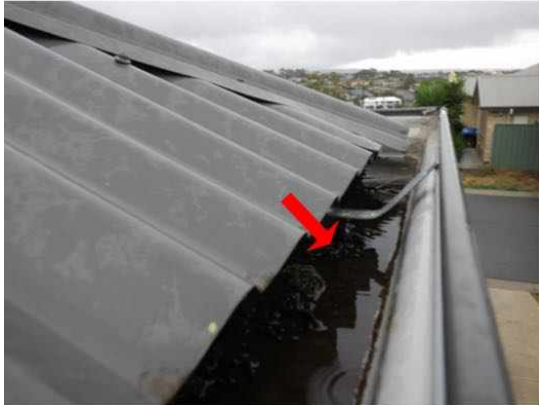
Defects 3.01

Building:	Building 1
Location:	All External Areas
Finding:	Gutters - Blocked
Information:	At the time of inspection it was noticed that gutters were blocked in few sections around the property. Gutters have to be cleaned in regular intervals.

Roof plumbing structures, such as guttering and downpipes, should be free of all debris to prevent blockages. Blockages of the guttering and downpipes will lead to pooling and accumulated water overflows, which is likely to subsequently flood eaves and exterior walls.

Blocked gutters are likely to lead to high levels of moisture in the affected areas. Such moisture will not only cause rust and decay of the associated building materials, but can also provide conditions that are conducive to termite and timber pest activity. Blockages in gutters should therefore be removed immediately to ensure dry conditions are maintained.

Consult a Licensed Plumber for further specific advice on remedial works that may be required. In the interim, it is highly advised that blocked gutters be removed by the homeowner or a general handyperson as a matter of urgency.

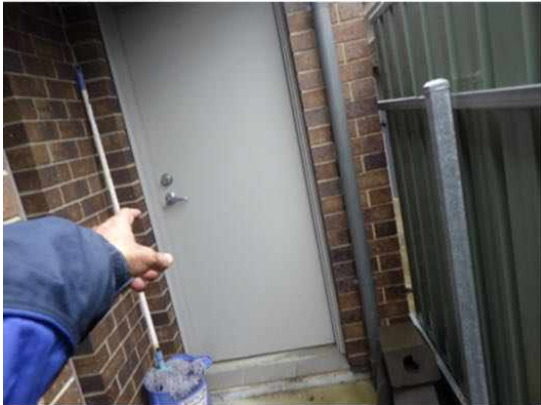
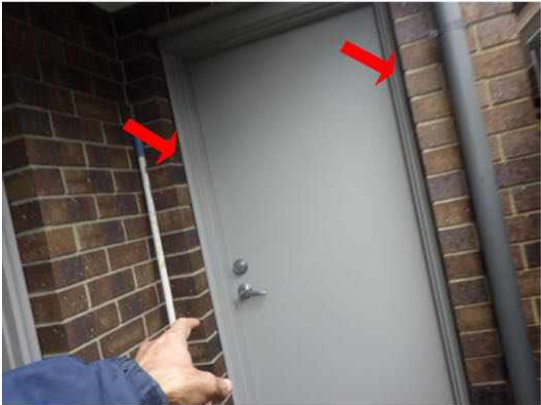
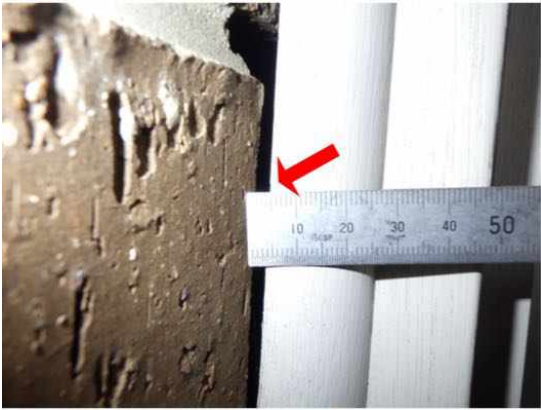
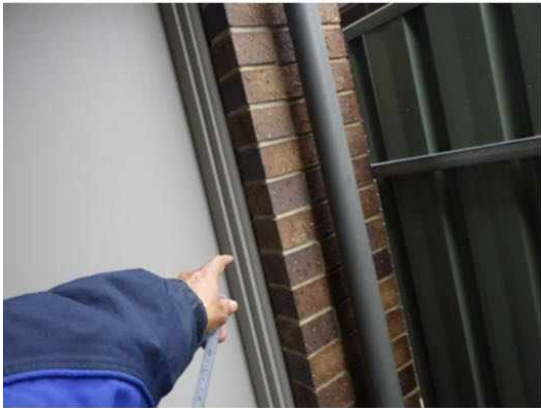
Defects 3.02

Building:	Building 1
Location:	All External Areas
Finding:	Rear Garage Area- External walls & Door frame assembly - Significant gaps
Information:	At the time of inspection it was noticed that significant gaps between external walls and door frame assembly in this rear garage area.

Breakage occurs generally when the building materials have either aged and decayed, or as a result of damage (accidental or deliberate).

Repair and/or replacement of broken elements is advised to ensure that additional secondary defects do not arise as a consequence. Such works are necessary, as all building elements play a key role in the operation and function of the overall structure and its performance.

A relevant tradesperson should be appointed to repair or replace the affected building element prior to any subsequent damage being caused.

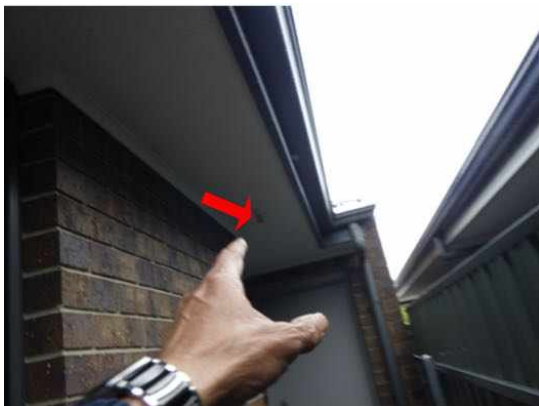
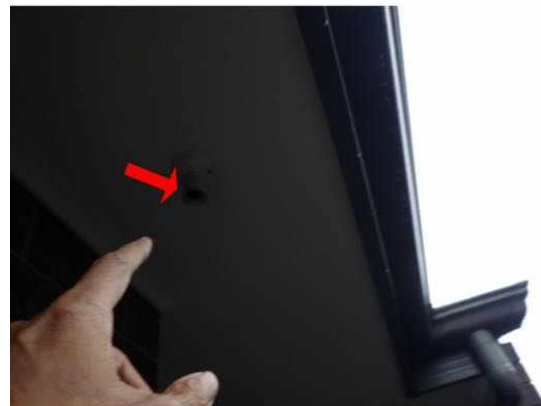
Defects 3.03

Building:	Building 1
Location:	All External Areas
Finding:	External Area - Eaves - Globe Missing
Information:	At the time of inspection it was noticed that one globe is missing from this eaves area.

Replacement of any missing building element should be conducted as soon as possible to ensure that no damage or functional issues occur to associated building materials.

The appropriate tradesperson should be appointed to replace the missing building element.

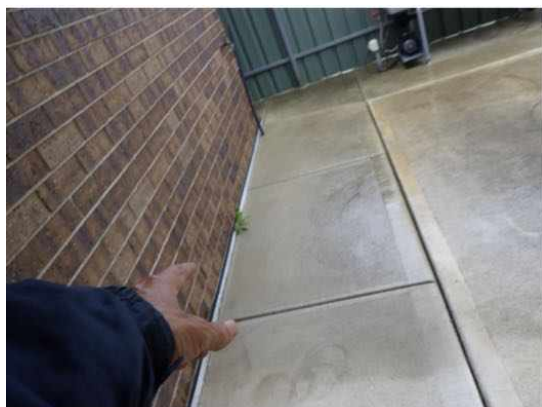
Defects 3.04

Building:	Building 1
Location:	All External Areas
Finding:	Bridging - Vegetation
Information:	Where vegetation obstructs inspection of building elements, also known as bridging

as it provides a bridging point for the access of termites, full inspection can not be achieved. Consequently moisture or dampness may be present and the areas becomes conducive to termite activity. Plants against or very close to buildings provide cover, shade and can provide an environment that is attractive to termite infestation.

The removal and replanting of species that do not provide "cover" or cutting back of existing vegetation will assist greatly in preventing Bridging from occurring.

The removal of any such materials that may be conducive to termite activity should be carried out as soon as possible and arrange re inspection to minimize the risk of termite attack.

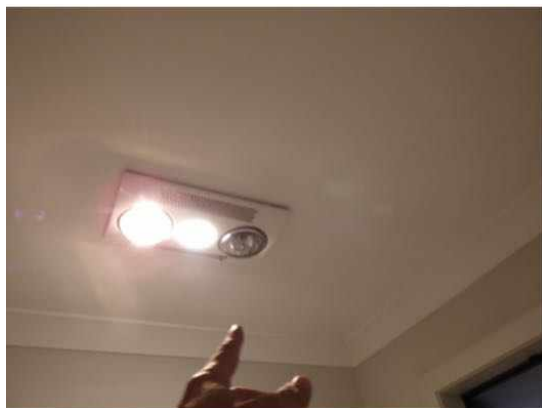
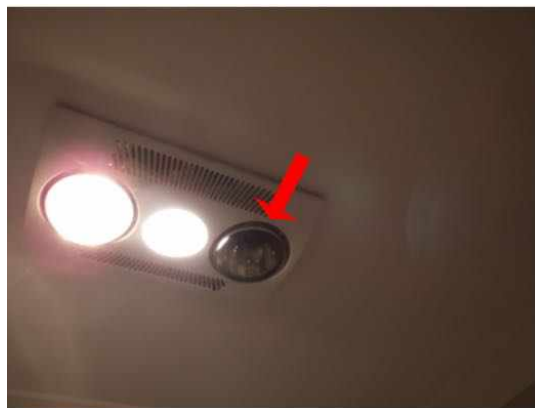
Defects 3.05

Building:	Building 1
Location:	Bathroom - Ensuite
Finding:	Bathroom - Ensuite - One globe - Not operating
Information:	At the time of inspection it was noticed one globe is not operational in this bathroom - ensuite area.

Non-operational items should be addressed to ensure that the full function of the building structure is available. Where some building elements are not operating as intended, it is possible that secondary building defects could arise due to their non-operation.

Repair and/or replacement of the faulty building element is recommended. It is highly recommended that the relevant tradesperson be engaged to perform any necessary works.

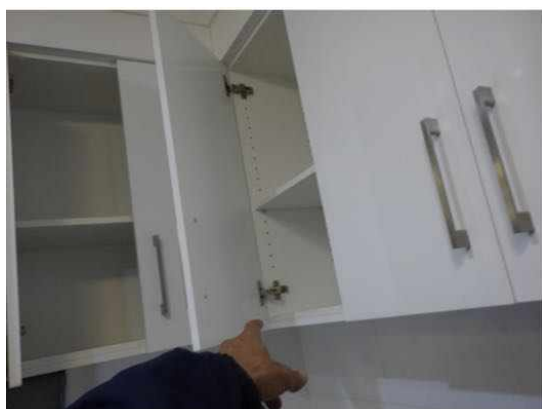
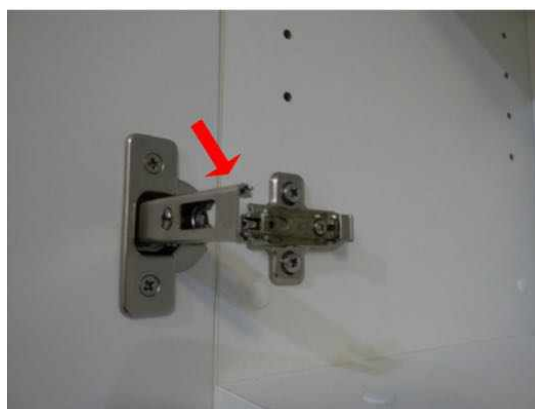
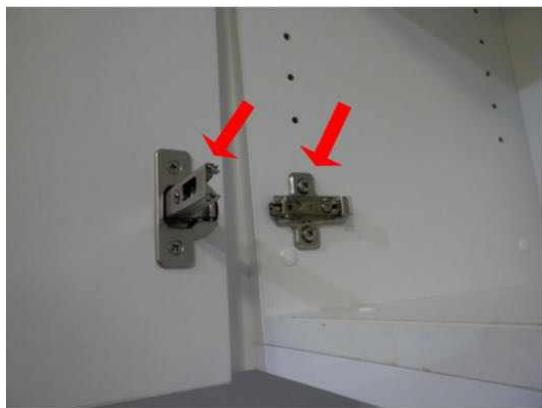
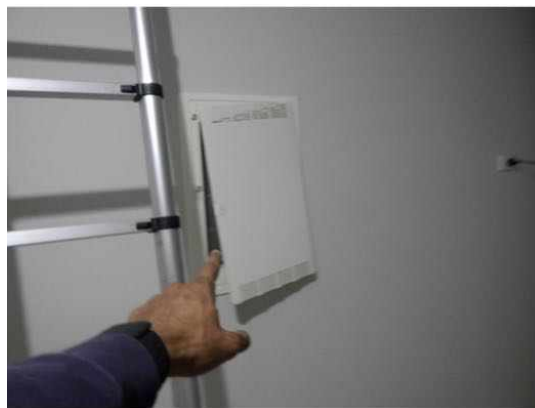
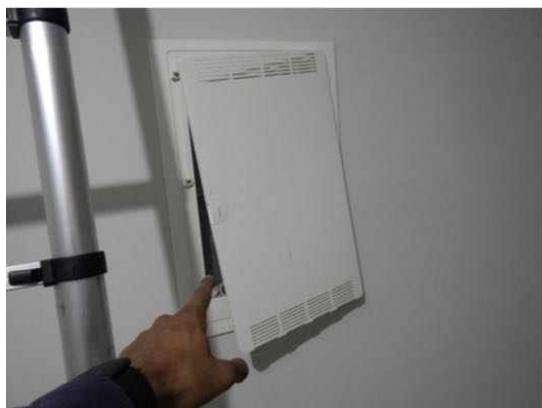
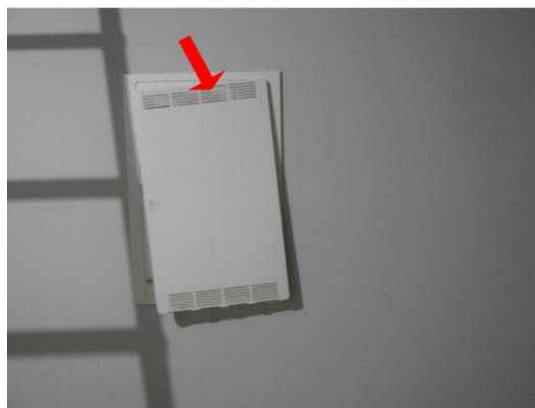
Defects 3.06

Building:	Building 1
Location:	All Internal Areas
Finding:	Building element - Damaged
Information:	At the time of inspection it was noticed that cabinets hinges were damaged in this kitchen area . Apart from that at the time of inspection it was also noticed that electrical panel was damaged in this garage area.

Breakage occurs generally when the building materials have either aged and decayed, or as a result of damage (accidental or deliberate).

Repair and/or replacement of broken elements is advised to ensure that additional secondary defects do not arise as a consequence. Such works are necessary, as all building elements play a key role in the operation and function of the overall structure and its performance.

A relevant tradesperson should be appointed to repair or replace the affected building element prior to any subsequent damage being caused.

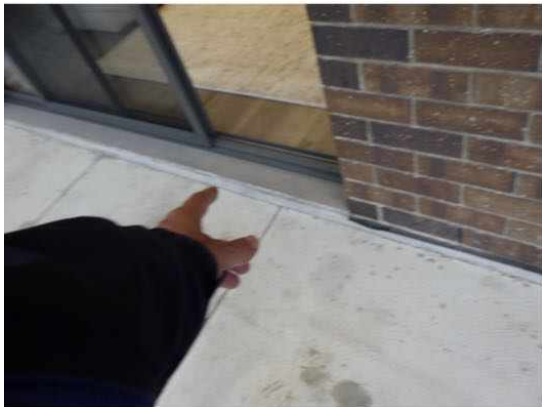
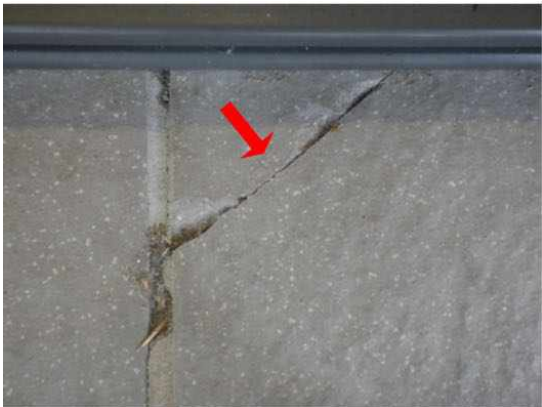
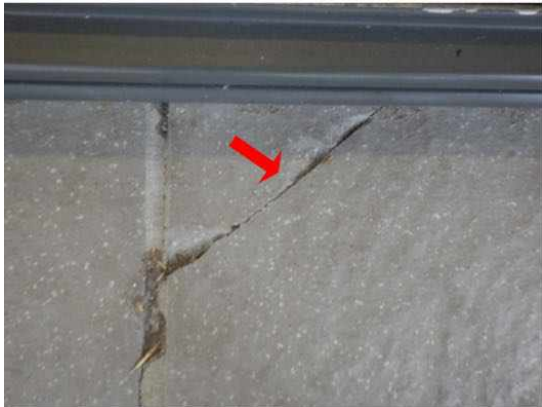
Defects 3.07

Building:	Building 1
Location:	All External Areas
Finding:	Tiles - Cracked or damaged
Information:	Cracking was evident to the tiling in this alfresco area at the time of inspection. While the cracking appears to be minor, this area is frequently exposed to water, allowing potential for water penetration into adjoining sections of walls or flooring.

If left unmanaged, water penetration to these areas may lead to subsequent water damage, which is likely necessitate repair work to affected building elements.

A tiling contractor should be appointed to ensure that no further water damage occurs. The re-application of silicone and grouting throughout remaining tile work is also advised, to further protect the area against water penetration.

Where water penetration has led to water damage, appointment of a relevant tradesperson may be required to repair damaged building elements.

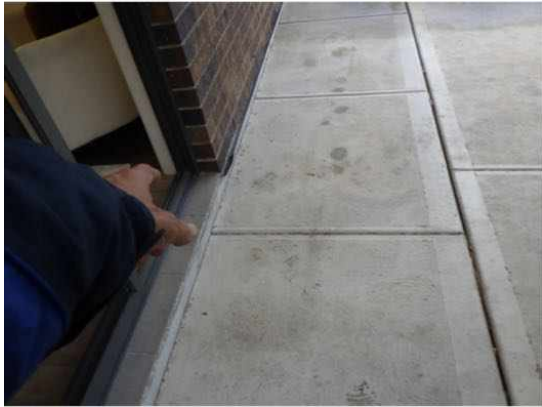
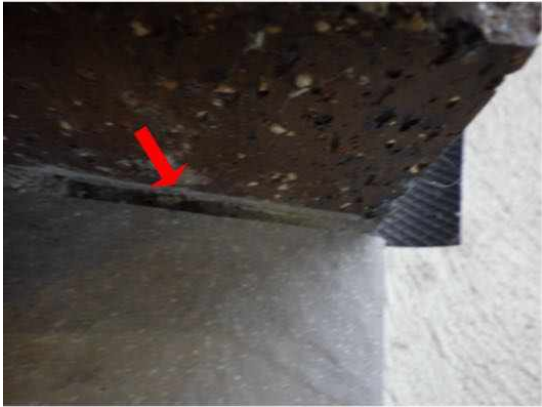
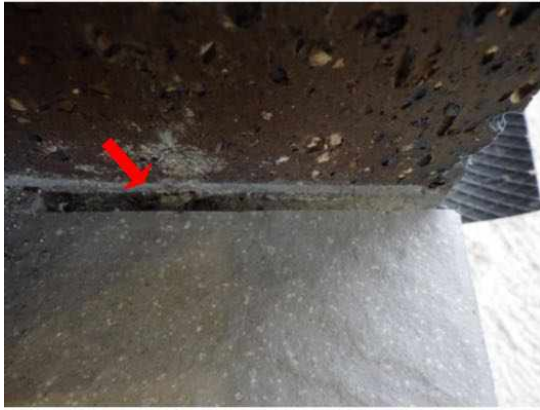
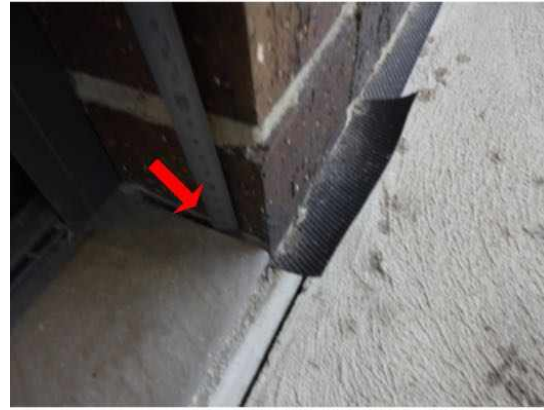
Defects 3.08

Building: Building 1
Location: All External Areas
Finding: Grout - Missing
Information: Grout is missing in this alfresco area. Grout is used to protect gaps and crevices in building materials to ensure that they are water-tight and prevent water penetration to the associated structures.

Where grout is missing, a tiling contractor should be appointed immediately to apply grout and re-apply any silicone where necessary. Failure to do so is likely to lead to water damage to the surrounding area.

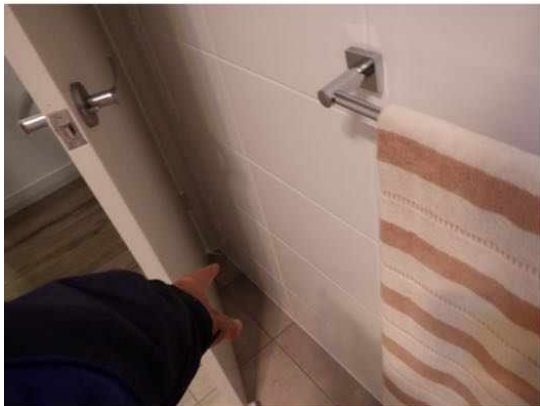
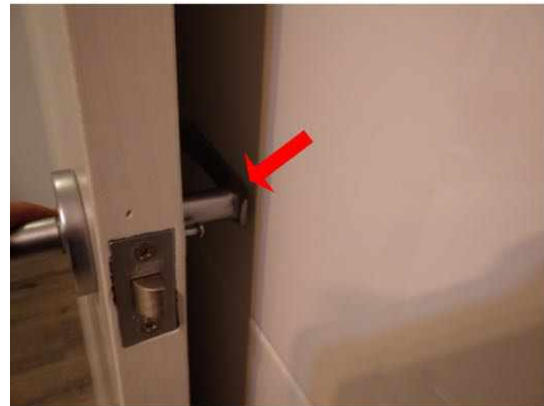
Defects 3.09

Building:	Building 1
Location:	All Internal Areas
Finding:	Door stop - Missing
Information:	The door stop is missing or is inadequate to stop the door handle from damaging the wall. Although some building elements may seem irrelevant or unnecessary, all building elements play a key role in the operation and function of the overall structure and its performance.

Re-installation or replacement of the door stop is advised as soon as possible to prevent any subsequent damage to the door or associated structures. A general handyman may be appointed to perform these works at client discretion.

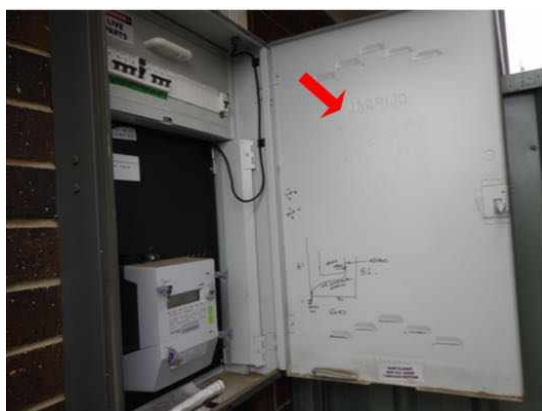
Building:	Building 1
Location:	All External Areas >
Finding:	Termite Management System - No evidence of a chemical installation
Information:	The application of a post-construction chemical termite barrier is highly recommended for all properties, particularly if live termite activity has been found on the site previously. Such barriers are highly effective in preventing termite attack on any timber building elements throughout the property.

A durable notice should be placed in the switchboard unit to indicate current termite barriers. At the time of inspection, it appeared as though no termite management system has been installed, with no evidence to suggest preventative works taking place.

The client may consider gaining further advice from a pest controller as to the costs and procedures involved with this application. It is recommended that obtaining such advice be a short-term priority.

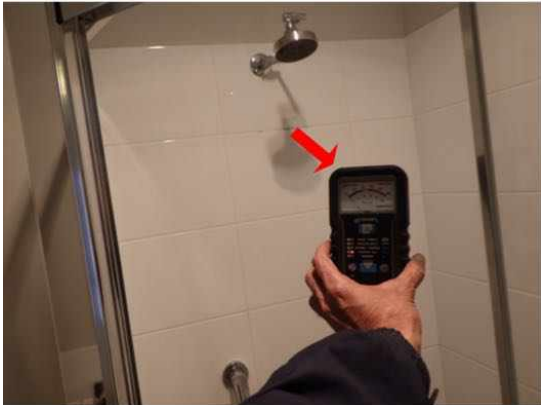
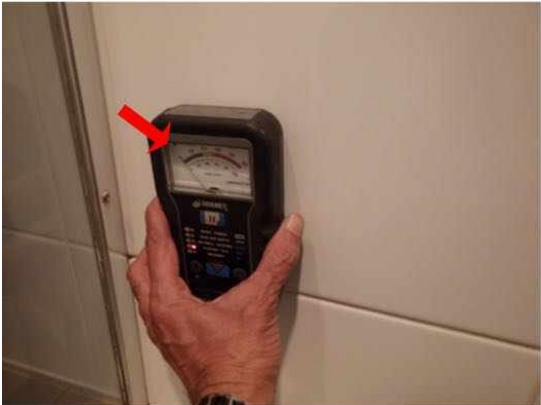
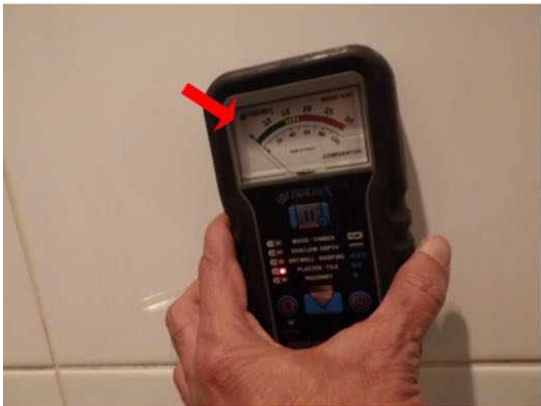
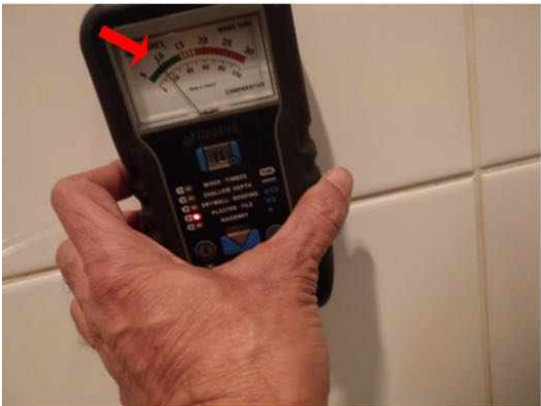
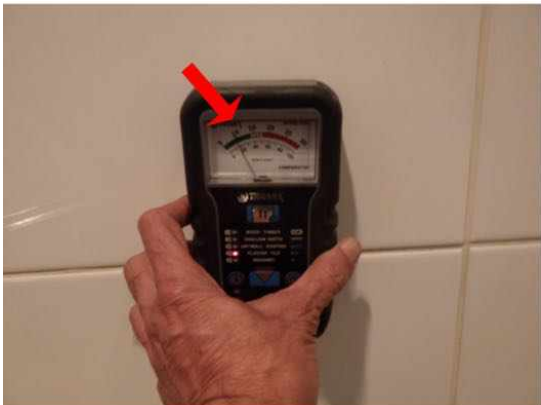
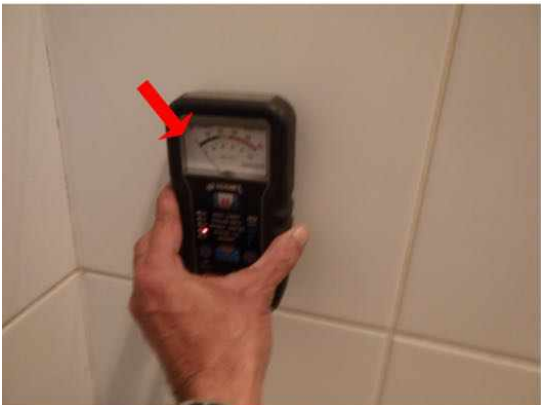
Building:	Building 1
Location:	Bathroom-Ensuite
Finding:	Shower Alcove - No Damp
Information:	At the time of inspection it was noticed that damp is not evident to the shower alcove.

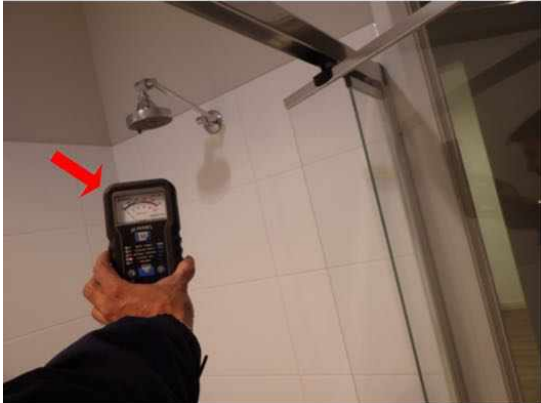
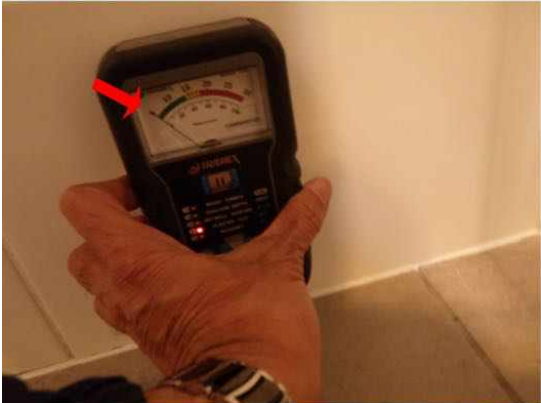
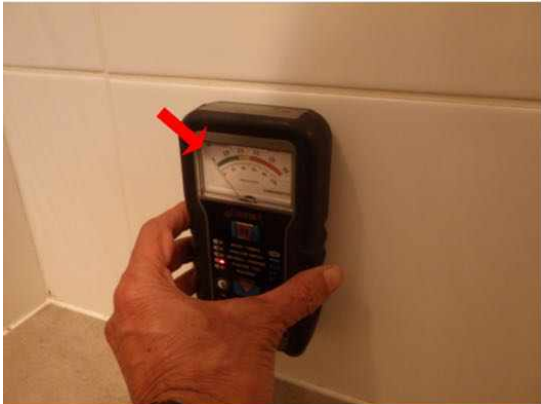
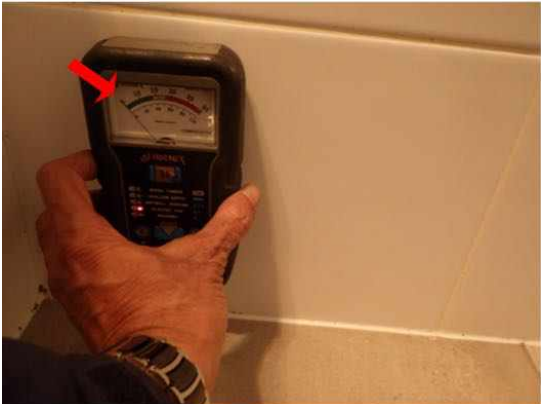
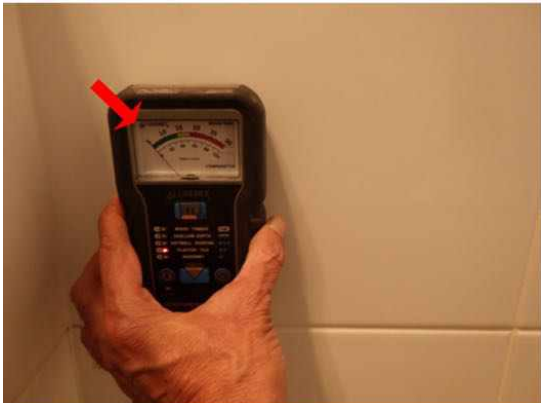
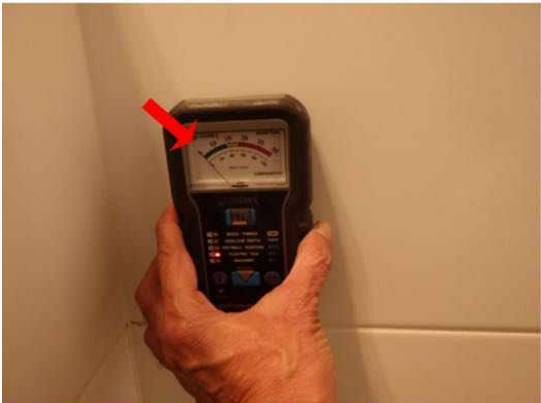
Building: Building 1
Location: Bathroom 2
Finding: Shower Alcove - No Damp
Information: At the time of inspection it was noticed that damp is not evident to the shower alcove.
