Building Inspection Report

Inspection Date: Thu, 1 Jan 2026

Property Address: 37 Leopold St, Caulfield South VIC 3162,
Australia

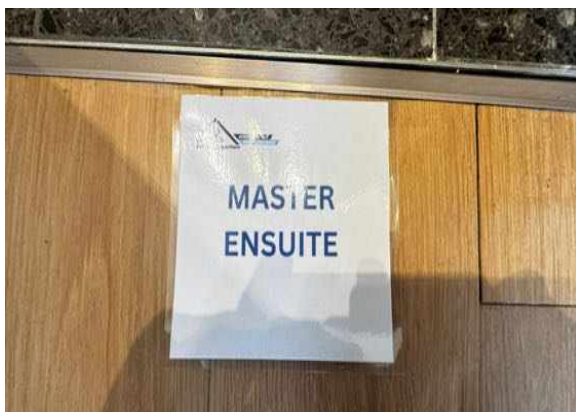
Defects 3.03

Building: Main Building
Location: All Areas >
Finding: Building Element - Swollen
Information: Swollen building elements generally indicate that the building materials have been affected by excessive moisture over a prolonged period of time, and have swollen as a result.

The formation and development of mould/fungi or mildew is also a likely consequence of excessive moisture if left unattended. Excessive moisture is likely to lead to the development of secondary damage to any associated building elements.

Rectification of the cause of the water leak should be addressed prior to any remedial works to the swollen building elements. It is also likely given the previous fridge leaks and damaged the surrounding building elements.

A licensed plumber, bathroom specialist or licensed remedial builder should be appointed to identify the cause of the leak and provide advice on remedial works as necessary.

Repair and/or replacement of swollen building elements may then be conducted by a qualified carpenter or general handyman at the clients discretion.

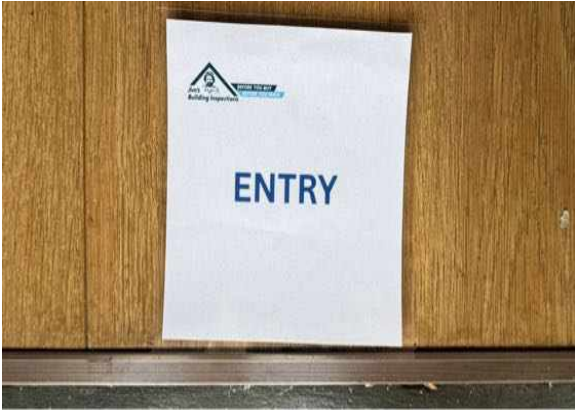
Defects 3.04

Building:	Main Building
Location:	All Areas >
Finding:	Paint - Paint Finish Substandard
Information:	The paint finish in this area was found to have been completed to a substandard level. Substandard painting is generally classified as an appearance defect. However, the substandard appearance may also be indicative of poor surface preparation and substandard workmanship.

If this applies, further areas of poor and incomplete finishes could develop over time. Furthermore, substandard paint finishes in areas exposed to moisture, e.g. external areas or wet areas, could lead to deterioration of underlying building materials.

Substandard paint finishes should be sanded back, filled, leveled and repainted, as applicable. Where inadequate paint protection has led to the deterioration of the associated building element, repair and/or replacement of this building element may be required.

A painting contractor should be appointed as soon as possible to perform necessary works to aid the appearance of the affected area and to ensure that the area is protected against further deterioration. Alternatively, the homeowner following manufacturer instructions may be able to provide this service.

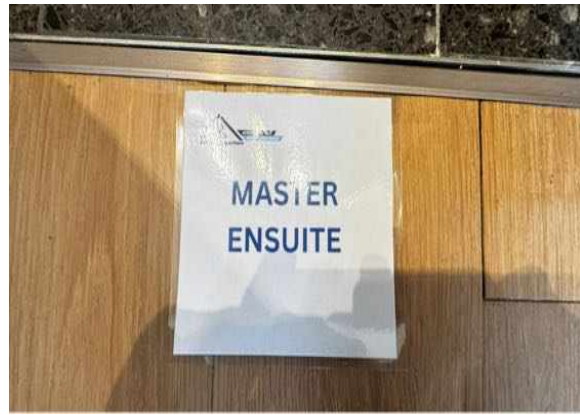
Defects 3.05

Finding: Doors - Missing Door Stops

Information: The inspection identified missing door stops in this area. Missing door stops can lead to damage to walls or doors and may impair the proper operation of the doors.

It is recommended that a qualified carpenter or competent handyman be engaged promptly to install the missing door stops. Correct installation will protect doors and walls and ensure proper door functionality.

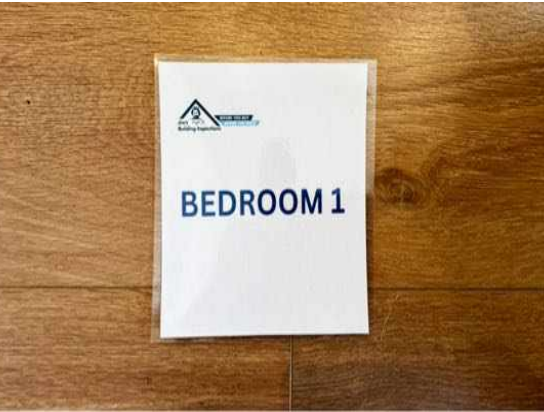
Defects 3.06

Building: Main Building
 Location: All Areas >
 Finding: Windows - Stiff To Open
 Information: Windows were observed to be stiff to open in this area. The stiffness can make the window difficult to operate, reduce usability, and may increase the risk of damage if force is applied.

Possible causes include misalignment, worn hardware, or buildup of debris.

It is recommended that the building owners engage a window specialist or registered builder immediately to assess the window and adjust, repair, or service it to restore smooth operation.

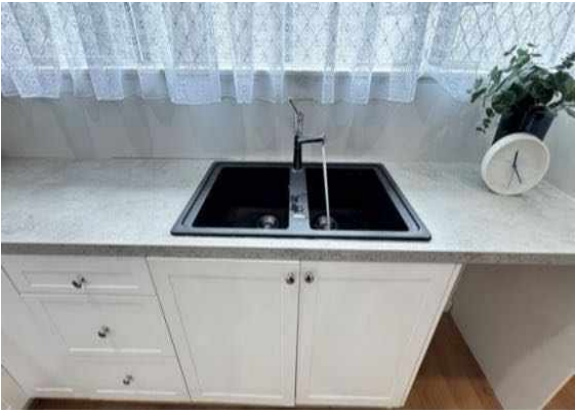
Defects 3.15

Building:	Main Building
Location:	Kitchen >
Finding:	Kitchen - Sealant Deteriated
Information:	The inspection identified sealant in the kitchen that is cracked, missing, deteriorated and failing. Defective sealant can allow moisture ingress, promote mould growth, and reduce the durability and hygiene of tiled surfaces and joinery.

This may have been caused by age-related deterioration of sealant, prolonged exposure to moisture, heat, or cleaning chemicals, or lack of routine maintenance and re-sealing.

A qualified tiler or competent handy man should be engaged immediately to remove the deteriorated sealant and apply new, compliant materials. Properly maintained sealant will prevent water ingress, maintain hygiene, and extend the life of tiled surfaces and cabinetry.

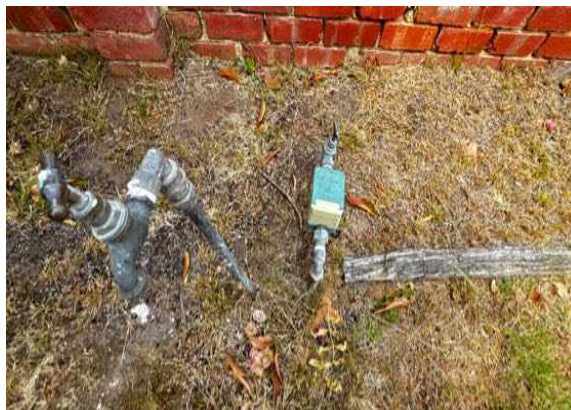
Noted Item

(AS 4349.1-2007: Water meter images are for your information only, as functional testing is outside the scope of a standard pre-purchase building inspection.)

It is recommended that a licensed plumber carry out routine inspections and maintenance to ensure continued safe and compliant operation. Observations are for informational purposes only and do not form part of a full safety or compliance inspection.
