Building and Timber Pest Inspection Report

Inspection Date: Wed, 18 Mar 2026

Property Address: 5/45 Kirkham Rd, Auburn NSW 2144,
Australia

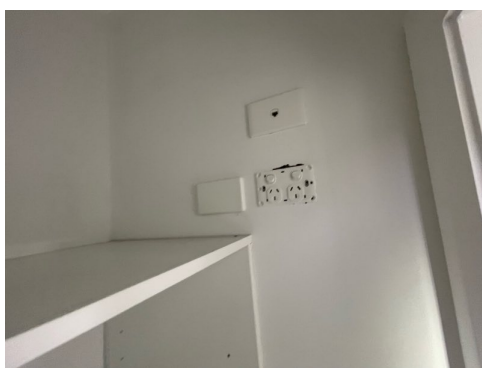
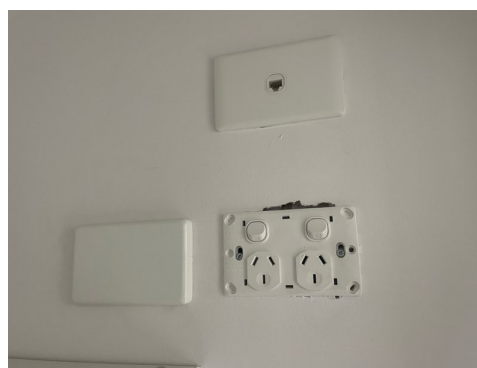
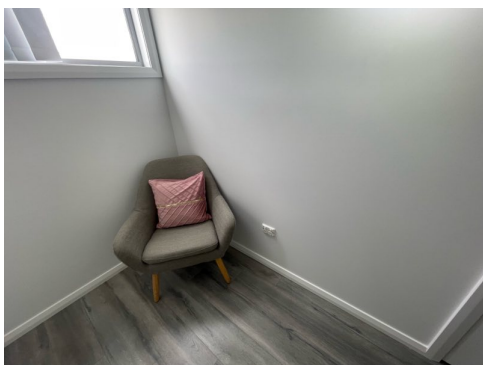
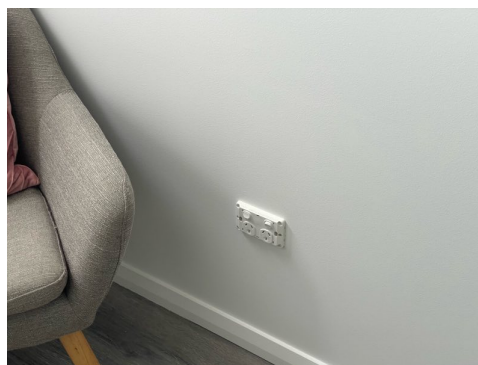
Finding: Electrical Socket – Cover Plate Missing

Information: During the inspection, it was observed that an electrical power outlet (socket) was missing its cover plate. This condition leaves internal components partially exposed and indicates incomplete installation or deterioration.

A missing cover plate presents a potential electrical safety hazard, including the risk of accidental contact with live parts, ingress of dust or moisture, and reduced protection of the outlet. This condition does not meet acceptable safety and maintenance standards.

It is recommended that the socket be made safe and the cover plate reinstated or replaced by a licensed electrician as a priority to restore safety and compliance.

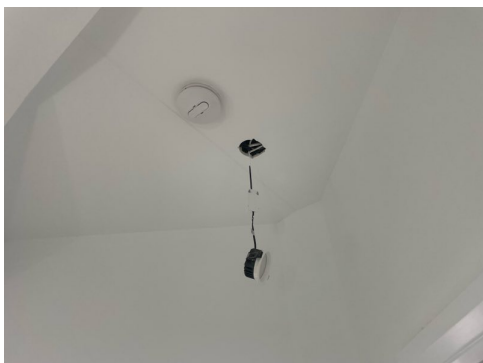
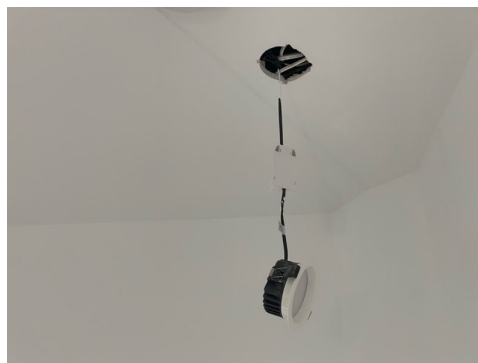
Finding 1.02

Finding: Electrical fitting - Broken

Information: The electrical fitting in this area was found to be broken at the time of inspection. Breakage occurs generally when the building materials have aged and decayed, but may also be indicative of impact damage to the building element (accidental or deliberate).

Left unmanaged, the fitting is unlikely to cause further damage to surrounding building elements. However, the broken fitting does expose electrical works, and may create a safety hazard if there is potential contact with persons in the area.

Repair and/or replacement of the broken fitting is advised. A Licensed electrician should be appointed to repair/replace the fitting immediately.

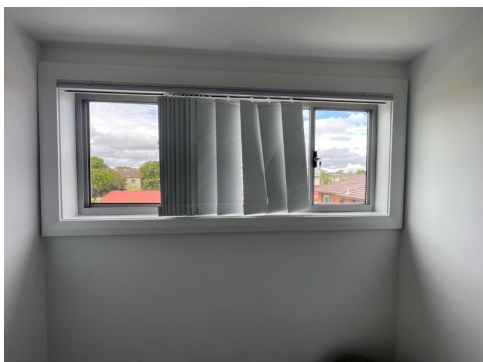
Finding 1.03

Finding: Window - Opening Restrictor / Barrier Missing

Information: During the inspection, a window was observed without an opening stopper/restrictor and with the required safety barrier protection missing. Where windows are located above lower ground levels or otherwise accessible, the absence of these safety measures may create an increased risk of falls, particularly for children.

Window opening control devices and barriers are important safety features intended to limit excessive opening and reduce the likelihood of accidental falls. Their absence indicates the window may not provide an adequate level of occupant protection in its current condition.

A qualified builder or suitably licensed contractor should be engaged to assess the affected window and install an appropriate window opening restrictor and/or compliant barrier system as required. This issue should be treated as a safety concern and addressed without delay.

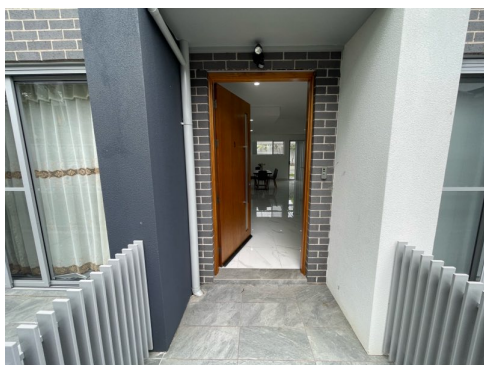
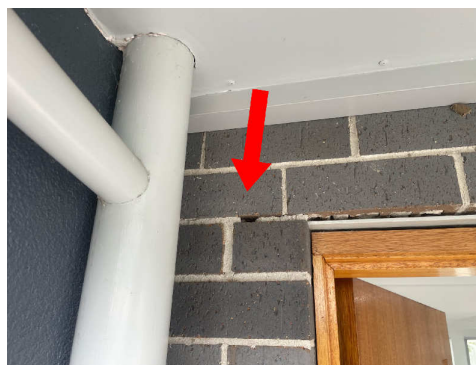
Information: During the inspection, multiple areas of the external brick wall were observed to have significant cavities within the mortar joints. These voids appear to be the result of poor mortar application or inadequate compaction during construction. The presence of these gaps compromises the wall's integrity, allowing moisture ingress and increasing the risk of long-term deterioration, including cracking, efflorescence, and reduced structural performance.

It is recommended that a qualified bricklayer or building contractor assess all affected areas and undertake remedial works, including raking out and repointing the defective joints with appropriate mortar.

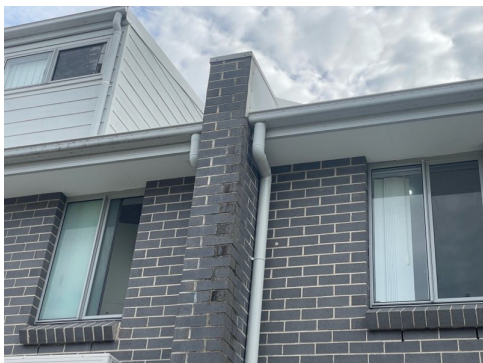
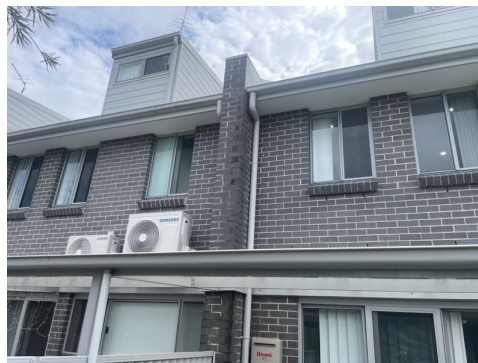
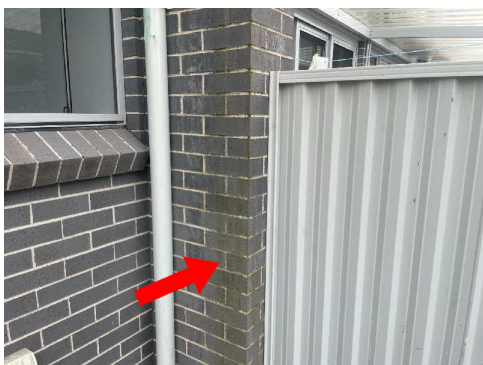
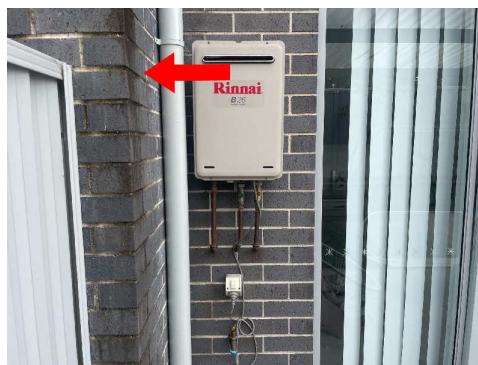
Finding 3.02

Finding: Wall / Step Flashings – Defective Weatherproofing and Moisture Damage

Information: During the inspection, areas of wall flashing and/or step flashing were observed to be inadequately detailed, with missing weathering folds, anti-capillary breaks and sealing. These components are important to help direct water away from wall junctions and prevent moisture tracking into the building envelope. Their absence increases the likelihood of water penetration at the affected locations.

Water marking and mould growth were also noted to the adjacent wall surface, which is consistent with past or ongoing moisture ingress. This suggests that the defective flashing and sealing arrangements may already be allowing water entry into the wall system. Prolonged moisture exposure can contribute to damage of wall linings, finishes and potentially concealed framing elements if not addressed.

A qualified roofing contractor or suitably experienced builder should be engaged to carry out further investigation and rectify the flashing installation and sealing to an appropriate weather-resistant standard. Any damaged or mould-affected wall finishes should be repaired once the source of moisture ingress has been identified and properly addressed.

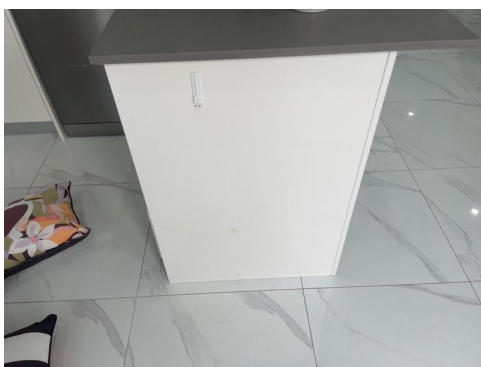
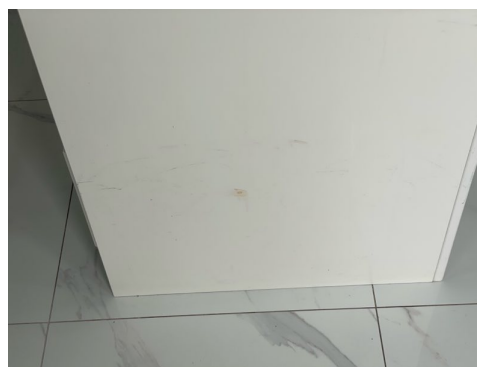
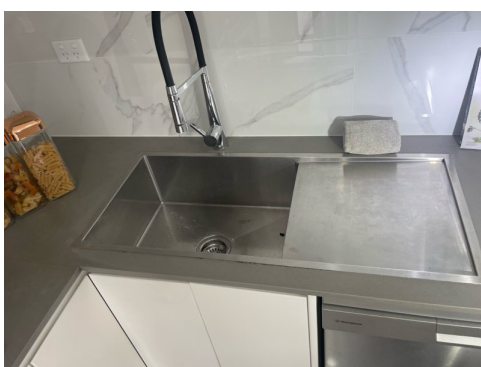
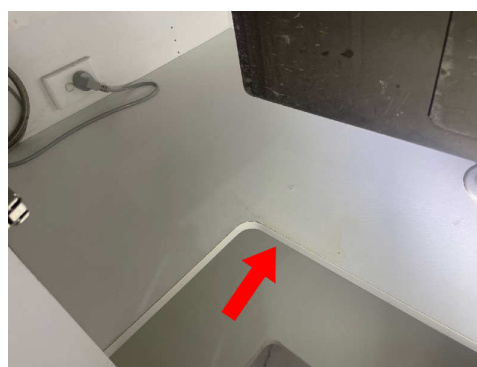
Finding 3.03

Some areas of the painted wall surfaces, ceilings, door frames, and other internal finishes were observed to have marks and scuffs, likely resulting from the normal use of the property. These marks do not indicate structural damage but have affected the overall aesthetic appearance of the internal spaces.

If left unaddressed, the marks may become more noticeable over time, particularly in high-traffic areas, which could reduce the visual appeal of the interiors. The integrity of the paint and finishes is not compromised, but cosmetic touch-ups may be required to maintain a uniform presentation.

It is recommended that the affected surfaces be cleaned or repainted in the near future by a suitably qualified tradesperson to restore the appearance and uniformity of the internal finishes. Regular maintenance of painted surfaces, including walls, ceilings, and trims, can help prolong their life and visual quality.

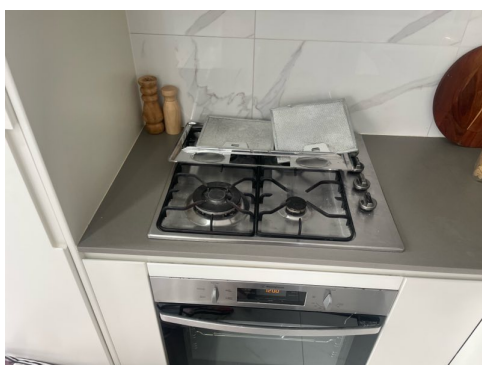
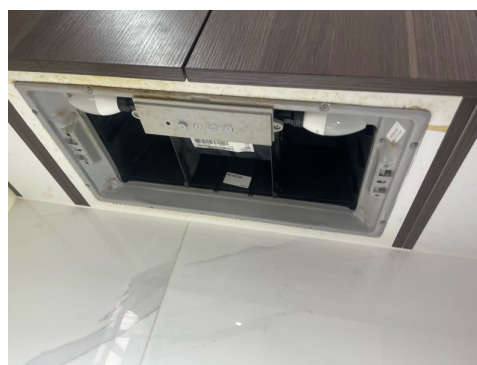
**Finding 3.04**

Finding: Rangehood – Defective / Non-Operational

Information: During the inspection, the rangehood was found to be defective at the time of assessment. The unit did not appear to be operating as intended and was not in proper working condition when tested.

A defective rangehood may reduce the effective extraction of cooking fumes, steam, grease and odours from the kitchen area. Over time, this can contribute to moisture build-up, staining and general deterioration of adjacent finishes if not addressed.

A qualified electrician and/or appliance technician should be engaged to further assess the rangehood, determine the cause of the defect and carry out the necessary repair or replacement as required.

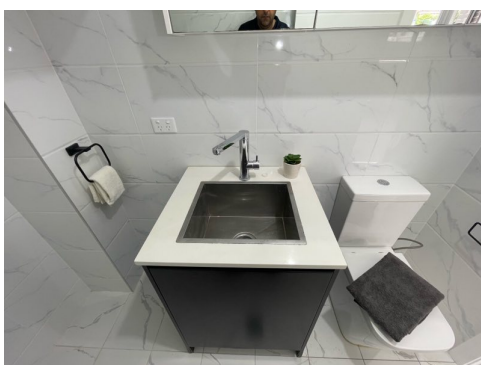
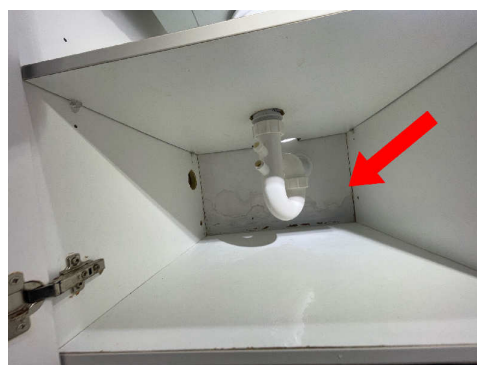
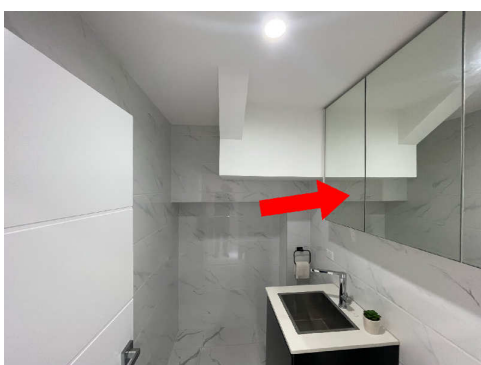
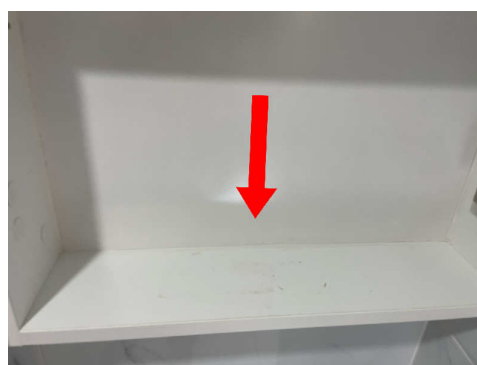
Finding 3.05

Finding: Bathroom Vanity – Damaged (Scratches, Water Staining, Wear & Tear, Broken Shelf)

The bathroom vanity was observed to be in a damaged condition at the time of inspection, including visible scratches to the vanity surfaces, water staining, general wear and tear, and a broken internal shelf. This condition affects both presentation and serviceability of the fixture.

The observed staining and deterioration may be consistent with ongoing moisture exposure (splashing, minor leakage, or poor drying/ventilation) combined with normal use over time. Where laminated or painted finishes are scratched, worn, or water stained, the protective coating can be compromised, which may allow moisture absorption and lead to swelling, delamination, and progressive deterioration of the cabinet materials.

It is recommended that the client arrange further assessment and repair or replacement of the affected vanity components as required to restore function and reduce the risk of further deterioration. If water staining is active or worsening, it is also recommended that the plumbing and surrounding junctions (basin waste, taps, silicone seals, and adjacent wall/floor interfaces) be checked to confirm there is no ongoing leak contributing to the damage.

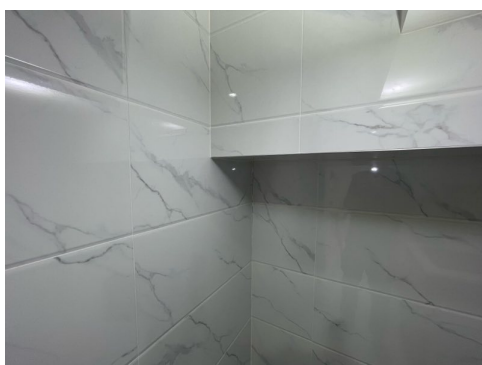
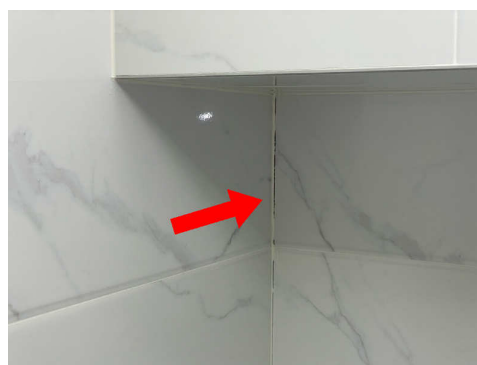
Finding 3.06

Building:	Main Building
Location:	Toilet (WC) Ground Level
Finding:	Sealant and grouting - Missing or damaged
Information:	It was noted on inspection that sealant or grout is degraded to the tiled shower alcove and or other areas of the bathroom.

Different materials and floor areas move at different rates, generally causing cracking to grout or sealant at this point. A flexible sealant is required to allow for expected expansion and contraction, while keeping the joint water tight and protective of all associated building materials.

There appears to be excessive mould to the sealant and grout which will likely require scraping out and replacement.

Flexible and mould resistant materials should be applied to affected areas to prevent any subsequent water damage that is likely to occur. Regular maintenance and replacement of damage or missing or damaged sealant and grout is highly recommended to the wet areas, as this is a regular wear and tear defect. Sealant and grouting in areas that come into regular contact with water should be maintained for the long term care of your property.

A sealant specialist or tiling contractor should be appointed to complete these works as soon as possible

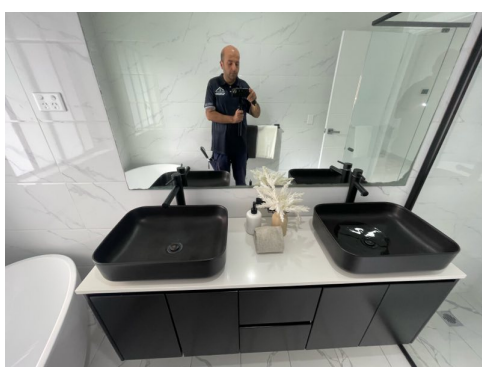
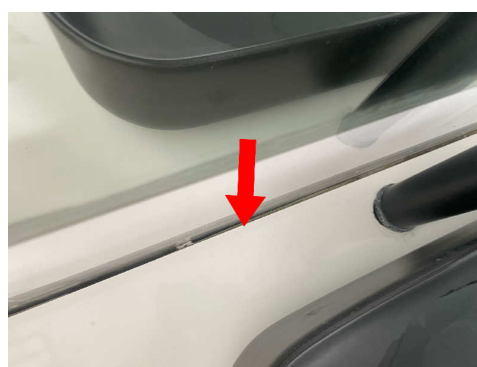
Finding 3.07

Building:	Main Building
Location:	Bathroom
Finding:	Cabinetry – Missing or Deteriorated Corner Sealant

Information: The cabinetry was observed to have missing or deteriorated sealant at the internal corners. In some areas, the sealant had not been applied, while in others it had broken down and no longer provided an effective seal.

Incomplete or deteriorated sealant can allow water, moisture, or debris to penetrate behind cabinetry panels, which may lead to swelling, staining, or damage to the cabinetry materials over time. It also detracts from the overall finish and appearance of the installation.

This matter is considered a maintenance defect. It is recommended that the affected cabinetry corners be re-sealed by a suitably qualified tradesperson to restore protection and appearance.

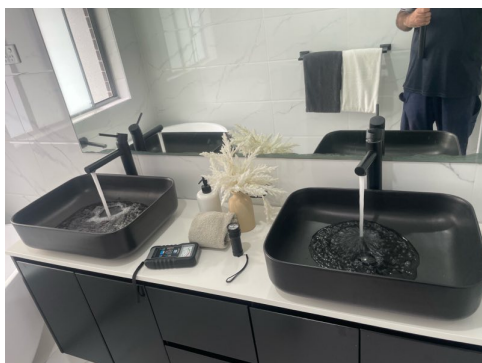
Finding 3.08

Finding: Loose Tap and Missing

Information: During the inspection, it was observed that the tap in this area has not been installed correctly, or has deteriorated with age, and is consequently loose. A loose tap creates the potential for water leaks and subsequent water damage to the surrounding finishes.

In addition, the tap handle to the bathtub basin was missing at the time of inspection. Missing handles reduce the functionality of the plumbing fixture and can make operation difficult or impossible. This condition also increases the likelihood of strain on the tap mechanism, leading to further deterioration or leakage.

It is recommended that a licensed plumber be appointed to re-secure the loose tap fitting and to supply and install a new handle for the bathtub basin tap. All remedial works should be completed in accordance with plumbing best practices to restore both safe operation and serviceability.

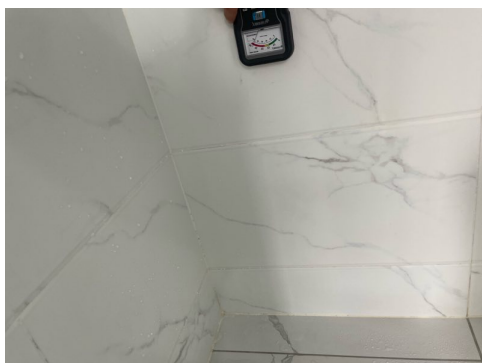
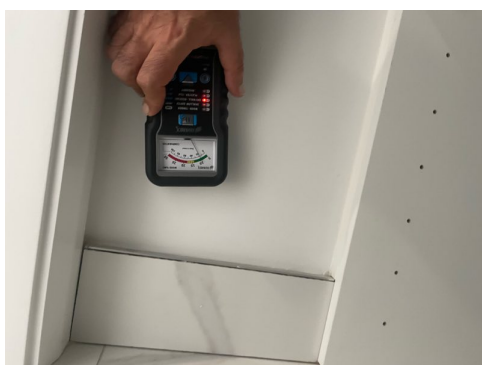
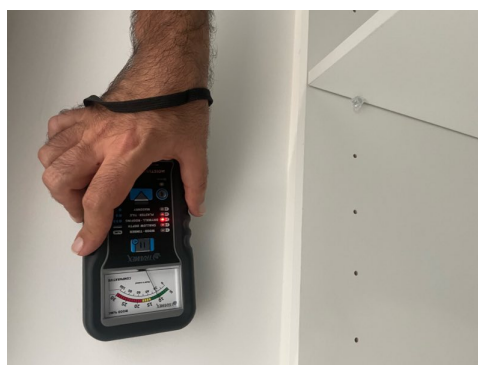
Finding 3.09

Finding: Shower Alcove Wall Damp - Elevated Moisture

Information: During inspection, damp was detected to the lower wall area of the shower alcove, extending up to approximately 1 metre. There were no elevated moisture readings identified around the taps, nor were there readings transferring through to the opposite side of the wall. The sealant appears to have been repaired recently, and both the sealant and grout are currently in acceptable condition.

This type of defect is quite common and is suspected to have been caused by moisture permeating or leaching through the grouting and/or gaps in the sealant prior to the recent repairs. Even when surface finishes appear intact, moisture can penetrate behind tiling and into the substrate over time.

Unmanaged damp in a shower recess is likely to facilitate mould and fungi growth, decay of associated building materials, and compromise of structural integrity. Excessive indoor moisture is also linked to the growth of microbes that can emit spores and cause health-related issues, particularly respiratory problems.

It is recommended that the affected wall area be rectified in the close future by a licensed plumber or bathroom waterproofing specialist to ensure the moisture issue is properly resolved. Monitoring should continue until rectification is carried out.

Ongoing maintenance of grout and sealant is essential to prevent future recurrence of damp conditions in the shower alcove.

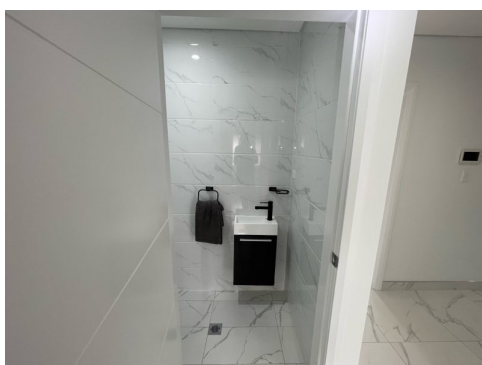
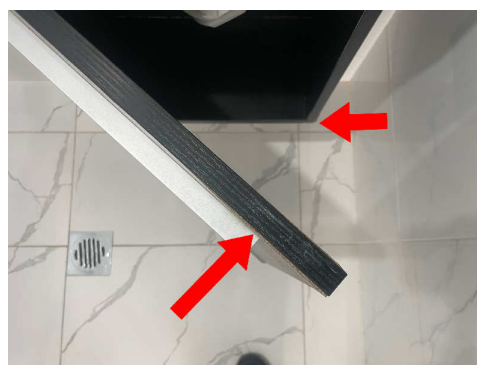
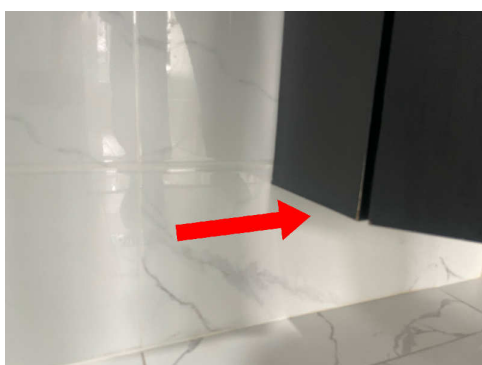
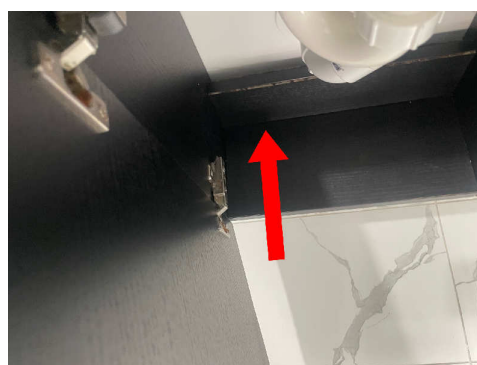
Finding 3.10

Finding: Bathroom Vanity – Damaged (Scratches, Water Staining, Wear & Tear, Broken Shelf)

The bathroom vanity was observed to be in a damaged condition at the time of inspection, including visible scratches to the vanity surfaces, water staining, general wear and tear, and a broken internal shelf. This condition affects both presentation and serviceability of the fixture.

The observed staining and deterioration may be consistent with ongoing moisture exposure (splashing, minor leakage, or poor drying/ventilation) combined with normal use over time. Where laminated or painted finishes are scratched, worn, or water stained, the protective coating can be compromised, which may allow moisture absorption and lead to swelling, delamination, and progressive deterioration of the cabinet materials.

It is recommended that the client arrange further assessment and repair or replacement of the affected vanity components as required to restore function and reduce the risk of further deterioration. If water staining is active or worsening, it is also recommended that the plumbing and surrounding junctions (basin waste, taps, silicone seals, and adjacent wall/floor interfaces) be checked to confirm there is no ongoing leak contributing to the damage.

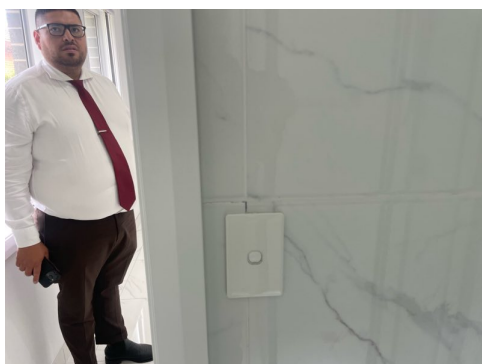
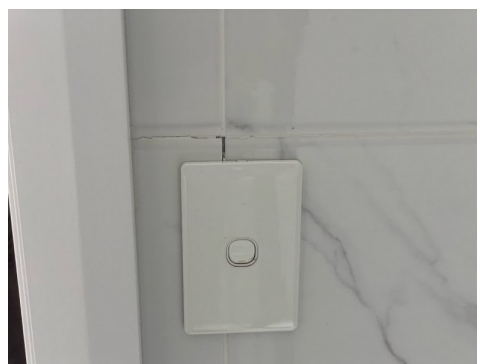
Finding 3.11

Building:	Main Building
Location:	Ensuite - Master
Finding:	Grout - Missing
Information:	Grout is missing in this area. Grout is used to protect gaps and crevices in building materials to ensure that they are water-tight and prevent water penetration to the associated structures.

Where grout is missing, a tiling contractor should be appointed immediately to apply grout and re-apply any silicone where necessary. Failure to do so is likely to lead to water damage to the surrounding area.

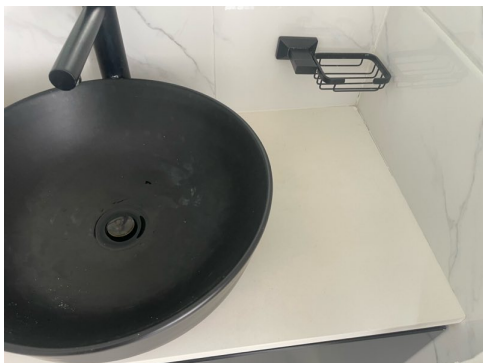
Finding 3.12

Building:	Main Building
Location:	Ensuite - Master
Finding:	Cabinetry – Missing or Deteriorated Corner Sealant
Information:	The cabinetry was observed to have missing or deteriorated sealant at the internal corners. In some areas, the sealant had not been applied, while in others it had broken down and no longer provided an effective seal.

Incomplete or deteriorated sealant can allow water, moisture, or debris to penetrate behind cabinetry panels, which may lead to swelling, staining, or damage to the cabinetry materials over time. It also detracts from the overall finish and appearance of the installation.

This matter is considered a maintenance defect. It is recommended that the affected cabinetry corners be re-sealed by a suitably qualified tradesperson to restore protection and appearance.

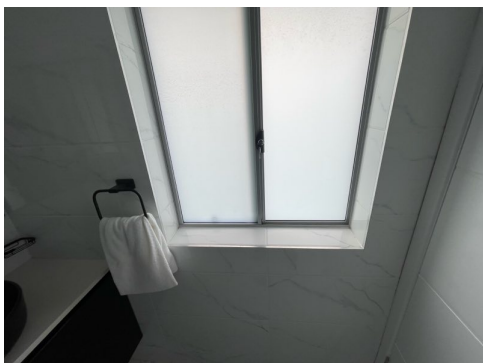
Finding 3.13

Finding: Cracked floor tiles

Information: Cracking in the floor tiles was evident in this area at the time of inspection. It is suspected that this cracking has occurred as a result of minor settlement or shrinkage of the slab.

Cracked tiles throughout the household detract from the overall appearance of the affected areas however it is unlikely to create or lead to any secondary defects.

While not considered a matter of urgency, replacement of cracked floor tiles is recommended at the clients discretion. A tiling contractor may be appointed to perform these works. Where cracks become more numerous, contact a licensed building inspector for further investigation.

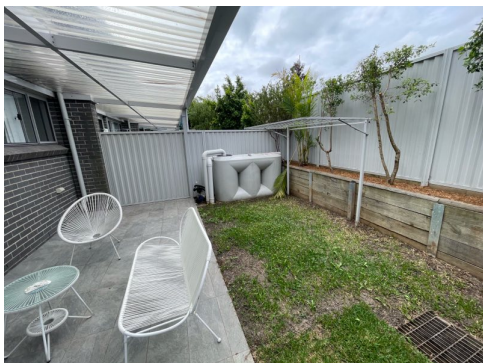
Finding 6.02

Building:	Main Building
Location:	Yard
Finding:	In ground contact
Information:	<p>Any timbers in direct ground contact provide opportunity for concealed termite entry and are likely to be subject to premature rot and decay as the soil retains moisture or damp conditions against the timbers.</p> <p>Remove untreated timber that is in direct contact with external grounds. Consider replacement with more durable materials i.e. treated timber or non timber elements. Frequent pest inspections are advised to readily identify any termite activity in these areas.</p>

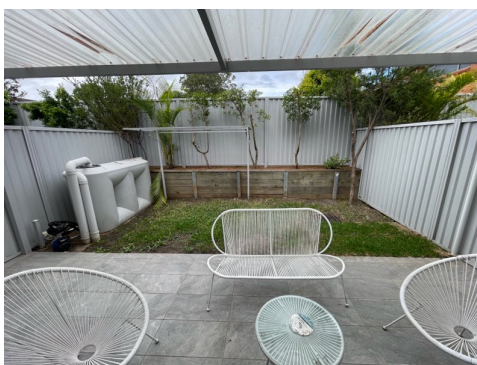
Finding 6.03

Finding: Large trees/stumps within 30m of house

Information: There are a number of large trees/stumps within 30m of the house which may contain natural termite activity. It is important to monitor these areas to ensure no natural activity is allowed to progress into the main house. Regular inspections are recommended. Consider test drilling any large trees. A pest controller can be contacted to carry out such testing at the owners discretion.
