Building and Timber Pest Inspection Report

Inspection Date: Wed, 8 Apr 2026

Property Address: 884 Chiltern-Yackandandah Rd, Indigo Valley VIC 3688, Australia

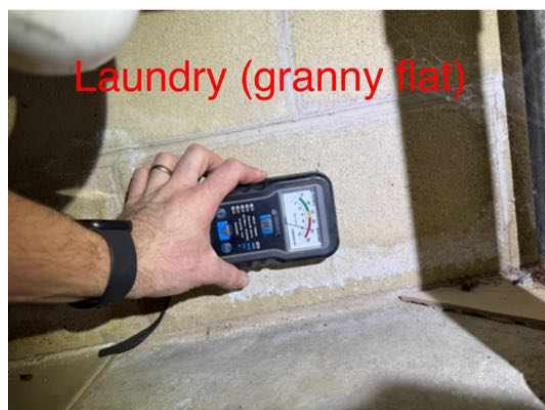
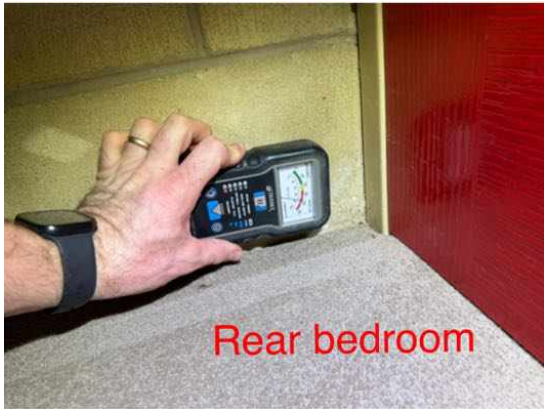
Finding 3.01

Building:	Main Building
Location:	Rear elevation, rear bedroom, laundry (granny flat)
Finding:	Rising Damp
Information:	It appears that damp conditions are evident to the base of the masonry walls, at but not limited to the rear bedroom, rear elevation (external) and laundry (granny flat) Rising damp refers to the upward movement of moisture through brickwork.

Causes of this defect include but aren't limited to, improper installation or deterioration of the DPC (damp-proof course) and/or water pooling against the brickwork. For areas of potential water pooling, a licensed plumber should be engaged in the short term, to provide further advice.

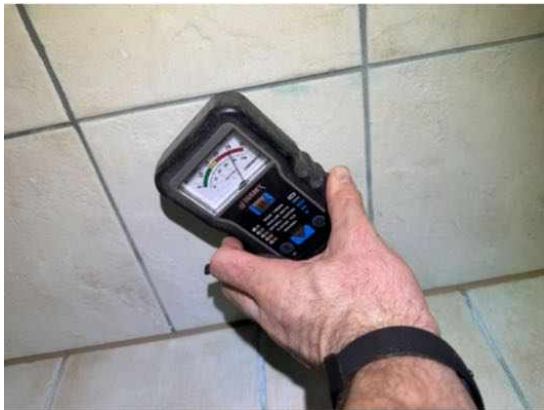
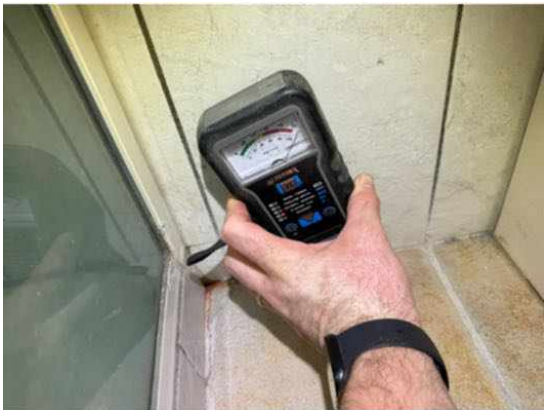
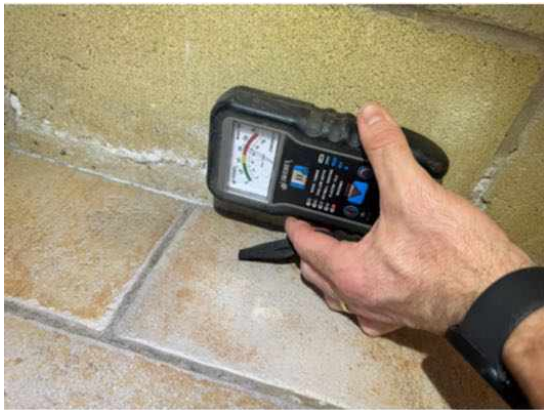
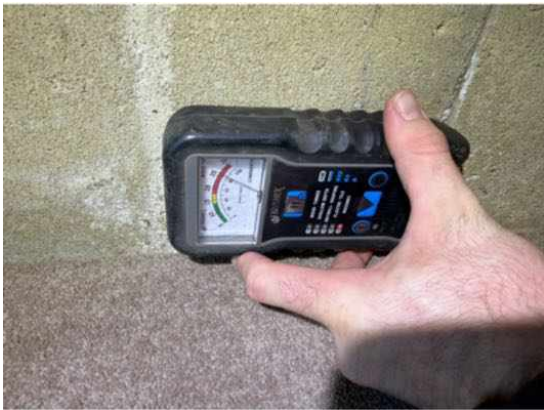
Finding 3.02

Building: Main Building
 Location: Main Shower
 Finding: Main Shower - High Moisture
 Information:

It appears that high moisture is present at but not limited to, the base of the main shower walls and to the bedroom & hallway side of the walls. Potential causes of leaking include but are not limited to loose or damaged plumbing fittings and fixtures, and/or deteriorated seals or waterproofing.

Recommend engaging a licensed plumber and/or tiling contractor promptly, to identify the cause of the moisture & provide remedial works where necessary.

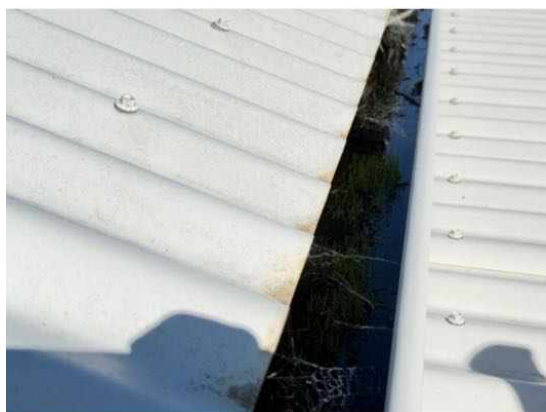
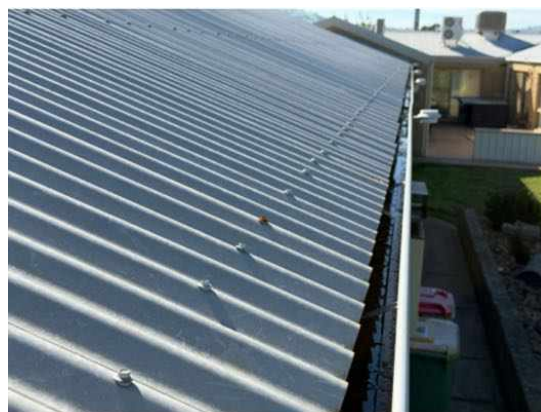
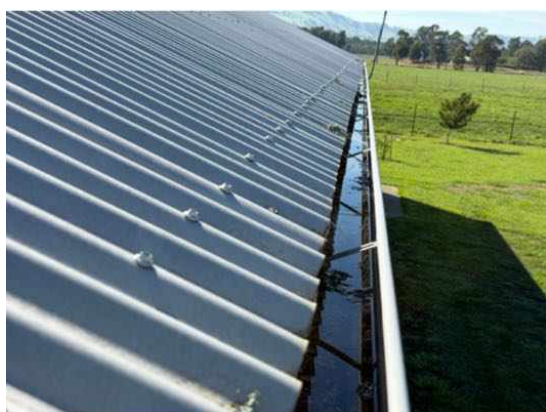
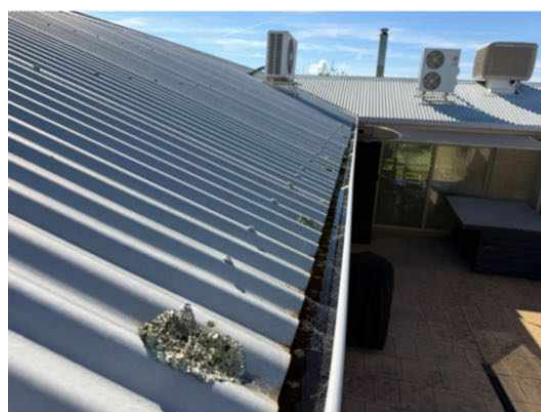
Finding 3.03

Building:	Main Building
Location:	Guttering
Finding:	Gutters - Debris & Water pooling
Information:	Water pooling and debris were noted in sections of the gutters at the time of inspection. Water pooling can lead to deterioration of the roof plumbing over time, if neglected. Recommend removing all debris from the gutters to ensure proper roof drainage and prevent debris accumulation and blockages.

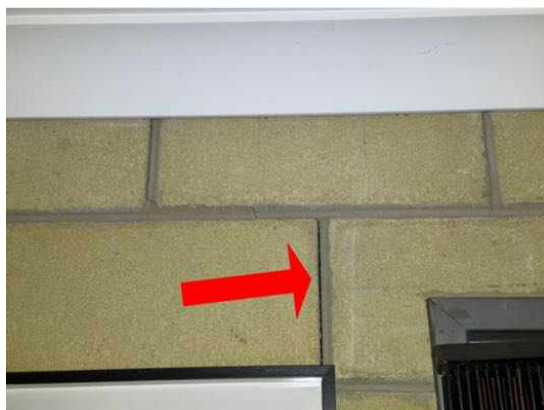
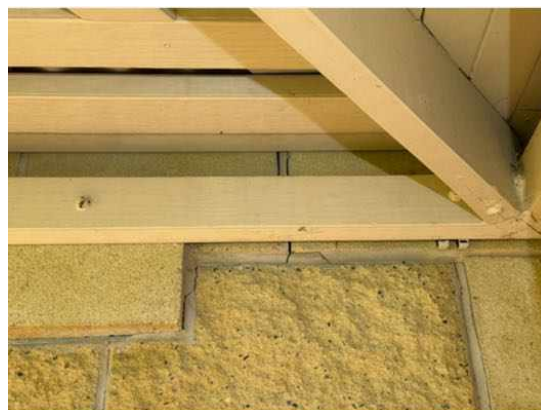
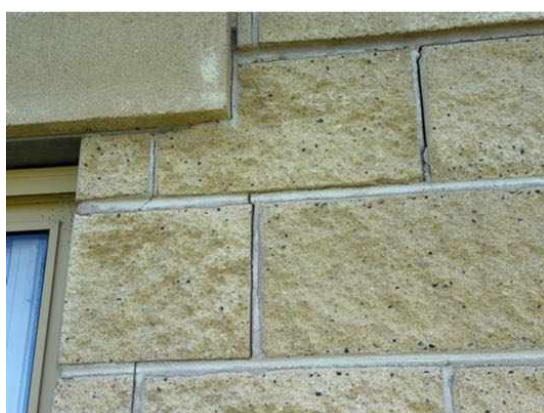
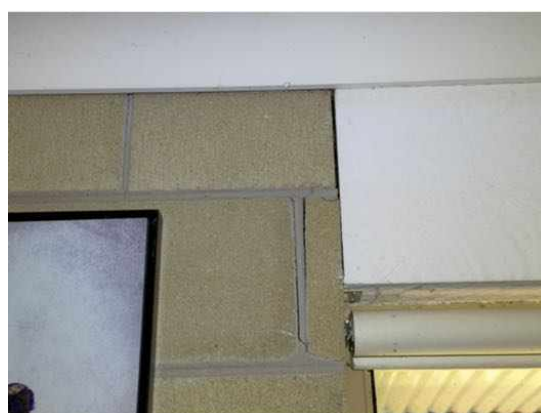
Finding 3.04

Building:	Main Building
Location:	All External Areas
Finding:	Brickwork - Step cracking
Information:	Minor step cracking was identified to some areas of the brickwork at the time of inspection. Step cracking, has a variety of possible causes. However, the most common is general movement of adjacent footings. Step cracking is a relatively common defect, and is most likely to occur adjacent to windows, doors and other openings.

The client should monitor the cracking. Should the step cracking lengthen, widen or

become more numerous, the client should consult with a structural engineer, to provide further advice.

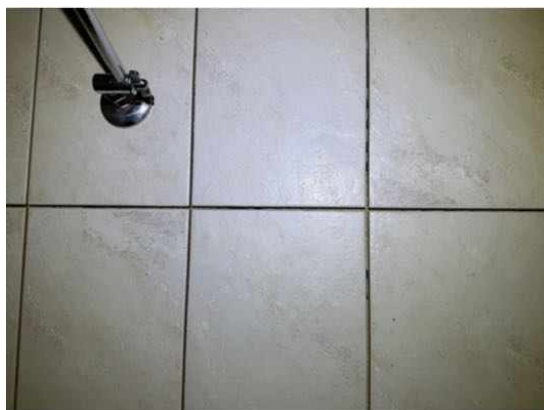
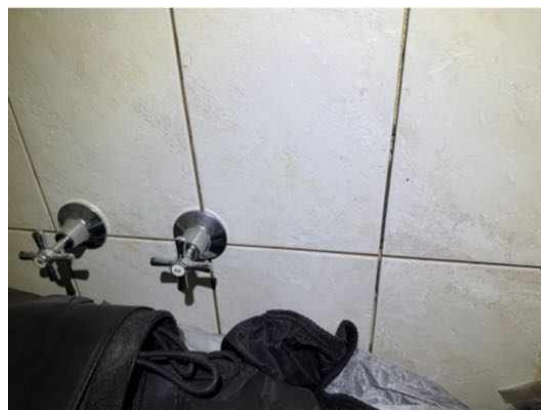
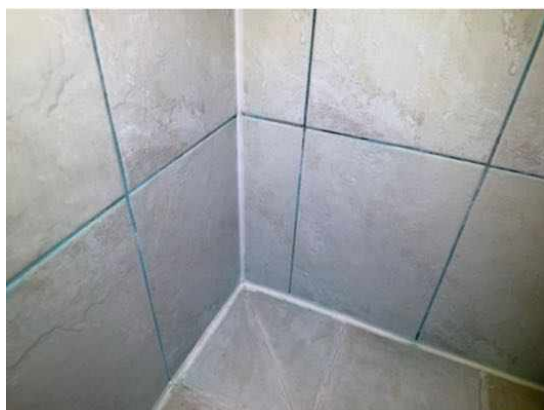
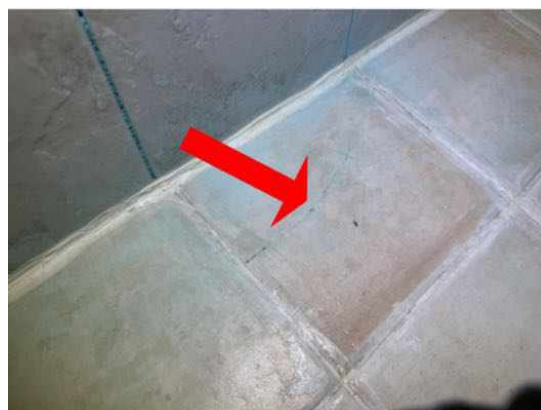
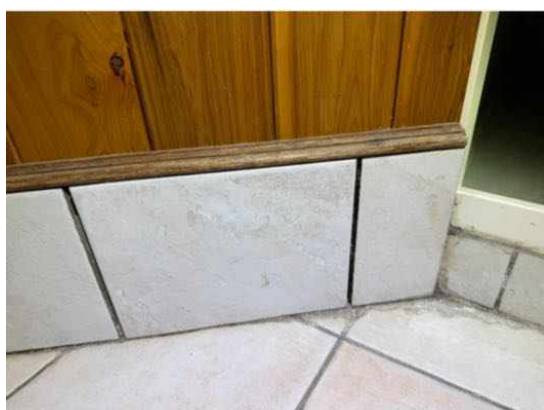
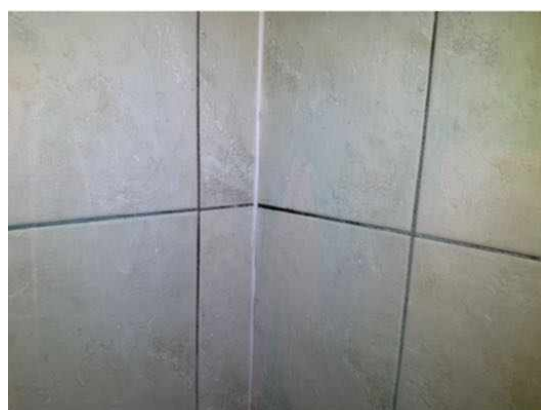
Finding 3.05

Building:	Main Building
Location:	Tiled Areas
Finding:	Sealant / grouting - deteriorated or missing & Cracked Tiles
Information:	It appears that the sealant and grout is missing and has deteriorated in some tiled areas, a common defect in buildings of a similar age. Some cracked tiles were also noted, which can allow for moisture ingress behind the tiles, if neglected.

Sealant and grouting in areas that come into regular contact with water should be maintained for the long term care of your property.

Recommend engaging a licensed tiling contractor in the short term, to provide maintenance works where necessary.

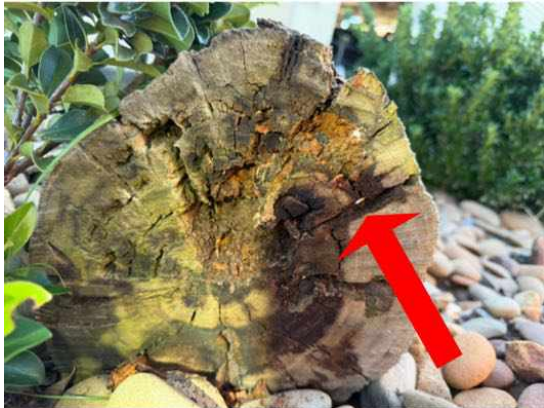
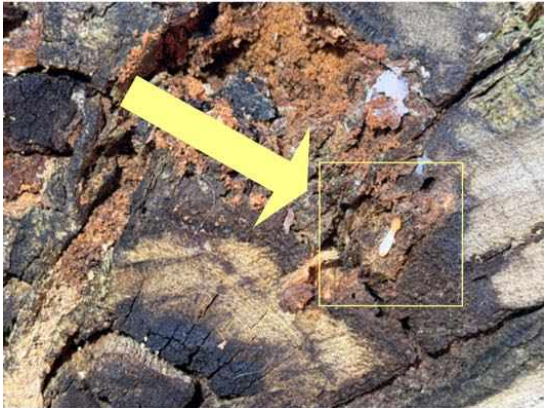
Finding 4.01

Building:	Main Building
Location:	Rear Elevation in decorative timber
Finding:	Evidence of live termite activity was identified
Information:	Live termite activity was identified on the property at, but not limited to the decorative landscaping Timbers to the rear of the building. The client should engage a licensed pest controller promptly, for further advice regarding application of a termite treatment and eradication of the colony.

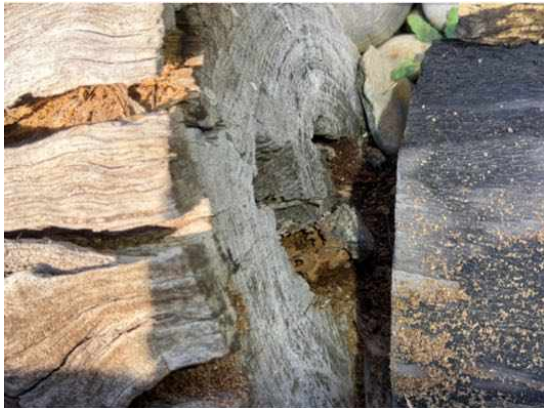
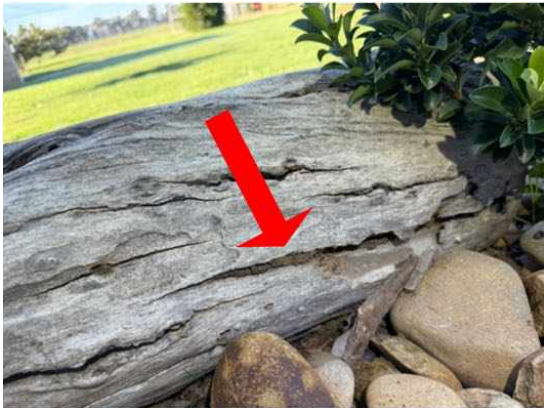
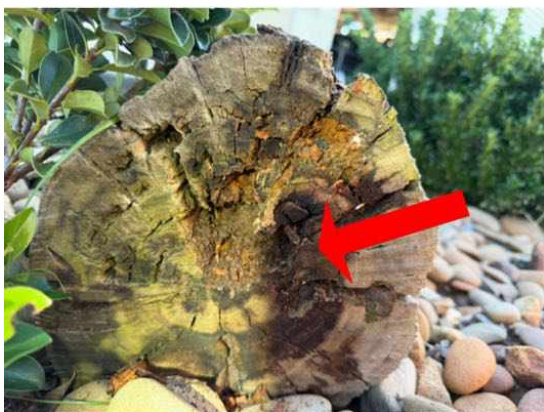
Finding 5.01

Building: Main Building
Location: Rear Elevation
Finding: Evidence of termite workings & damage
Information: Termite damage & workings were identified at, but not limited to, the decorative timbers to the front and rear elevation. The client should engage a licensed pest controller promptly, to provide further advice regarding installation of a termite treatment. 12 monthly ongoing termite inspections, conducted by a qualified termite inspector, are also recommended

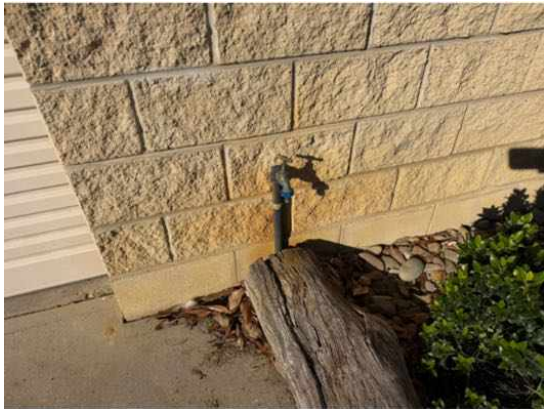
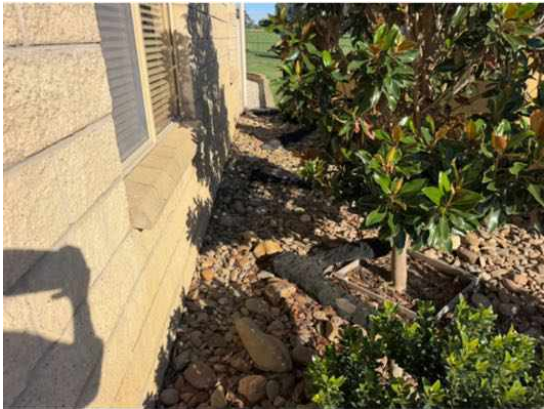
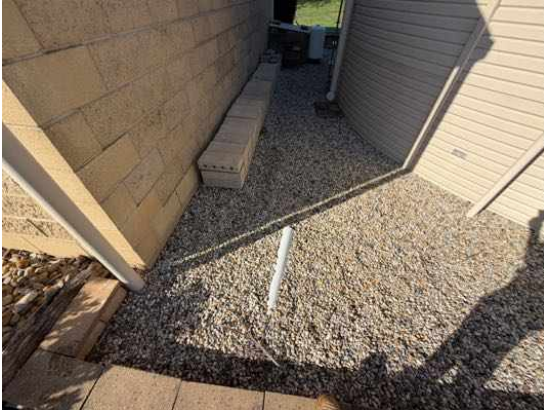
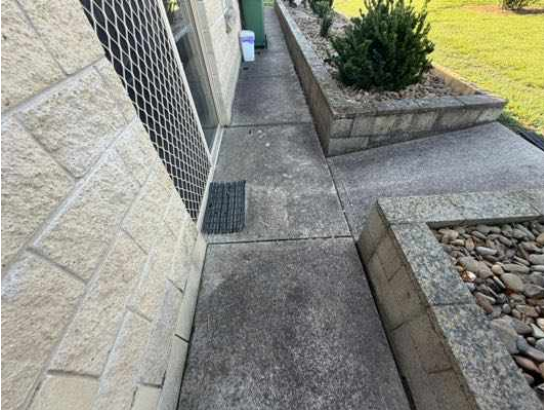
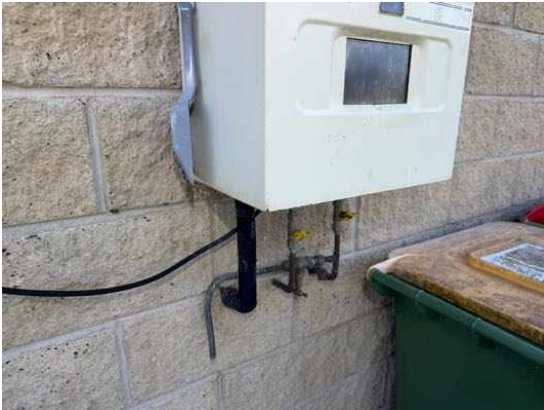
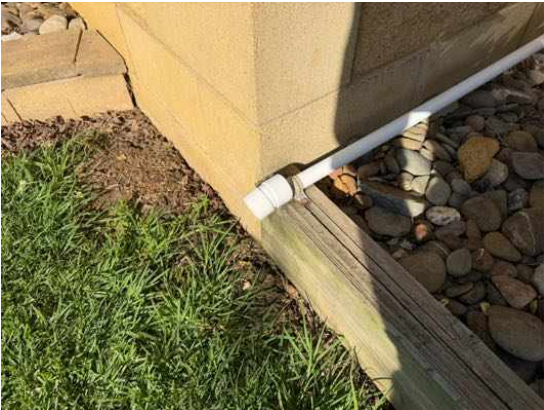
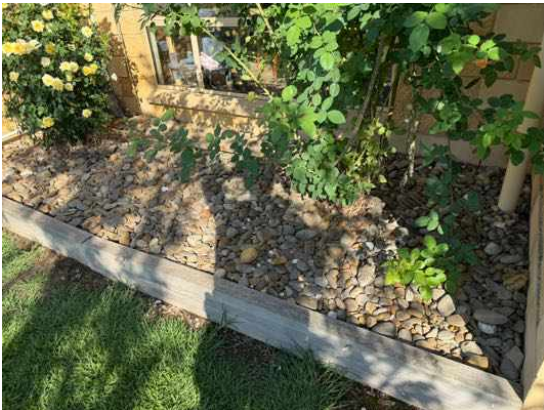
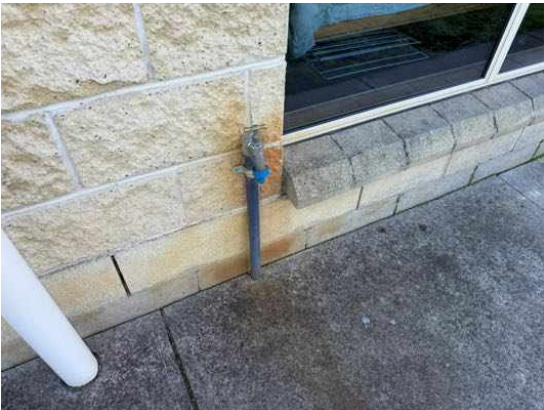
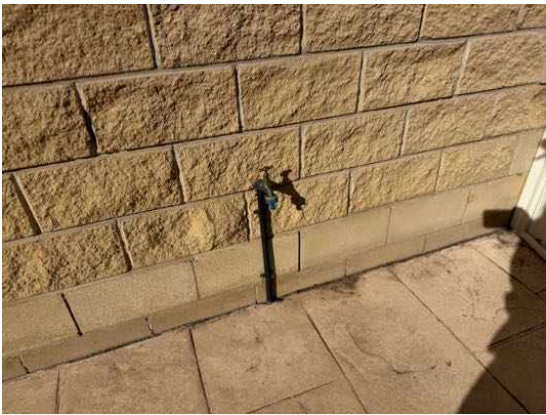
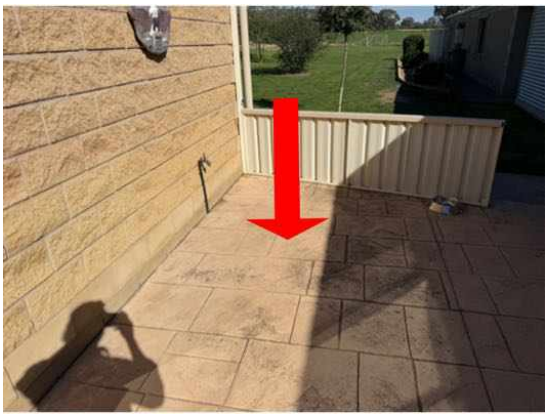
Finding 6.02

Building:	Main Building
Location:	All external areas
Finding:	Potential Water pooling - against property
Information:	Potential areas of water pooling around the perimeter of the property were identified. Where insufficient site drainage and drainage of taps, hot water system & aircon overflows, and garden beds against the house are present, water pooling is likely to occur, and can create areas conducive to timber pests.

Recommend consulting with a licensed plumber and/or landscaping contractor to provide further advice.

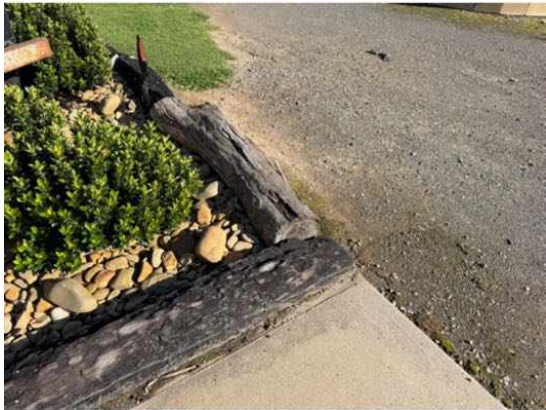
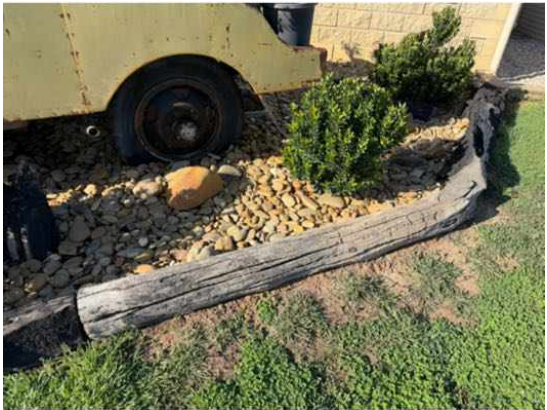
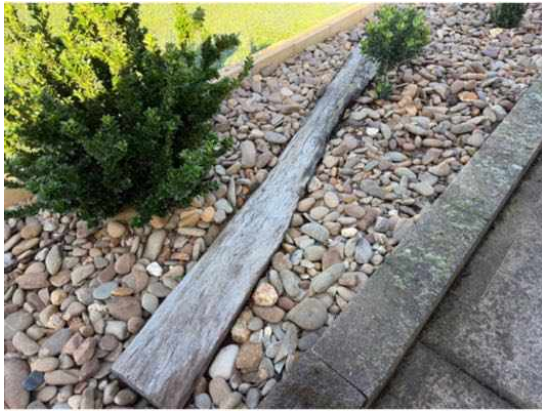
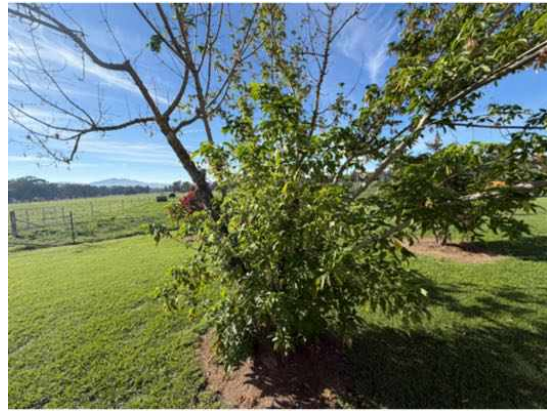
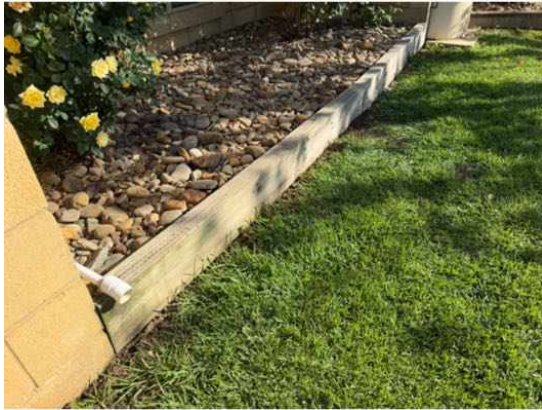
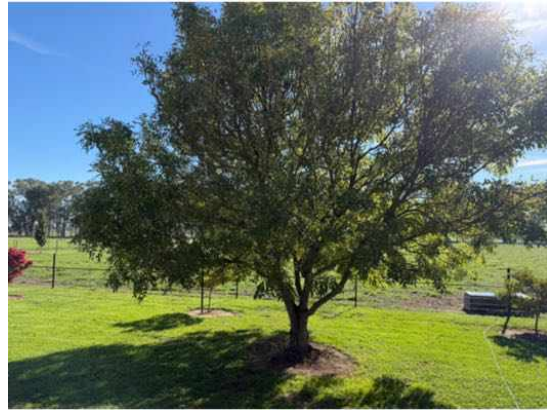
Finding 6.03

Building: Main Building
Location: All External Areas
Finding: Timber in direct ground contact & trees - conducive to termites
Information: Where timber materials are in direct contact with the ground and consequently moisture, they become conducive to termite activity. The decorative timbers, landscaping timbers, and trees surrounding the building create an environment conducive to termite infestation.

Where feasible, any timbers in direct contact with the ground should be removed and any trees in close proximity to the building should be removed or test drilled (inspected) at least annually to reduce the risk of termite infestation & detect any early signs of termite activity.

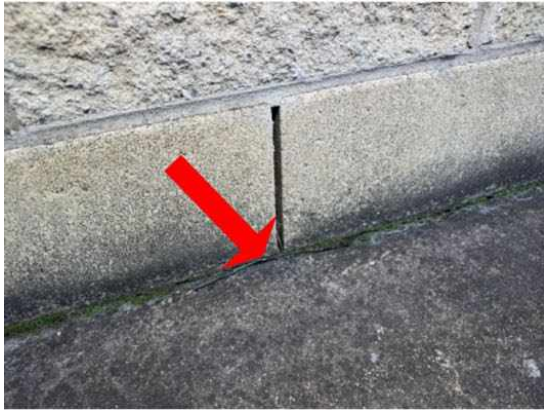
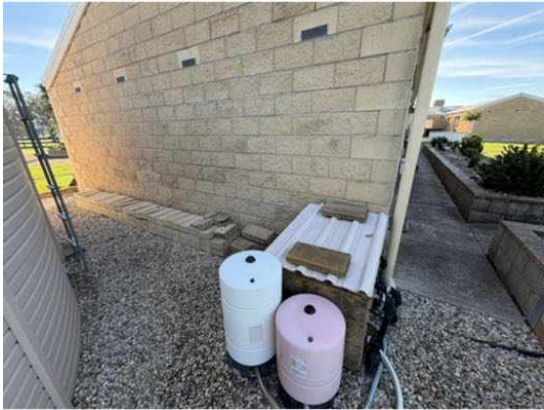
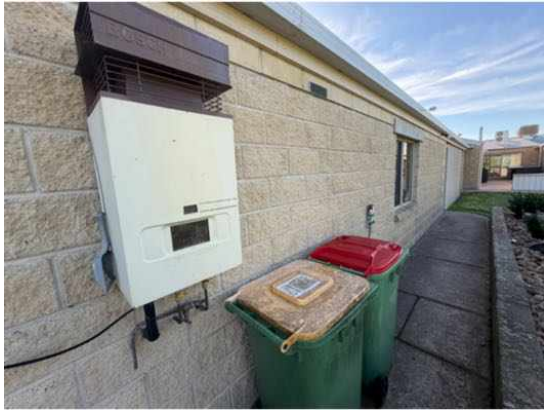
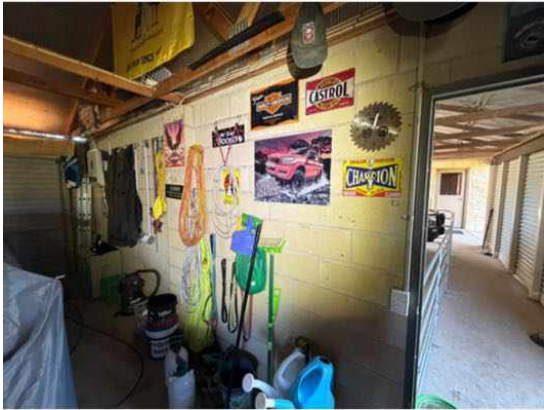
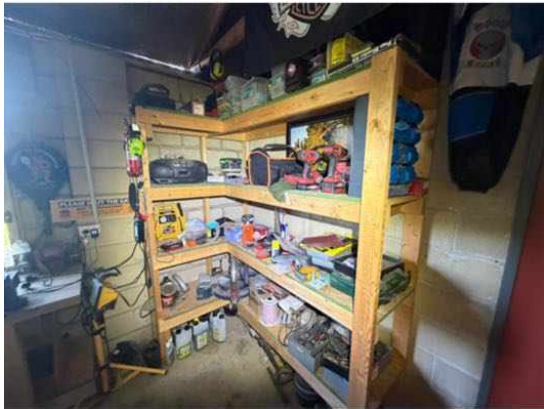
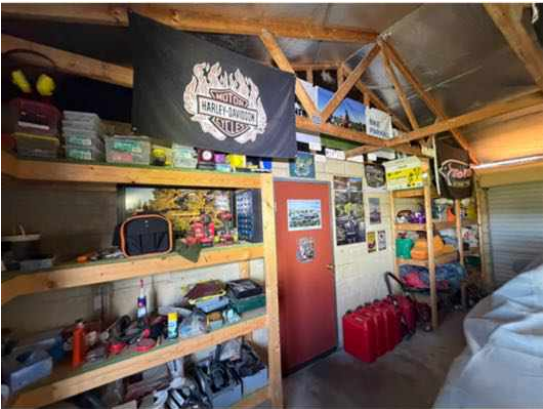
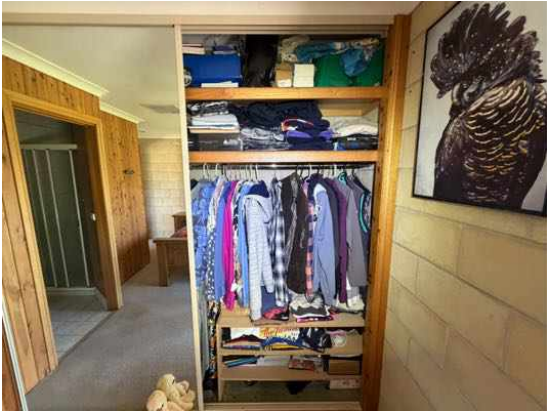
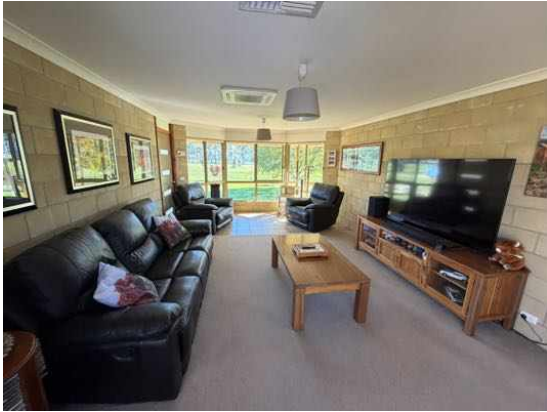
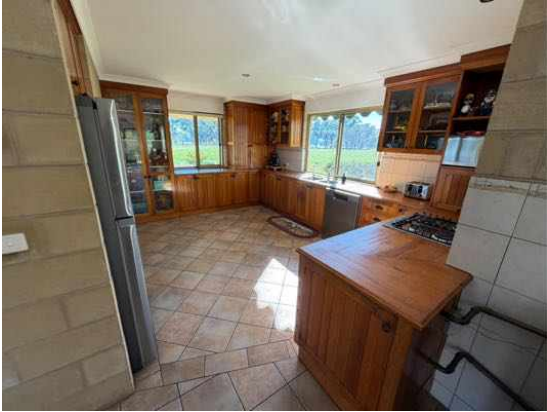
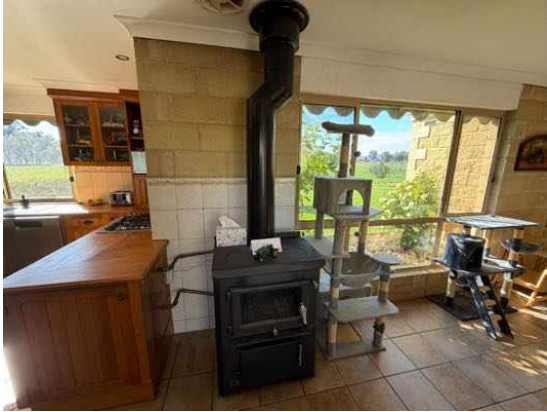
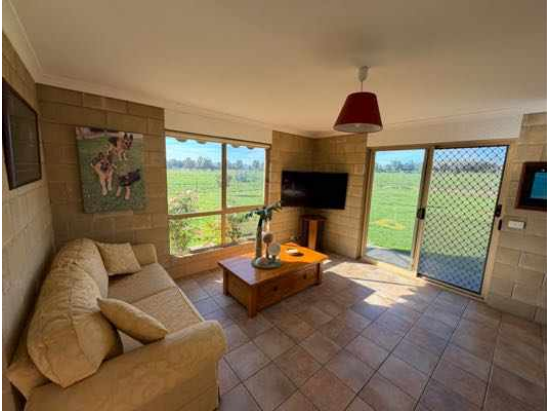
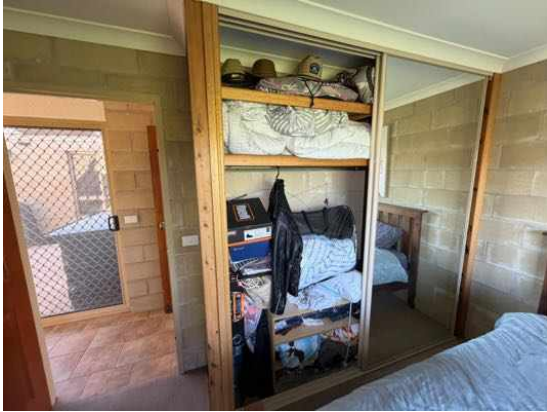
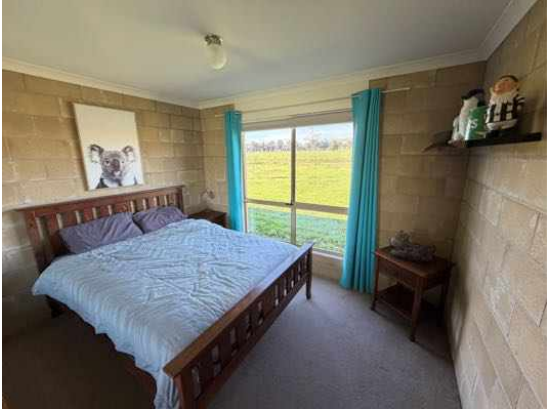
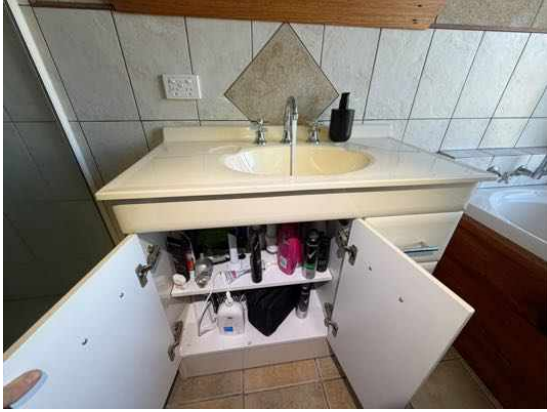
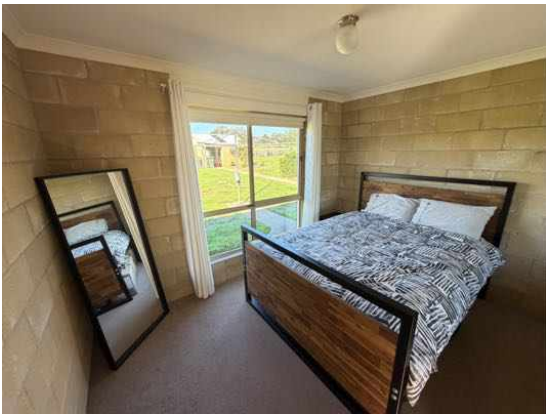
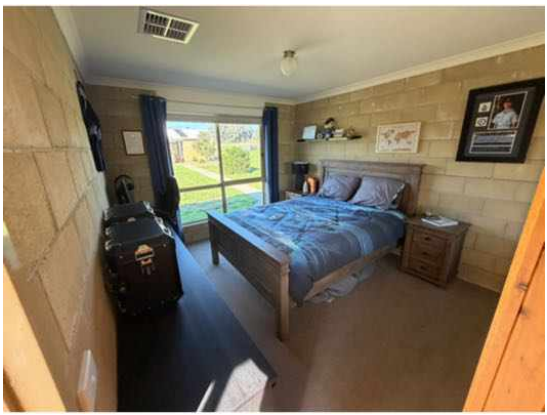
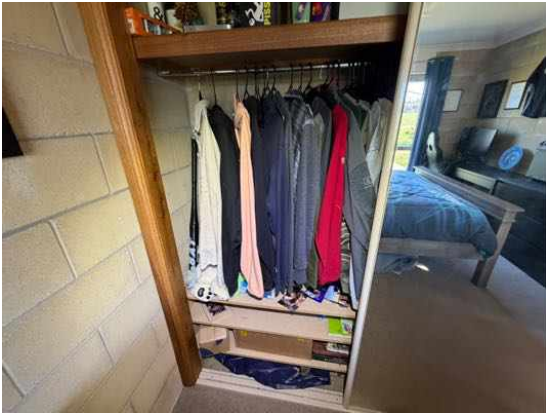
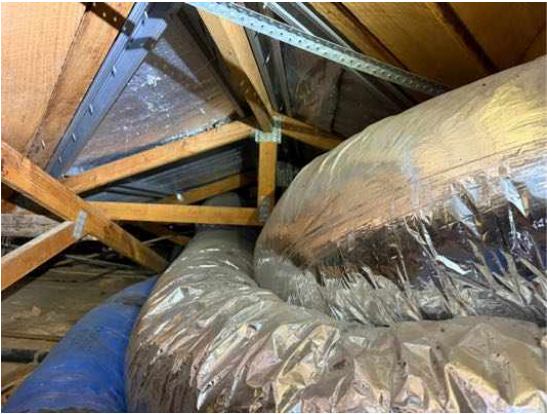
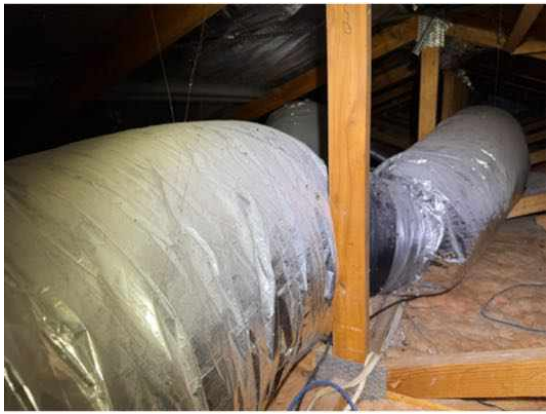
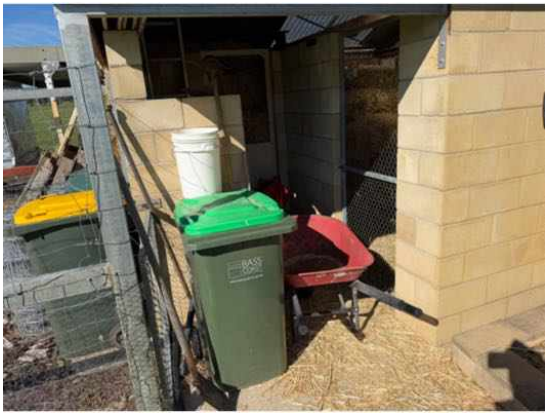
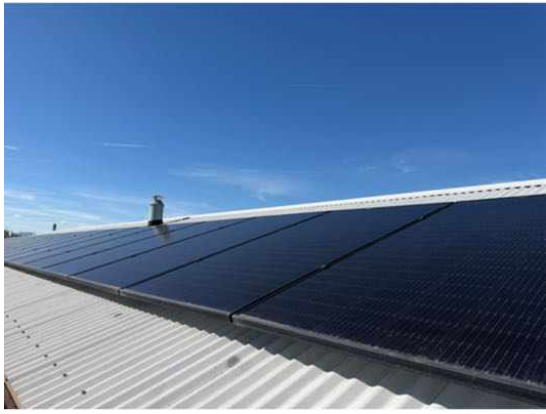
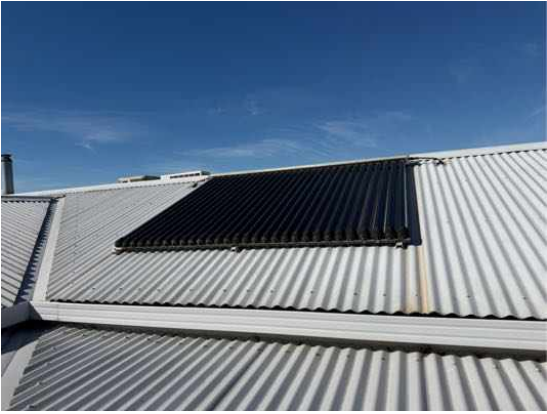
Building: Main Building
Location: All Areas
Finding: Additional Photos - Obstructions and Limitations
Information: These photographs are an indication of the obstructions and limitations which impeded full inspection of the property at the time of inspection. These obstructions can hide an array of defects and should be removed to allow full inspection to be carried out. A re-inspection is recommended once the areas are made accessible.

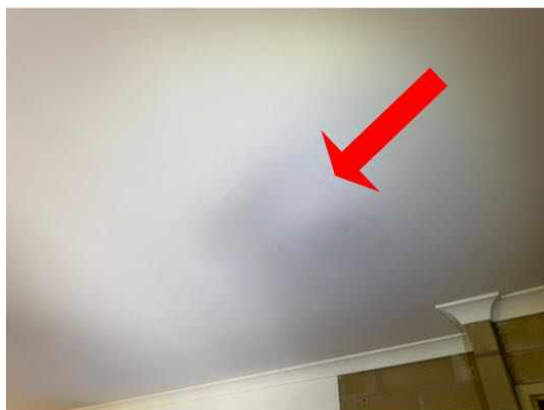
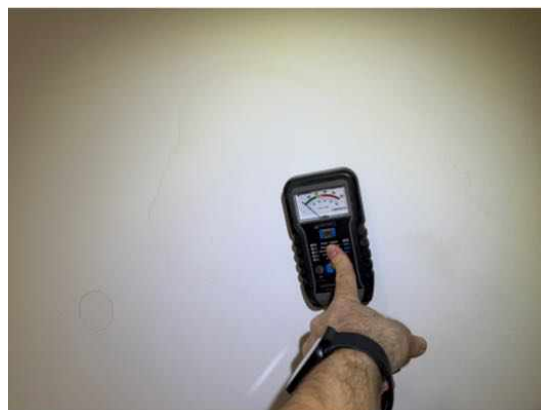
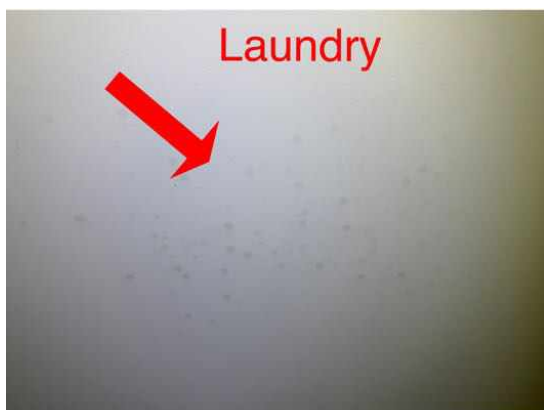
Building: Main Building
 Location: Laundry, Dining Room Ceilings
 Finding: Water Staining Present
 Information: It appears that water staining was present at but not limited to, the laundry & dining room ceiling. No high moisture was evident in these areas at the time of inspection. Recommend the client closely monitor these areas and engage a licensed roof plumber promptly, should the leak persist or return.

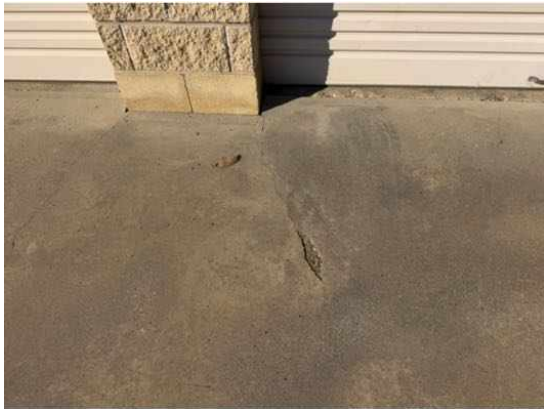
Building: Main Building
 Location: Driveway
 Finding: Cracking - Pavement & Footpath
 Information: It was noted there is minor cracking in areas of the driveway. Cracks in the driveway are a common occurrence in houses of a similar age.

Recommend that the client monitor the cracking. A licensed concreter can be engaged at clients discretion, should cracks widen, lengthen, or become more numerous.

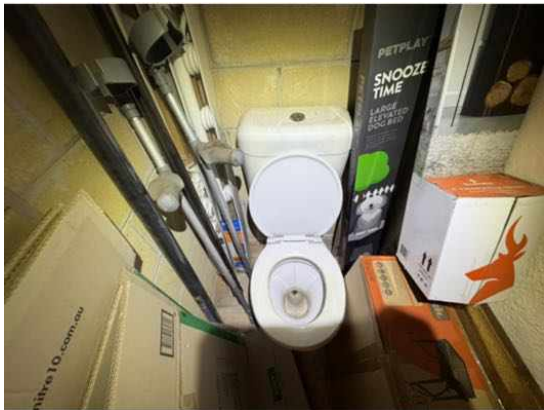
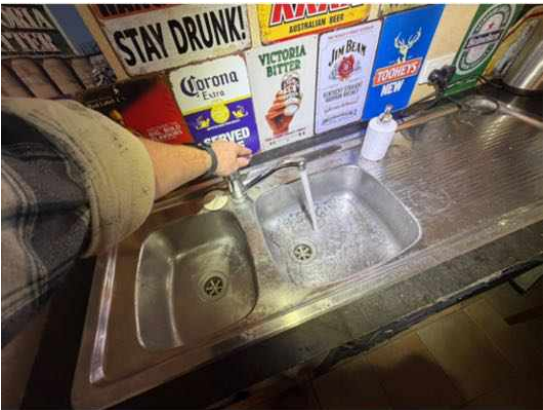
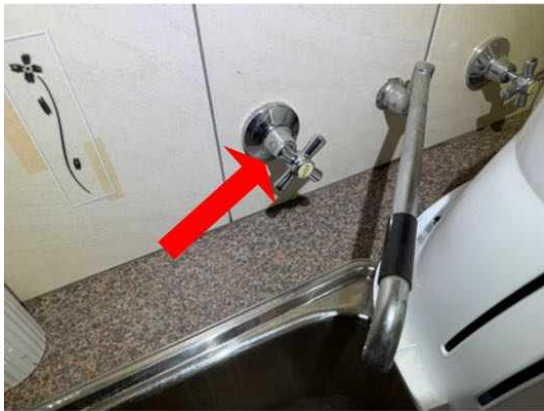
Building: Main Building
Location: Granny Flat Toilet & Hot Water, Laundry Hot Water
Finding: Hot Water & Toilet - Not Operating
Information: It appears that the hot water taps were not operating at, but not limited to the granny flat laundry sink and the main laundry sink. The granny flat toilet also appeared to not be operating. Recommend engaging a licensed plumber at clients discretion, to provide further advice and maintenance works where necessary.
