# Building and Timber Pest Inspection Report

Inspection Date: Mon, 16 Mar 2026

Property Address: 37 Kerwin Cir, Hebersham NSW 2770,  
Australia

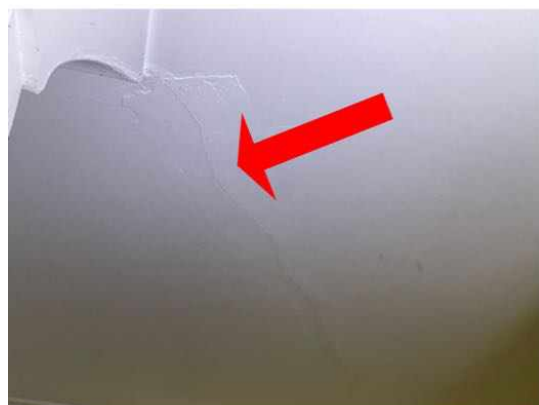
Building: Main Building  
Location: All Internal Areas  
Finding: Cracking to Ceiling and Wall – Possible Structural Load Influence  
Information: Cracking was observed to the internal ceiling lining and adjacent wall surfaces. The cracking appears to follow the line where the roof structure strutting transfers dead loads down to the supporting wall framing.

Such cracking may occur due to:

- Load concentration from roof framing members
- Minor movement or settlement of the supporting wall framing
- Shrinkage or movement in plasterboard joints

While the cracking currently appears to be relatively minor and typical of stress movement in plasterboard linings, monitoring is recommended. If the cracking continues to widen or propagate, further assessment by a qualified structural engineer or licensed builder is recommended.

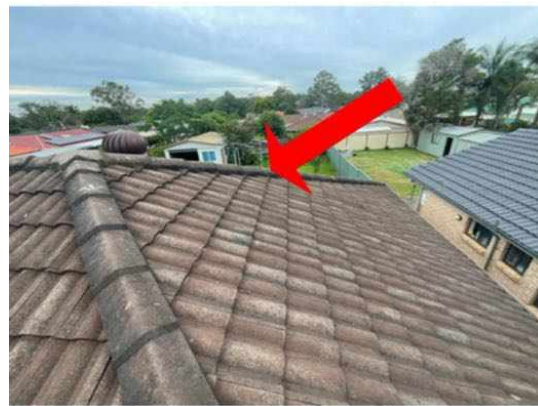
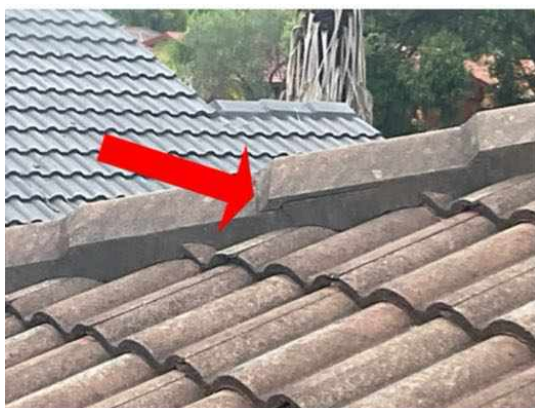
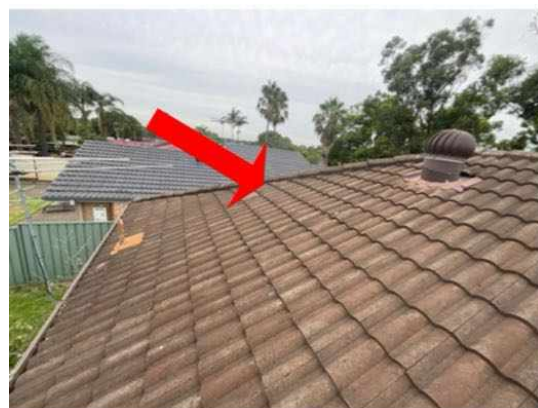
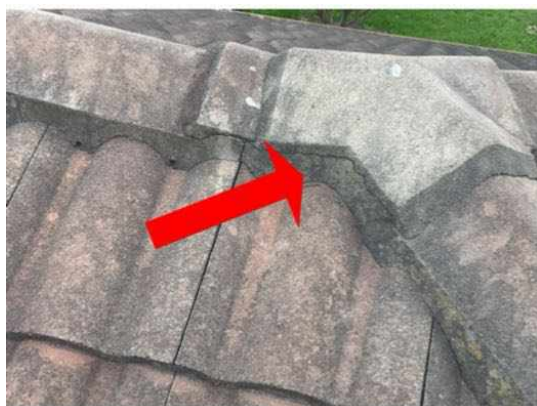
Finding 3.04

Building: Main Building  
Location: Roof Exterior  
Finding: Mortar - Deterioration  
Information: Mortar, or 'bedding', is the material which fills joins and intersections between tiles and other building elements on the exterior roof covering, such as gable ends, hip capping and valleys. Upon inspection of the exterior roof, it was noted that sections of the mortar show varying levels of deterioration.

Mortar generally deteriorates as a result of frequent exposure to weather conditions over a prolonged period of time. Mortar that is deteriorating may allow water ingress into the roof void, putting associated building elements and roofing structures at risk of water damage. Deteriorated mortar also detracts from the functionality of roof tiles and other roofing elements, potentially decreasing weather tightness and roof drainage.

Mortar deterioration can be attended to by a handyperson where areas of deterioration are localised and easily accessible. Otherwise, consultation with a roofing contractor is advised where greater works are required.

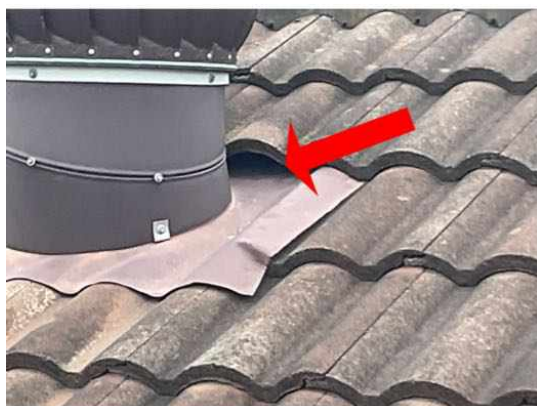
| Finding: | Roof plumbing - Flashing inadequate |
| Information: | Some sections of the roof are missing or have inadequate roof flashings. Flashings are metal and other materials which are applied to seals and intersections between roof coverings and building elements. They are designed to aid in weatherproofing of roof joins. |

Flashings that are not installed adequately or are missing are likely to result in water penetration to the interior of the property, as well as creating excessively damp conditions against the exterior surfaces and around the base perimeter of the building.

Premature ageing and secondary building defects are imminent where roof plumbing is missing or inadequately installed. Additionally, water pooling also creates an environment that is susceptible to termite and pest infestation.

A roofing plumber should be appointed as soon as possible to install relevant roof plumbing materials, ensuring that no further damage is sustained.

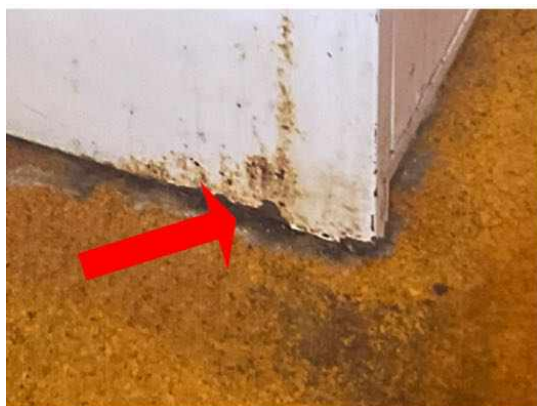
| Finding: | Evidence of excessive moisture was present at the time of inspection - laundry |
| Information: | Moisture was identified in the laundry involving moisture accumulation on the wall. Upon inspection, there's noticeable dampness spreading across the surface, suggesting potential water ingress or inadequate waterproofing. This issue warrants immediate attention to prevent further damage, such as mold growth or structural deterioration. This moisture poses a risk of structural damage and mold development if left unattended. |

It is highly recommended that all plumbing and drainage fixtures and fittings be maintained regularly in order to prevent excessive moisture being present in the external / internal property.

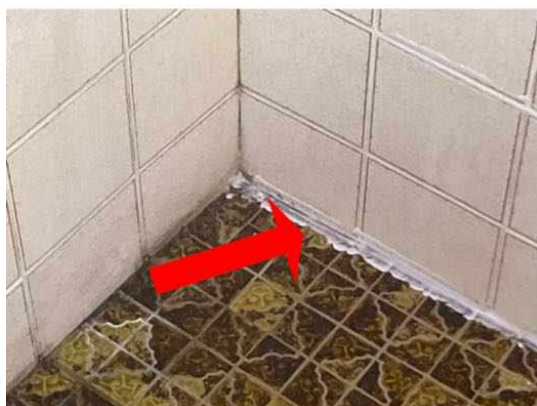
| Finding: | Sealant and grouting - Missing or damaged |
| Information: | It was noted on inspection that sealant or grout is degraded to the tiled shower alcove and or other areas of the bathroom. |

Different materials and floor areas move at different rates, generally causing cracking to grout or sealant at this point. A flexible sealant is required to allow for expected expansion and contraction, while keeping the joint water tight and protective of all associated building materials.

There appears to be excessive mould to the sealant and grout which will likely require scraping out and replacement.

Flexible and mould resistant materials should be applied to affected areas to prevent any subsequent water damage that is likely to occur. Regular maintenance and replacement of damage or missing or damaged sealant and grout is highly recommended to the wet areas, as this is a regular wear and tear defect. Sealant and grouting in areas that come into regular contact with water should be maintained for the long term care of your property.

A sealant specialist or tiling contractor should be appointed to complete these works as soon as possible

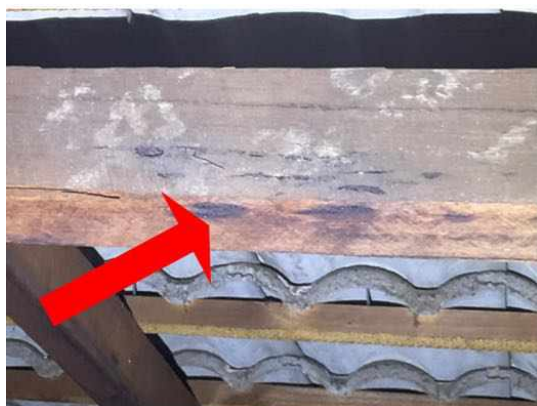
| Information: | Chemical delignification also known as wood defibration refers to the chemical breakdown of timber building elements. This breakdown of the Lignin deteriorates the wood impacting on the structural integrity and tensile strength of the affected building element. |

Chemical delignification is most common near marine environments due to the high levels of salt in the air however this deterioration may also occur in other areas where timber elements are frequently exposed to damaging gases chemicals etc.

Where timber building elements have deteriorated repair and / or replacement is required immediately to ensure the safety of the associated structures. The likely cause of the defibration should also be investigated and dealt with accordingly.

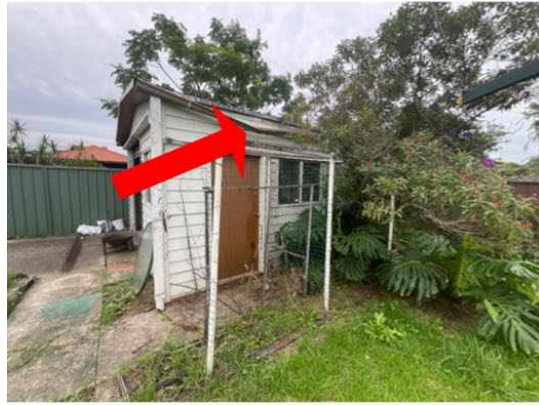
| Finding: | Building Element (Gutter) - Damaged |
| Information: | Damaged gutter were found to be present to roof plumbing work. The damage of gutter creates damp conditions in the affected area , causing potential for water pooling and subsequent water damage if left unattended. These conditions may also attract termite attack, particularly if the area is subject to minimal levels of sun throughout daylight hours. |

It is highly advised that a licensed roof plumber or proper tradesperson be appointed to rectify any water leaks that may be present. Areas of repair and replacement of plumbing fittings and fixtures may be required and, as such, a quotation should be sought.

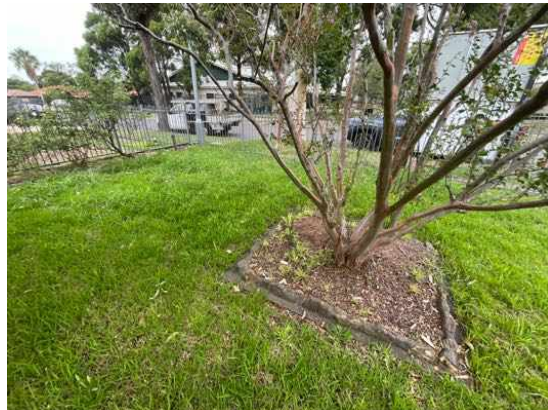
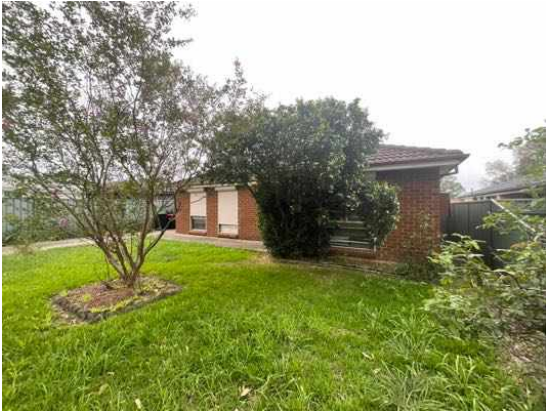
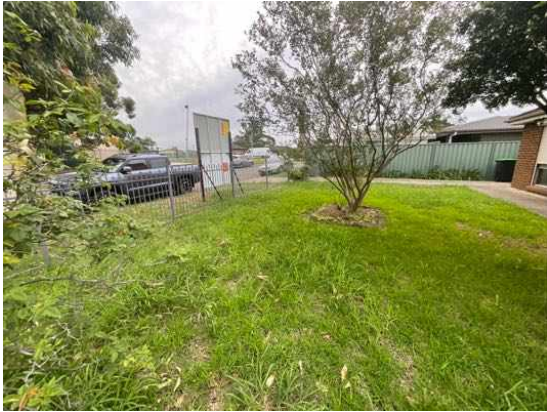
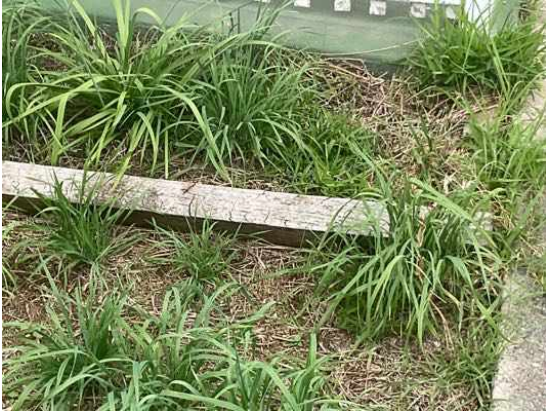
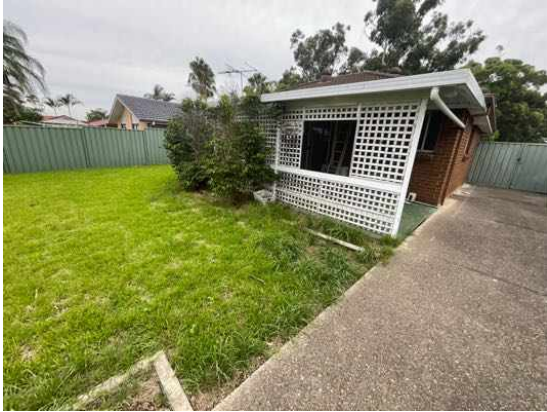
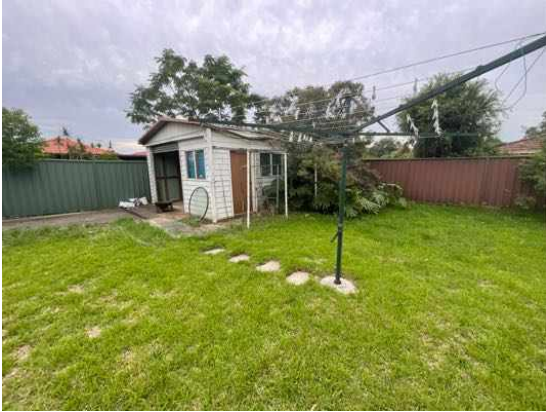
Building: Main Building  
Location: All Areas  
Finding: Garden Beds - Conditions Conducive to Termites  
Information: Garden beds were found to be evident in the garden area. These garden beds can include untreated timber, and with a combination of moisture from watering hosing can make conditions conducive to termite activity and termite ingress.

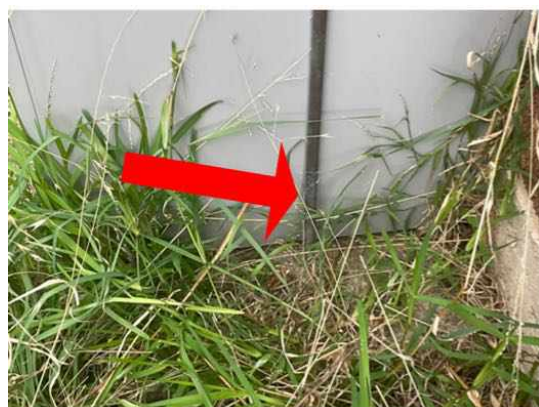
| Information: | The Hot Water System (HWS) overflow was found to be disconnected from storm water drainage and is creating excessive moisture in the surrounding area. |

These damp conditions can lead to secondary defects such as rot, rust or corrosion of associated building elements, the formation of fungal decay, or even the creation of potential slip hazards. When coupled with poor site drainage, pooling of water may also attract termite activity to this area.

It is highly recommended that a licensed plumber be appointed to connect the HWS overflow in order to prevent such an environment from being created. These minor works should be carried out as soon as possible.

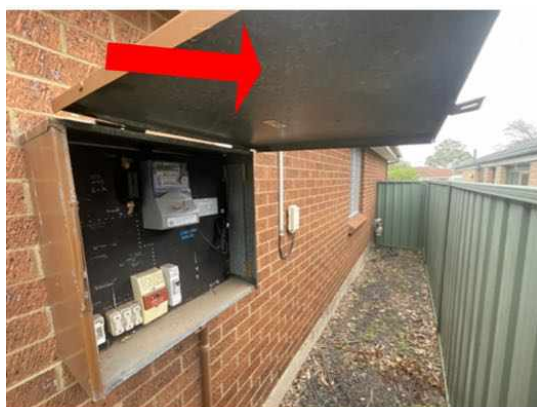
A durable notice should be placed in the switchboard unit to indicate current termite barriers. At the time of inspection, it appeared as though no termite management system has been installed, with no evidence to suggest preventative works taking place.

The client may consider gaining further advice from a pest controller as to the costs and procedures involved with this application. It is recommended that obtaining such advice be a short-term priority.
