Building and Timber Pest Inspection Report

Inspection Date: Thu, 26 Mar 2026

Property Address: 5 Yanco Ave, Jamisontown NSW 2750,
Australia

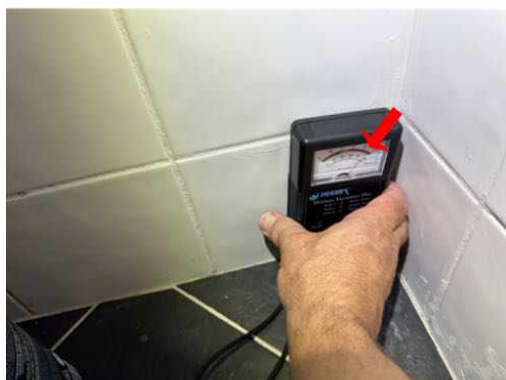
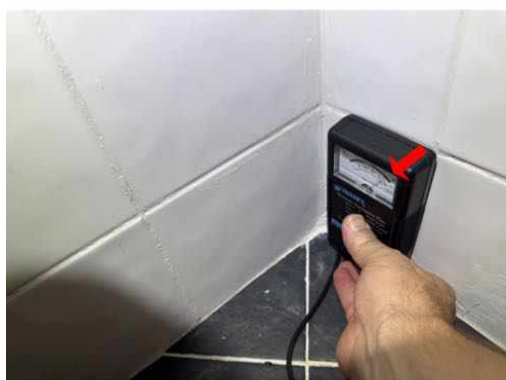
Building: Main Building
Location: Bathroom > Centre Left
Finding: Moisture meter: used in Shower area.
Information: A moisture meter was used during the inspection and isolated spots of excessive moisture was detected to accessible walls inside the property at the time of inspection.

It was noted on inspection that sealant or grout is in fair condition to most of the tiled shower alcove, with some areas requiring maintenance.

Different materials and floor areas move at different rates, generally causing cracking to grout or sealant at this point. A flexible sealant is required to allow for expected expansion and contraction, while keeping the joint water tight and protective of all associated building materials.

Flexible and mould resistant materials should be applied to affected areas to prevent any subsequent water damage that is likely to occur. Regular maintenance and replacement of damage or missing or damaged sealant and grout is highly recommended to the wet areas, as this is a regular wear and tear defect. Sealant and grouting in areas that come into regular contact with water should be maintained for the long term care of your property.

Monitoring the area is advised and if any visual signs of excessive moisture appear (peeling paint, mould) then consultation with a qualified plumber or bathroom specialist would be advised to identify the cause of damp and to perform remedial works as required.

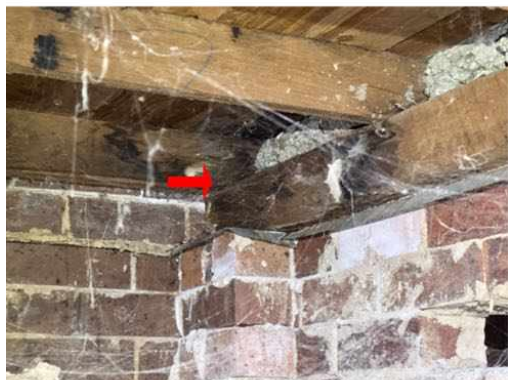
Finding 2.02

Building:	Main Building
Location:	Subfloor/Bathroom > Centre Left
Finding:	Water leak - subfloor.
Information:	A water leak was found in this area at the time of inspection. Subfloor water leaks can be detrimental to surrounding building elements; their potential causes include damage to plumbing fittings and fixtures, through to water damage and deterioration of associated building elements.

Rust, corrosion, decay and water damage are potential outcomes where a minor water leak is left unattended. More serious defects may also result, such as water damage to structural building elements.

In extreme cases, structural damage may develop due to a prolonged water leak. It is highly advised that subfloor water leaks be addressed by a licensed plumber as a matter of relative urgency.

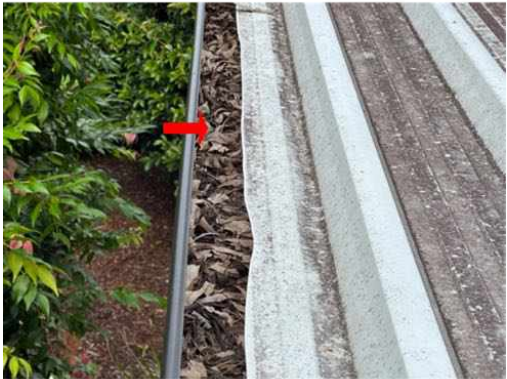
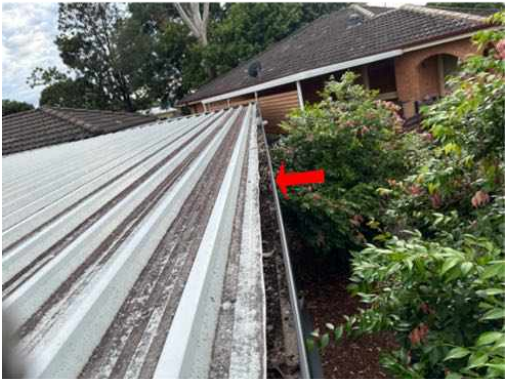
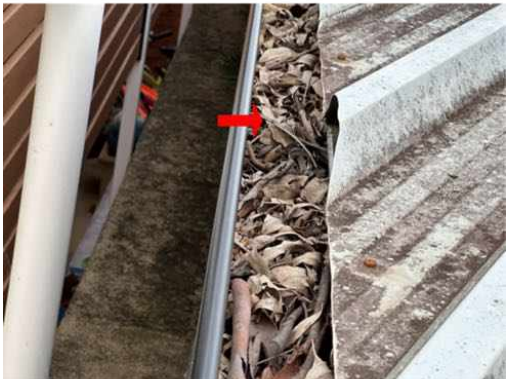
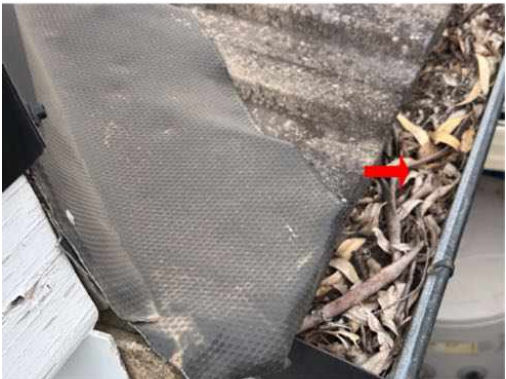
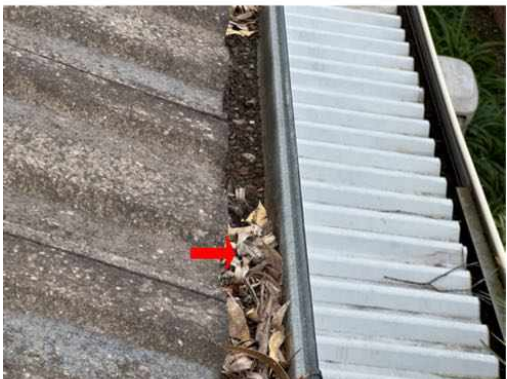
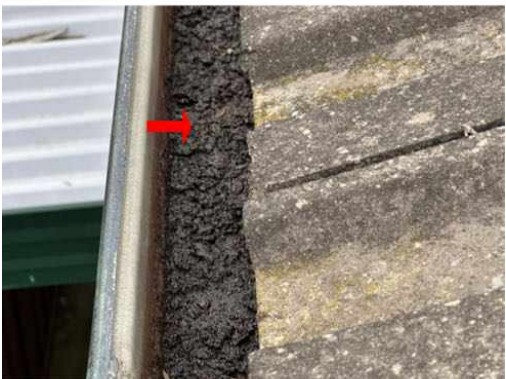
Finding 3.01

Blocked gutters are likely to lead to high levels of moisture in the affected areas. Such moisture will not only cause rust and decay of the associated building materials, but can also provide conditions that are conducive to termite and timber pest activity. Blockages in gutters should therefore be removed immediately to ensure dry conditions are maintained.

Consult a Licensed Plumber for further specific advice on remedial works that may be required. In the interim, it is highly advised that blocked gutters be removed by the homeowner or a general handyperson as a matter of urgency.

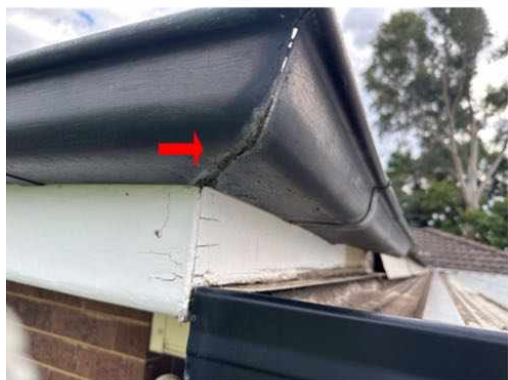
Finding 3.02

Building: Main Building
 Location: Roof Exterior > Front Left
 Finding: Roof plumbing - leaking.
 Information: Some sections of the roof are not adequately drained via gutters and downpipes. Gutters and downpipes that are not installed adequately are likely to result in excessively damp conditions against the exterior surfaces and around the base perimeter of the building.

Excessive moisture creates an environment which accelerates the deterioration of building elements in the area, as well as being conducive to termite and pest infestation. Such an environment is likely to necessitate repair and/or replacement of building elements, which are prone to sustaining wood rot, rust or corrosion.

A roofing plumber should be appointed as soon as possible to install relevant roof plumbing materials. Depending on the extent of the damage, repair and/or replacement of damaged building elements may be required.

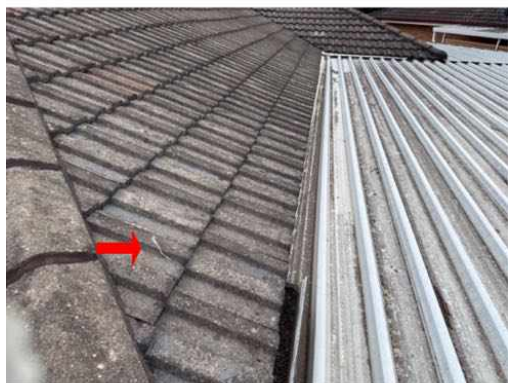
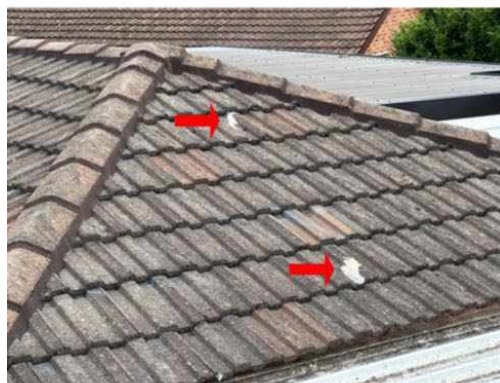
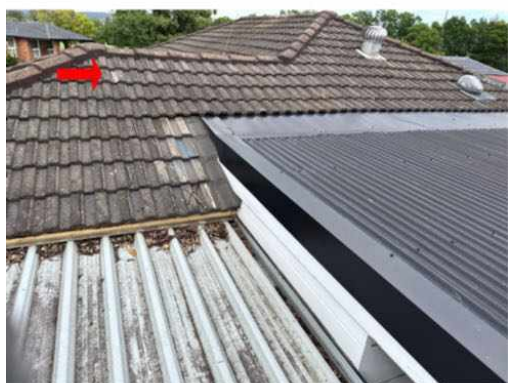
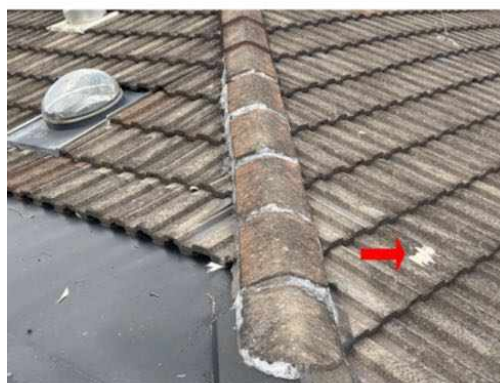
Finding 3.03

Building: Main Building
 Location: Roof Exterior > All Areas
 Finding: Roof tiles - Broken
 Information: Upon inspection of the exterior roof covering, broken roofing tiles were identified. Broken and friable roof tiles are generally the result of ageing and weathering of what is essentially a porous material.

If left to further deteriorate, broken and brittle roof tiles are likely to lead to water penetration via the roof into the ceiling space, causing secondary damage to ceiling linings, insulation and roof structures. Broken roof tiles are also likely to detract from the effectiveness of the roof drainage system, creating potential for secondary damage to the exterior roof covering and roof plumbing.

Replacement of broken tiles is required and should be performed by a roofing contractor as soon as possible.

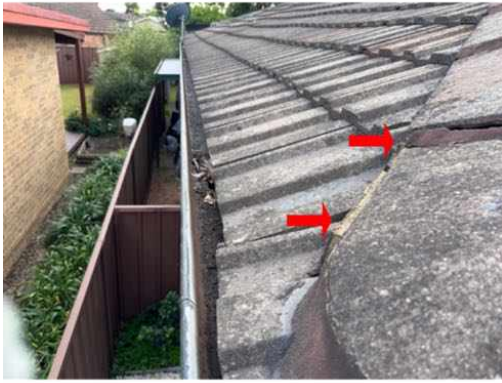
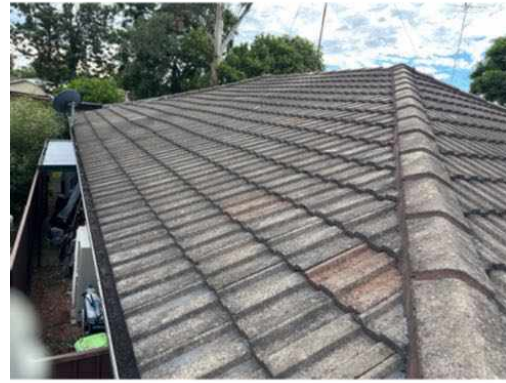
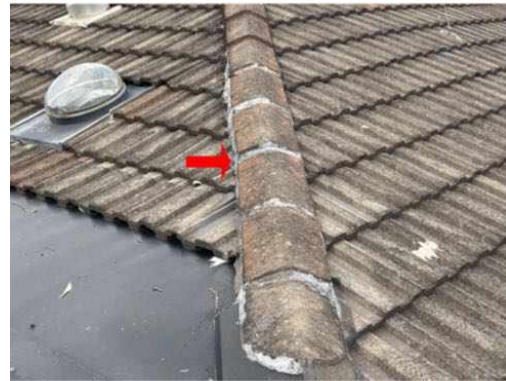
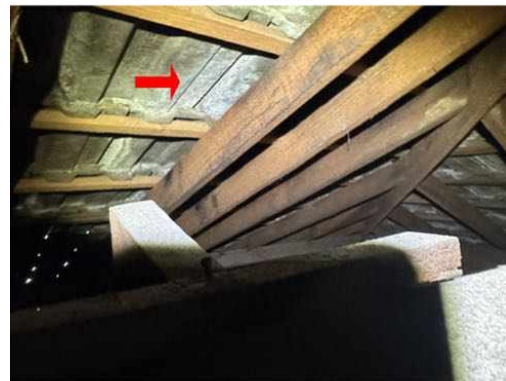
Finding 3.04

Building:	Main Building
Location:	Roof Exterior > All Areas
Finding:	Roof tiles - Weathered
Information:	Upon inspection of the exterior roofing, the majority of roof tiles were considered to be in a fair condition. While weathering of the tiles is consistent with the age of the property, maintenance works are required.

Isolated areas of mortar have come loose in the valleys and minor cracking is also present. Re-pointing and re-sealing the may be considered as an interim solution by the client to help preserve and extend the life span of the tiles.

Where left unmanaged, deteriorating roof tiles are likely to lead to a number of secondary defects, including minor water leaks and weather exposure to internal roofing structures.

Consultation with a roofing contractor is highly advised to gain advice on cost of remedial works that may be required in the short to medium term. Remedial works are likely to increase the longevity of the exterior roofing structure.

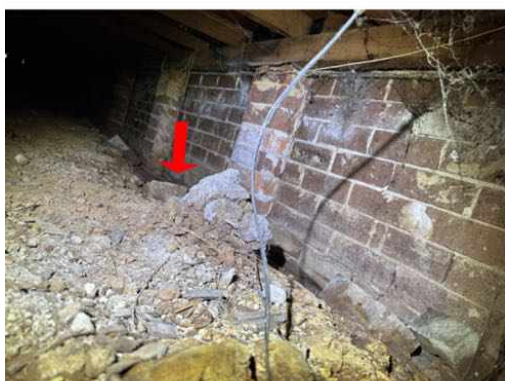
Finding 3.05

Building: Main Building
 Location: Subfloor > Front
 Finding: Water pooling - subfloor area.
 Information: Water appears to be pooling against the sub floor walls. It is suspected that this is a result of poor site drainage but may also be due to excessive moisture from disconnected awning downpipes drains.

Where water is pooling under the house, water damage to the sub structure may occur.

fungal decay in the area.

Consult a Licensed Plumber regarding the cost of potential site drainage rectification works.

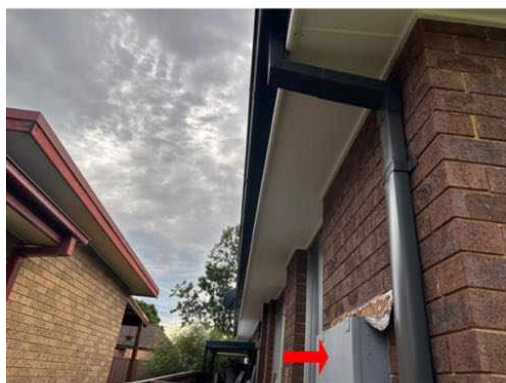
Building:	Main Building
Location:	Electrical circuit box > Front Left
Finding:	Termite Management System - no evidence of a chemical installation
Information:	The application of a post-construction chemical termite barrier is highly recommended for all properties, particularly if live termite activity has been found on the site

A durable notice should be placed in the switchboard unit to indicate current termite barriers. At the time of inspection, it appeared as though no termite management system has been installed, with no evidence to suggest preventative works taking place.

The client may consider gaining further advice from a pest controller as to the costs and procedures involved with this application. It is recommended that obtaining such advice be a short-term priority.

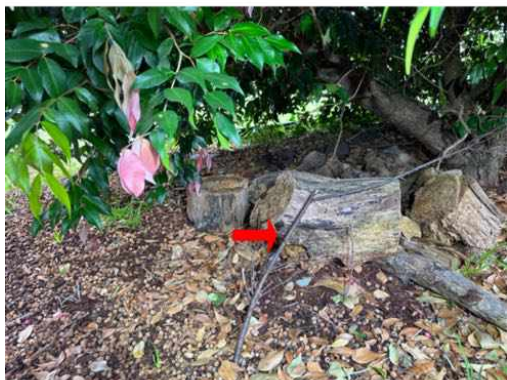
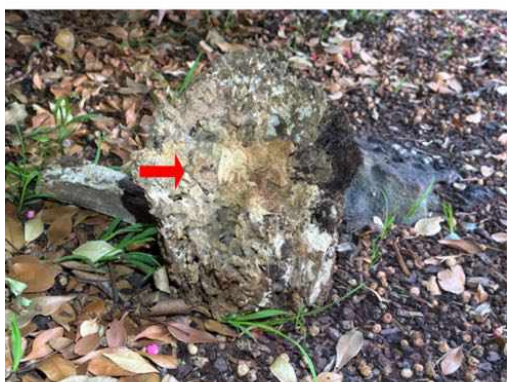
Finding 6.02

Building:	Main Building
Location:	Front Elevation > Front Right
Finding:	In ground contact
Information:	Any timbers in direct ground contact, including tree stumps provide opportunity for concealed termite entry and are likely to be subject to premature rot and decay as the soil retains moisture or damp conditions against the timbers.

Remove untreated timber and all tree stumps that is in direct contact with external grounds. Consider replacement with more durable materials i.e. treated timber or non timber elements. Frequent pest inspections are advised to readily identify any termite activity in these areas.

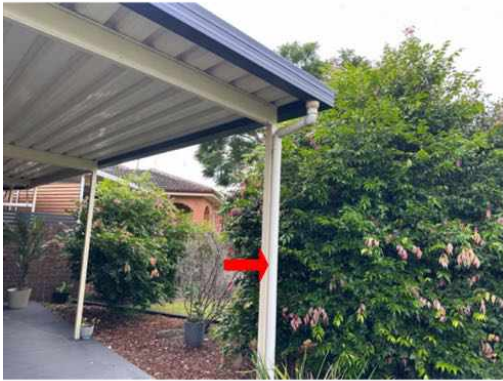
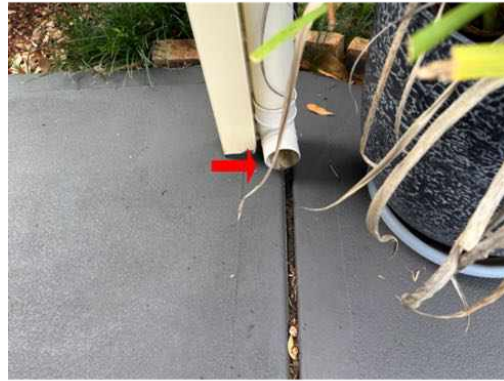
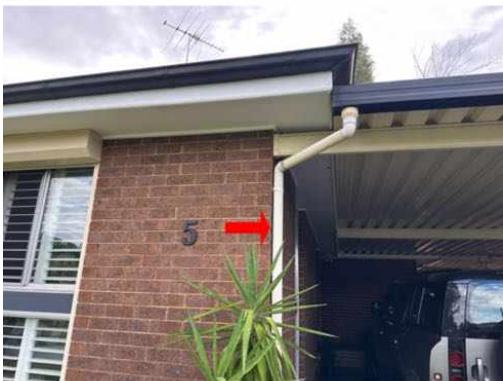
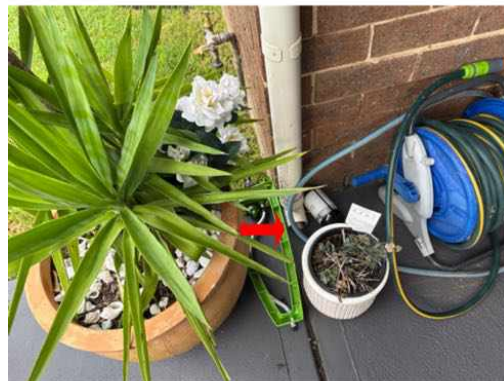
Finding 6.03

Building:	Main Building
Location:	Carport > Front Right
Finding:	Awning down pipes - Disconnected overflow
Information:	The awning down pipe overflow was found to be disconnected from storm water drainage and is creating excessive moisture in the surrounding area.

Such leaking creates an environment which is conducive to an array of defects, including water damage to associated building elements and the attraction of termite or timber pest infestation.

It is highly recommended that a licensed plumber be appointed to connect the awning down pipes overflow in order to prevent such an environment from being created. These minor works should be carried out as soon as possible.

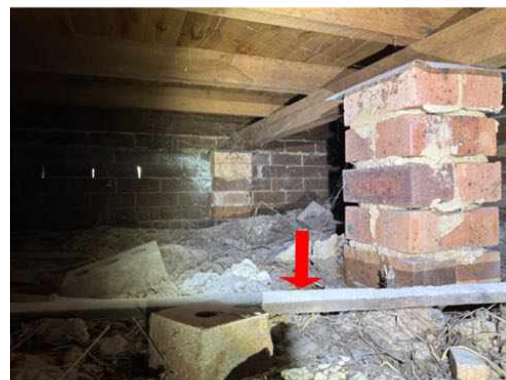
Information: An array of debris was found in the subfloor area at the time of inspection. Debris in this area restricts subfloor ventilation and creates potential for concealed pest entry. Stored timbers and other materials may also make the area susceptible to termite activity and wood rot.

A clear and empty subfloor will be better ventilated and easier to maintain in a dry condition. The removal of any timber debris is vital in minimising the risk of termite or wood borer activity.

Debris in the subfloor should be removed as soon as possible. Depending on the location and amount of debris and stored items, the homeowner may elect to undertake this task. Alternatively there are a large number of rubbish removal subcontractors that could undertake these works.

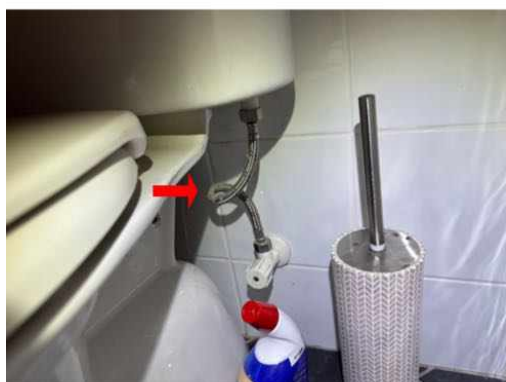
Building: Main Building
 Location: All Areas > All Areas
 Finding: Pipe: Flexible Braided pipes.
 Information: Braided Stainless Steel Flexi connector hose are popular in modern home fit outs because they can be bent into shape. They started to be installed in the early two thousands and their use is now extremely widespread in contemporary construction and renovations.

Flexible braided hoses accounted for more than one in five water damage claims lodged by Australian households according to research released by general insurer IAG.

It is recommended that the Flexi pipes to be replaced at the owners discretion to avoid an “escape water incident” which may lead to water damage to other building elements in the home.

This work can be undertaken by a licensed plumber, general handy person at the owners discretion.

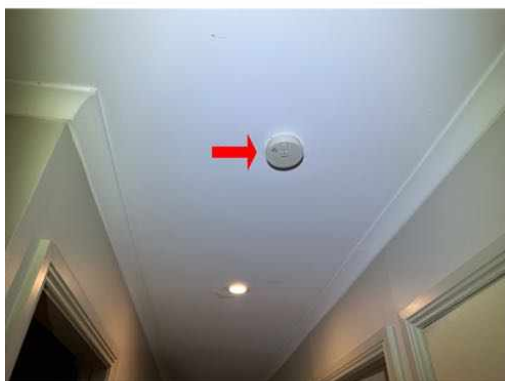
Building: Main Building
 Location: Hallway > Centre
 Finding: Smoke Detectors and Alarms
 Information: Reporting on Smoke Detectors or Alarms, including hard wired smoke detection

Please note that this defect is highlighted as a caution only. We suspect, based on our experience in the building industry, that the absence of smoke detectors, or their poor condition, should be addressed as a matter of urgency to improve occupant safety.

Always ensure sufficient working and suitable smoke detectors are installed prior to occupying any building. Additionally, it is advised that all smoke detectors be tested by the homeowner on a monthly basis.

Please refer to AS3786 and state based legislation, which may also apply.

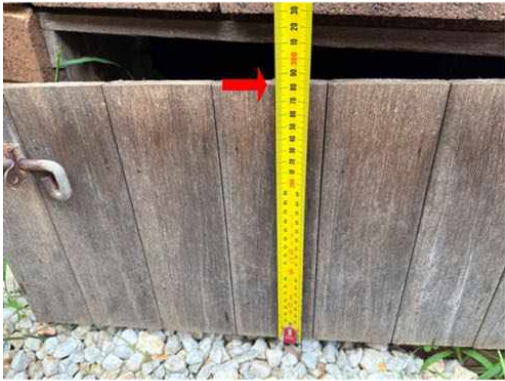
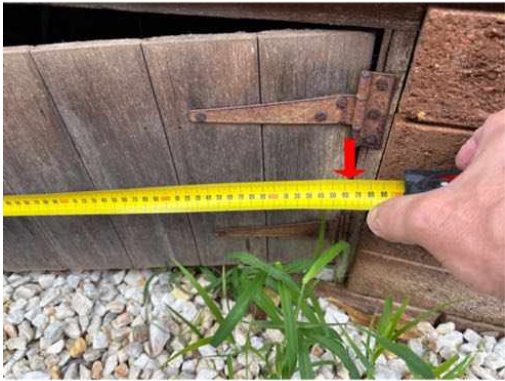
Building: Main Building
Location: Subfloor > Front Left
Finding: Sub Floor restricted Access.
Information: At the time of inspection the sub floor area had restricted access due to manhole size.
