Building and Timber Pest Inspection Report

Inspection Date: Wed, 11 Feb 2026

Property Address: 21 Ucres Wy, Golden Square VIC 3555,
Australia

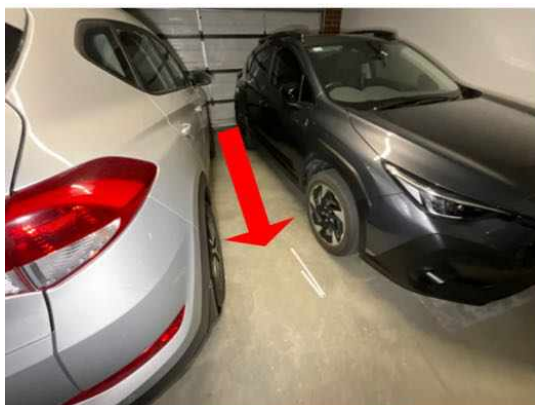
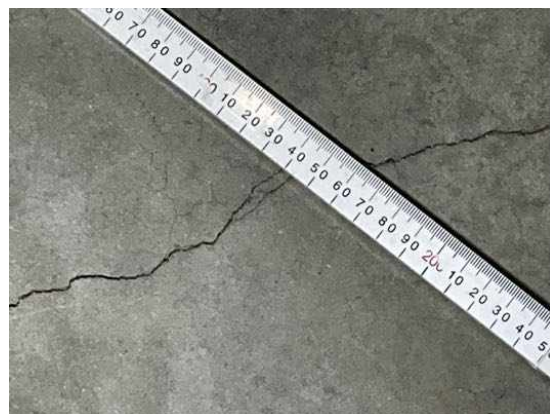
Finding 3.01

Building: Building 1
Location: Garage
Finding: Crack in concrete slab - Category 1
Information: A crack coded as Category 1 was identified in the slab. A Category 1 crack is described as a fine but noticeable crack, with the slab at an otherwise reasonable level.

To be considered Category 1, the approximate width of the crack is less than 1.0mm, or a less than 10mm change in offset when a 3m straight edge is placed over the defect.

Category 1 cracks should be monitored for a period of 12 months. At the end of the monitoring period, identified cracks that are rated greater than Category 2 are considered defects, and require rectification.

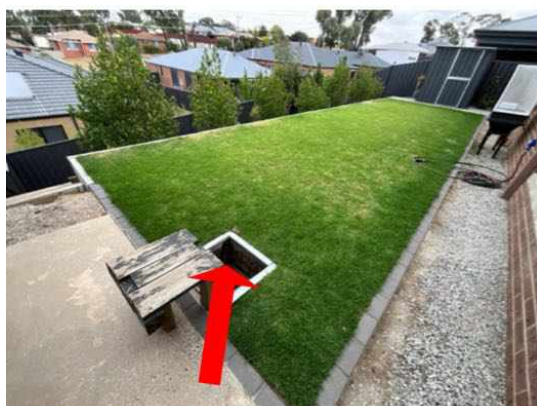
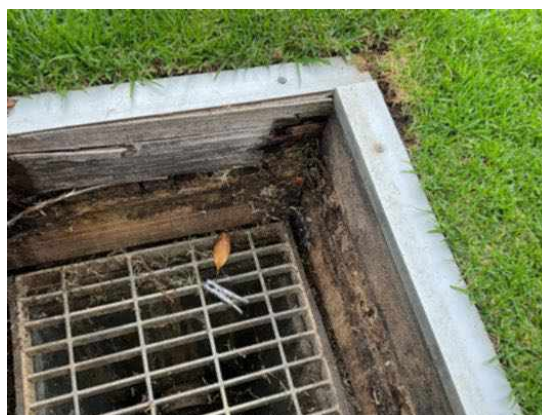
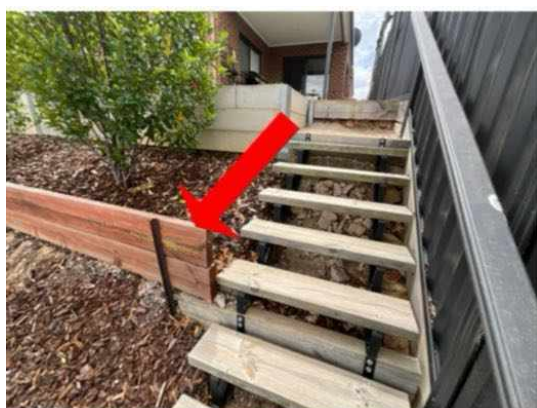
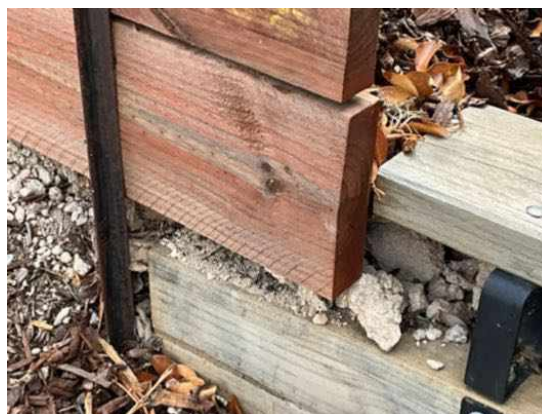
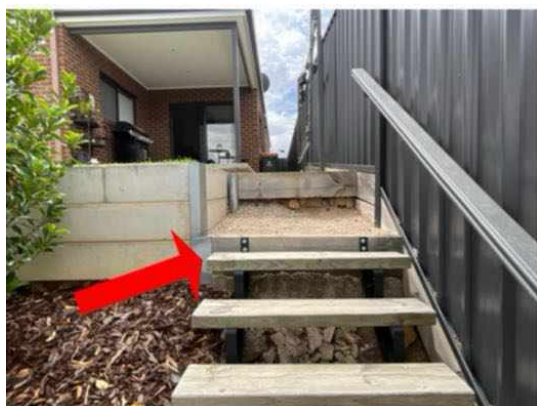
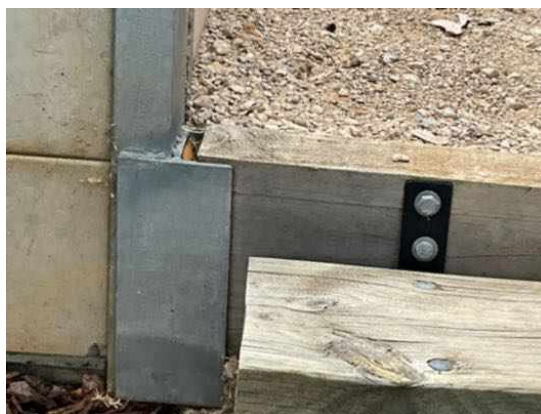
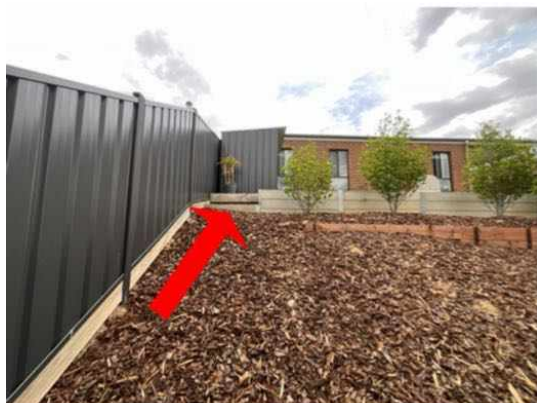
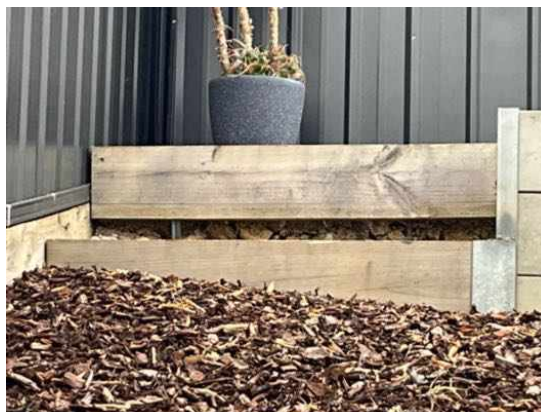
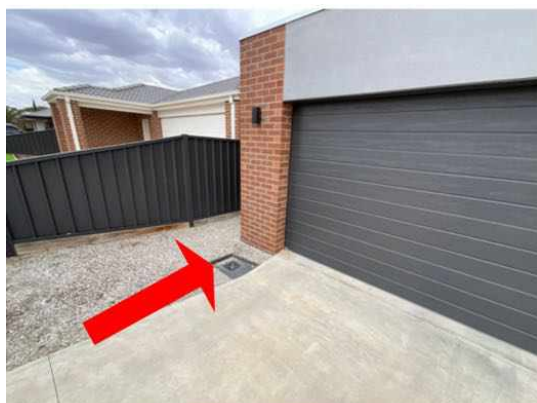
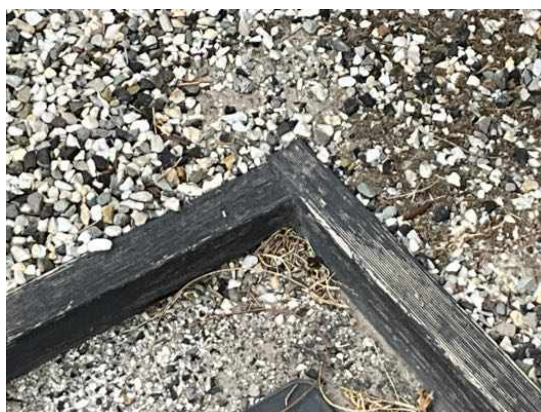
Finding 6.01

Building:	Building 1
Location:	Yard - Back, front
Finding:	Untreated or non-durable timbers in a hazardous environment
Information:	To reduce the risk of timber pest attack it is essential that timber used in a hazardous environment (e.g. in direct contact with the ground or frequently exposed to damp conditions) is of sufficient durability and/or is adequately preservative treated.

Untreated timbers in direct contact with the ground are likely to develop severe wood rot and/or fungal decay if left unattended creating attraction for subterranean termites to infest the timbers from surrounding areas.

If untreated or non-durable timbers are found to be in a hazardous environment it is highly advised that replacement of these building elements be performed as soon as possible to aid the protection of the property against termite / timber pest attack.

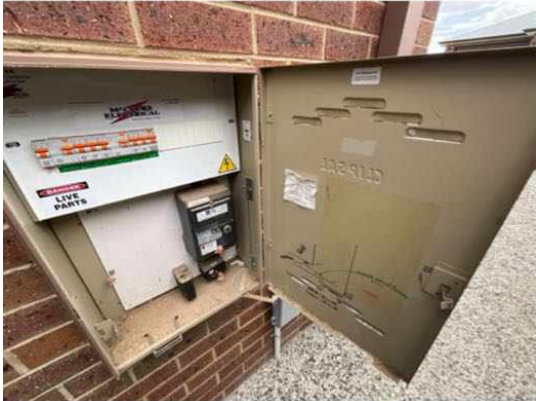
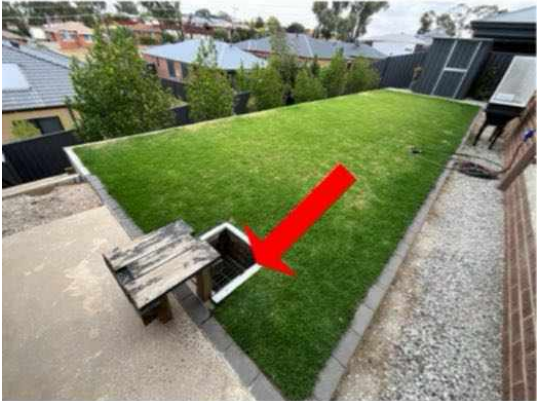
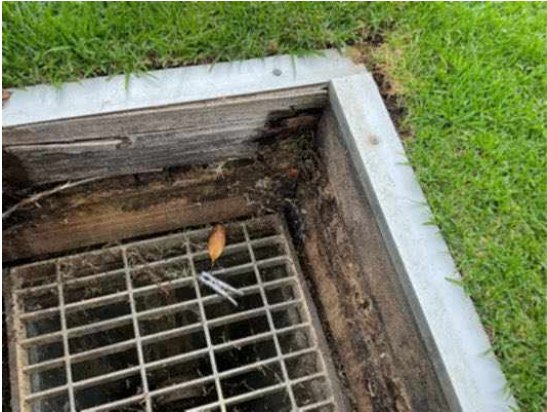
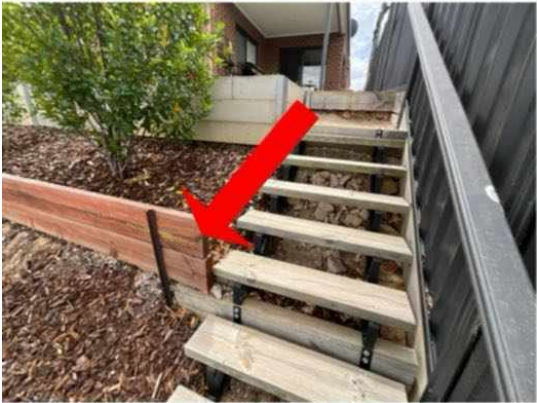
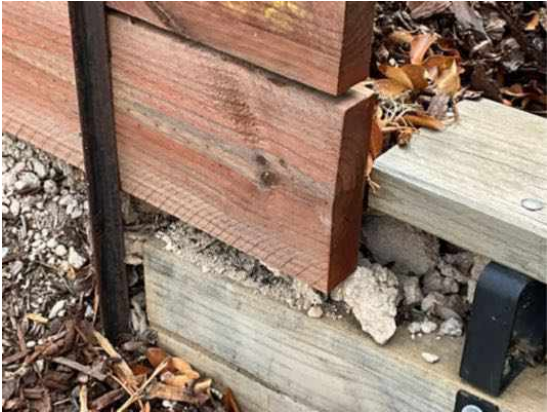
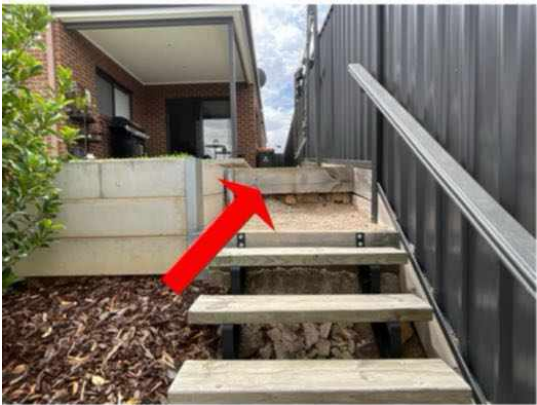
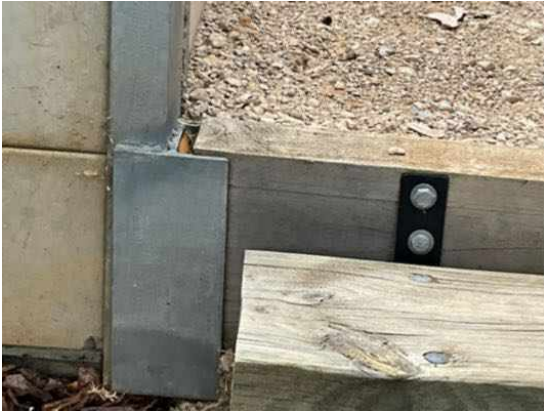
Finding 6.02

Building:	Building 1
Location:	All External Areas
Finding:	Termite Management System - no evidence of a chemical installation
Information:	The application of a post-construction chemical termite barrier is highly recommended for all properties, particularly if live termite activity has been found on the site previously. Such barriers are highly effective in preventing termite attack on any timber building elements throughout the property.

A durable notice should be placed in the switchboard unit to indicate current termite barriers. At the time of inspection, it appeared as though no termite management system has been installed, with no evidence to suggest preventative works taking

place.

The client may consider gaining further advice from a pest controller as to the costs and procedures involved with this application. It is recommended that obtaining such advice be a short-term priority.

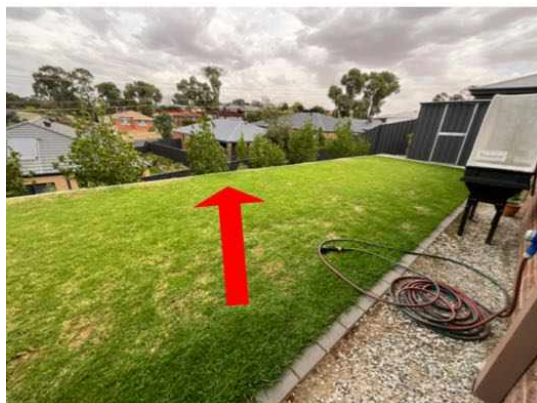
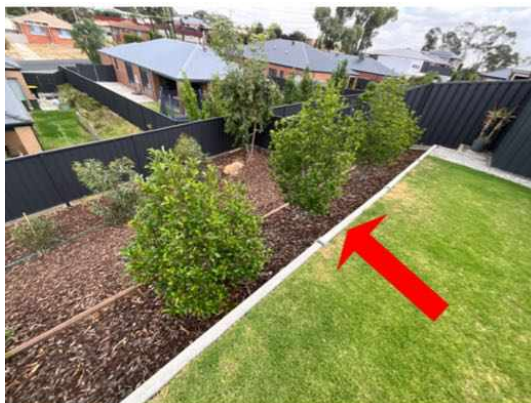
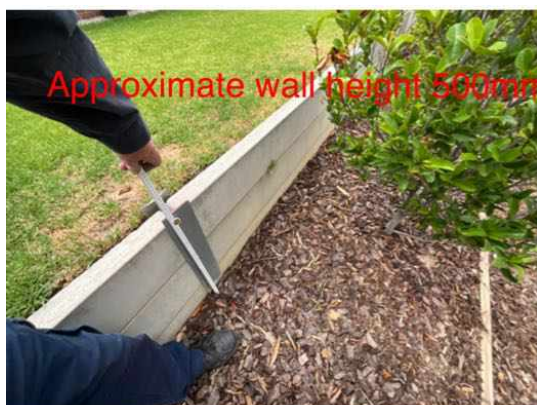
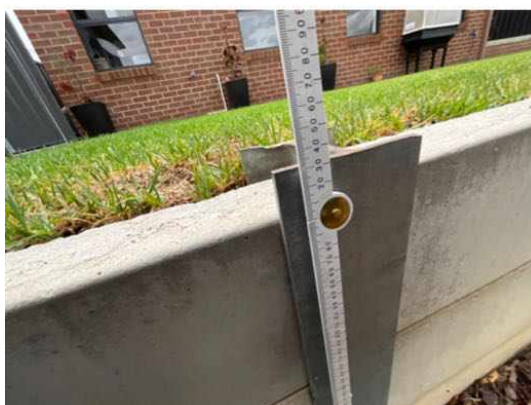
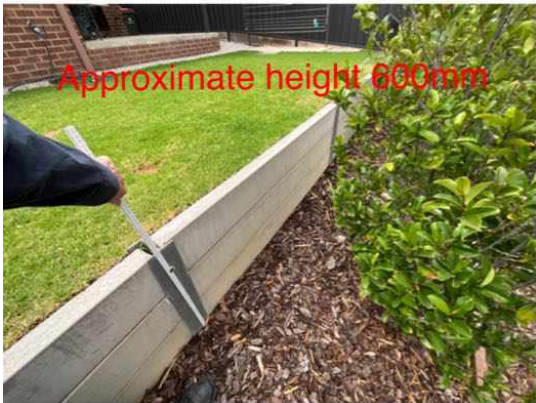
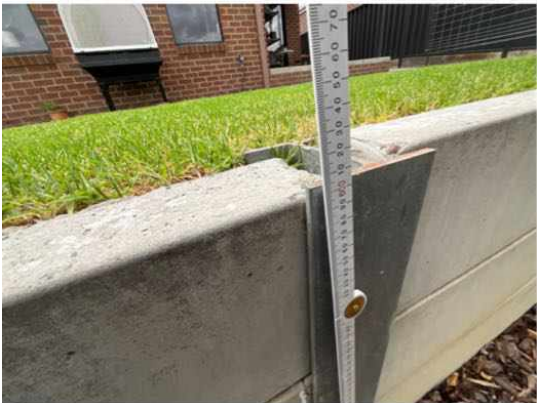
Building: Building 1
Location: Yard - Back
Finding: Retaining wall drop off
Information: At the discretion of the client, a barrier may be installed to improve the safety of this area.

Depending upon intended use of the area, inattentive persons may fall.

A fencing specialist or registered builder should be contacted if improvements are needed.

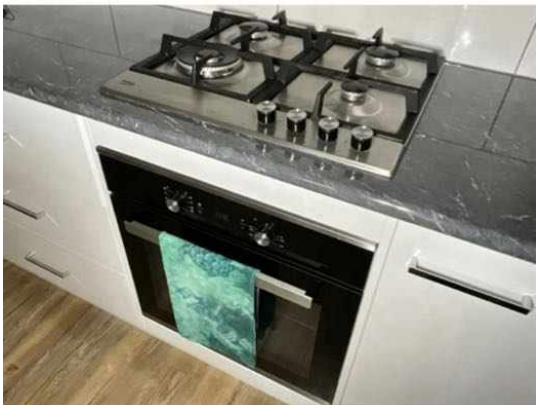
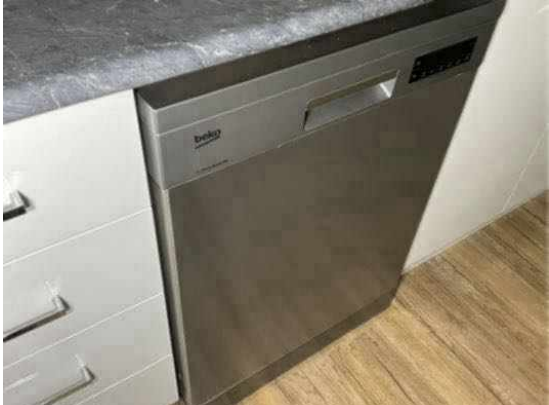
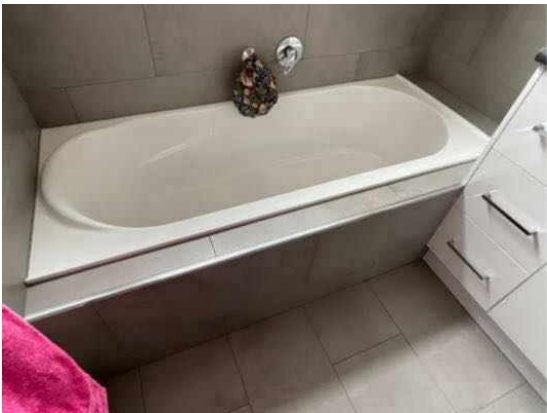
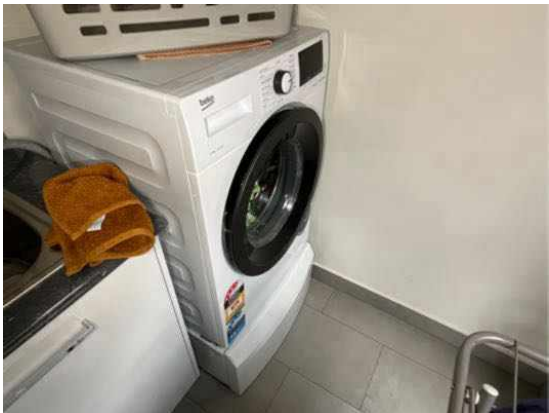
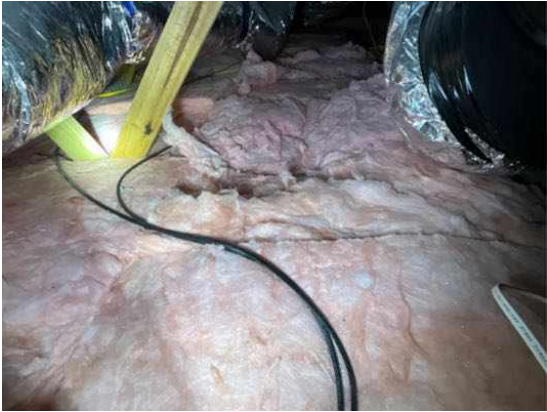
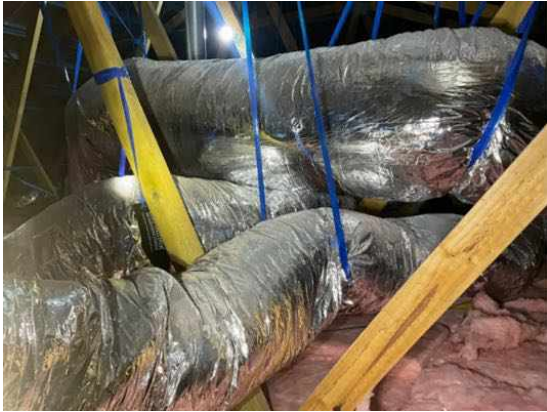
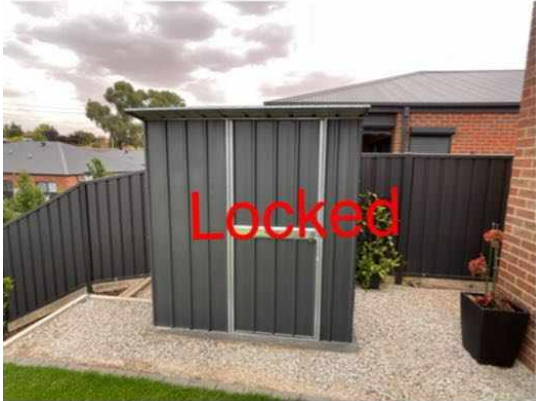
Building: Building 1
Location: All Areas
Finding: Additional Photos - Obstructions and Limitations
Information: These photographs are an indication of the obstructions and limitations which impeded full inspection of the property at the time of inspection. These obstructions can hide an array of defects and should be removed to allow full inspection to be carried out. A re-inspection is recommended once the areas are made accessible.
