# Building and Timber Pest Inspection Report

Inspection Date: Wed, 18 Feb 2026

Property Address: 7A Foote St, Templestowe Lower VIC 3107,  
Australia

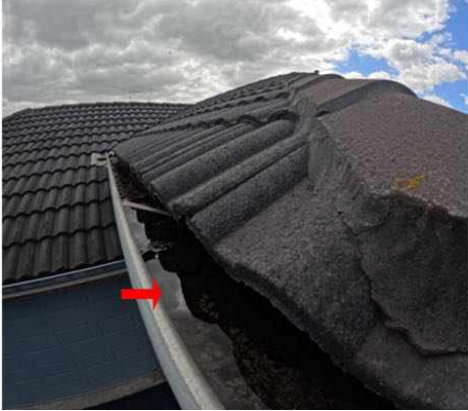
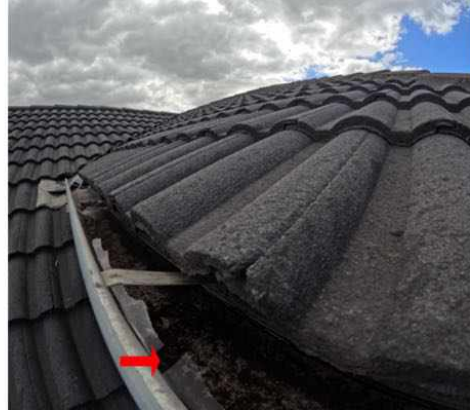
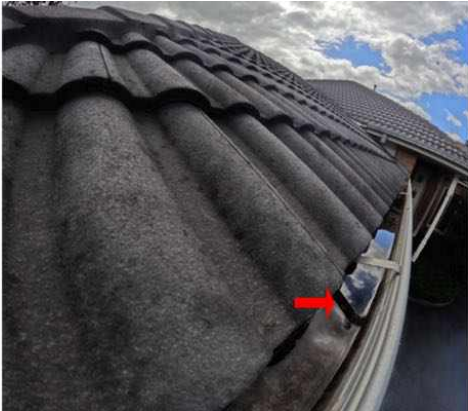
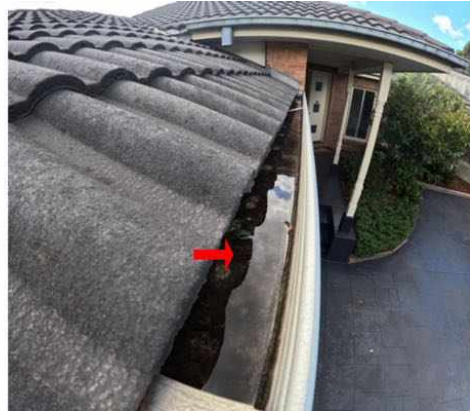
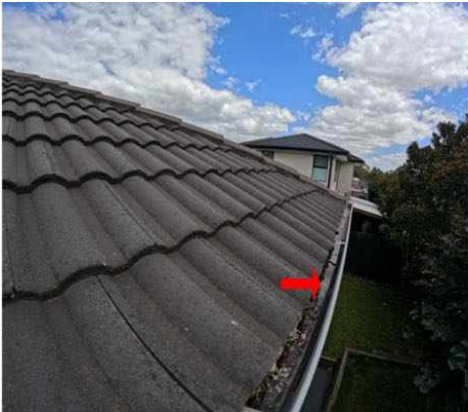
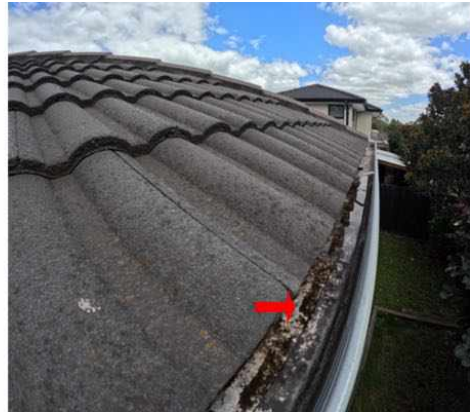
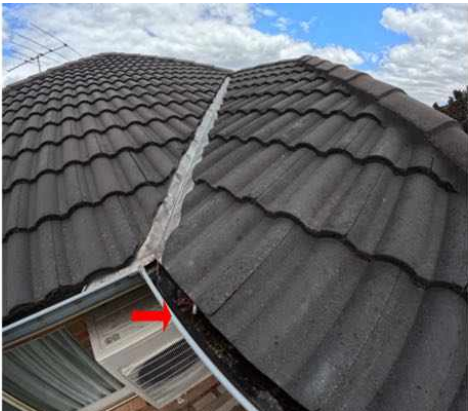
| Information: | Water was observed ponding in the gutter during the inspection. Prolonged standing water can contribute to corrosion, blockages, mosquito breeding, and moisture-related damage to adjoining structures. |

Engage a licensed roofing plumber to adjust the gutter alignment and reinstate a proper fall to ensure effective drainage. Prompt action is advised to maintain the gutter's function and prevent long-term deterioration.

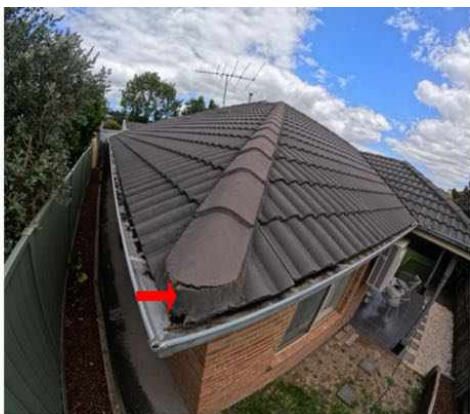
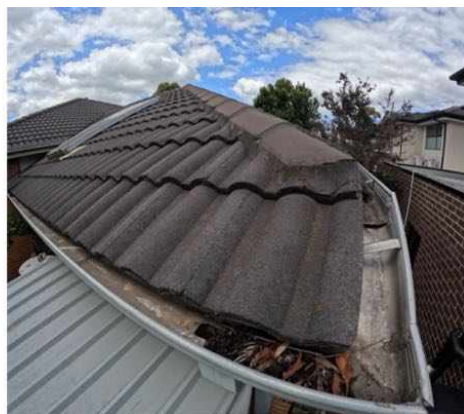
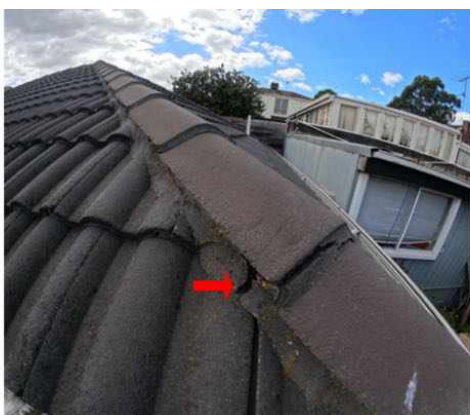
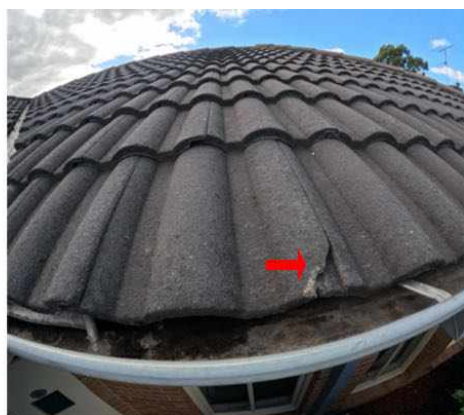
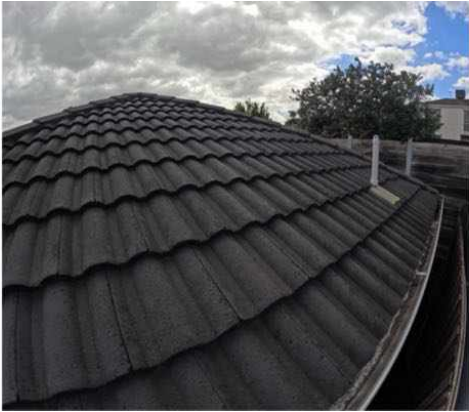
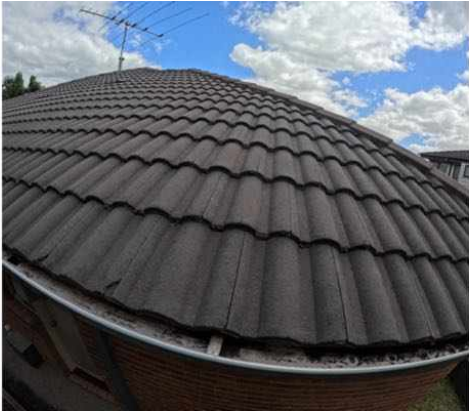
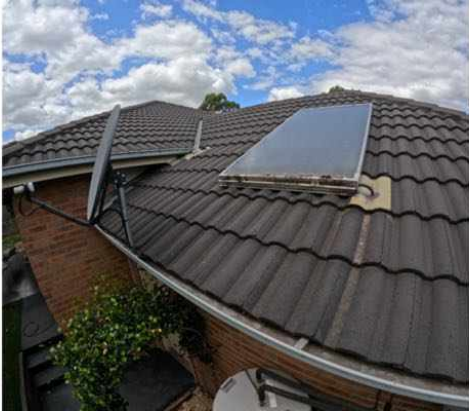
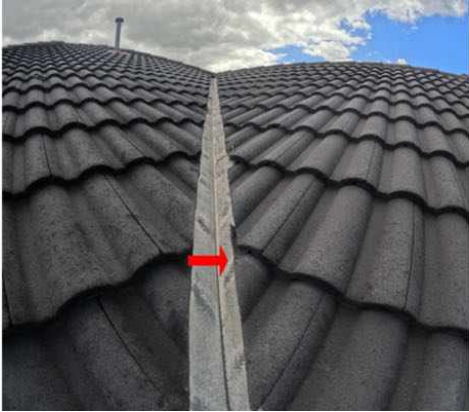
### Finding 3.03

| Information: | Upon inspection of the exterior roofing, the majority of roof tiles were considered to be in a fair condition. While weathering of the tiles is consistent with the age of the property, maintenance works are required. |

Isolated areas of mortar have come loose in the valleys and minor cracking is also present. Re-pointing and re-sealing the may be considered as an interim solution by the client to help preserve and extend the life span of the tiles.

Where left unmanaged, deteriorating roof tiles are likely to lead to a number of secondary defects, including minor water leaks and weather exposure to internal roofing structures.

Consultation with a roofing contractor is highly advised to gain advice on cost of remedial works that may be required in the short to medium term. Remedial works are likely to increase the longevity of the exterior roofing structure.

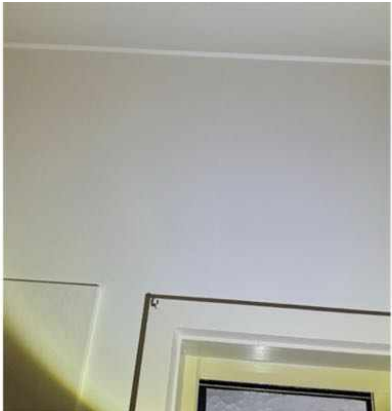
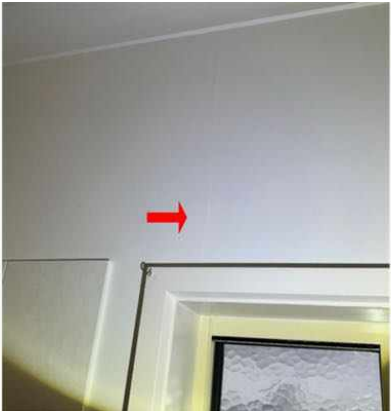
**Finding 3.04**

Building: Main Building  
 Location: Bathroom  
 Finding: Plaster cracks  
 Information: Interior plaster cracks can result from factors such as normal settling, temperature and humidity changes, structural movement, or poor application.

Please continue to monitor these cracks. If they worsen or raise concerns, consider consulting a professional structural engineer to assess potential underlying issues

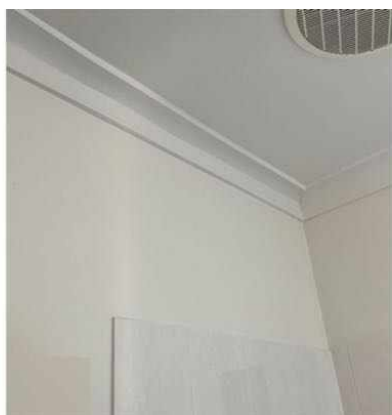
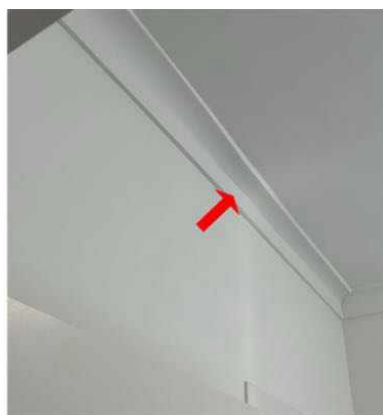
**Finding 3.05**

Building: Main Building  
 Location: Bathroom  
 Finding: For your information  
 Information: The cornice profile appears uneven/misshapen, with visible irregularities consistent with previous patching or repair.

This may indicate prior movement or past repair work, and the finish may continue to crack or deteriorate over time.

Monitor the area for any worsening cracks or displacement, and engage a qualified plasterer/builder to assess and carry out remedial patching/rectification if required.

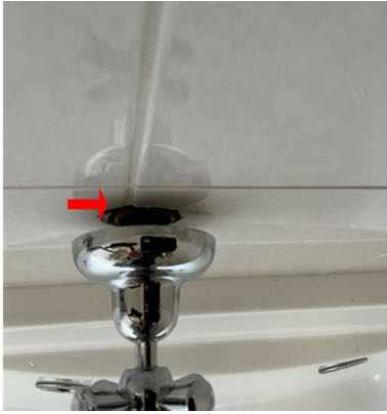
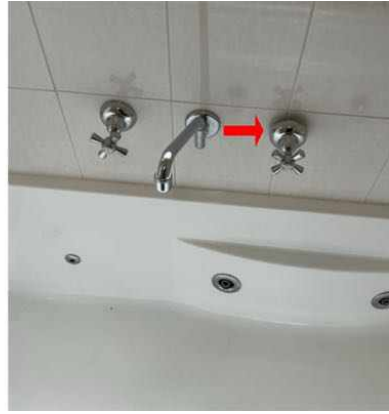
### Finding 3.06

Building: Main Building  
 Location: Bathroom  
 Finding: Bath tap cover plate loose and penetrations not sealed  
 Information: The tap cover plate is loose and a visible gap is present between the cover plate and tile; additionally, the tap penetration does not appear to be fully sealed.

Gaps at penetrations may allow water ingress into the wall substrate, increasing the risk of moisture damage and deterioration over time.

Secure the cover plate and seal penetrations appropriately (wet-area grade sealant) and monitor for any signs of moisture issues. As the bathroom appears to have been renovated as a complete package, it is recommended that all wet-area penetrations (e.g., taps, shower fittings and other fixtures) be checked to ensure they are fully sealed.

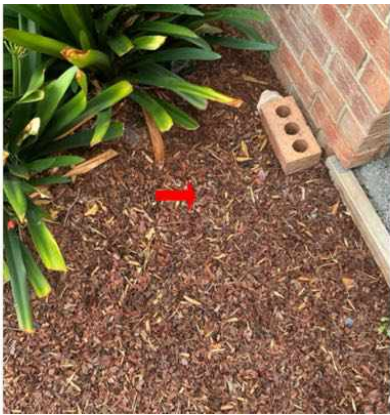
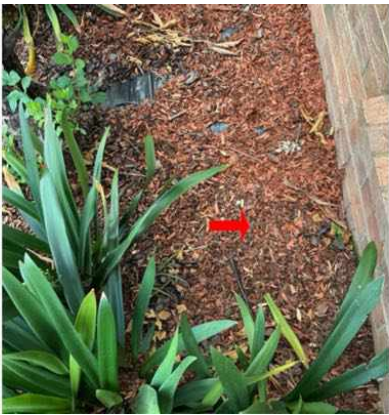
## Finding 6.02

Building: Main Building  
 Location: All Areas  
 Finding: Stored timbers - subfloor space or external area  
 Information: The storing of timbers in the subfloor space or around the external property (including bark mulch) increases the risk of termite activity being present. As they are likely to come into contact with weather conditions or excessive moisture wood rot is likely to develop on timbers that are not treated.

It is highly recommended that any stored timbers be immediately removed from areas in which they may attract any termite / timber pest attack. Minimisation of risk / prevention of termite attack is far more adequate than dealing with the presence of termite activity.

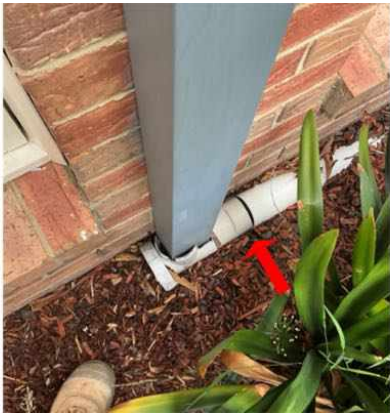
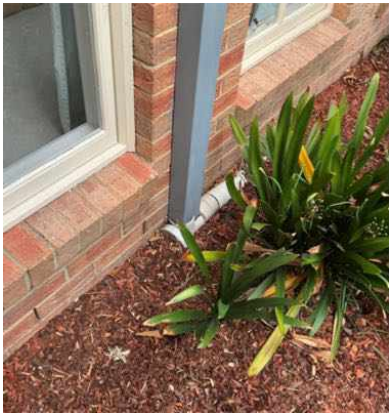
**Finding 6.03**

Building: Main Building  
 Location: Downpipes  
 Finding: Downpipe(s)-not connected  
 Information: The roof plumbing is not adequately connected to the stormwater drainage system on site. This disconnection reduces the functional performance of the roof plumbing.

Where roof plumbing does not drain adequately, water can discharge directly to the soil around the building perimeter, leading to excessive damp conditions. Over time, this may contribute to rust and corrosion of nearby building elements and create conditions that can attract termites and other pests. Prolonged water discharge to soil can also potentially contribute to structural movement.

It is recommended that a licensed plumber further inspect the area and install appropriate drainage connections where required.

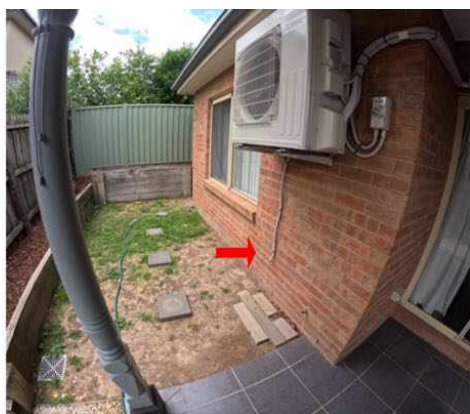
**Finding 6.04**

Building: Main Building  
 Location: Hot water/aircon unit(s)  
 Finding: The air conditioning condensation pipe is not properly connected and discharges directly into the soil adjacent to the building.

Information: This creates a conducive condition for termite activity by providing a constant moisture source near the structure. It may also lead to soil erosion, mould growth, or damage to nearby building materials.

The overflow should be redirected to an appropriate discharge point—such as a stormwater connection or designated drainage area—away from the building foundation, in accordance with plumbing and termite management standards.

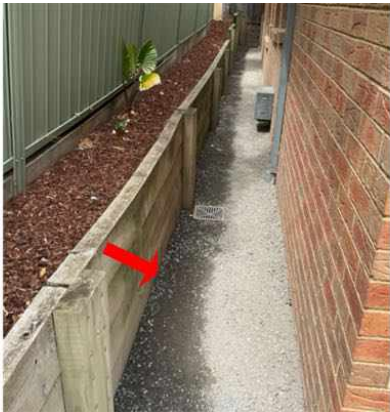
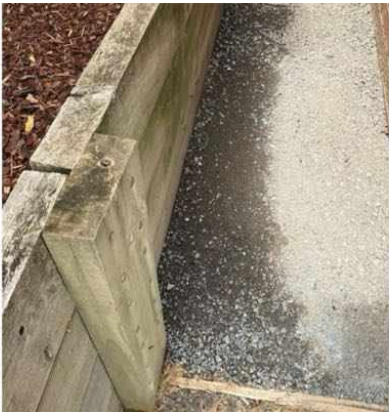
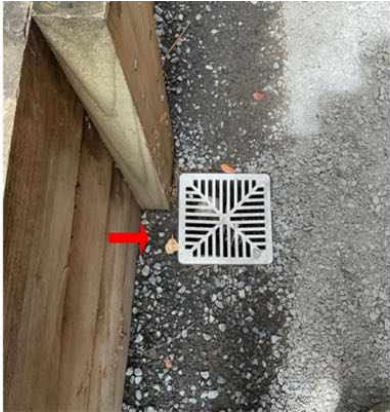
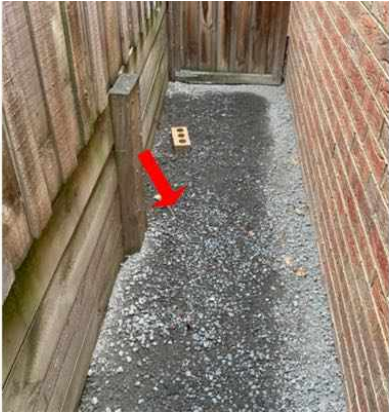
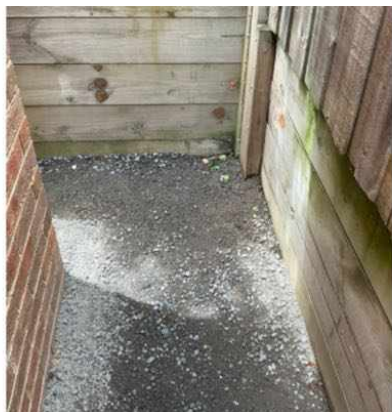
Building: Main Building  
Location: Yard - Back  
Finding: Retaining Wall Seepage (Low Side Staining)  
Information: Moisture staining was observed along the lower side of the timber retaining wall. This staining is consistent with water seepage migrating from the higher retained ground side during rainfall events, rather than water originating at the low side.

Ongoing seepage may contribute to premature deterioration of the retaining wall components and can lead to soft/wet ground conditions adjacent to the wall if not addressed.

It is recommended that the retaining wall drainage provisions (e.g., agi pipe/subsoil drainage and discharge points) be checked and maintained to ensure water can relieve from behind the wall. Further assessment by a suitably qualified contractor is recommended if seepage continues or worsens.

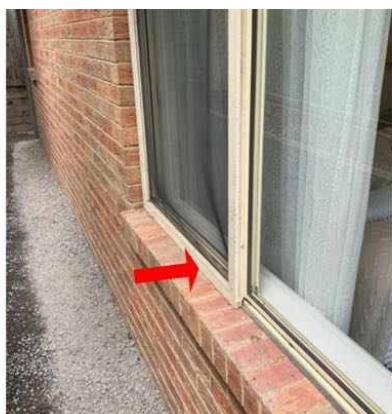
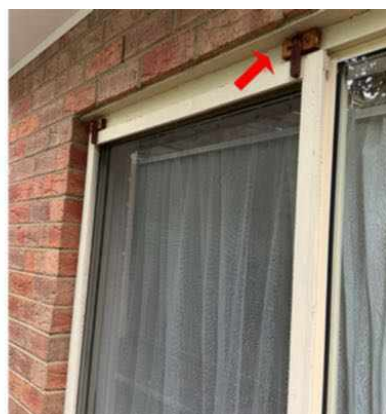
Building: Main Building  
 Location: Bedroom  
 Finding: Window flyscreen  
 Information: The window flyscreen appears to be a later addition and does not match the original window system; the fixing method (external brackets/screws) appears non-standard and may not provide secure, aligned installation.

Poor fixing can lead to loosening/damage to the window frame, reduced insect sealing, and potential operational issues with the window/screen over time.

Have a qualified window/flyscreen contractor assess and re-fit using a compatible screen system and proper proprietary fixings, or replace with a correctly sized, purpose-made flyscreen to suit the window.

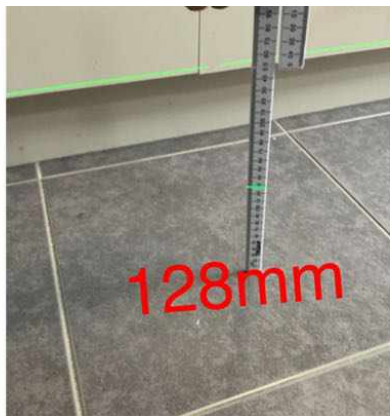
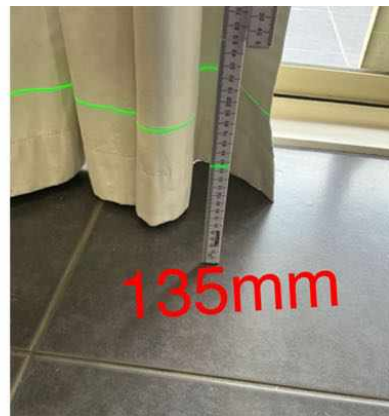
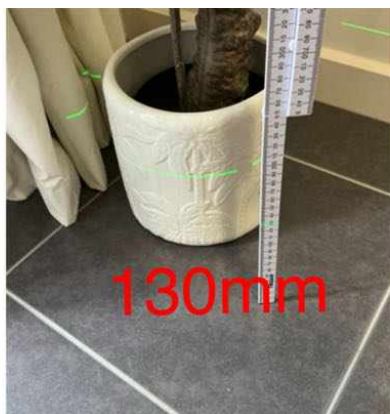
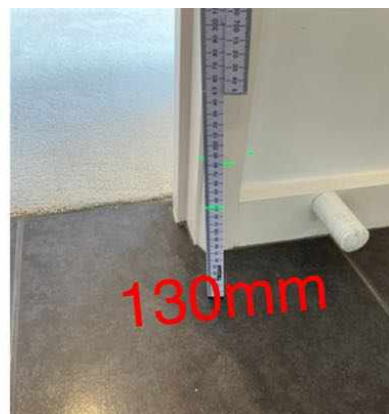
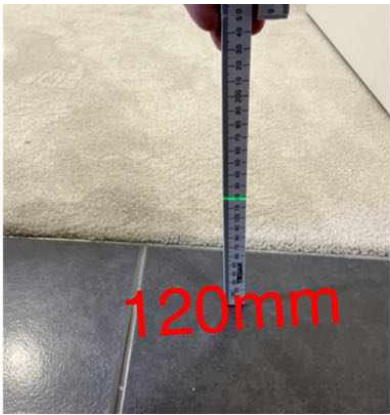
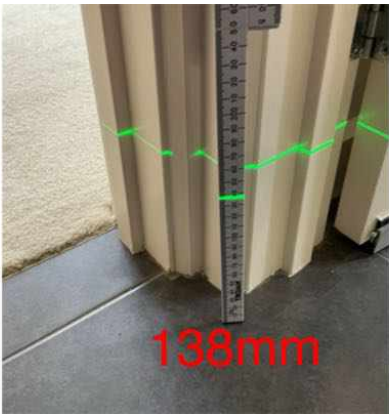
Building: Main Building  
 Location: All Areas  
 Finding: floor unevenness - v4  
 Information: The standard laser level was positioned 125 mm above the floor, as shown in the photo. The measured floor deviation across the room ranges from the lowest point to

Considering the age of the property and no visible significant cracks were observed at time of inspection. This degree of settlement is generally within an acceptable range for a building of its era. However, for buyers who have higher expectations regarding floor levelness or sensitivity to uneven floors, it should be noted that restumping or re-leveling can involve a considerable cost. This should be taken into account when planning the overall purchase budget.

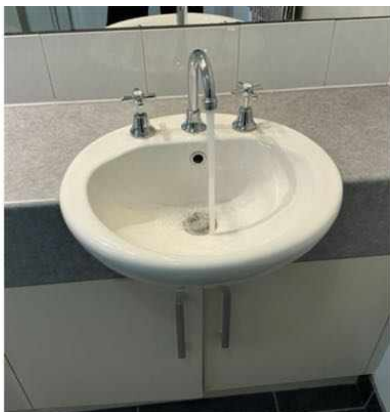
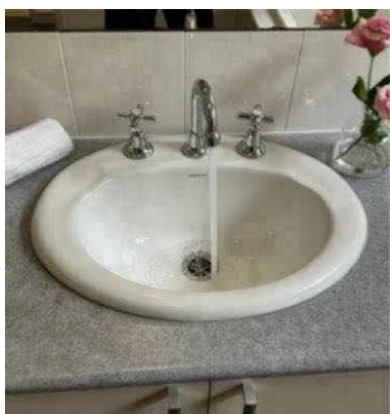
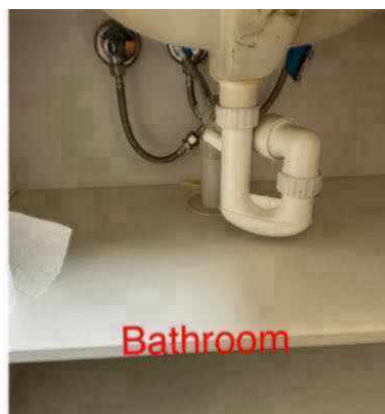
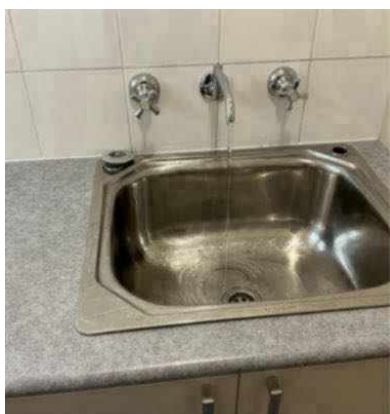
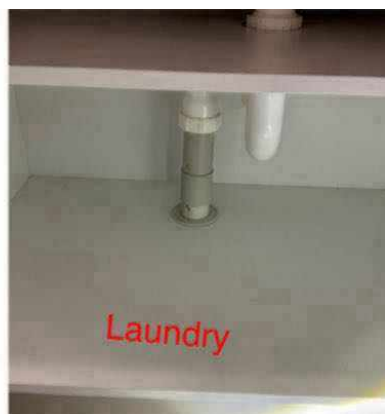
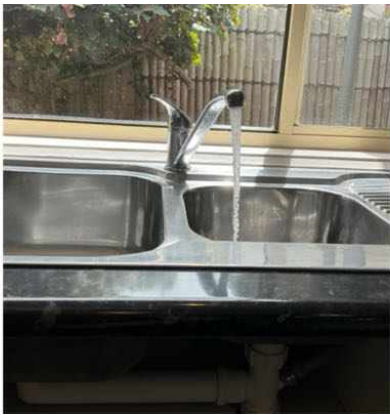
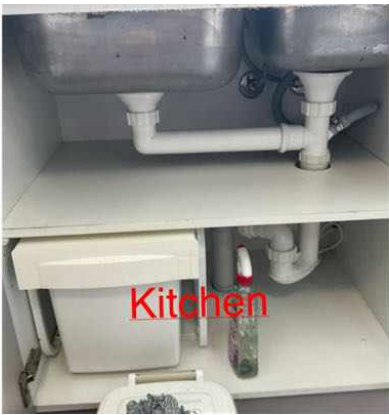
Building: Main Building  
 Location: Cabinet plumbing  
 Finding: For your information  
 Information: Cabinetry plumbing - No leaks evident

All cupboards where sinks and basins with drainage plumbing were inspected and no evidence of leaks were present at the time of inspection.

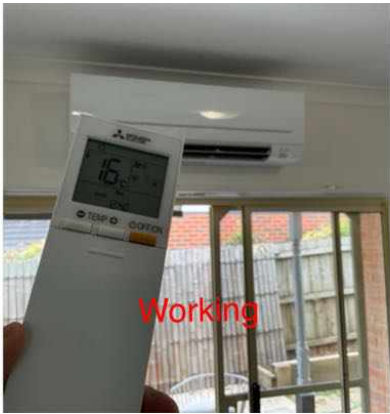
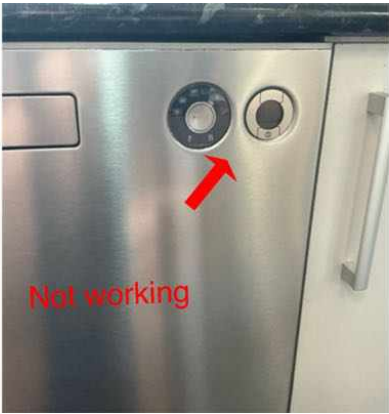
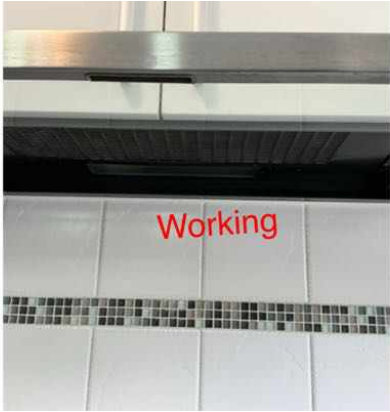
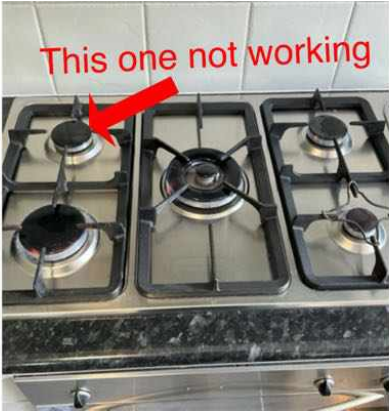
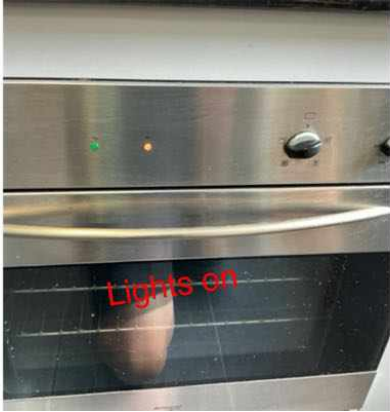
Building: Main Building  
 Location: Plumbing/electrical/gas/aircon/appliances/pool equipment/fire safety etc  
 Finding: For your information  
 Information: Plumbing and electrical inspections are outside the scope of the building inspection and must be conducted by a Licensed and registered Trades person.

It is highly recommended that the client makes immediate arrangements to have the gas appliances checked by a licensed gas plumber to ensure that the appliances are working safely and efficiently.

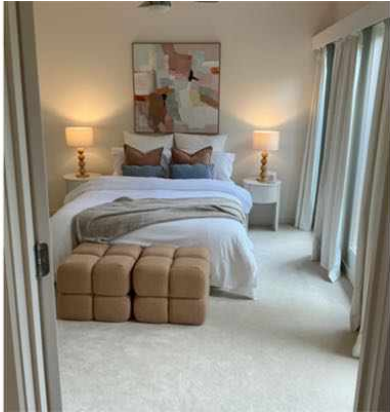
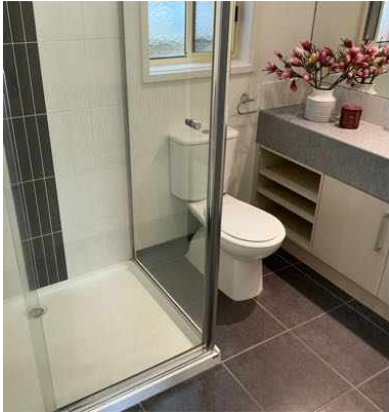
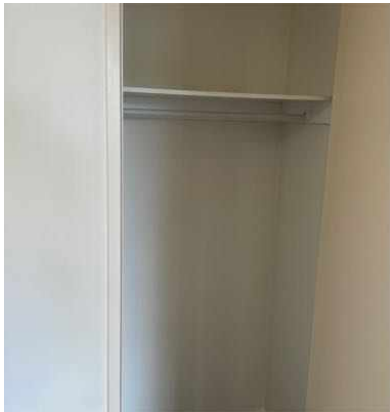
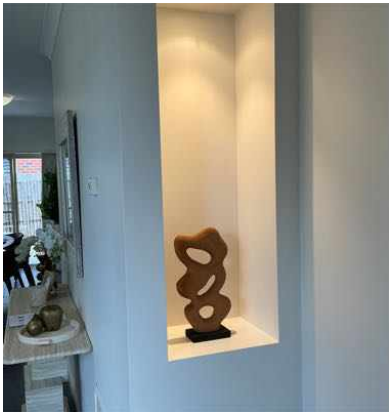
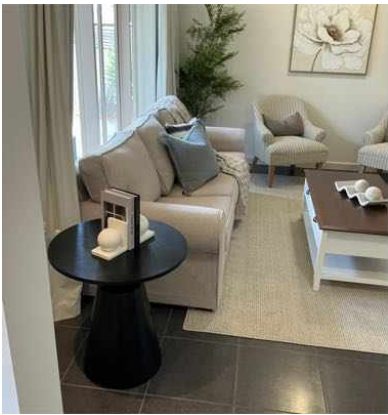
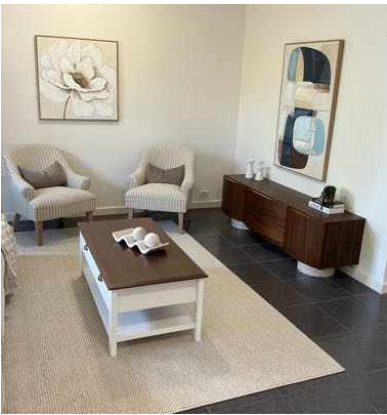
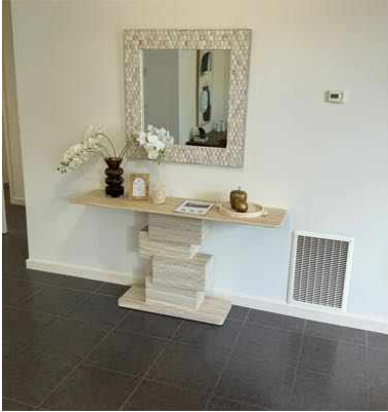
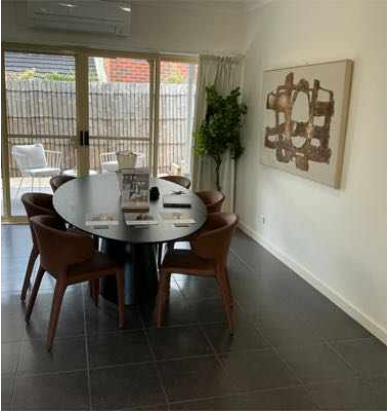
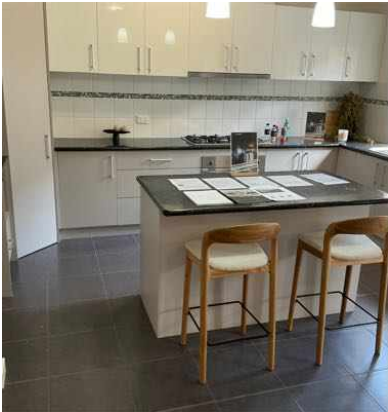
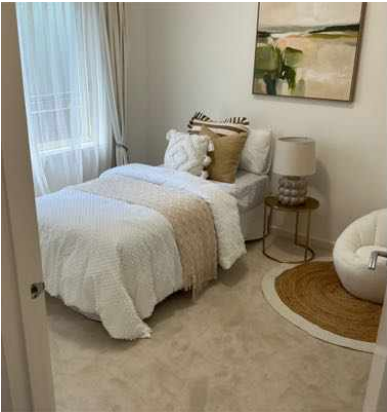
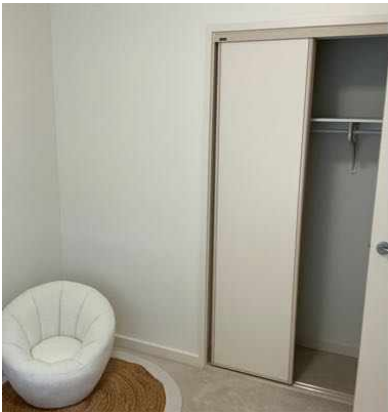
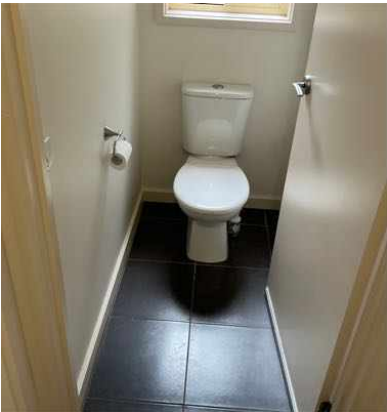
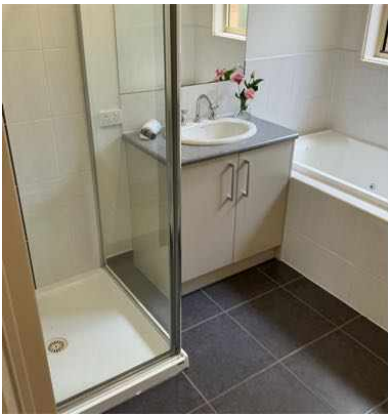
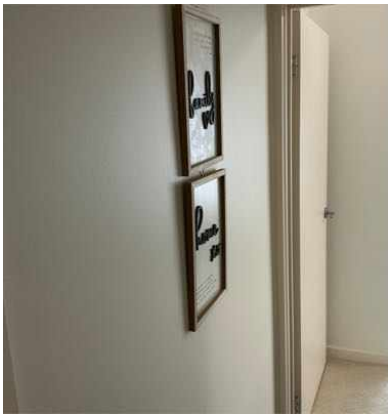
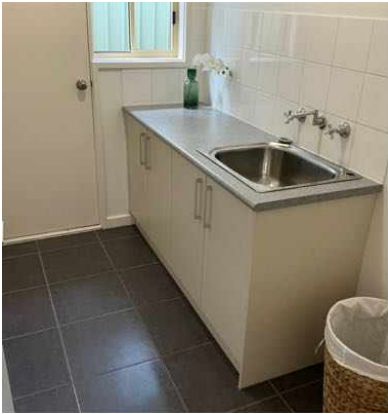
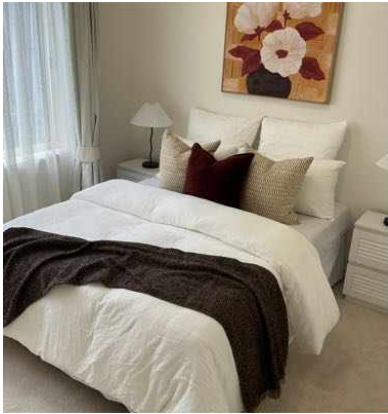
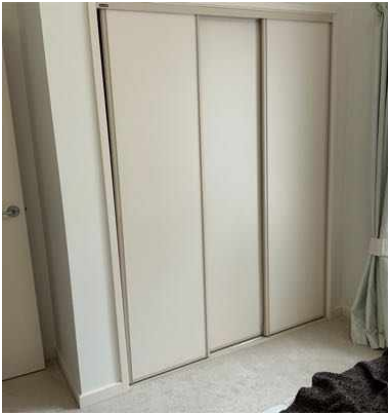
Building: Main Building  
Location: All Areas  
Finding: Additional Photos - Obstructions and Limitations  
Information: These photographs are an indication of the obstructions and limitations which impeded full inspection of the property at the time of inspection. These obstructions can hide an array of defects and should be removed to allow full inspection to be carried out. A re-inspection is recommended once the areas are made accessible. Arrows and highlights have been included to identify minor defects. The purchaser can discuss further with the building inspector.
