# Building and Timber Pest Inspection Report

Inspection Date: Thu, 12 Mar 2026

Property Address: 9 William Ln, Redfern NSW 2016, Australia

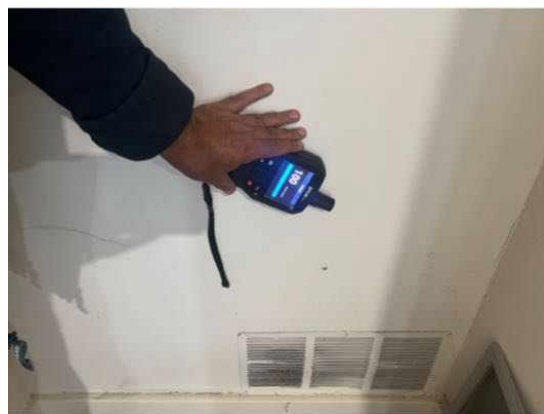
#### Finding 3.01

Building: Main Building  
Location: All Internal Areas  
Finding: Elevated Moisture – Further Investigation Recommended - rear cupboard , laundry , ceiling below laundry/bathroom  
Information: Elevated moisture readings were detected in several locations, dampness can contribute to deterioration if left unaddressed. Inspector was not able to inspect the external wall due to space constraints. A further investigation by a licensed plumber or waterproofing specialist is recommended to confirm the source and ensure no concealed issues are developing.

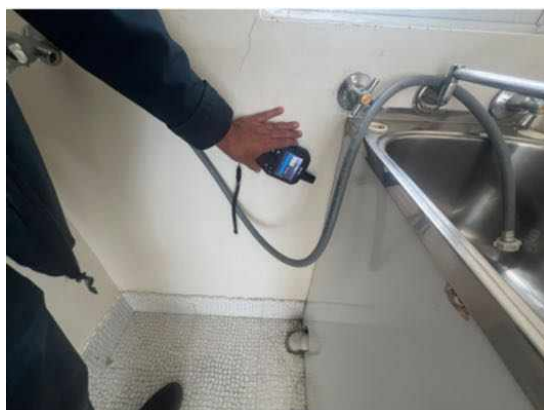
### Finding 3.02

Building:	Main Building
Location:	Bathroom, Laundry
Finding:	Elevated Moisture Bathroom (No visible deterioration noted) - Further investigation recommended
Information:	Elevated moisture levels were detected to tiled surfaces in bathroom/shower areas. Persistent moisture ingress can lead to concealed damage, including timber rot and mould growth.

Elevated moisture readings in tiled wet areas can occur from normal shower use, age/deterioration of waterproofing membranes, plumbing leaks or moisture absorption through grout lines. While no damage was visible, elevated readings may indicate moisture retention behind tiles, which can be a conducive condition for future deterioration if not monitored.

A further inspection by a licensed waterproofing specialist is recommended.

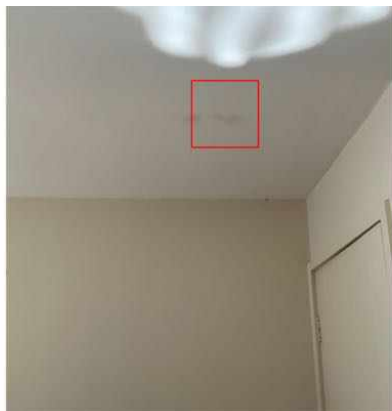
### Finding 3.03

Building:	Main Building
Location:	Kitchen
Finding:	Ceiling - Water stained
Information:	Water staining to ceiling linings in this area was evident at the time of inspection. Water staining indicates that surfaces have been exposed to excessive moisture over time. The minerals and other elements in the water lead to staining, which may graduate to corrosion and deterioration if left unmanaged.

While mostly an appearance defect, water staining can be indicative of more serious defects, which may be currently concealed by interior ceilings.

Where water staining is active, a licensed plumber must be consulted to identify the cause of the staining and to provide advice on any reparation works that may be required. Replacement of any damaged structures is advised.

Conversely, where water staining is old and inactive, affected building materials may be repaired or replaced at client discretion.

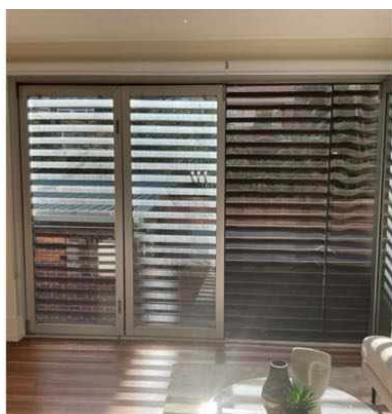
### Finding 3.04

Building:	Main Building
Location:	All Internal Areas - Level 1 and 2
Finding:	Facade and glazing door
Information:	The glazing doors were observed opening internally toward a recessed façade area containing external timber screening elements. This arrangement appears to be part of the architectural façade design to provide shading and privacy, however, the screening should not be used as a handrail or balustrade system and may not be designed to withstand loads. Care must be taken when opening or closing the door and leaning into the facade structure. There is also risk of water ingress towards the property during wind driven rain in particular if windows are not adequately sealed. A further inspection externally is recommended to confirm the area is adequately sealed given the signs of previous water staining.

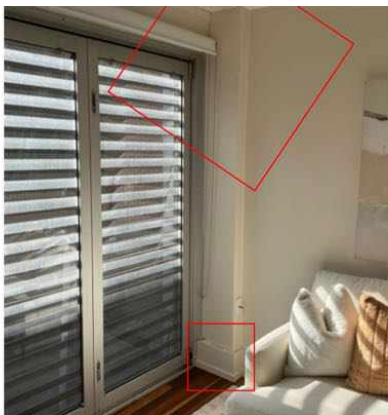
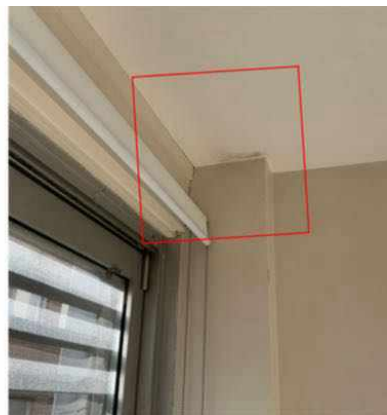
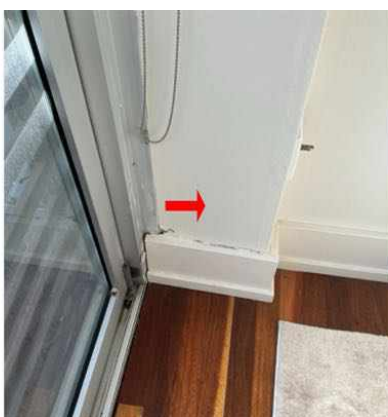
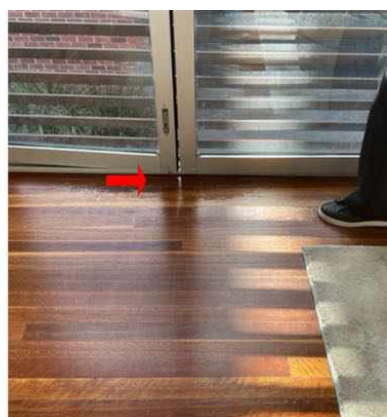
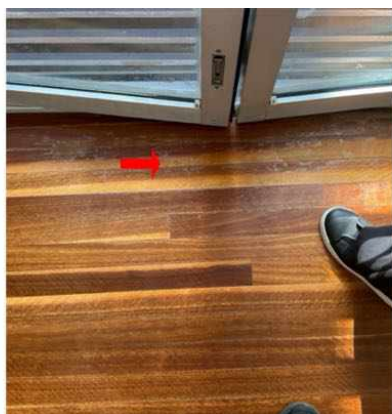
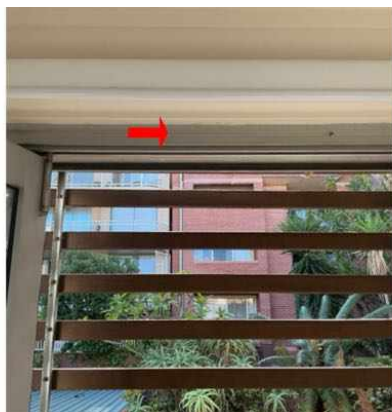
### Finding 3.05

Building: Main Building  
Location: All External Areas - Balcony & Lounge  
Finding: Water staining - lounge facade  
Information: Water staining was evident in this area at the time of inspection. Water staining indicates that surfaces have been exposed to excessive moisture over time. The minerals and other elements in the water lead to staining, which may graduate to corrosion and deterioration if left unmanaged.

While mostly an appearance defect, water staining can be indicative of more serious defects, which may be currently concealed by other building elements.

Where water staining is active, a licensed plumber must be consulted to identify the cause of the staining and to provide advice on any reparation works that may be required. Replacement of any broken or damaged structures is advised.

Conversely, where water staining is old and inactive, affected building materials may be repaired or replaced at client discretion. A qualified carpenter or registered builder may be appointed to perform these works.

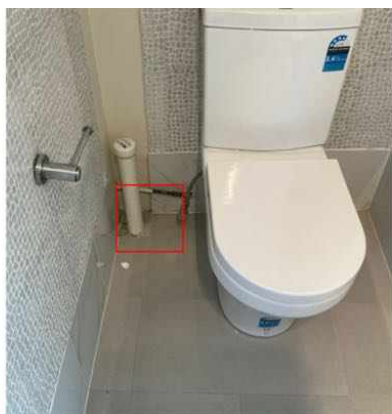
### Finding 3.06

Information: The installation of this building element appears to have been completed to a substandard level of workmanship or is incomplete. Generally substandard repairs or installation are related to poor workmanship, the use of inappropriate materials, or a failure to complete installation to a suitable standard.

Where installation is substandard and/or incomplete, the client should contact the responsible trade to undertake rectification. Unfinished and substandard building works are likely to degrade more quickly and may create potential for secondary defects to associated building elements.

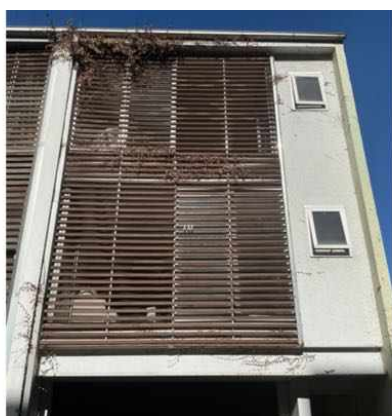
### Finding 3.07

Building:	Main Building
Location:	All Internal Areas
Finding:	Vegetation
Information:	Climbing vegetation was observed growing across sections of the external wall, façade and screening elements of the building. Vegetation in direct contact with building surfaces can trap moisture, contribute to deterioration of finishes over time, and obscure areas of the wall that would otherwise be visible for inspection. The dense growth also limited full visual assessment of some wall surfaces during the inspection. It is recommended that vegetation be trimmed back and removed from direct contact with the building to allow proper inspection and reduce the risk of moisture retention and concealed defects.

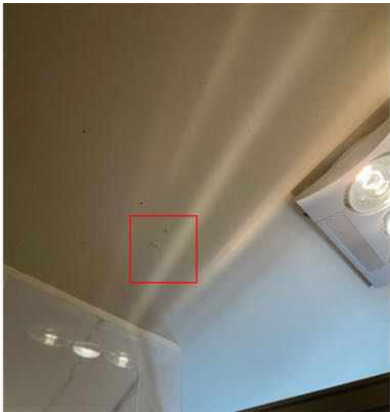
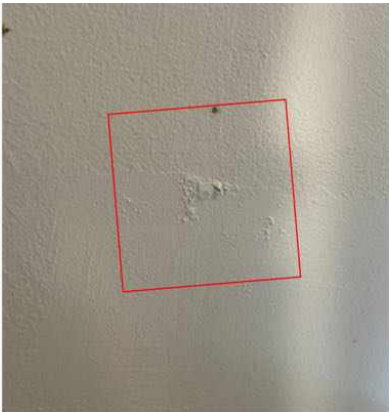
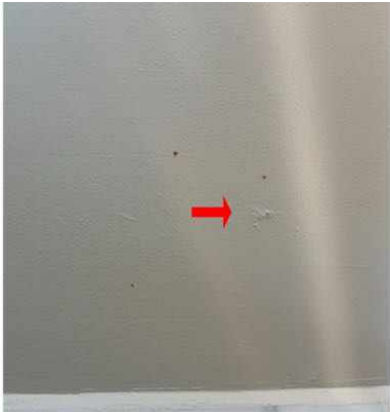
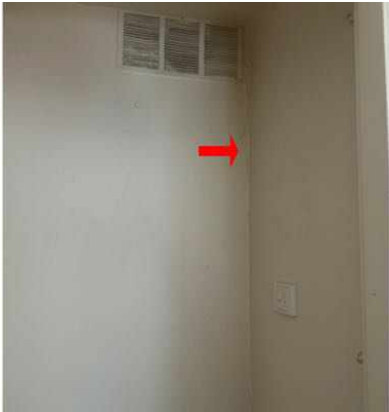
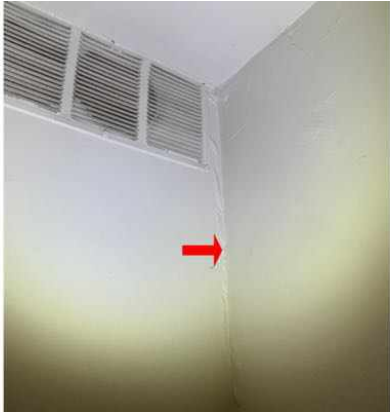
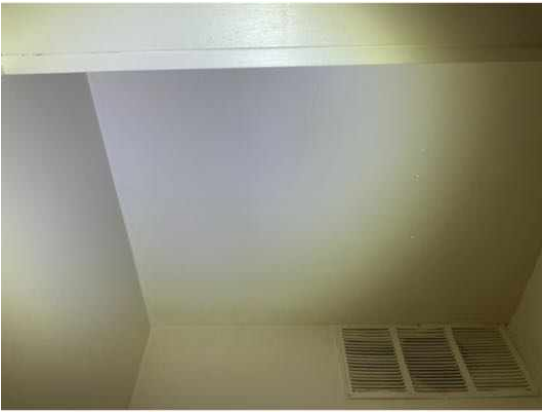
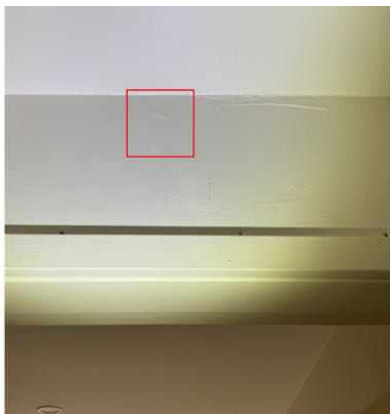
### Finding 3.08

Building:	Main Building
Location:	All Internal Areas - Bathroom, cupboards
Finding:	Painted surface - Bubbling to some areas
Information:	Sections of paint in this area was found to have bubbled and deteriorated. Paint bubbling is generally an indication of excessive moisture in the area, that is currently hidden by the painted surface.

The presence of excessive moisture can have major implications on associated building elements if left unattended. While only seemingly minor at this stage, the damage cannot be determined due to the paint obstructing any further inspection of the damage.

It is highly advised that the affected paint be cleaned to allow a further, more invasive inspection by a licensed plumber. Failure to act on this defect may necessitate major works in the future.

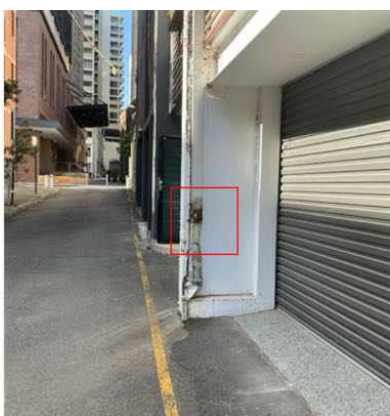
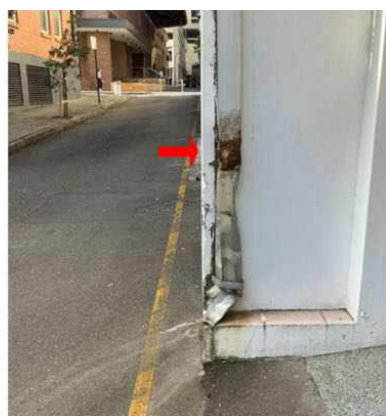
### Finding 3.09

Building:	Main Building
Location:	All External Areas - Front
Finding:	Building element - Rusted or corroded - downpipe rusted and damaged
Information:	This building element shows evidence of rusting and corrosion, which is likely to have developed as a result of excessive exposure to moisture and or inadequate coatings.

As surface rust provides no protection to the underlying iron, the deteriorating condition is likely to worsen if not addressed in the short-term future.

Where possible, the use of galvanized (treated) metals or aluminium coated metals aid in rust prevention, as does regular general maintenance. Rust formation can be controlled with coatings, such as paint, that isolate the iron from the environment.

Rusting and corrosion should be managed by ideally removing or limiting the affected surface from exposure to moisture. A registered builder may be appointed to replace any building elements that have been severely affected by rust or water damage.

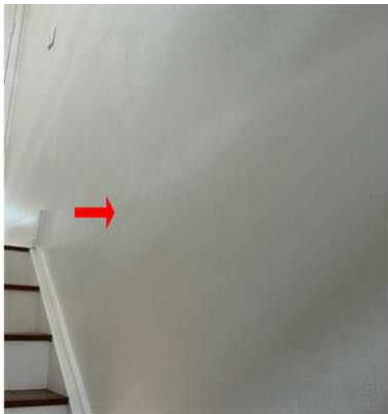
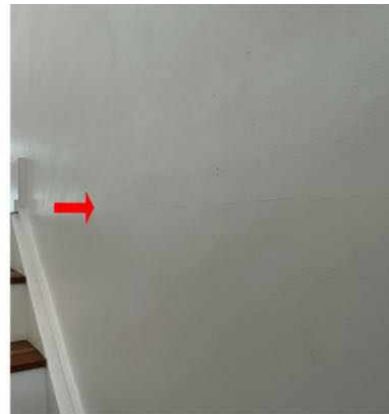
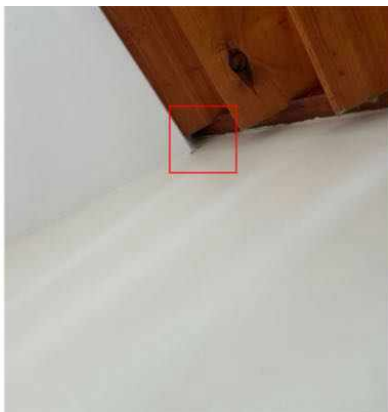
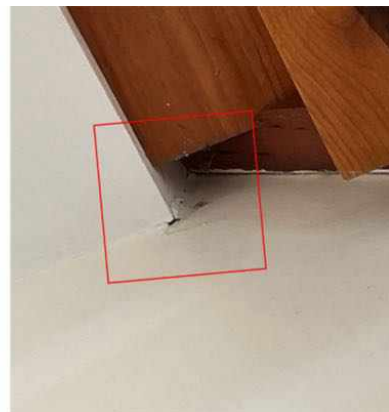
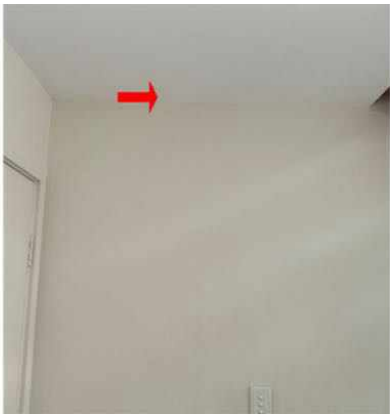
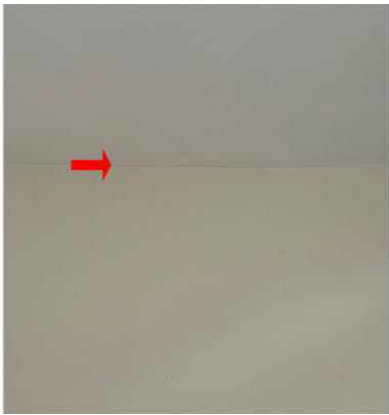
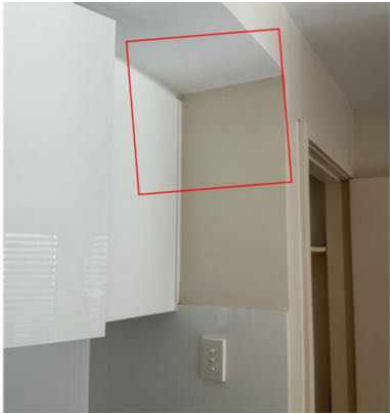
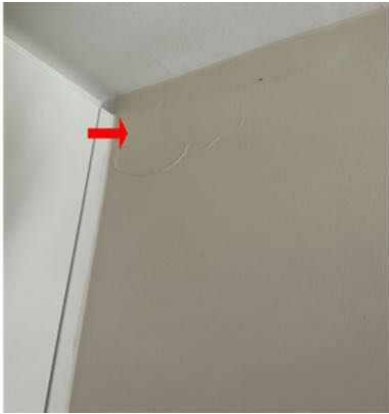
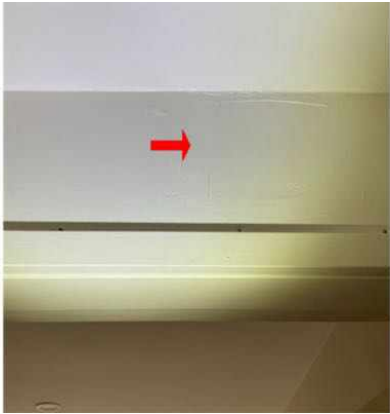
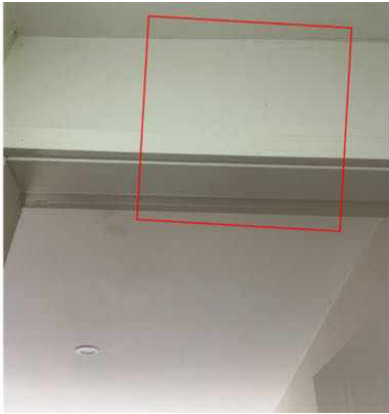
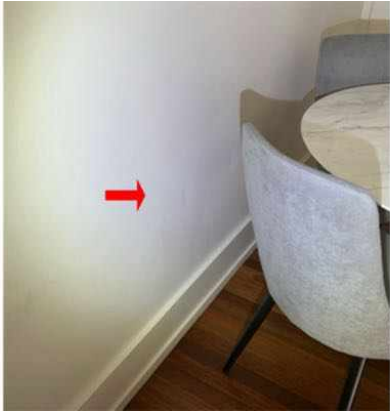
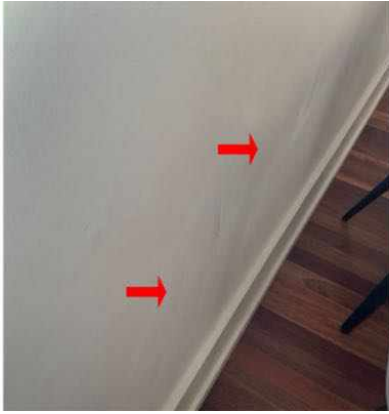
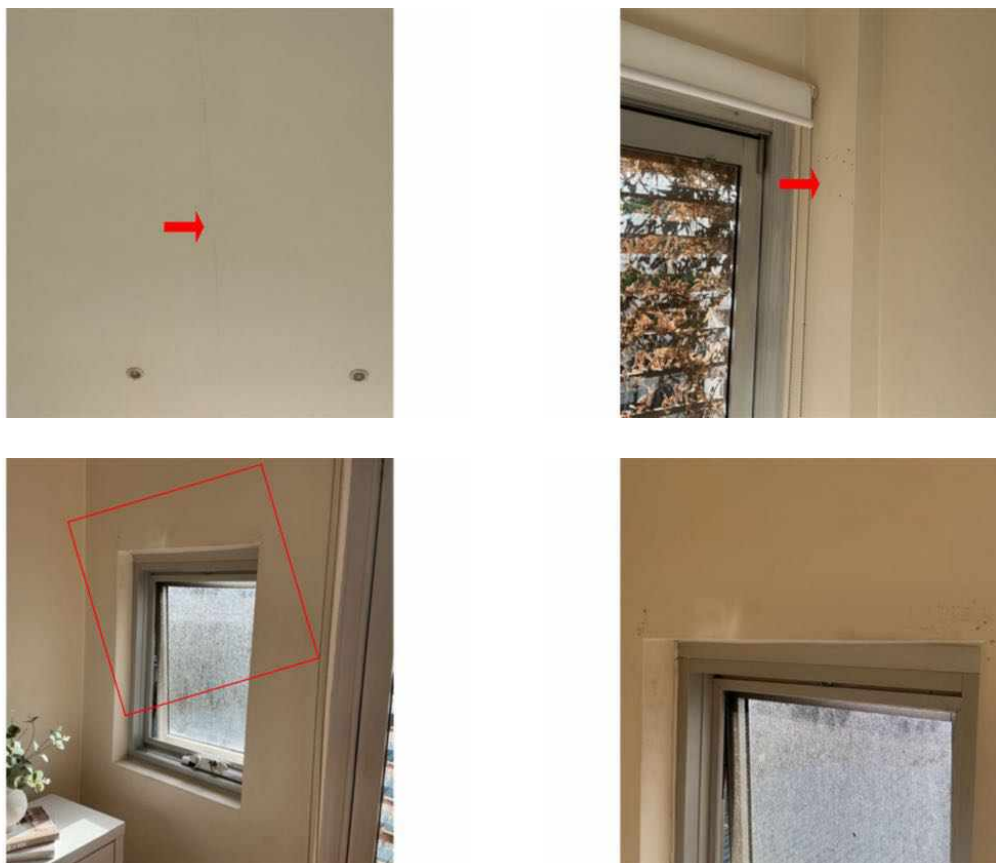
### Finding 3.10

Building:	Main Building
Location:	All Internal Areas
Finding:	Paint finish and hairline cracking

Information: The paint finish in this area was identified as being incomplete at the time of inspection including some hairline minor cracking.

Whilst incomplete or missing paint finish is generally an appearance defect, it can also lead to the development of secondary building defects over time. Incomplete areas of paint finish expose the area to moisture, potentially accelerating the deterioration of underlying building materials.

Incomplete paint finishes should be sanded back, filled, leveled and painted, as applicable. Where inadequate or missing paint protection has led to the deterioration of the associated building element, repair and/or replacement of this building element may be required.

A painting contractor should be appointed as soon as possible to perform necessary works to aid the appearance of the affected area and to ensure the area is protected against further deterioration. Alternatively, the homeowner following manufacturer instructions may perform these works.

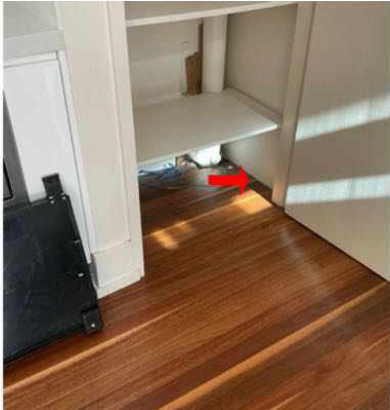
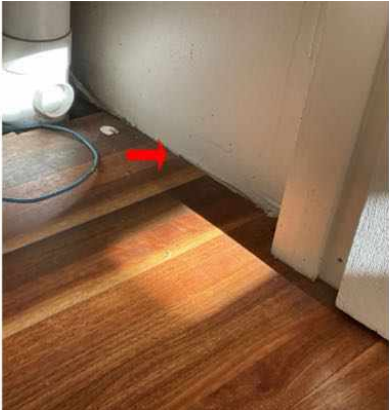
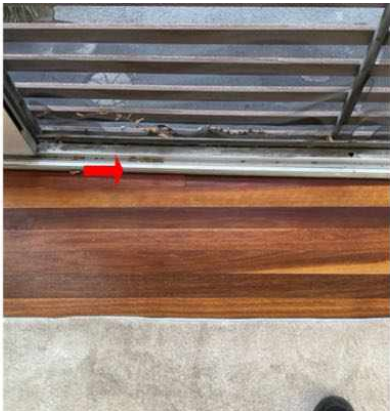
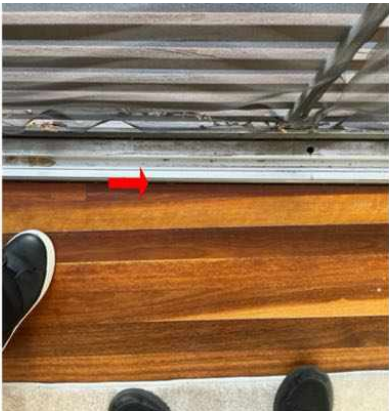
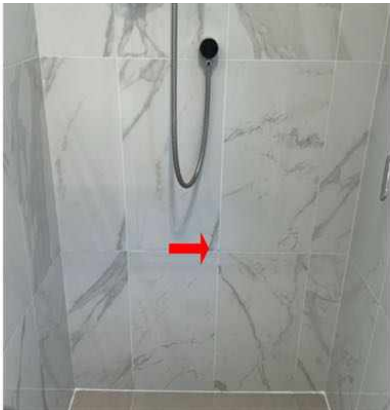
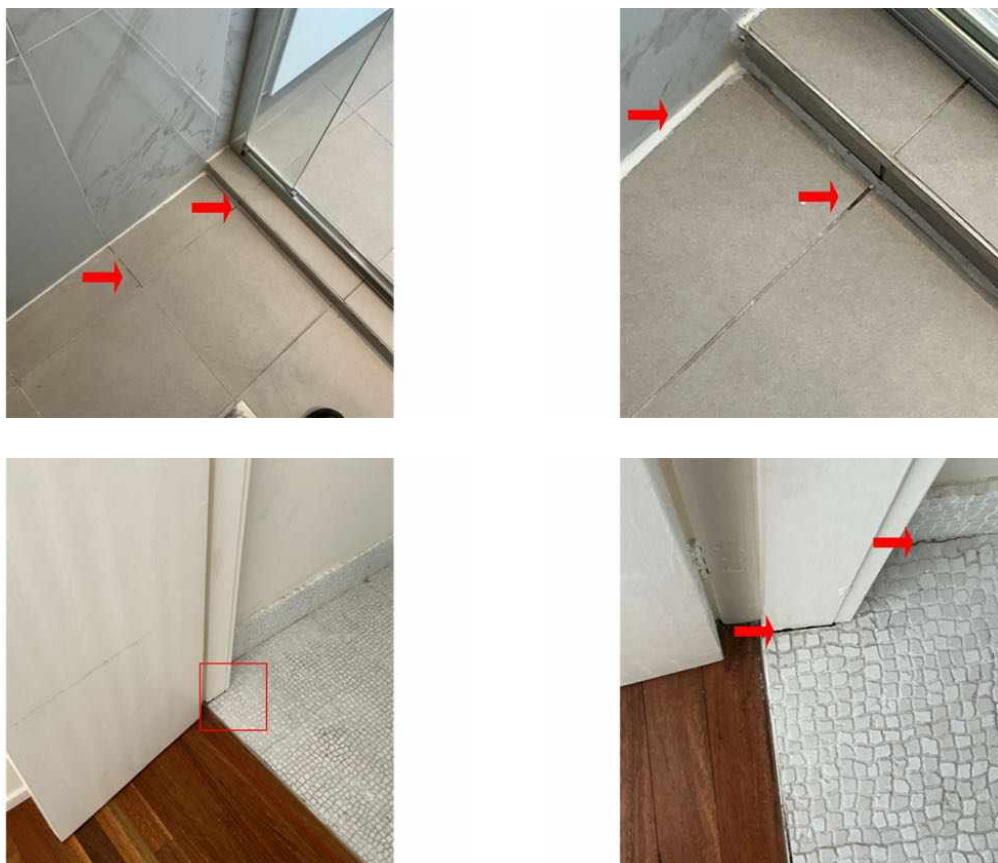
### Finding 3.11

Building:	Main Building
Location:	All Internal Areas
Finding:	Sealant and grouting - Missing or degraded
Information:	It was noted on inspection that sealant or grout is degraded. There is also evidence of poor workmanship and excessive use of sealant. Silicone should never be used as a first line of defence against waterproofing. Further inspection by a licensed waterproofing contractor is highly recommended.

Different materials and floor areas move at different rates, generally causing cracking to grout or sealant at this point. A flexible sealant is required to allow for expected expansion and contraction, while keeping the joint water tight and protective of all associated building materials.

There appears to be excessive mould to the sealant and grout which will likely require scraping out and replacement.

Flexible and mould resistant materials should be applied to affected areas to prevent any subsequent water damage that is likely to occur. Regular maintenance and replacement of damage or missing or damaged sealant and grout is highly recommended to the wet areas, as this is a regular wear and tear defect. Sealant and grouting in areas that come into regular contact with water should be maintained for the long term care of your property.

A sealant specialist or tiling contractor should be appointed to complete these works as soon as possible

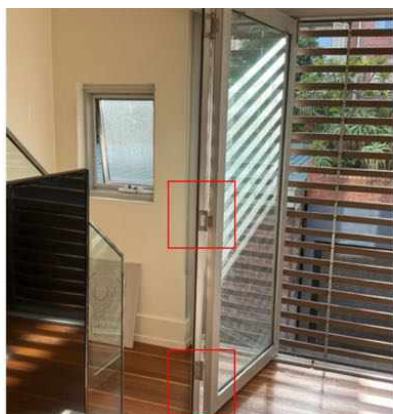
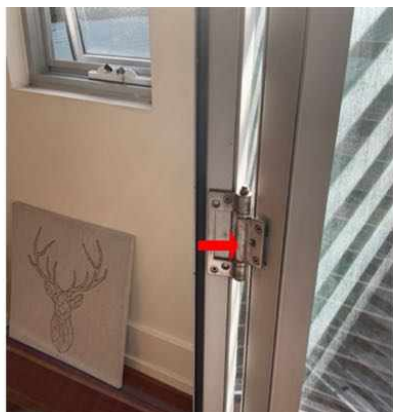
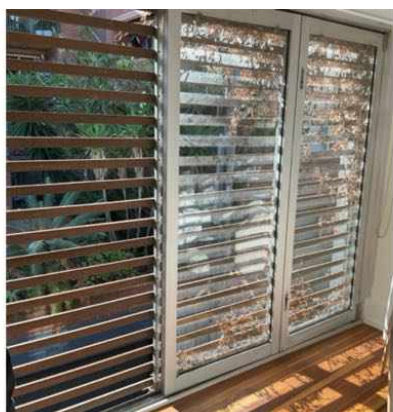
### Finding 3.12

Building:	Main Building
Location:	All Internal Areas
Finding:	Building element - Damaged - doors missing fixings and second story not opening
Information:	Breakage occurs generally when the building materials have either aged and decayed, or as a result of damage (accidental or deliberate).

Repair and/or replacement of broken elements is advised to ensure that additional secondary defects do not arise as a consequence. Such works are necessary, as all building elements play a key role in the operation and function of the overall structure and its performance.

A relevant tradesperson should be appointed to repair or replace the affected building element prior to any subsequent damage being caused.

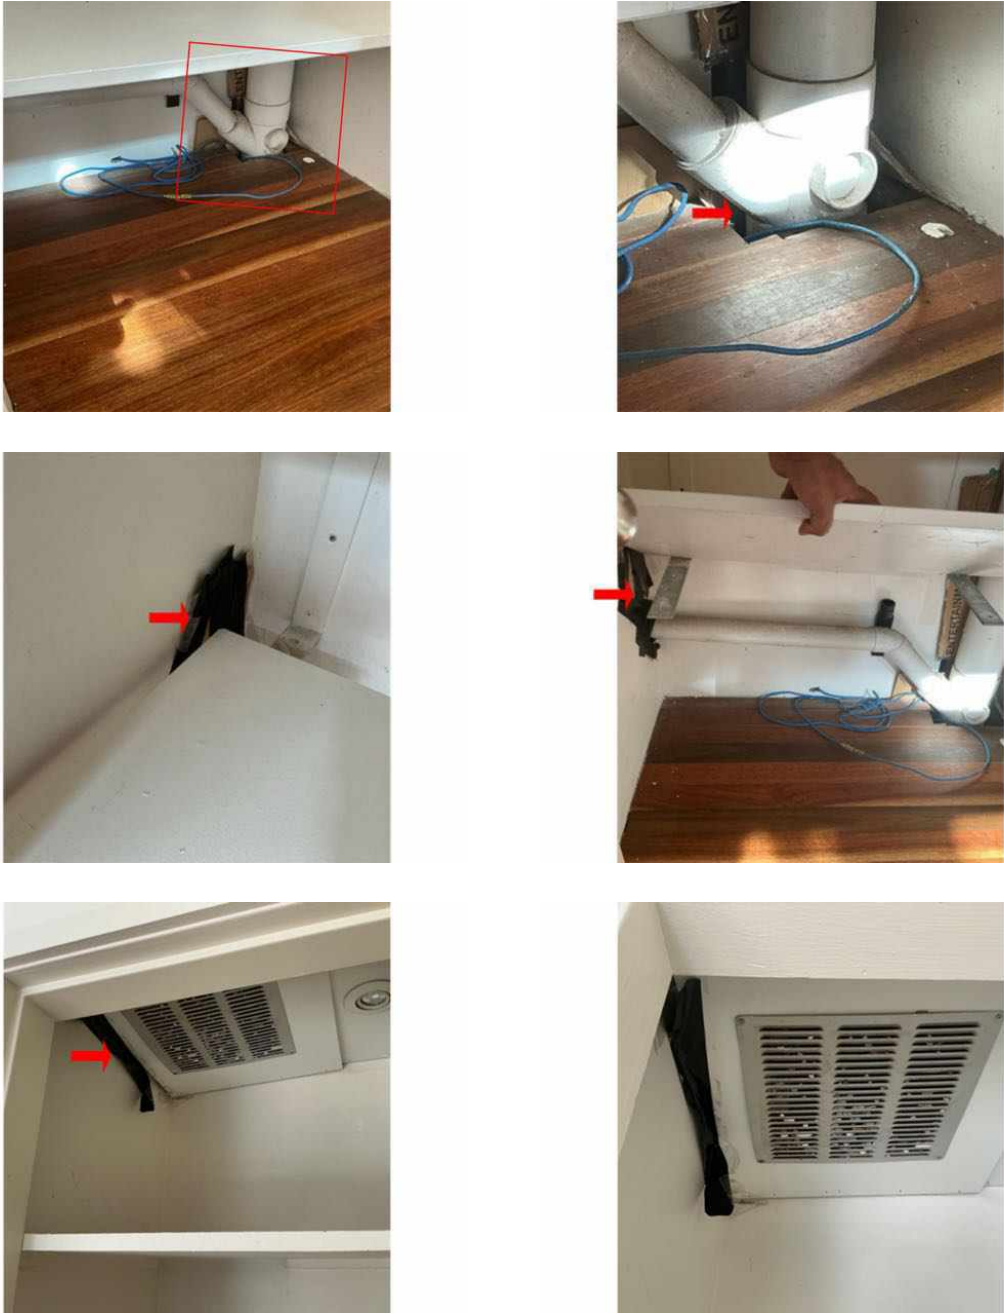
### Finding 3.13

Building:	Main Building
Location:	All Internal Areas - Cupboard
Finding:	Installation - substandard or incomplete - Hole not sealed , duct tape used to secure fixings
Information:	The installation of this building element appears to have been completed to a substandard level of workmanship or is incomplete. Generally substandard repairs or installation are related to poor workmanship, the use of inappropriate materials, or a failure to complete installation to a suitable standard.

Where installation is substandard and/or incomplete, the client should contact the responsible trade to undertake rectification. Unfinished and substandard building

works are likely to degrade more quickly and may create potential for secondary defects to associated building elements.

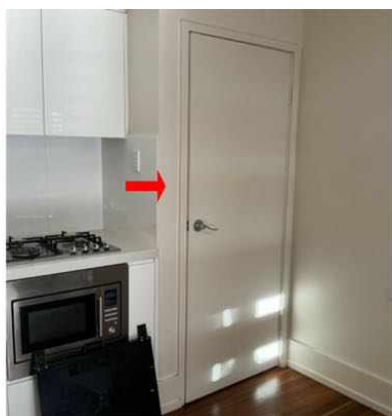
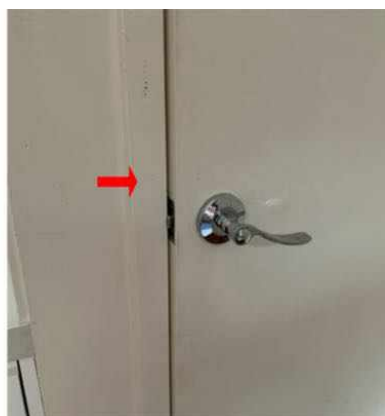
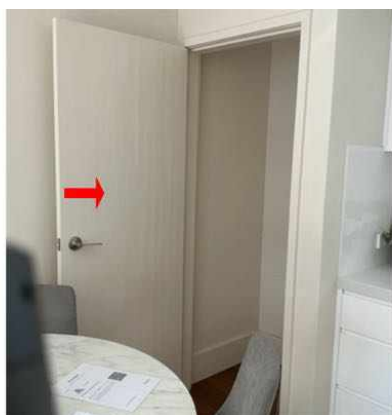
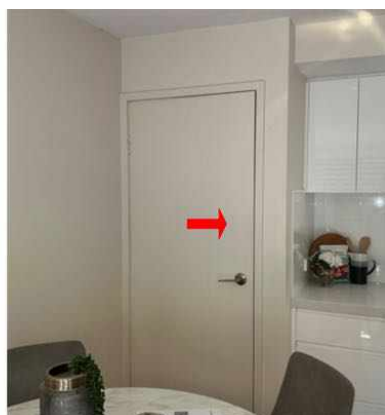
**Finding 3.14**

Building: Main Building  
Location: All Internal Areas - Kitchen Area  
Finding: Door - Binding/jamming  
Information: Binding and/or jamming of this door is evident during standard operation. This defect inhibits the functionality of the affected door as well as creating potential for secondary defects to associated building elements, such as damage to the floor covering.

A door that binds to flooring or to the associated door frame may have several causes, ranging from minor defects, such as poor installation of the door or deteriorated hinges, through to major structural issues, such as damage to subfloor structures.

Where door binding/jamming appears to indicate major structural issues, a registered builder specialising in re-stumping should be appointed to provide an estimate on the cost of rectification.

For minor causes, a qualified carpenter or general handyperson should be appointed to perform minor rectification works at client discretion.

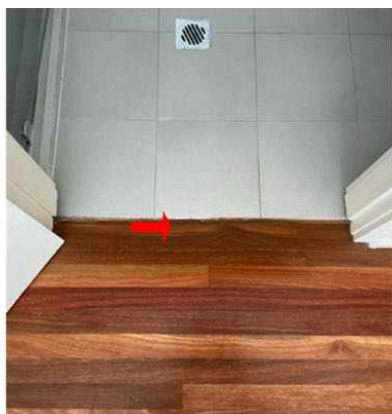
### Finding 3.15

Building:	Main Building
Location:	Bathroom
Finding:	Bathroom & external floor threshold
Information:	The bathroom floor is at the same level as the adjoining timber flooring. This configuration is typical in modern apartments and is permitted where compliant waterproofing and floor falls are provided. No evidence of moisture damage was observed at the time of inspection; however, waterproofing performance cannot be confirmed without invasive inspection.

Care should be taken to avoid excessive water migration beyond the bathroom during use.

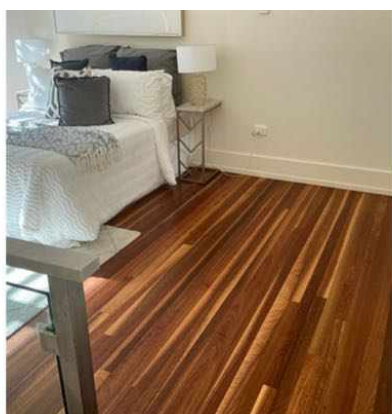
### Finding 3.16

Building:	Main Building
Location:	Bedroom
Finding:	Floors - bouncy or creaking
Information:	The internal flooring in this area was identified as being bouncy at the time of inspection. A bouncy floor surface generally presents as a discernible change in level as they are walked across, in noisy or creaking flooring, or in consequent movement of surrounding furniture and fixtures.

Bouncy floors generally indicate that the floorboards or the subfloor structures are coming loose from the joists that they are installed on. Bouncy flooring may also be the result of gaps between flooring and stumps or joist structures, which require packing.

The client is advised to seek quotations for required repairs from a Registered Builder specialising in re-stumping. The potential resolution may range from packing gaps in subfloor structures through to replacement of subfloors stumps and refixing of flooring.

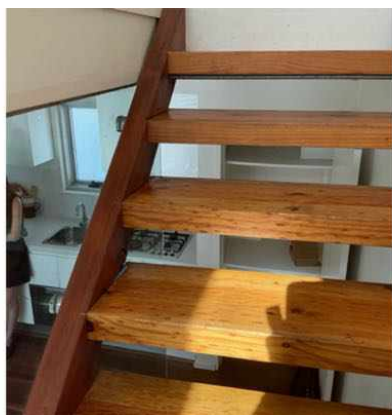
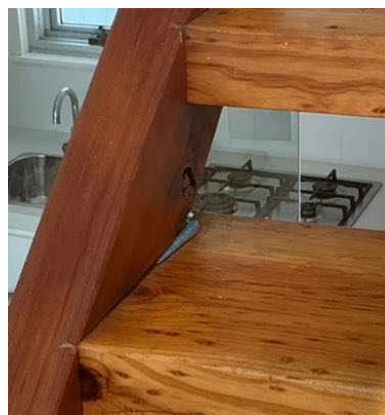
### Finding 3.17

Building:	Main Building
Location:	Lounge Room
Finding:	Staircase – Creaking and Bouncy When Walked On
Information:	The stair treads produce creaking noises and a slight bouncy sensation when under load. The cause could not be confirmed during the visual inspection but may relate to normal material flex, loose fixings, or subframe movement. No visible structural damage was evident. Monitoring is recommended, and further assessment by a licensed builder or carpenter may be considered if movement increases or noise persists.

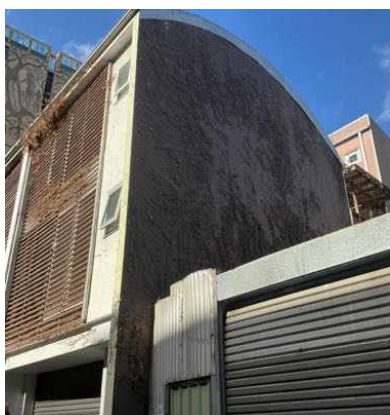
Building:	Main Building
Location:	All External Areas
Finding:	Bridging - Vegetation
Information:	Where vegetation obstructs inspection of building elements, also known as bridging as it provides a bridging point for the access of termites, full inspection can not be achieved. Consequently moisture or dampness may be present and the areas becomes conducive to termite activity. Plants against or very close to buildings provide cover, shade and can provide an environment that is attractive to termite infestation.

existing vegetation will assist greatly in preventing Bridging from occurring.

The removal of any such materials that may be conducive to termite activity should be carried out as soon as possible and arrange re inspection to minimize the risk of termite attack.

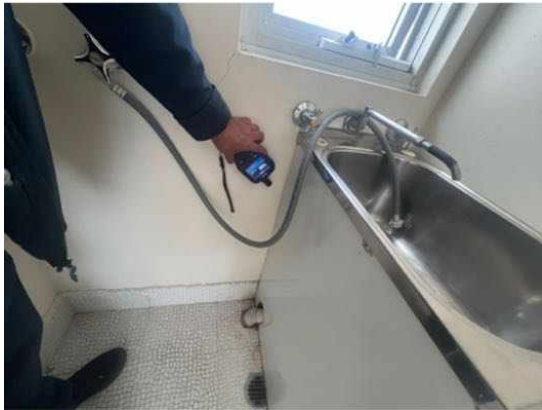
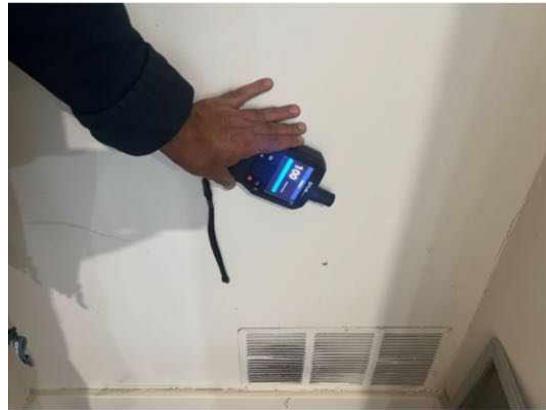
### Finding 6.02

Building:	Main Building
Location:	All Internal Areas - Laundry and cupboard
Finding:	Elevated moisture - identified
Information:	Elevated moisture can attract termites and produce conditions that promote fungal growth and wood decay.

Elevated moisture is generally caused by deteriorated, inadequate or missing roof drainage, leaking plumbing pipes or fixtures, poorly plumbed HWS overflows or condenser units and poor site drainage.

If mould growth has been found there may be environmental biological or health issues involved. In these cases an appropriately qualified inspector should also be contacted.

Prior to any remedial works being performed a qualified plumber should be appointed to further inspect the property and to identify the cause of the excessive moisture.

Works to remove affected building elements may then be necessary and should be performed by an appropriate tradesperson.
