# Building and Timber Pest Inspection Report

Inspection Date: Tue, 10 Feb 2026

Property Address: 15 Oak St, Beaumaris VIC 3193, Australia

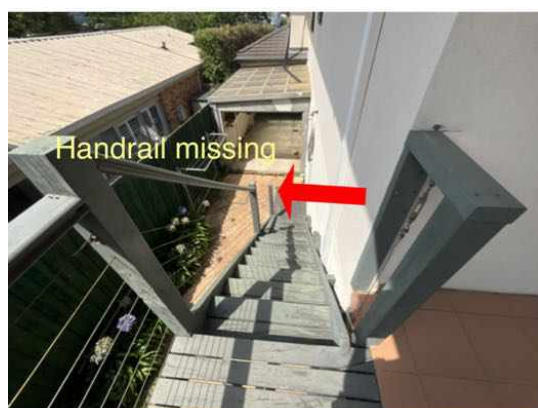
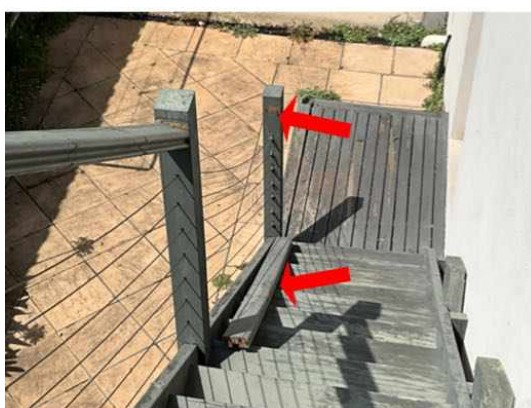
Building:  
 Location: All External Areas  
 Finding: Steps and handrails deteriorated/ missing - urgent safety hazard  
 Information: The timber step outside the laundry shows evidence of wood rot and has collapsed. It is suspected that a lack of maintenance over the years may have caused deterioration in the area resulting in rotting and collapse of the step. This poses a tripping falling hazard.

It was also noted that the handrail to the stairs from the upstairs balcony was not connected which also poses a falling hazard.

A qualified carpenter or registered builder should be engaged to replace affected building materials as a matter of urgency.

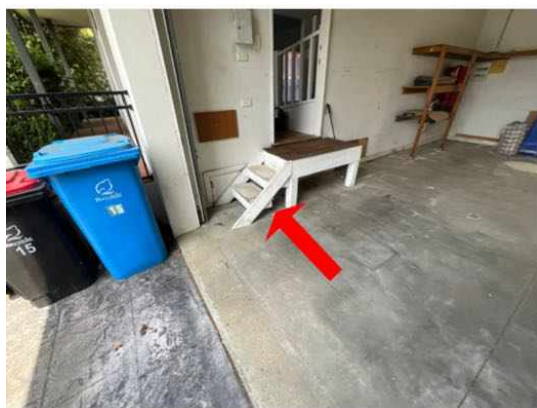
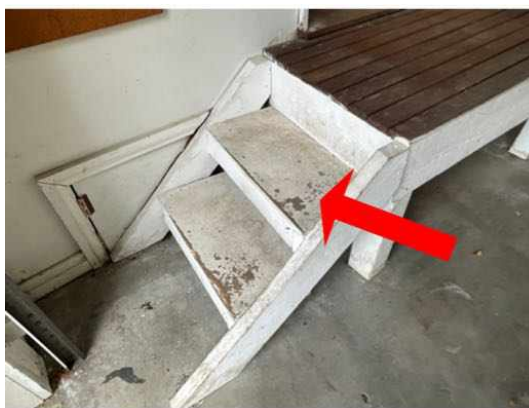
### Finding 1.03

At the time of inspection the steps in the garage were found to be of varying heights and uneven, creating a potential trip hazard for users of the steps. It is suspected this has developed over time as the steps have been left to deteriorate.

According to normal building practices, all steps should be measured and levelled to exact heights so as to prevent tripping. The steps as they stand at the moment are classified as a safety hazard.

It is recommended that a licensed carpenter be engaged as a matter of urgency to inspect the steps and rebuild them to be of consistent height and level.

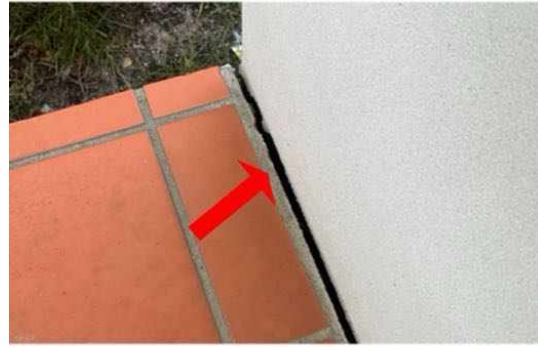
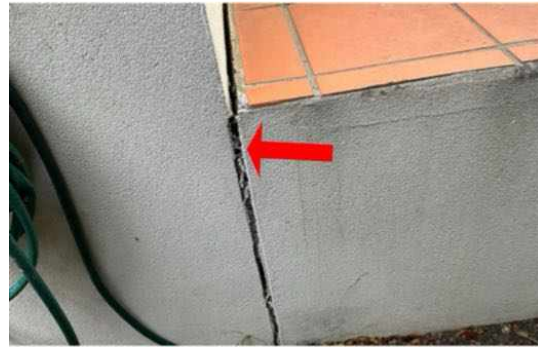
### Finding 2.01

Finding: Distinct Cracking - External Concrete Paving

Information: Distinct cracks were identified between the front porch paving and the wall. It is suspected that the cracking may have occurred due to subsidence and movement in the front porch - away from the house.

Expansion and contraction of the concrete may also have occurred due to environmental factors. Such factors include variable moisture and weather conditions, the presence of trees and their roots having a settling or lifting affect on the soil over a sustained period of time

Cracking to this degree may also be due to poor original installation of the concrete. Factors such as poor compaction of the sub surface and/or inadequate reinforcing of the slab may create cracking and other secondary defects.

Repairs are likely to be required to prevent further cracking and to reduce hazards associated with cracking, such as tripping. Monitoring of all cracking should be conducted frequently. Always contact a building inspector should cracks widen, lengthen, or become more numerous.

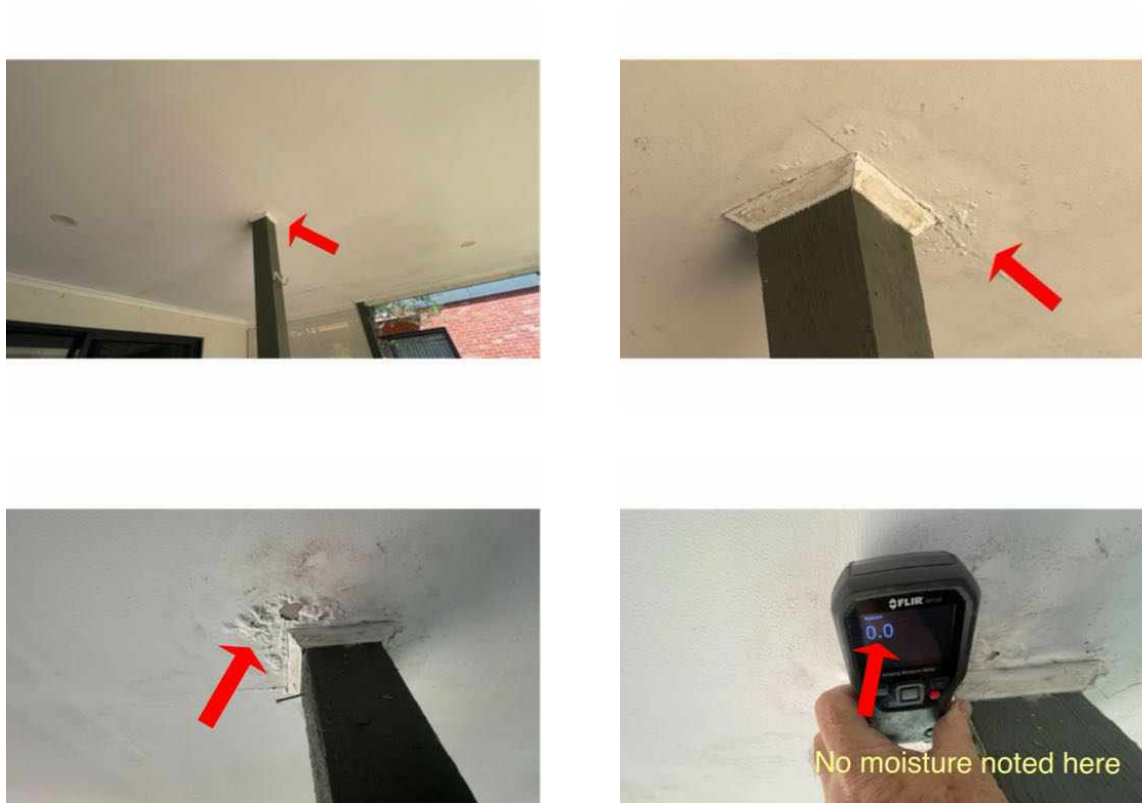
Finding: Ceiling linings - Water stained with moisture noted in some areas

Information: At the time of inspection, there appeared to be some staining to various areas of the ceiling linings at the rear of the property ( underneath the balcony). When the area was tested with a moisture meter, moisture was noted in one of the areas. This is classified as a major defect.

Staining can be indicative of more serious defects, which may be currently concealed. It is suspected that the staining in this instance may be from moisture entering the area via gaps / damage to the balcony surface above.

Where water staining is active (as noted in some areas here) , a licensed plumber must be consulted to identify the cause of the staining and to provide advice on any reparation works that may be required. Replacement of any damaged structures is advised.

Once the water leaks have been addressed, all affected building materials may be repaired or replaced at client discretion. A registered builder may be engaged to perform this task.

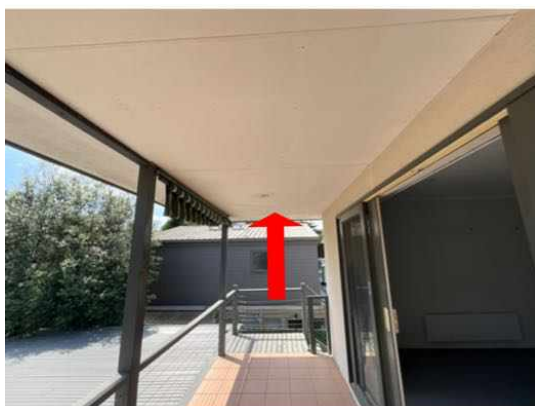
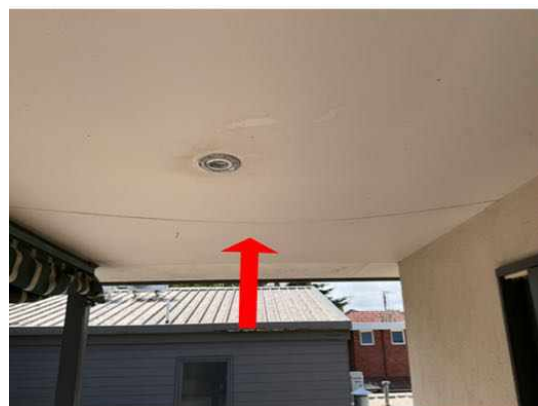
Information: A section of the ceiling was found to be sagging above the rear balcony at the time of inspection. Sagging to the fixed ceiling structure generally indicates that the fixings (e.g. nails or glue) have become loose and require reattachment (as suspected in this instance) or that excess moisture has caused the ceiling to sag. This is a major defect.

Where excessive moisture has caused the roofing structure to swell and sag, the source of the water leak should primarily be identified prior to any remedial works being performed.

The appropriate action should be taken by the client immediately to ensure that any potential further damage is limited.

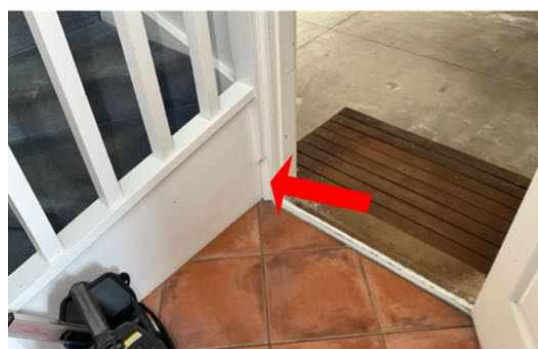
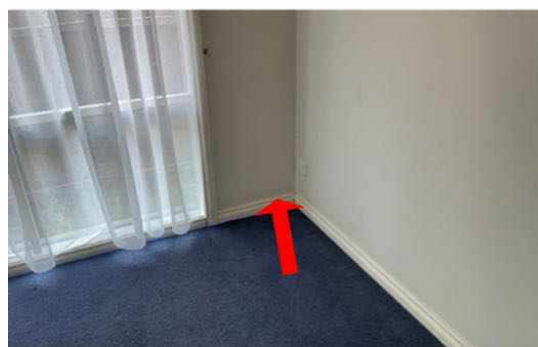
### Finding 3.01

Building:  
Location: All Areas  
Finding: Cracking - fine  
Information: Some fine cracking was noted throughout the property.

Although fine cracks are quite noticeable, they are often only considered to be an appearance defect, and usually do not indicate any structural damage. Generally, the cause of a fine crack is indicative of a separation between building materials and finishes (e.g. paint, plaster, etc.) along joints.

Cracking of this nature can generally be repaired with minor sanding, filling and/or repainting. Such works should be performed by a qualified painter or a general handyman.

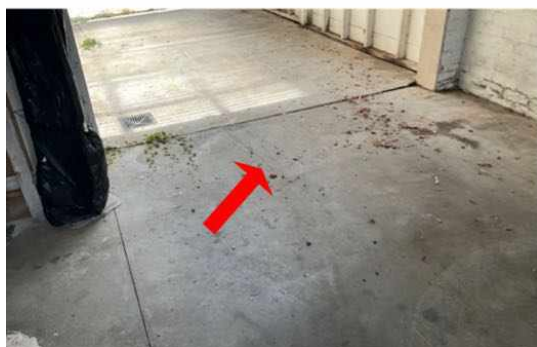
Building:  
 Location: Garage  
 Finding: Cracking - Concrete flooring within garage - Fine  
 Information: Fine cracks were identified in the concrete flooring of the garage . Although fine cracks are quite noticeable, they are often only considered to be an appearance defect, and usually do not indicate any structural damage.

Generally the cause of a fine crack in existing concrete paving such as driveways and pathways is indicative of the expansion and contraction of the concrete. Such causes are generally due to environmental factors, such as moisture levels, weather conditions, root systems of nearby trees or the soil types on which they are laid.

Fine cracks may also be due to poor original installation of the concrete. Factors such as poor compaction of the sub surface and/or inadequate reinforcing of the slab may create cracking and other secondary defects.

Monitoring of all cracking should be conducted frequently. Always contact a building inspector should cracks widen, lengthen, or become more numerous.

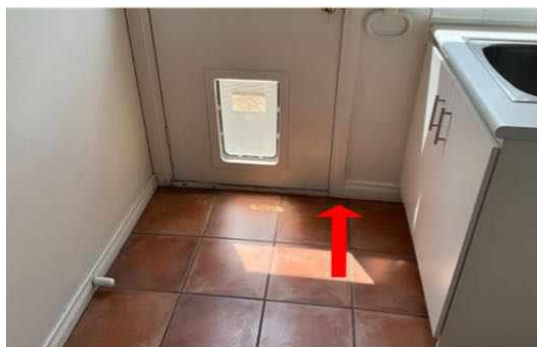
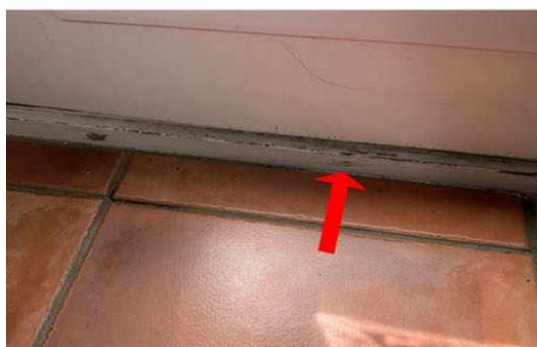
Building:  
Location: Laundry  
Finding: Moisture damage to architraves and door frame in the laundry area

Information: Evidence of moisture damage was identified to the architraves and door frame in the laundry area.

It is suspected that this has occurred as a result of excess moisture from either internal spills or external sources.

At the time of inspection no current moisture was noted when checked with a moisture meter. As a result , no further damage is likely in this area.

A licenced carpenter or competent handyman should be engaged to inspect the moisture damaged areas and repair or replace any items where necessary.

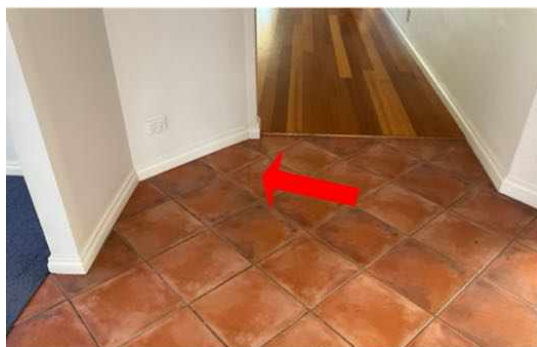
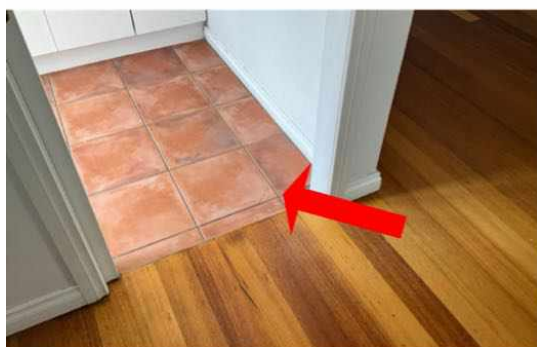
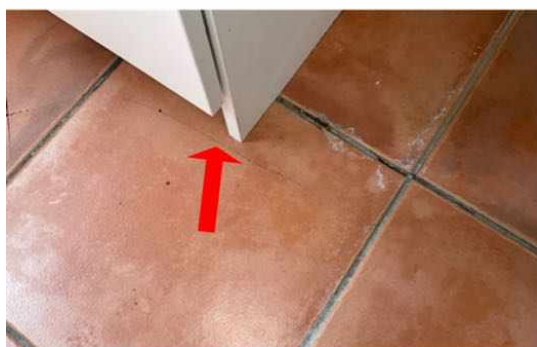
Cracked tiles throughout the household detract from the overall appearance of the affected areas, as well as creating potential for water penetration to adjoining building elements. If left unmanaged, water damage may occur as a result of constant water penetration over a prolonged period of time.

While not considered a matter of urgency, replacement of cracked floor tiles is advised as a solution. A tiling contractor or general handyperson may be appointed to perform these works at client discretion. Where cracks become more numerous, consultation with a registered builder specialising in re-stumping may be required.

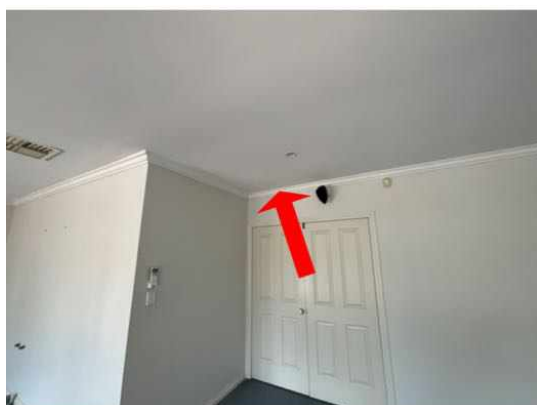
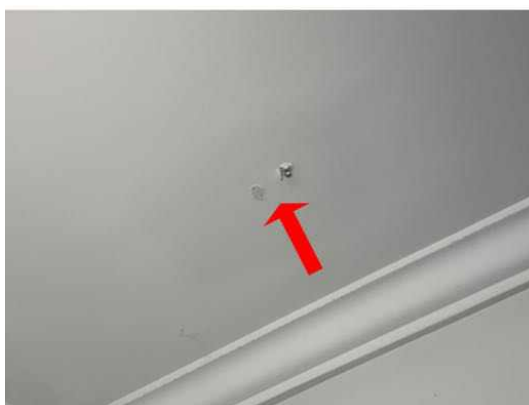
If left unmanaged, the ceiling sheets may become loose and unstable, increasing the rate of deterioration of the internal ceiling and creating potential for the development of secondary defects.

Re-fastening of popped nails will help to maintain the stability of the internal ceiling and associated building elements. Such minor works will also help to improve the appearance of the affected area and secure the ceiling sheets, so as to prevent the onset of ceiling sagging. These works should be performed by a qualified carpenter or plasterer at client discretion.

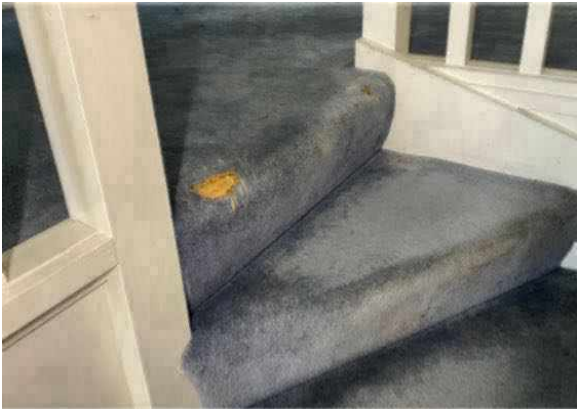
Information: At the time of inspection, some areas of the carpet throughout the property showed signs of wear . This is consistent with properties of this age, in particular where the property hasn't been looked after.

The carpet may be replaced at the discretion of the homeowner.

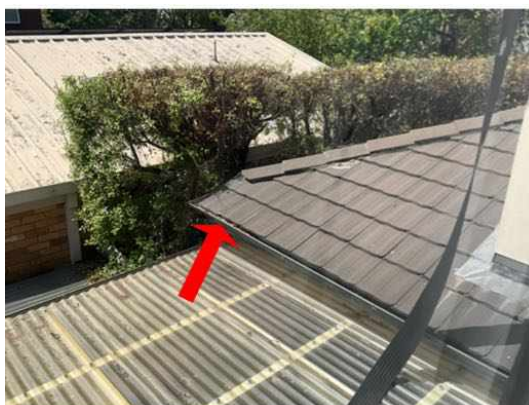
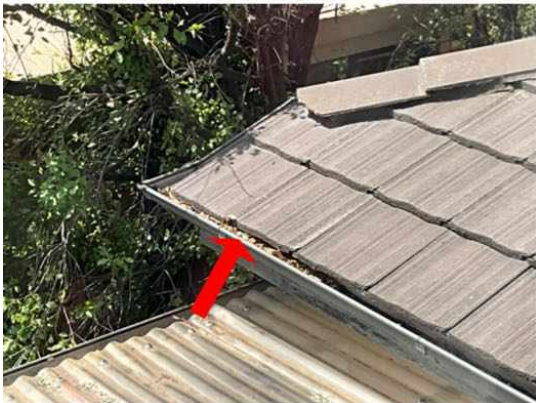
Blocked gutters are likely to lead to high levels of moisture in the affected areas. Such moisture will not only cause rust and decay of the associated building materials, but can also provide conditions that are conducive to termite and timber pest activity. Blockages in gutters should therefore be removed immediately to ensure dry conditions are maintained.

Consult a Licensed Plumber for further specific advice on remedial works that may be required. In the interim, it is highly advised that blocked gutters be removed by the homeowner or a general handyperson as a matter of urgency.

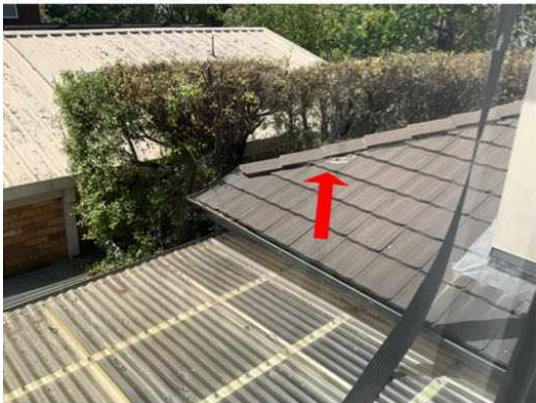
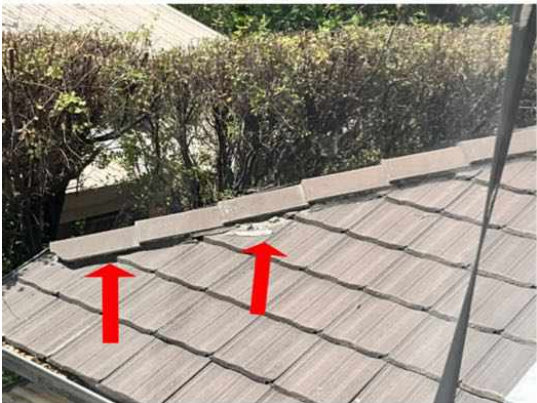
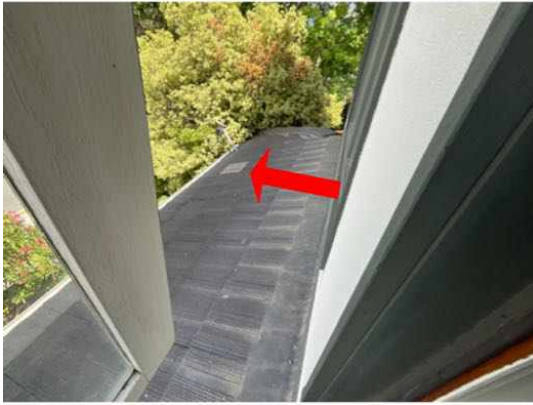
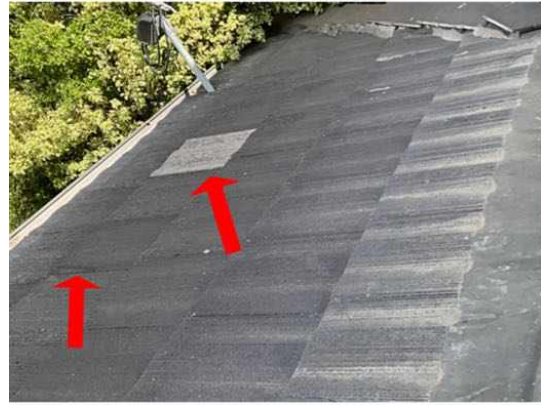
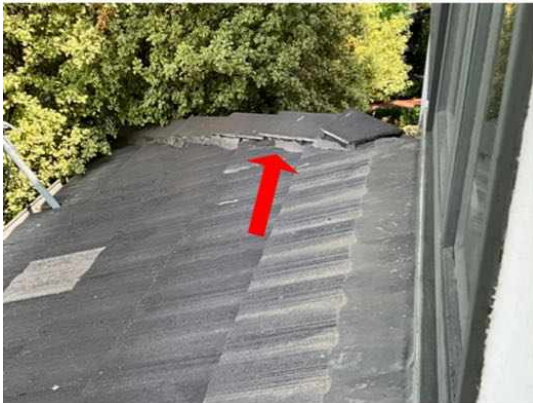
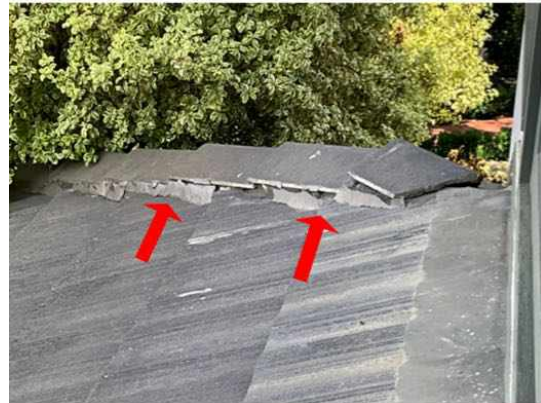
**Finding 3.33**

Building:  
Location: All Areas  
Finding: Roof tiles - fair condition but with some maintenance required  
Information: Upon inspection of the exterior roofing, the roof tiles appeared weathered but were considered to be in a fair condition. While weathering of the tiles is consistent with the age of the property, some maintenance works are required.

Repairs to cracked mortar and minor chipped or cracked tiles is required.

Consultation with a roofing contractor is highly advised to gain advice on remedial works that will be required . Where left unmanaged, damage is likely to lead to a number of secondary defects, including potential water leaks and moisture exposure to internal roofing structures.

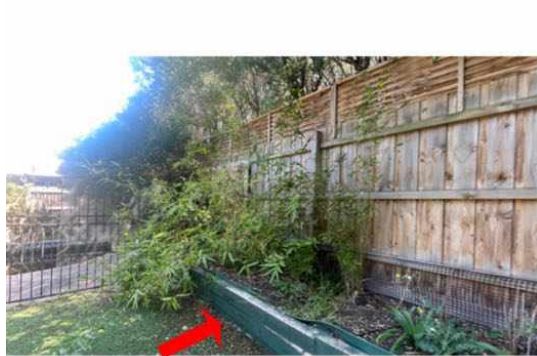
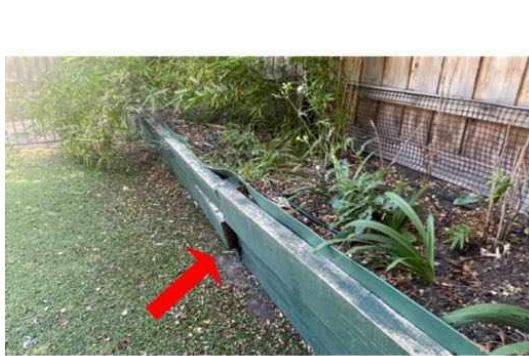
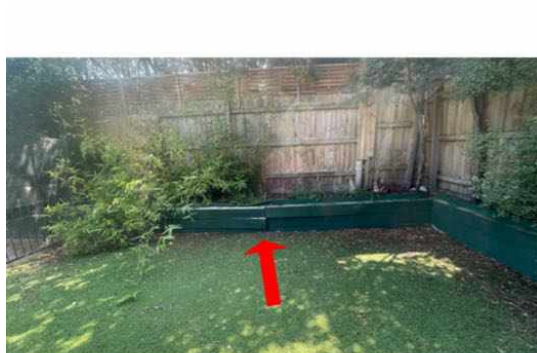
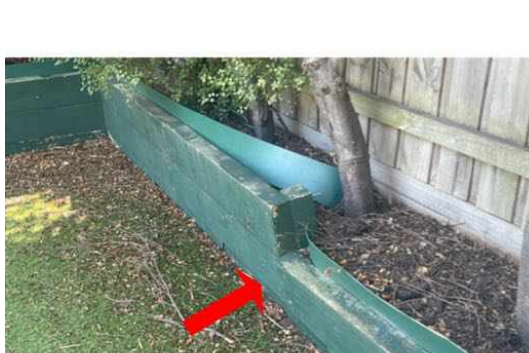
### Finding 3.34

If the retaining wall continues to move and lean further, repair or replacement should be expected.

Where retaining walls are considered structural walls ( not in this instance) , a structural engineer / surveyor should be consulted regarding required remedial works. Otherwise, a landscaper may be appointed to repair or replace the wall, when required, at the discretion of the client.

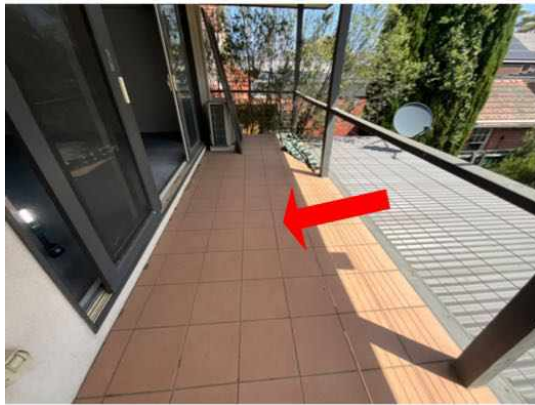
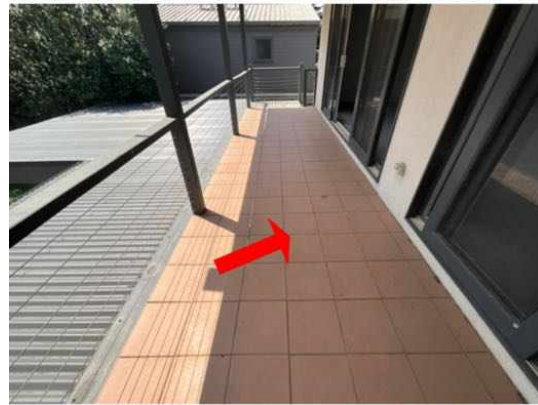
### Finding 3.35

Information: The tiled flooring on the balcony was creaking slightly when walked upon at the time of inspection. It is unclear as to the reason for this, however damage to the subfloor substrate may be an option. Creaking tiled flooring can also indicate that the fixings for the flooring may be coming loose slightly.

The area should be monitored for any changes or unevenness. Should this occur, consultation with a registered builder should be undertaken to determine the cause. The potential resolution may involve regluing and screwing the floor down through to replacement of subfloor support structures.

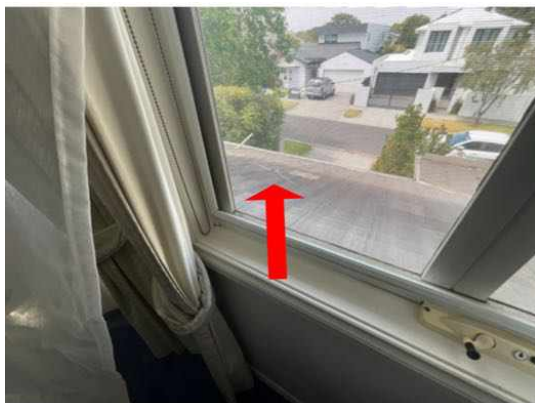
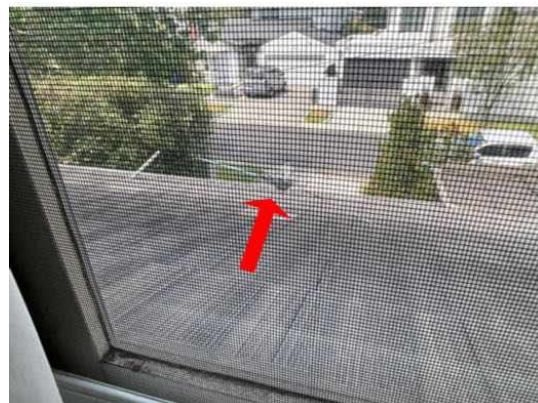
### Finding 3.36

The likelihood of this windowpane further cracking and shattering is increased exponentially, providing a safety hazard in the area. The cracked window also impairs the weather tightness of the building, creating potential for minor water leaks.

A qualified glazier is required to repair the window as soon as possible. Depending on the extent of the cracking, replacement of the window may be required. Please be advised that any persons coming into contact with the cracked window should do so with due caution to avoid any personal injury that may ensue.

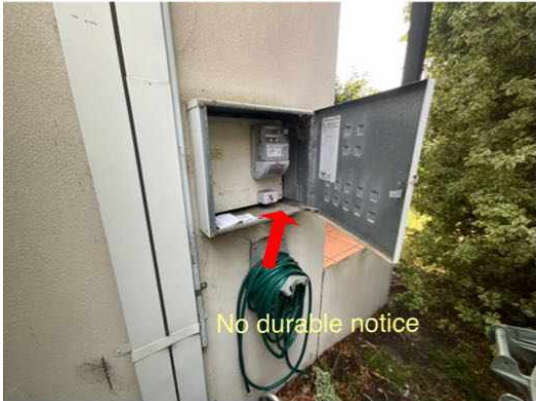
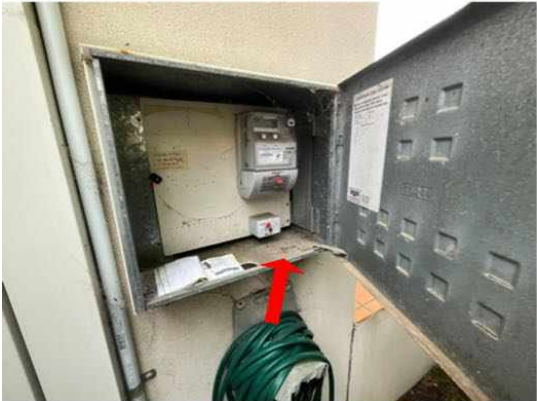
A durable notice should be placed in the switchboard unit to indicate current termite barriers. At the time of inspection, it appeared as though no termite management system has been installed, with no evidence to suggest preventative works taking place.

The client may consider gaining further advice from a pest controller as to the costs and procedures involved with this application. It is recommended that obtaining such advice be a short-term priority.

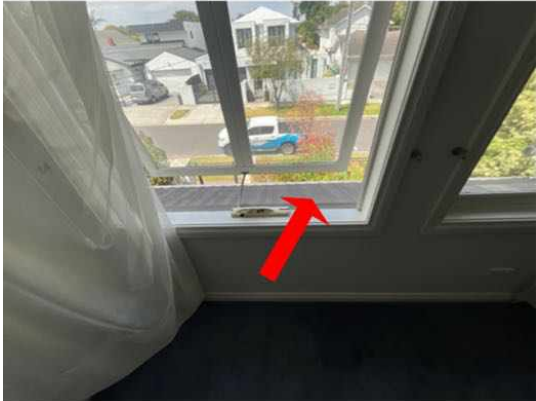
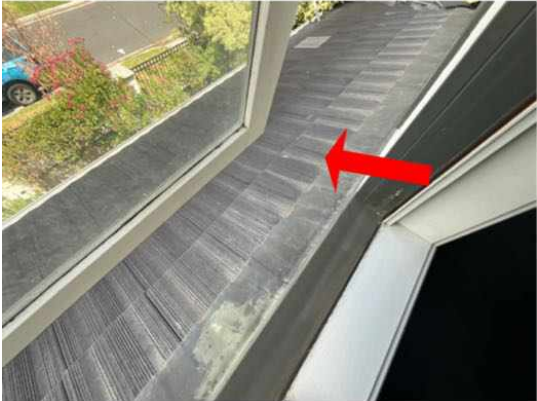
Building:  
Location: All Areas > Upstairs  
Finding: Windows opening wider than current regulations  
Information: The upstairs external windows of the property appear to open wider than current standards allow for second storey windows. Windows at this height should only be allowed to open up to 125mm , to prevent any falling hazards

Some changes to the building regulations are made to ensure the safety of all inhabitants and windows are definitely one of those crucial regulations. This defect can create a potential safety hazard for young children and caution should be taken around these areas.

Opening limiters or safety screens can be retro fitted to ensure safety in this area and bring the windows up to current standards. This may be considered by the homeowner as additional safety measures.
