Building and Timber Pest Inspection Report

Inspection Date: Mon, 16 Feb 2026

Property Address: 93 Village way Maribyrnong

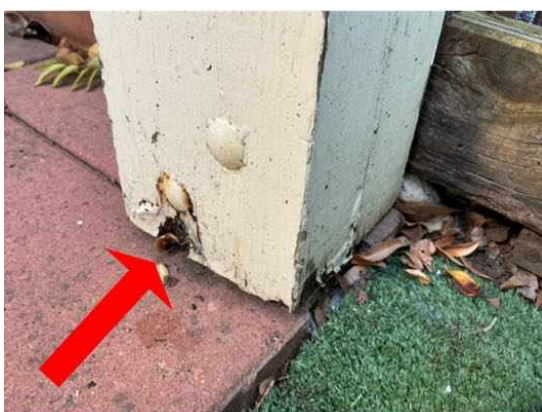
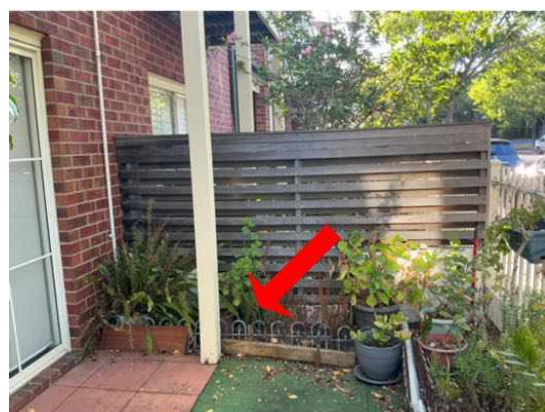
Building:	Main Building
Location:	Balcony
Finding:	Wood rot
Information:	This balcony post shows evidence of wood rot. Wood rot, also known as Fungal Decay, occurs when timbers and other cellulose building materials are exposed to damp conditions on an ongoing basis. This could be the result of exposure to weathering over a prolonged period of time, or the attraction of excessive moisture from other abutting building materials. Contributing factors also include poor air ventilation in the area.

Wood rot is often associated with general damp problems and is evidenced by a 'musty' smell or mould and mildew occurring on surfaces. If left unmanaged, damp conditions can lead to further health problems and the decay of timbers will continue.

A qualified plumber may be appointed to assess the cause of excessive moisture and to provide advice on any remedial works as required. A qualified carpenter or registered builder should be engaged to repair the post immediately

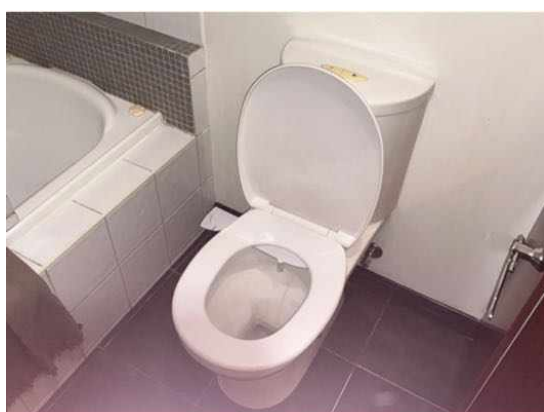
Building: Main Building
 Location: Bathroom
 Finding: Toilet seat loose
 Information: It was observed that the toilet seat was loose and unstable.

Loose seats can cause fall injury to persons while in use and lead to serious injury

A licensed sanitary plumber should be engaged to review prior to use

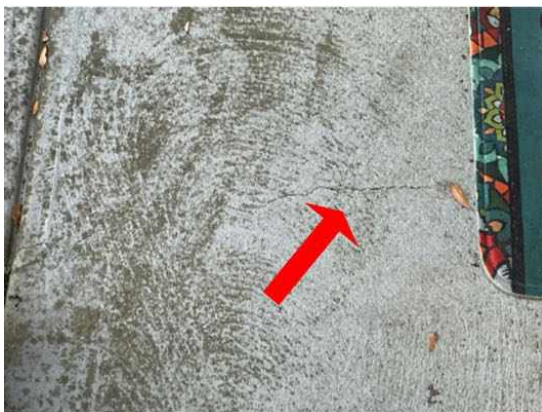
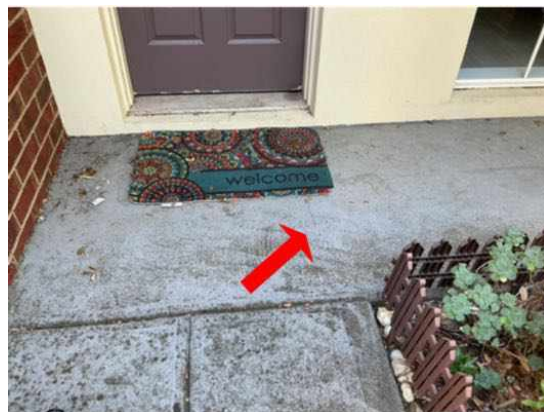
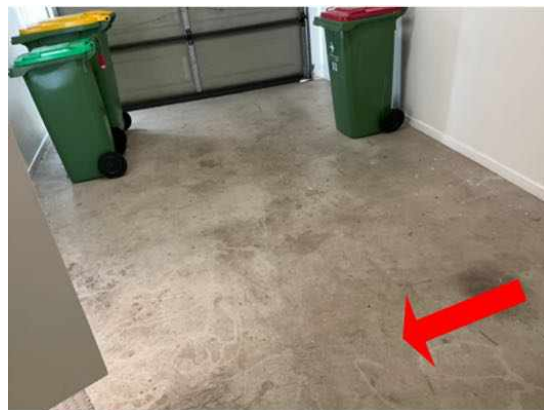
Building: Main Building
Location: Porch
Finding: Cracking - Damage Category 0 - Hairline (less than 1mm)
Information: Hairline cracks are very minor in nature and generally are only ever an appearance defect. While such cracking may be noticeable in some cases, it is quite common and does not indicate any structural damage.

Cracking of this nature can generally be repaired with minor sanding, filling and/or repainting. Such works should be performed by a qualified painter or a general handyman.

Monitoring of all cracking should be conducted frequently. Always contact a building inspector should cracks widen, lengthen, or become more numerous.

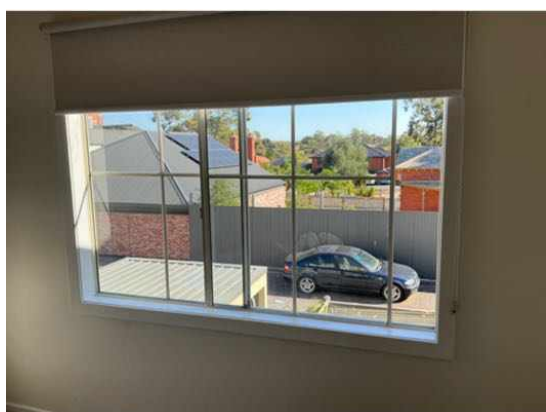
Building:	Main Building
Location:	Bedroom 2 and 3
Finding:	Windows - Stiff to slide
Information:	Several windows throughout the property were jammed and difficult to operate at the time of the inspection. Windows provide ventilation to the adjoining area and should be at a fully operational level to ensure user comfort. Restricted function of the window may also pose as a potential safety hazard if required for emergency egress from the building.

Generally, factors such as general age of the building element and a lack of maintenance are the usual causes for this type of defect.

Replacement of window hardware or frame may be required, as well as minor repairs and cleaning. A registered builder or general handy person will be required to repair the affected windows.

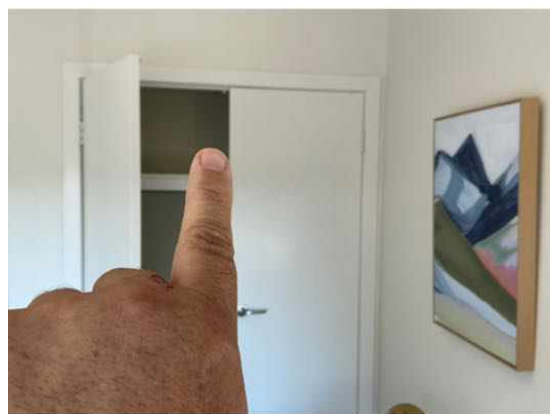
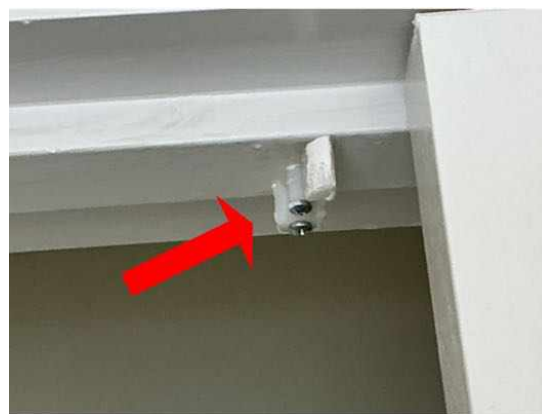
Finding 3.05

Building:	Main Building
Location:	Bathroom 2
Finding:	Door catch – broken
Information:	It was observed that the door to wardrobe in bedroom two requires a door catch repair. It is not holding the door closed.

The door should be operational and unattended to the door the door and building elements could prematurely deteriorate.

A general handyman should be engaged to review at the owners discretion

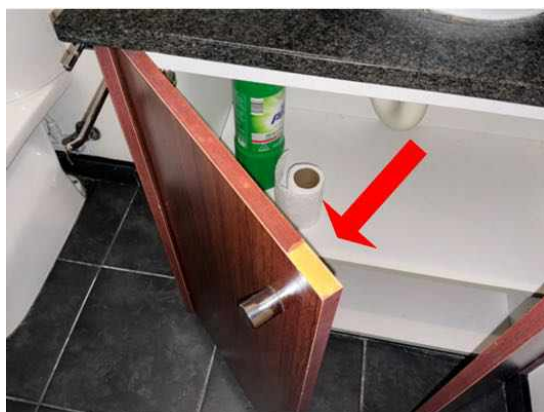
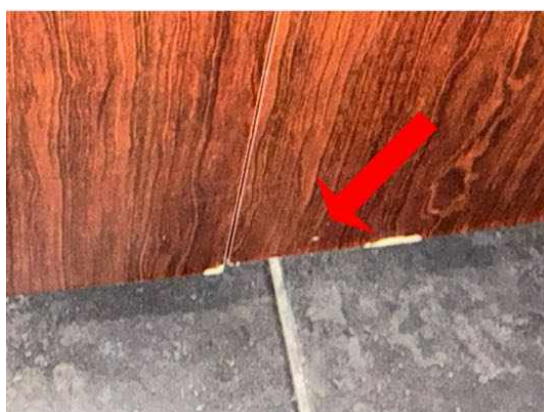
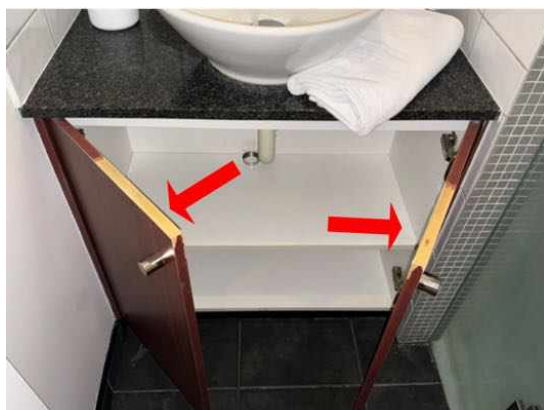
Building: Main Building
Location: Bathroom 2 and 3
Finding: Cabinet edge tape
Information: It was observed that the tape to the bathroom cabinets have sustained some previous damage

Edge tape is required to prevent the ingress of moisture to the substrate of the cabinet carcass preventing swelling and premature deterioration of the cabinet structure

A qualified cabinet maker should be engaged to review at the clients discretion

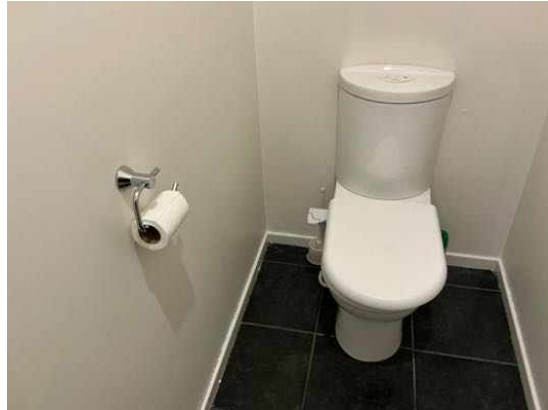
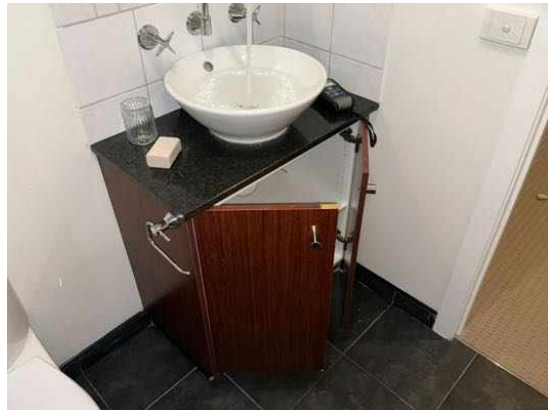
Building: Main Building
 Location: Bathrooms and WC
 Finding: Toilet roll holder - Loose
 Information: The toilet roll holder was found to be loose at the time of inspection. While not a major operational defect, function can deteriorate if the problem is left unmanaged.

It is advised that the homeowner performs remedial works to re-attach the toilet roll holder to its original fixing. A general handyperson may be required to perform these

works.

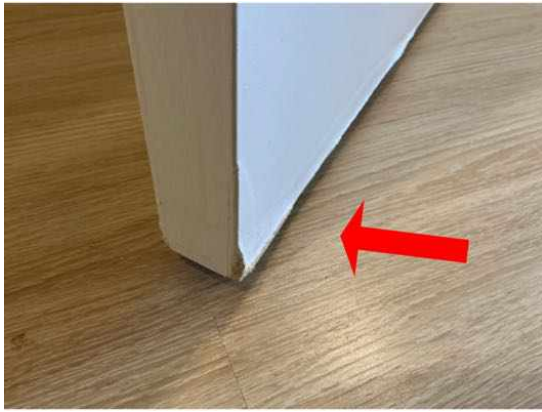
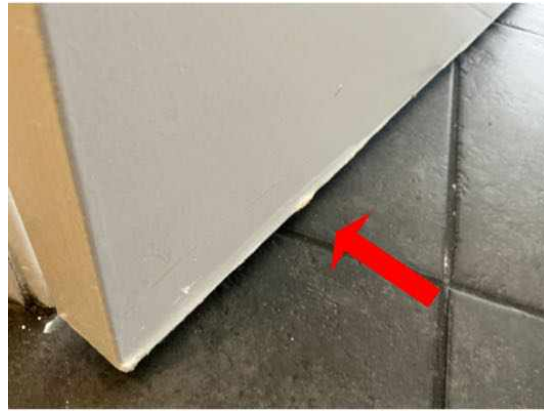
Building: Main Building
 Location: Laundry
 Finding: Door water damaged
 Information: It was observed at the time of the inspection that the doors to the laundry closet had been water damaged at the bottom. It appears that the doors were not sealed at the time of construction and overtime has wicked up water from the floor tiles and or steam from clothes washing activities

Unattended to the doors could continue to deteriorate to a point where replacement may be required.

A qualified carpenter and painter should be engaged to review at the owners discretion

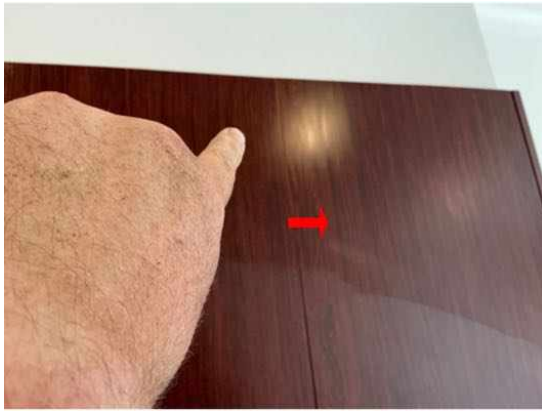
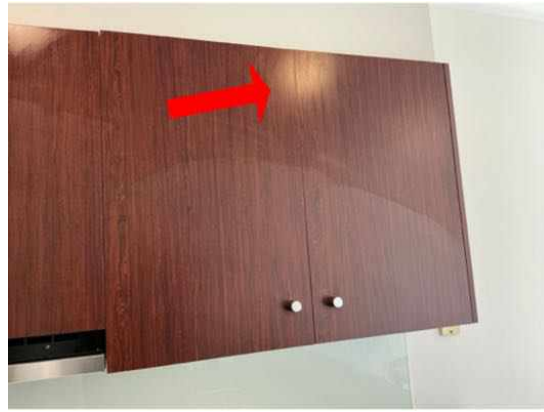
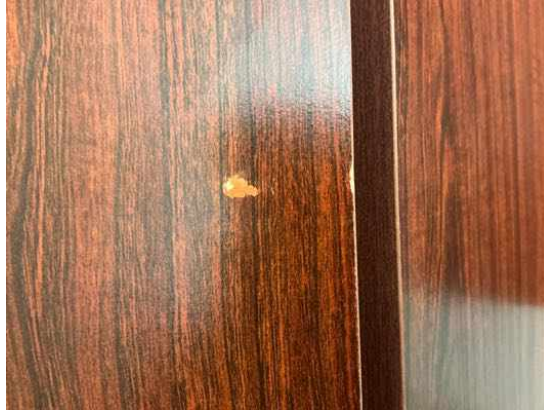
Building:	Main Building
Location:	Kitchen
Finding:	Cabinet doors require adjustment
Information:	It was noted that several cabinet to the kitchen had become loose overtime and has caused the doors to bind and become difficult to open.

Doors which catch and bind can damage laminated surfaces and allow water ingress into cabinetry elements. This can cause swelling of the chipboard substrate and premature deterioration of the structure of the cabinet.

A qualified cabinet maker should review at the owners discretion.

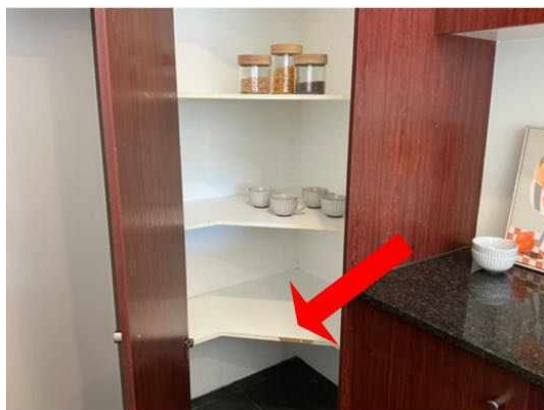
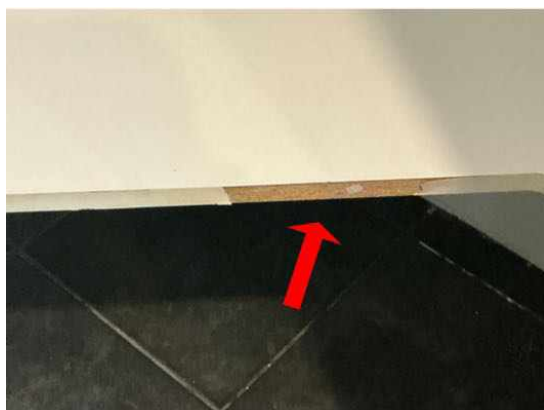
Building:	Main Building
Location:	Kitchen
Finding:	Cabinet edge tape and minor chips to laminate
Information:	It was observed that the tape to the kitchen cabinets have sustained some previous damage

Edge tape is required to prevent the ingress of moisture to the substrate of the cabinet carcass preventing swelling and premature deterioration of the cabinet structure . There were also chips in the laminate observed.

A qualified cabinet maker should be engaged to review at the clients discretion

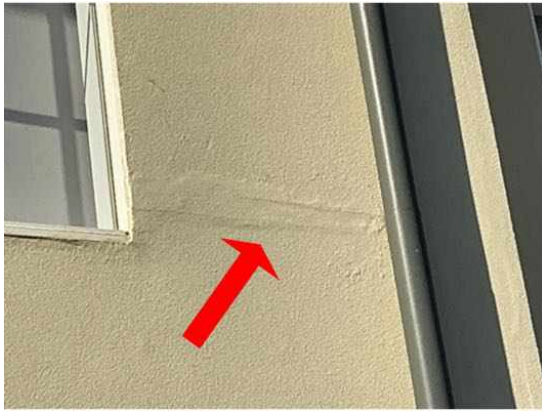
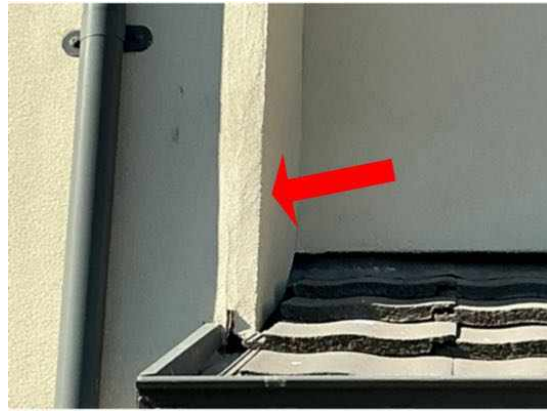
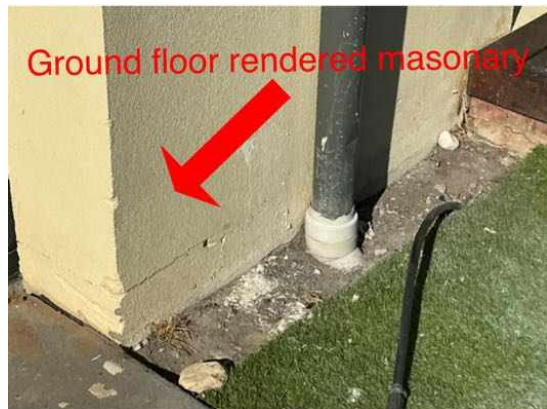
Building:	Main Building
Location:	Exterior walls - rear
Finding:	Building elements deteriorating /blueboard/ render
Information:	It was observed at the time of the inspection that the render substrate to the first floor was a blue board cement sheet type product. It appears that the rendering was applied over unsealed joints to the board and the board has swollen and caused cracking to the joints. The cracks and damage repairs are showing signs of poor workmanship.

When blue board shows signs of this type of deterioration, often the rendering requires professional repair to prevent further deterioration.

There was also cracking observed to the rendering on the ground floor brickwork, which although is mainly a cosmetic item, detracts from the overall appearance of the building.

An experienced rendering contractor should be engaged to review at their own discretion.

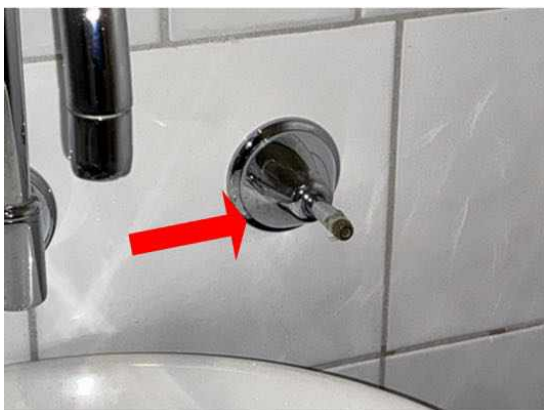
Finding: Tap - Loose

Information: The tap to the bathroom basin has not been installed correctly, or has deteriorated with age, and is consequently loose. This tap being loose creates potential for water leaks and subsequent water damage to the surrounding area.

Where taps or spouts are loose, a qualified plumber should be appointed to re-fix the plumbing fitting.

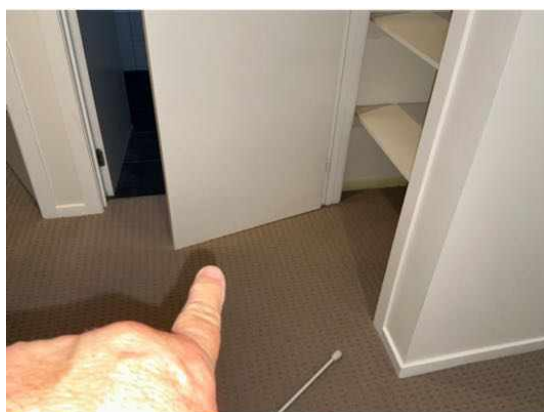
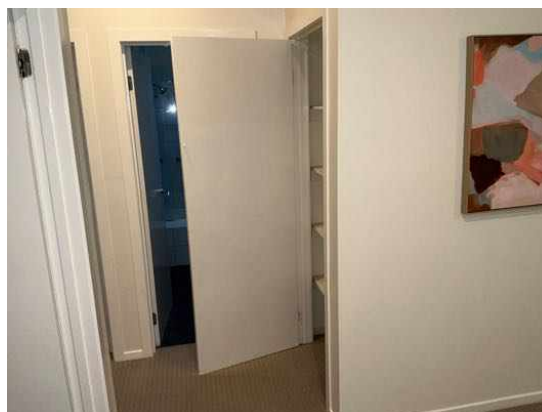
Building: Main Building
 Location: Linen Cupboard
 Finding: Door - Binding/jamming
 Information: Binding and/or jamming of the linen cupboard door is evident during standard operation. This defect inhibits the functionality of the affected door as well as creating potential for secondary defects to associated building elements, such as damage to the floor covering.

A door that binds to flooring or to the associated door frame may have several causes, ranging from minor defects, such as poor installation of the door or deteriorated hinges.

For minor causes, a qualified carpenter or general handyperson should be appointed to perform minor rectification works at client discretion.

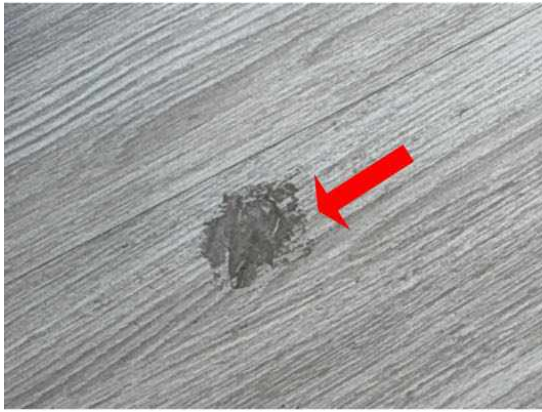
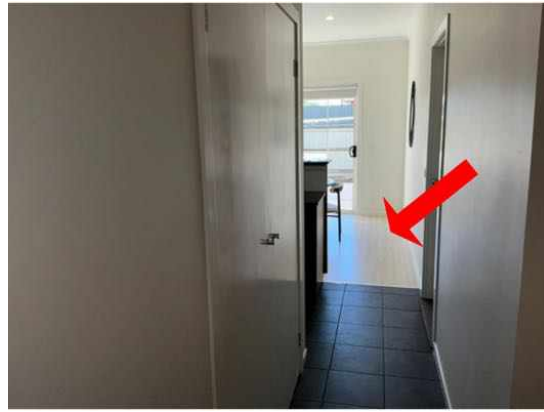
Building: Main Building
 Location: Kitchen
 Finding: Damaged floating floor elements
 Information: It was noted at the time of the inspection that there was some minor impact damage to the floating floorboards. Although this is an anaesthetic defect, it attracts from the overall appearance of the building.

An experienced flooring contractor should review at the owners discretion

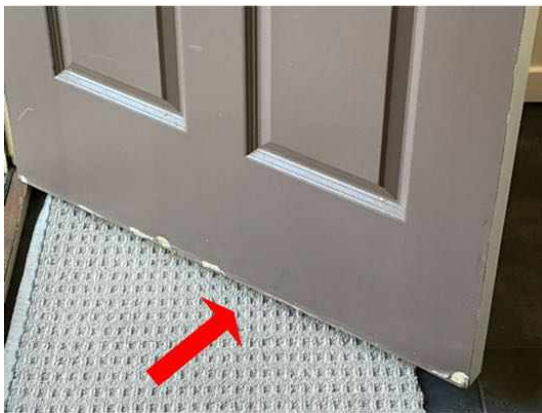
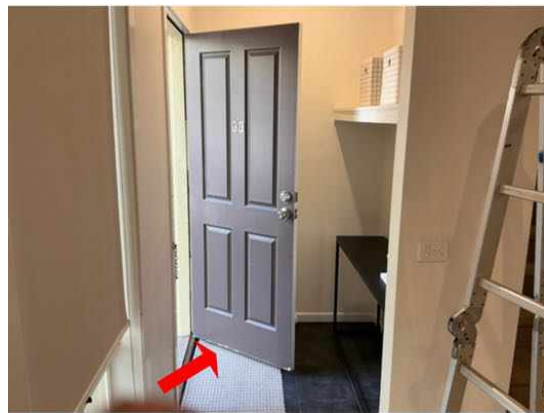
Building: Main Building
 Location: Entry
 Finding: Paint deterioration
 Information: It was observed at the time of the inspection that the paint to the bottom of the front door has deteriorated due to excessive moisture. Unattended to the excessive moisture ingress could prematurely deteriorate the door and eventually require replacement.

A general handyman should be engaged to review at the owners discretion.

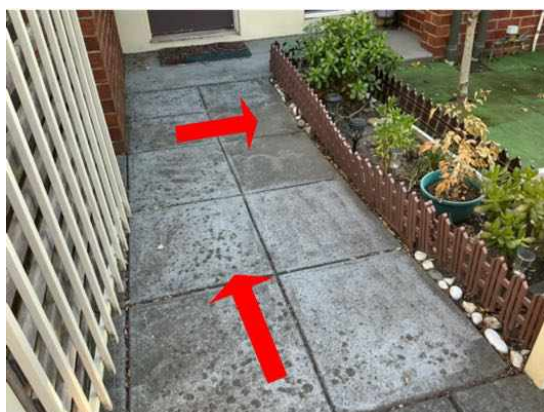
Building:	Main Building
Location:	Yard - Front
Finding:	Site drainage - Inadequate
Information:	The site drainage in the front yard area was found to be inadequate at the time of inspection, creating potential for subsequent water damage to associated building elements.

Excessive ground moisture is conducive to termite infestation

Where site drainage is inadequate, installation of an Agricultural (Aggie) Drain may be required. A qualified plumber should be appointed to further inspect the property and perform any remedial works as necessary. Water damage and secondary defects are likely to occur if left unmanaged.

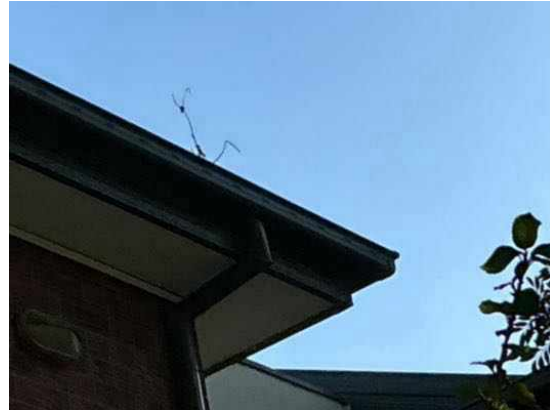
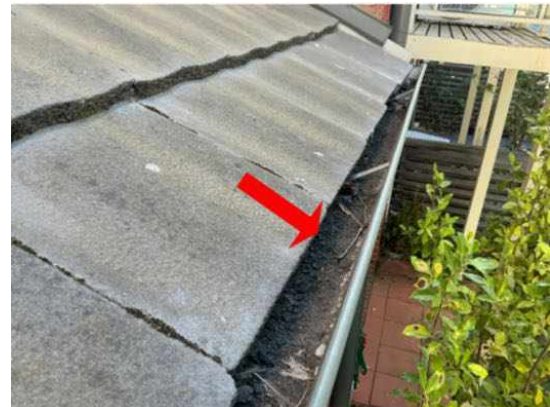
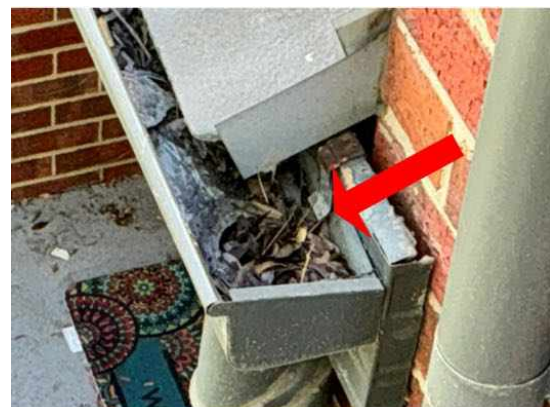
Blocked gutters are likely to lead to high levels of moisture in the affected areas. Such

moisture will not only cause rust and decay of the associated building materials, but can also provide conditions that are conducive to termite and timber pest activity. Blockages in gutters should therefore be removed immediately to ensure dry conditions are maintained.

Consult a Licensed Plumber for further specific advice on remedial works that may be required. In the interim, it is highly advised that blocked gutters be removed by the homeowner or a general handyperson as a matter of urgency.

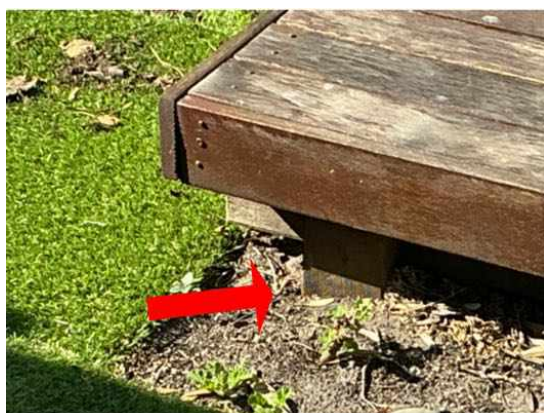
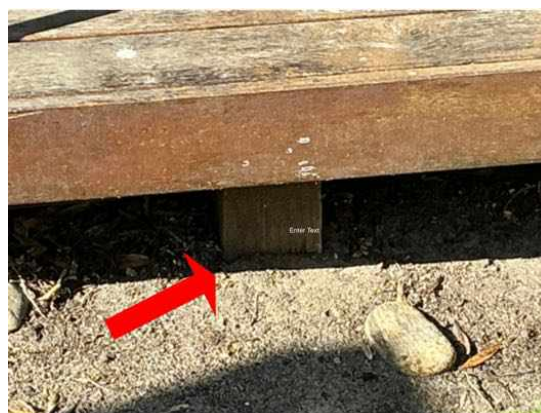
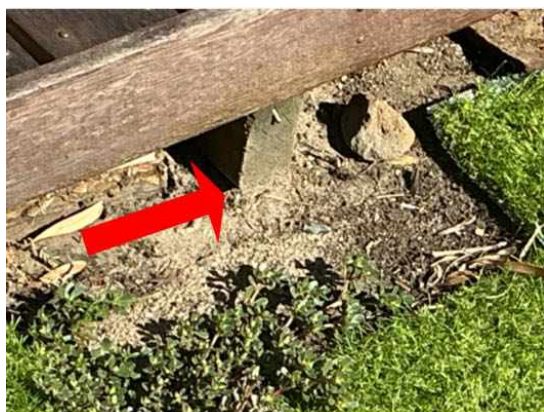
Location:	All External Areas
Finding:	Untreated or non-durable timbers in a hazardous environment
Information:	To reduce the risk of timber pest attack it is essential that timber used in a hazardous environment (e.g. in direct contact with the ground or frequently exposed to damp conditions) is of sufficient durability and/or is adequately preservative treated.

Untreated timbers in direct contact with the ground are likely to develop severe wood rot and/or fungal decay if left unattended creating attraction for subterranean termites to infest the timbers from surrounding areas.

If untreated or non-durable timbers are found to be in a hazardous environment it is highly advised that replacement of these building elements be performed as soon as possible to aid the protection of the property against termite / timber pest attack.

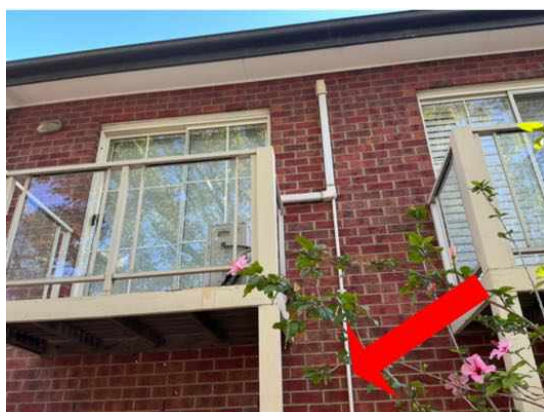
Building:	Main Building
Location:	Front Elevation
Finding:	Air conditioner condenser pipe not connected
Information:	The A/C Condenser overflows were found to be disconnected from the stormwater system and is creating excessive moisture to the surrounding area.

Such leaking creates an environment which is conducive to an array of defects including water damage to associated building materials and the attraction of termites or timber pest infestation.

A Licensed plumber should be engaged to review as soon as possible

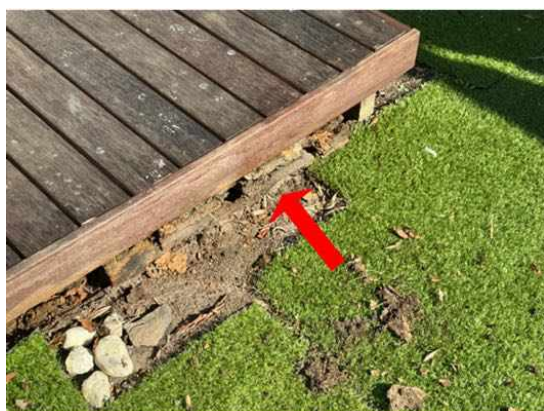
Finding 7.01

Building:	Main Building
Location:	Deck
Finding:	Wood rot
Information:	This building element shows evidence of wood rot. Wood rot, also known as Fungal

Decay, occurs when timbers and other cellulose building materials are exposed to damp conditions on an ongoing basis. This could be the result of exposure to weathering over a prolonged period of time, or the attraction of excessive moisture from other abutting building materials. Contributing factors also include poor air ventilation in the area.

Wood rot is often associated with general damp problems and is evidenced by a 'musty' smell or mould and mildew occurring on surfaces. If left unmanaged, damp conditions can lead to further health problems and the decay of timbers will continue.

Early intervention and regular maintenance, particularly of exterior timbers, will prolong the useful life of these building elements. Prior to any works being performed, the cause of the moisture that has created the visible wood rot should be identified and addressed in a suitable manner. Replacement of affected timbers may then be a necessary step in protecting surrounding building elements from such deterioration.

A qualified plumber may be appointed to assess the cause of excessive moisture and to provide advice on any remedial works as required. A qualified carpenter or registered builder may also be required to replace affected building materials.

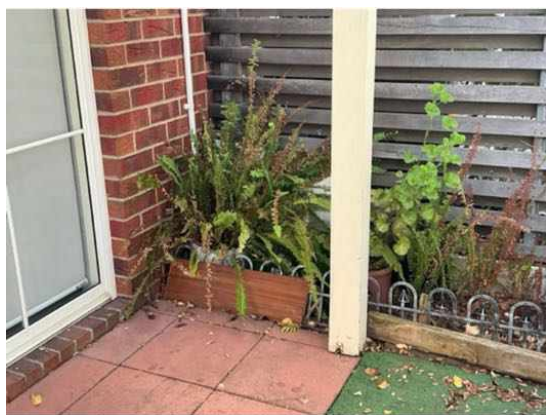
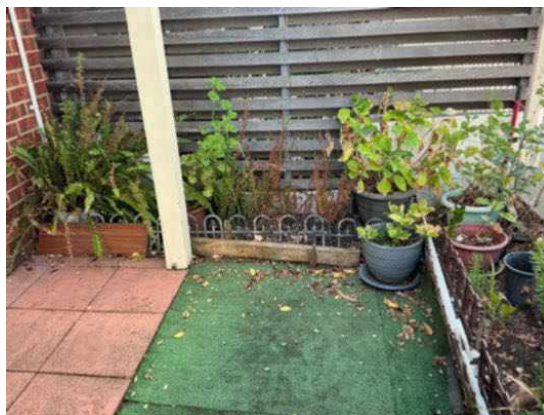
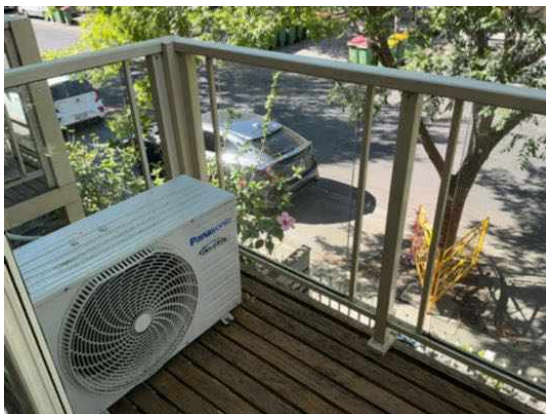
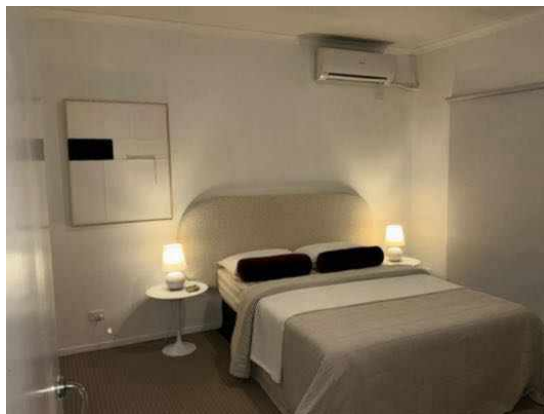
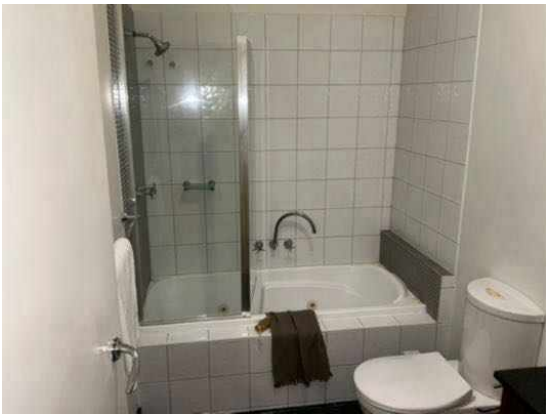
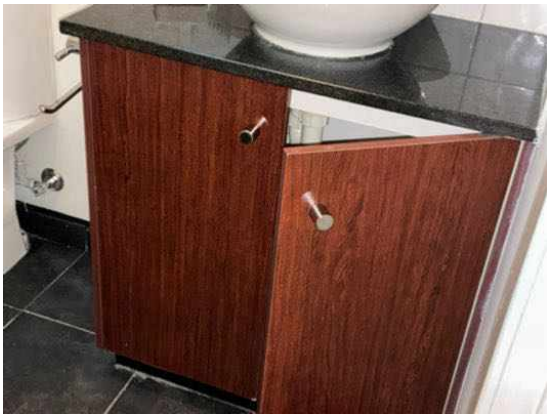
Finding: Additional Photos - Obstructions and Limitations

Information: These photographs are an indication of the obstructions and limitations which impeded full inspection of the property at the time of inspection. These obstructions can hide an array of defects and should be removed to allow full inspection to be carried out. A re-inspection is recommended once the areas are made accessible.
