Building and Timber Pest Inspection Report

Inspection Date: Thu, 22 Jan 2026

Property Address: 119B MacKays Rd, Upper Kangaroo River
NSW 2577, Australia

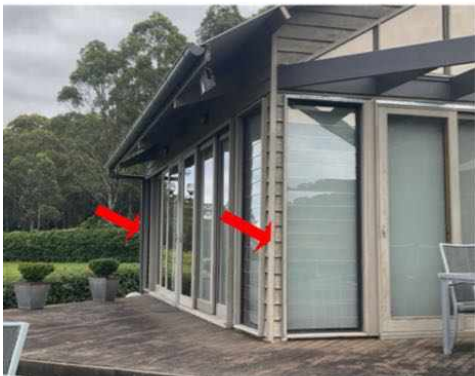
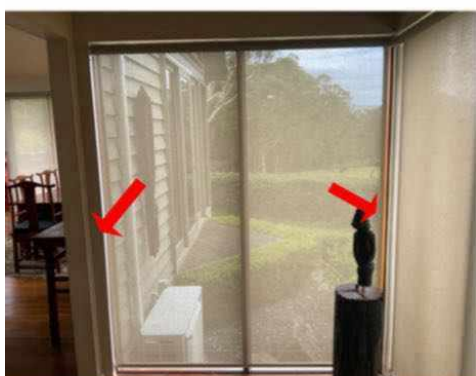
Building: Building 1
Location: Two bedrooms, loungeroom, hall
Finding: Evidence of excessive moisture was present at the time of inspection
Information: Excessive moisture was found in many window and wall areas at the time of the inspection. Moisture readings of between 50.8 and 100 were found in these pictured areas.

Nil readings were found next to most of these areas for reference.

Excessive moisture can attract termites and produce conditions that promote termite attack, fungal growth and wood decay. Excessive moisture is generally caused by deteriorated, inadequate or missing roof drainage, damaged external sealant, cladding or flashings and poor site drainage.

It is highly recommended that all window and cladding areas be checked, sealed and maintained regularly in order to prevent excessive moisture being present in the internal property.

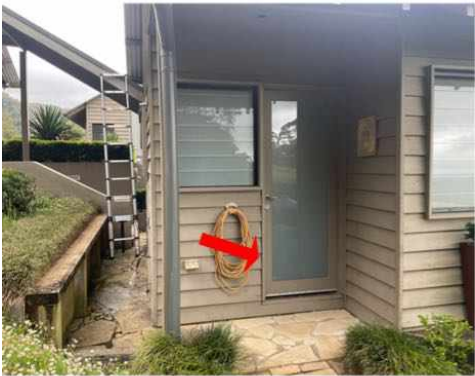
Finding 3.02

Building:	Building 1
Location:	Exterior walls
Finding:	Sealant (external) - missing
Information:	It was noted on inspection that areas of external sealant was missing to small areas of many external walls.

It is thought this is the reason for the excessive moisture found in some internal walls areas.

Flexible sealants should be applied to these affected areas to prevent any subsequent water damage that is likely to occur.

A sealant specialist or skilled handy person should be appointed to complete these works as soon as possible to stop any internal moisture damage.

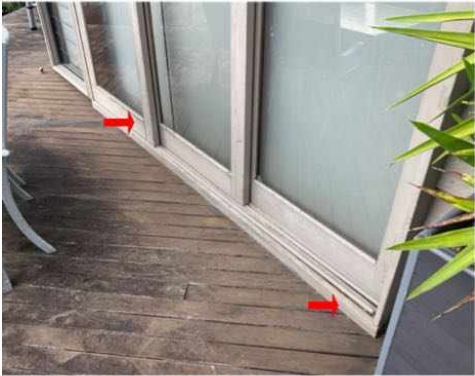
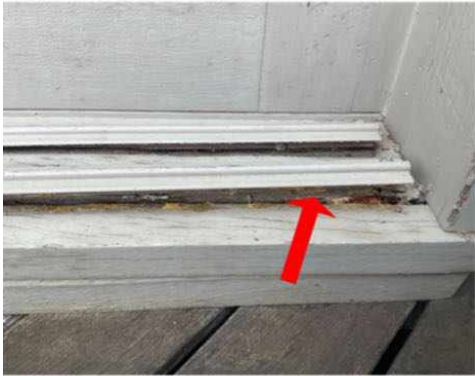
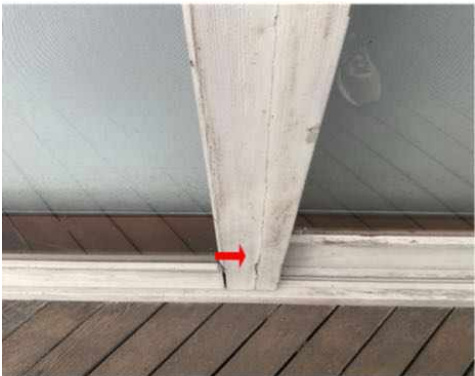
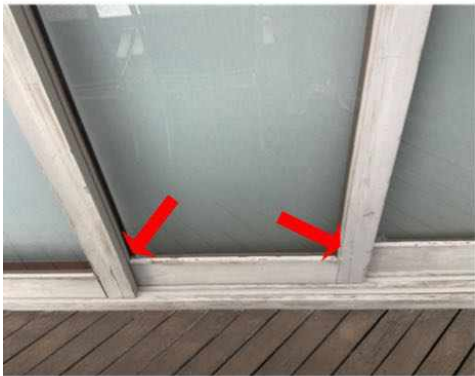
Building:	Building 1
Location:	Pictured areas
Finding:	Doors damaged (minor)

Information: These pictured rear doors and door track were found to be damaged at the time of the inspection. Some joints are coming apart and have minor splitting.

Repairs to these broken doors is advised to improve the operational state of the associated doors.

A qualified carpenter should be appointed to repair these doors in ten next few months.

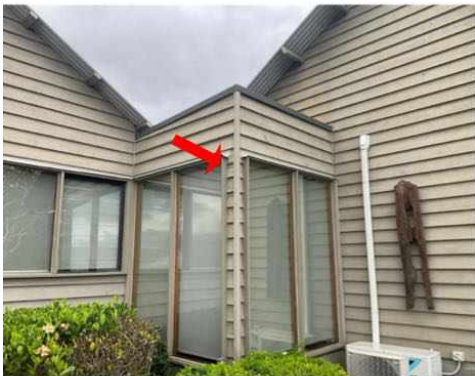
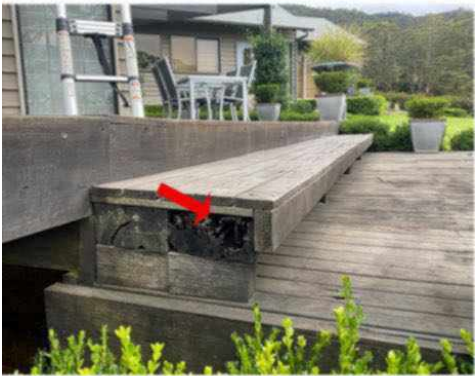
Building:	Building 1
Location:	Pictured areas
Finding:	Wood rot and loose timber
Information:	The building shows evidence of wood rot to some decks, cladding and pergola areas. Wood rot, also known as Fungal Decay, occurs when timbers and other cellulose building materials are exposed to damp conditions on an ongoing basis. This could be the result of exposure to weathering over a prolonged period of time, or the attraction of excessive moisture from other abutting building materials.

Early intervention and regular maintenance, particularly of exterior timbers, will prolong the useful life of these building elements. Replacement of these affected timbers may then be a necessary step in protecting surrounding building elements from such deterioration.

A qualified carpenter or registered builder may also be required to replace affected building materials.

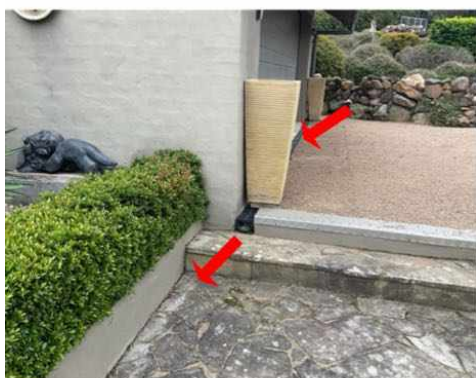
Building:	Building 1
Location:	Central paving areas
Finding:	Site drainage - Inadequate
Information:	The site drainage in this area was found to be inadequate at the time of inspection, creating potential for subsequent water damage to associated building elements.

It is important that water does not lie against the base of walls; surrounding paths and ground levels should be sloped to drain water away from walls. Downpipes should not discharge stormwater onto lower walls or plinths. Stormwater should be carried away by large, regularly cleaned drains. Ground levels may need to be lowered to expose a buried DPC.

Where site drainage is inadequate, installation of an Agricultural (Aggie) Drain may be required. A qualified plumber should be appointed to further inspect the property and perform any remedial works as necessary. Secondary defects are likely to occur if left unmanaged.

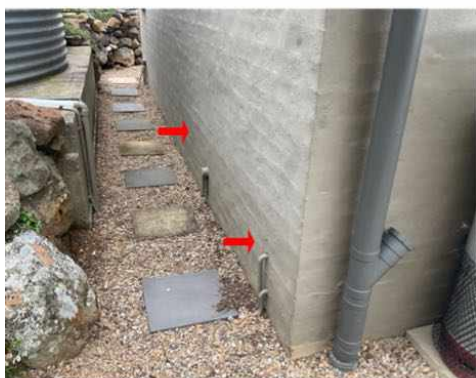
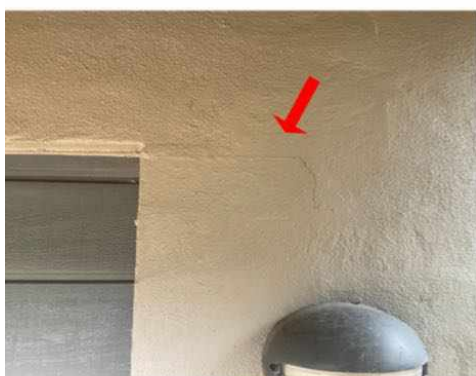
Finding 3.10

Building:	Building 4
Location:	Exterior walls
Finding:	Render (external) cracking.
Information:	It has been observed that cracking to some external rendered surfaces mostly small garage wall areas. The degree of damage is described as “slight” noticeable cracks which are easily filled. Cracking of this size are generally less than 5mm in width.

Always contact your building inspector should cracks widen, lengthen, or become more numerous.

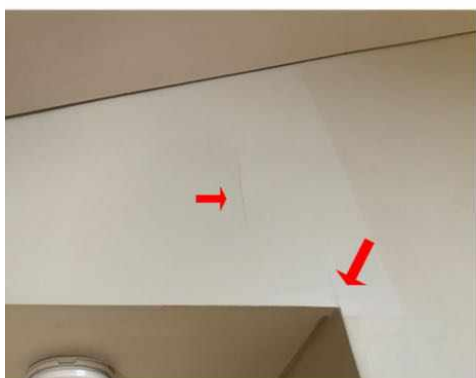
Finding 3.11

Building:	Building 1
Location:	Hall areas
Finding:	Cracking - Damage Category 1 - Fine (up to 1mm)
Information:	Although fine cracks are quite noticeable, they are often only considered to be an appearance defect, and usually do not indicate any structural damage. Generally, the cause of a fine crack is indicative of a separation between building materials and finishes (e.g. paint, plaster, etc.) along joints.

Cracking of this nature can generally be repaired with minor sanding, filling and/or repainting. Such works should be performed by a qualified painter or a general handyman.

Monitoring of all cracking should be conducted frequently. Always contact a building inspector should cracks widen, lengthen, or become more numerous.

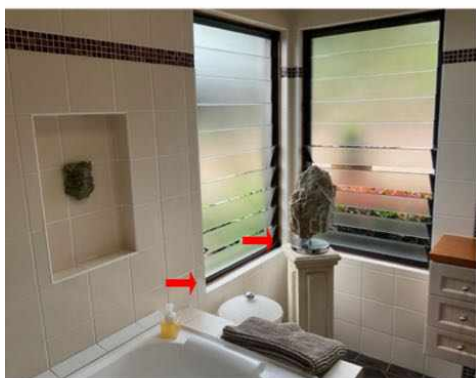
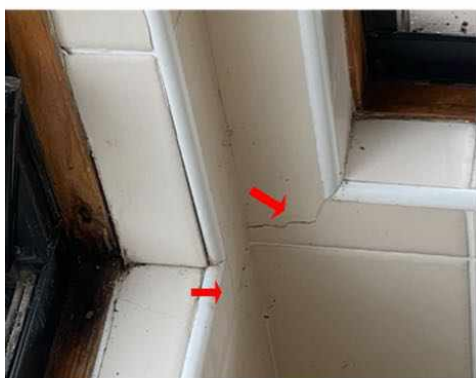
Finding 3.12

Building:	Building 1
Location:	Bathroom & laundry
Finding:	Tiles cracked
Information:	Cracked tiles were evident in these two pictured areas at the time of inspection. It is suspected that this cracking has occurred as a result of minor settlement.

Cracked tiles throughout the household detract from the overall appearance of the affected areas. In wet areas of kitchens and bathrooms, it can lead to water damage of adjoining walls and floors.

Replacement of cracked tiles is recommended as soon as possible. A tiling contractor may be appointed to perform these works. Where cracks become more numerous, contact a licensed building inspector for further investigation.

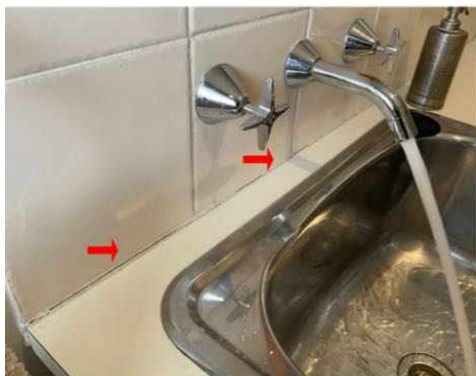
Building:	Building 1
Location:	Laundry and bathroom
Finding:	Sealant and grouting - Missing or damaged
Information:	It was noted on inspection that sealant or grout is degraded to these pictured areas.

Different materials and floor areas move at different rates, generally causing cracking to grout or sealant at this point. A flexible sealant is required to allow for expected expansion and contraction, while keeping the joint water tight and protective of all associated building materials.

Flexible and mould resistant materials should be applied to affected areas to prevent any subsequent water damage that is likely to occur. Regular maintenance and replacement of damage or missing or damaged sealant and grout is highly recommended to the wet areas, as this is a regular wear and tear defect. Sealant and grouting in areas that come into regular contact with water should be maintained for the long term care of your property.

A sealant specialist or tiling contractor should be appointed to complete these works as soon as possible

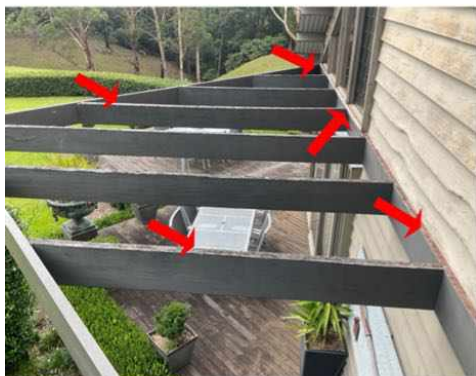
Finding 3.15

Building:	Building 2
Location:	Pictured areas
Finding:	External painting deteriorated
Information:	Much of the external paintwork on the pergola and small areas of the garage ceiling have been neglected and require attention to prepare and re-paint.

Whilst incomplete or missing paint finish is generally an appearance defect, it can also lead to the development of secondary building defects over time. Incomplete areas of paint finish expose the area to moisture, potentially accelerating the deterioration of underlying building materials.

Degraded paint finishes should be sanded back, filled, leveled and painted, as applicable. Where inadequate or missing paint protection has led to the deterioration of the associated building element, repair and/or replacement of this building element may be required.

A painting contractor should be appointed as soon as possible to perform necessary works to aid the appearance of the affected area and to ensure the area is protected against further deterioration. Alternatively, the homeowner following manufacturer instructions may perform these works.

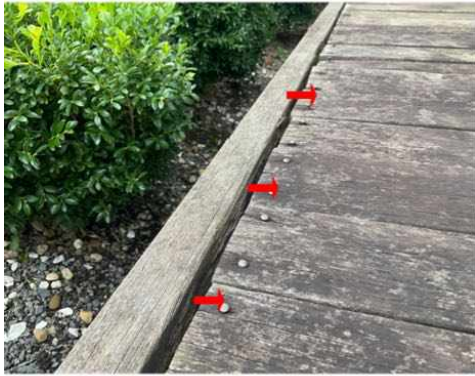
Finding 3.16

Building: Building 1
Location: Pictured areas
Finding: Nails - Popping
Information: Numerous popped nails were identified at the time of inspection. Nails and screws are held by the friction between them and the surface that they are applied to. Over time, the nails and screws can back out, which is often a result of general ageing and deterioration of the building structure.

If left unmanaged, internal wall and ceiling sheeting may become loose and unstable, increasing the rate of deterioration of these building elements and creating potential for the development of secondary defects.

Re-fastening of popped nails will help to maintain the stability of these, and associated, building elements. Such minor works will also help to improve the appearance of the affected area and secure the linings. These works should be performed by a qualified carpenter or plasterer at client discretion.

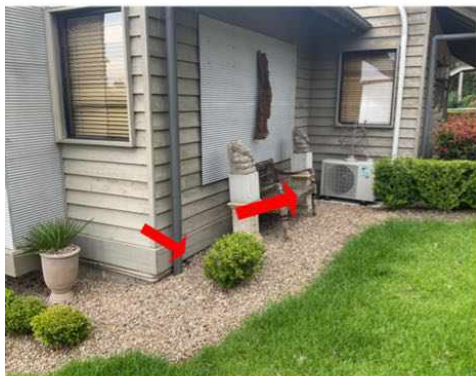
Building:	Building 1
Location:	Yard - front
Finding:	Bridging - Vegetation and decking
Information:	Where vegetation and decking obstructs inspection of building elements, also known as bridging as it provides a bridging point for the access of termites, full inspection can not be achieved. Consequently moisture or dampness may be present and the areas becomes conducive to termite activity. Plants and decks against or very close to buildings provide cover, shade and can provide an environment that is attractive to

Where the slab edge cannot be properly inspected, it is highly recommended that termite or timber pest inspections be carried out every 6-12 months to aid protection of the property against infestation.

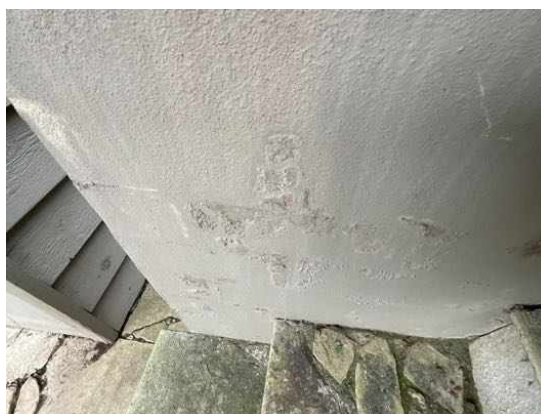
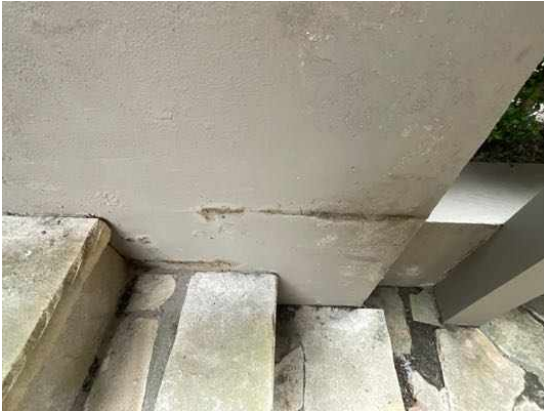
Building:	Building 1
Location:	Central stairs and some subfloor areas
Finding:	Damp rising and paint damage from moisture
Information:	Rising damp describes the upward movement of water in low sections of building elements (e.g. walls) by capillary action - the movement of water through porous materials such as bricks, sandstone or mortar.

Rising damp is generally managed by the installation of a damp proof course during construction. A Damp Proof Course (DPC) is an impermeable barrier at the base of the wall above ground level. However, many 19th Century buildings have no damp course installed, or the materials have failed. The DPC may have been omitted as a consequence of poor workmanship, or it may have been bridged where materials built up against the side of the house allow moisture ingress above the DPC level.

The first step in addressing rising damp is to diagnose the cause. The identified cause should be addressed first before addressing the appearance and other defects which have resulted from the rising damp. If the original cause is not resolved, further cases of damp are likely to ensue, resulting in secondary defects.

Consultation with a qualified plumber is advised immediately to identify the cause of the damp and perform remedial works as required.

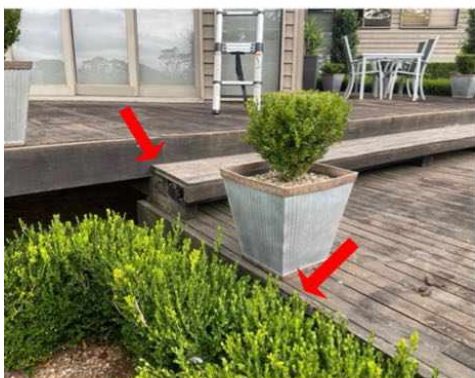
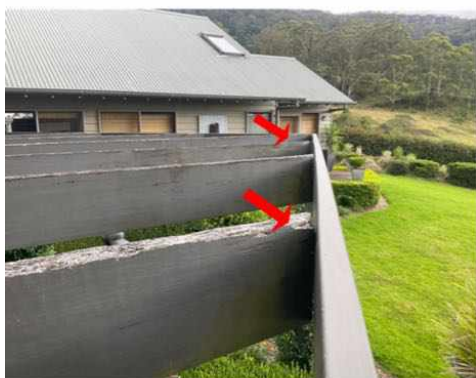
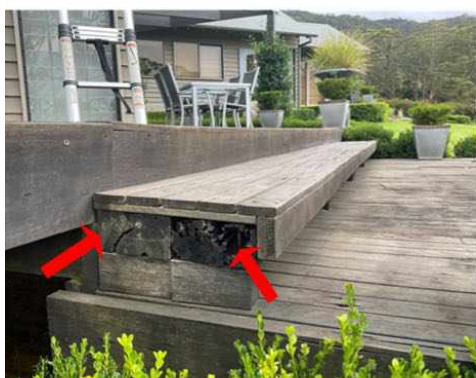
Finding 7.01

Building:	Building 1
Location:	Small reads of decks, cladding and rear left pergola
Finding:	Fungal decay - present (localised)
Information:	Fungal decay also known as wood decay or wood rot generally refers to the deterioration of timber elements when in contact with excessive levels of moisture for a prolonged period of time.

The development of fungal decay is accelerated by temperatures from 5degreeC to 40degreeC as well as the presence of oxygen. Generally fungal decay develops on timber elements that are in use in an external environment which are exposed to rain penetration.

In this case, the affected timber element is in a decaying state and will need replacement by a carpenter or licensed builder.

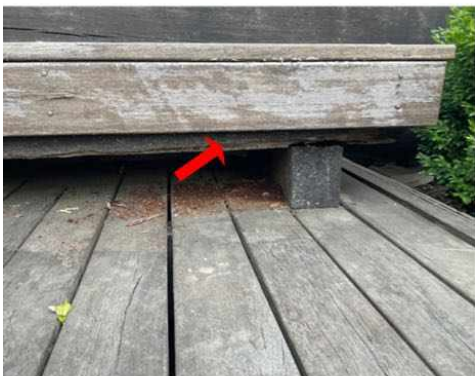
Finding 8.01

Building:	Building 2
Location:	Pictured areas
Finding:	Evidence of wood borer activity identified
Information:	Wood borers small beetles that colonise in exposed timber elements are a common timber pest that are regularly mistaken for termites. Although wood borer activity is generally not detrimental to the affected timber they may lead to serious damage and necessitate replacement of certain building elements if left unattended.

The other commonly known borer the Anobium borer is more likely to attack floorboards and may cause severe structural damage to flooring areas.

As no live wood borer activity was identified treatment is not required at this time. Replacement of affected timbers may be considered by the client for superficial reasons.

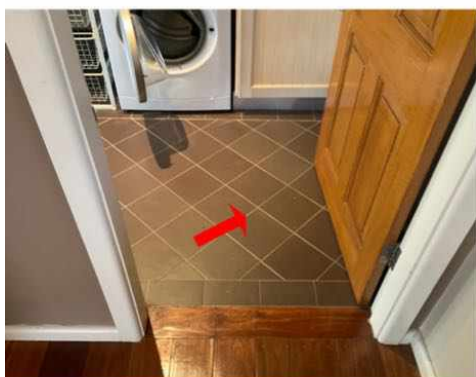
Building: Building 1
 Location: Bathrooms and laundry
 Finding: Waterproofing membranes - Information Only
 Information: Internal Water Proofing Membranes, are crucial in preventing water ingress into the property is important to know that the Membrane System used is to Australian Standards and has been installed correctly.

With older property's where this information is unavailable all wet areas should be monitored. If any leaks, water staining, peeling or bubbling of the paint become evident to any adjacent walls or ceilings below a licensed builder or waterproofing specialist is recommended to investigate further.
