# Building and Timber Pest Inspection Report

Inspection Date: Fri, 13 Mar 2026

Property Address: 61 Waruda St, Yagoona NSW 2199,  
Australia

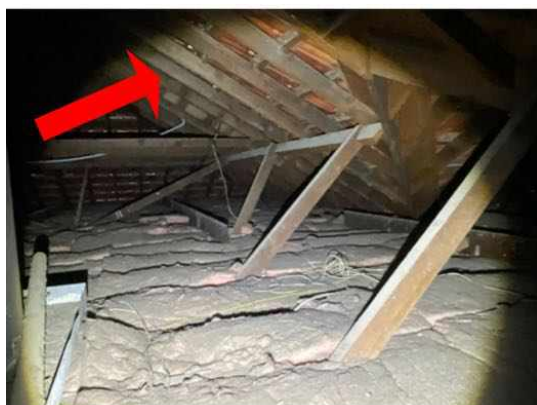
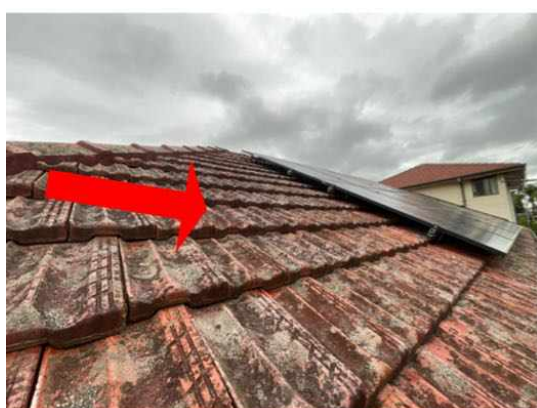
Building:	Main Building
Location:	Roof Void / Roof Exterior
Finding:	Exterior roof - Leaking
Information:	Active roof leaks were evident at the time of inspection. Roof leaks can have a number of causes, including damage to roof coverings, deterioration of roof fixtures and fittings, or loosely associated materials (fascias etc.).

Where water leaks are active, rain penetration is likely to cause water damage to associated structures and building elements in this area, which can have a range of implications. If left unmanaged, the development of major structural damage to the roofing and associated structures may occur.

A roof plumber should be appointed as soon as possible to primarily identify the cause of the leak, and to provide subsequent repair works as necessary. Depending on the extent of the damage, replacement of sections of the roof covering and/or

roofing structures may be required, and may be performed by a registered builder or qualified carpenter.

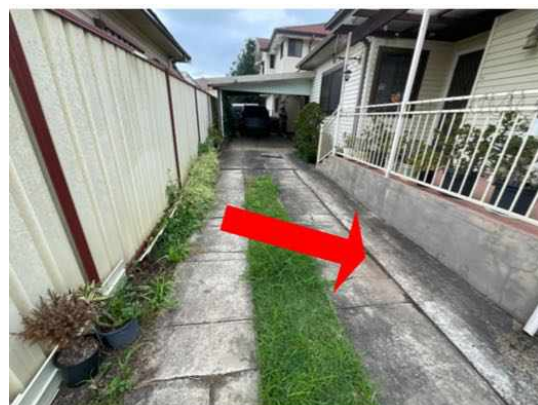
Building:	Main Building
Location:	All External Areas
Finding:	Concrete paving - Erosion
Information:	Erosion under concrete paving was identified at the time of inspection. For all the concrete paving without the right support, concrete will crack, sink and cease to be the sturdy. It's imperative to fix erosion under concrete immediately as well as improve rainwater drainage away from the building foundations.

Suggestion of the inspection from the structure engineer and A qualified tradesmen to be nominated to fix the defect as soon as possible.

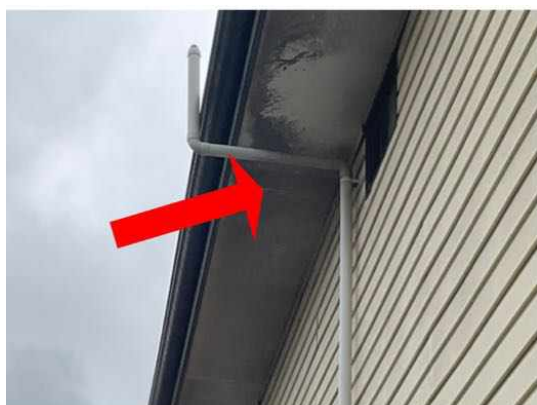
Building:	Main Building
Location:	All External Areas
Finding:	Eaves lining - Mould
Information:	Mould to eave linings in this area was evident at the time of inspection. Mould indicates that surfaces have been exposed to excessive moisture over time. The minerals and other elements in the water lead to staining, which may graduate to corrosion and deterioration if left unmanaged.

While mostly an appearance defect, mould can be indicative of more serious defects, which may be currently concealed by lining.

Where water staining is active, a licensed plumber must be consulted to identify the cause of the staining and to provide advice on any reparation works that may be required. Replacement of any damaged structures is advised.

Conversely, where water staining is old and inactive, affected building materials may be repaired or replaced at client

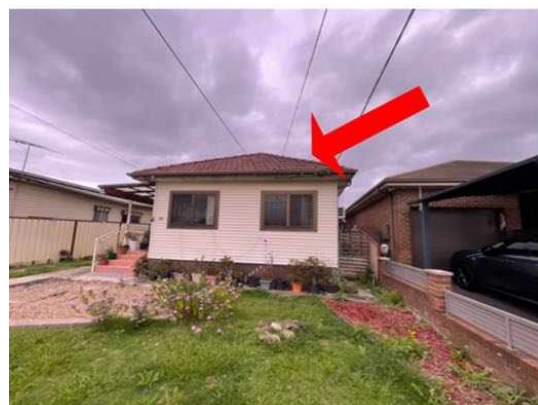
Building:	Main Building
Location:	Roof Exterior
Finding:	Mortar - Deterioration
Information:	Mortar, or 'bedding', is the material which fills joins and intersections between tiles and other building elements on the exterior roof covering, such as gable ends, hip capping and valleys. Upon inspection of the exterior roof, it was noted that sections of the mortar show varying levels of deterioration.

Mortar generally deteriorates as a result of frequent exposure to weather conditions over a prolonged period of time. Mortar that is deteriorating may allow water ingress into the roof void, putting associated building elements and roofing structures at risk of water damage. Deteriorated mortar also detracts from the functionality of roof tiles and other roofing elements, potentially decreasing weather tightness and roof drainage.

Mortar deterioration can be attended to by a handyperson where areas of deterioration are localised and easily accessible. Otherwise, consultation with a roofing contractor is advised where greater works are required.

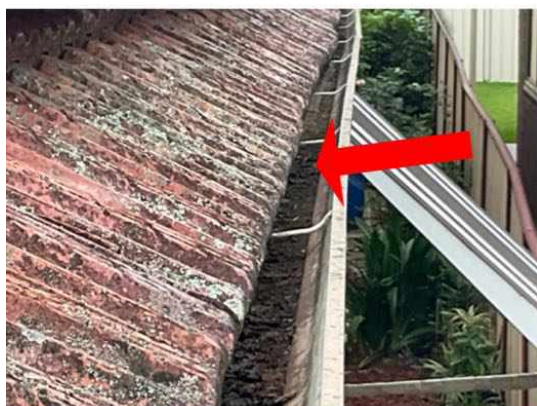
Building:	Main Building
Location:	Roof Exterior
Finding:	Gutters - Blocked
Information:	Roof plumbing structures, such as guttering and downpipes, should be free of all debris to prevent blockages. Blockages of the guttering and downpipes will lead to pooling and accumulated water overflows, which is likely to subsequently flood eaves and exterior walls.

Blocked gutters are likely to lead to high levels of moisture in the affected areas. Such moisture will not only cause rust and decay of the associated building materials, but can also provide conditions that are conducive to termite and timber pest activity. Blockages in gutters should therefore be removed immediately to ensure dry conditions are maintained.

Consult a Licensed Plumber for further specific advice on remedial works that may be required. In the interim, it is highly advised that blocked gutters be removed by the homeowner or a general handyperson as a matter of urgency.

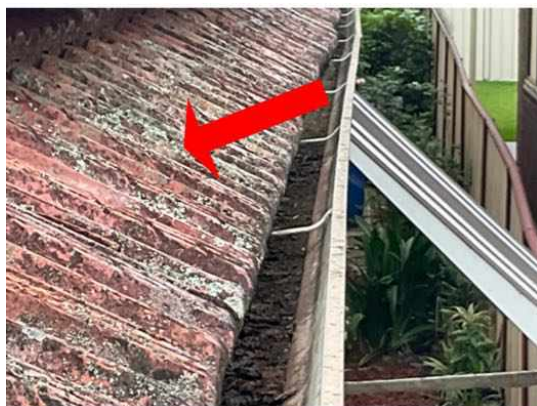
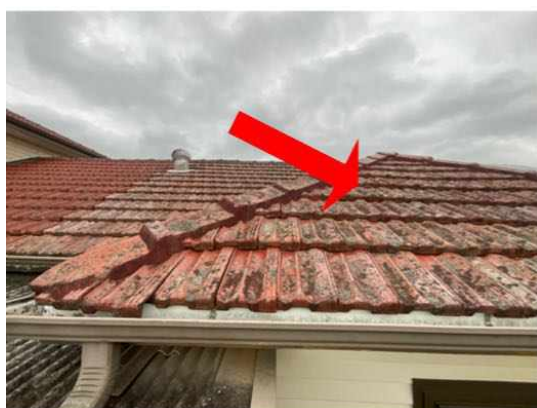
Building:	Main Building
Location:	Roof Exterior
Finding:	Mould Growth on Roof Tiles
Information:	Green mould and organic growth are visible along the edges of the roof tiles. This indicates prolonged moisture retention on the tile surfaces, likely due to limited sunlight exposure, humidity, or debris build-up.

If left untreated, mould and moss growth can retain moisture, leading to deterioration of the roof tile surface coating, increased water absorption, and potential long-term

damage. It can also contribute to blocked roof drainage systems and cause leaks.

It is recommended that the roof be professionally cleaned to remove mould and moss build-up. Preventative maintenance such as installing zinc or copper strips, ensuring adequate roof drainage, and applying an appropriate roof sealant/coating should be considered. Regular inspection and cleaning are advised to maintain the durability of the roof system.

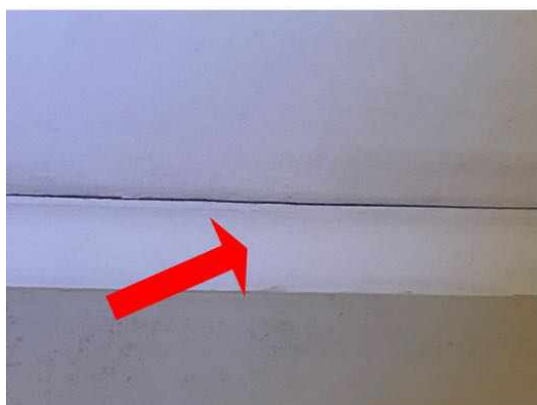
Building:	Main Building
Location:	Bathroom
Finding:	Cornices - Sagging
Information:	Sagging and uneven cornices generally indicate that the building materials have swollen, due to contact with water, or the movement of the ceiling joints or that fixings (e.g. nails or glue) have become loose and require reattachment. In some cases, sagging and uneven surfaces may also indicate that there are structural issues causing surfaces to warp, twist, or sag.

Where sagging appears to be major, appointment of a structural engineer is advised to further inspect the property. Otherwise, minor works such as re-gluing of wall/ceiling sheets may be required and should be performed by an aptly qualified plasterer or carpenter.

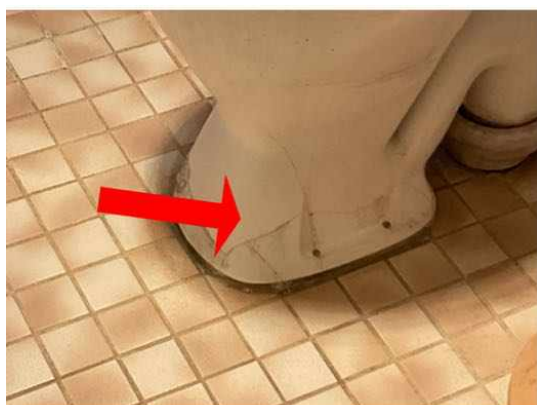
Building:	Main Building
Location:	Bathroom
Finding:	Toilet - Not functional
Information:	The toilet did not functional properly at the time of inspection.

Non-operational building elements such as this are vital to the function of the household and must be fixed.

A qualified plumber should be appointed immediately to repair the toilet and return it to an operational state.

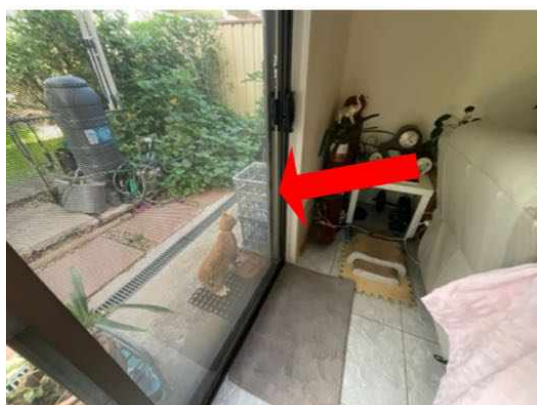
Building: Main Building  
 Location: Living Room  
 Finding: Sliding Door - Stiff to slide  
 Information: The door in this area was jammed and difficult to slide along the associated tracks at the time of the inspection. Restricted function of the affected door may pose as a potential safety hazard if required for emergency egress from the building.

Generally, factors such as general age of the building element and a lack of maintenance are the usual causes for this type of defect.

Replacement of door hardware or tracks may be required, as well as minor repairs and cleaning. A registered builder or general handy person will be required to repair the affected doors.

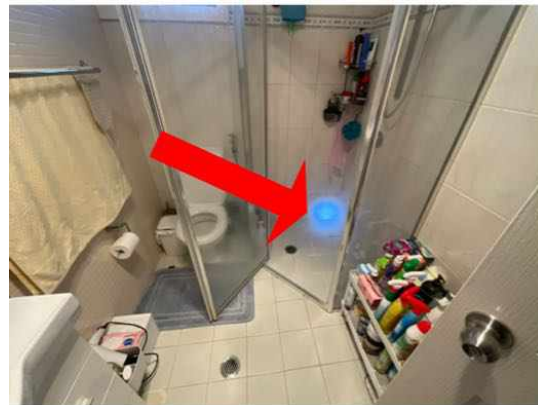
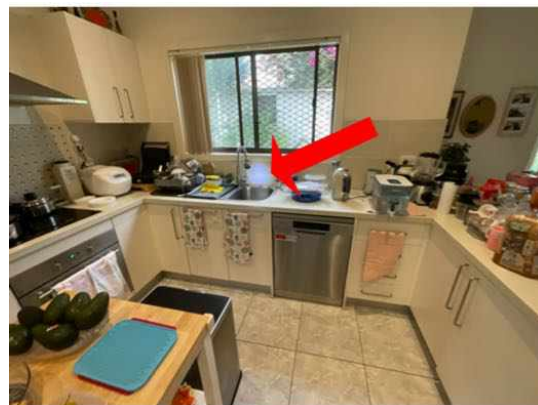
Building: Main Building  
Location: Bathroom / Kitchen  
Finding: Sealant and grouting - Missing or damaged  
Information: It was noted on inspection that sealant or grout is degraded to the tiled shower alcove and or other areas of the bathroom.

Flexible and mould resistant materials should be applied to affected areas to prevent any subsequent water damage that is likely to occur. Regular maintenance and replacement of damage or missing or damaged sealant and grout is highly recommended to the wet areas, as this is a regular wear and tear defect. Sealant and grouting in areas that come into regular contact with water should be maintained for the long term care of your property.

A sealant specialist or tiling contractor should be appointed to complete these works as soon as possible

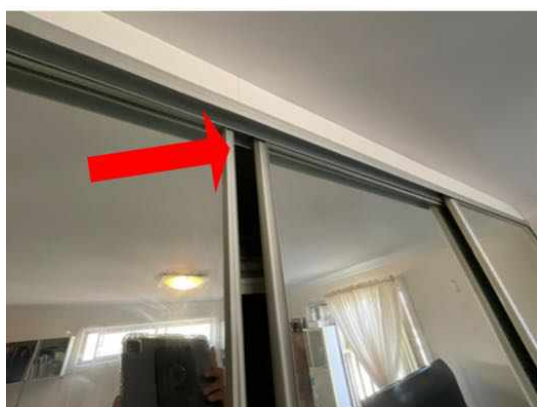
Building:	Main Building
Location:	Bedroom > Upstairs
Finding:	Misaligned Sliding Door – Wardrobe
Information:	The sliding door to the wardrobe was found to be misaligned. The door panels are not sitting level within the tracks and do not close flush, resulting in poor operation and uneven appearance.

The builder/tradesperson is to realign the sliding door panels by adjusting the rollers and track guides to ensure smooth operation and flush closure in accordance with manufacturer's installation requirements.

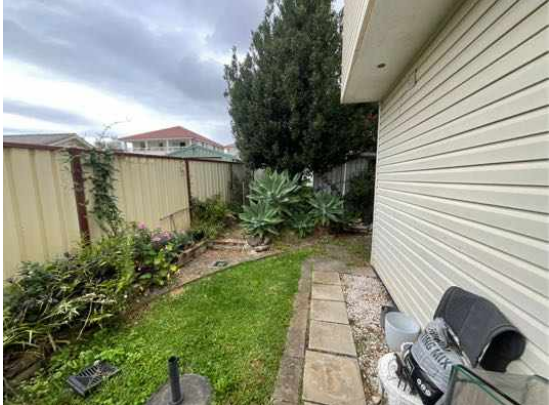
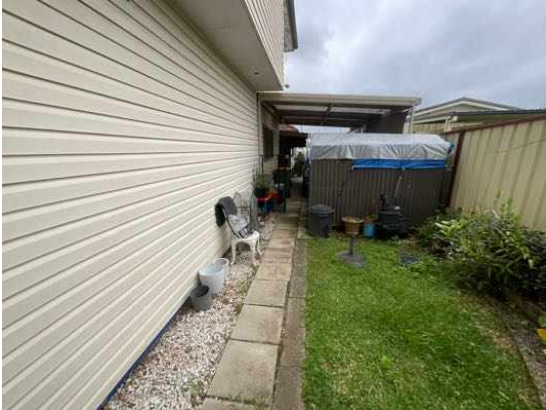
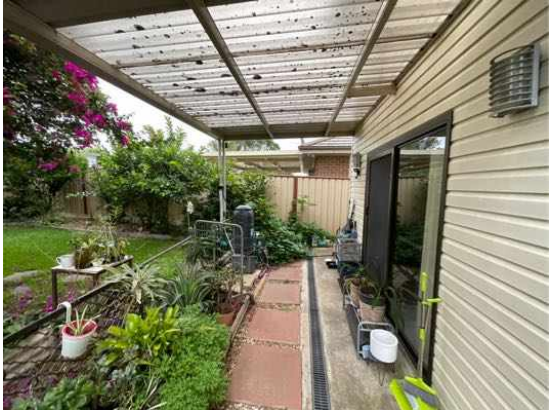
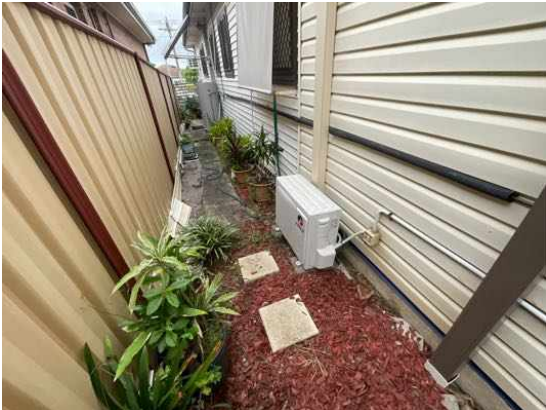
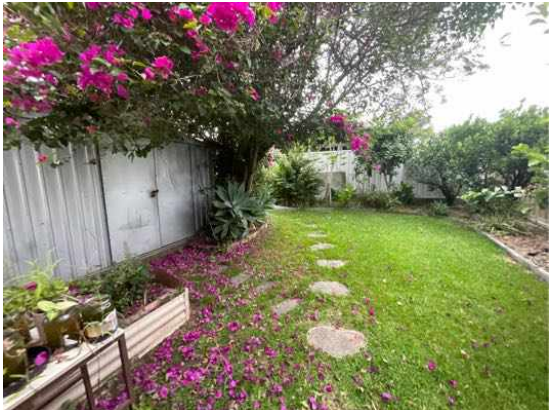
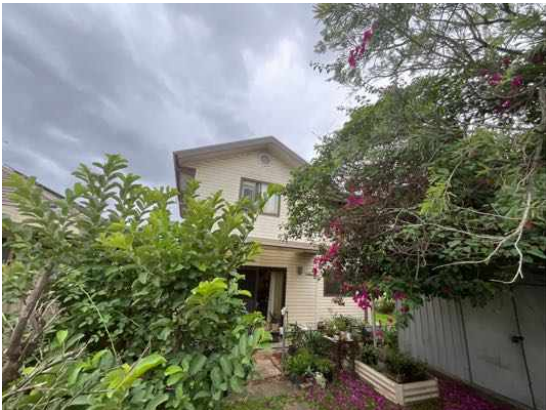
Building:	Main Building
Location:	All Areas
Finding:	Garden Beds - Conditions Conducive to Termites
Information:	Garden beds were found to be evident in the garden area. These garden beds can include untreated timber, and with a combination of moisture from watering hosing can make conditions conducive to termite activity and termite ingress.

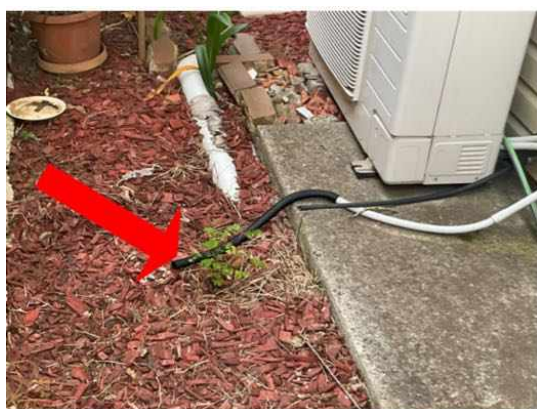
Building:	Main Building
Location:	All Areas
Finding:	Air conditioner - Disconnected overflow
Information:	The Air Conditioner (A/C) overflow was found to be disconnected from storm water drainage and is creating excessive moisture in the surrounding area.

Such leaking creates an environment which is conducive to an array of defects, including water damage to associated building elements and the attraction of termite or timber pest infestation.

It is highly recommended that a licensed plumber be appointed to connect the A/C overflow in order to prevent such an environment from being created. These minor works should be carried out as soon as possible.

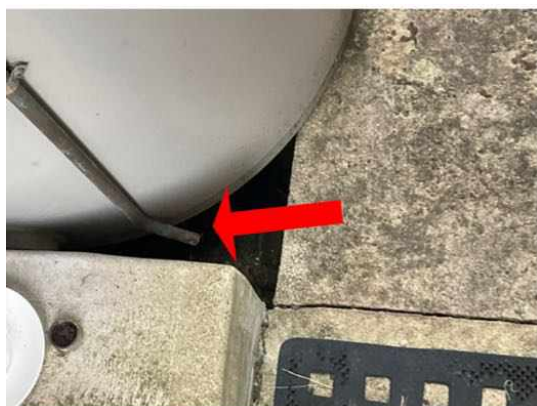
Building:	Main Building
Location:	All Areas
Finding:	HWS Overflow - Not Connected
Information:	The Hot Water System (HWS) overflow was found to be disconnected from storm water drainage and is creating excessive moisture in the surrounding area.

These damp conditions can lead to secondary defects such as rot, rust or corrosion of associated building elements, the formation of fungal decay, or even the creation of potential slip hazards. When coupled with poor site drainage, pooling of water may also attract termite activity to this area.

It is highly recommended that a licensed plumber be appointed to connect the HWS overflow in order to prevent such an environment from being created. These minor works should be carried out as soon as possible.

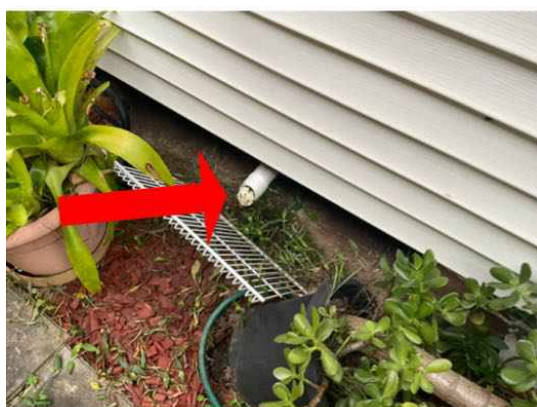
Building:	Main Building
Location:	All Areas
Finding:	Overflow - Not plumbed for drainage
Information:	The overflow is not plumbed or connected to suitable drainage, which has resulted in the surrounding area becoming excessively damp. These damp conditions can lead to secondary defects such as rot, rust or corrosion of associated building elements, the formation of fungal decay, or even the creation of potential slip hazards. When coupled with poor site drainage, pooling of water may also attract termite activity to this area. It is highly recommended that a qualified plumber be appointed to install adequate drainage to the overflow. These works will ensure that the area remains dry and free of any secondary defects.

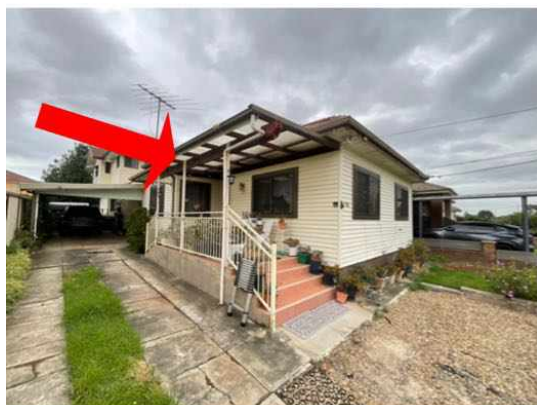
Building:	Main Building
Location:	All Areas
Finding:	Timber - exposed to weather
Information:	External timbers that are frequently exposed to harsh weather conditions require adequate protection in order to maintain their condition. Where timbers have not been painted or treated adequately, general deterioration is likely to occur at an accelerated rate.

If left unattended, replacement of these timbers is likely to be necessary in the short-term future. Adequate treatment of these timbers is required as soon as possible by a painting contractor or general handyman.

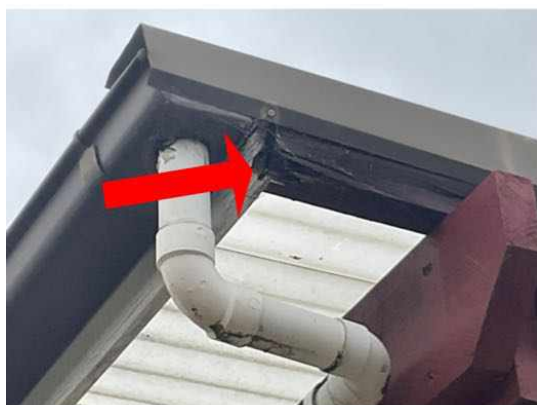
Early intervention and regular maintenance, particularly of exterior timbers, will prolong the useful life of these building elements. Prior to any works being performed, the cause of the moisture that has created the visible wood rot should be identified and addressed in a suitable manner. Replacement of affected timbers may then be a necessary step in protecting surrounding building elements from such deterioration.

A qualified plumber may be appointed to assess the cause of excessive moisture and to provide advice on any remedial works as required. A qualified carpenter or registered builder may also be required to replace affected building materials.

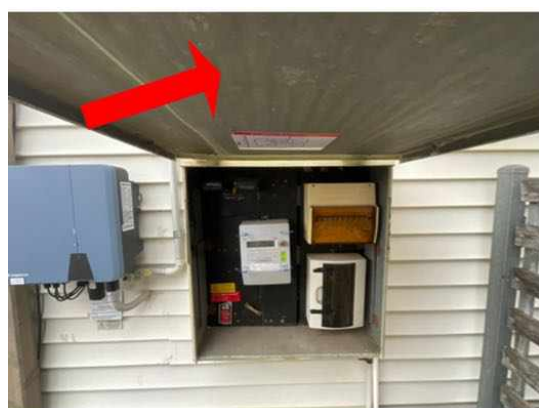
Building: Main Building  
 Location: All Areas  
 Finding: Termite Management System - no evidence of a chemical installation  
 Information: The application of a post-construction chemical termite barrier is highly recommended for all properties, particularly if live termite activity has been found on the site previously. Such barriers are highly effective in preventing termite attack on any timber building elements throughout the property.

A durable notice should be placed in the switchboard unit to indicate current termite barriers. At the time of inspection, it appeared as though no termite management system has been installed, with no evidence to suggest preventative works taking place.

The client may consider gaining further advice from a pest controller as to the costs and procedures involved with this application. It is recommended that obtaining such advice be a short-term priority.
