Building Inspection Report

Inspection Date: Mon, 23 Feb 2026

Property Address: 8 McFarlane Ct, Highett VIC 3190, Australia

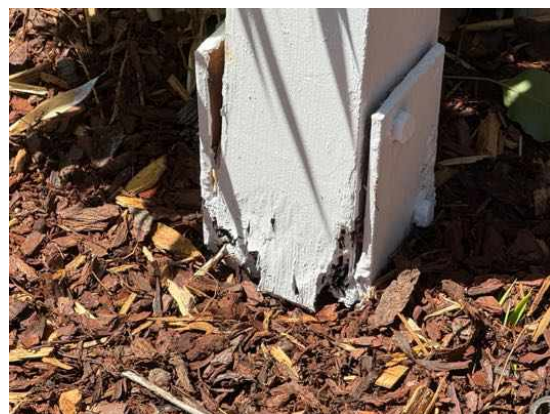
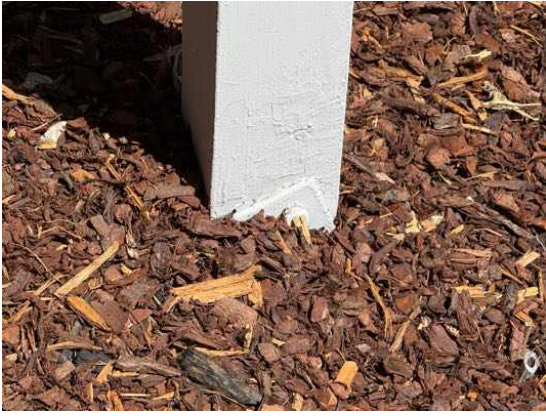
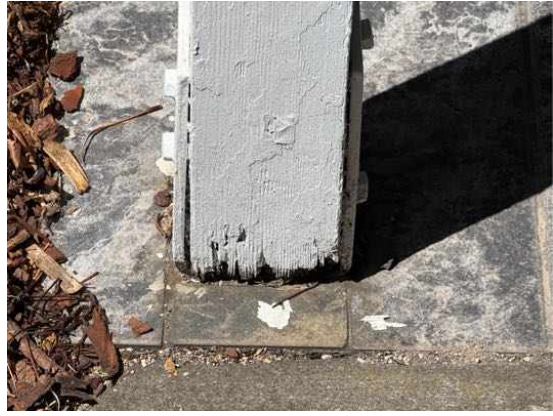
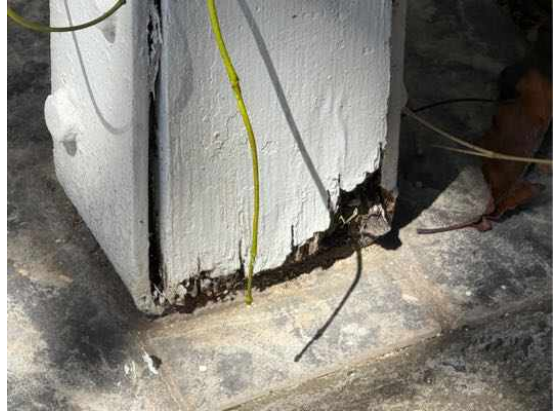
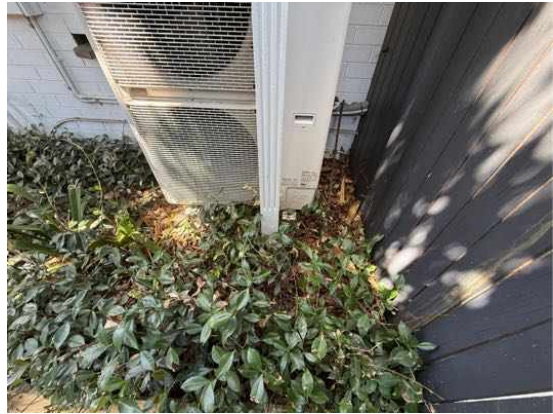
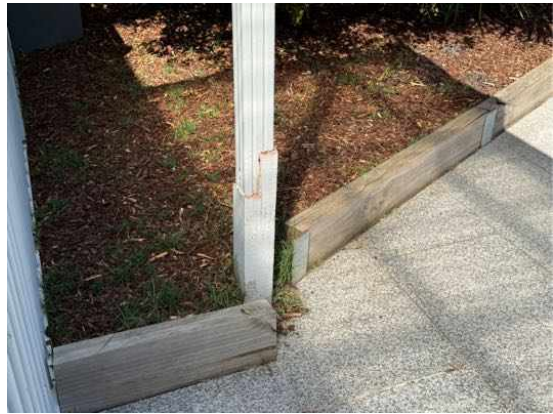
Defects 3.01

Building: Building 1
Location: All Areas > All Areas
Finding: Timber in the ground and exposed to excessive weather conditions
Information: External timbers in the ground and are frequently exposed to harsh and extreme weather conditions, will require adequate protection and maintenance in order to maintain their condition. Other timbers are exposed to moisture from ground contact which exposes these areas to accelerated wood rot and decay, damage and deterioration. Where timbers have not been painted properly or treated adequately, general deterioration is likely to occur at an accelerated rate.

If left unattended, replacement of these timbers is likely to be necessary in the future. Adequate treatment of these timbers is required to ensure excessive weathering does not occur, painting of these areas may be carried out by the client or by a painting contractor or general handyman.

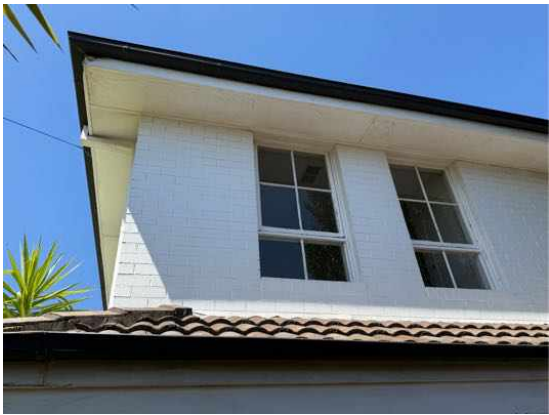
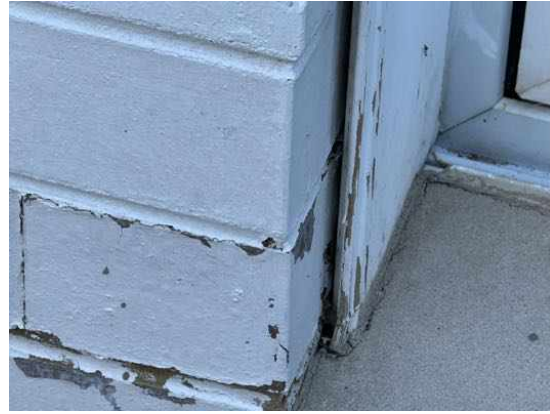
Defects 3.02

Building:	Building 1
Location:	All Areas > All Areas
Finding:	Timber - exposed to excessive weather conditions
Information:	External timbers that are frequently exposed to harsh and extreme weather conditions and will require adequate protection and maintenance in order to maintain their condition. Other timbers are exposed to moisture from ground contact which exposes these areas to accelerated damage and deterioration. Where timbers have not been painted properly or treated adequately, general deterioration is likely to occur at an accelerated rate.

If left unattended, replacement of these timbers is likely to be necessary in the short-term future. Adequate treatment of these timbers is required as soon as possible by a painting contractor, home owner or general handyman.

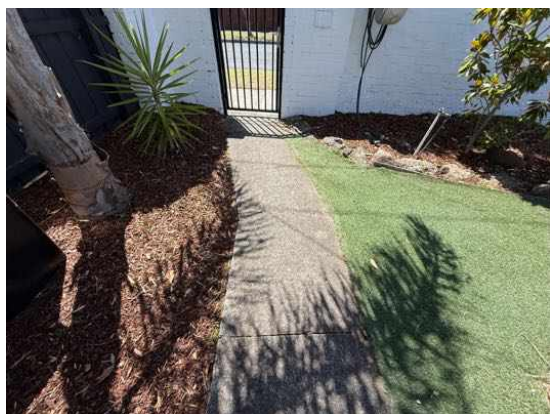
Defects 3.03

Building:	Building 1
Location:	All Areas > All Areas
Finding:	Concrete driveway cracks
Information:	Numerous cracks on the driveway were observed at the time of the inspection. Also the rear pergola concrete showed concrete cracked and lifted, this area is considered to be a tripping hazard for occupants, especially young children and elderly. This area should be removed and re-instated to improve the overall appearance and aesthetics of the area.

Concrete cracks are a common occurrence as a result of many primary defects. Such causes may include age, general wear and tear, expected building movement, general

expansion/contraction of building materials in different weather conditions, and/or minor failings in the installation or application of building materials. Monitoring of all cracking should be conducted periodically. Contact a relevant tradespersons, especially where cracks have become trip hazards for occupants.

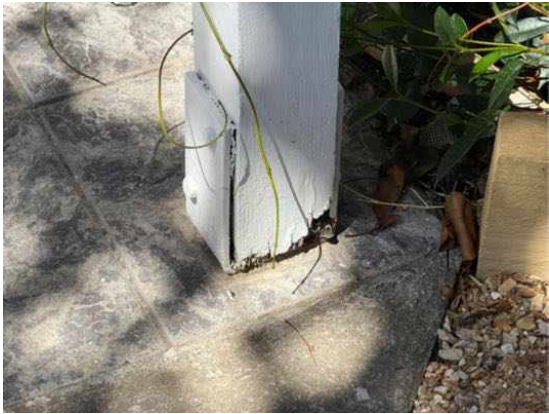
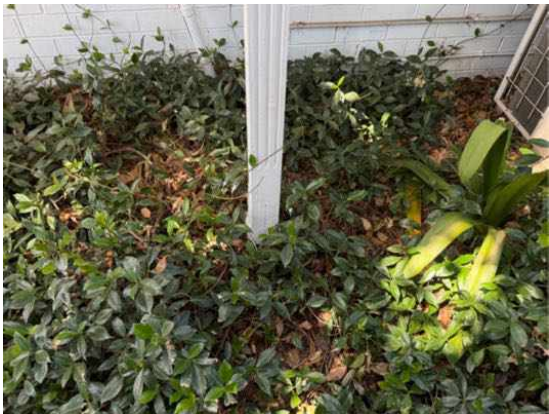
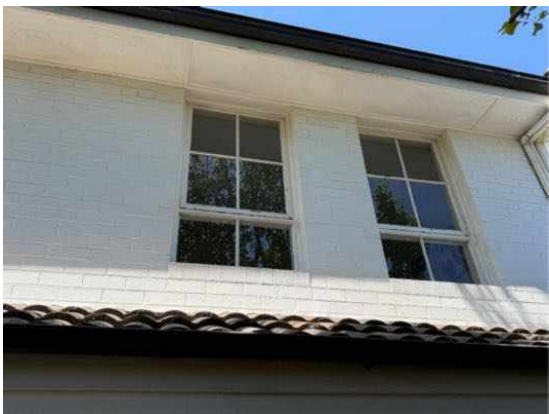
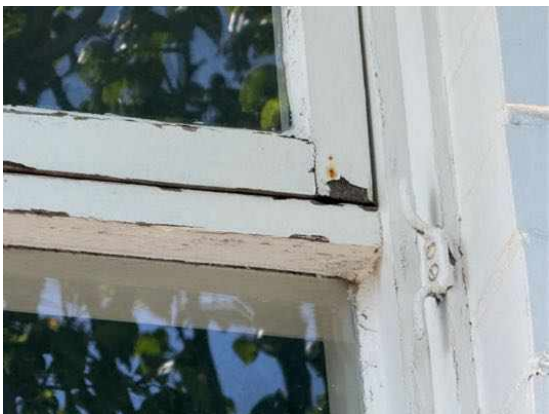
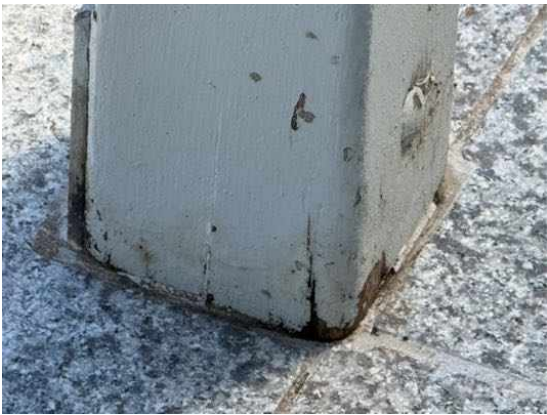
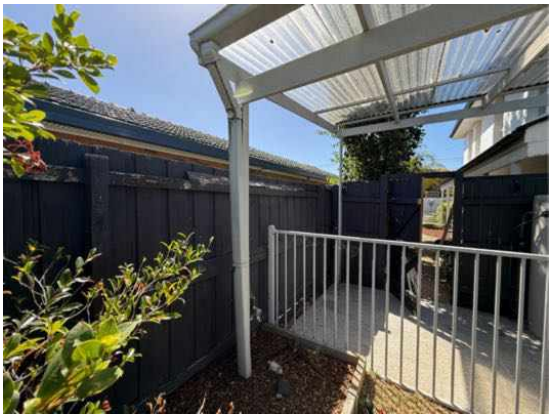
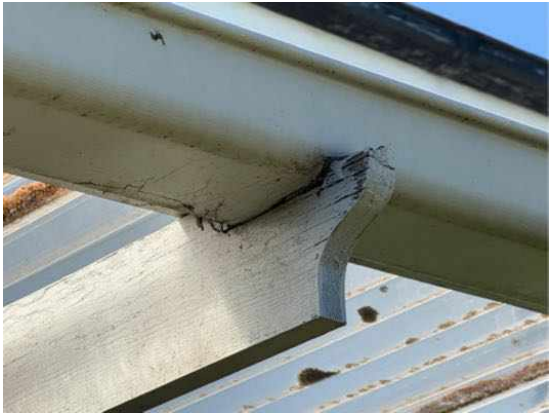
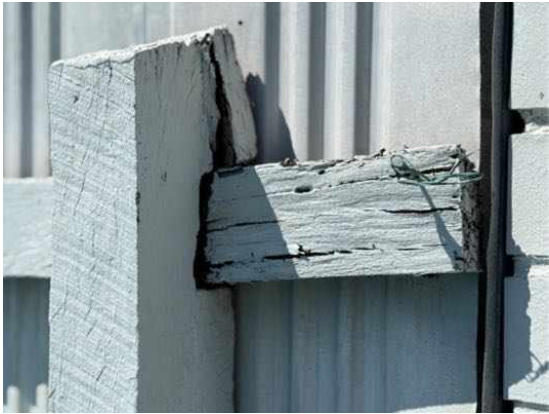
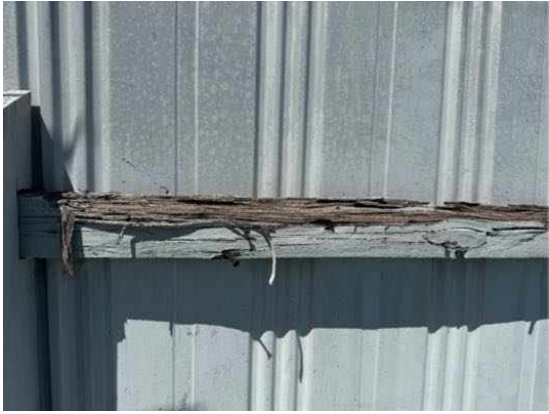
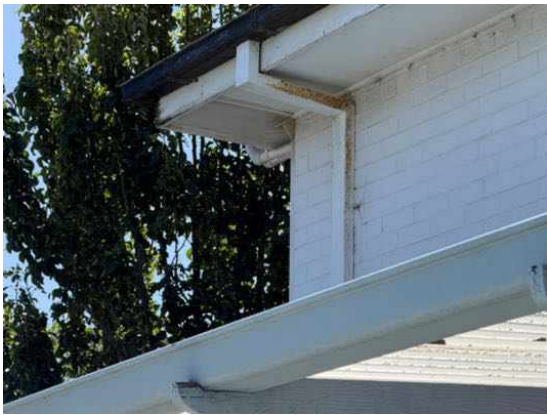
Defects 3.04

Building:	Building 1
Location:	All Areas > All Areas
Finding:	Wood rot
Information:	Wood rot was found to be affecting some fascias and numerous other building elements and materials around the exterior and interior areas of the home. Wood rot, also known as Fungal Decay, occurs when timbers and other cellulose building materials are exposed to damp conditions on an ongoing basis.

The roof plumbing in these areas may be creating excessive moisture in this areas and or it may be due to frequent exposure to rain and other weather conditions also make fascias and other numerous building elements susceptible to accelerated deterioration. Early intervention and regular maintenance such as painting will prolong the useful life of these building elements. Prior to any works being performed, the cause of the moisture that has created the visible wood rot should be identified and addressed in a suitable manner.

It is advised that the relevant tradespersons be appointed to inspect and subsequently identify the cause of the numerous areas of wood rot. Replacement of affected building elements and materials may then be a necessary step in protecting surrounding areas from secondary damage and deterioration. A qualified plumber and other specialists may be appointed to assess the cause of excessive moisture and to provide advice on any remedial works as required. A qualified carpenter or registered

builder may also be required to replace affected building materials.

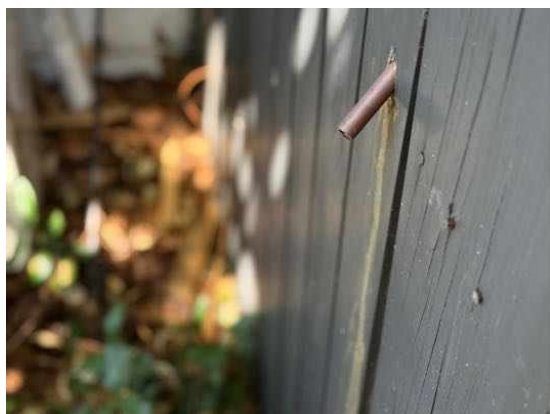
Defects 3.05

Building: Building 1
Location: All Areas > All Areas
Finding: HWS and air-conditioning overflows not connected
Information: The Hot Water System (HWS) and external air-conditioning units showed that the overflow pipes not to be connected to any form of storm water drainage system and may in the future create excessive moisture in the surrounding area, as these units as they get aged, deteriorated and particularly during their use. These damp conditions can lead to secondary defects such as rot, rust or corrosion of associated and adjoining building elements, as well as the formation of fungal decay and even the creation of potential slip hazards for occupants. When coupled with poor site

drainage, pooling of water may also attract termite activity to these areas. It is highly recommended that a licensed plumber be appointed to connect the HWS and air-conditioning overflows in order to prevent such an environment from being created. These remedial works should be carried out as soon as possible.

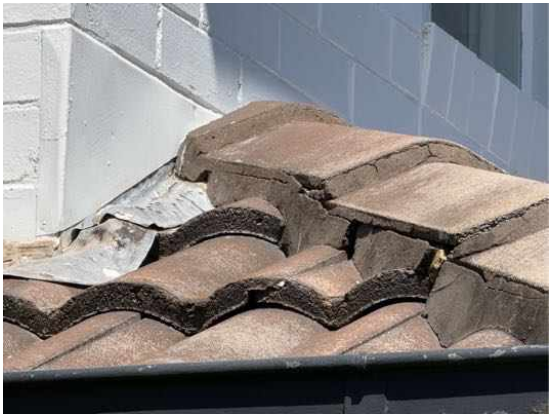
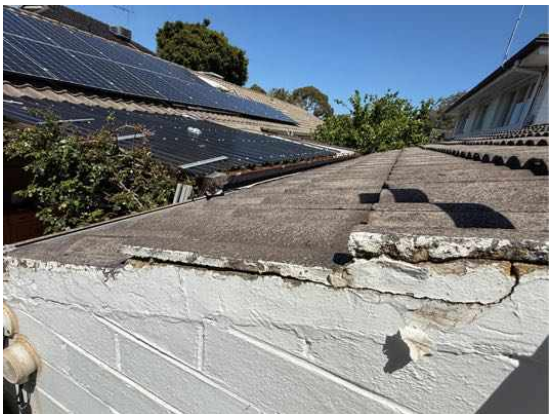
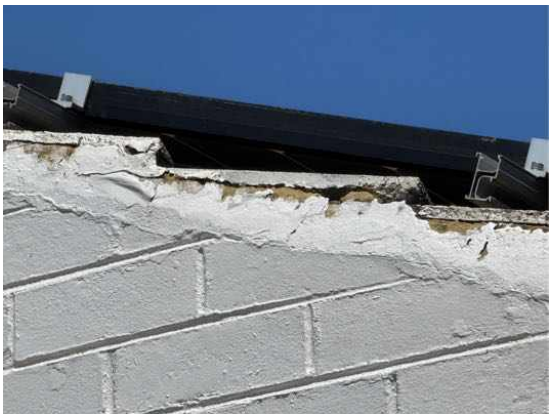
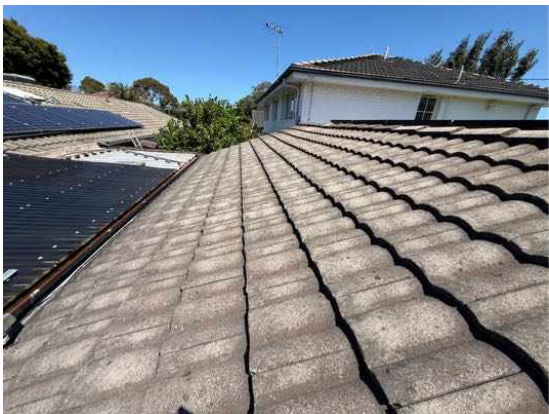
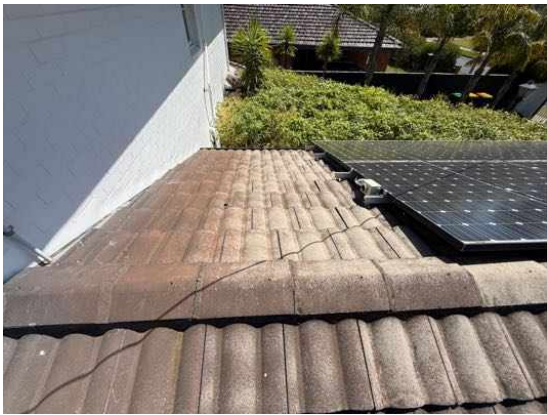
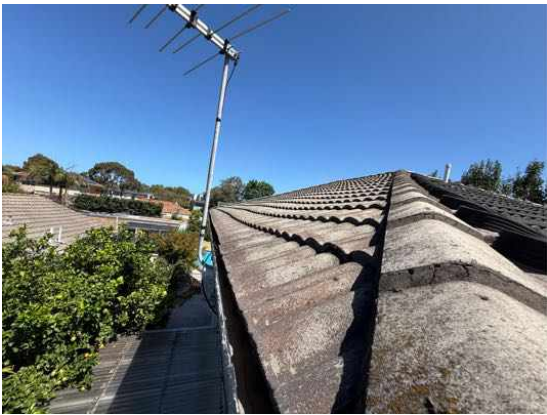
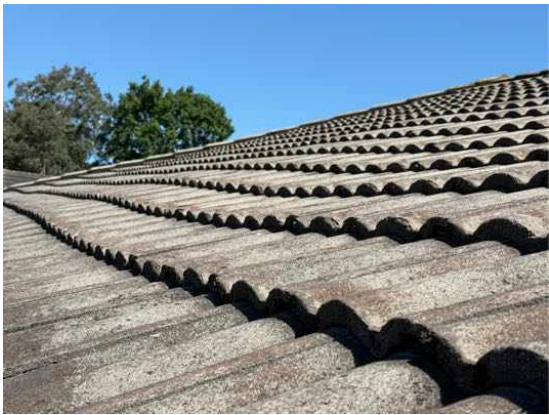
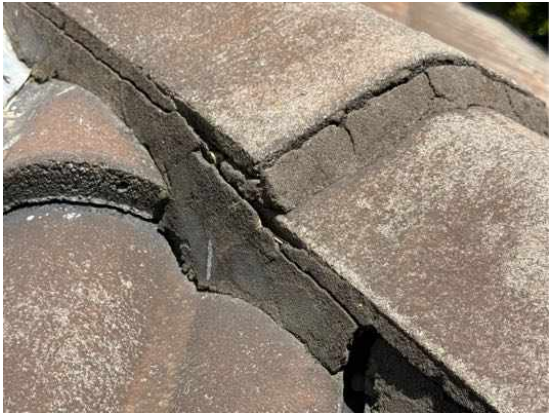
Defects 3.06

Building:	Building 1
Location:	All Areas > All Areas
Finding:	Roof tiles - Weathered
Information:	Upon inspection of the exterior roofing, the majority of roof tiles were considered to be aged and in a weathered and deteriorated condition. Also some roof tiles were observed to be chipped or dislodged and not in their original positions. The roof tiles due to the weathering are suspected to becoming porous and becoming wet and moist on the underside of the roof tiles during outside wet conditions and therefore the possibility of secondary defects in the future. While weathering of the tiles is consistent with the age of the property, maintenance works are and will be required in the future to maintain a weather and waterproof roof.

Isolated areas of mortar are coming loose on the ridge and hip areas, minor chipping to numerous tiles is also present. Re-pointing and re-sealing the may be considered as an interim solution by the client to help preserve and extend the life span of the tiles. Where left unmanaged, deteriorating roof tiles are likely to lead to a number of secondary defects, including minor water leaks and weather exposure to internal roofing structures. Consultation with a roofing contractor is highly recommended to gain advice on cost of remedial works that may be required in the short to medium term. Remedial works are likely to increase the longevity of the exterior roofing structure.

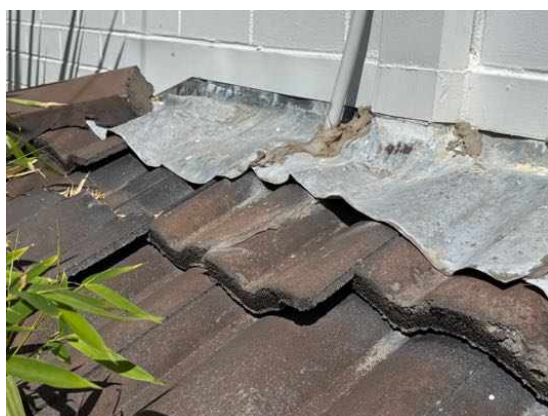
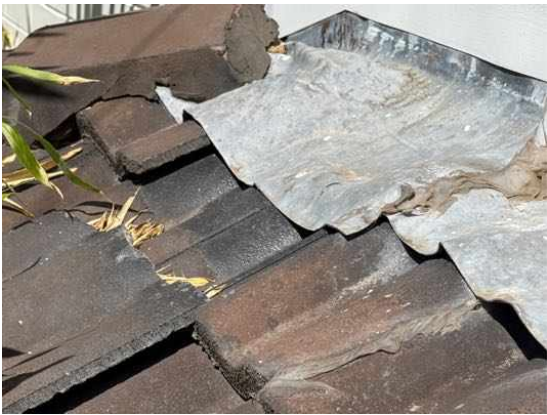
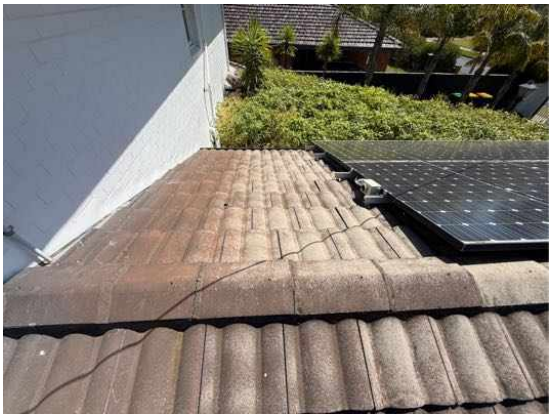
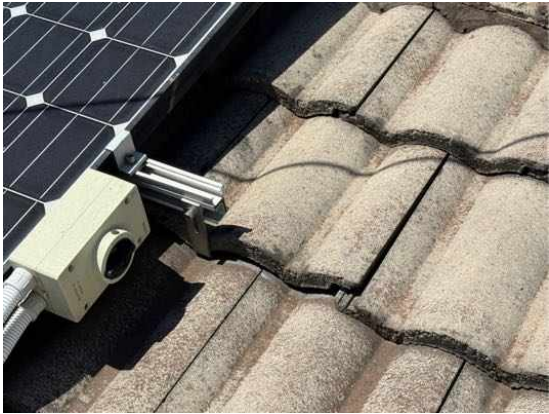
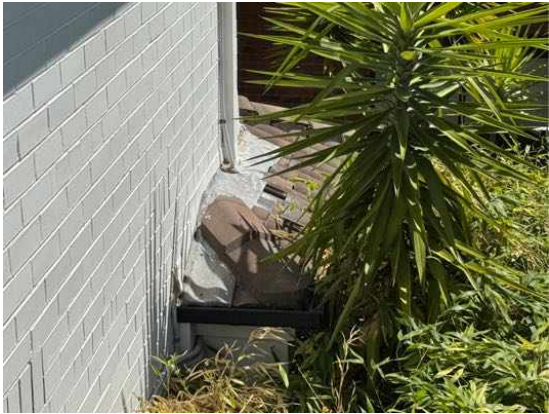
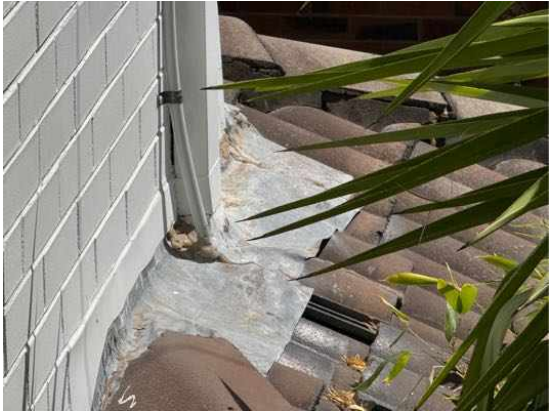
Defects 3.07

Building: Building 1
Location: All Areas > All Areas
Finding: Roof tiles - Dislodge or slippage
Information: Upon inspection of the roof tiles, it was observed that a couple of roof tiles have either slipped or have been dislodged from their original positions. Roof tiles may slip over time due to a number of minor causes, including not placed correctly upon installation, not stuck down on the top of valley irons, flashings, roof tile chips and breakages, failings in the adjoining battens, or fixings that may have failed.

In this case I suspect that tiles have slipped or dislodged from they original positions, these roof tiles will require replacement and some form of fixing down or a good quality silicon sealant, client may consider to add silicon to the bottom side of the tiles to stick them down to the top of the metal flashings. Roof tiles that have moved from their original position may allow water penetration into the roof void, exposing roofing structures to excessive moisture. This creates an environment that is conducive to water damage and accelerated deterioration of all associated building elements below. Replacement of broken, loose or missing roofing tiles is recommended immediately or in the short term future to prevent the development of any secondary defects. A roofing plumber or roof tiler should be appointed to complete such works immediately or in the short term future.

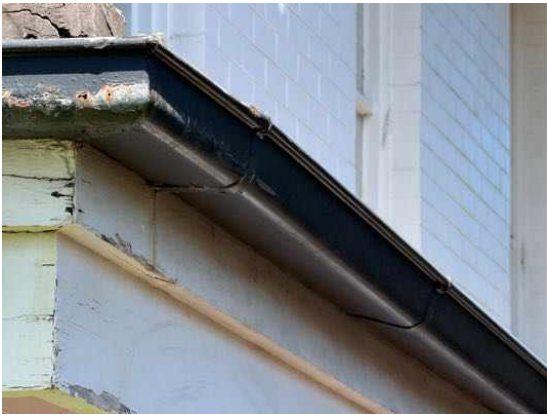
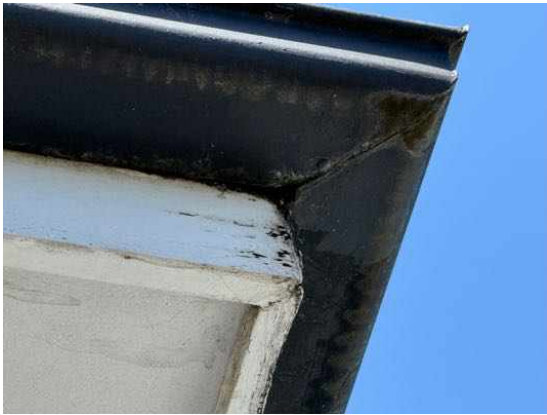
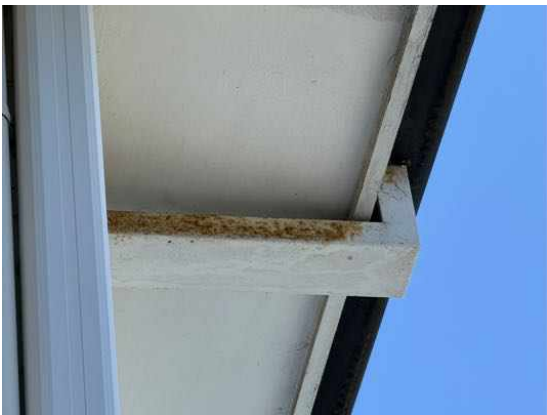
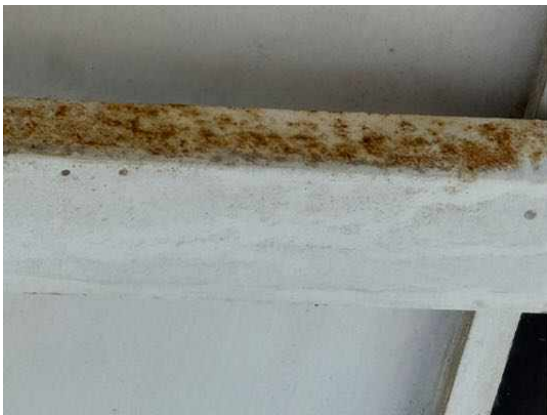
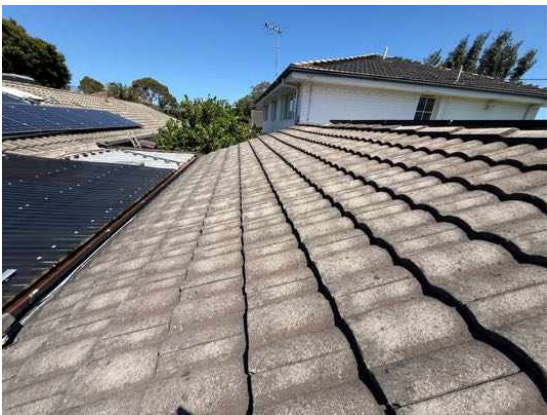
Defects 3.08

Building:	Building 1
Location:	All Areas > All Areas
Finding:	Roof gutters and down-pipes
Information:	Guttering and down-pipe are showing signs of rust and corrosion. It has likely developed as a result of debris and leaf matter sitting in the guttering. A surface that is found to be rusted provides no protection to the underlying iron, the deteriorating condition is likely to worsen if not addressed and left unmanaged, it is therefore recommended that the relevant tradespersons remove and replace any building elements observed to be rusted or as much rust as possible, clean and re-paint these areas.

Where possible, the use of galvanized (treated) metals or colour-bond metals aid in rust prevention, as does regular general maintenance of the gutters. Rust formation can be controlled with coatings, such as paint, that isolate the iron from the environment. Rusting and corrosion should be managed by ideally removing or limiting the affected surface from exposure to moisture and harsh weather conditions. A licensed roof plumber or other relevant tradespersons may be appointed to rectify the affected areas and a qualified carpenter to replace any building elements that have been severely affected by wood rot and water damage.

Upon inspection of the roof gutters, numerous were observed to have excessive leaf matter and debris. Roof plumbing structures, such as guttering and downpipes, should be free of all debris to prevent blockages. Blockages of the guttering and downpipes will lead to pooling and accumulated water overflows, which is likely to subsequently flood eaves and exterior walls.

Blocked gutters are likely to lead to high levels of moisture in the affected areas. Such moisture will not only cause rust and decay of the associated building materials, but can also provide conditions that are conducive to termite and timber pest activity. Blockages in gutters should therefore be removed immediately to ensure dry conditions are maintained. Consultation with a Licensed Plumber for further specific advice on remedial works is required. In the interim, it is highly advised that blocked gutters be removed by a gutter cleaning company or a relevant tradespersons in the short term future.

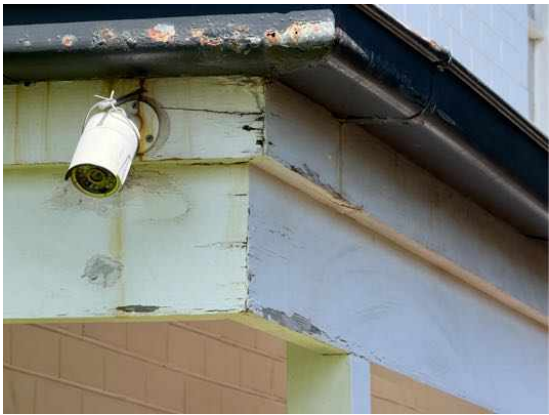
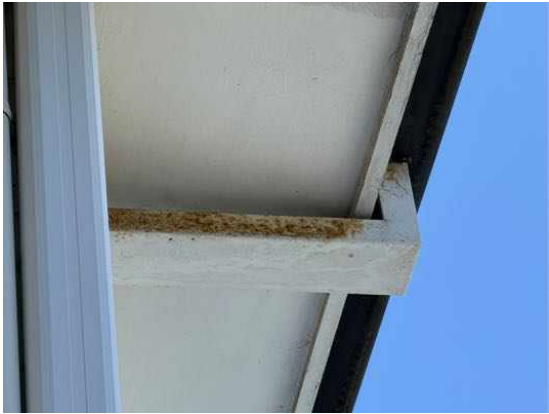
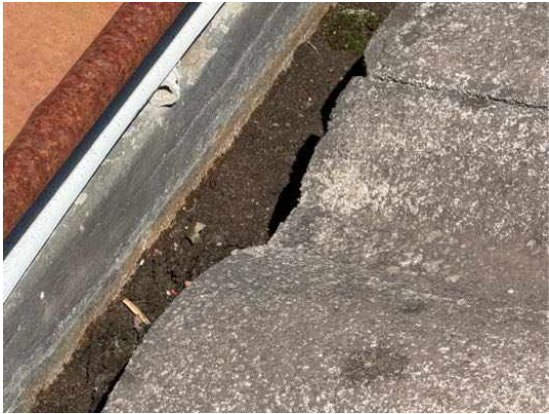
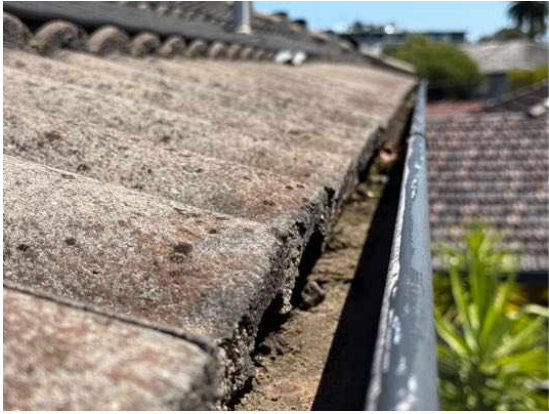
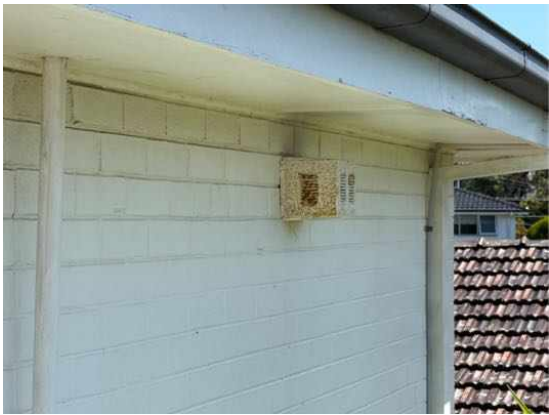
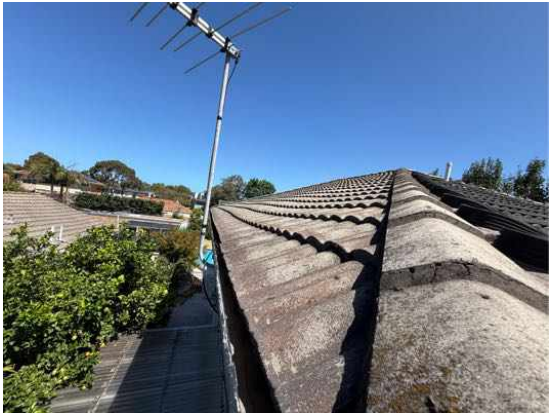
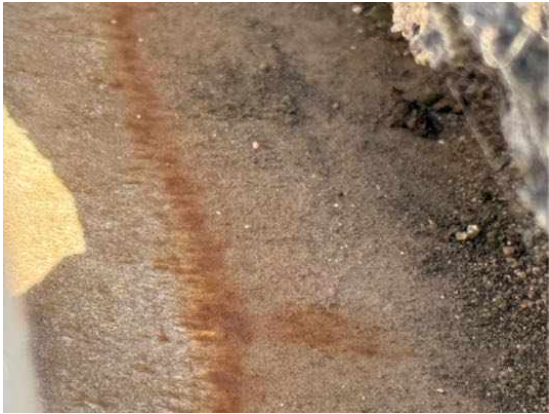
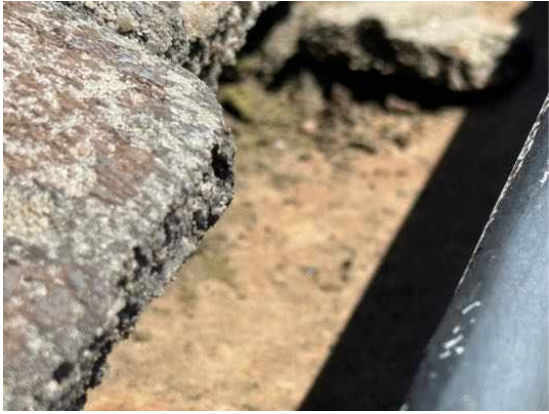
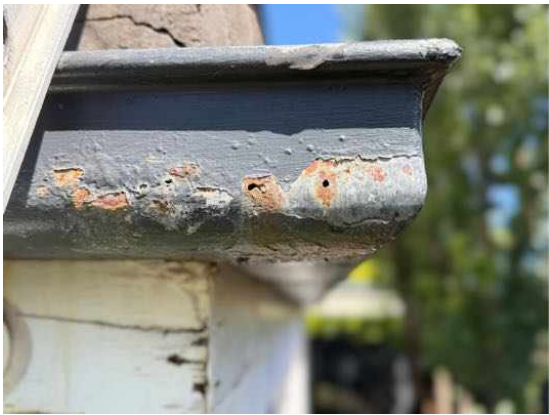
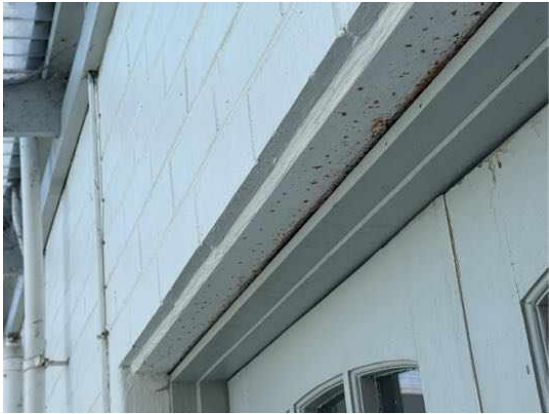
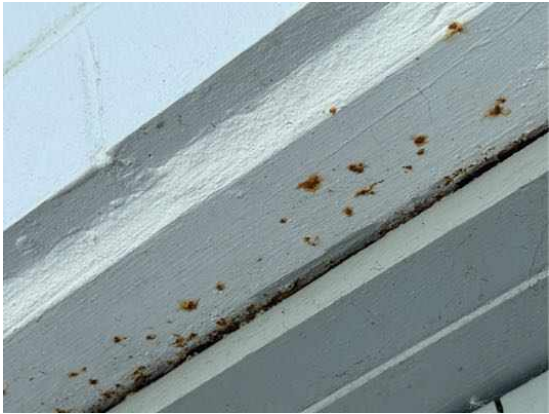
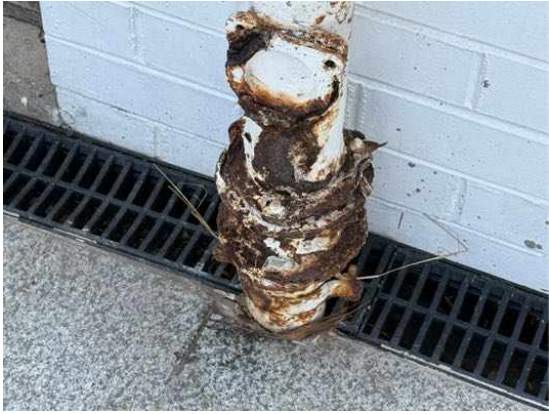
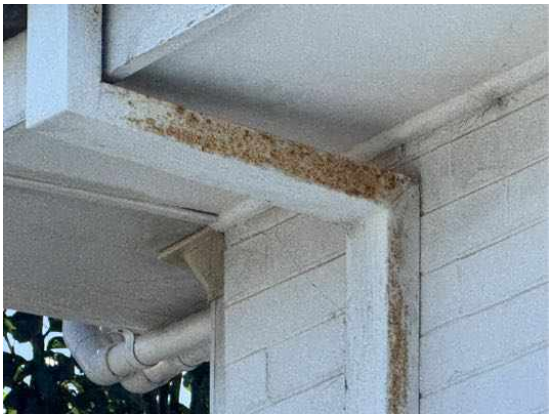
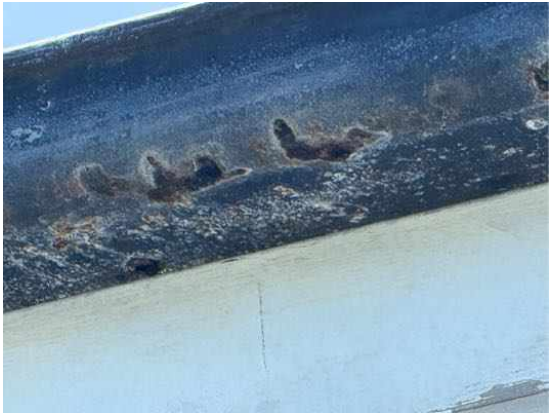
Defects 3.09

Building:	Building 1
Location:	All Areas > All Areas
Finding:	Building elements show excessive rust and deterioration
Information:	Numerous building elements, gutters and down-pipes were observed to be rusted and deteriorated at the time of the inspection. Roof plumbing, such as guttering and downpipes, should be free of all debris to prevent rust, blockages and accelerated deterioration. Rust and decay in roof plumbing will lead to secondary defects that may affect building roof structure and interior areas if left unmanaged. Blockages of the guttering is suspected to have already caused eaves damage, water pooling and suspected gutter water overflows.

Blocked, rusted and deteriorated gutters are likely to lead to high levels of moisture to the adjoining perimeter building structures in affected areas. Such moisture will not only cause wood rot, rust and decay of the associated building materials, but can also provide conditions that are conducive to termite and timber pest activity. Rusted and decayed gutters, valleys, flashings and downpipes should be rectified immediately or in the short term future to ensure dry conditions are maintained. Consultation with a licensed plumber for further specific advice on remedial works is recommended and required.

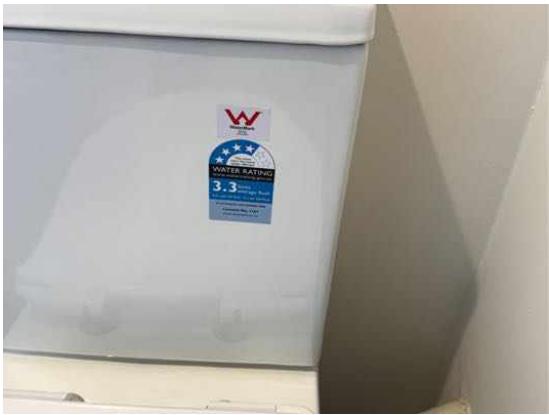
Defects 3.11

Building:	Building 1
Location:	Bathroom > All Areas
Finding:	Toilet manufacturers stickers
Information:	At the time of the inspection it was observed that the toilets have manufactures stickers still on them, this is considered to detract from the overall quality and appearance of the home. These should be removed and cleaned off all bathroom and toilets, fittings and fixtures. This should be performed as part of the handover cleaning.

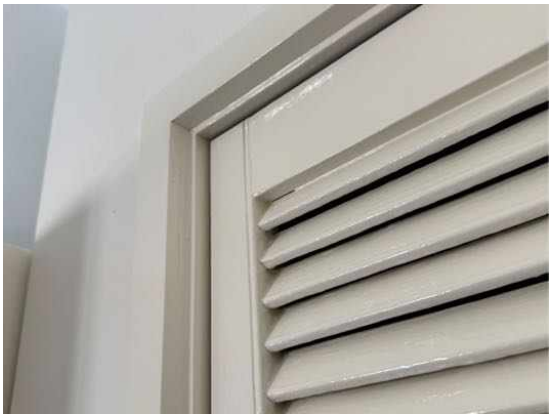
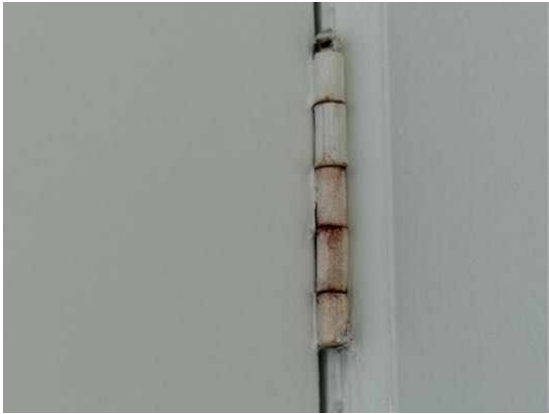
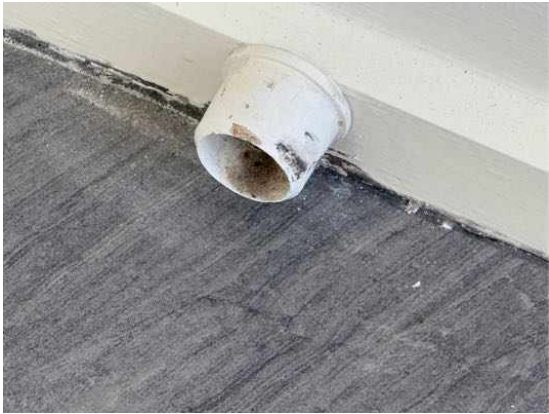
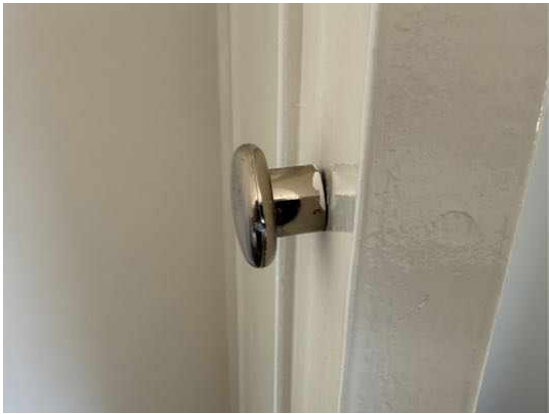
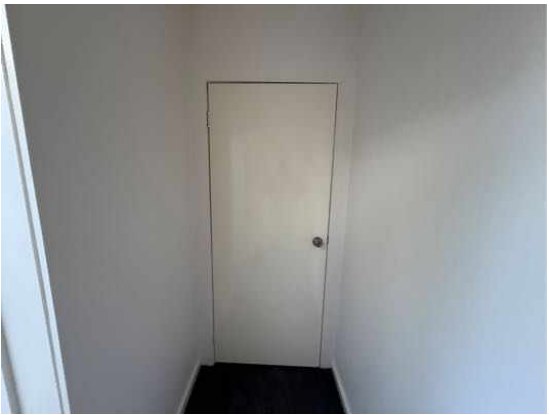
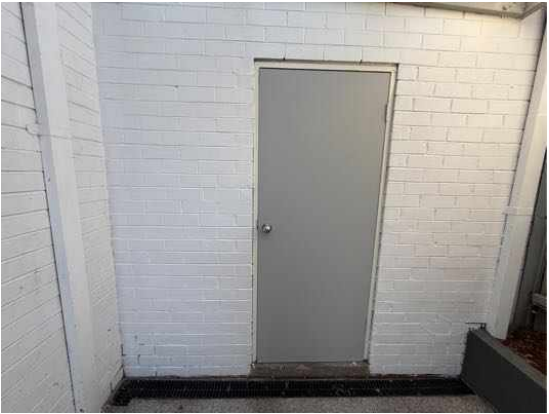
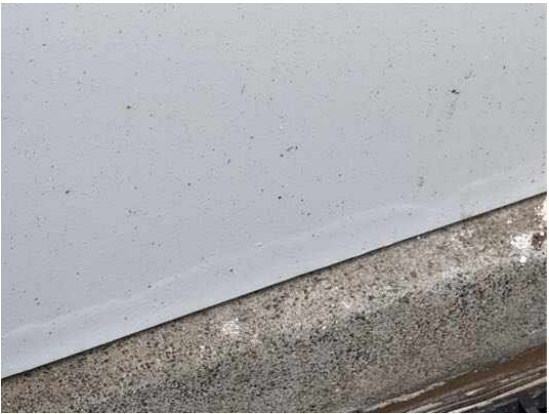
Defects 3.12

Building: Building 1
Location: All Areas > All Areas
Finding: Doors adjustments and maintenance
Information: Some doors throughout the home were observed to require only minor maintenance and adjustments to make good during standard operation. Doors should get some adjustment and maintenance to ensure doors operate correctly during standard operation. These types of defects can inhibit the functionality of the affected doors as well as creating potential for secondary defects to associated building elements, such as the door jamb and floor. Generally, factors such as a lack of maintenance or general deterioration are the usual causes for these types of defects.

It is suspected that back garage door is damaged and deteriorated beyond repair. Replacement of some door hardware may be required where deemed to be necessary, as well as minor repairs and cleaning. A qualified carpenter should be appointed to perform minor rectification works in the future.

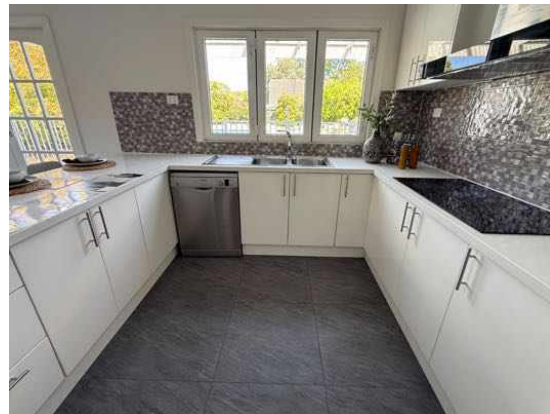
Defects 3.15

Building:	Building 1
Location:	All Areas > All Areas
Finding:	Flyscreens
Information:	Flyscreens were found to be missing to the windows and exterior doors throughout the home at the time of inspection. Whether the flyscreens have not been installed or have been removed for maintenance and or painting purposes, this missing building element detracts from the operational state of the window. Where not replaced, missing flyscreens allow pest and insect ingress into the adjoining room/s. It is advised that all missing building elements be installed or replaced in order to ensure the full function of all building structures. A flyscreen company or a qualified carpenter may be appointed to replace flyscreens at the discretion of the client.

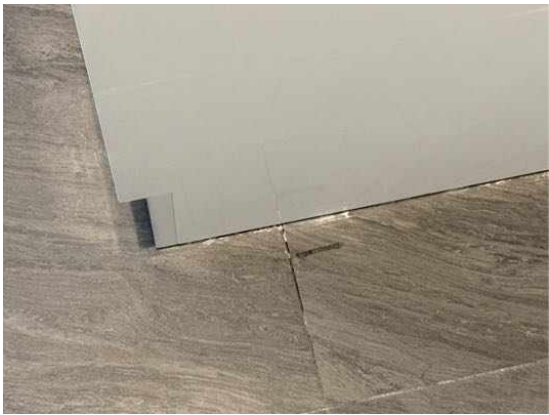
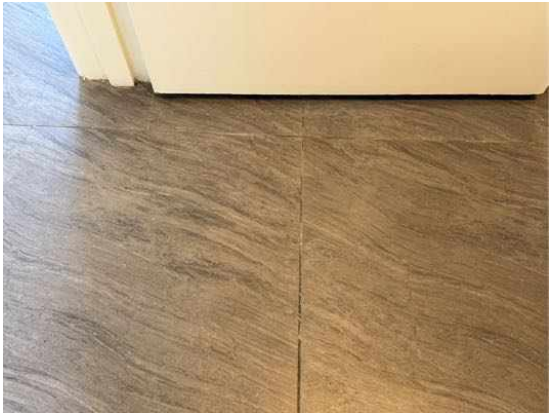
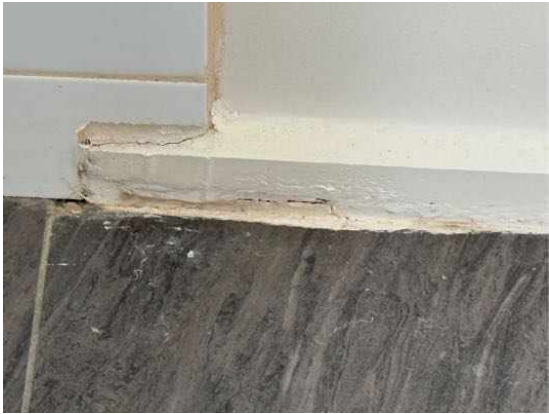
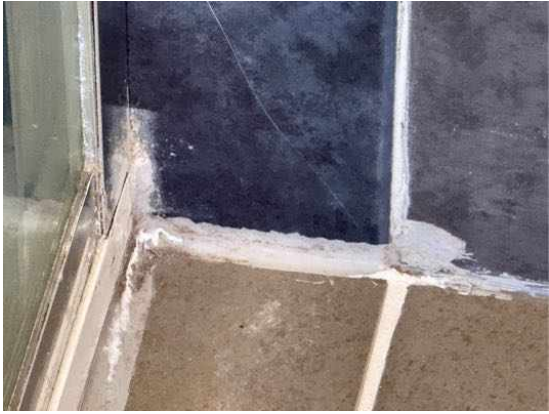
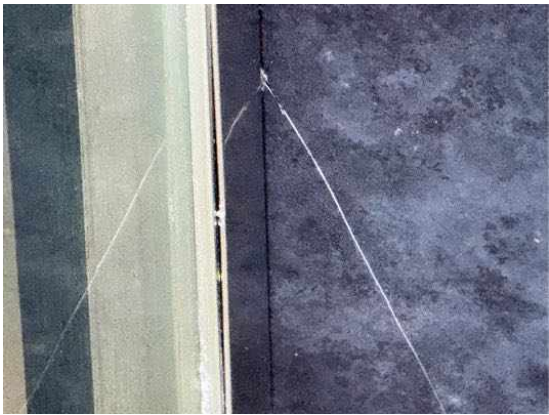
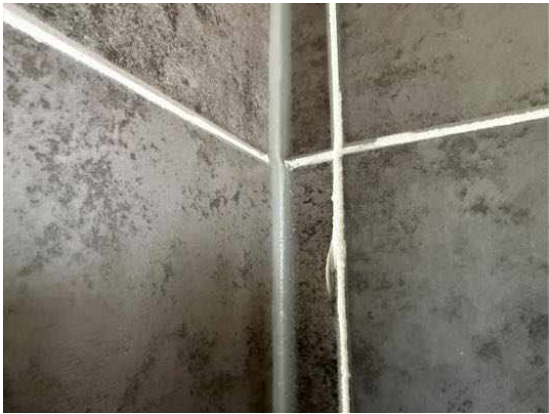
Defects 3.16

Building:	Building 1
Location:	Bathroom > All Areas
Finding:	Grout and sealant maintenance
Information:	It was observed that grout and sealant in the tiled shower alcove and in the bathrooms, laundry and kitchen areas require maintenance to ensure these areas remain watertight at all times. It is highly recommended that the client appoint a professional wall and floor tiler to provide remedial work to rectify the shower floor grout and sealant before any further use, water damage to the adjoining areas is likely to occur if left unmanaged.

Grout and sealant were observed to have been either deteriorated, dislodged or missing, in these types of wet areas if not rectified and maintained adequately it is highly likely that these areas will have accelerated damage and deterioration to the substrate as well as more serious secondary defects to the adjoining floor and wall structures. Regular maintenance and replacement of grout to any holes or damaged sealant is highly recommended to the wet areas, as this is a regular wear and tear defect. Sealant and grouting in areas that come into regular contact with water should be maintained for the long term care of your property.

Different materials on the walls and floor areas move at different rates, generally causing cracking to grout or sealant at these points. A flexible sealant is required to allow for expected expansion and contraction, while keeping the joint water tight and protective of all associated building structures and materials. Flexible and mould resistant materials should be applied to affected areas to prevent any subsequent water damage that is likely to occur if left unmanaged. A sealant specialist or tiling contractor should be appointed to complete these works immediately or as soon as possible.
