Building and Timber Pest Inspection Report

Inspection Date: Mon, 16 Mar 2026

Property Address: 103/6 River Rd W, Parramatta NSW 2150,
Australia

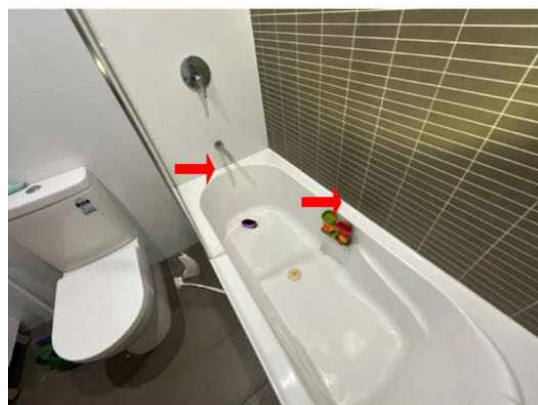
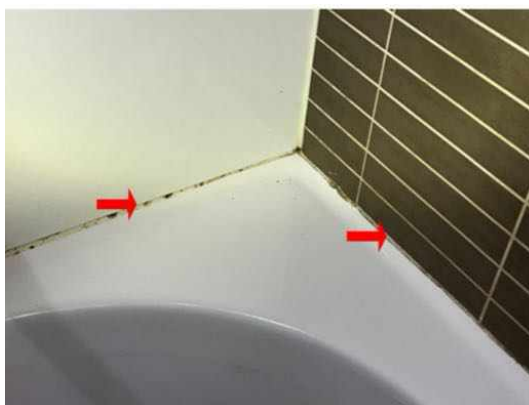
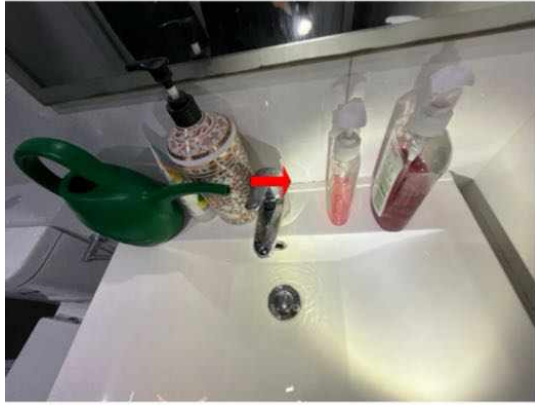
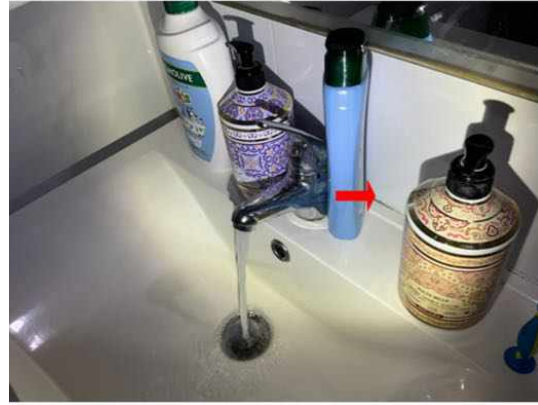
Finding 3.01

Building: Main Building
Location: All Wet Areas
Finding: Sealant and grouting - Missing or damaged
Information:

It was noted on inspection that sealant or grout is degraded to this area.

Different materials and floor areas move at different rates, generally causing cracking to grout or sealant at this point. A flexible sealant is required to allow for expected expansion and contraction, while keeping the joint water tight and protective of all associated building materials.

Flexible and mould resistant materials should be applied to affected areas to prevent any subsequent water damage that is likely to occur. Regular maintenance and replacement of damage or missing or damaged sealant and grout is highly recommended to the wet areas, as this is a regular wear and tear defect. Sealant and grouting in areas that come into regular contact with water should be maintained for the long term care of your property.

A sealant specialist should be appointed to complete these works as soon as possible.

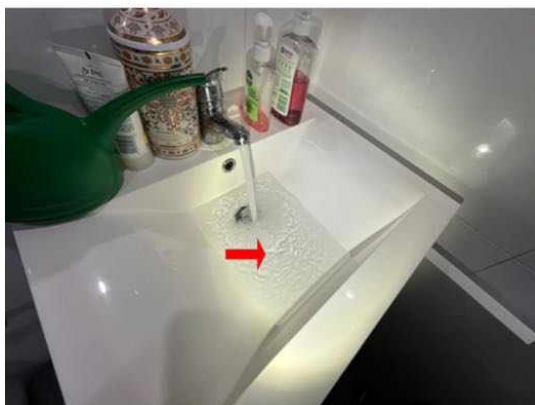
Finding 3.02

Building: Main Building
 Location: Ensuite
 Finding: Sink/basin - slow draining
 Information:

The sink/basin drain appeared to be partially blocked at the time of inspection. Blockages here are usually caused by hair and other debris. If left unmanaged, a lack of general maintenance may lead to the development of more significant defects, such as water damage to surrounding building materials.

A licensed plumber should be appointed to remove the blockage at the client discretion.

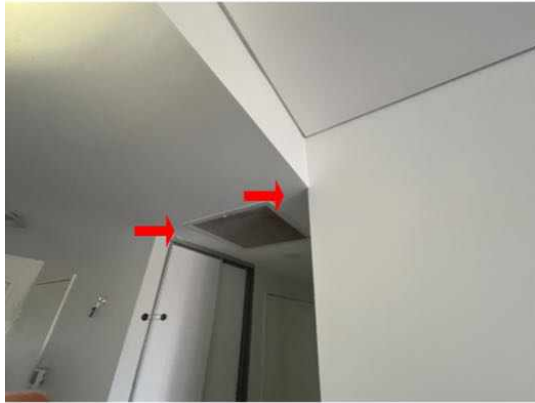
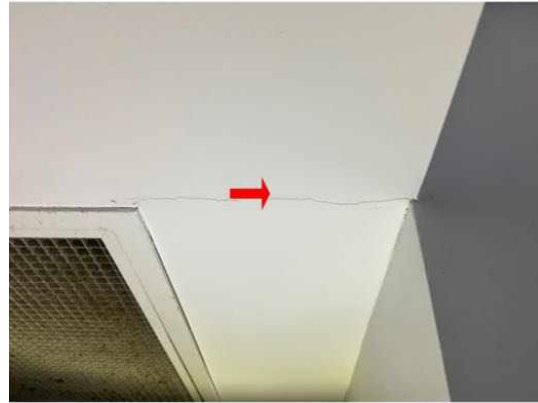
Finding 3.03

Building: Main Building
 Location: Hallway
 Finding: Cracking - Damage Category 1 - Fine (up to 1mm)
 Information: Although fine cracks are quite noticeable, they are often only considered to be an appearance defect, and usually do not indicate any structural damage. Generally, the cause of a fine crack is indicative of a separation between building materials and finishes (e.g. paint, plaster, etc.) along joins.

Cracking of this nature can generally be repaired with minor sanding, filling and/or repainting. Such works should be performed by a qualified painter or a general handyman.

Monitoring of all cracking should be conducted frequently. Always contact a building inspector should cracks widen, lengthen, or become more numerous.

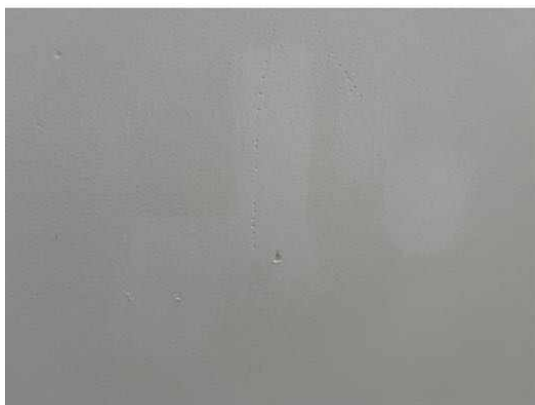
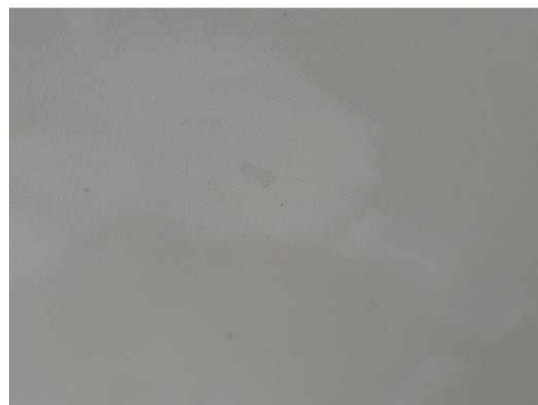
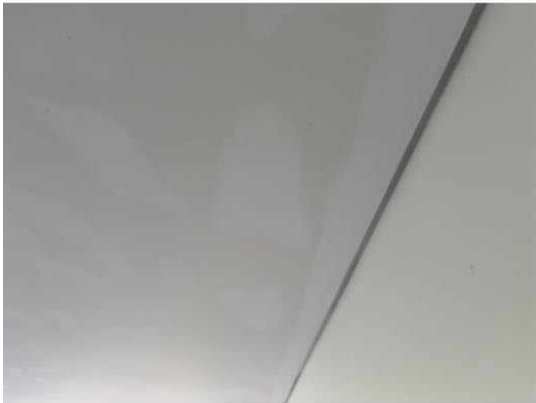
Finding 3.04

Building: Main Building

Location: Lounge Room

Finding: Surface - Marked

Information: Although detracting from the overall appearance, marked or stained surfaces do not indicate any operational or structural damage. This degree of surface damage is consistent with general wear and tear and is expected of a property of this age and condition.

Marked surfaces may be left as is at client discretion, as no repairs or replacement are necessarily required for this appearance defect. However, the client may wish to seek quotations for the cost to refurbish or replace the identified building element.

A painting or cleaning contractor may be appointed to rectify marked surfaces at the discretion of the client.

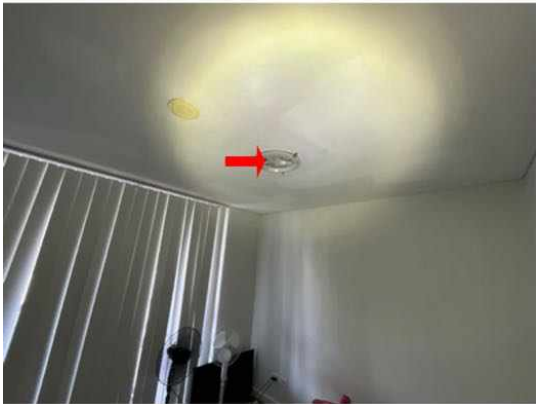
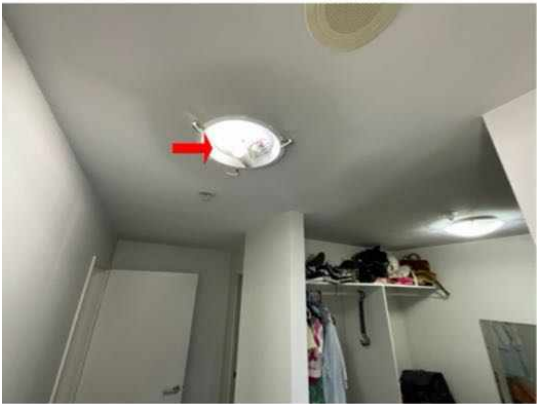
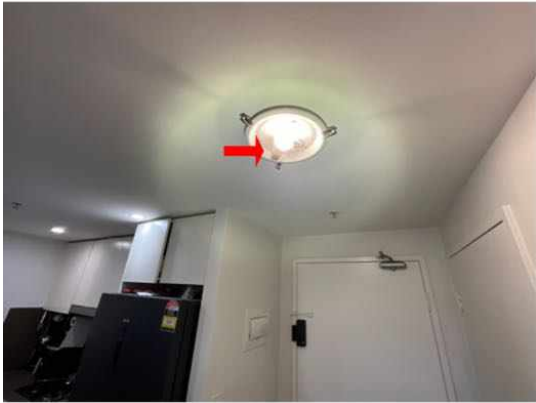
Finding 3.05

Building: Main Building
Location: Multiple areas
Finding: Light cover - Missing (Cosmetic)
Information: The light cover in this area was found to be missing at the time of inspection. Breakage occurs generally when the building materials have aged and decayed, but may also be indicative of impact damage to the building element (accidental or deliberate). This is mainly a cosmetic defect which can be replaced by the home owner.

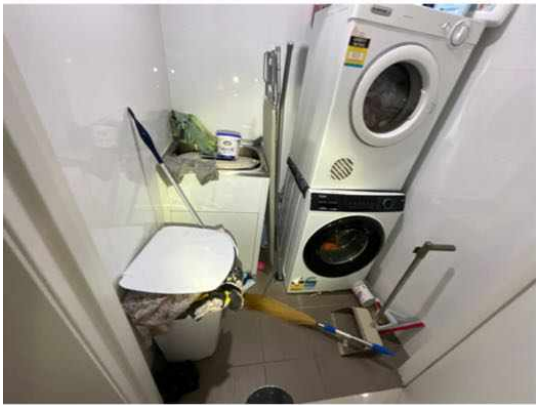
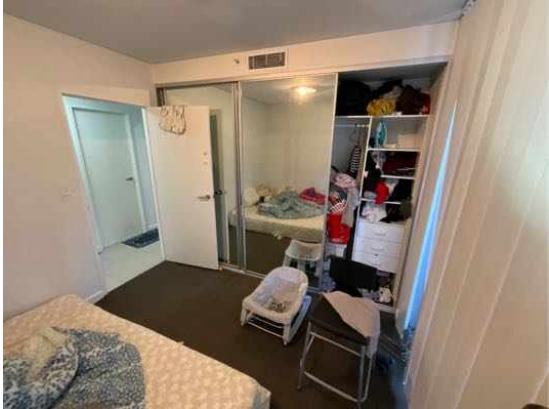
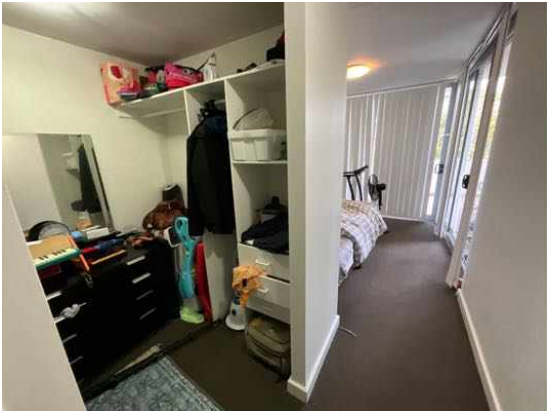
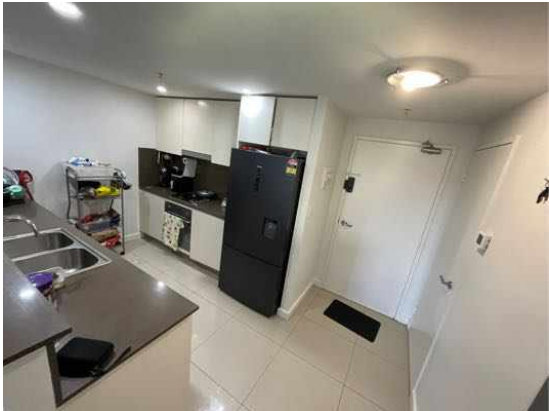
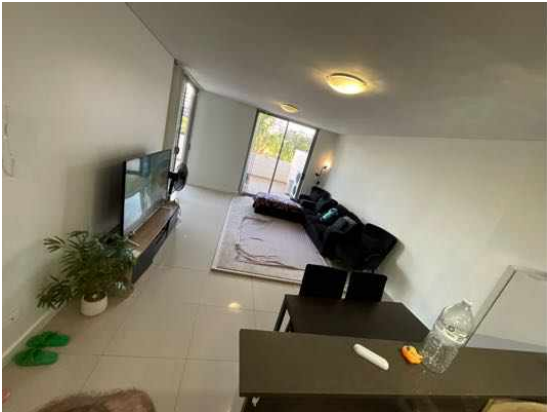
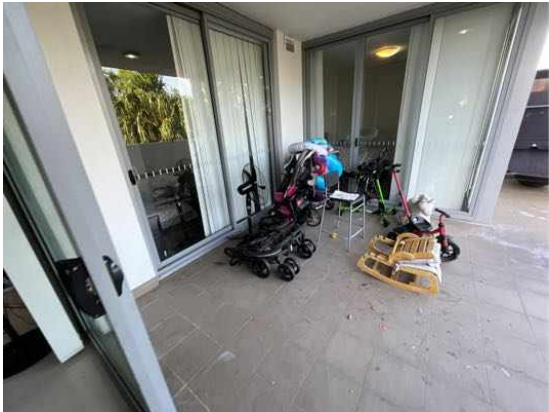
Finding: Additional Photos - Obstructions and Limitations
Information:

These photographs are an indication of the obstructions and limitations which impeded full inspection of the property at the time of inspection. These obstructions can hide an array of defects and should be removed to allow full inspection to be carried out. A re-inspection is recommended once the areas are made accessible.
