Building and Timber Pest Inspection Report

Inspection Date: Wed, 18 Mar 2026

Property Address: 49 Kean Rd, Nagambie VIC 3608, Australia

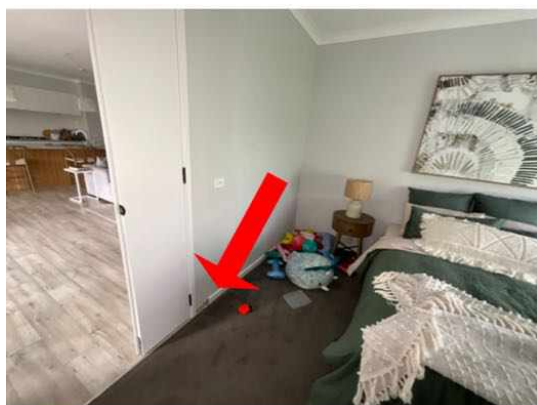
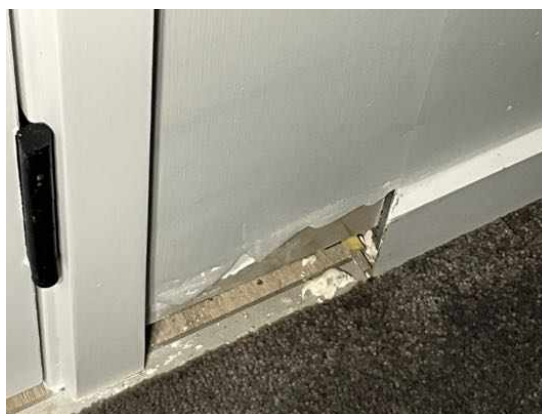
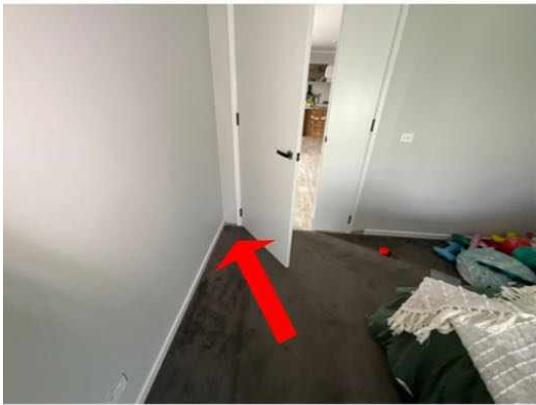
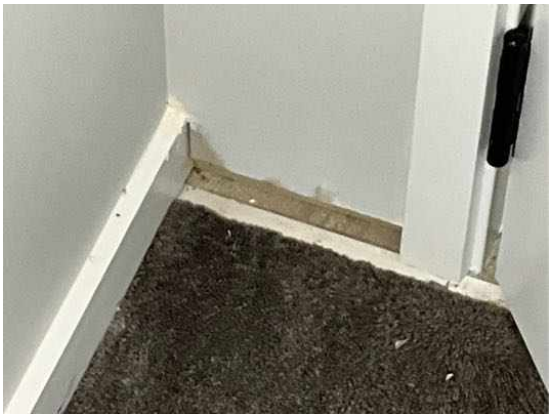
Finding 3.01

Building:	Building 1
Location:	Bed 3
Finding:	Installation - substandard or incomplete
Information:	The installation of this building element appears to have been completed to a substandard level of workmanship or is incomplete. Generally substandard repairs or installation are related to poor workmanship, the use of inappropriate materials, or a failure to complete installation to a suitable standard.

Where installation is substandard and/or incomplete, the client should contact the responsible trade to undertake rectification. Unfinished and substandard building works are likely to degrade more quickly and may create potential for secondary defects to associated building elements.

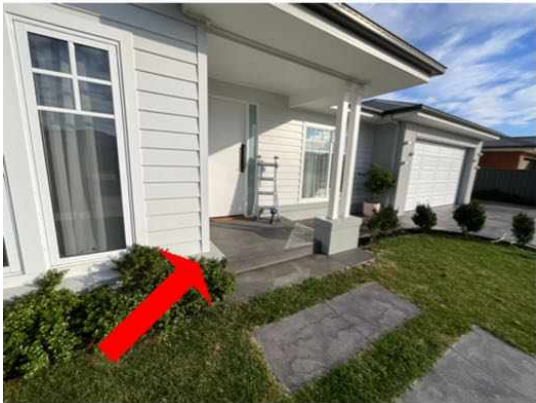
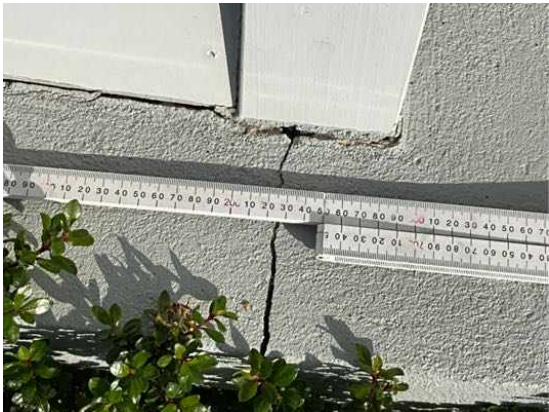
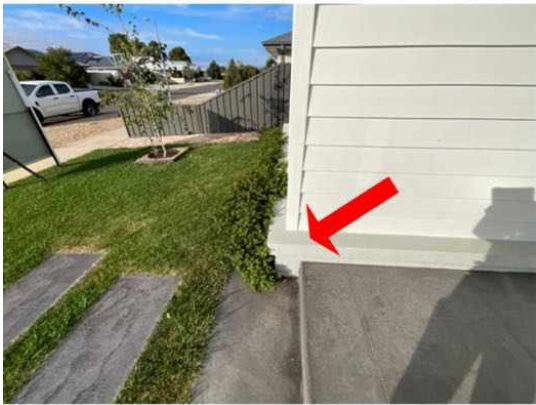
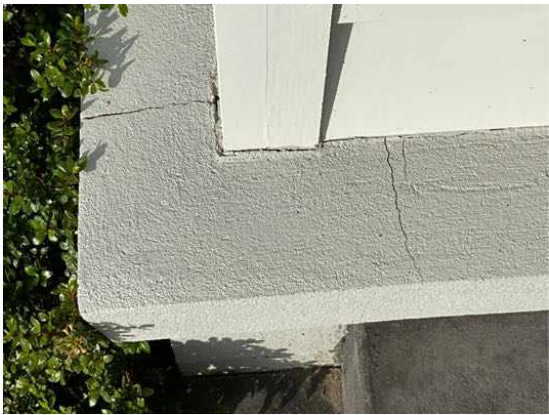
Finding 3.02

Building: Building 1
Location: Front wall
Finding: Brickwork - Cracking [Fine]
Information: Although fine cracks are quite noticeable, they are often only considered to be an appearance defect and usually do not indicate any structural damage. Generally, the cause of a fine crack is indicative of a separation between brickwork and mortar throughout the structure, but single bricks may also show cracks of this nature.

Cracking of this nature can generally be repaired with minor filling and should be conducted by a qualified bricklayer.

Always contact a building inspector should cracks widen lengthen or become more numerous.

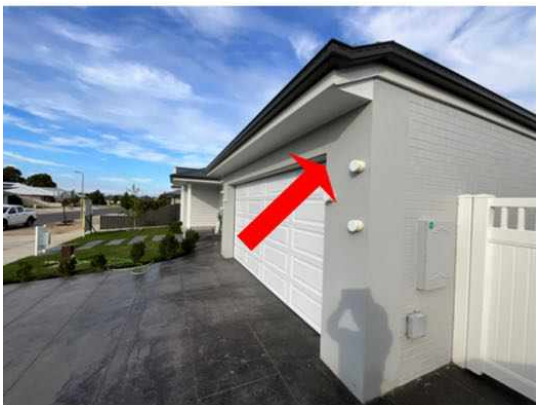
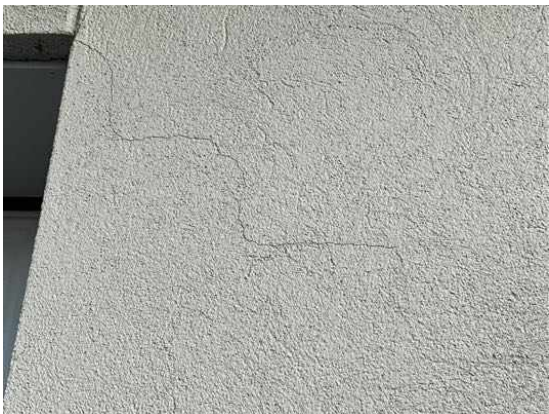
Finding 3.03

Building: Building 1
 Location: Garage
 Finding: Brickwork- Step cracking
 Information: Step cracking was identified to the brickwork in this area at the time of inspection. Step cracking, which is similar to other forms of cracking, has a variety of possible causes. However, the most common is the subsidence of adjacent footings.

Step cracking is a relatively common defect, and is most likely to occur adjacent to windows, doors and other openings. Mortar failure in the gaps between affected bricks indicates the stresses and tensions affecting the wall.

Minor step cracking can be used as a warning sign to address factors causing stress to the wall, which can include the effect of surrounding trees, water leaks, soil erosion, or even the presence of reactive soils in the surrounding area.

If cracks increase in size or number contact a Licensed builder immediately to make all needed repairs.

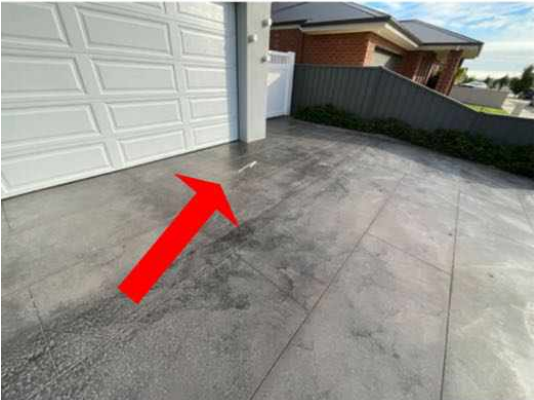
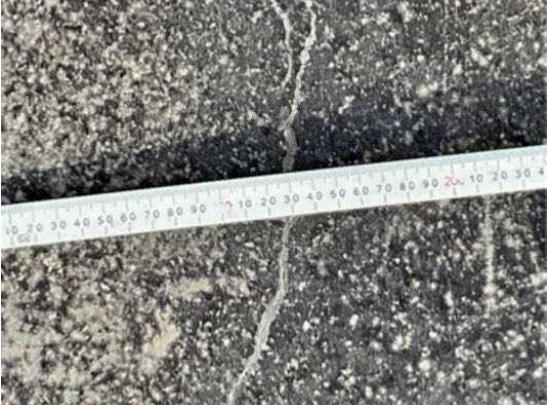
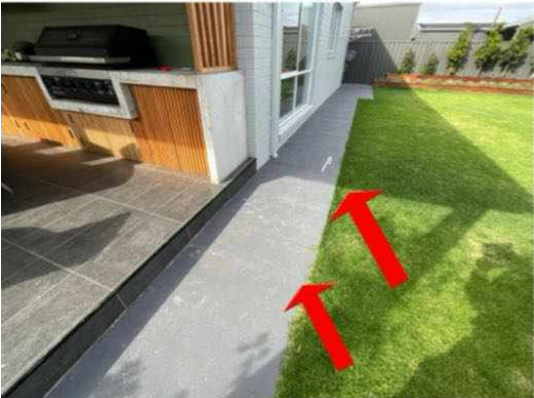
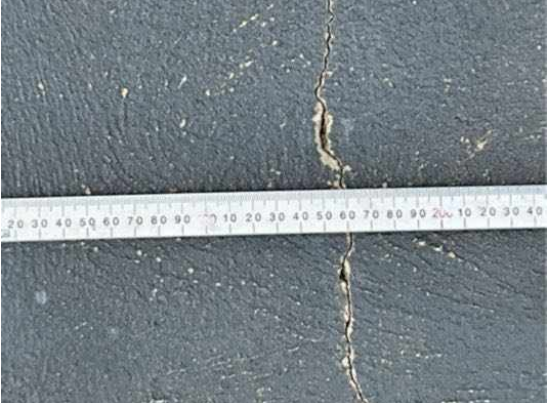
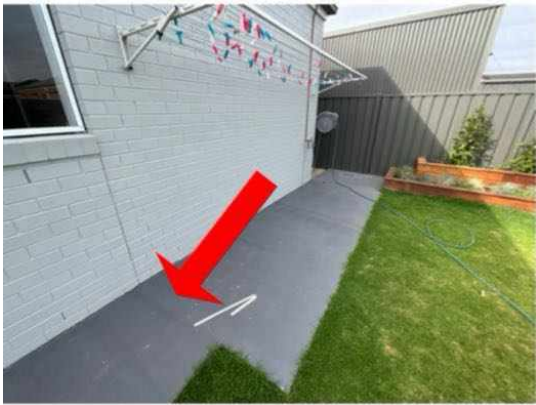
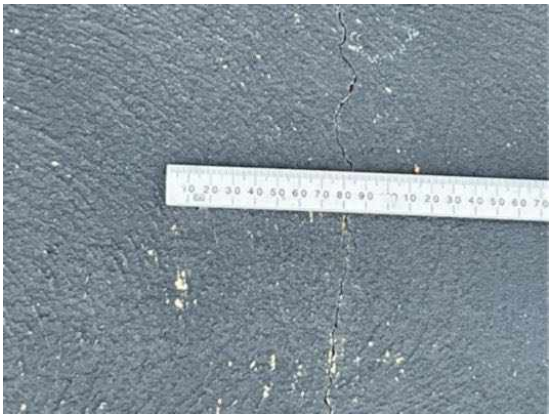
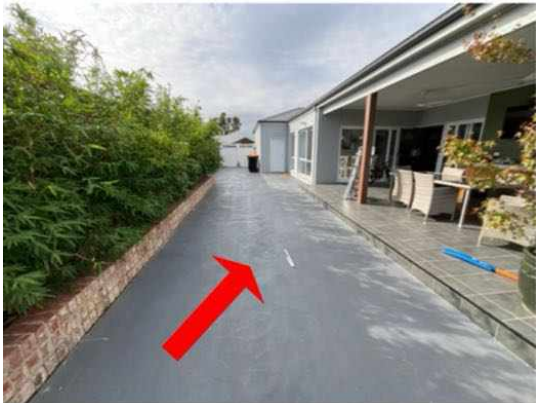
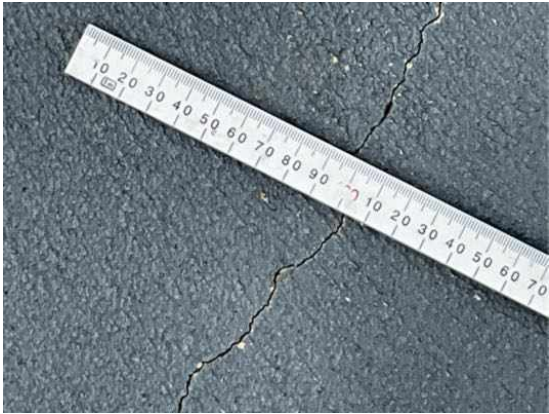
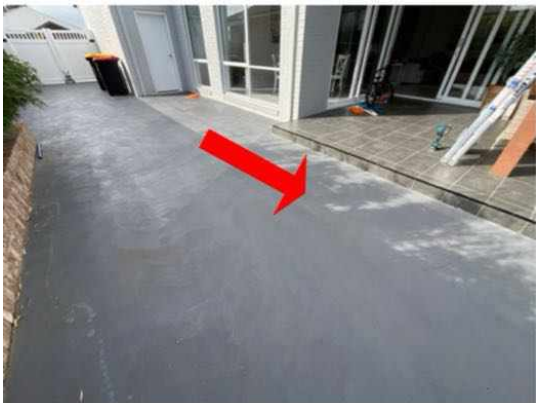
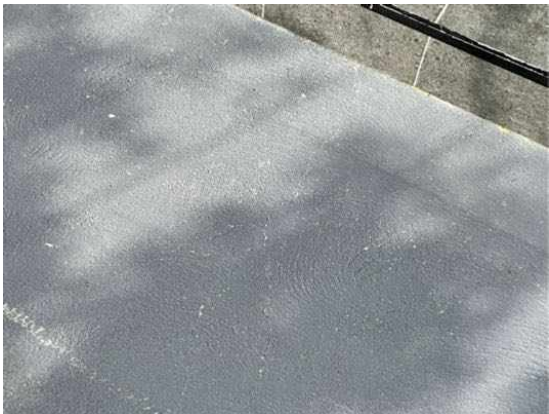
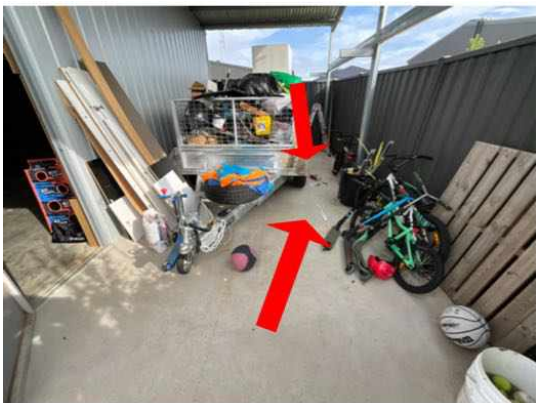
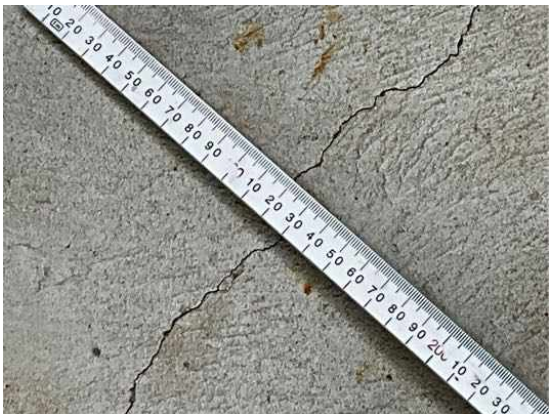
Finding 3.04

Building: Building 1
 Location: Driveway, yard- back, carport

Finding: Cracking - External Concrete Paving Damage Category 1 - Fine (less than 2mm)
Information: Fine cracks were identified in external concrete paving. Although fine cracks are quite noticeable, they are often only considered to be an appearance defect, and usually do not indicate any structural damage. To be considered a Category 1 or fine crack, the crack is found to be less than 2mm in width.

Generally the cause of a hairline crack in existing concrete paving such as driveways and pathways is indicative of the expansion and contraction of the concrete. Such causes are generally due to environmental factors, such as moisture levels, weather conditions, root systems of nearby trees or the soil types on which they are laid.

Fine cracks may also be due to poor original installation of the concrete. Factors such as poor compaction of the sub surface and/or inadequate reinforcing of the slab may create cracking and other secondary defects.

Monitoring of all cracking should be conducted frequently. Always contact a building inspector should cracks widen, lengthen, or become more numerous.

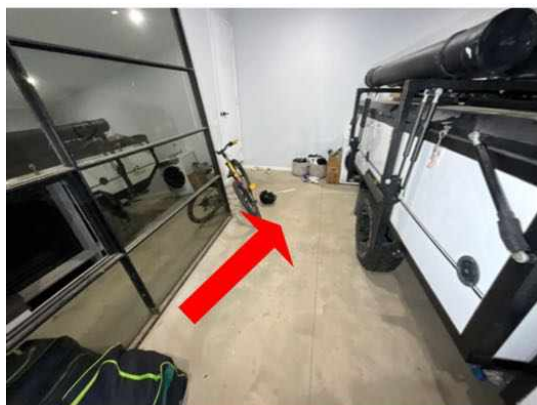
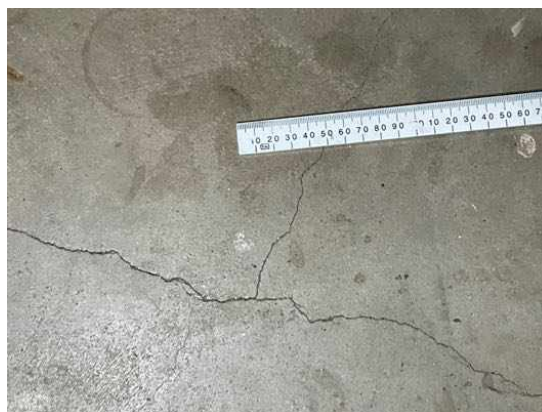
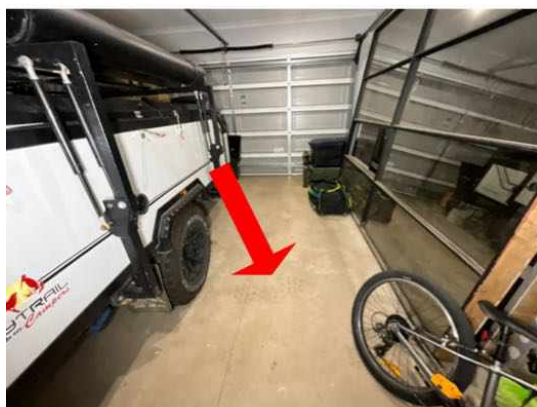
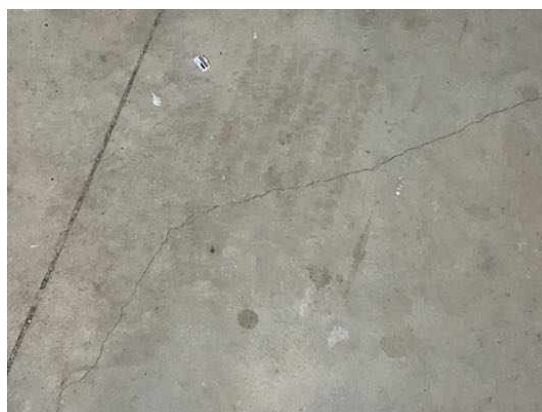
Finding 3.05

Building: Building 1
Location: Garage
Finding: Crack in concrete slab - Category 1
Information: A crack coded as Category 1 was identified in the slab. A Category 1 crack is described as a fine but noticeable crack, with the slab at an otherwise reasonable level.

To be considered Category 1, the approximate width of the crack is less than 1.0mm, or a less than 10mm change in offset when a 3m straight edge is placed over the defect.

Category 1 cracks should be monitored for a period of 12 months. At the end of the monitoring period, identified cracks that are rated greater than Category 2 are considered defects, and require rectification.

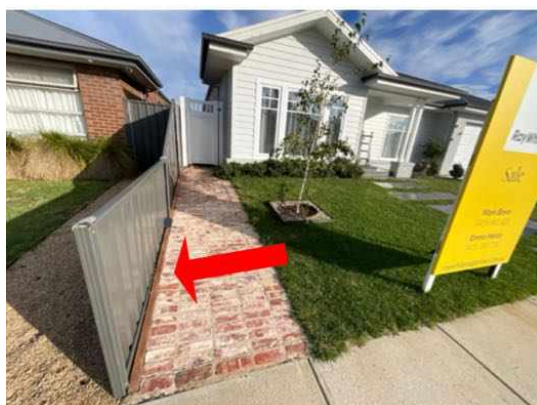
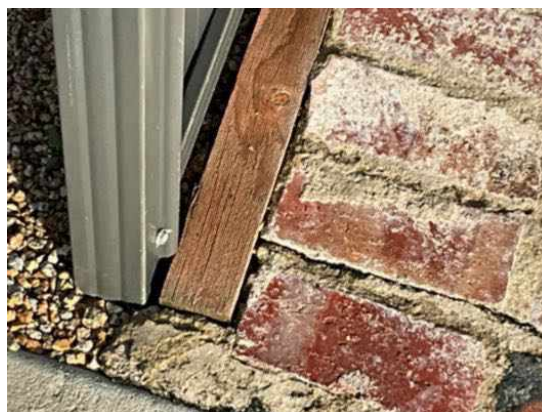
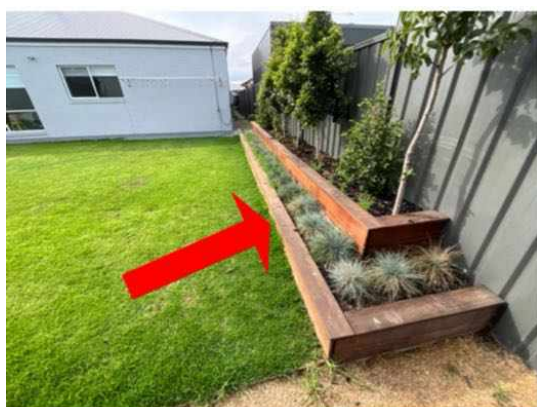
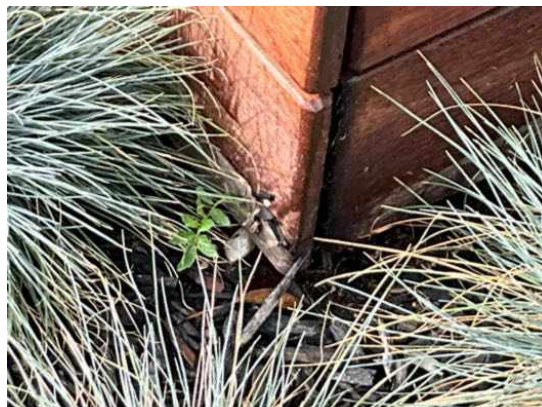
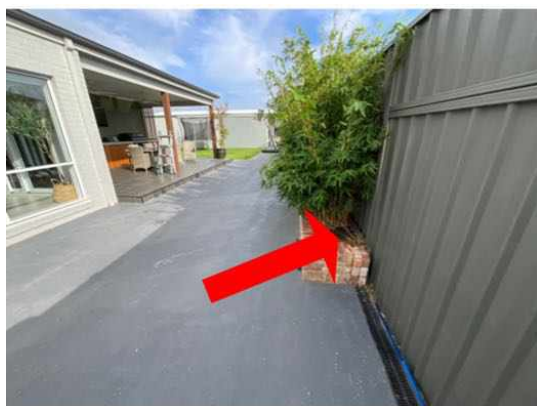
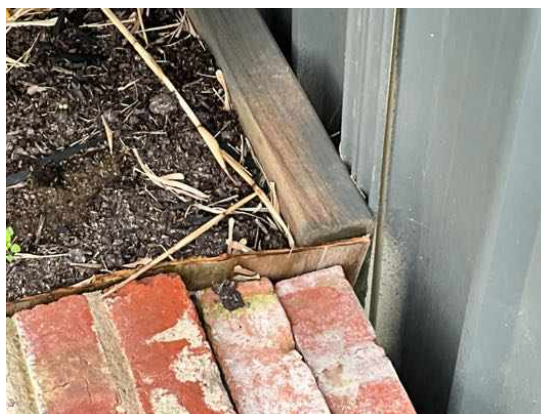
Finding 6.01

Building:	Building 1
Location:	Yard - Front, back
Finding:	Untreated or non-durable timbers in a hazardous environment
Information:	To reduce the risk of timber pest attack it is essential that timber used in a hazardous environment (e.g. in direct contact with the ground or frequently exposed to damp conditions) is of sufficient durability and/or is adequately preservative treated.

Untreated timbers in direct contact with the ground are likely to develop severe wood rot and/or fungal decay if left unattended creating attraction for subterranean termites to infest the timbers from surrounding areas.

If untreated or non-durable timbers are found to be in a hazardous environment it is highly advised that replacement of these building elements be performed as soon as possible to aid the protection of the property against termite / timber pest attack.

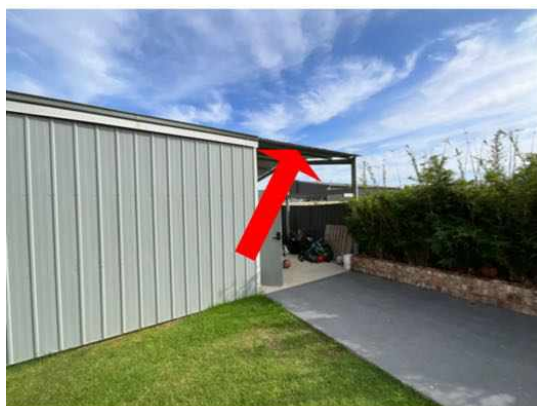
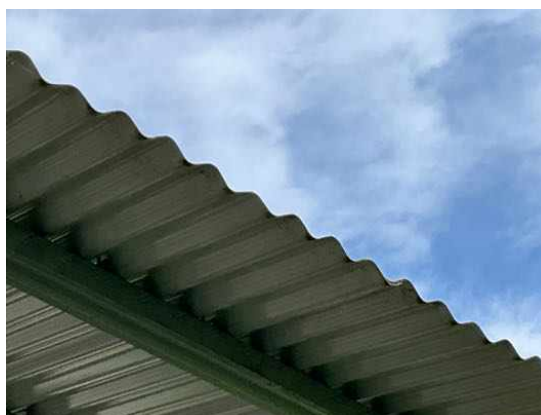
Finding 6.02

Building: Building 1
 Location: Garage
 Finding: Guttering Missing
 Information: The Guttering in this area was missing at the time of inspection. Guttering, Downpipes and Stormwater drainage are vital to protect the integrity of the structure and to prevent an environment conducive to Timber Pest attack.

A Plumber should be contacted as soon as possible to replace and connect to drainage the missing Guttering.

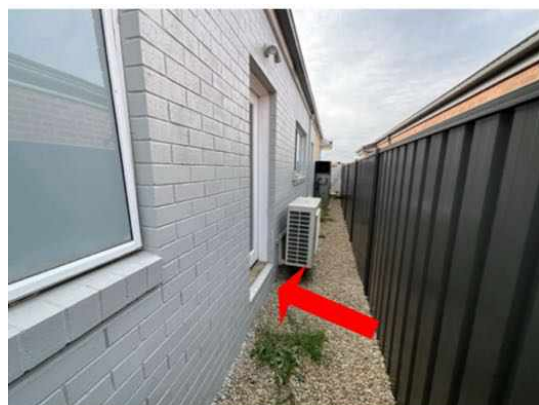
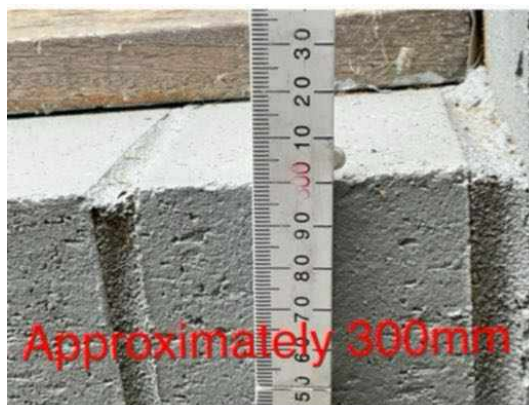
Building: Building 1
 Location: Laundry
 Finding: Step down laundry
 Information: The step down from the laundry is approximately 300mm. The maximum stair height proscribed for a staircase is 225mm. This is not a staircase.

At the discretion of the client, a transitional step could be installed to make the area more user friendly. A general handy person could complete this work.

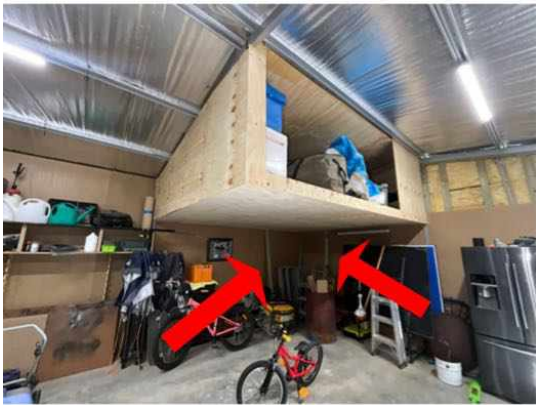
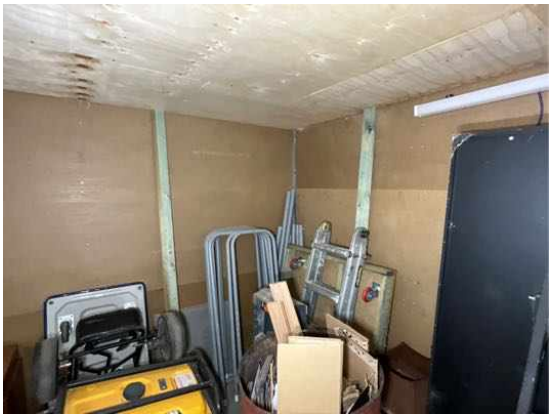
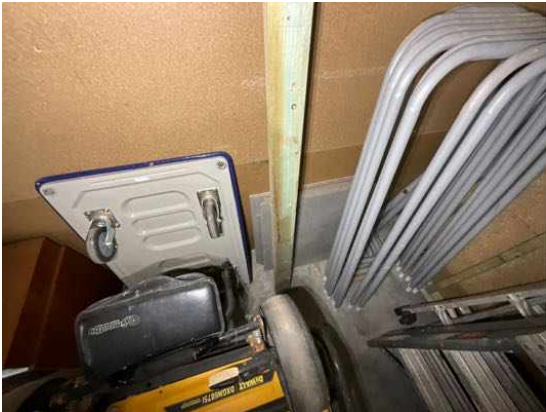
Building: Building 1
 Location: Garage
 Finding: Loft- weight capacity
 Information: The loft element in the garage has no engineering plate with load maximums specified. This is not necessarily a requirement by law. Props have been placed underneath to help support the current load.

The client should be aware to only load light items in this area. If needed a registered builder or structural engineer could be consulted to improve the installation and prevent potential deterioration.

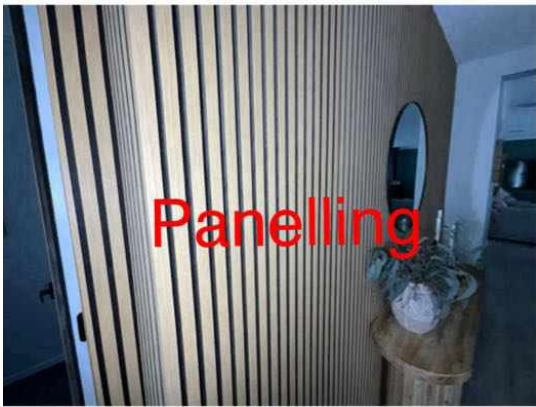
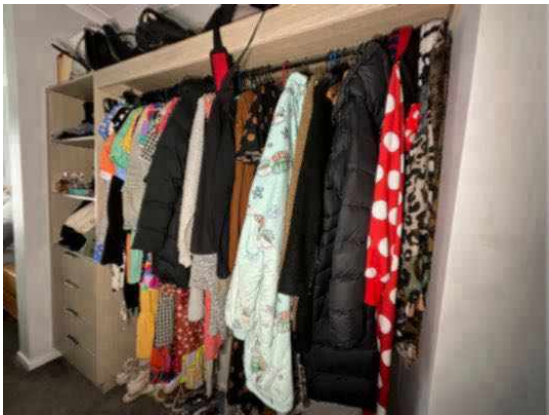
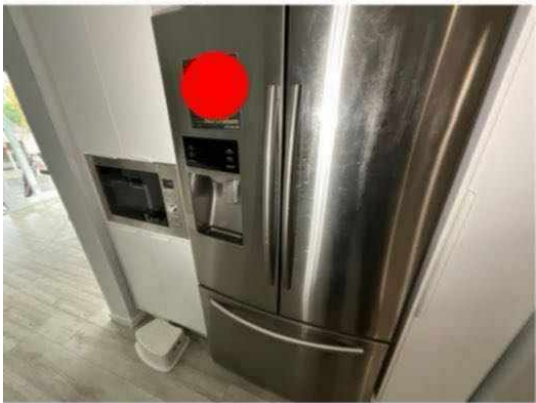
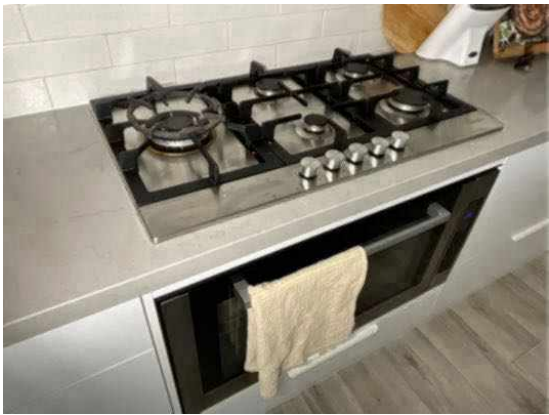
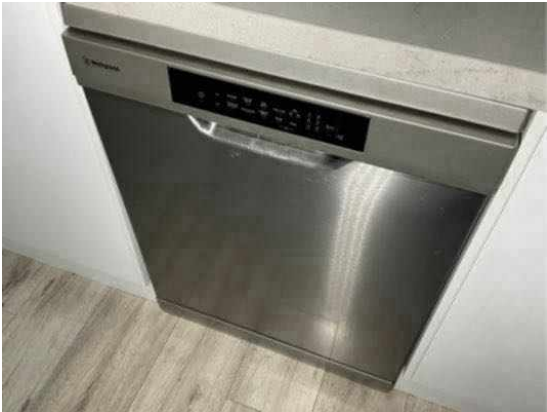
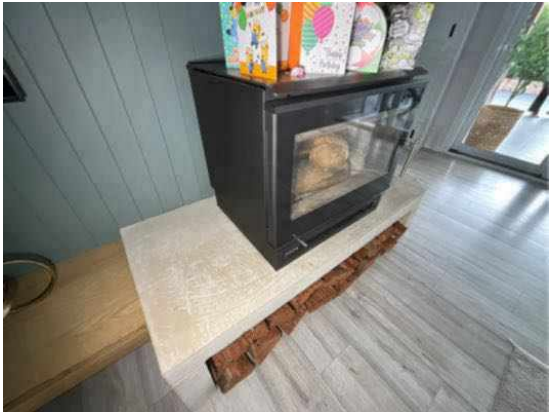
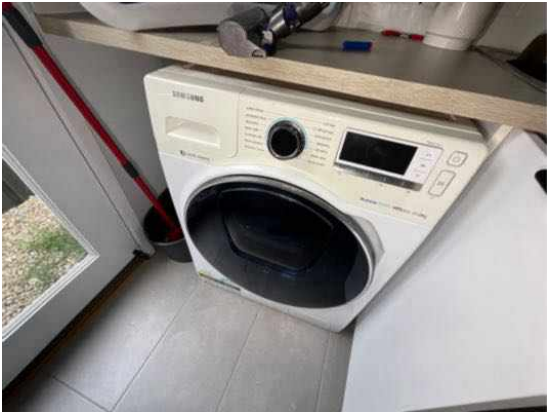
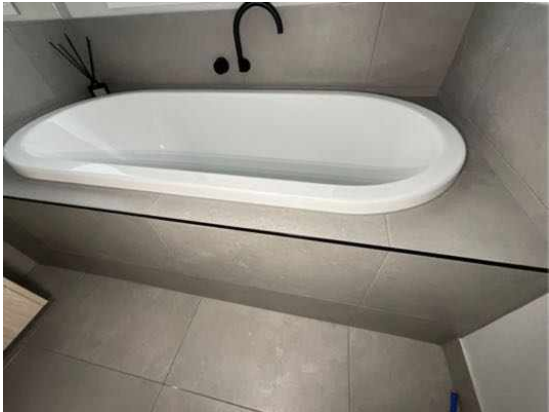
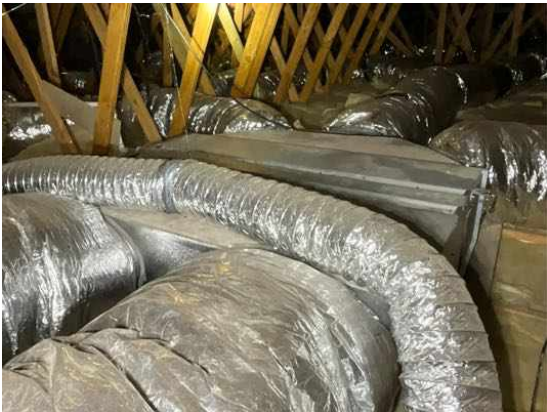
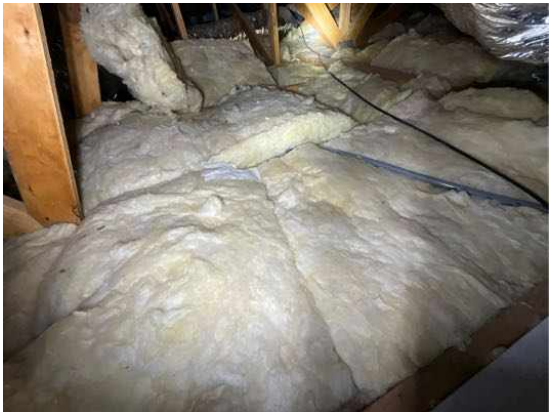
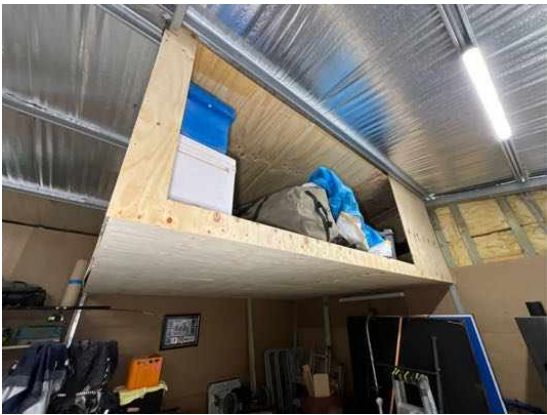
Building: Building 1
 Location: All Areas
 Finding: Additional Photos - Obstructions and Limitations
 Information: These photographs are an indication of the obstructions and limitations which impeded full inspection of the property at the time of inspection. These obstructions can hide an array of defects and should be removed to allow full inspection to be carried out. A re-inspection is recommended once the areas are made accessible.
