Building and Timber Pest Inspection Report

Inspection Date: Wed, 1 Apr 2026

Property Address: 70 Edgeware Rd, Enmore NSW 2042,
Australia

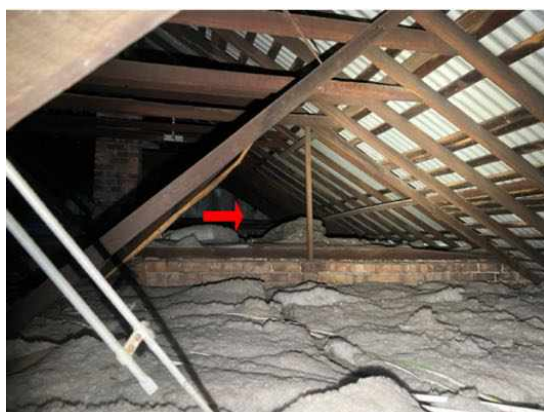
Finding 1.01

Building:	Main Building
Location:	All Internal Areas
Finding:	Roof Void – Inadequate Separation Between Dwellings
Information:	The roof void was observed to be continuous between adjoining terrace dwellings, with the separating masonry wall not extending to the underside of the roof covering. This condition represents a significant fire safety risk, as it may permit the spread of fire between properties. Adequate fire separation is typically required under the NCC. Urgent assessment by a suitably qualified building professional or fire engineer is recommended.

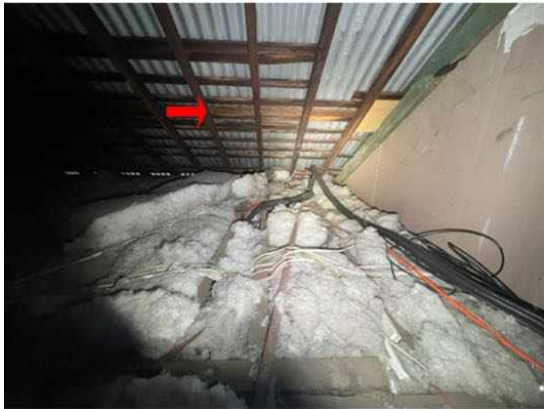
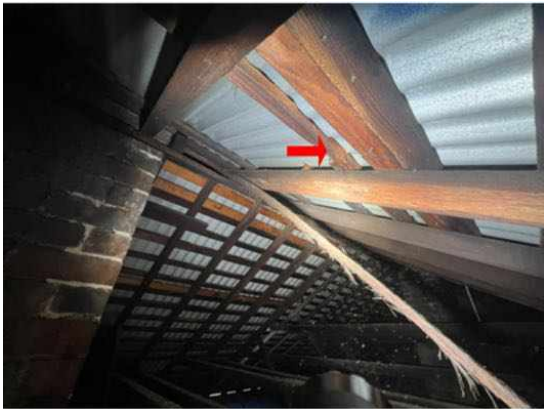
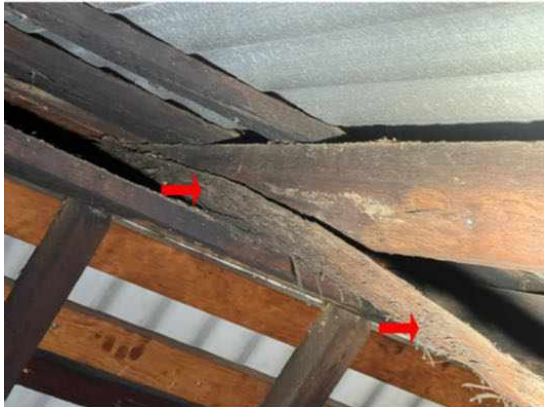
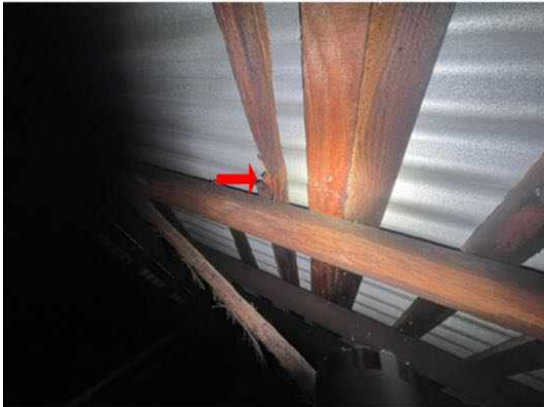
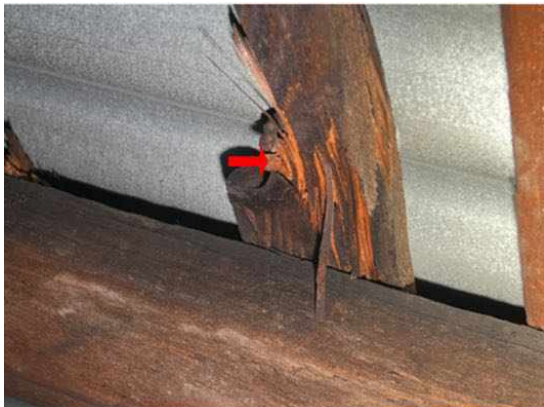
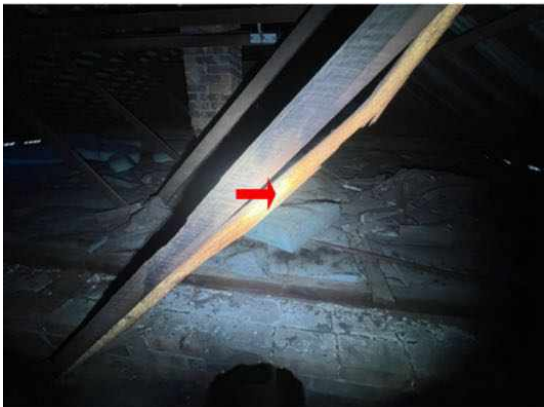
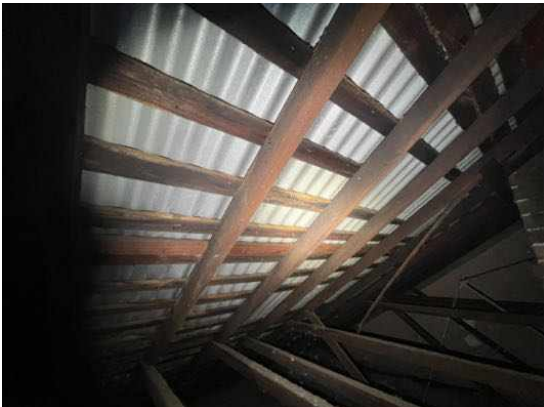
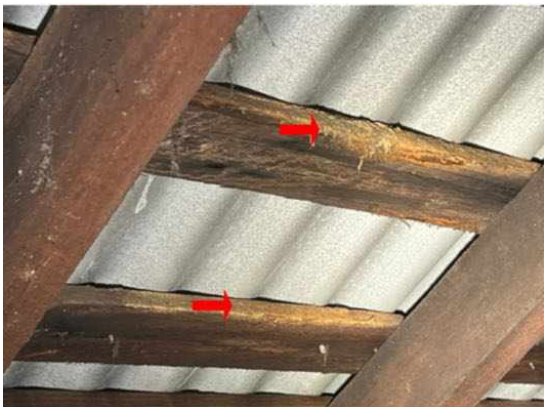
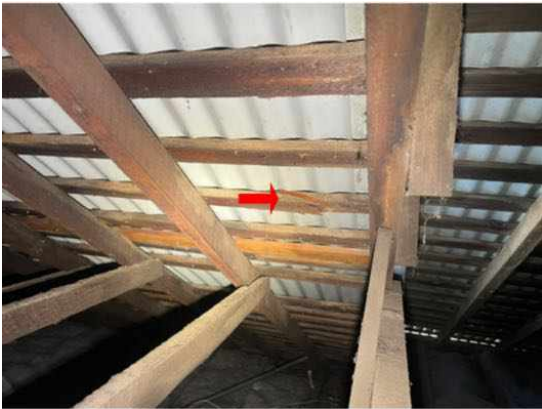
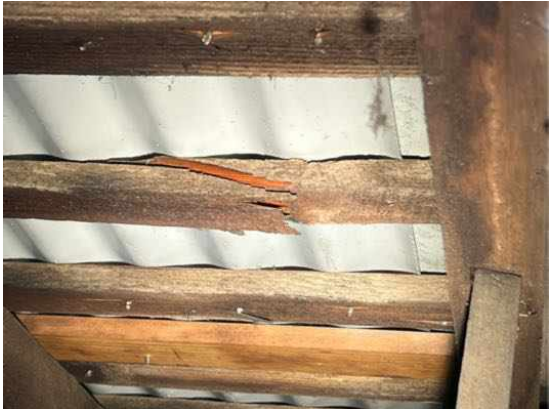
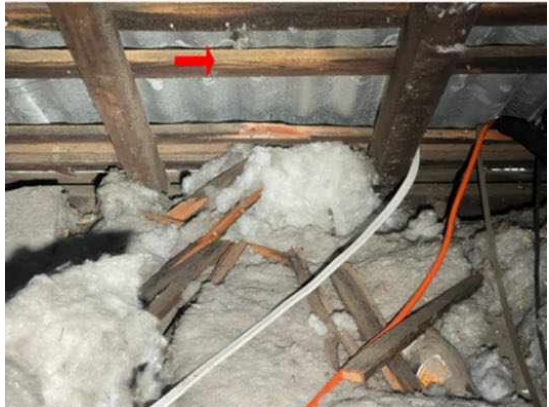
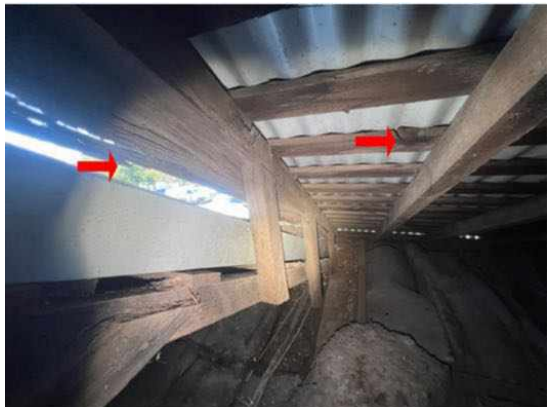
Building:	Main Building
Location:	Roof Void
Finding:	Roof Void condition (Timber splitting , Decay , elevated moisture and delignification)
Information:	Significant deterioration was observed to multiple roof framing members, including splitting, decay, and early-stage delignification consistent with prolonged moisture exposure. Localised areas of advanced deterioration were noted, including a substantial void within a fascia element, which may allow water ingress and indicates material failure. Elevated moisture readings at the time of inspection suggest an active or ongoing moisture source.

These findings indicate progressive structural degradation of roof timbers. If not addressed, further deterioration may occur, potentially impacting structural performance over time.

Urgent investigation to identify the source of moisture, along with rectification by a licensed carpenter and/or roofing contractor, is recommended.

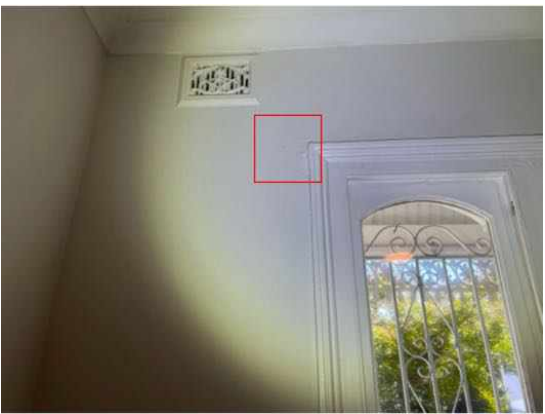
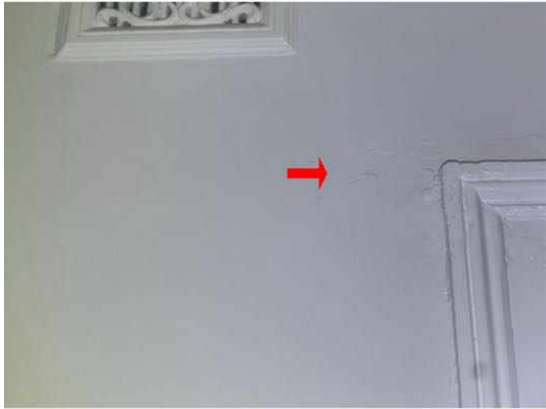
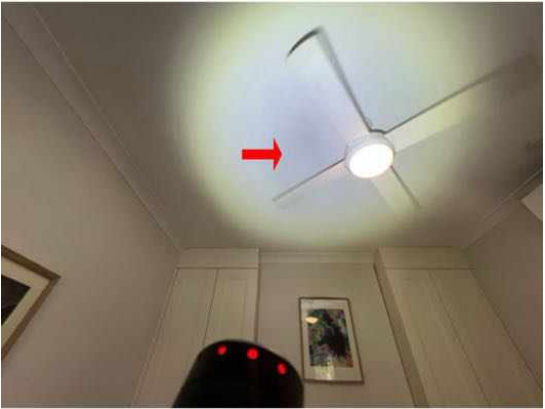
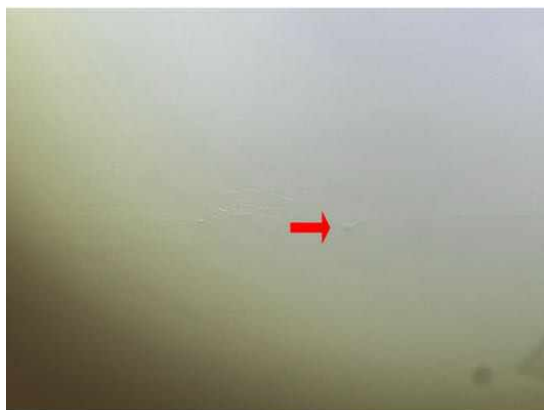
Information: Sections of paint in this area was found to have bubbled and deteriorated. Paint bubbling is generally an indication of excessive moisture in the area, that is currently hidden by the painted surface.

The presence of excessive moisture can have major implications on associated building elements if left unattended. While only seemingly minor at this stage, the damage cannot be determined due to the paint obstructing any further inspection of the damage.

It is highly advised that the affected paint be cleaned to allow a further, more invasive

inspection by a licensed plumber. Failure to act on this defect may necessitate major works in the future.

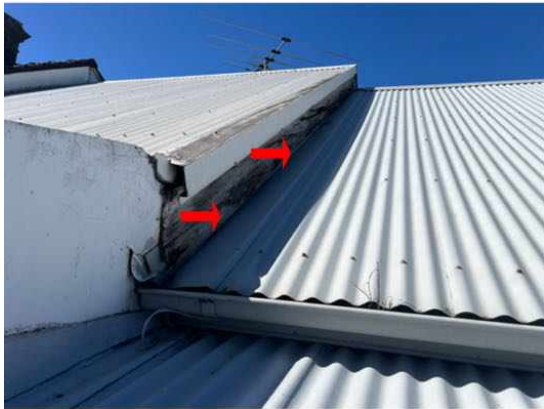
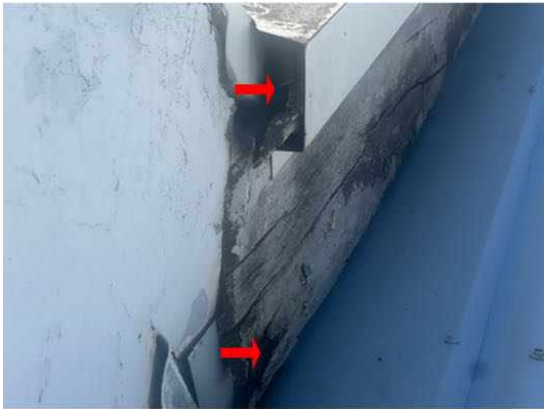
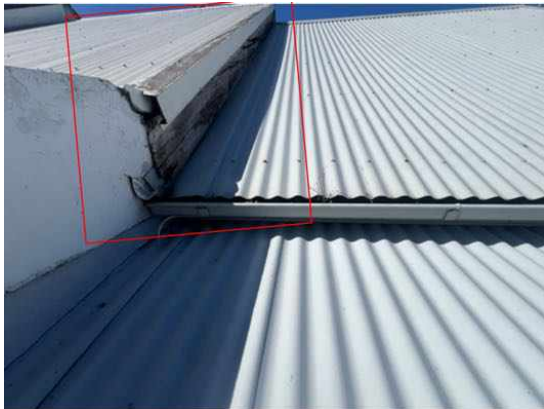
Finding 3.04

Building:	Main Building
Location:	All External Areas
Finding:	Fascias - Wood rot
Information:	Wood rot was found to be affecting fascias and barges in this area, evidenced by the presence of mould on the surface in some areas. Wood rot, also known as Fungal Decay, occurs when timbers and other cellulose building materials are exposed to damp conditions on an ongoing basis.

It is likely that this wood rot has developed as a result of faults in the roof plumbing, creating excessive moisture in this areas. Frequent exposure to rain and other weather conditions also make fascias and barges susceptible to accelerated deterioration.

Early intervention and regular maintenance will prolong the useful life of these building elements. Prior to any works being performed, the cause of the moisture that has created the visible wood rot should be identified and addressed in a suitable manner.

It is advised that a roof plumber be appointed to inspect all roof plumbing and subsequently identify the cause of the wood rot. Replacement of affected fascias and barges may then be a necessary step in protecting surrounding building elements from such deterioration.

A qualified plumber may be appointed to assess the cause of excessive moisture and to provide advice on any remedial works as required. A qualified carpenter or registered builder may also be required to replace affected building materials.

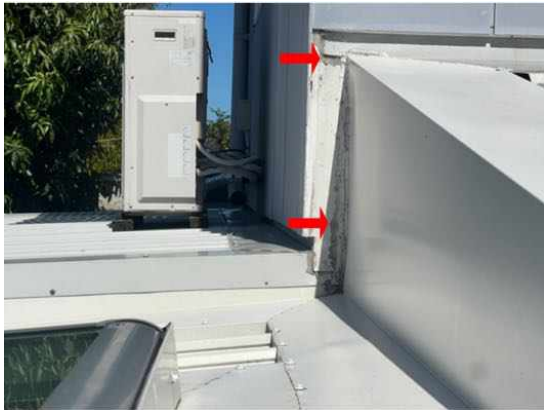
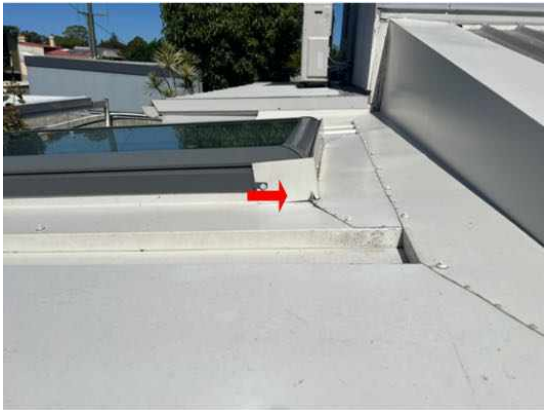
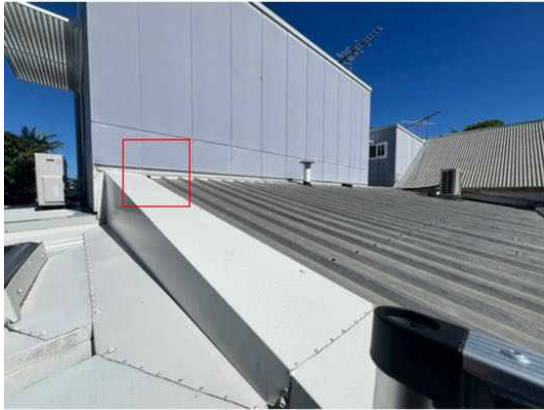
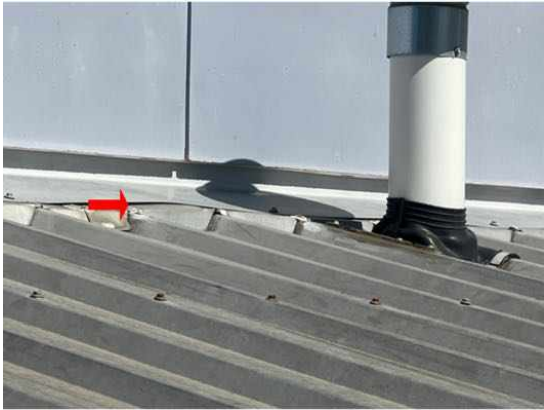
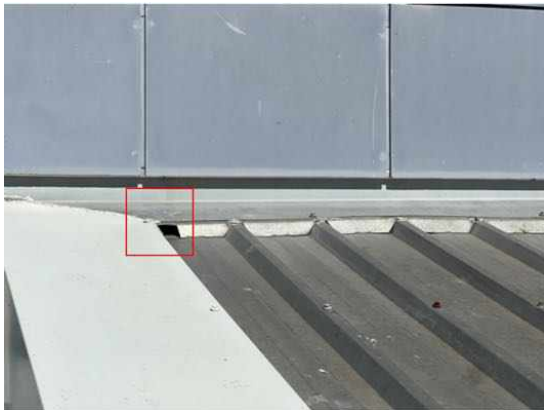
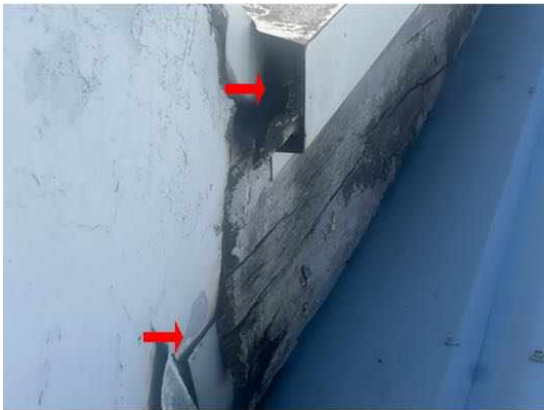
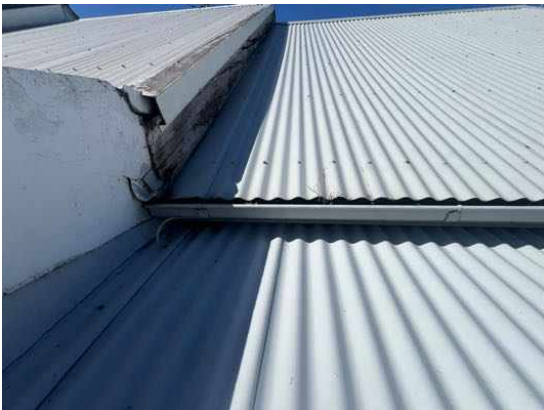
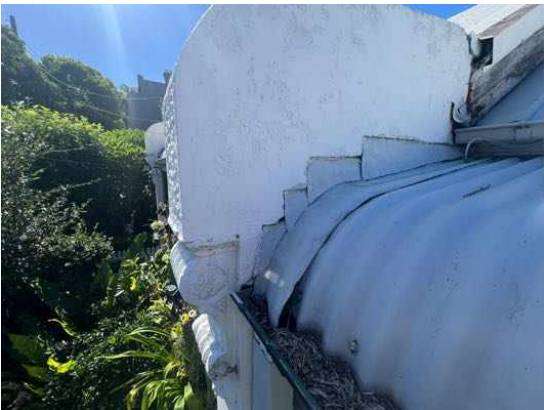
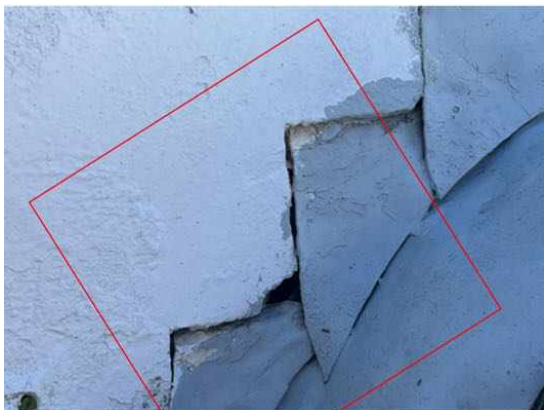
Finding 3.05

Building: Main Building
Location: Roof Exterior
Finding: Flashing defective -poor installation
Information: The metal flashing at the wall junction appears inadequately installed, with visible gaps and/or lifting and reliance on surface sealant rather than a properly chased and continuous detail. The junction does not appear fully weather-tight, increasing the risk of moisture ingress into the wall cavity or roof structure over time. Defective flashing installation can lead to concealed deterioration if not addressed. Recommend assessment and rectification by a qualified roofing contractor to ensure compliant and effective weatherproofing as soon as possible

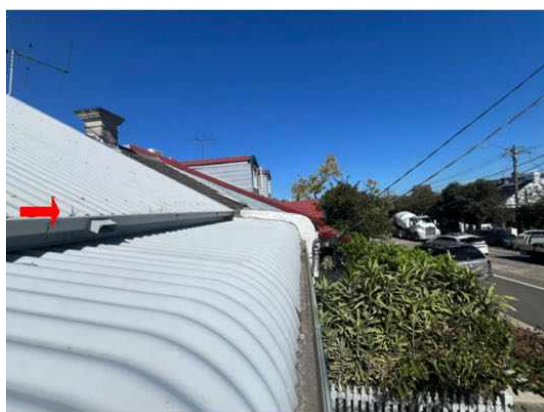
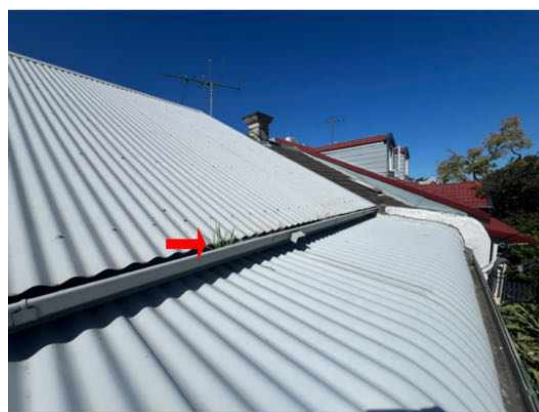
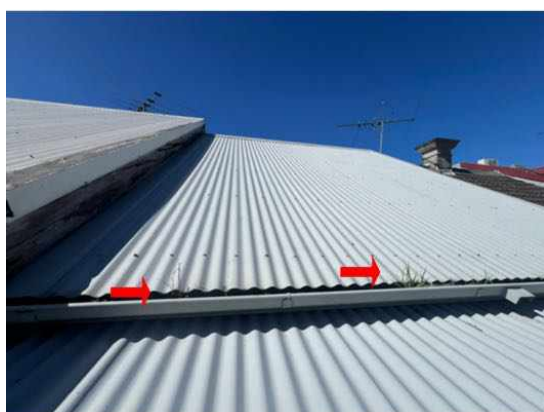
Blocked gutters are likely to lead to high levels of moisture in the affected areas. Such moisture will not only cause rust and decay of the associated building materials, but can also provide conditions that are conducive to termite and timber pest activity. Blockages in gutters should therefore be removed immediately to ensure dry conditions are maintained.

Consult a Licensed Plumber for further specific advice on remedial works that may be required. In the interim, it is highly advised that blocked gutters be removed by the homeowner or a general handyperson as a matter of urgency.

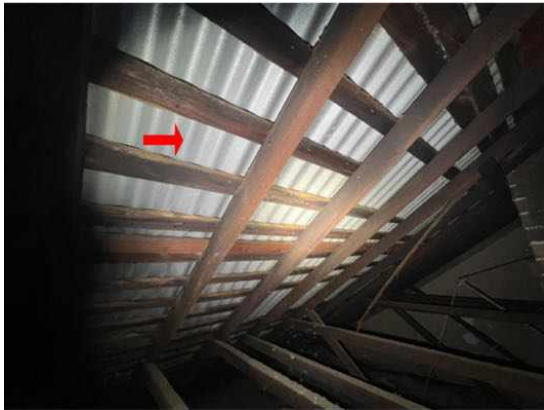
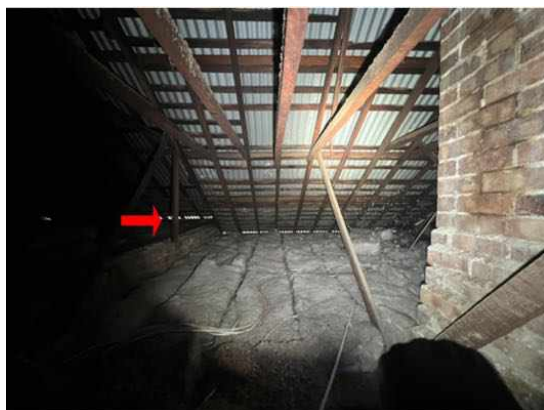
Building: Main Building
 Location: Roof Void
 Finding: Roof Void – No Sarking & Light Ingress
 Information: Light ingress is visible through multiple roof tile laps, which is typical of older tile roofs without sarking and may allow minor wind-driven moisture or dust into the space, though no active leaks were observed.

Consider retrofitting sarking or roof wrap in the future to improve thermal and moisture performance.

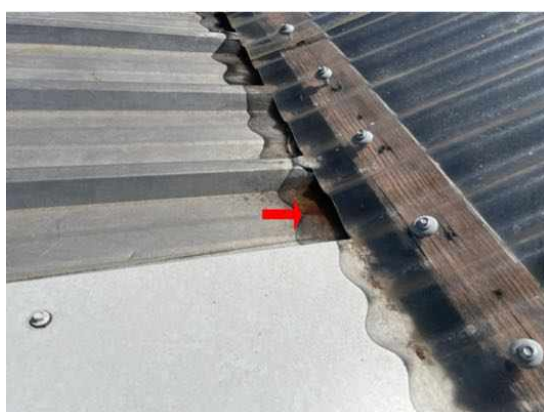
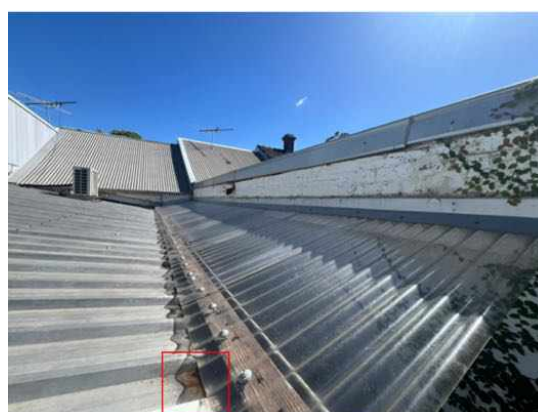
Where possible, the use of galvanized (treated) metals or aluminium coated metals aid in rust prevention, as does regular general maintenance. Rust formation can be controlled with coatings, such as paint, that isolate the iron from the environment.

Rusting and corrosion should be managed by ideally removing or limiting the affected surface from exposure to moisture. A registered builder may be appointed to replace any building elements that have been severely affected by rust or water damage.

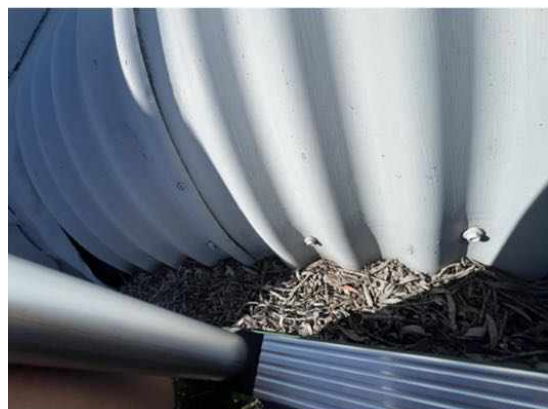
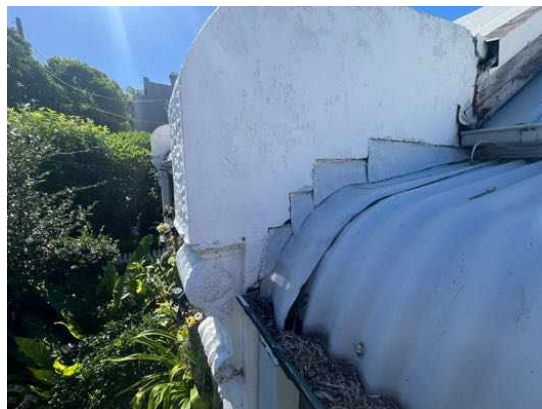
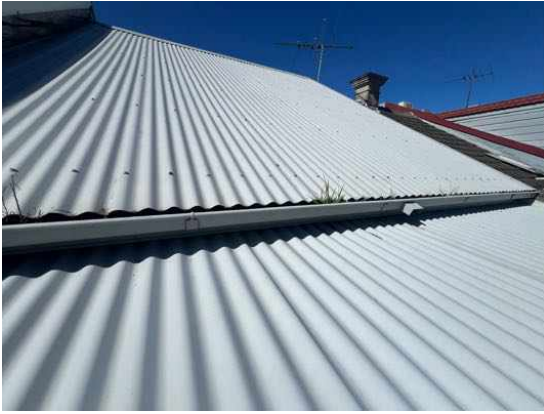
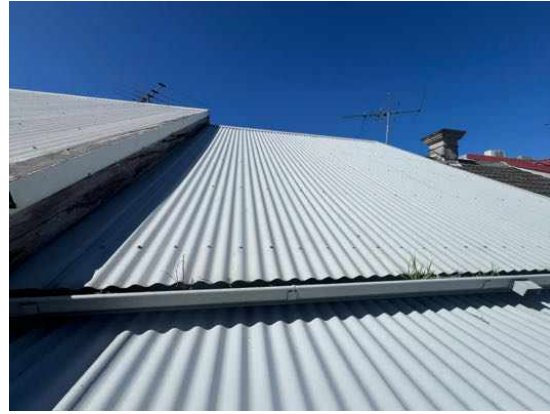
Blocked gutters are likely to lead to high levels of moisture in the affected areas. Such moisture will not only cause rust and decay of the associated building materials, but can also provide conditions that are conducive to termite and timber pest activity. Blockages in gutters should therefore be removed immediately to ensure dry conditions are maintained.

Consult a Licensed Plumber for further specific advice on remedial works that may be required. In the interim, it is highly advised that blocked gutters be removed by the homeowner or a general handyperson as a matter of urgency.

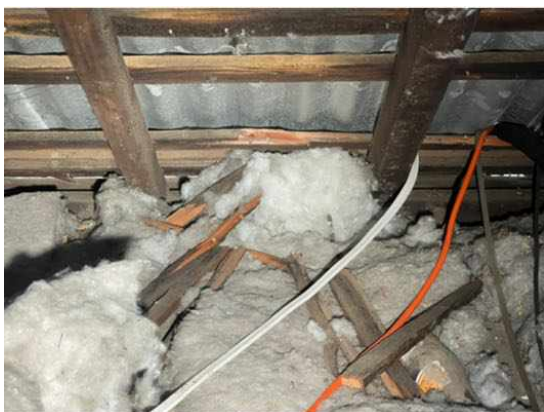
Finding 6.05

Building:	Main Building
Location:	All Internal Areas - Roof void
Finding:	Elevated moisture - identified
Information:	Elevated moisture can attract termites and produce conditions that promote fungal growth and wood decay.

Prior to any remedial works being performed a qualified plumber should be appointed to further inspect the property and to identify the cause of the excessive moisture. Works to remove affected building elements may then be necessary and should be performed by an appropriate tradesperson.

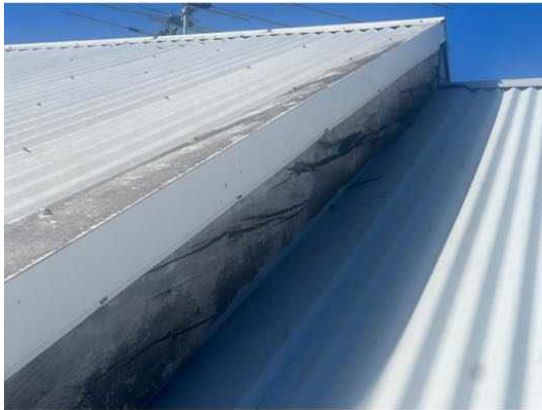
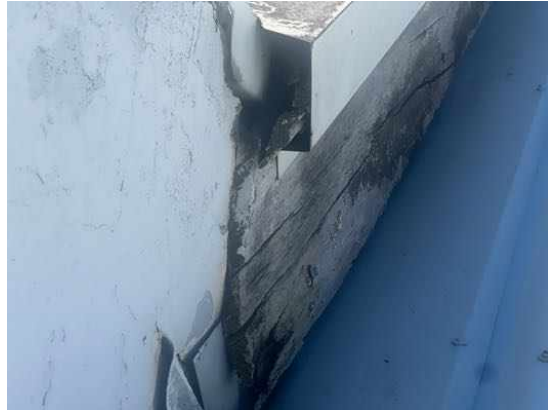
In this case although the affected timber element is in a decaying state the extent of any visible damage appears to be localised to a specific area and is yet to spread to other parts of the building element or affect adjoining structures. The fungal decay is therefore likely to be of a relatively superficial nature with minimal impact on the structural integrity or tensile strength of the timber element.

A further invasive inspection by a licensed timber pest technician is highly recommended to check for concealed activity.
