Building and Timber Pest Inspection Report

Inspection Date: Mon, 16 Mar 2026

Property Address: 3 Annesley Ave, Bowral NSW 2576,
Australia

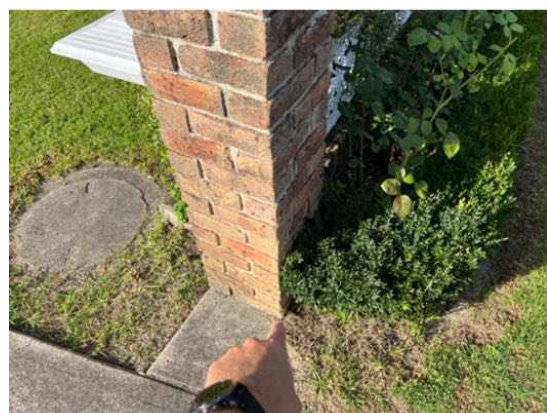
Building: Yard
Location: Yard - Front
Finding: Brick Pier - Unstable
Information: Upon inspection of the brick pier to the front wall, it was noted that the brick pier appears unstable. The pier may not have been adequately reinforced, as it appears the core of the pier may not have been properly filled with mortar or concrete to provide sufficient internal strength.

Where masonry piers are not adequately filled or reinforced, they may lack the structural rigidity required to resist movement, which can result in instability at the base and potential deterioration over time.

Remedial works are recommended. A registered builder or bricklayer should be appointed to inspect the pier and undertake repairs as required in the short term.

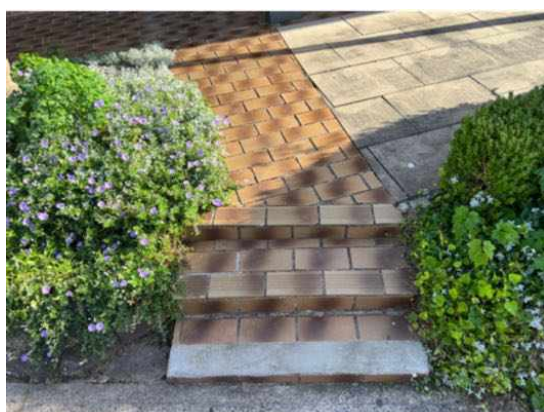
Building: Main Building
Location: Front path
Finding: Grout - degraded
Information: Grout is degraded in this area. Grout is used to protect gaps and crevices in building materials to ensure that they are water-tight and prevent water penetration to the associated structures.

Where grout is missing, a tiling contractor should be appointed immediately to apply grout and re-apply any silicone where necessary. Failure to do so is likely to lead to water damage to the surrounding area.

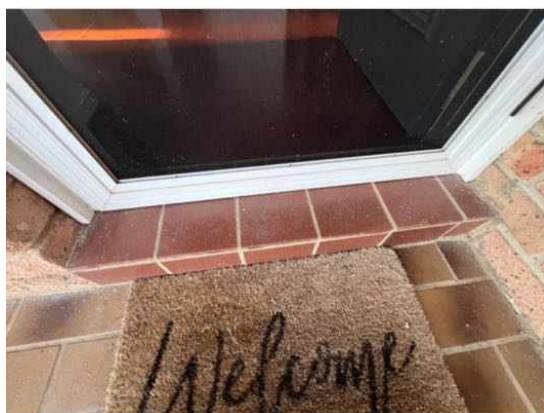
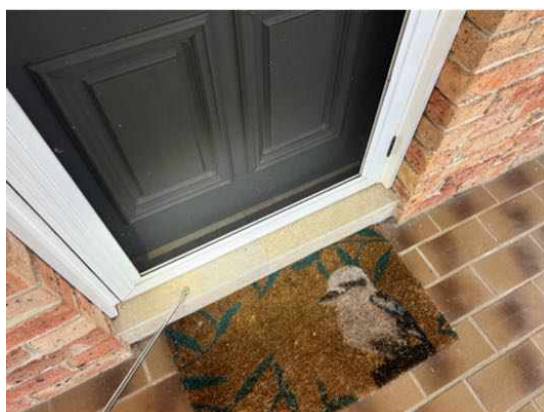
Information: Drummy tiled areas were identified at the time of inspection. The term 'drummy' refers to tiles that have become detached from their fixing, despite otherwise being in relatively good condition. Such defects are generally caused by physical or moisture damage to the area. Drummy tiled areas may also be a direct result of poor workmanship during the construction process.

Tiled areas may swell and shrink with changes in air humidity if the area has sustained moisture damage. Any exposure to moisture is capable of causing tiled areas to become drummy and/or cracked over a prolonged period of time. Drummy tiled areas generally require removal and replacement of affected tiles, with adequate sealant and grouting.

Specialist trades are available for these types of services. A registered builder may be required to undertake works if damage is extensive or if secondary building defects have resulted. Otherwise, it is advised that a tiling contractor be appointed to perform works as necessary. Immediate action is recommended to ensure that no further damage is sustained in the affected area.

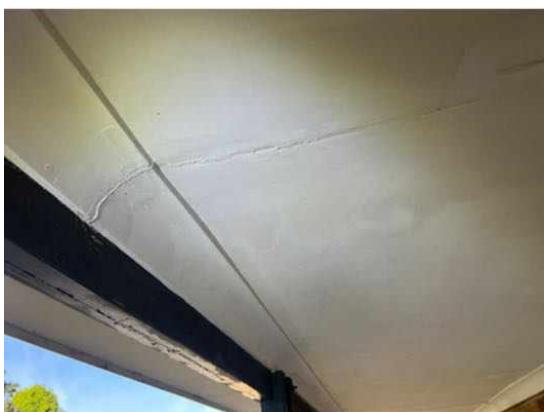
Finding 3.04

Works that have not been completed to a satisfactory level create potential for the development of building defects and may impede on the safety and integrity of the overall structure.

It is highly recommended that a licensed plasterboard contractor should be appointed to repair the ceiling. To ensure the safety of the area and the longevity of all associated building elements.

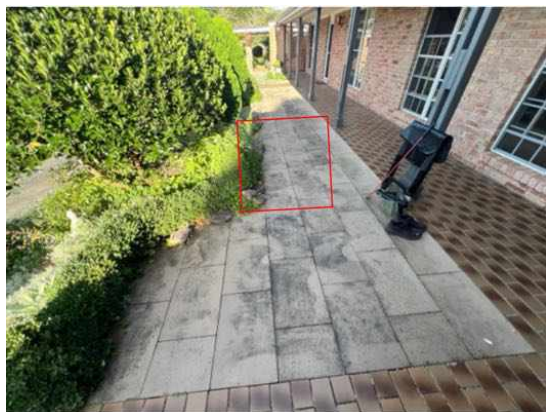
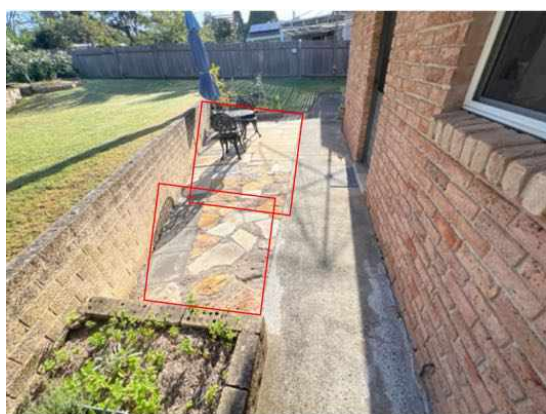
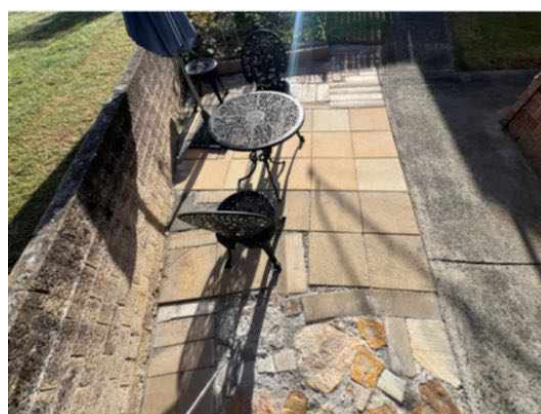
Building:	Main Building
Location:	Yard - Front, Back
Finding:	Paving - Uneven
Information:	Sections of the external paved area are uneven, creating a potential trip hazard. It appears as though the area has been subject to rough installation, or that paving

sections have lifted due to movements in the foundation of the property.

Where paving creates a trip hazard, personal injury may ensue if due caution is not taken by all persons within this area.

Re-paving of the area is required as soon as possible to remedy this situation. Further consultation with a specialist concreter is advised.

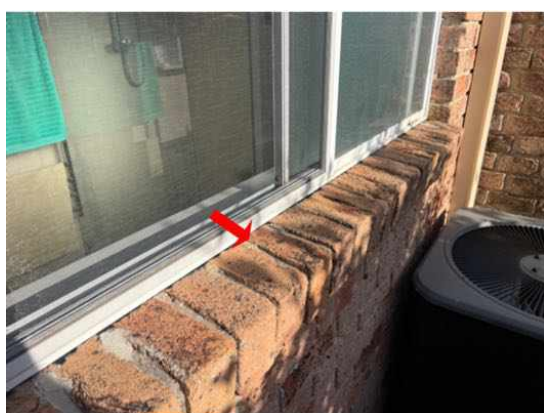
Finding 3.09

Building:	Main Building
Location:	Exterior walls - right side
Finding:	Window Sill Seals - damaged/compromised
Information:	The window seals have been damaged/compromised at the time of installation and subsequent failure to provide adequate protection and coverage. Due to frequent exposure to weather conditions and subsequent moisture, will lead to water ingress, energy loss and even pest entry.

Where window seals have not fully covered the gap between the brickwork and window, the window is no longer weather-tight; rain penetration and subsequent water damage is therefore likely to ensue. Insulation of the area against external weather conditions will also be compromised.

It is recommended that all window sill seals be replaced by a general handyman or

sealant expert to prevent any further damage and to restore the window to a fully functional level.

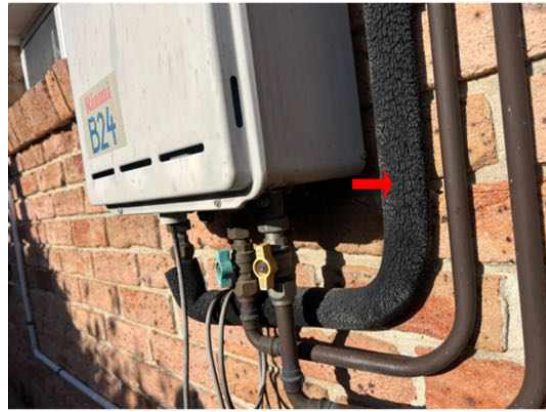
Finding 3.10

Building:	Main Building
Location:	Exterior walls - right side
Finding:	Pipework - Insulation deteriorated
Information:	Sections of the pipe insulation show evidence of damage and deterioration. It is suspected that this deterioration has developed as a result of excessive exposure to weather, including UV exposure in daylight. Deteriorated insulation reduces the effectiveness of the material in helping to maintain the desired temperature and work most efficiently.

If left in an exposed position, it is likely that the deterioration will continue and worsen over time, potentially resulting in secondary building defects as well as a further loss in insulating properties.

Some areas of replacement of pipe insulation is likely to be required. Further preventative measures to remove or protect the material from future exposure are also advisable. Consultation with a licensed plumber is advised to gain quotes for the repair and/or replacement of deteriorated insulation.

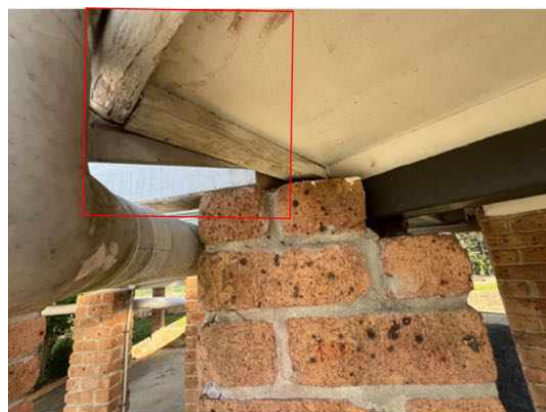
Finding 3.11

Finding: Eaves - Water Staining

Information: Water staining was observed to sections of the eave lining at the time of inspection. This staining is typically the result of moisture ingress from roof drainage issues, such as blocked or overflowing gutters, damaged flashing, or roof leaks above the affected area.

While no active leak was confirmed, the presence of water staining suggests a history of water exposure that may lead to material deterioration over time if left unaddressed. The appearance of staining also detracts from the overall condition of the eaves and associated roofing structures.

It is recommended that a licensed roof plumber be engaged to assess the area, identify the source of the staining, and carry out any required repairs to prevent further water ingress and deterioration.

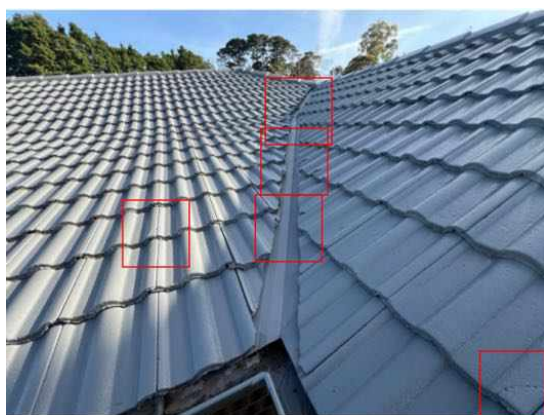
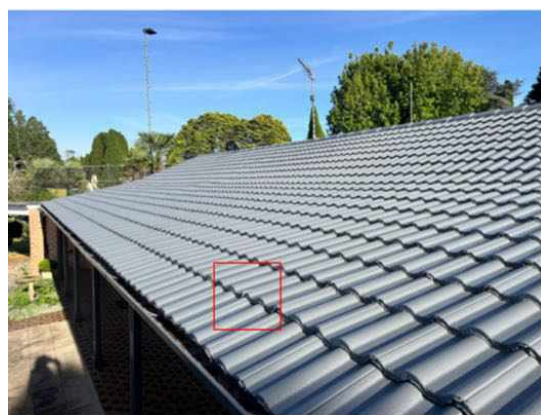
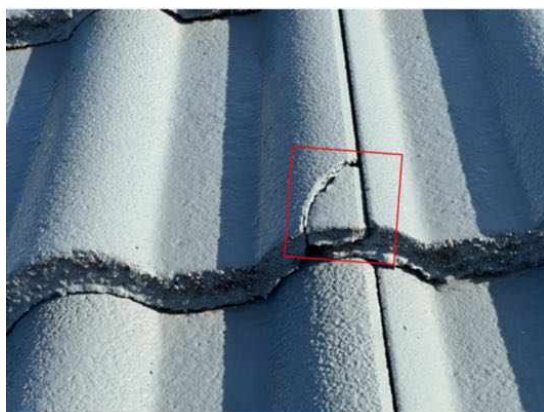
Finding 3.12

Finding: Roof tiles - Broken

Information: Upon inspection of the exterior roof covering, broken roofing tiles were identified. Broken and friable roof tiles are generally the result of ageing and weathering of what is essentially a porous material.

If left to further deteriorate, broken and brittle roof tiles are likely to lead to water penetration via the roof into the ceiling space, causing secondary damage to ceiling linings, insulation and roof structures. Broken roof tiles are also likely to detract from the effectiveness of the roof drainage system, creating potential for secondary damage to the exterior roof covering and roof plumbing.

Replacement of broken tiles is required and should be performed by a roofing contractor as soon as possible.

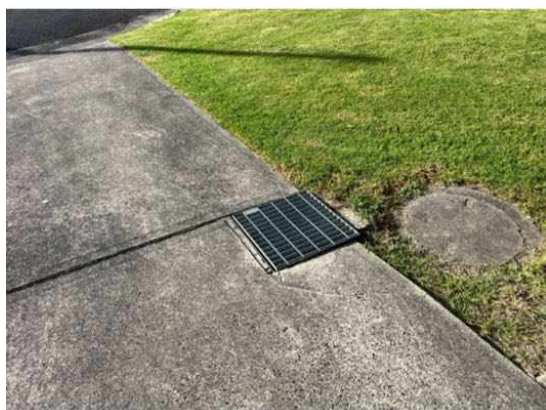
Building:	Yard
Location:	Driveway
Finding:	Stormwater Pit - Not Trafficable
Information:	The stormwater pit located within the driveway area was observed to be constructed from a lightweight plastic unit which is not considered suitable for trafficable locations. The pit structure shows signs of damage and deformation consistent with vehicle loading. Drainage pits installed within driveways are typically required to be of a traffic-rated construction capable of supporting vehicle loads.

Where non-trafficable pits are installed in vehicle areas, the surrounding pavement and pit structure may deteriorate over time as loading is transferred through materials not designed for this purpose.

It is recommended that the installation be assessed by a qualified plumber to confirm whether the pit is appropriate for the driveway loading conditions and to determine if upgrading to a traffic-rated pit is required.

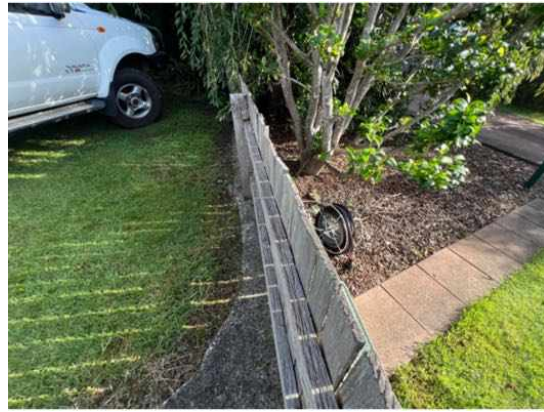
If left unattended, it is likely that further damage will occur. It is suspected that repair of several elements of the fencing may be required however replacement may be a consideration of the client also.

A licensed fencing contractor should be appointed to provide further advice and perform rectification works as necessary.

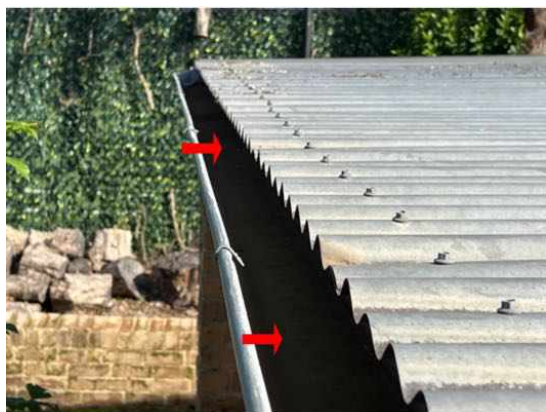
rusted elements of the roof plumbing.

A licensed plumber or specialist roof restoration company should be appointed to undertake these works. It is advised that such works be completed as soon as possible to prevent any further damage and deterioration.

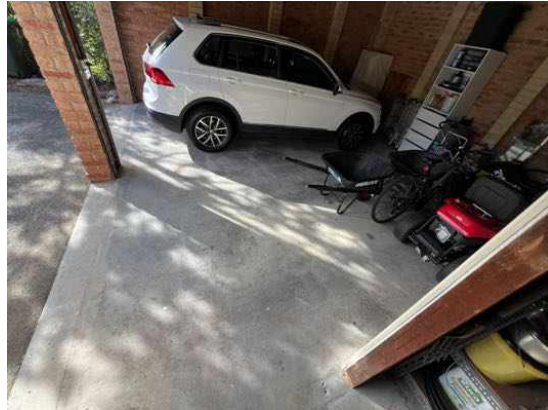
Finding 3.25

Building:	Garage
Location:	Garage
Finding:	Cracking - External Concrete Paving Damage Category 0 - Hairline (less than 1mm)
Information:	Hairline cracks were identified in external concrete paving. Hairline cracks are very minor in nature and generally are only ever an appearance defect. To be classified as a Category 0 or hairline crack, the crack width would be less than 0.3mm. While such cracking may be noticeable in some cases, it is common and does not indicate any structural damage.

Monitoring of all cracking should be conducted frequently. Always contact a building inspector should cracks widen, lengthen, or become more numerous.

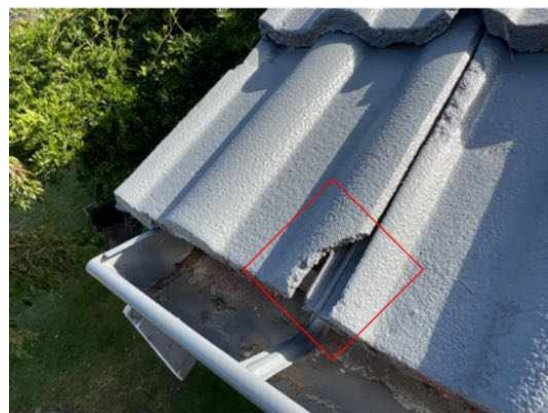
Finding 3.26

Building:	Garage
Location:	Roof Exterior - Garage
Finding:	Roof tiles - Broken
Information:	Upon inspection of the exterior roof covering, broken roofing tiles were identified. Broken and friable roof tiles are generally the result of ageing and weathering of what is essentially a porous material.

Replacement of broken tiles is required and should be performed by a roofing contractor as soon as possible.

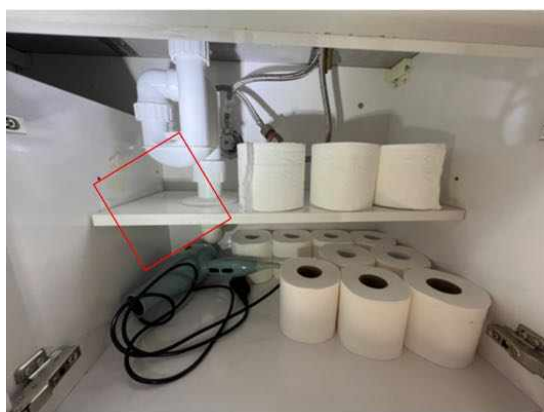
If left unmanaged, persistent moisture can lead to material deterioration, mould growth, and potential damage to adjacent cabinetry or flooring. It is advised that a licensed plumber be engaged to inspect the area, determine if an active leak is present, and undertake any necessary rectification works.

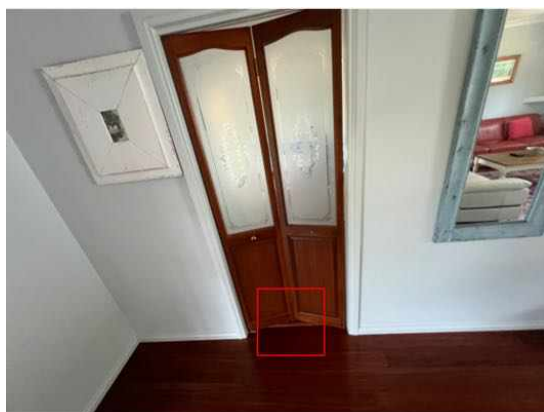
Building:	Main Building
Location:	Rumpus Room
Finding:	Door - Binding/jamming
Information:	Binding and/or jamming of this door is evident during standard operation. This defect inhibits the functionality of the affected door as well as creating potential for secondary defects to associated building elements, such as damage to the floor covering.

For minor causes, a qualified carpenter or general handyperson should be appointed to perform minor rectification works at client discretion.

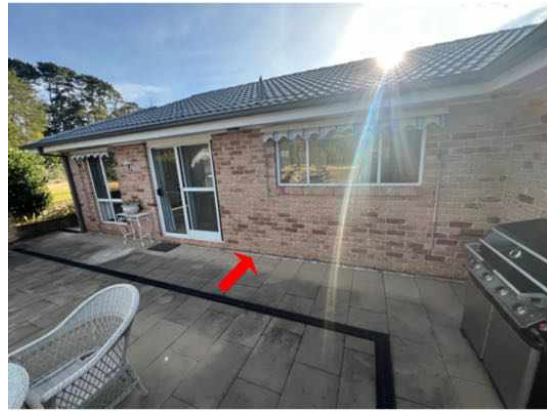
Finding 3.47

Building:	Main Building
Location:	Bedroom 4
Finding:	Doors - Stiff to slide
Information:	Several doors throughout the property were jammed and difficult to slide along the associated tracks at the time of the inspection. Restricted function of the affected doors may pose as a potential safety hazard if required for emergency egress from the building.

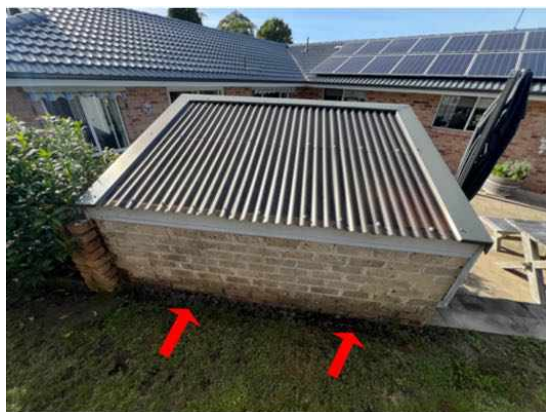
Information: Excessive moisture can attract termites and produce conditions that promote termite attack, fungal growth and wood decay. Excessive moisture is generally caused by deteriorated, inadequate or missing roof drainage, leaking plumbing pipes or fixtures, poorly plumbed HWS overflows or condenser units and poor site drainage. It is highly recommended that all plumbing and drainage fixtures and fittings be maintained regularly in order to prevent excessive moisture being present in the external / internal property.

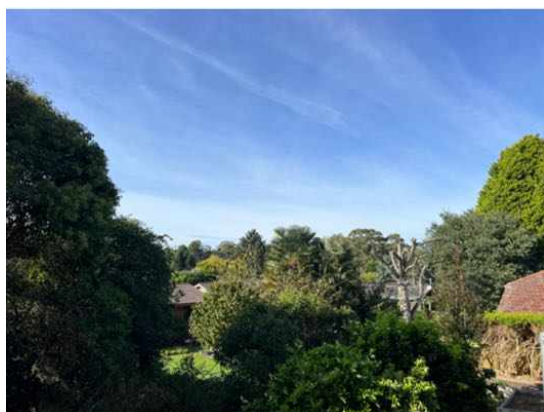
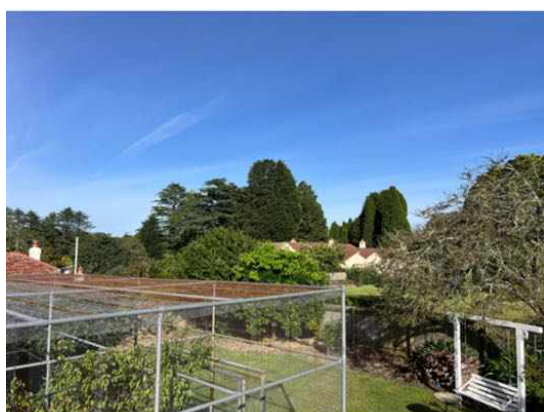
Finding 6.15

Building:	Yard
Location:	The Site
Finding:	Timber Pest Risk – Trees Within 50m of Dwelling
Information:	Mature trees were identified within 50 metres of the dwelling. The presence of trees in close proximity to the structure increases the risk of termite activity, as trees provide a natural food source and nesting environment for termites. Tree roots can also contribute to excessive moisture retention in the soil, creating conducive conditions for timber pest activity.
