Building Inspection Report

Inspection Date: Mon, 2 Mar 2026

Property Address: 418/19 Epping Rd, Epping NSW 2121,
Australia

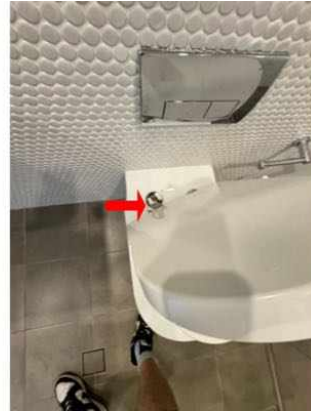
Defects 3.03

Building: Main Building
 Location: Bathroom
 Finding: Toilet pan - Loose
 Information: The toilet pan was found to be loose and relatively unstable at the time of inspection. It is suspected that this defect has developed due to general aging of the toilet pan and associated materials. However, the loose fixing may also be a result of impact damage.

If left unmanaged, the toilet pan could deteriorate further, leading to greater destabilisation and the potential for water leaks to surrounding building elements.

It is recommended that the pan be refixed to the floor with concrete or silicone by a licensed plumbing contractor.

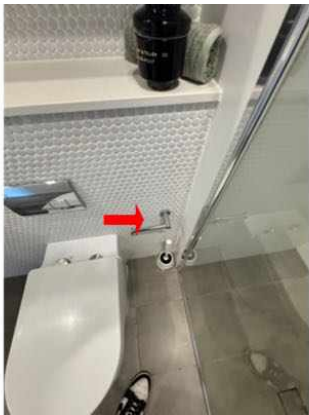
Defects 3.04

Finding: Toilet roll holder - Loose

Information: The toilet roll holder was found to be loose at the time of inspection. While not a major operational defect, function can deteriorate if the problem is left unmanaged.

It is advised that the homeowner performs remedial works to re-attach the toilet roll holder to its original fixing. A general handyperson may be required to perform these works.
