Building and Timber Pest Inspection Report

Inspection Date: Fri, 27 Feb 2026

Property Address: 1108/13 Verona Dr, Wentworth Point NSW
2127, Australia

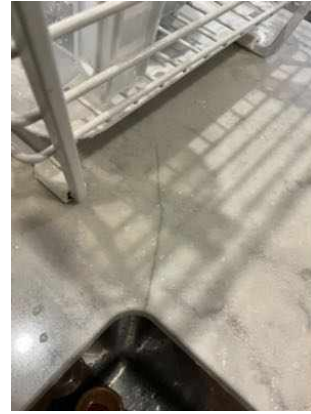
Building: Main Building
Location: Kitchen
Finding: Kitchen benchtop - crack fine
Information: A crack has been identified in the kitchen benchtop, compromising its structural integrity and aesthetic appeal.

The crack in the kitchen benchtop poses several risks, including:

1. Safety Hazard: The crack may widen over time, leading to potential injuries from sharp edges or structural instability.
2. Hygiene Concerns: The crack can harbor bacteria, mold, and other contaminants, posing a risk to food safety and hygiene.
3. Damage to Surrounding Areas: Water or other liquids may seep into the crack, causing damage to the underlying cabinets, flooring, or walls.

A qualified contractor or carpenter specializing in countertop repair or replacement should address the issue promptly. Depending on the severity of the crack, repair options may include filling the crack with epoxy or resin, reinforcing the benchtop, or replacing the entire countertop.

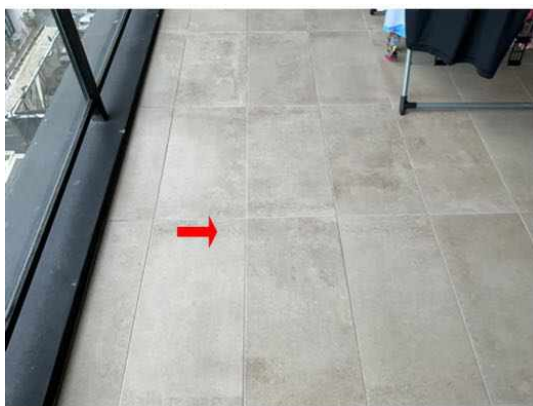
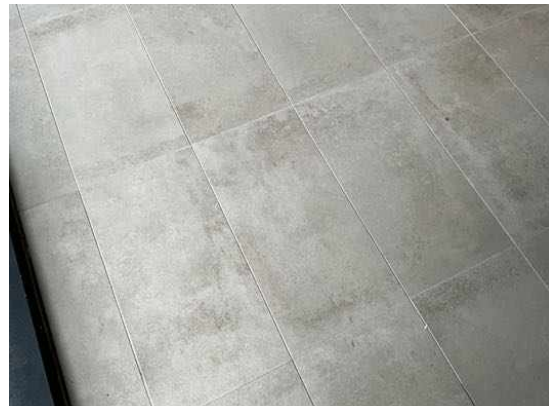
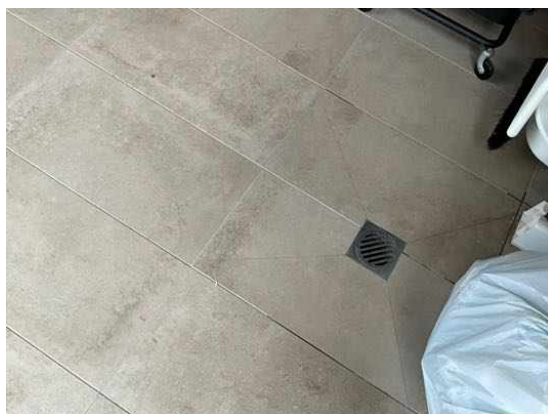
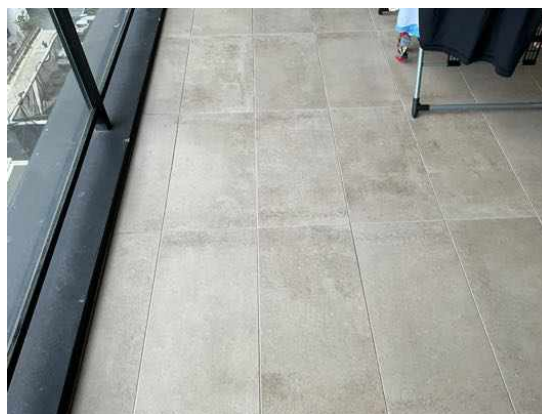
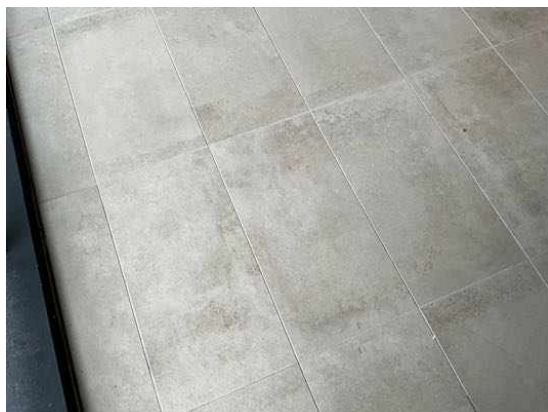
Finding 3.02

Finding: Water staining

Information: Water staining was evident in this area at the time of inspection. Water staining indicates that surfaces have been exposed to excessive moisture over time. The minerals and other elements in the water lead to staining, which may graduate to corrosion and deterioration if left unmanaged.

While mostly an appearance defect, water staining can be indicative of more serious defects, which may be currently concealed by other building elements.

Where water staining is active, a licensed plumber must be consulted to identify the cause of the staining and to provide advice on any reparation works that may be required. Replacement of any broken or damaged structures is advised.

Conversely, where water staining is old and inactive, affected building materials may be repaired or replaced at client discretion. A qualified carpenter or registered builder may be appointed to perform these works.

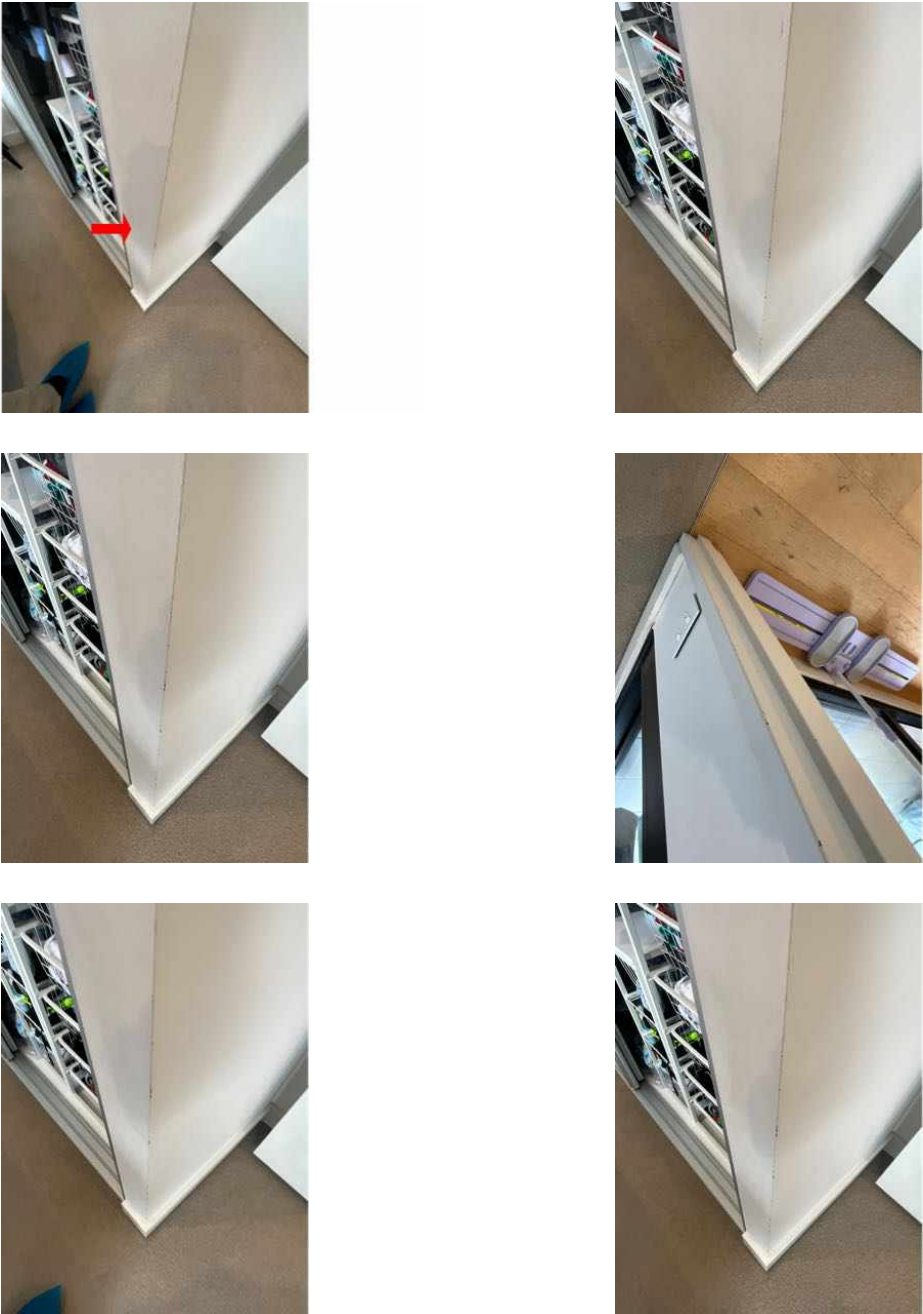
Finding 3.03

Building:	Main Building
Location:	All Areas
Finding:	Paint surface - Scratches
Information:	Scratches have been identified on the paint surface, detracting from the overall appearance and quality of the painted surface.

1. Aesthetic Degradation: Scratches mar the appearance of the painted surface, diminishing its visual appeal and potentially lowering property value.
2. Corrosion Vulnerability: Exposed areas of bare metal due to scratched paint are susceptible to corrosion, leading to structural damage and compromised durability.
3. Environmental Hazards: Scratched paint can release hazardous chemicals into the environment, posing risks to both human health and the ecosystem.

A qualified painter should address the issue promptly to repair the scratched paint. Depending on the severity of the scratches, repair options may include sanding,

priming, and repainting the affected area to restore the integrity and appearance of the paint surface.

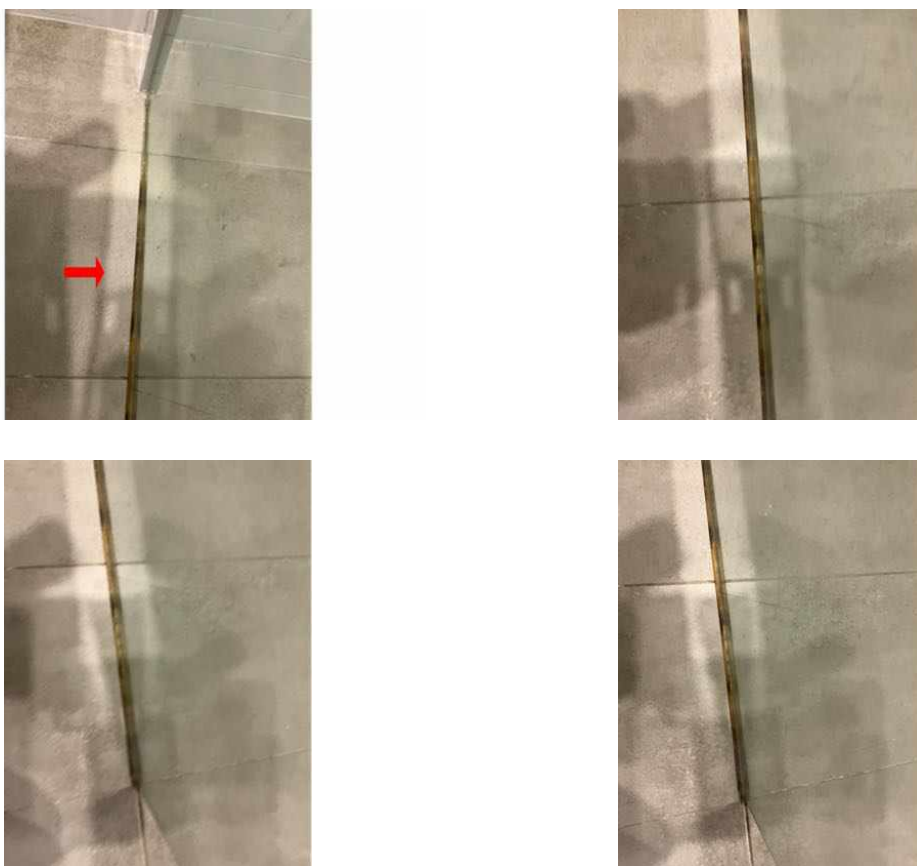
Finding 3.04

Building: Main Building
Location: Ensuite
Finding: Sealant and grouting - Missing or damaged
Information: It was noted on inspection that sealant or grout is degraded to the tiled shower alcove and or other areas of the bathroom.

Different materials and floor areas move at different rates, generally causing cracking

There appears to be excessive mould to the sealant and grout which will likely require scraping out and replacement.

Flexible and mould resistant materials should be applied to affected areas to prevent any subsequent water damage that is likely to occur. Regular maintenance and replacement of damage or missing or damaged sealant and grout is highly recommended to the wet areas, as this is a regular wear and tear defect. Sealant and grouting in areas that come into regular contact with water should be maintained for the long term care of your property.

A sealant specialist or tiling contractor should be appointed to complete these works as soon as possible

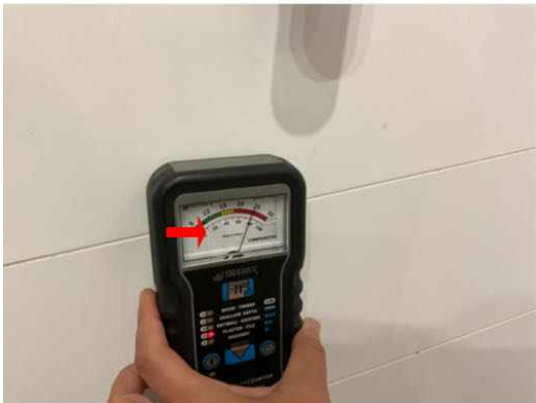
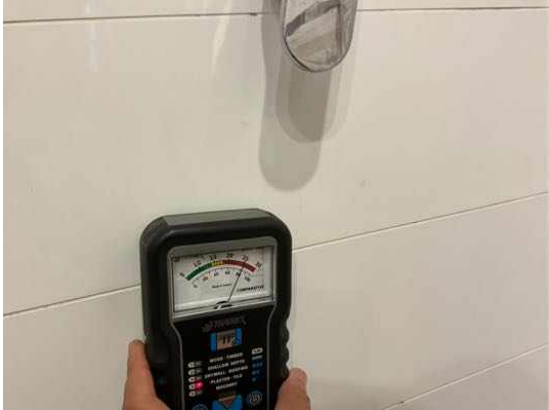
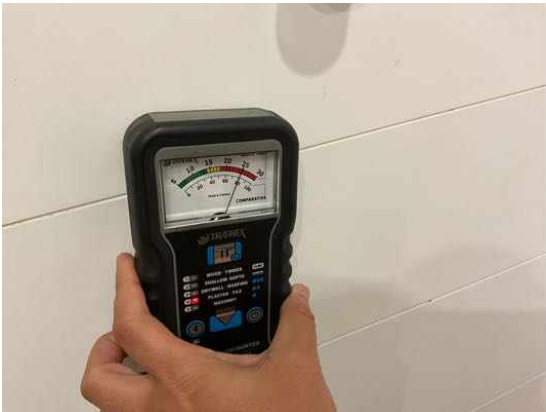
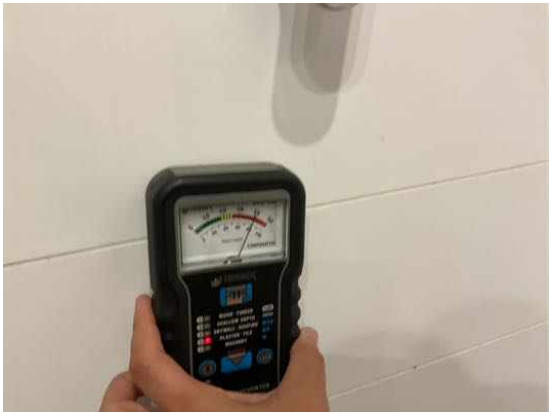
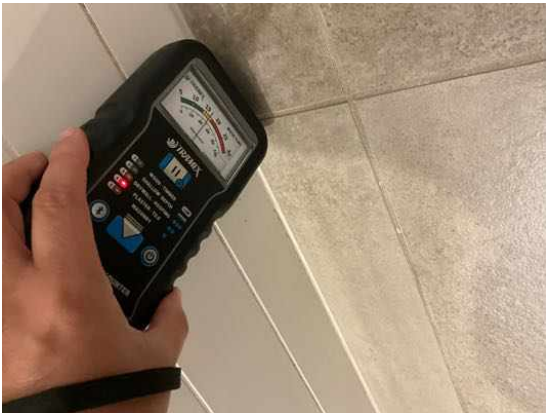
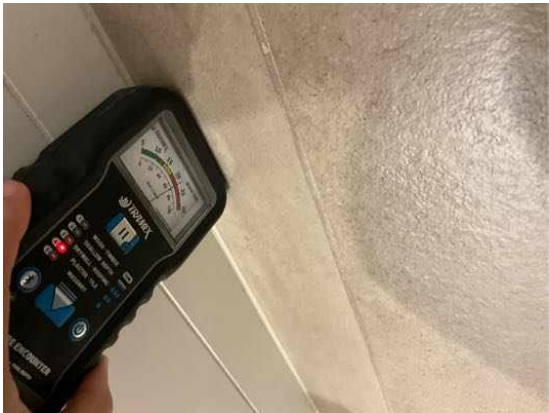
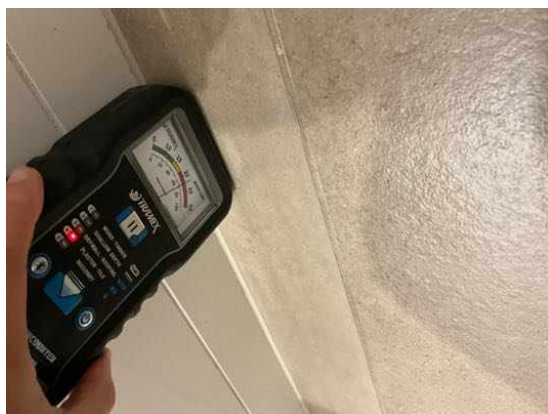
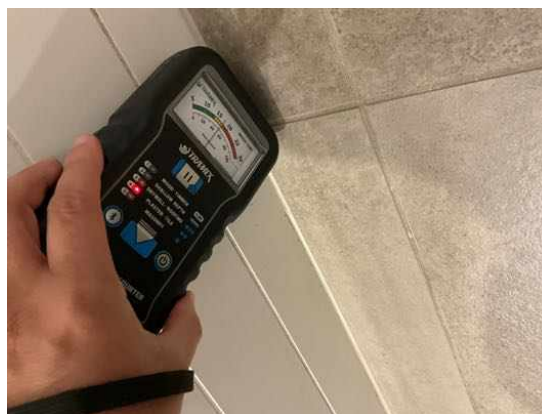
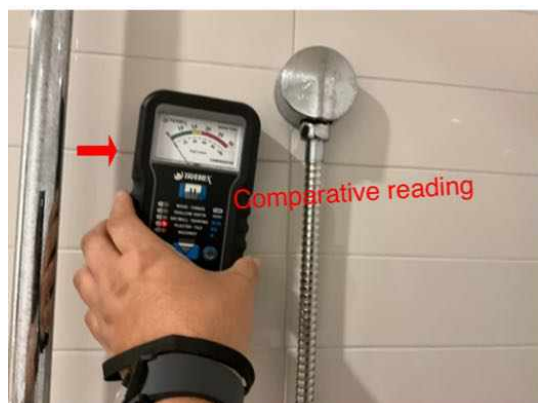
Finding 3.05

Building:	Main Building
Location:	Ensuite
Finding:	Evidence of excessive moisture was present at the time of inspection
Information:	Excessive moisture is present behind the bathroom tiles, indicating a potential water leakage issue within the wall.

The prolonged presence of moisture can lead to mold growth, deteriorate the structure, and create an environment conducive to health hazards. Additionally, it may compromise the adhesive holding the tiles, leading to their detachment.

A licensed plumber or a qualified contractor specializing in water damage remediation should investigate the source of the moisture, fix any leaks, and address the damage. Additionally, replacing affected tiles and ensuring proper waterproofing are crucial to preventing future issues.

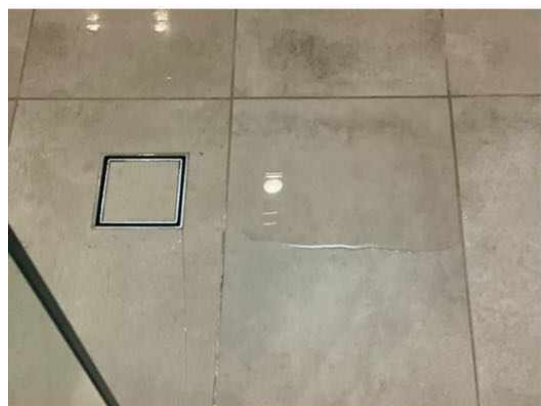
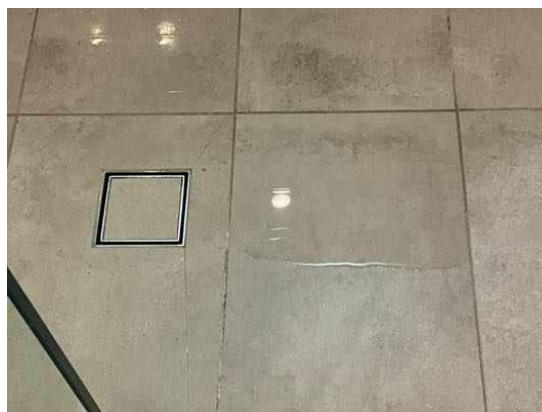
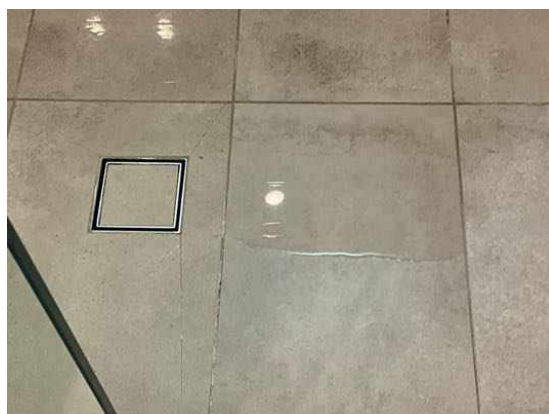
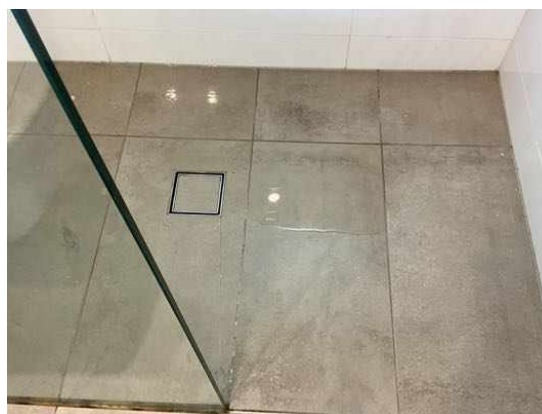
Finding 3.06

Building:	Main Building
Location:	Ensuite
Finding:	Shower base - Water pooling
Information:	Evidence of water pooling around the floor waste in the shower recess was noticed at the time of inspection. It is suspected that this excessive moisture is attributed to insufficient fall in the shower floor tiles.

This pooling is minor overall but is still considered unsatisfactory, as standard tiling practices would not permit this situation to occur. Pooling water around floor wastes can create a slip hazard in extreme cases and create conditions that are conducive to mould growth over time. Where left unmanaged, the degradation of sealant and grouting is also likely to occur, possibly necessitating further repair works.

Remedial works may involve some sections of tiling and flooring repair and replacement. A tiling contractor or bathroom specialist should be appointed to provide further advice on reparation options and to perform works as necessary.

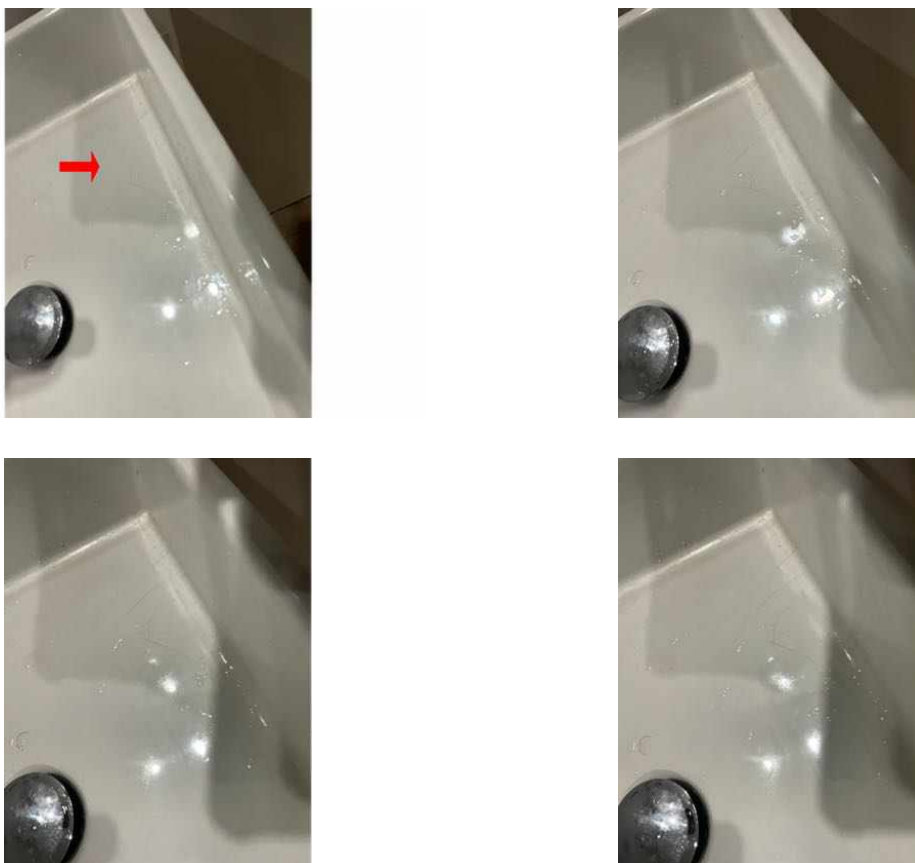
Finding 3.07

Finding: Basin - Cracks

Information: Cracking was evident to the basin at the time of inspection. While the cracking appears to be minor, any further impact damage sustained by the basin may lead to additional cracking.

As the cracking provides potential ingress for water, secondary water damage may occur to associated cabinetry, walls or flooring, if the cracking is left unmanaged.

Consultation with a plumber regarding basin repair or replacement is required. Remedial works may be required to protect against any further damage.

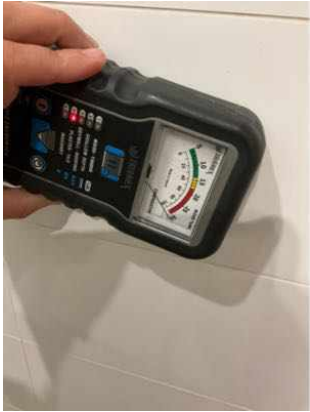
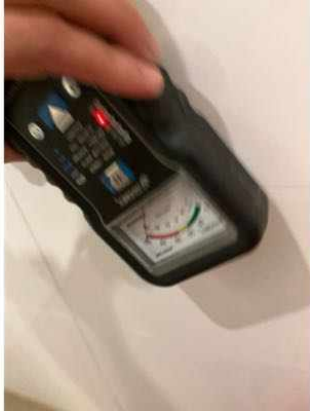
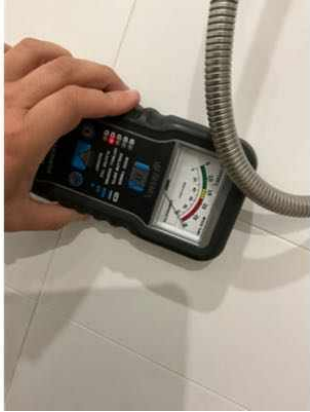
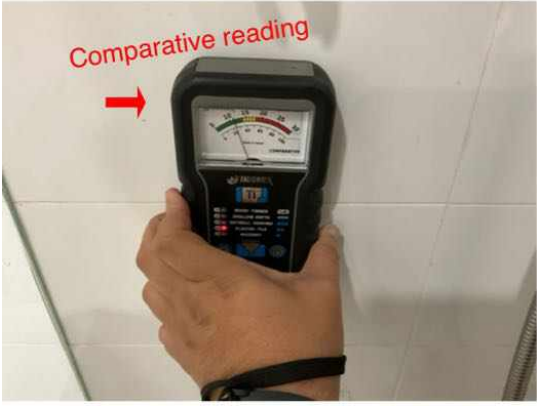
Finding 3.08

Building:	Main Building
Location:	Bathroom
Finding:	Evidence of excessive moisture was present at the time of inspection
Information:	Excessive moisture is present behind the bathroom tiles, indicating a potential water leakage issue within the wall.

The prolonged presence of moisture can lead to mold growth, deteriorate the structure, and create an environment conducive to health hazards. Additionally, it may compromise the adhesive holding the tiles, leading to their detachment.

A licensed plumber or a qualified contractor specializing in water damage remediation should investigate the source of the moisture, fix any leaks, and address the damage. Additionally, replacing affected tiles and ensuring proper waterproofing are crucial to preventing future issues.

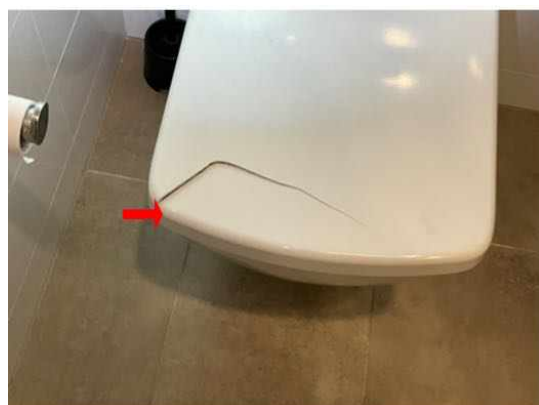
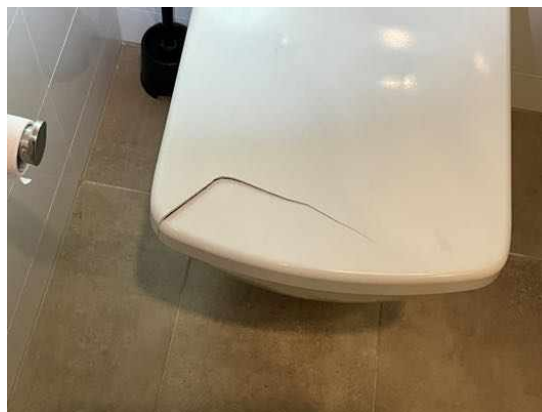
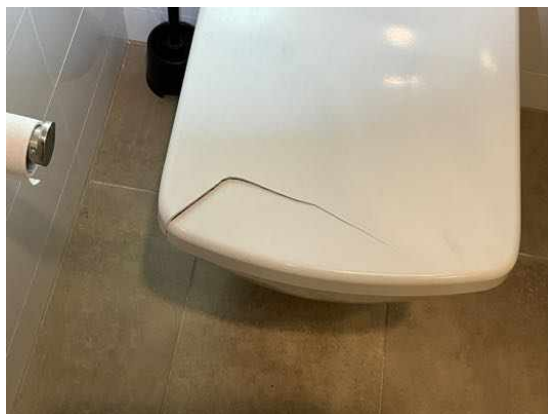
Finding 3.09

Building: Main Building
 Location: Bathroom
 Finding: Toilet seat cover - damaged
 Information: The toilet seat cover is damaged, exhibiting potential instability.

The damaged toilet seat cover poses a risk of injury, discomfort, and may lead to further breakage. Additionally, it can compromise hygiene standards and affect the overall functionality of the toilet.

A maintenance or facilities personnel should be notified to inspect and replace the damaged toilet seat cover promptly. Timely replacement is essential to ensure user comfort, safety, and maintain proper sanitation standards in the restroom.

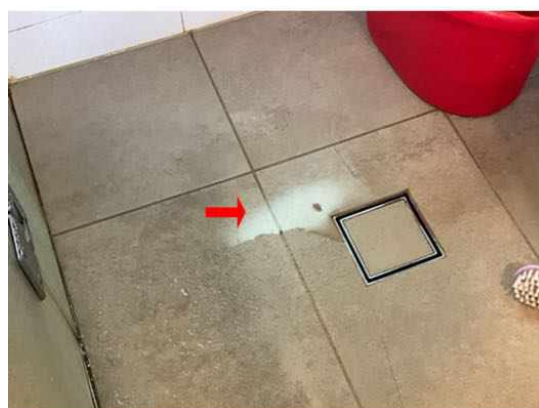
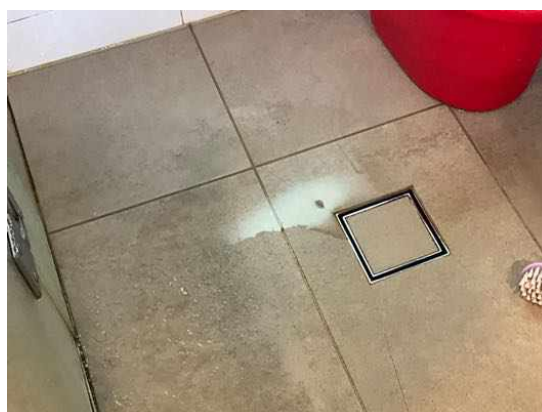
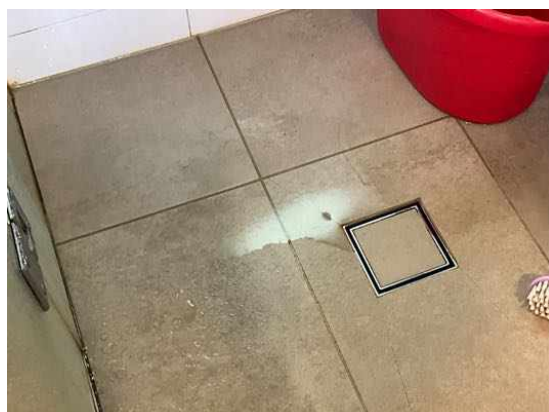
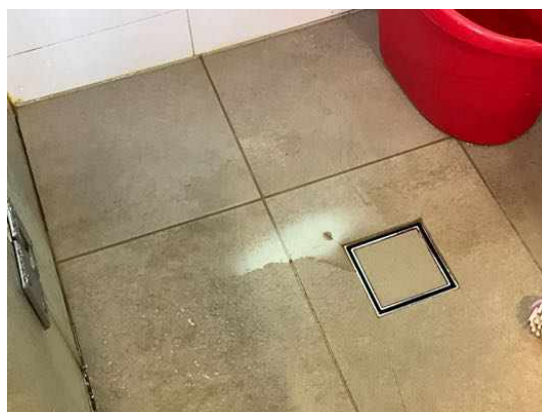
Finding 3.10

Building: Main Building
 Location: Bathroom
 Finding: Shower base - Water pooling
 Information: Evidence of water pooling around the floor waste in the shower recess was noticed at the time of inspection. It is suspected that this excessive moisture is attributed to insufficient fall in the shower floor tiles.

practices would not permit this situation to occur. Pooling water around floor wastes can create a slip hazard in extreme cases and create conditions that are conducive to mould growth over time. Where left unmanaged, the degradation of sealant and grouting is also likely to occur, possibly necessitating further repair works.

Remedial works may involve some sections of tiling and flooring repair and replacement. A tiling contractor or bathroom specialist should be appointed to provide further advice on reparation options and to perform works as necessary.

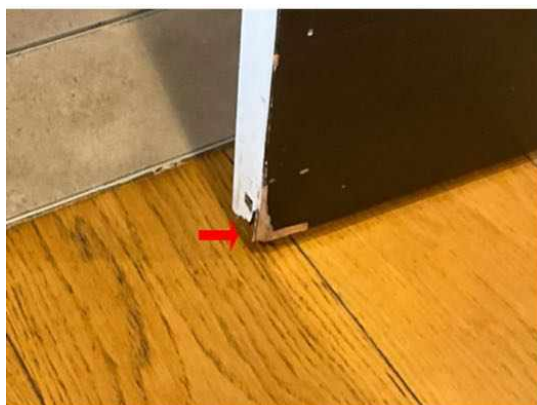
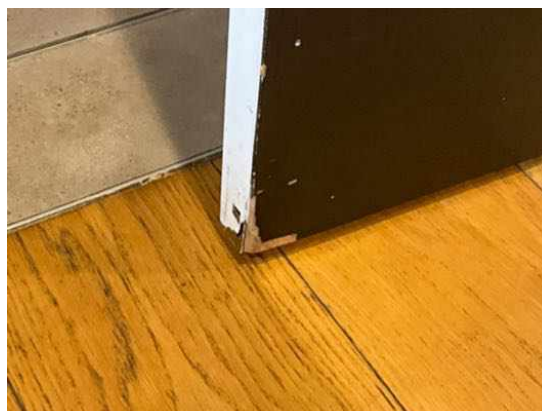
Finding 3.11

Building: Main Building
 Location: Front door
 Finding: Damaged Door
 Information: The door exhibits visible damage, including scratches, dents, and/or cracks, compromising its structural integrity and aesthetic appeal.

The damaged door poses security risks, reduced insulation efficiency, and an unsightly appearance that can affect property value and aesthetics.

A skilled carpenter or door specialist should address the damage by repairing or replacing the affected door components to restore functionality, security, and appearance.

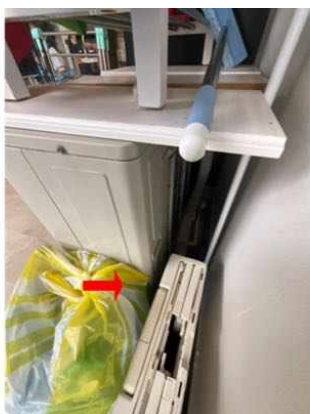
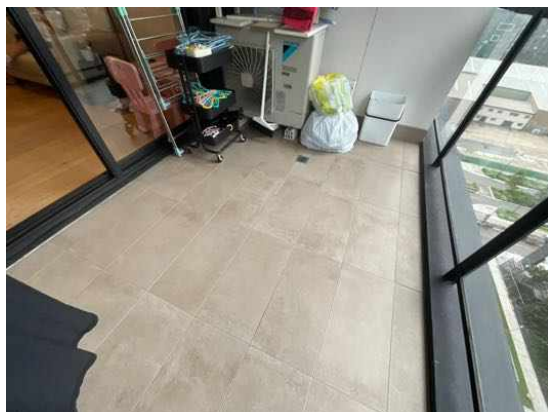
Where bridging has occurred full inspection is prevented and termites may enter a property in a concealed or undetected manner.

Recommended moving obstructions away from the external walls for further and future inspections.

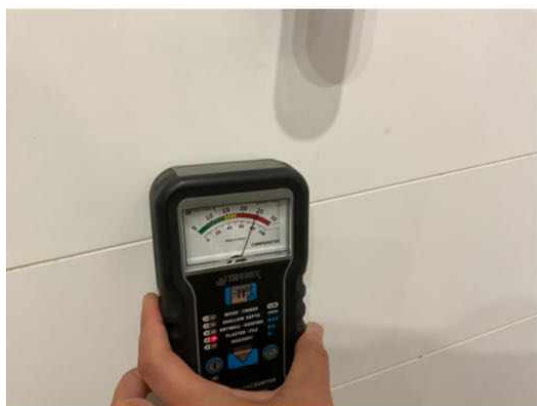
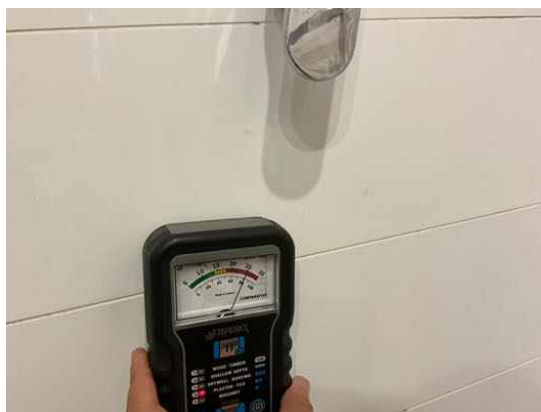
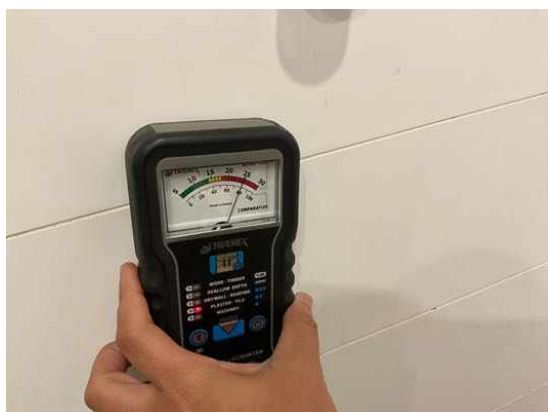
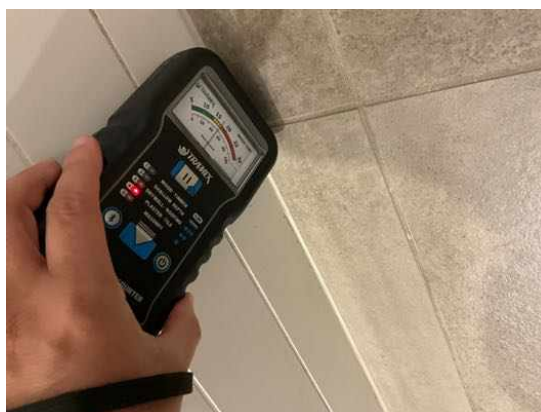
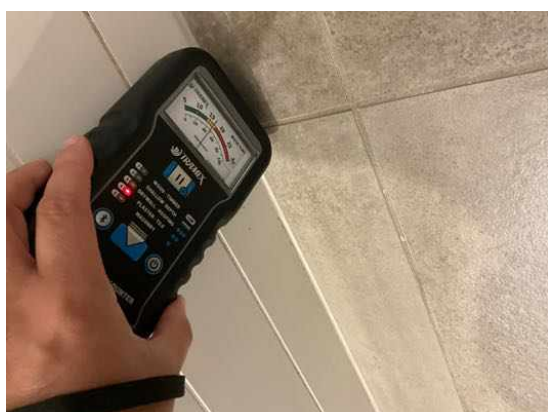
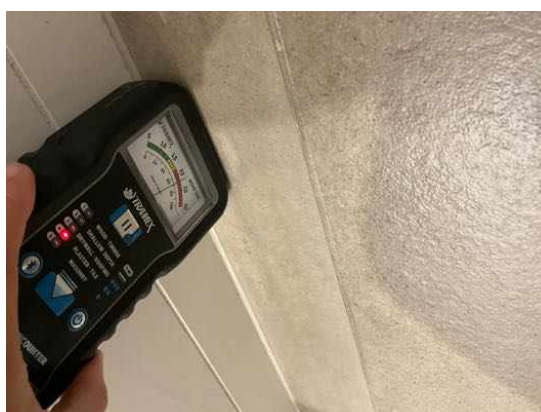
Finding 6.02

Building:	Main Building
Location:	Ensuite
Finding:	Excessive moisture - Conducive to Timber pest
Information:	Excessive moisture can attract termites and produce conditions that promote fungal growth and wood decay.

Excessive moisture is generally caused by deteriorated inadequate or missing roof drainage leaking plumbing pipes or fixtures poorly plumbed HWS overflows or condenser units and poor site drainage.

Prior to any remedial works being performed a qualified plumber should be appointed to further inspect the property and to identify the cause of the excessive moisture. Works to remove affected building elements may then be necessary and should be performed by an appropriate tradesperson.
