Building Inspection Report

Inspection Date: Mon, 2 Feb 2026

Property Address: 6 Westward Ho Dr, Sunbury VIC 3429,
Australia

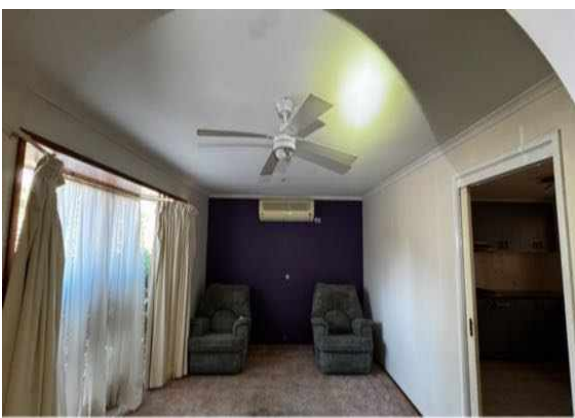
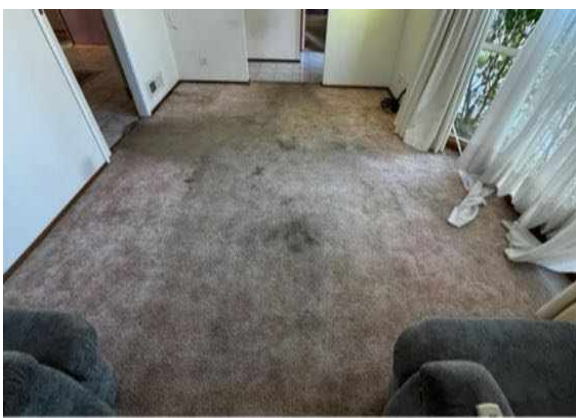
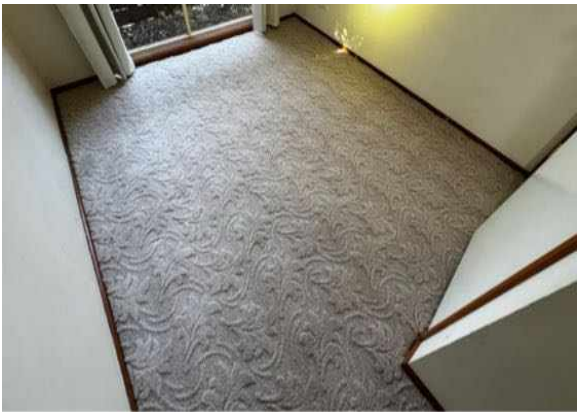
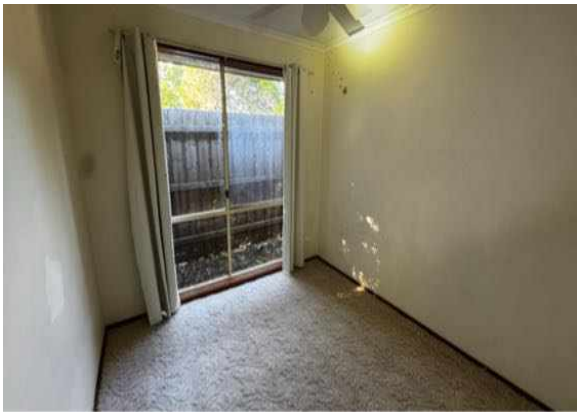
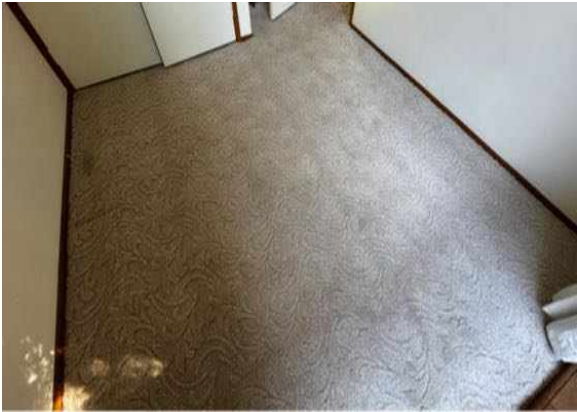
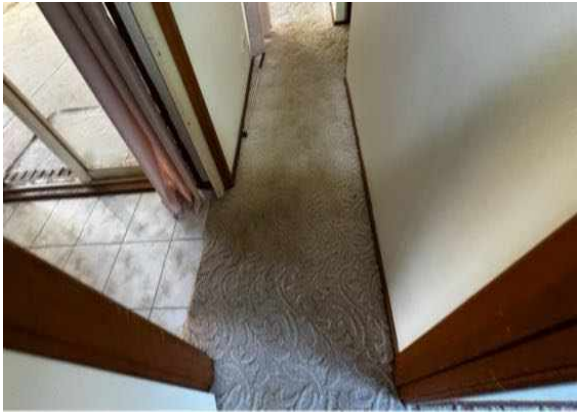
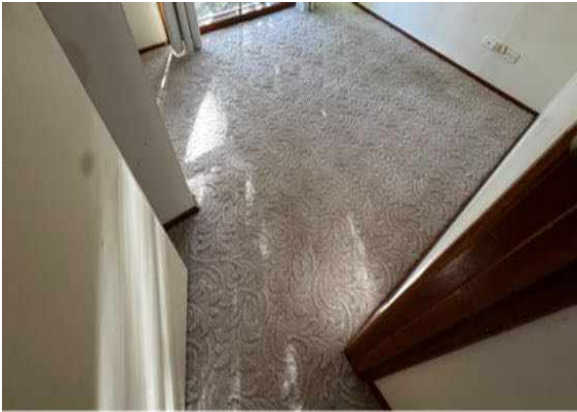
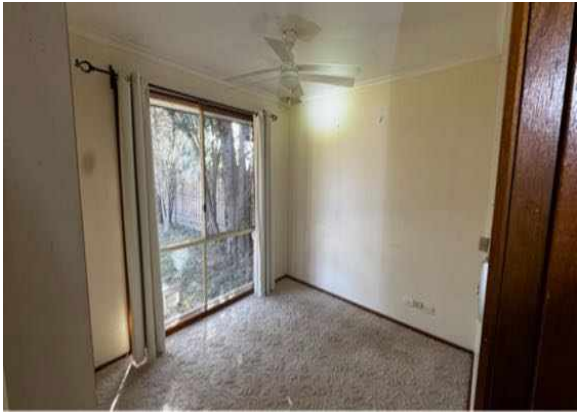
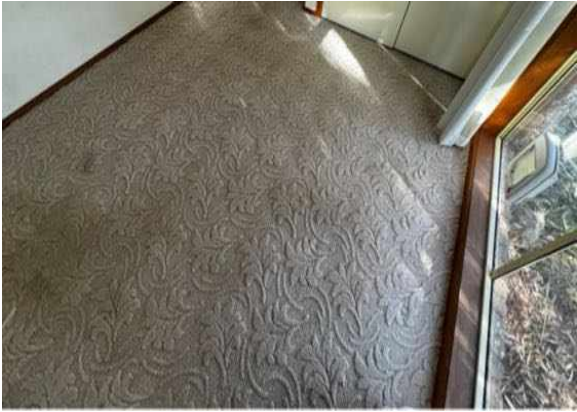
Defects 3.05

Finding: Floors - Carpet Damaged

Information: The carpet was inspected and found to be damaged in these areas, with signs of wear and staining. Damaged carpet can reduce comfort, detract from the appearance of the space, and, over time, expose the subfloor to additional wear or moisture.

This condition may result from everyday use, accidental impact, or age-related deterioration.

A qualified flooring installer should be engaged when practical to clean, repair and or replace the affected carpet. Timely attention will restore visual appeal, comfort, and the longevity of the flooring.

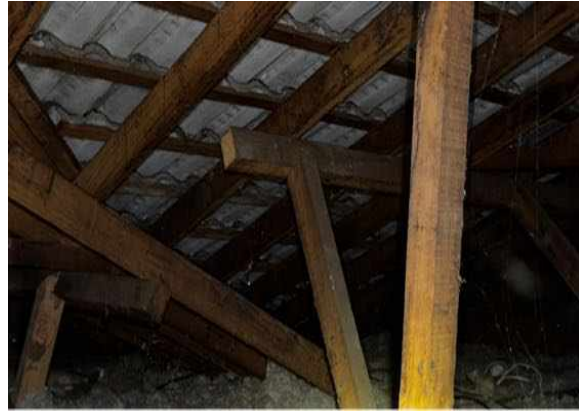
Defects 3.12

Building: Main Building
 Location: Roof Void
 Finding: Roof Void - Limited Access
 Information: Limited access to the roof void was present due to facts including but not limited to, limited access, insulation, Air condition Unit & ducting, obstructions or placement of insulation and or sarking, for this reason complete access to the roof void was not possible.

NOTE: Unless all insulation is removed from the roof space a full inspection is never possible, timber pest or termite activity and/or damage may not be visible.

A visual inspection was carried out from accessible areas only, recommend installing another access hatch in a more accessible area for a re-inspection.

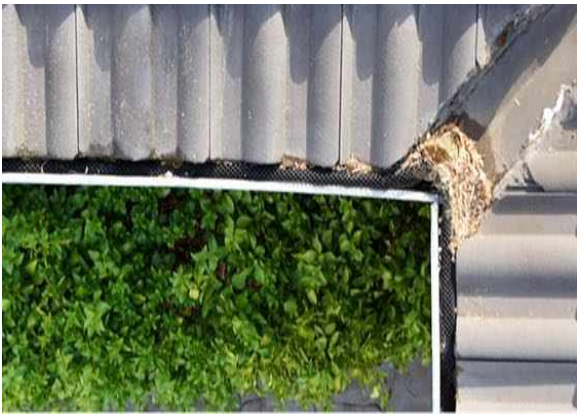
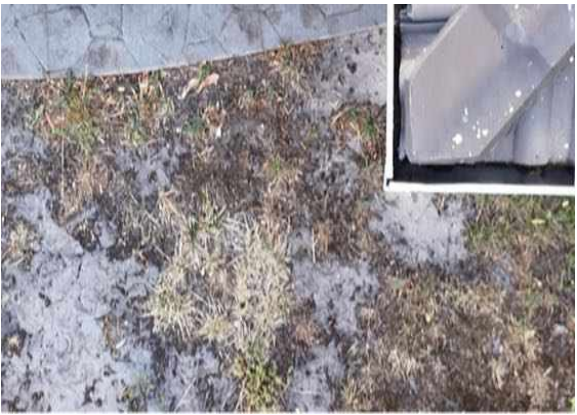
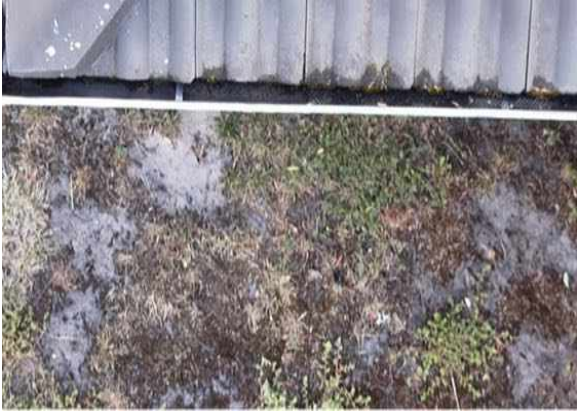
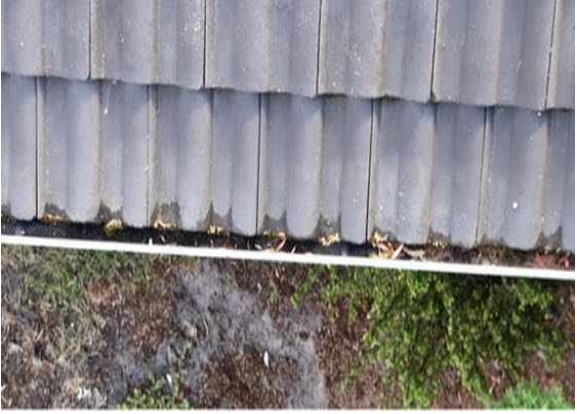
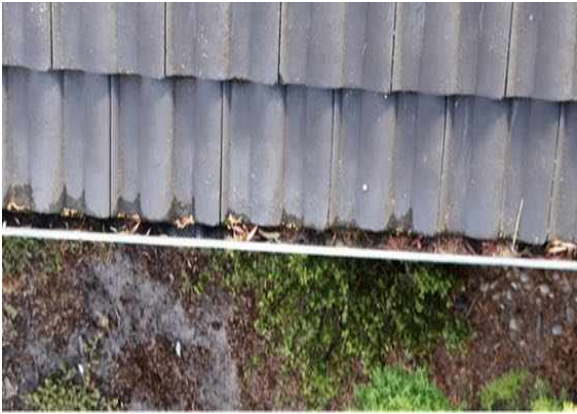
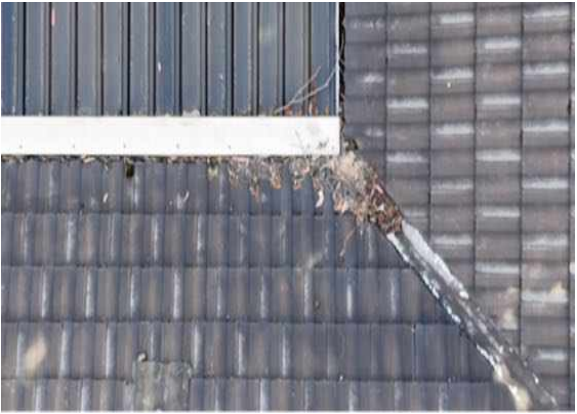
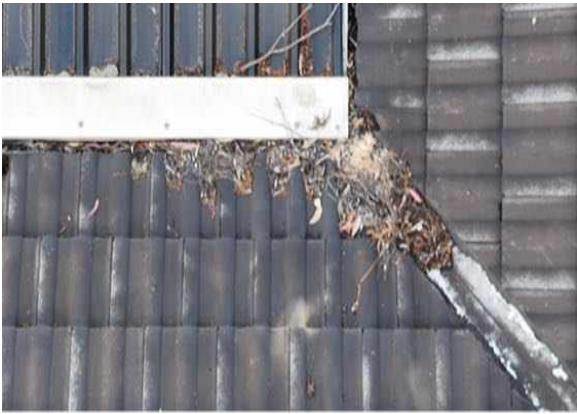
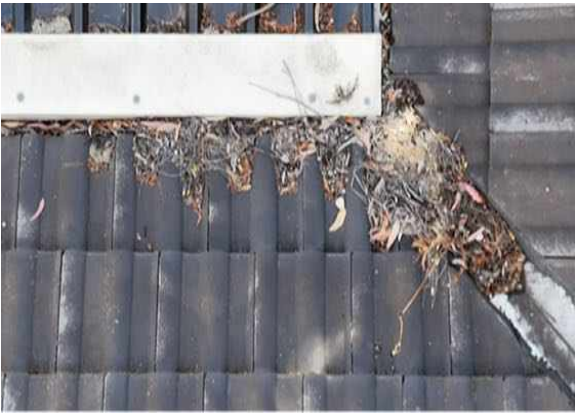
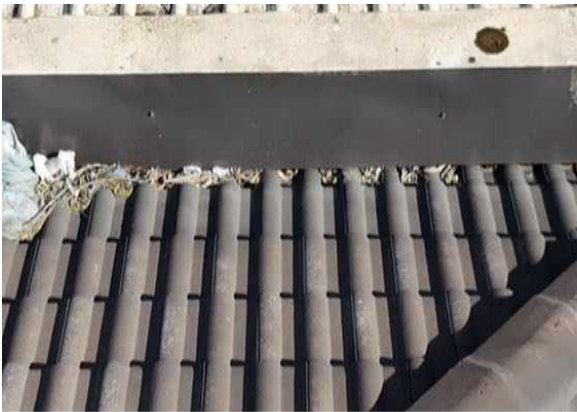
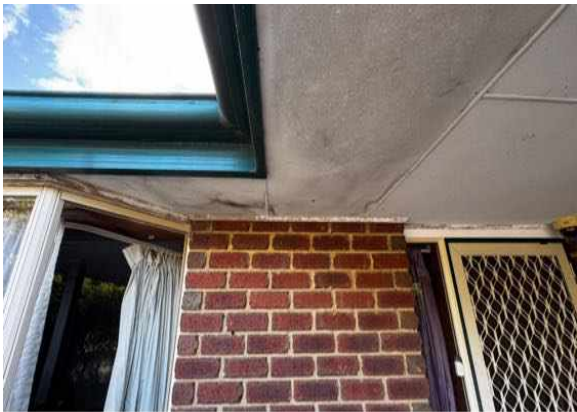
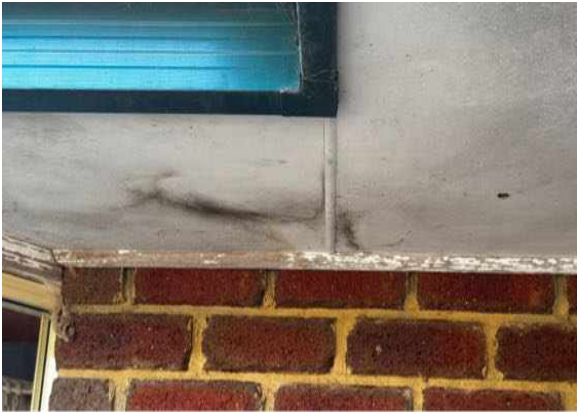
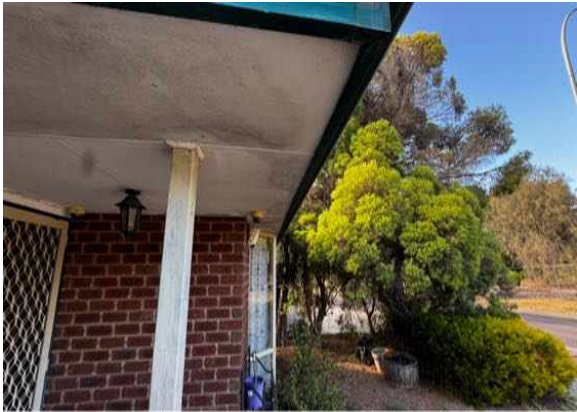
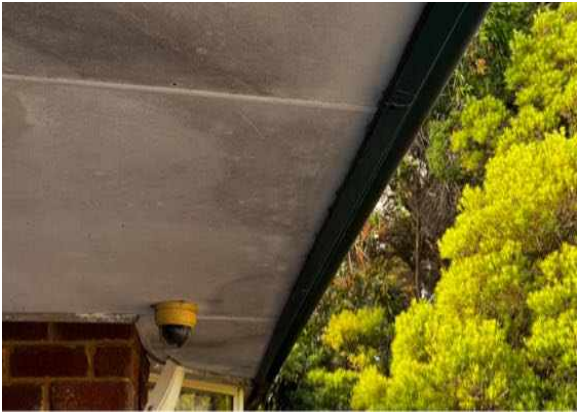
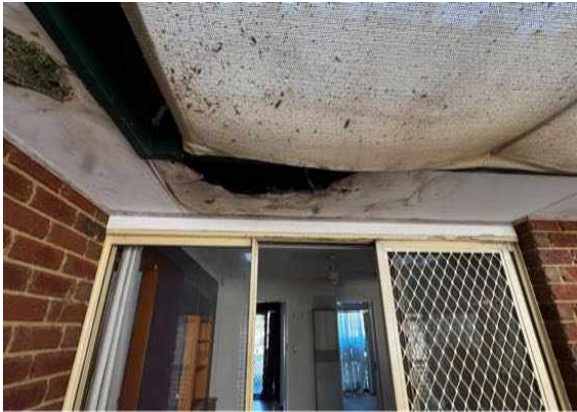
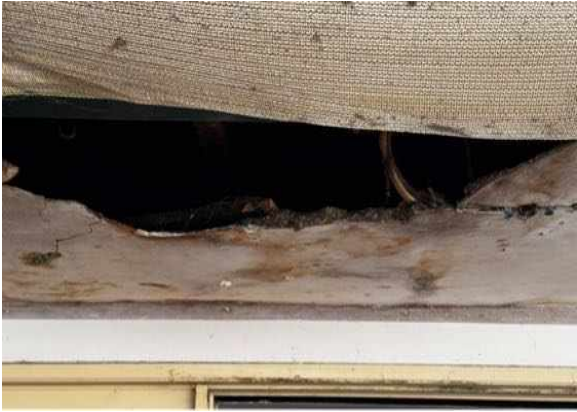
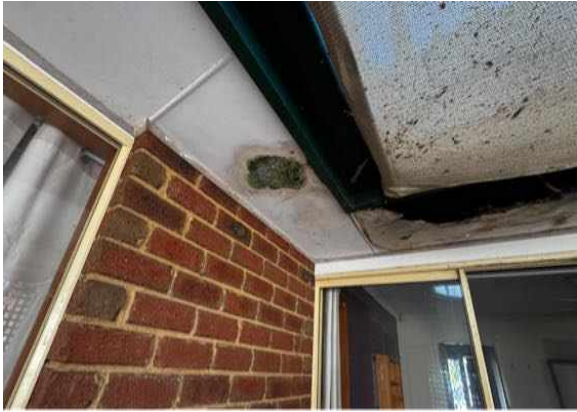
Defects 3.16

Building: Main Building
Location: All Roof Areas
Finding: Roof Plumbing - Gutters Blocked & Leaking
Information: Gutters in this area are blocked and leaking and not allowing water to flow freely. The issue is observed along the gutter runs where leaves, debris, or other obstructions have accumulated.

This has likely occurred due to lack of maintenance or build-up of debris over time. Blocked gutters may cause water to overflow, damage the roof, walls, or foundations, and increase the risk of erosion or water ingress.

A licensed roof plumber is required to inspect and clear the blocked gutters in this area immediately. This should be rectified immediately to ensure water drains correctly and to prevent potential damage to the building.

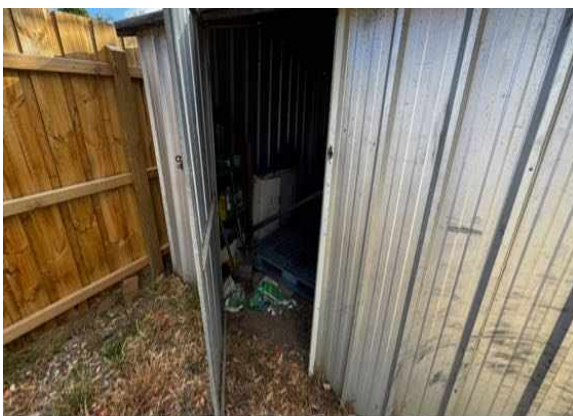
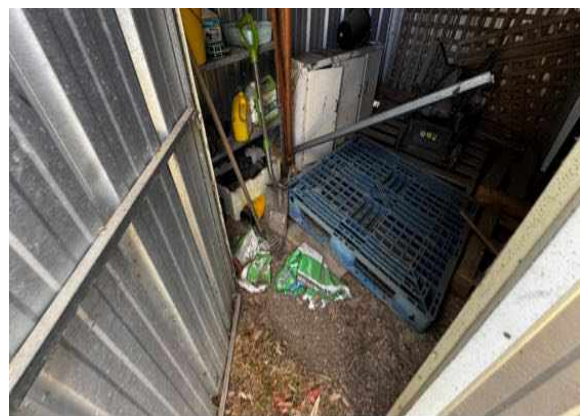
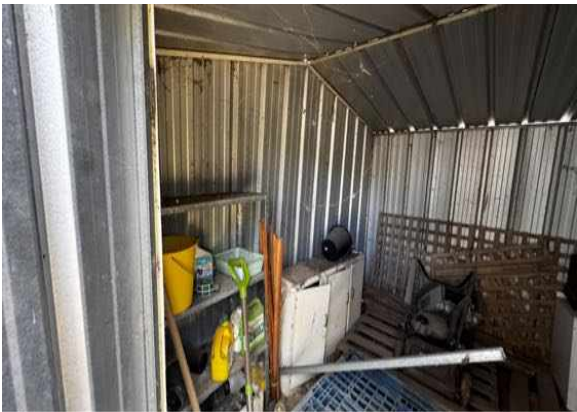
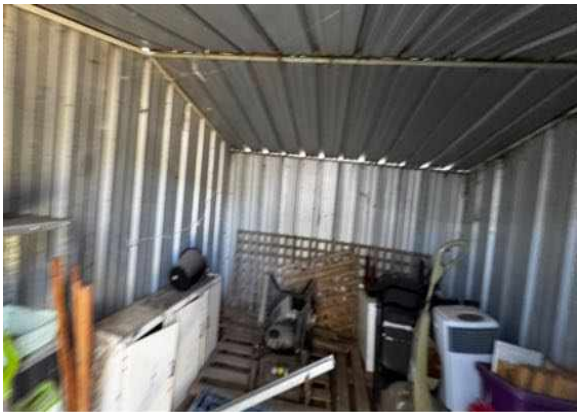
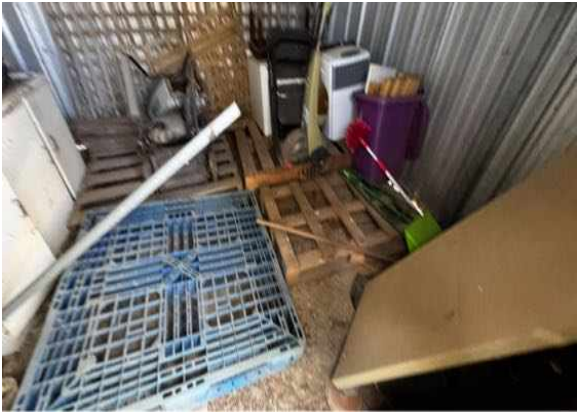
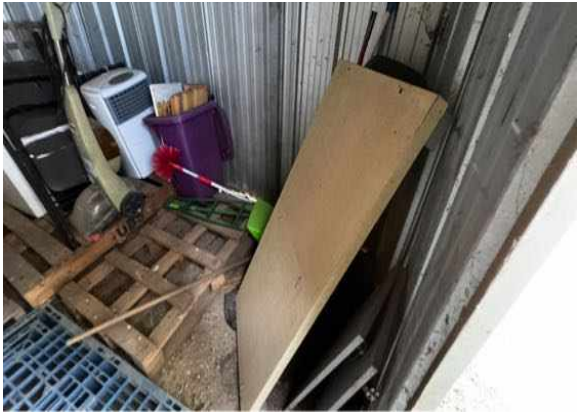
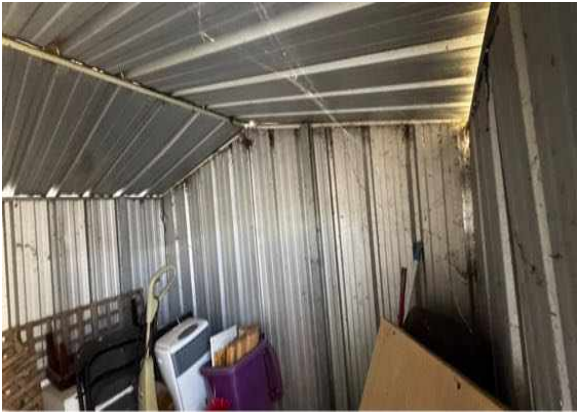
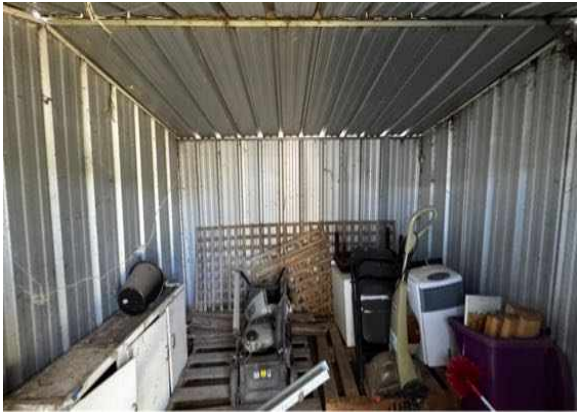
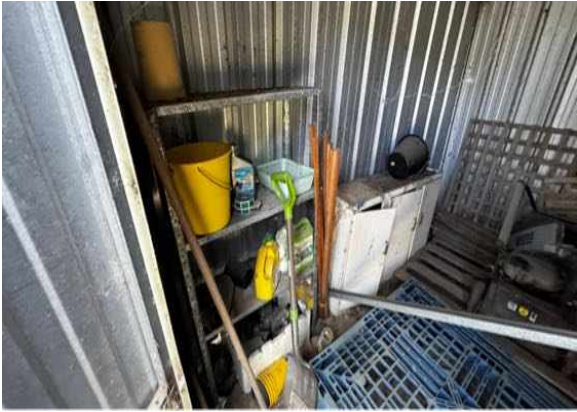
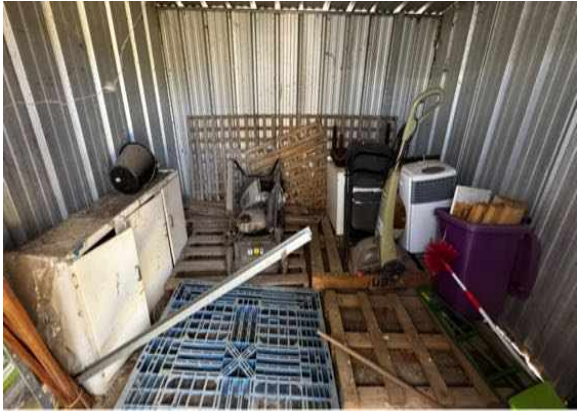
The shed does not appear to compromise the primary dwelling structure but may reduce usability, weatherproofing, and amenity. This deterioration is likely due to age, exposure to weather, and a lack of regular maintenance.

When practical, a competent hand man should be engaged to repair or replace damaged, missing, or weathered components. Rectification will restore functionality, durability, and weatherproofing of the shed.

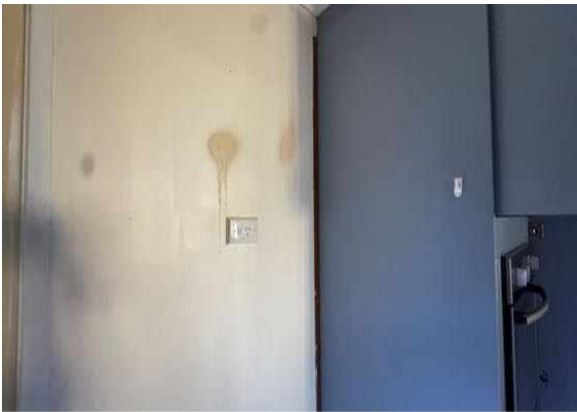
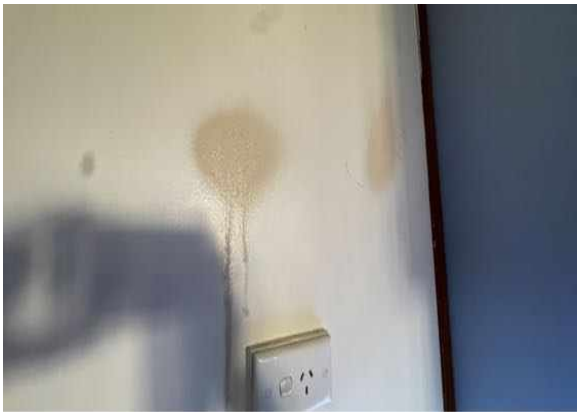
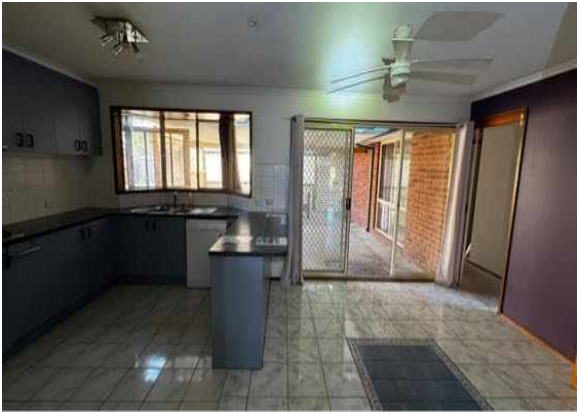
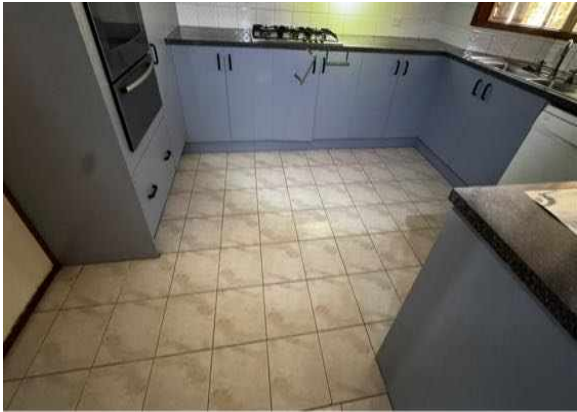
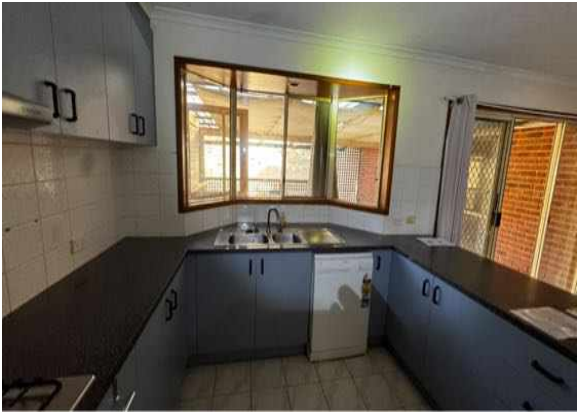
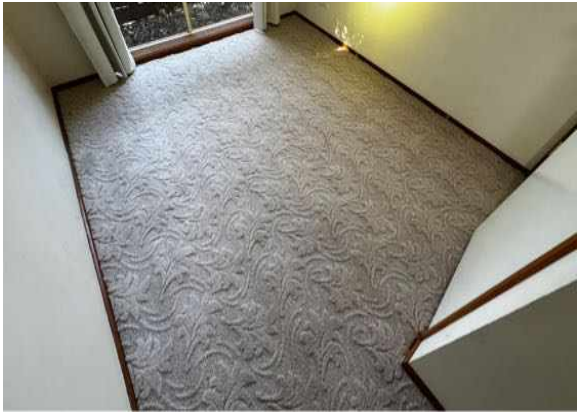
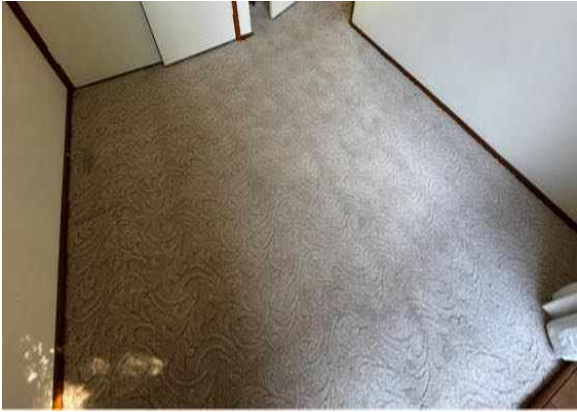
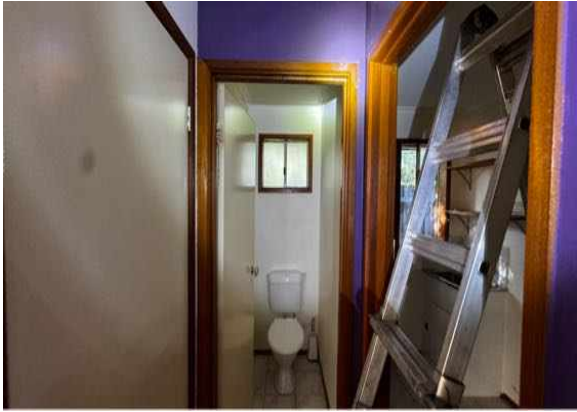
Noted Item

Building: Main Building
Location: All Areas
Finding: Cleanliness & Hygiene - Internal Property Requires Commercial Cleaning
Information: The internal areas of the property, including bedrooms, bathrooms, laundry, floors, carpets, tiles, kitchen surfaces, cupboards, walls, and windows, were observed to require a thorough commercial clean. Accumulated dust, dirt, and general soiling may affect hygiene, indoor air quality, and the overall presentation of the property.

When practical, a professional commercial cleaning service should be engaged to clean all internal surfaces, including bedrooms, bathrooms, laundry, floors, carpets, tiles, kitchen surfaces, cupboards, walls, and windows. Regular cleaning is recommended to maintain hygiene, presentation, and overall amenity of the property.
