# Building and Timber Pest Inspection Report

Inspection Date: Tue, 20 Jan 2026

Property Address: 26 zeinert street wodonga

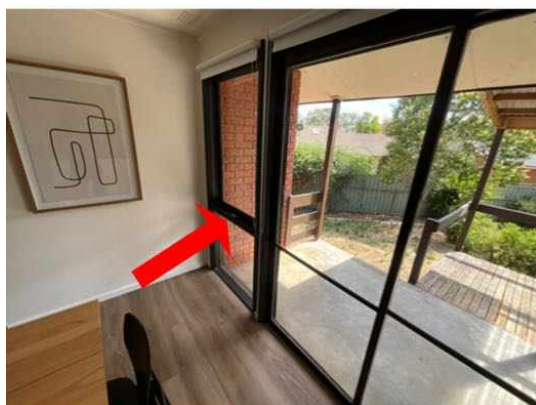
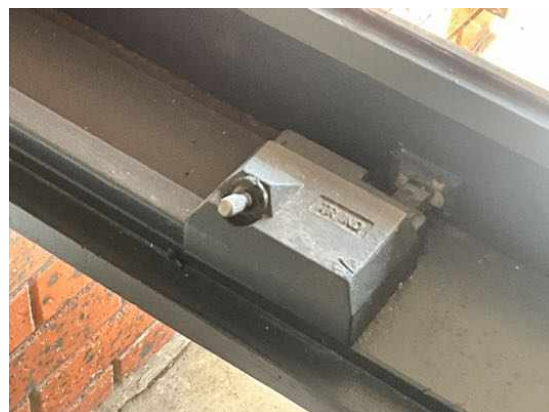
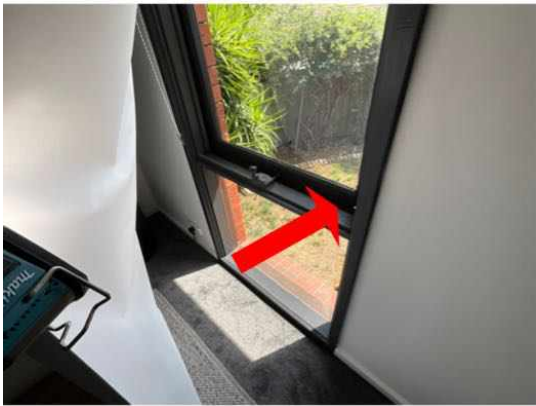
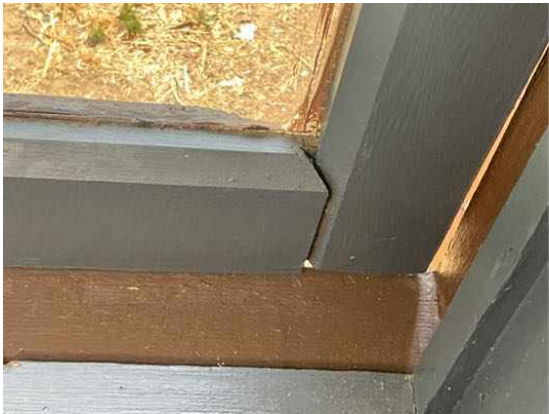
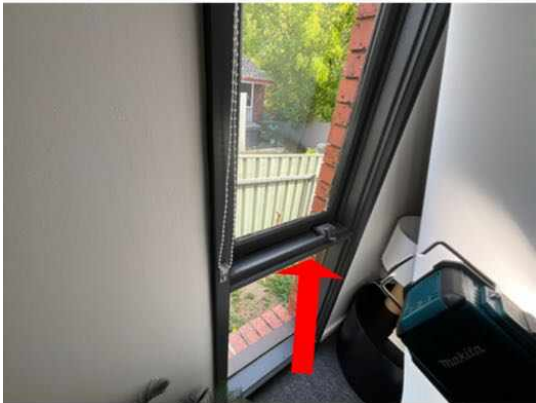
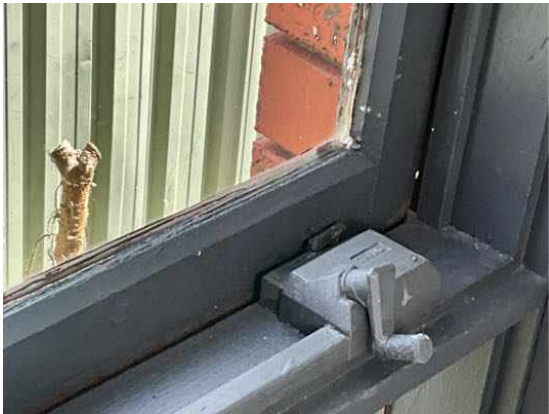
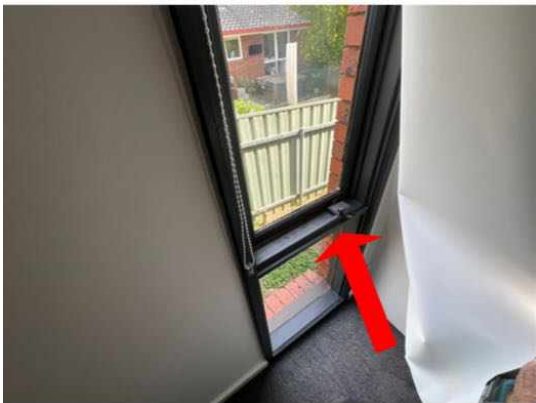
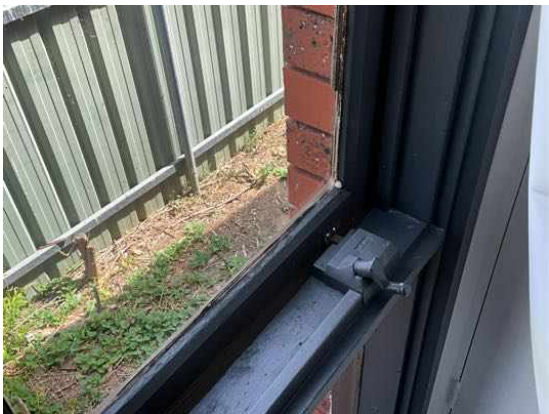
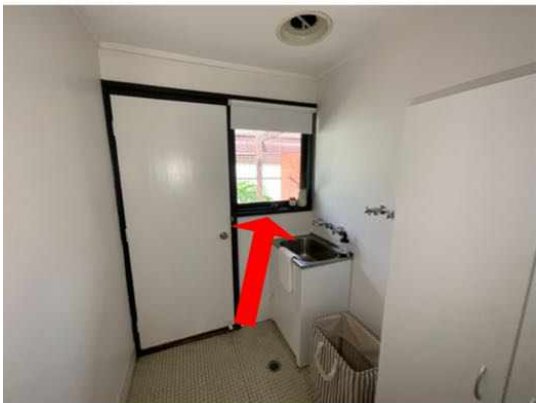
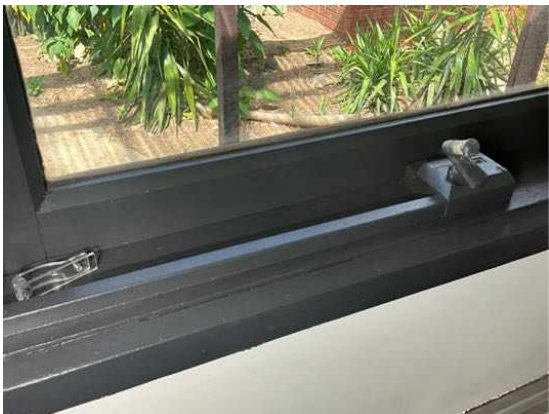
Building: Building 1  
Location: Most timber windows  
Finding: Window - Binding/jamming  
Information: Binding and/or jamming of this window is evident during standard operation. This defect inhibits the functionality of the affected window as well as creating potential for secondary defects to associated building elements, such as damage to the frame.

A window that binds to the associated frame may have several causes, ranging from minor defects, such as poor installation or deteriorated hinges, through to major structural issues, such as damage to framing structures.

Painted closed, winder handle missing and poor maintenance are the items that can be summarised in this defect.

Where binding/jamming appears to indicate major structural issues, a registered builder specialising in re-stumping should be appointed to provide an estimate on the cost of rectification.

For minor causes, a qualified carpenter, general handy person or window specialist should be appointed to perform minor rectification works at client discretion.

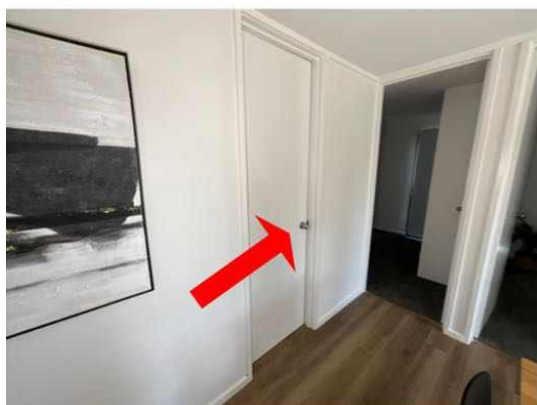
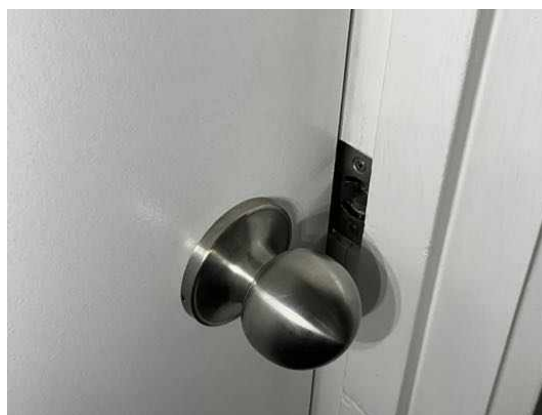
Finding 3.02

Building: Building 1  
 Location: Laundry  
 Finding: Door - Striker plate misaligned  
 Information: The striker plate to this door appears to have become misaligned and has consequently resulted in the door's operation being compromised.

This is a common defect and is expected in a property of this age, whether being due to substandard installation or general deterioration of the door hardware.

Readjustment of the striker plate is recommended at client discretion. Works such as these can be completed by a general handyman or qualified carpenter.

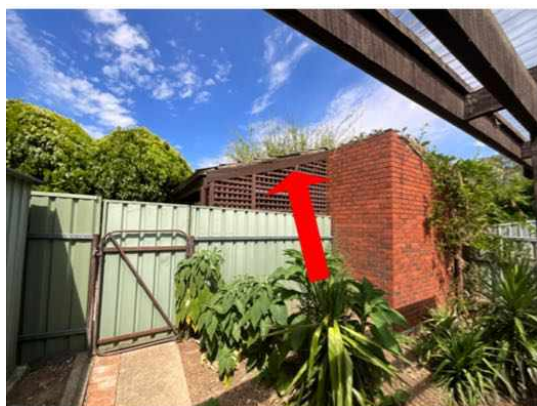
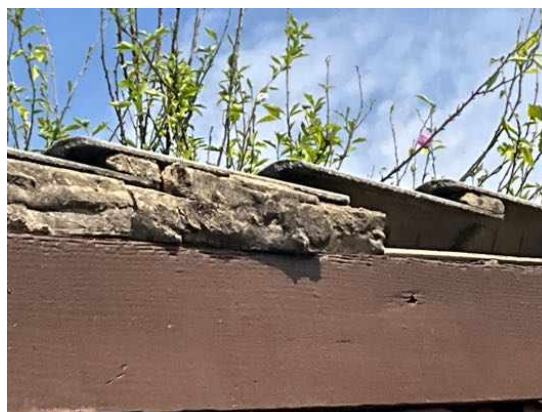
### Finding 3.03

Building: Building 1  
 Location: Carport  
 Finding: Mortar - Deterioration  
 Information: Mortar, or 'bedding', is the material which fills joints and intersections between tiles and other building elements on the exterior roof covering, such as gable ends, hip capping and valleys. Upon inspection of the exterior roof, it was noted that sections of the mortar show varying levels of deterioration.

Mortar generally deteriorates as a result of frequent exposure to weather conditions over a prolonged period of time. Mortar that is deteriorating may allow water ingress into the roof void, putting associated building elements and roofing structures at risk of water damage. Deteriorated mortar also detracts from the functionality of roof tiles and other roofing elements, potentially decreasing weather tightness and roof drainage.

Mortar deterioration can be attended to by a handyperson where areas of deterioration are localised and easily accessible. Otherwise, consultation with a roofing contractor is advised where greater works are required.

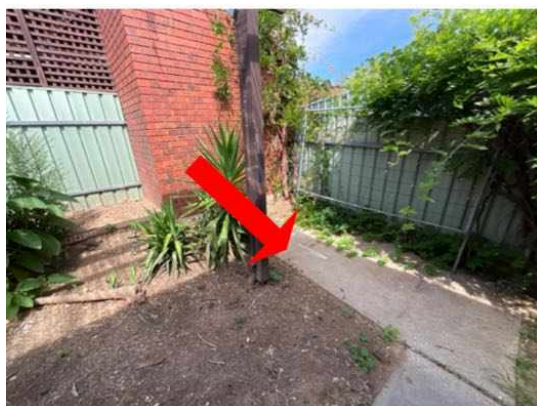
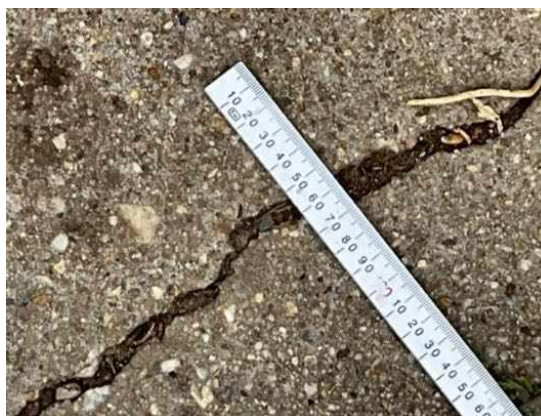
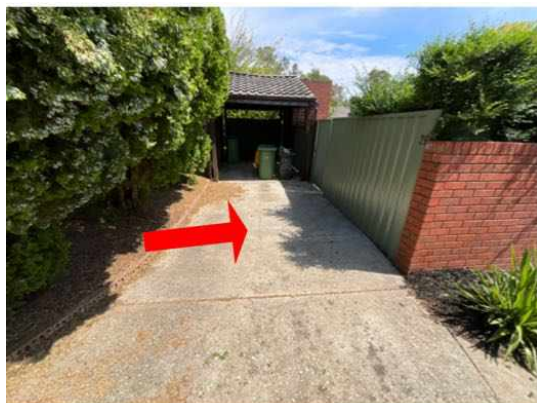
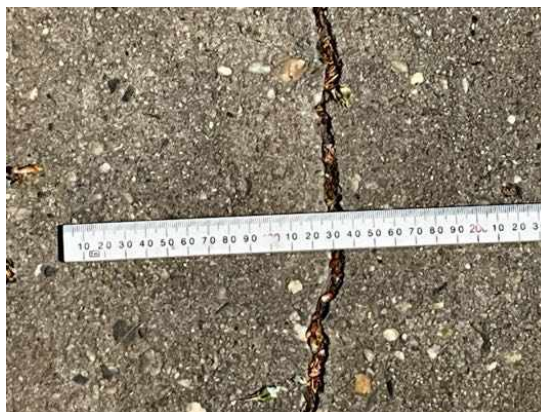
### Finding 3.04

| Finding: | Cracking - External Concrete Paving Damage Category 3 - Wide Cracks (2mm - 4mm) |
| Information: | Wide cracks were identified in external concrete paving Wide cracks are significant and are likely to lead to the development of safety hazards and secondary defects if left unmanaged. |

General age and expected deterioration of the paved areas is a common cause of this type of cracking. However, expansion and contraction of the slab may also have occurred due to environmental factors. Such factors include variable moisture and weather conditions, the presence of trees and their roots having a settling or lifting affect on the soil, or the effect of load bearing, e.g. heavy vehicles over a sustained period of time.

Cracking to this degree may also be due to poor original installation of the concrete. Factors such as poor compaction of the sub surface and/or inadequate reinforcing of the slab may create cracking and other secondary defects. Wide cracks may also have a more significant structural cause, such as subsidence of soils.

Where the crack is located adjacent to structural elements of the building, the advice of a Structural Engineer is advisable before undertaking repairs. Significant repair and likely replacement of the concrete paving is probable.

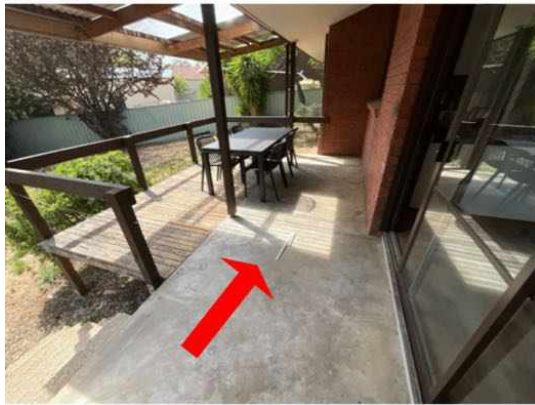
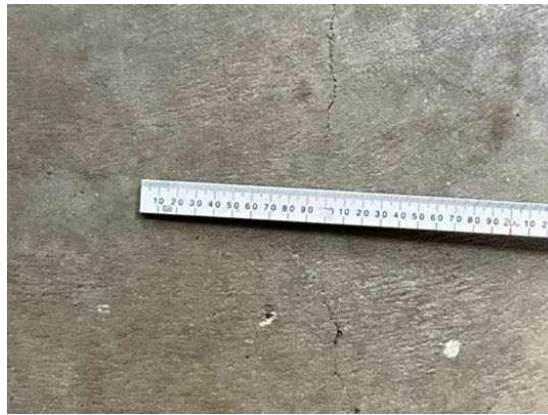
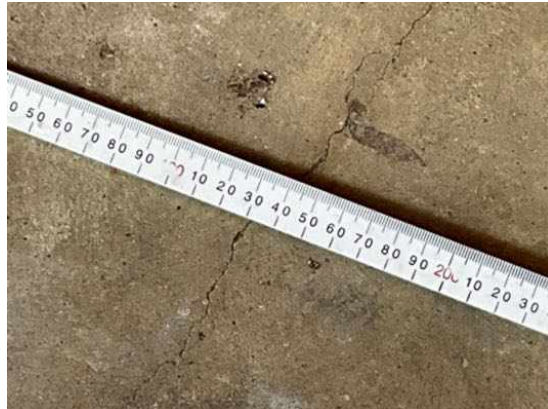
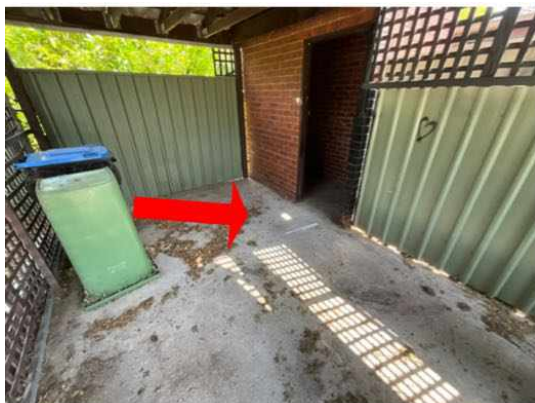
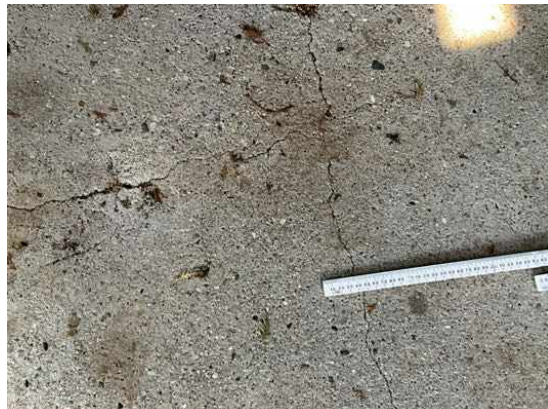
### Finding 3.05

| Finding: | Cracking - External Concrete Paving Damage Category 1 - Fine (less than 2mm) |
| Information: | Fine cracks were identified in external concrete paving. Although fine cracks are quite noticeable, they are often only considered to be an appearance defect, and usually do not indicate any structural damage. To be considered a Category 1 or fine crack, the crack is found to be less than 2mm in width. |

Generally the cause of a hairline crack in existing concrete paving such as driveways and pathways is indicative of the expansion and contraction of the concrete. Such causes are generally due to environmental factors, such as moisture levels, weather conditions, root systems of nearby trees or the soil types on which they are laid.

Fine cracks may also be due to poor original installation of the concrete. Factors such as poor compaction of the sub surface and/or inadequate reinforcing of the slab may create cracking and other secondary defects.

Monitoring of all cracking should be conducted frequently. Always contact a building inspector should cracks widen, lengthen, or become more numerous.

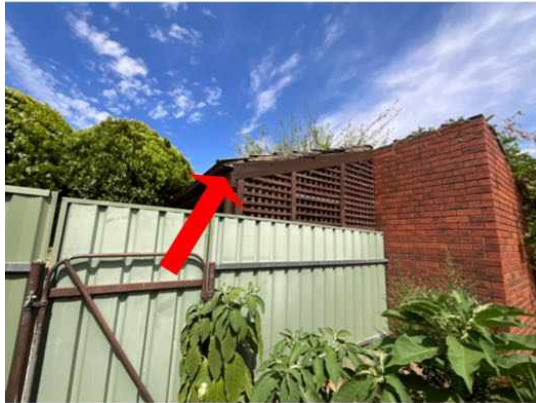
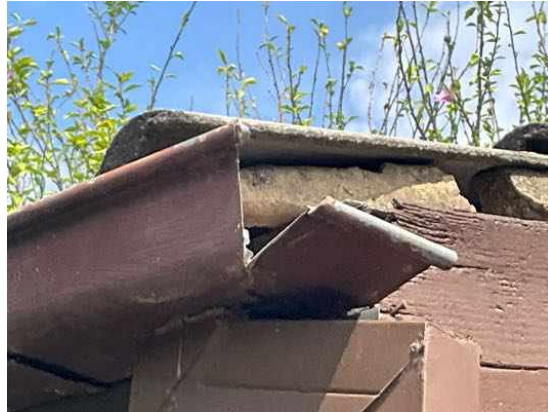
Building: Building 1  
 Location: Carport  
 Finding: Gutter- damaged  
 Information: The gutter in this area shows damage. This negatively affects the stormwater drainage.

A licensed plumber should be contacted as soon as possible to restore the area and prevent further deterioration.

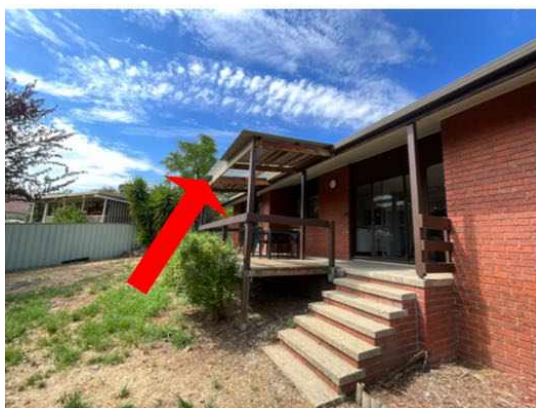
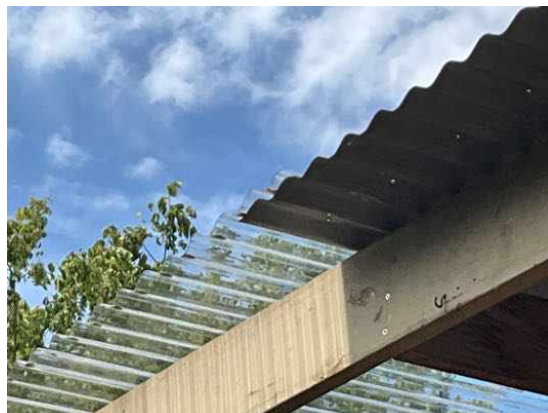
### Finding 6.02

Building: Building 1  
 Location: Alfresco  
 Finding: Guttering Missing  
 Information: The Guttering in this area was missing at the time of inspection. Guttering, Downpipes and Stormwater drainage are vital to protect the integrity of the structure and to prevent an environment conducive to Timber Pest attack.

A Plumber should be contacted as soon as possible to replace and connect to drainage the missing Guttering.

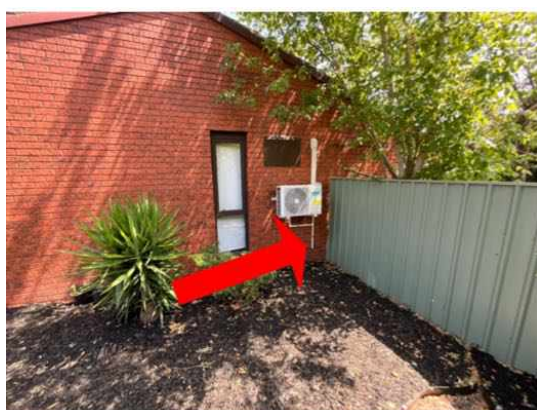
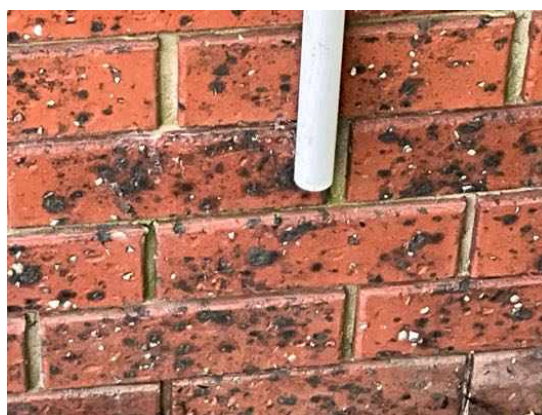
### Finding 6.03

Building: Building 1  
 Location: Yard - Side  
 Finding: Air conditioner - Disconnected overflow  
 Information: The Air Conditioner (A/C) overflow was found to be disconnected from storm water drainage and is creating excessive moisture in the surrounding area.

Such leaking creates an environment which is conducive to an array of defects, including water damage to associated building elements and the attraction of termite or timber pest infestation.

It is highly recommended that a licensed plumber be appointed to connect the A/C overflow in order to prevent such an environment from being created. These minor works should be carried out as soon as possible.

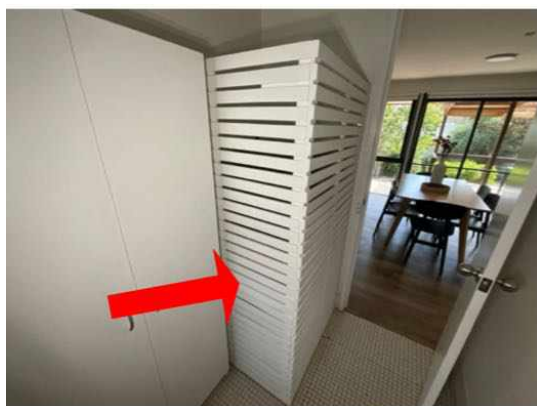
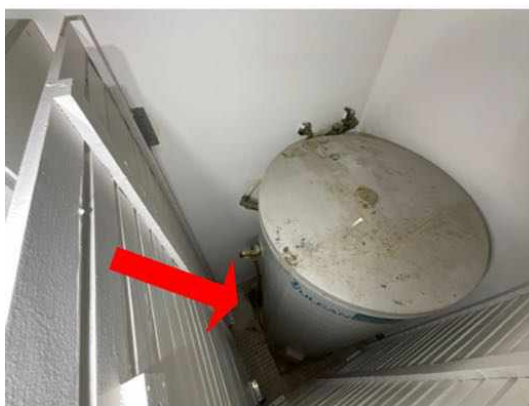
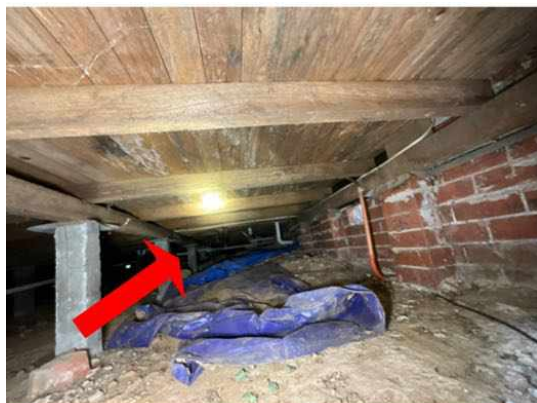
## Finding 6.04

Building: Building 1  
 Location: Laundry  
 Finding: HWS Overflow - Not Connected  
 Information: The Hot Water System (HWS) overflow was found to be disconnected from storm water drainage and is creating excessive moisture in the surrounding area.

These damp conditions can lead to secondary defects such as rot, rust or corrosion of associated building elements, the formation of fungal decay, or even the creation of potential slip hazards. When coupled with poor site drainage, pooling of water may also attract termite activity to this area.

It is highly recommended that a licensed plumber be appointed to connect the HWS overflow in order to prevent such an environment from being created. These minor works should be carried out as soon as possible.

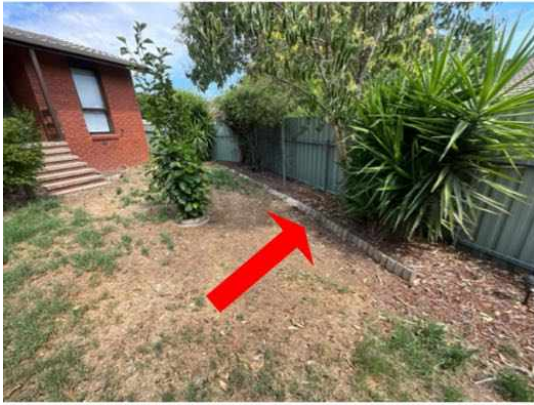
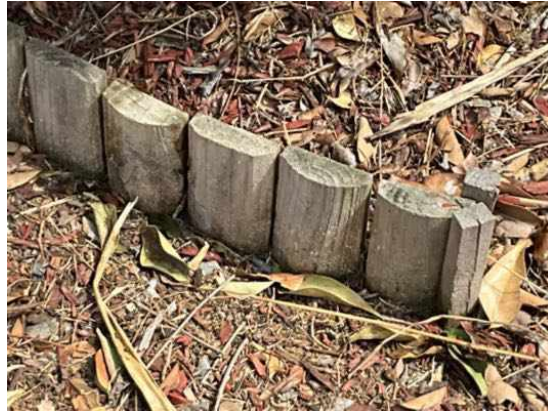
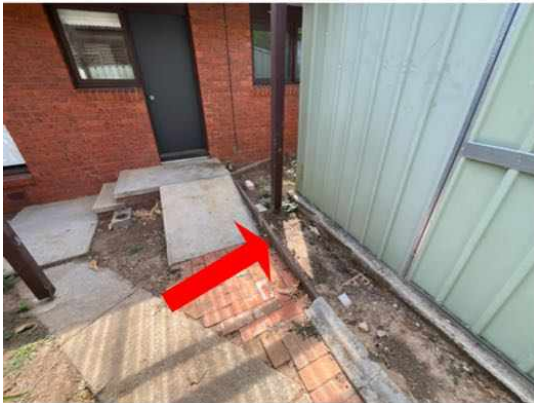
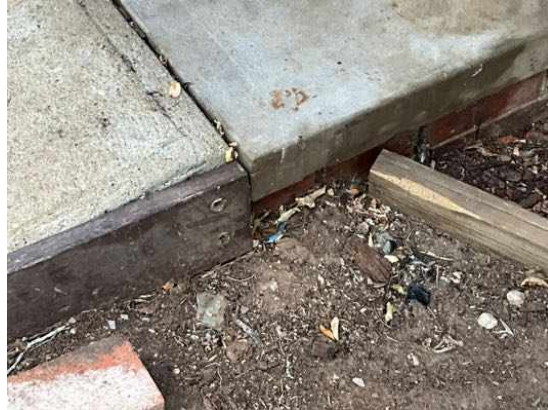
### Finding 6.05

| Finding: | Untreated or non-durable timbers in a hazardous environment |
| Information: | To reduce the risk of timber pest attack it is essential that timber used in a hazardous environment (e.g. in direct contact with the ground or frequently exposed to damp conditions) is of sufficient durability and/or is adequately preservative treated. |

Untreated timbers in direct contact with the ground are likely to develop severe wood rot and/or fungal decay if left unattended creating attraction for subterranean termites to infest the timbers from surrounding areas.

If untreated or non-durable timbers are found to be in a hazardous environment it is highly advised that replacement of these building elements be performed as soon as possible to aid the protection of the property against termite / timber pest attack.

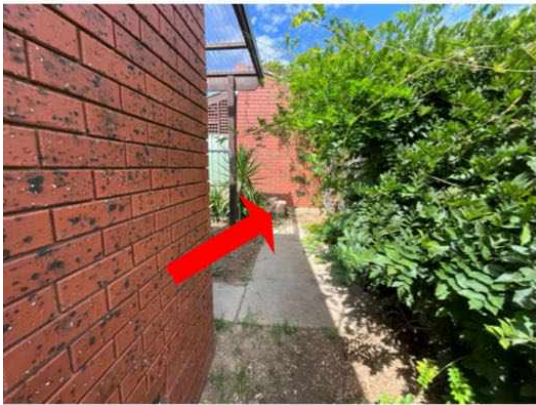
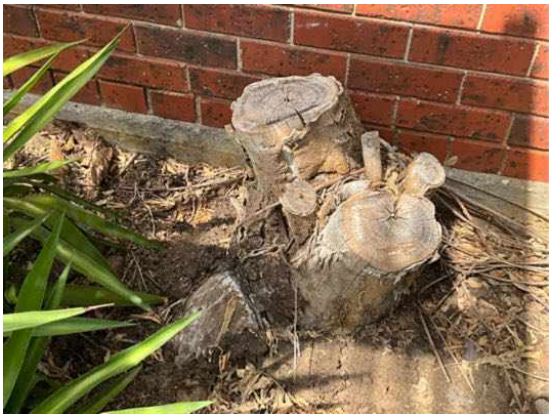
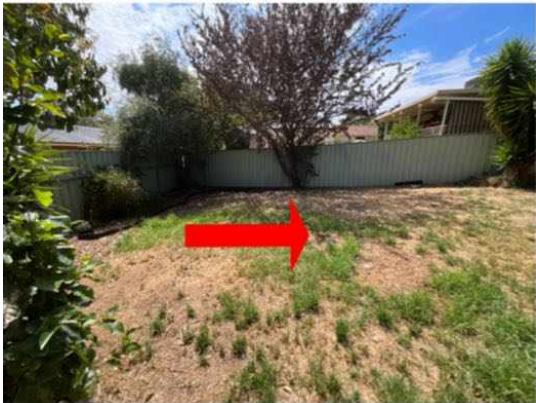
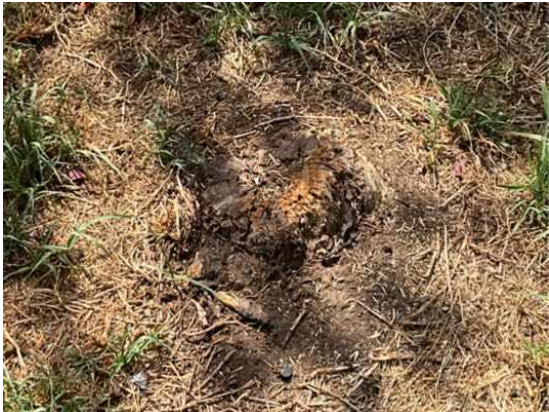
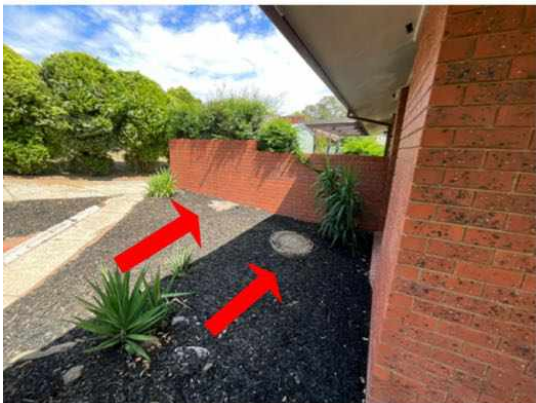
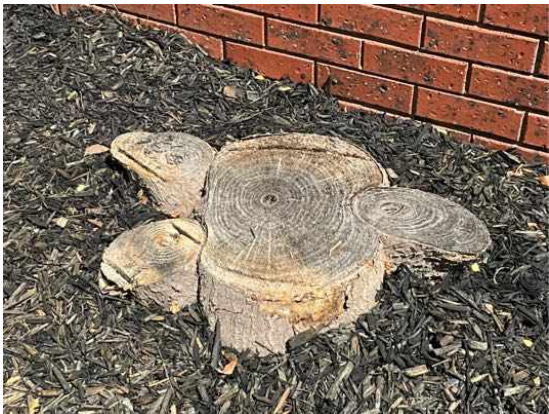
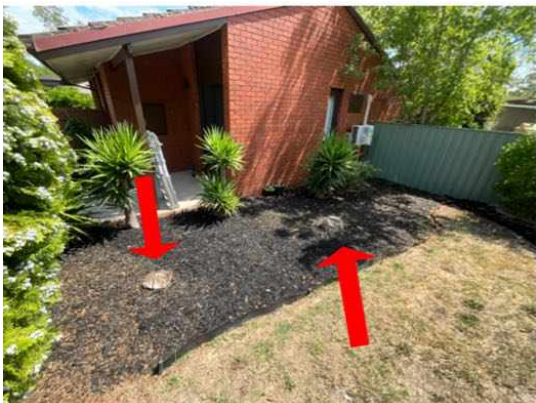
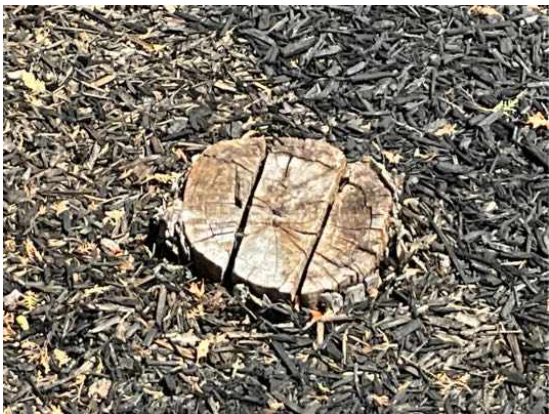
### Finding 6.06

| Information: | Any tree stumps in the yard not removed during the tree removal process provides the opportunity for Termite infestation and is likely to be subject to decay from damp conditions against the stump. |

All tree stumps should be removed by professional tree removal services where possible. Meanwhile regular inspections are advised to identify any termite activity in the areas identified.

Services for tree stump removal should be contacted as soon as possible to reduce the risk of timber pest attack.

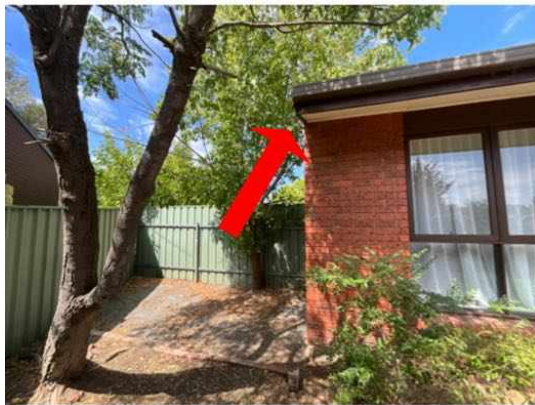
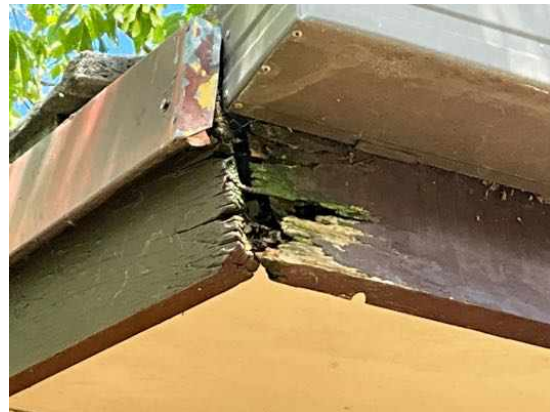
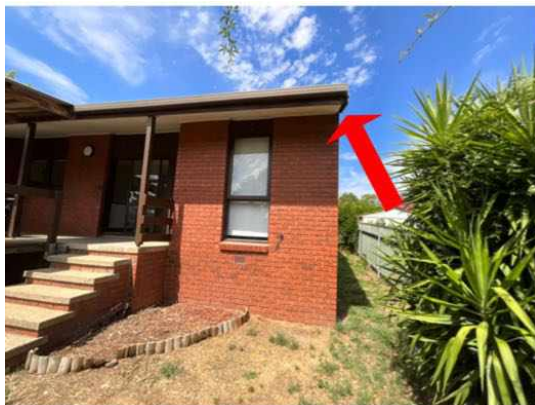
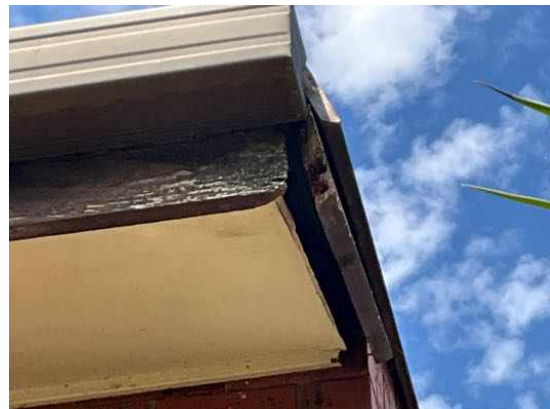
### Finding 7.01

| Finding: | Fungal decay - present (localised) |
| Information: | Fungal decay also known as wood decay or wood rot generally refers to the deterioration of timber elements when in contact with excessive levels of moisture for a prolonged period of time. |

The development of fungal decay is accelerated by temperatures in the range of 5degreeC to 40degreeC as well as the presence of oxygen. Generally fungal decay develops on timber elements that are in use in an external environment which are exposed to rain penetration.

In this case although the affected timber element is in a decaying state the extent of any visible damage appears to be localised to a specific area and is yet to spread to other parts of the building element or affect adjoining structures. The fungal decay is therefore likely to be of a relatively superficial nature with minimal impact on the structural integrity or tensile strength of the timber element.

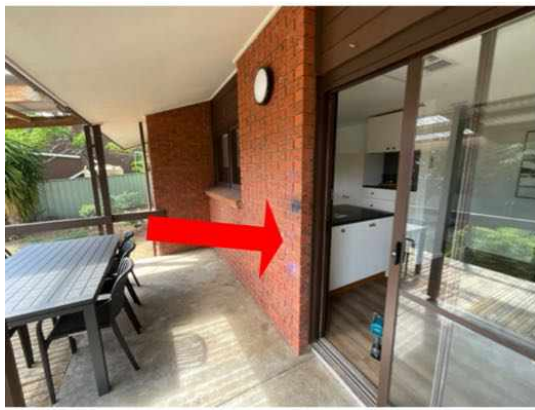
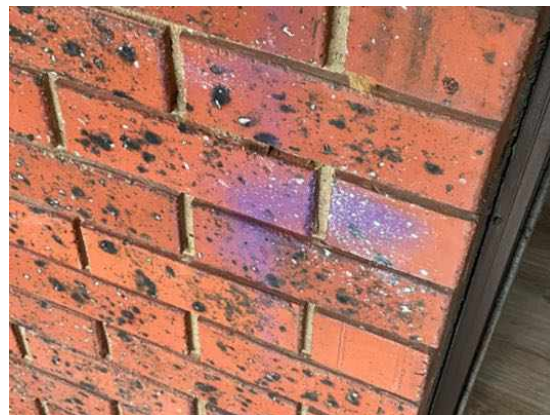
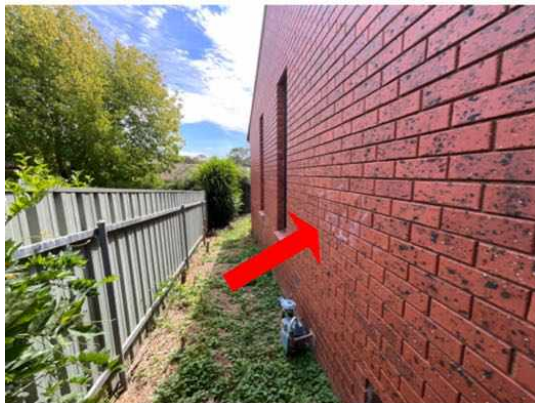
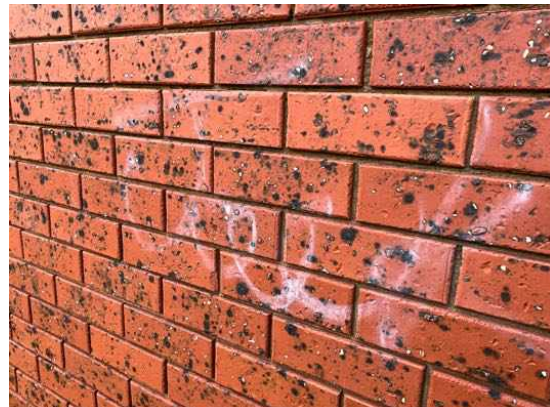
Building: Building 1  
 Location: Alfresco, side yard  
 Finding: Paint residue  
 Information: Several areas show a kind of overspray of paint. This is a cosmetic defect in this case.

No action is required except at the discretion of the client.

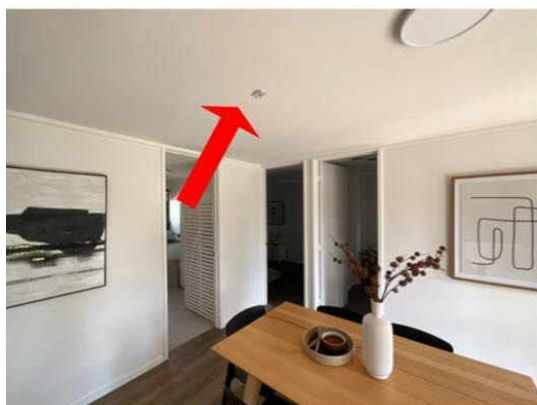
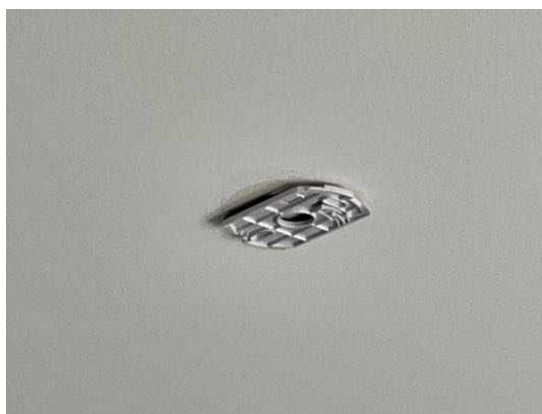
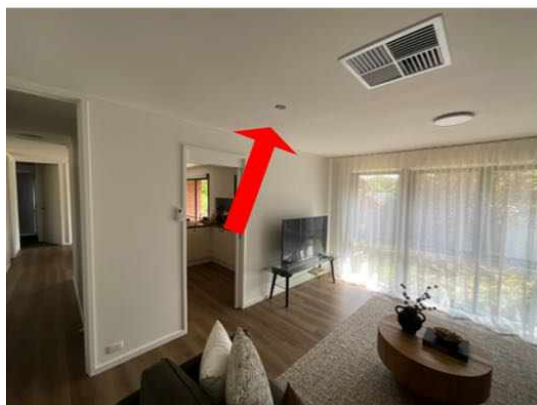
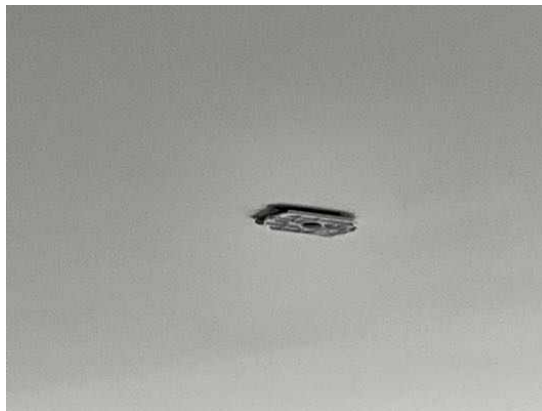
Building: Building 1  
 Location: All Internal Areas  
 Finding: Smoke Detectors and Alarms  
 Information: Reporting on Smoke Detectors or Alarms, including hard wired smoke detection systems and their legislative requirements, is outside the Scope of this Report.

Please note that this defect is highlighted as a caution only. We suspect, based on our experience in the building industry, that the absence of smoke detectors, or their poor

condition, should be addressed as a matter of urgency to improve occupant safety.

Always ensure sufficient working and suitable smoke detectors are installed prior to occupying any building. Additionally, it is advised that all smoke detectors be tested by the homeowner on a monthly basis.

Please refer to AS3786 and state based legislation, which may also apply.

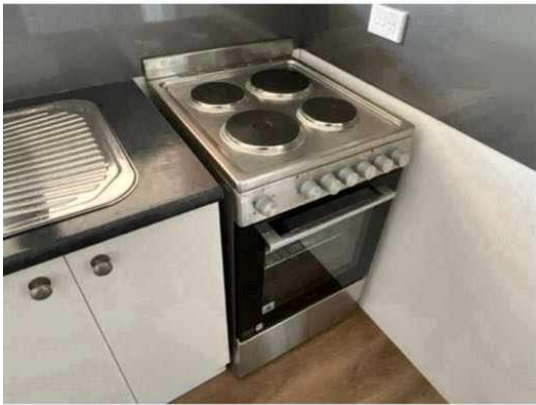
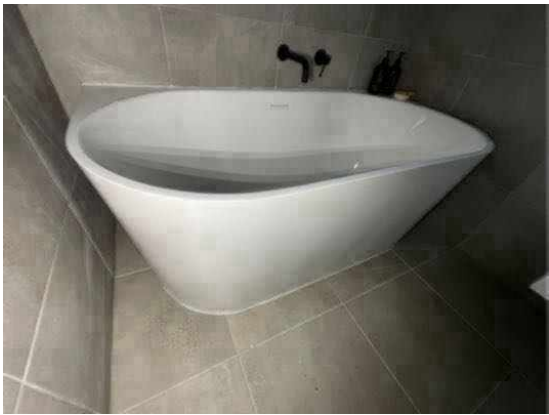
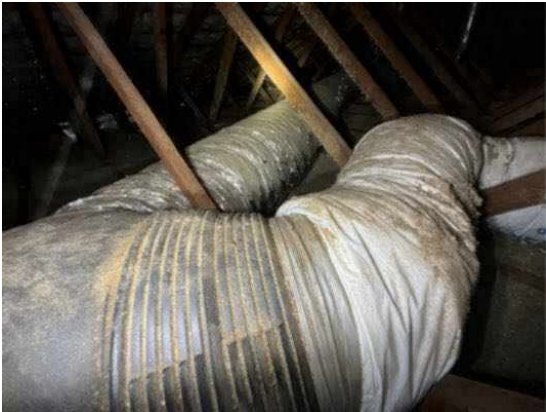
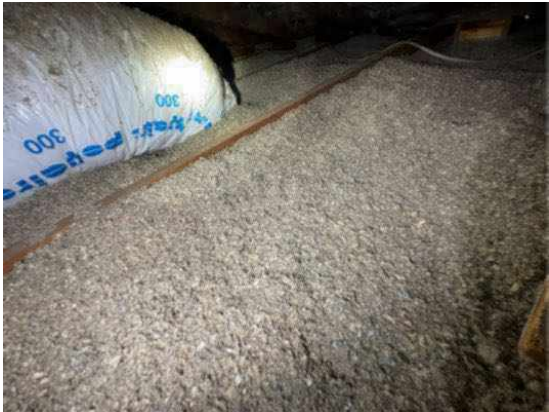
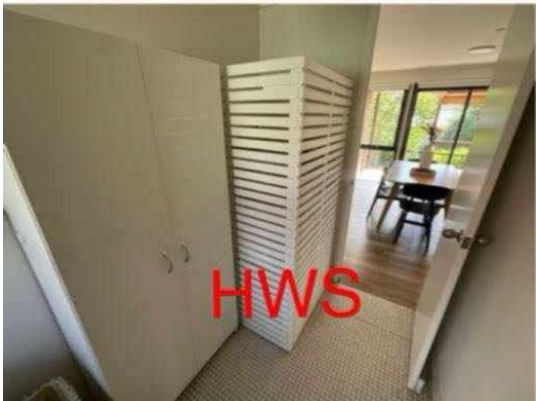
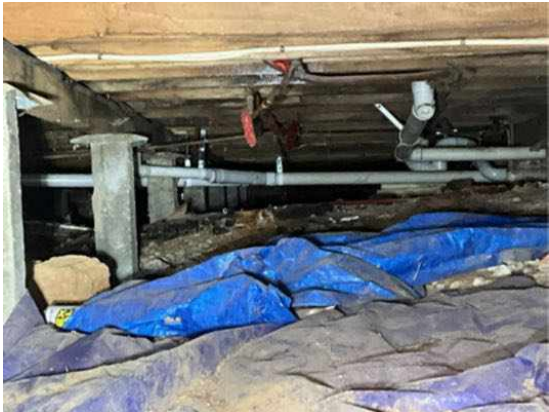
Building: Building 1  
Location: All Areas  
Finding: Additional Photos - Obstructions and Limitations  
Information: These photographs are an indication of the obstructions and limitations which impeded full inspection of the property at the time of inspection. These obstructions can hide an array of defects and should be removed to allow full inspection to be carried out. A re-inspection is recommended once the areas are made accessible.
