# Building and Timber Pest Inspection Report

Inspection Date: Wed, 25 Feb 2026

Property Address: 136 High St, Violet Town VIC 3669,  
Australia

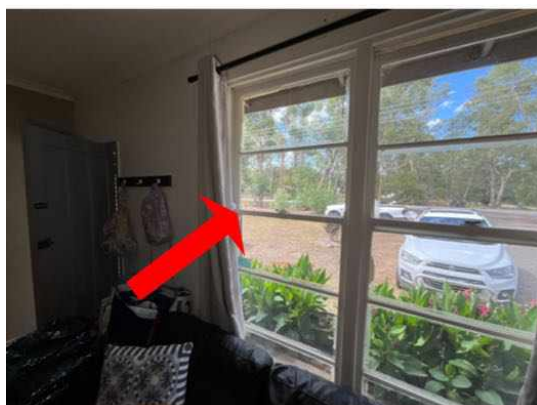
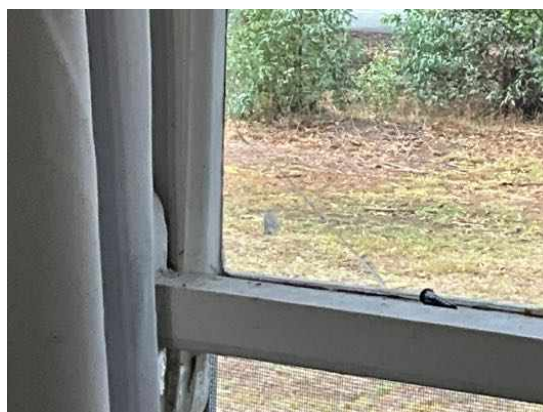
Building:	Building 1
Location:	Living Room
Finding:	Window - Cracked
Information:	Cracks were identified in the window in this area. Cracking in windows is generally the result of impact damage, and is likely to develop further when left unmanaged.

The likelihood of this windowpane further cracking and shattering is increased exponentially, providing a safety hazard in the area. The cracked window also impairs the weather tightness of the building, creating potential for minor water leaks.

A qualified glazier is required to repair the window as soon as possible. Depending on the extent of the cracking, replacement of the window may be required. Please be advised that any persons coming into contact with the cracked window should do so with due caution to avoid any personal injury that may ensue.

A safety hazard is noted. The living room window is cracked. A glazier should be contacted immediately to restore the area and prevent potential injury.

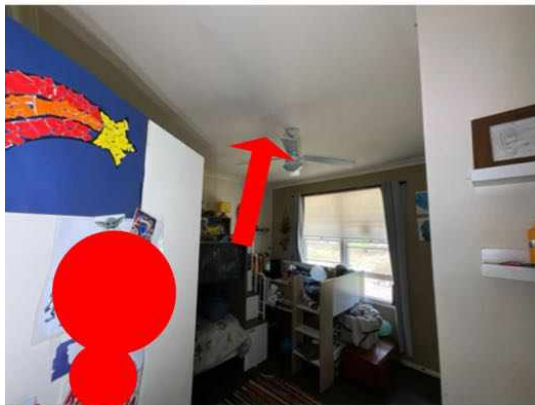
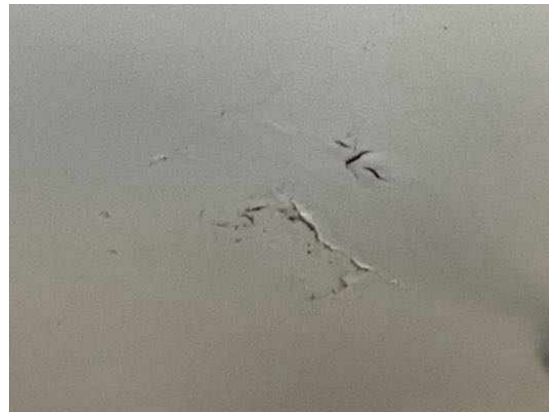
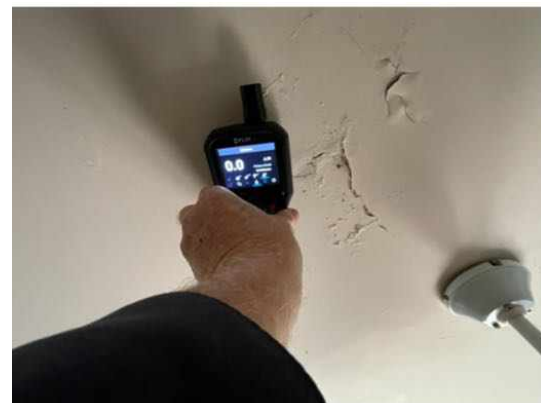
Building:	Building 1
Location:	Bedroom 2
Finding:	Painted surface - Flaking
Information:	Sections of paint in this area was found to have deteriorated. Paint flaking is generally

an indication of excessive moisture in the area, that is currently hidden by the painted surface.

The presence of excessive moisture can have major implications on associated building elements if left unattended. While only seemingly minor at this stage, the damage cannot be determined due to the paint obstructing any further inspection of the damage.

A qualified Painter should be contacted at the Owner's discretion to re-paint the ceiling.

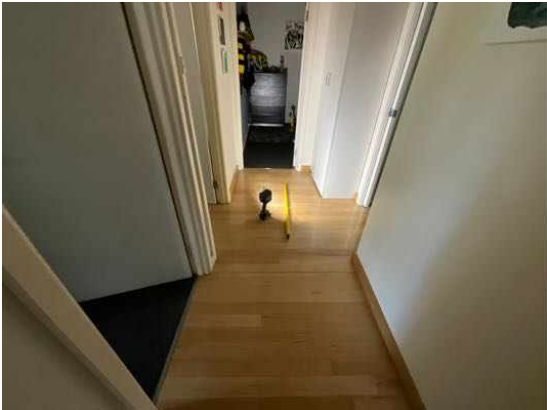
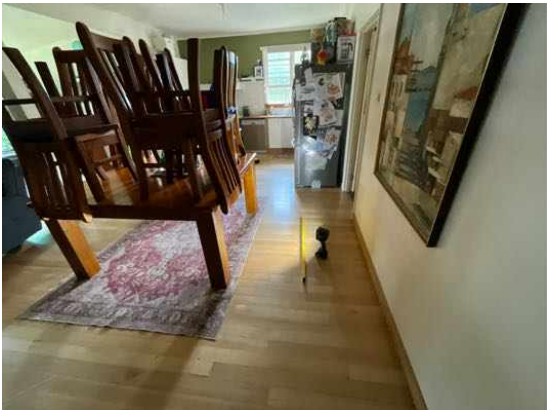
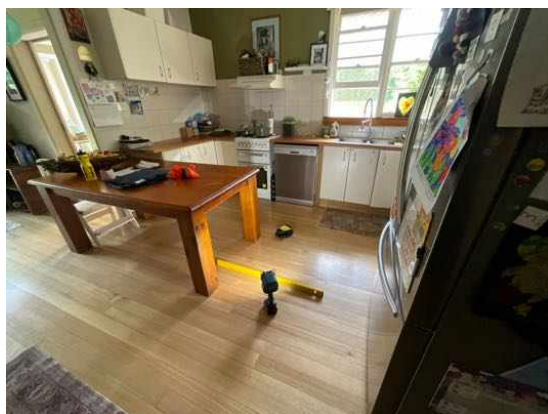
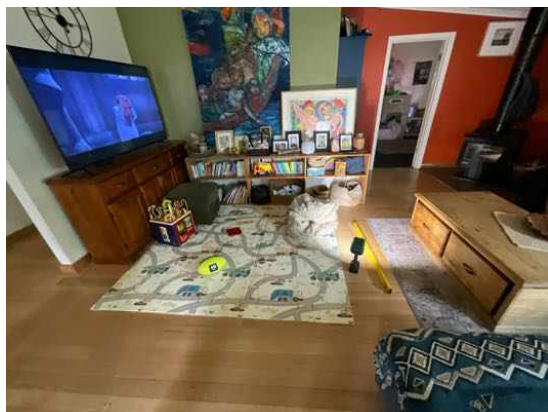
### Finding 3.02

Building:	Building 1
Location:	All Internal Areas
Finding:	Flooring - Uneven
Information:	The internal flooring in this area is out of level and uneven. Uneven flooring is likely to indicate minor defects such as expected movement of the foundations of the property, but may also indicate subsidence of the associated subfloor stumps.

It is advised that the flooring be closely monitored to identify any further movement. Where flooring remains relatively unchanged for an extended period of time (i.e. several months), it is likely that this defect has been caused by expected movement of the

foundations of the property.

However, where flooring is uneven further, potentially invasive inspection of the subfloor structures and stumps in this area is required. In this case, works to repair are likely to be required, and would be carried out by a registered builder specialising in re-stumping.

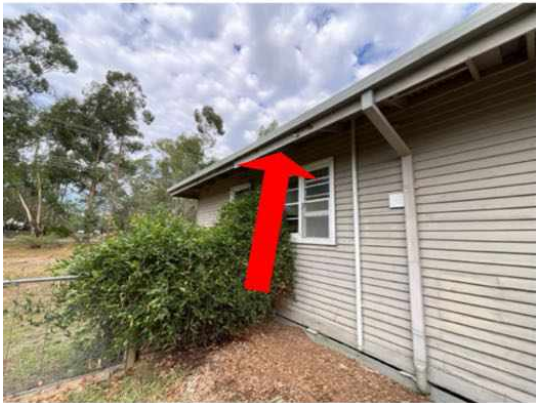
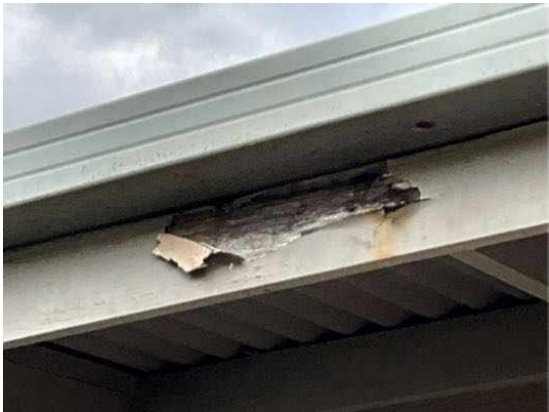
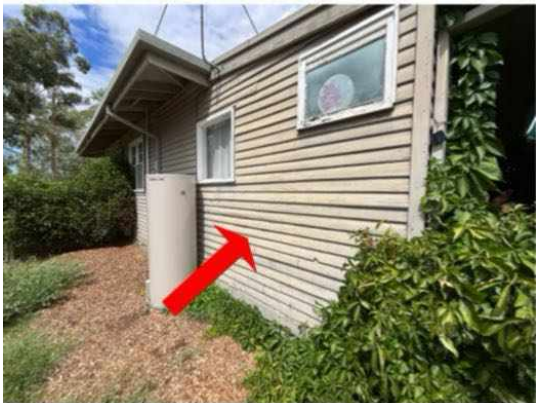
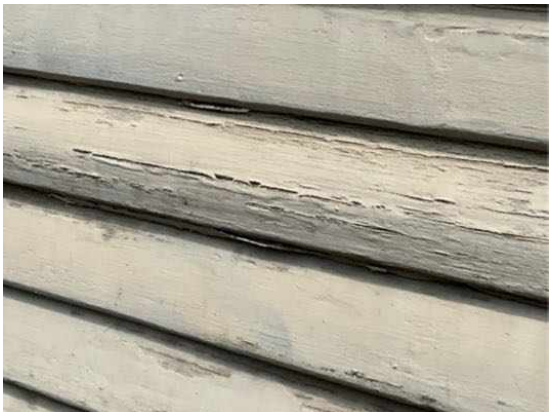
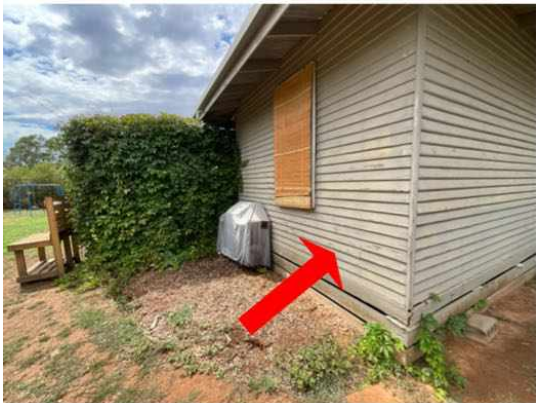
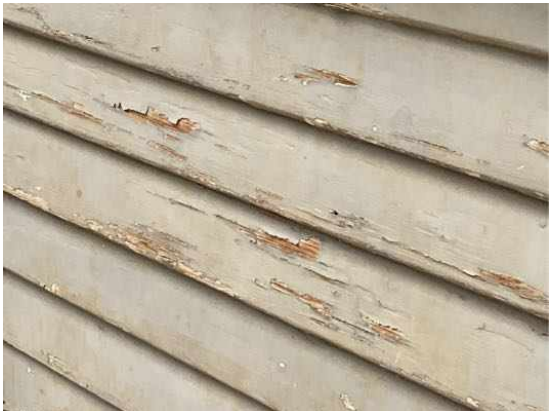
### Finding 3.03

Building:	Building 1
Location:	All External Areas
Finding:	External painting deteriorated
Information:	Much of the external paintwork including but not limited to windows, fascias, guttering, veranda and other external fitments have been neglected and require attention to prepare and re-paint.

Whilst incomplete or missing paint finish is generally an appearance defect, it can also lead to the development of secondary building defects over time. Incomplete areas of paint finish expose the area to moisture, potentially accelerating the deterioration of underlying building materials.

Degraded paint finishes should be sanded back, filled, leveled and painted, as applicable. Where inadequate or missing paint protection has led to the deterioration of the associated building element, repair and/or replacement of this building element may be required.

A painting contractor should be appointed as soon as possible to perform necessary works to aid the appearance of the affected area and to ensure the area is protected against further deterioration. Alternatively, the homeowner following manufacturer instructions may perform these works.

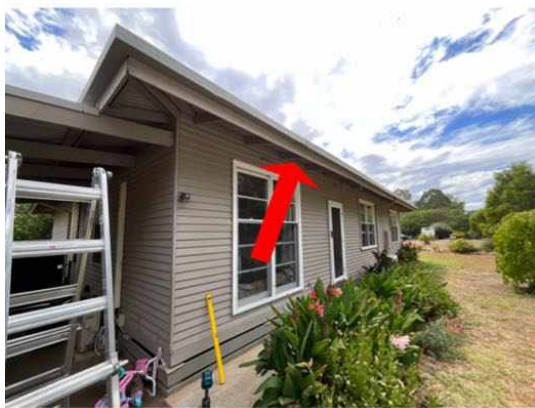
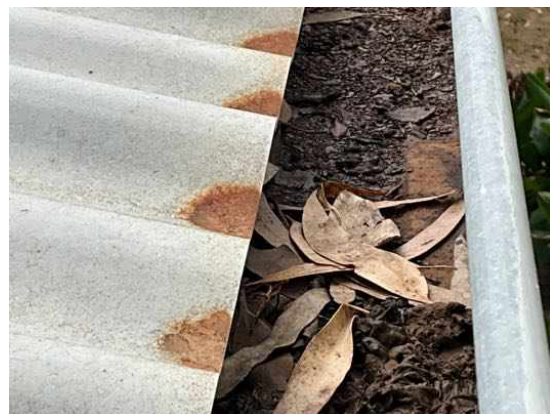
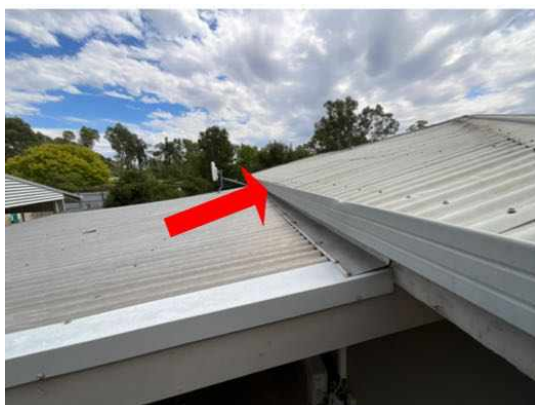
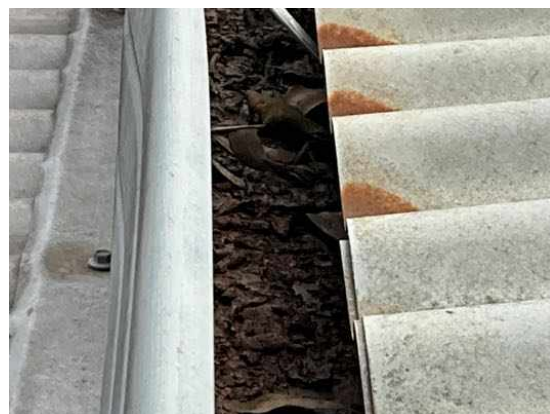
Blocked gutters are likely to lead to high levels of moisture in the affected areas. Such moisture will not only cause rust and decay of the associated building materials, but can also provide conditions that are conducive to termite and timber pest activity. Blockages in gutters should therefore be removed immediately to ensure dry conditions are maintained.

Consult a Licensed Plumber for further specific advice on remedial works that may be required. In the interim, it is highly advised that blocked gutters be removed by the homeowner or a general handyman as a matter of urgency.

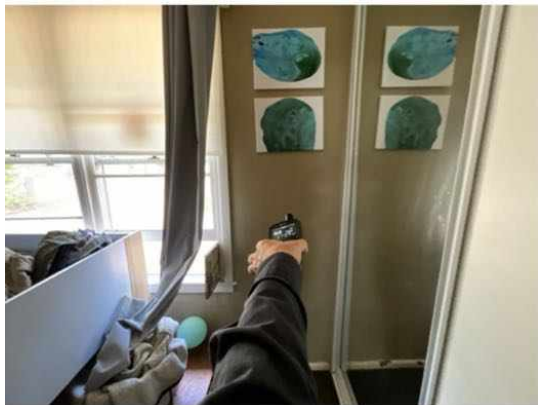
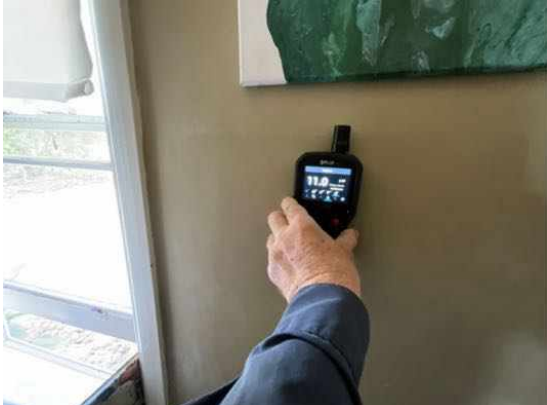
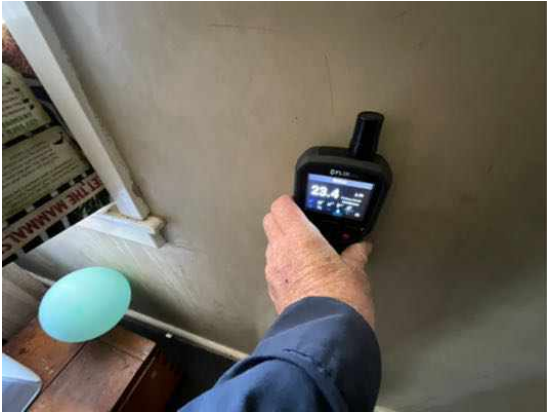
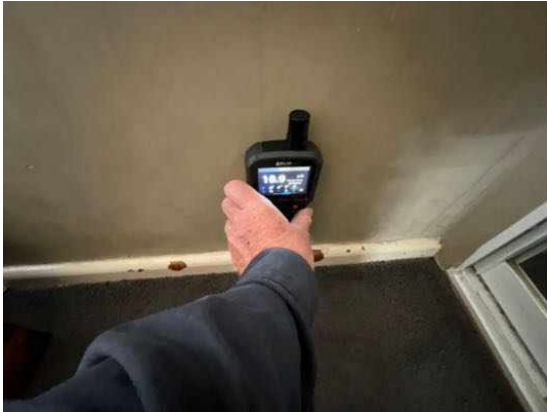
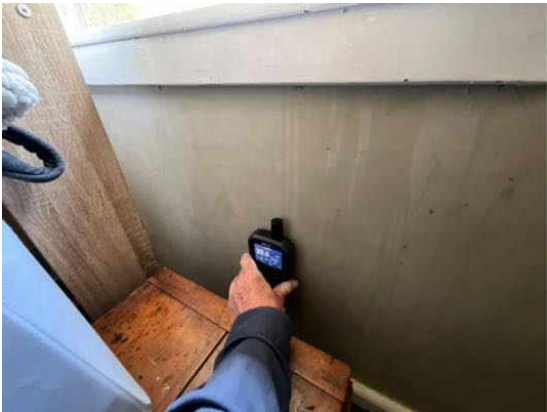
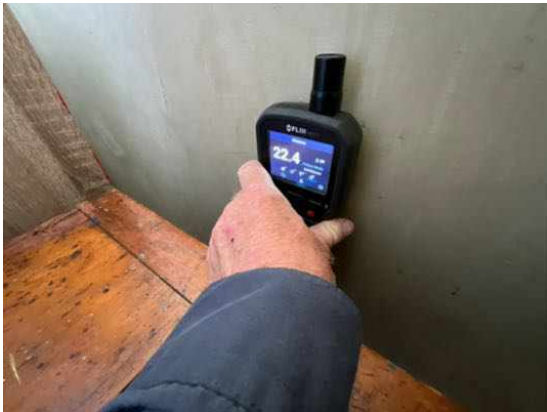
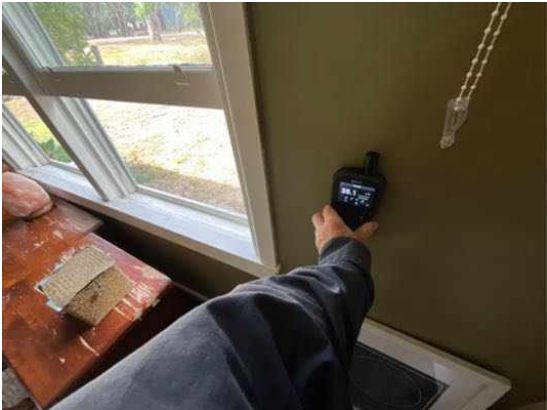
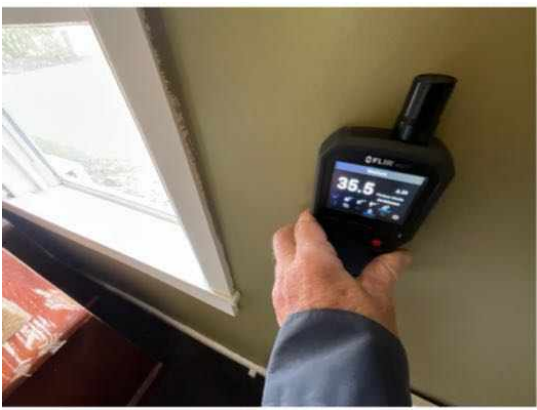
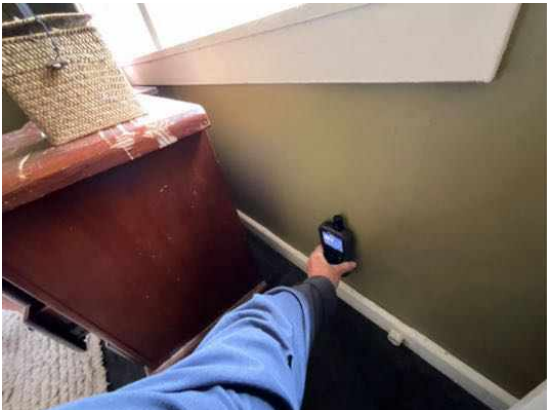
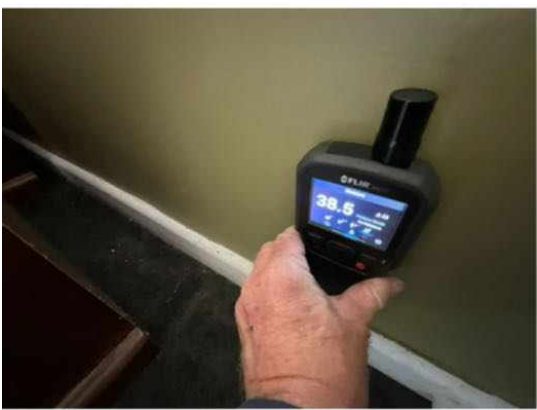
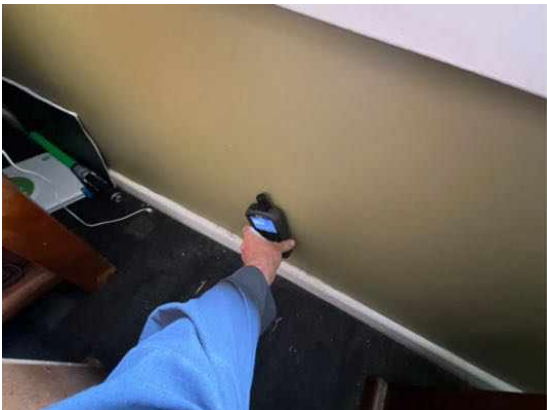
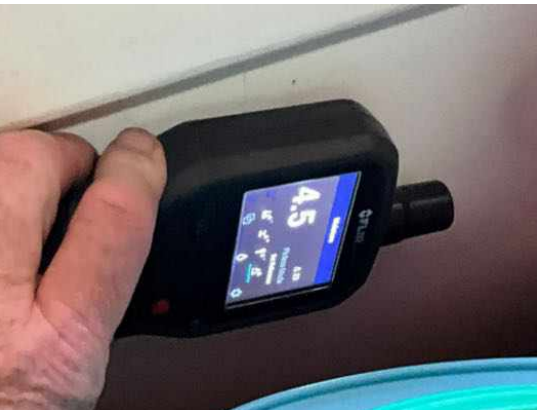
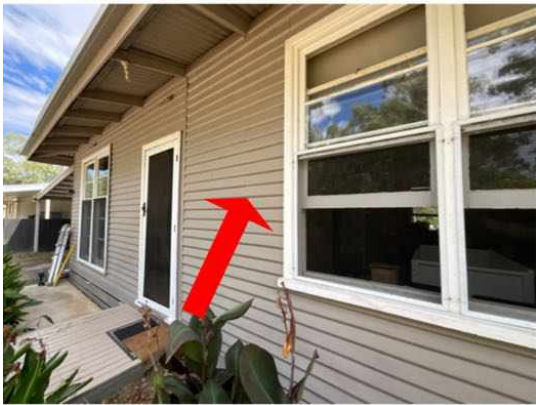
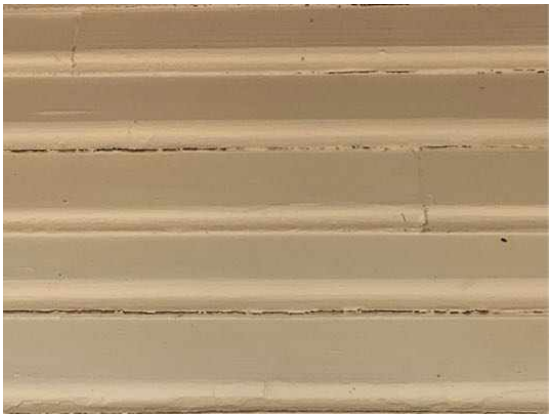
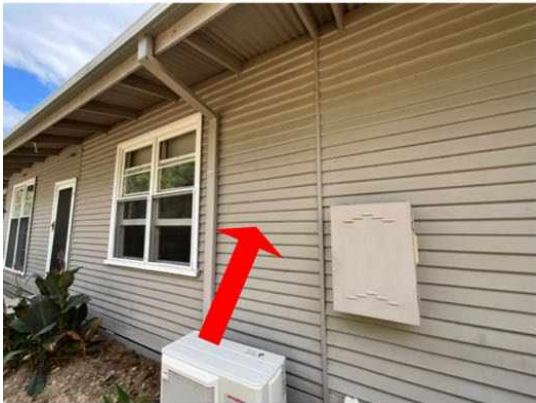
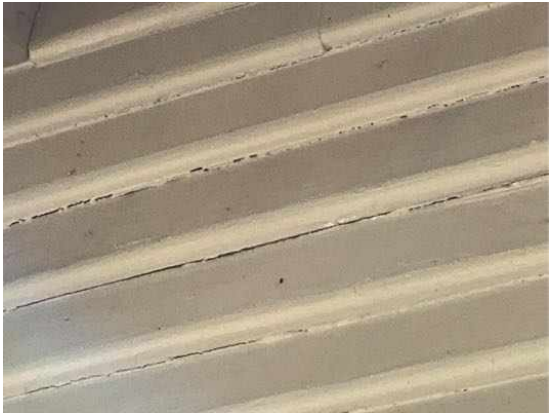
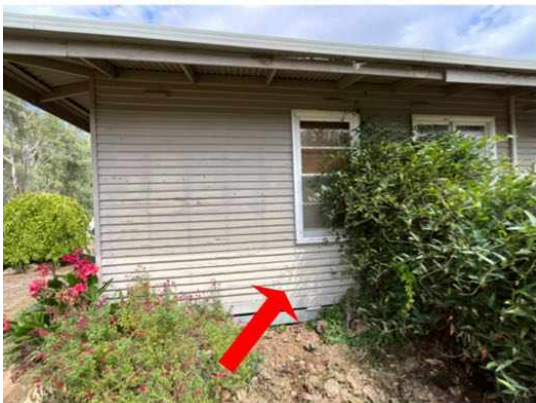
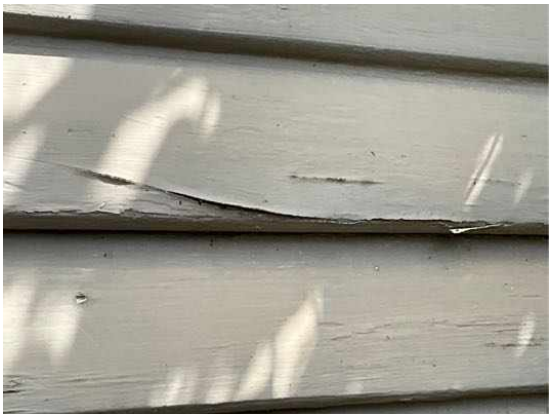
### Finding 6.02

Building: Building 1  
 Location: All rooms on front wall  
 Finding: Evidence of excessive moisture was present at the time of inspection

Information: Excessive moisture can attract termites and produce conditions that promote termite attack fungal growth and wood decay.

Excessive moisture is generally caused by deteriorated inadequate or missing roof drainage leaking plumbing pipes or fixtures poorly plumbed HWS overflows or condenser units and poor site drainage.

In this case, the combination of enthusiastic pressure cleaning and deteriorated paint have allowed water to penetrate the walls. This will mostly dry out over time un assisted.

Monitoring should be maintained to ensure mould or cracking does not occur.

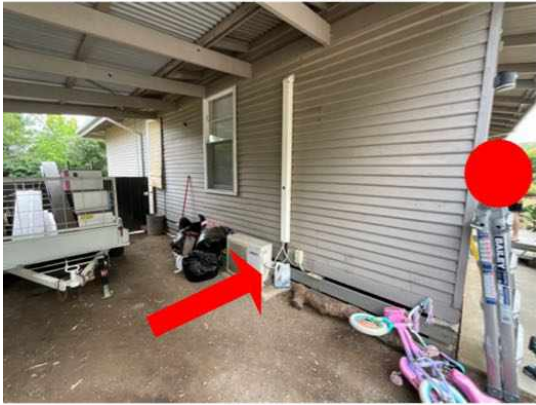
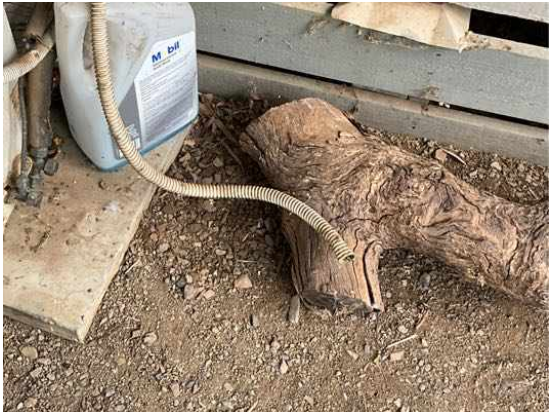
**Finding 6.03**

Building: Building 1  
Location: Carport  
Finding: Air conditioner - Disconnected overflow  
Information: The Air Conditioner (A/C) overflow was found to be disconnected from storm water drainage and is creating excessive moisture in the surrounding area.

Such leaking creates an environment which is conducive to an array of defects, including water damage to associated building elements and the attraction of termite or timber pest infestation.

It is highly recommended that a licensed plumber be appointed to connect the A/C

overflow in order to prevent such an environment from being created. These minor works should be carried out as soon as possible.

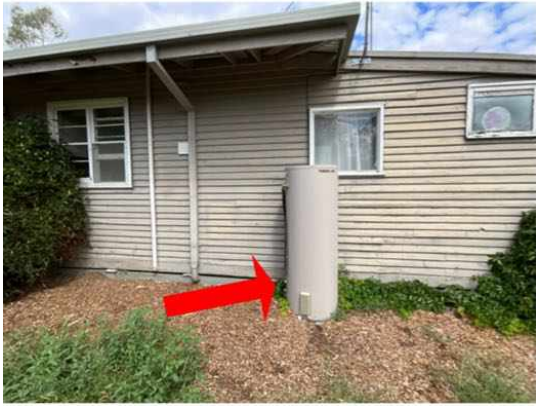
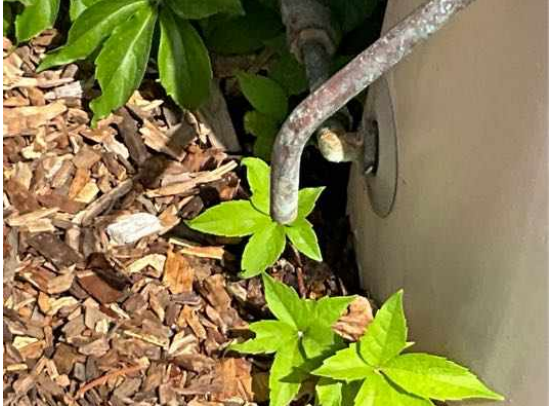
**Finding 6.04**

Building: Building 1  
 Location: Yard - Side  
 Finding: HWS Overflow - Not Connected  
 Information: The Hot Water System (HWS) overflow was found to be disconnected from storm water drainage and is creating excessive moisture in the surrounding area.

These damp conditions can lead to secondary defects such as rot, rust or corrosion of associated building elements, the formation of fungal decay, or even the creation of potential slip hazards. When coupled with poor site drainage, pooling of water may also attract termite activity to this area.

It is highly recommended that a licensed plumber be appointed to connect the HWS overflow in order to prevent such an environment from being created. These minor works should be carried out as soon as possible.

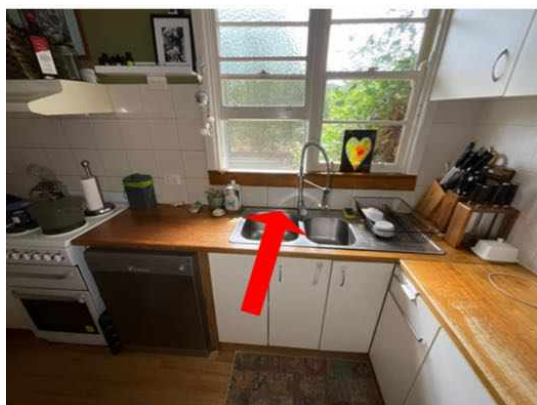
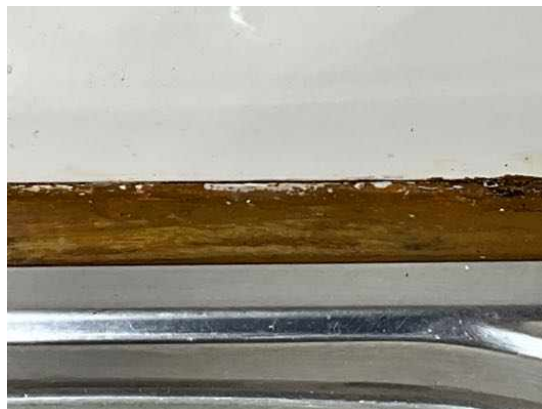
**Finding 6.05**

Location: Kitchen  
 Finding: Inadequate sealant or Grout  
 Information: This area has a lack of effective Sealant or Grout. This is allowing the ingress of water to the structure inside the wall.

The presence of water encourages Termite attack, Mould and Fungal Decay.

A Tiler or General Handy person must be contacted as soon as possible to effect repairs and prevent further deterioration.

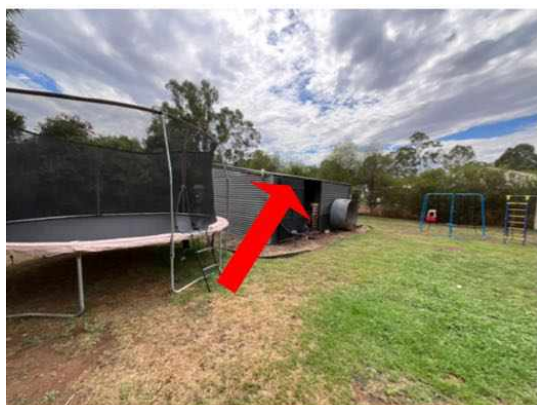
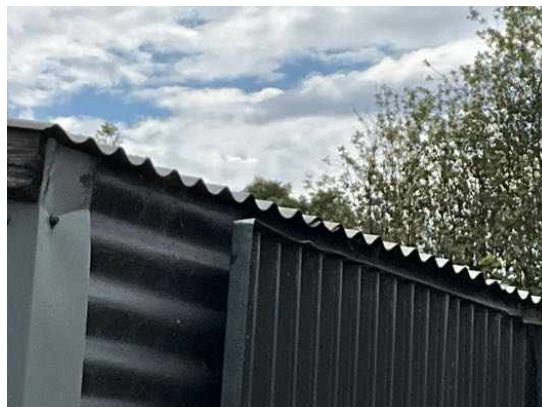
### Finding 6.06

Building: Building 1  
 Location: Shed  
 Finding: Guttering Missing  
 Information: The Guttering in this area was missing at the time of inspection. Guttering, Downpipes and Stormwater drainage are vital to protect the integrity of the structure and to prevent an environment conducive to Timber Pest attack.

A Plumber should be contacted as soon as possible to replace and connect to drainage the missing Guttering.

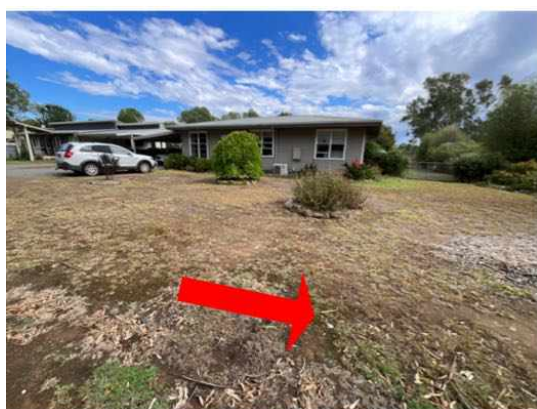
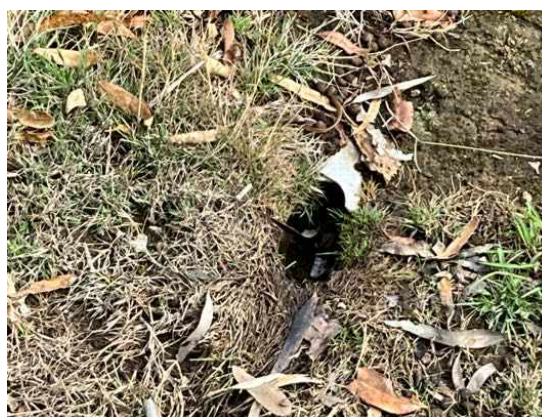
### Finding 6.07

Building:	Building 1
Location:	Yard - Front
Finding:	Stormwater drain - Not connected
Information:	The roof plumbing is not adequately connected to stormwater drainage on the site. This disconnection negatively impacts the functional capacity of the roof plumbing.

Where roof plumbing doesn't drain adequately, the area at the base perimeter can become excessively damp, potentially creating an environment that is susceptible to rust and corrosion of surrounding building elements, as well as attracting termites and other pests.

It is highly recommended that a plumber be appointed to further inspect the area and to install adequate drainage equipment where necessary.

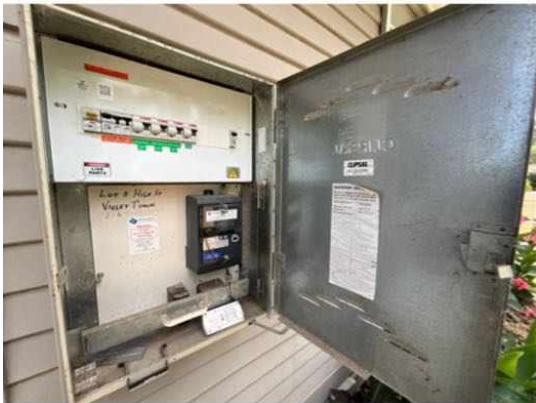
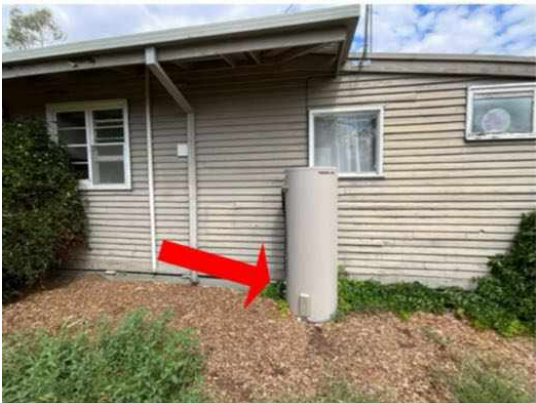
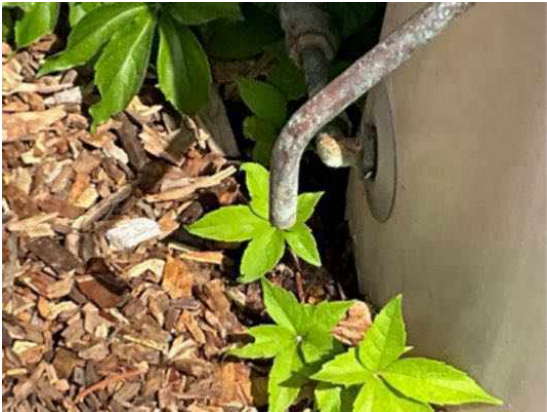
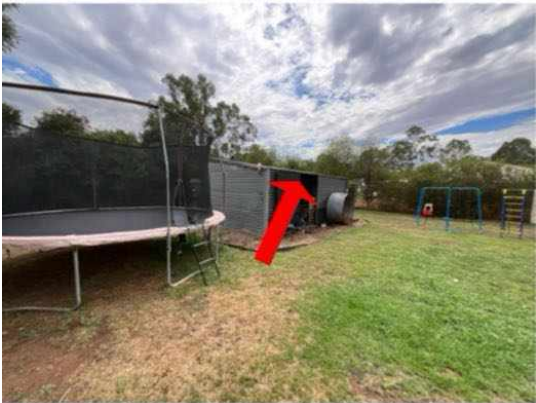
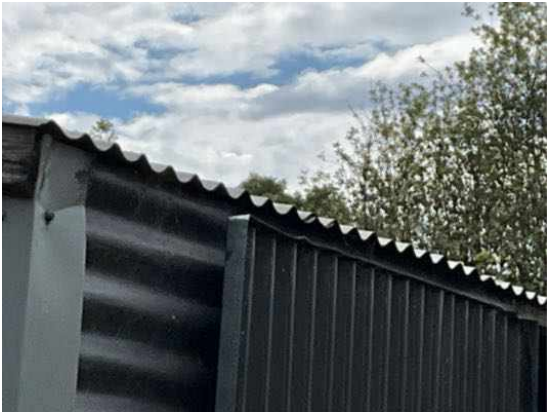
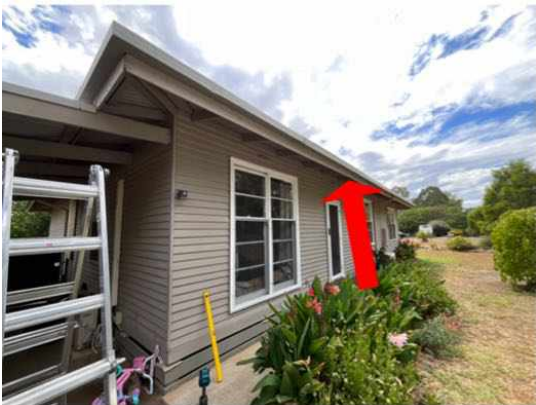
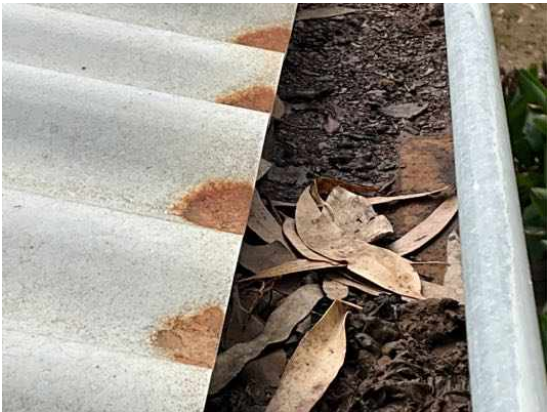
### Finding 6.08

Building:	Building 1
Location:	All External Areas
Finding:	Termite Management System - no evidence of a chemical installation
Information:	The application of a post-construction chemical termite barrier is highly recommended for all properties, particularly if live termite activity has been found on the site previously. Such barriers are highly effective in preventing termite attack on any timber building elements throughout the property.

A durable notice should be placed in the switchboard unit to indicate current termite barriers. At the time of inspection, it appeared as though no termite management system has been installed, with no evidence to suggest preventative works taking place.

The client may consider gaining further advice from a pest controller as to the costs and procedures involved with this application. It is recommended that obtaining such advice be a short-term priority.

There is no evidence of previous Termite Management services. The property has factors that are conducive to Termite attack. A Licensed Pest controller should be contacted soon to advise on a Termite Management Plan and avoid potentially costly repairs.

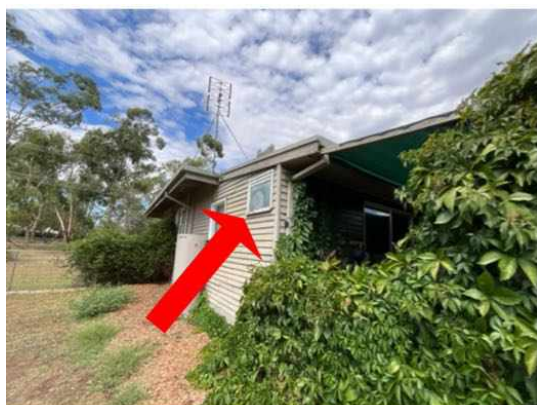
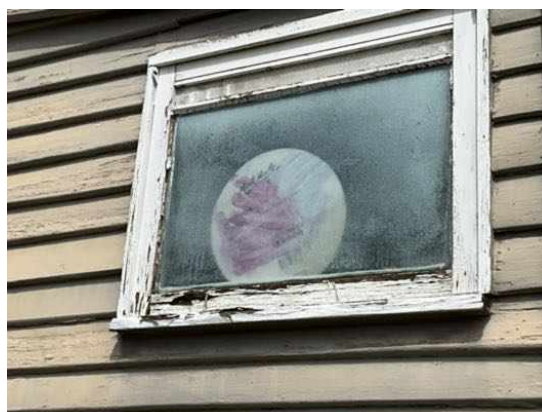
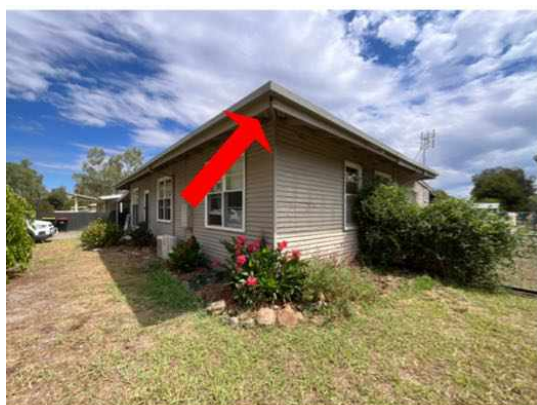
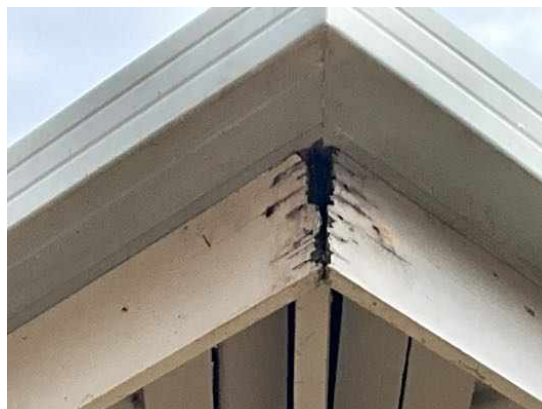
### Finding 7.01

Building:	Building 1
Location:	Laundry, eaves
Finding:	Fungal decay - present (localised)
Information:	Fungal decay also known as wood decay or wood rot generally refers to the deterioration of timber elements when in contact with excessive levels of moisture for a prolonged period of time.

The development of fungal decay is accelerated by temperatures in the range of 5degreeC to 40degreeC as well as the presence of oxygen. Generally fungal decay develops on timber elements that are in use in an external environment which are exposed to rain penetration.

In this case although the affected timber element is in a decaying state the extent of any visible damage appears to be localised to a specific area and is yet to spread to other parts of the building element or affect adjoining structures. The fungal decay is therefore likely to be of a relatively superficial nature with minimal impact on the structural integrity or tensile strength of the timber element.

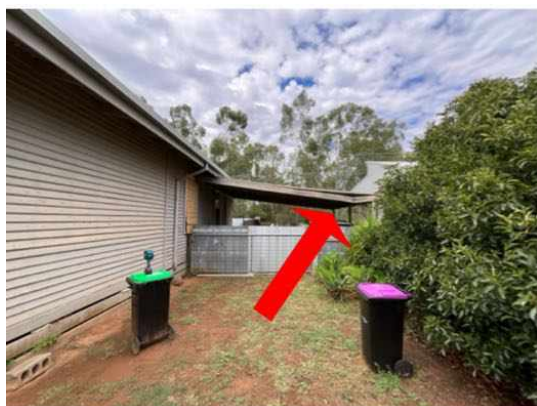
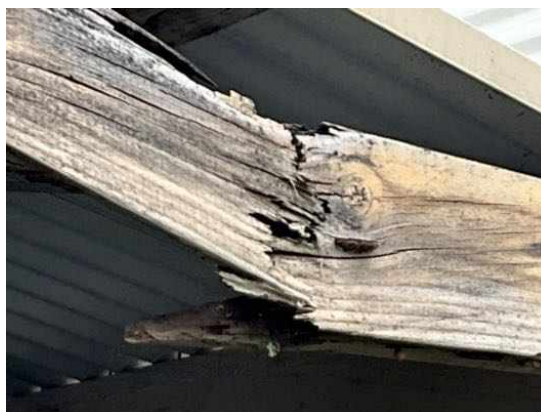
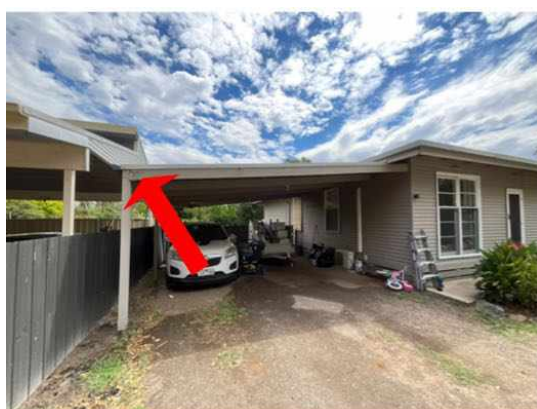
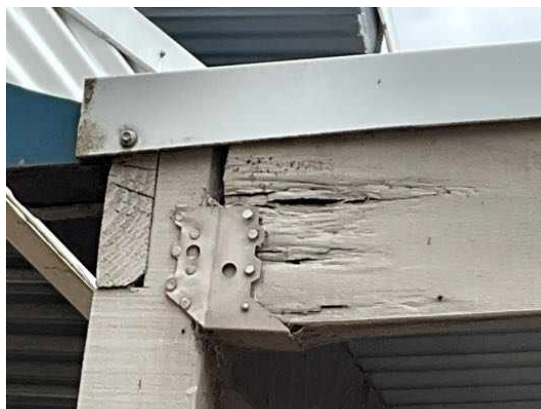
### Finding 7.02

Building:	Building 1
Location:	Carport
Finding:	Fungal decay - present (widespread)
Information:	Fungal decay is also known as wood decay or wood rot generally refers to the deterioration of timber elements when in contact with excessive levels of moisture for a prolonged period of time.

The development of fungal decay is accelerated by temperatures in the range of 5degreeC to 40degreeC as well as the presence of oxygen. Generally fungal decay develops on timber elements that are in use in an external environment which are exposed to rain penetration.

In this case, fungal decay appears to have become widespread and is likely to have affected any adjoining timber elements/structures. The widespread development of fungal decay is likely to have heavily impacted the structural integrity and tensile strength of the affected timber elements and the associated structure.

Timbers affected by widespread fungal decay should be replaced immediately. The cause of the moisture that has led to the development of such decay should also be identified and dealt with in an appropriate manner.

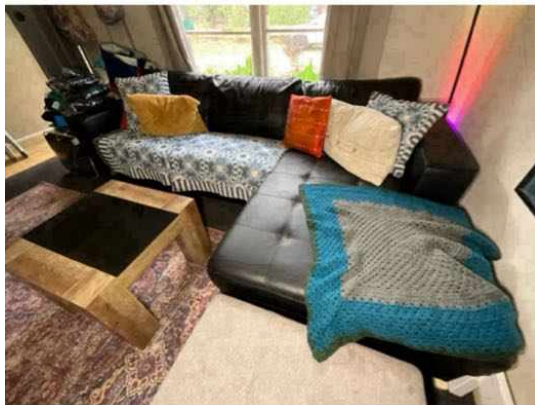
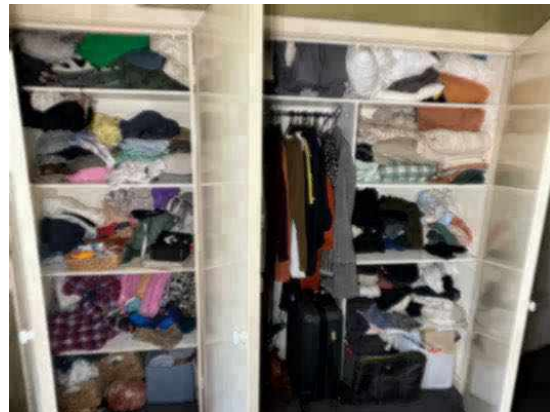
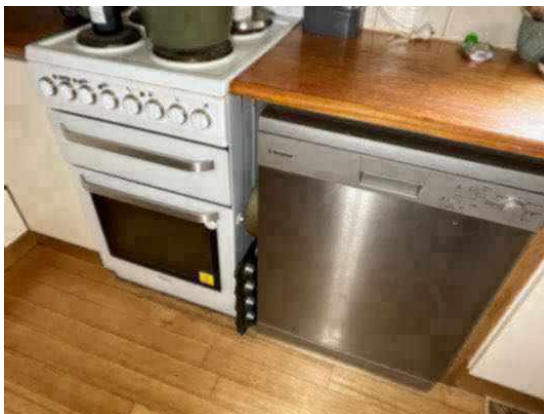
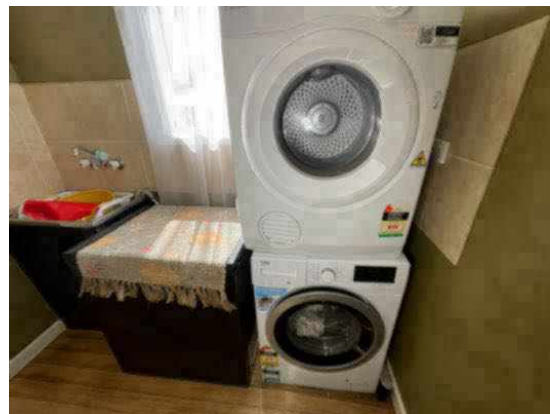
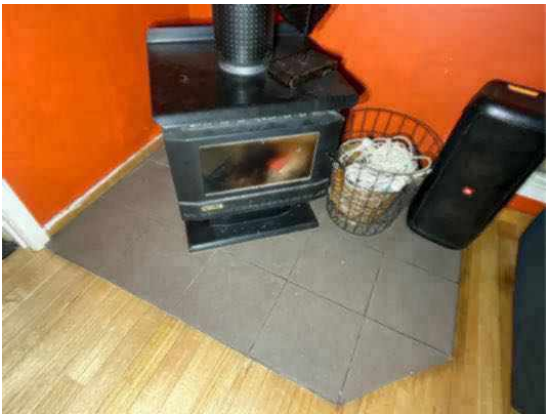
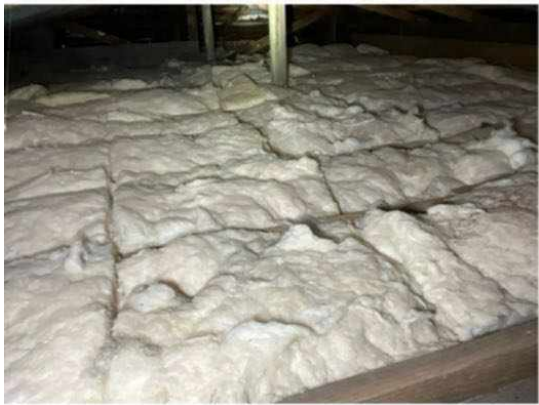
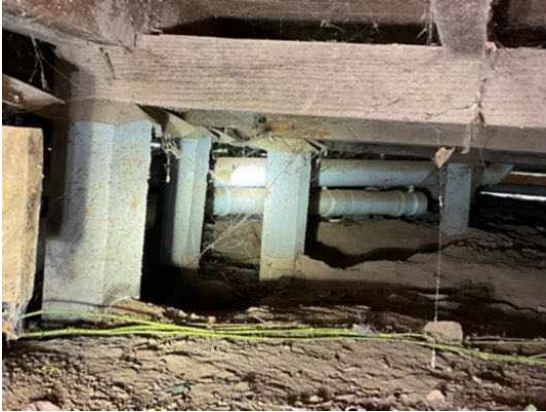
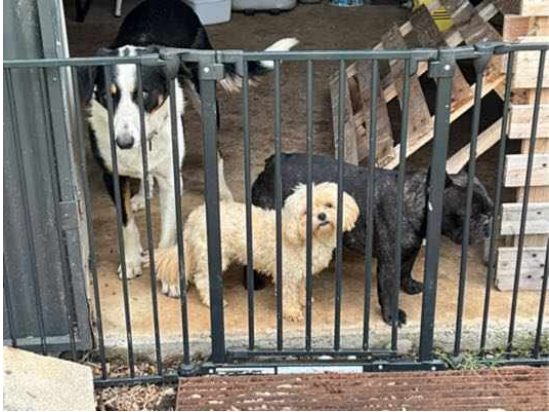
Building: Building 1  
Location: All Areas  
Finding: Additional Photos - Obstructions and Limitations  
Information: These photographs are an indication of the obstructions and limitations which impeded full inspection of the property at the time of inspection. These obstructions can hide an array of defects and should be removed to allow full inspection to be carried out. A re-inspection is recommended once the areas are made accessible.
